Memorandum

Subject: THP No. 1-03-173 SCR
Hydrologic Review

This memorandum reports the results of a field inspection of THP No. 1-03-173 SCR held on March 11, 2004. This was a focused Pre-Harvest Inspection (PHI) inspection that followed two previous PHIs and took place prior to the CDF Second Review of the THP. It is limited to comments regarding the Class II watercourse protection zone. Specifically, I was asked to help evaluate if the trees marked in the Class II WLPZ were in the channel zone as defined by the California Forest Practice Rules, and to determine if the mark in the Class II was appropriate based on watershed processes such as large wood recruitment and bank stability. Participants for the field inspection held on March 11, 2004 included:

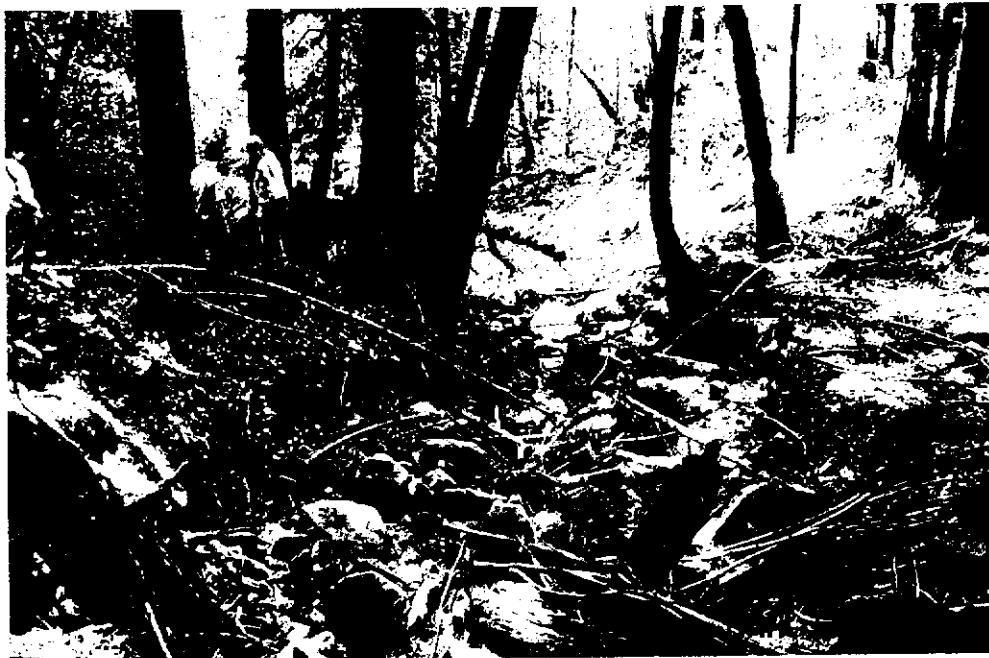
Figure 2. Pre-Harvest Inspection team examining the Class II watercourse channel and WLPZ mark. Note boulders, small wood, and limited large wood in the channel.

The channel is incised and well confined by the valley walls, and is a transport reach for sediment due to its steep gradient (Figure 2). For much of the channel, large pieces of wood were scarce. Some areas had small pieces present, sometimes forming organic debris steps, and one large madrone tree appears to have entered the channel in the past 2-5 years (Figure 3). The channel base level along this reach is controlled by boulder accumulations. Therefore, large wood is not needed here to prevent downcutting and overall channel lowering. Large wood will have little influence on channel form from this fluvial geomorphic perspective.

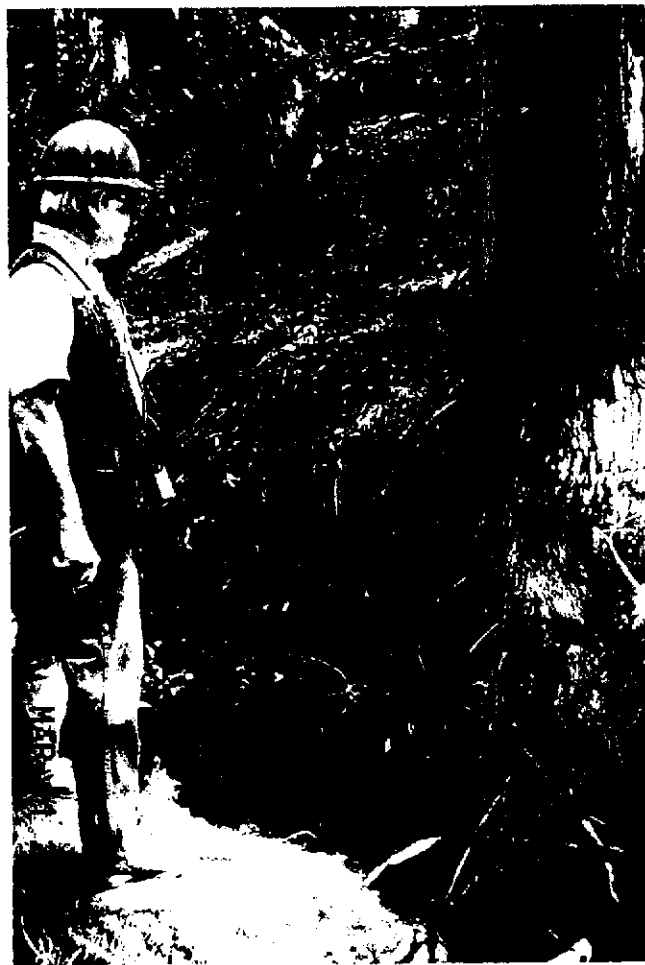
Figure 4. Mr. Twight standing next to a redwood tree that was determined to be within the channel zone.

We encountered several trees that were immediately next to the incised channel that did qualify as channel zone trees and had not been marked (Figure 4). We found the FPR rule for confined channels related to the channel zone hard to apply in many instances, however, due to the inability to determine clearly where the bole of the tree ends and the roots and/or root ball begins. Based on discussions held during the previous PHIs for this THP, four trees/tree areas where marking had occurred were identified as questionable regarding the channel zone FPR interpretation. We reinvestigated these areas during this focused PHI.

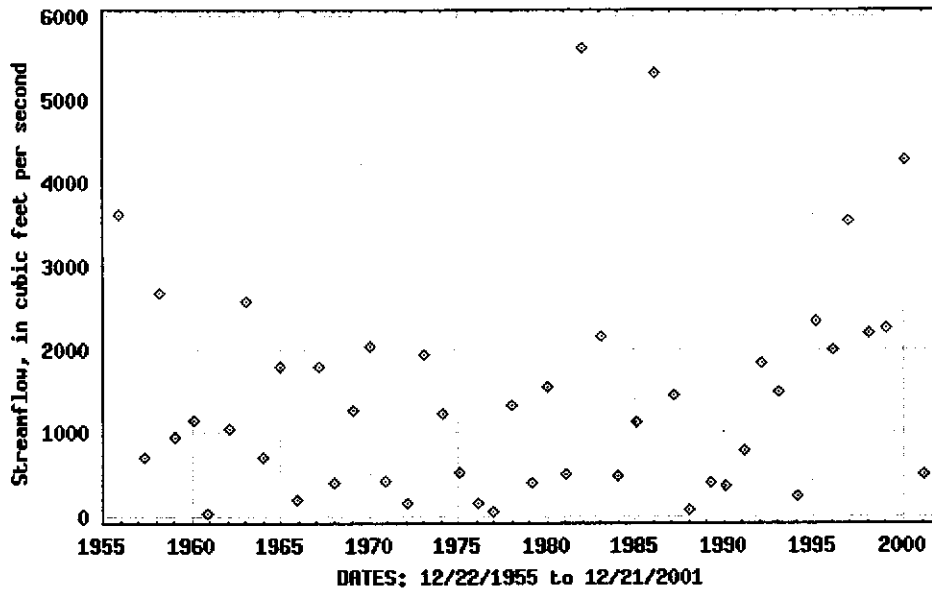
USGS 11159200 CORRALITOS C A FREEDOM CA

Figure 5. Annual peak discharges for the Corralitos Creek at Freedom USGS gaging station

At tree site 1, where we began our field observations, we estimated that the elevation of the water of a riffle area would be approximately 12 to 14 inches higher than the depth currently present, and two times this depth would be 24 to 26 inches above the existing water elevation. The marked redwood tree (approximately 30 inches at dbh) was found to be considerably higher than this on the hillslope. Therefore, we concluded that this tree was not in the channel zone. No sediment marks were observed on the tree from past flood events. Four floods of 20 year recurrence interval or higher have occurred in the Corralitos Creek drainage since 1982 (see Figures 5 and 6, and the following discussion section).¹

Recurrence intervals for flood events can be determined relatively easily for USGS gaging stations through the use of PEAKFQ, a USGS produced computer software program available online that performs a flood-frequency analysis based on Bulletin 17B, which is the accepted methodology published by the Interagency Advisory Committee on Water Data. It is available from the USGS website at: <http://water.usgs.gov/software/peakfq.html>. The USGS gaging station for Corralitos Creek at Freedom was used to determine recurrence intervals for recent flood events in this drainage (see Figures 5 and 6).² Using the USGS PEAKFQ software program and its output for this station, I determined the following approximate return intervals: 1982 -- 70 yrs; 1986--55 yrs; 1997--20 yrs; and 2000--30 yrs.

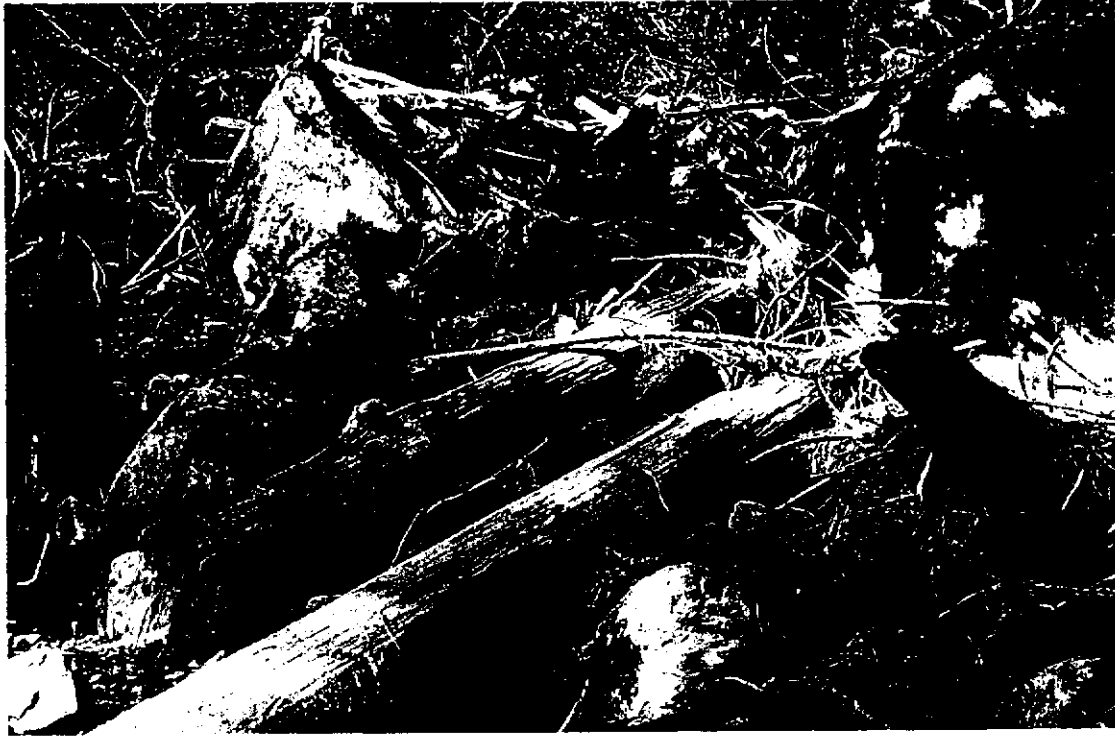
Figure 9. Debris jam area where abundant large wood was observed, located in the lower reach along the THP boundary. Large wood pieces appear to be mostly related to past old-growth logging activities. Some coarse bedload sediment is being retained by this debris jam feature.

Based on our rapid field reconnaissance, the dominant input mechanisms for large wood over the past 100-200 years in this part of the Pryce Fork channel have been landsliding and past old-growth logging activities. Bank erosion and mortality/windthrow appear to be much less important processes. While a comprehensive inventory of large wood in the channel was not undertaken, it was clear that greater than 50 percent of the pieces of wood of significant size currently in the channel are the result of past historic logging activities (Figure 9). It is my opinion that the selective mark required in Santa Cruz County THPs, as well as the conifers retained in the WLPZ, will supply abundant large wood when large landslide events occur in this drainage.
