Cambria Enforcement Items

Administrative Civil Liability Complaint

Item # 9 R3-2017-0015

Item # 10 Cease and Desist Order R3-2017-0016

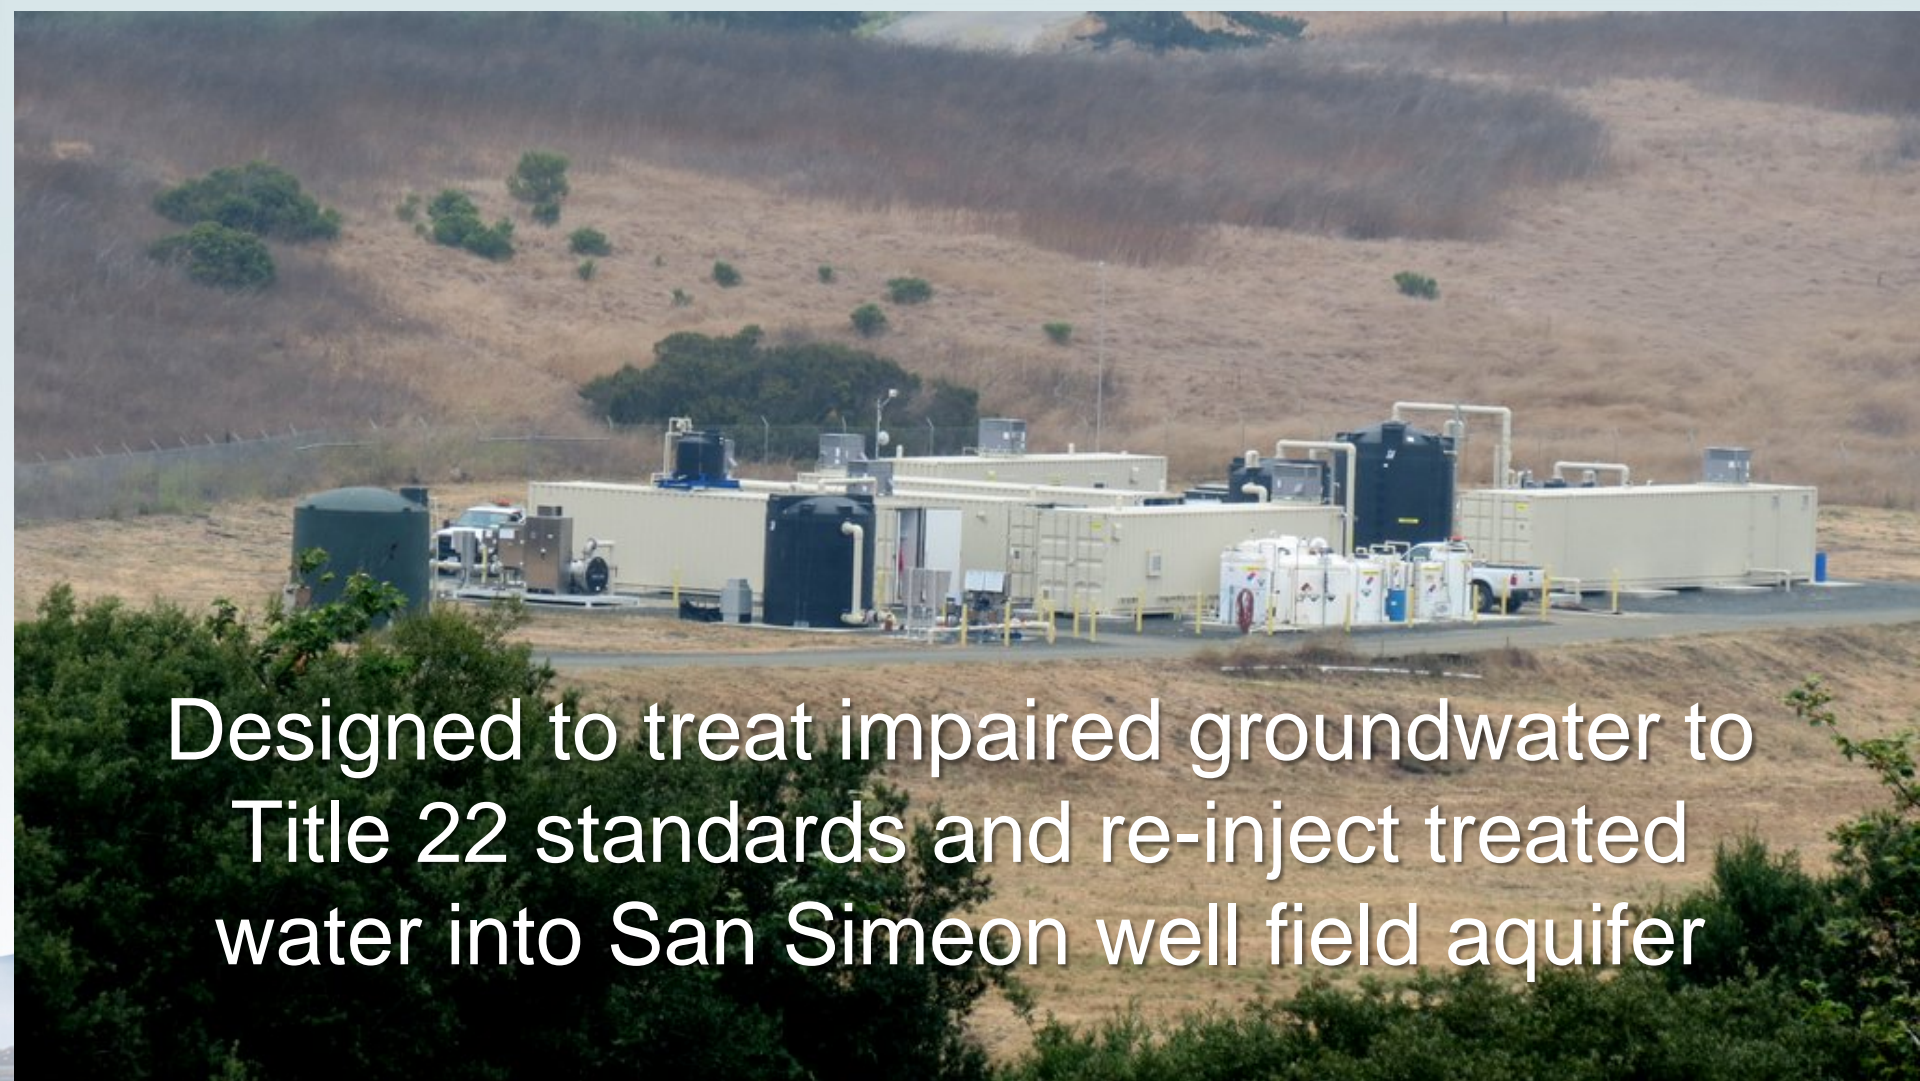
Advanced Treatment System

Designed to treat impaired groundwater to Title 22 standards and re-inject treated water into San Simeon well field aquifer

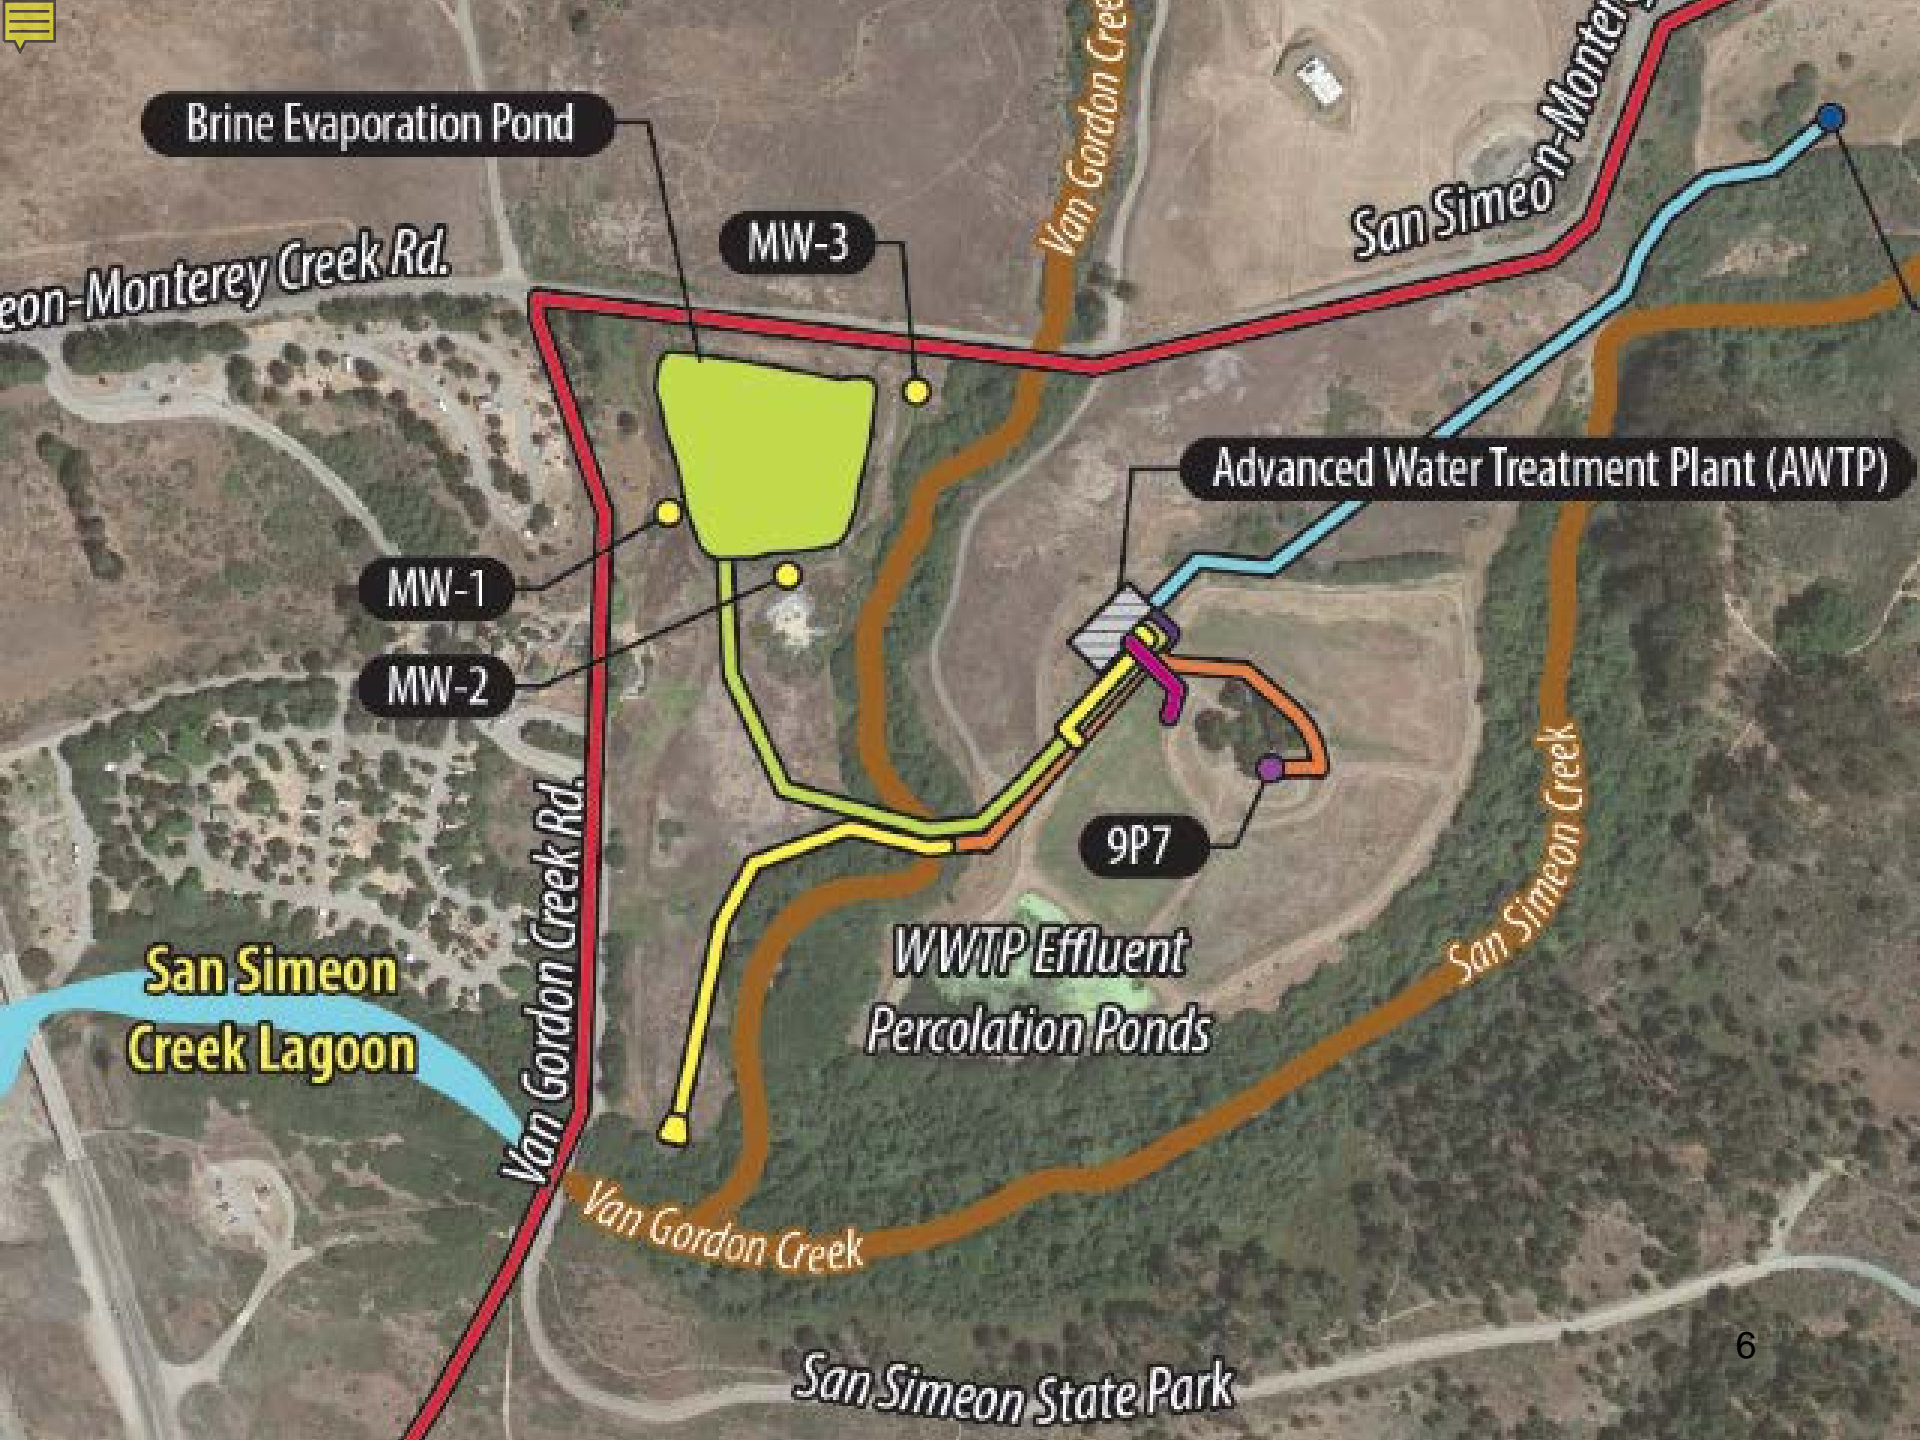
Brine Evaporation Pond

Advanced Water Treatment Plant (AWTP)

WWTP Effluent Percolation Ponds

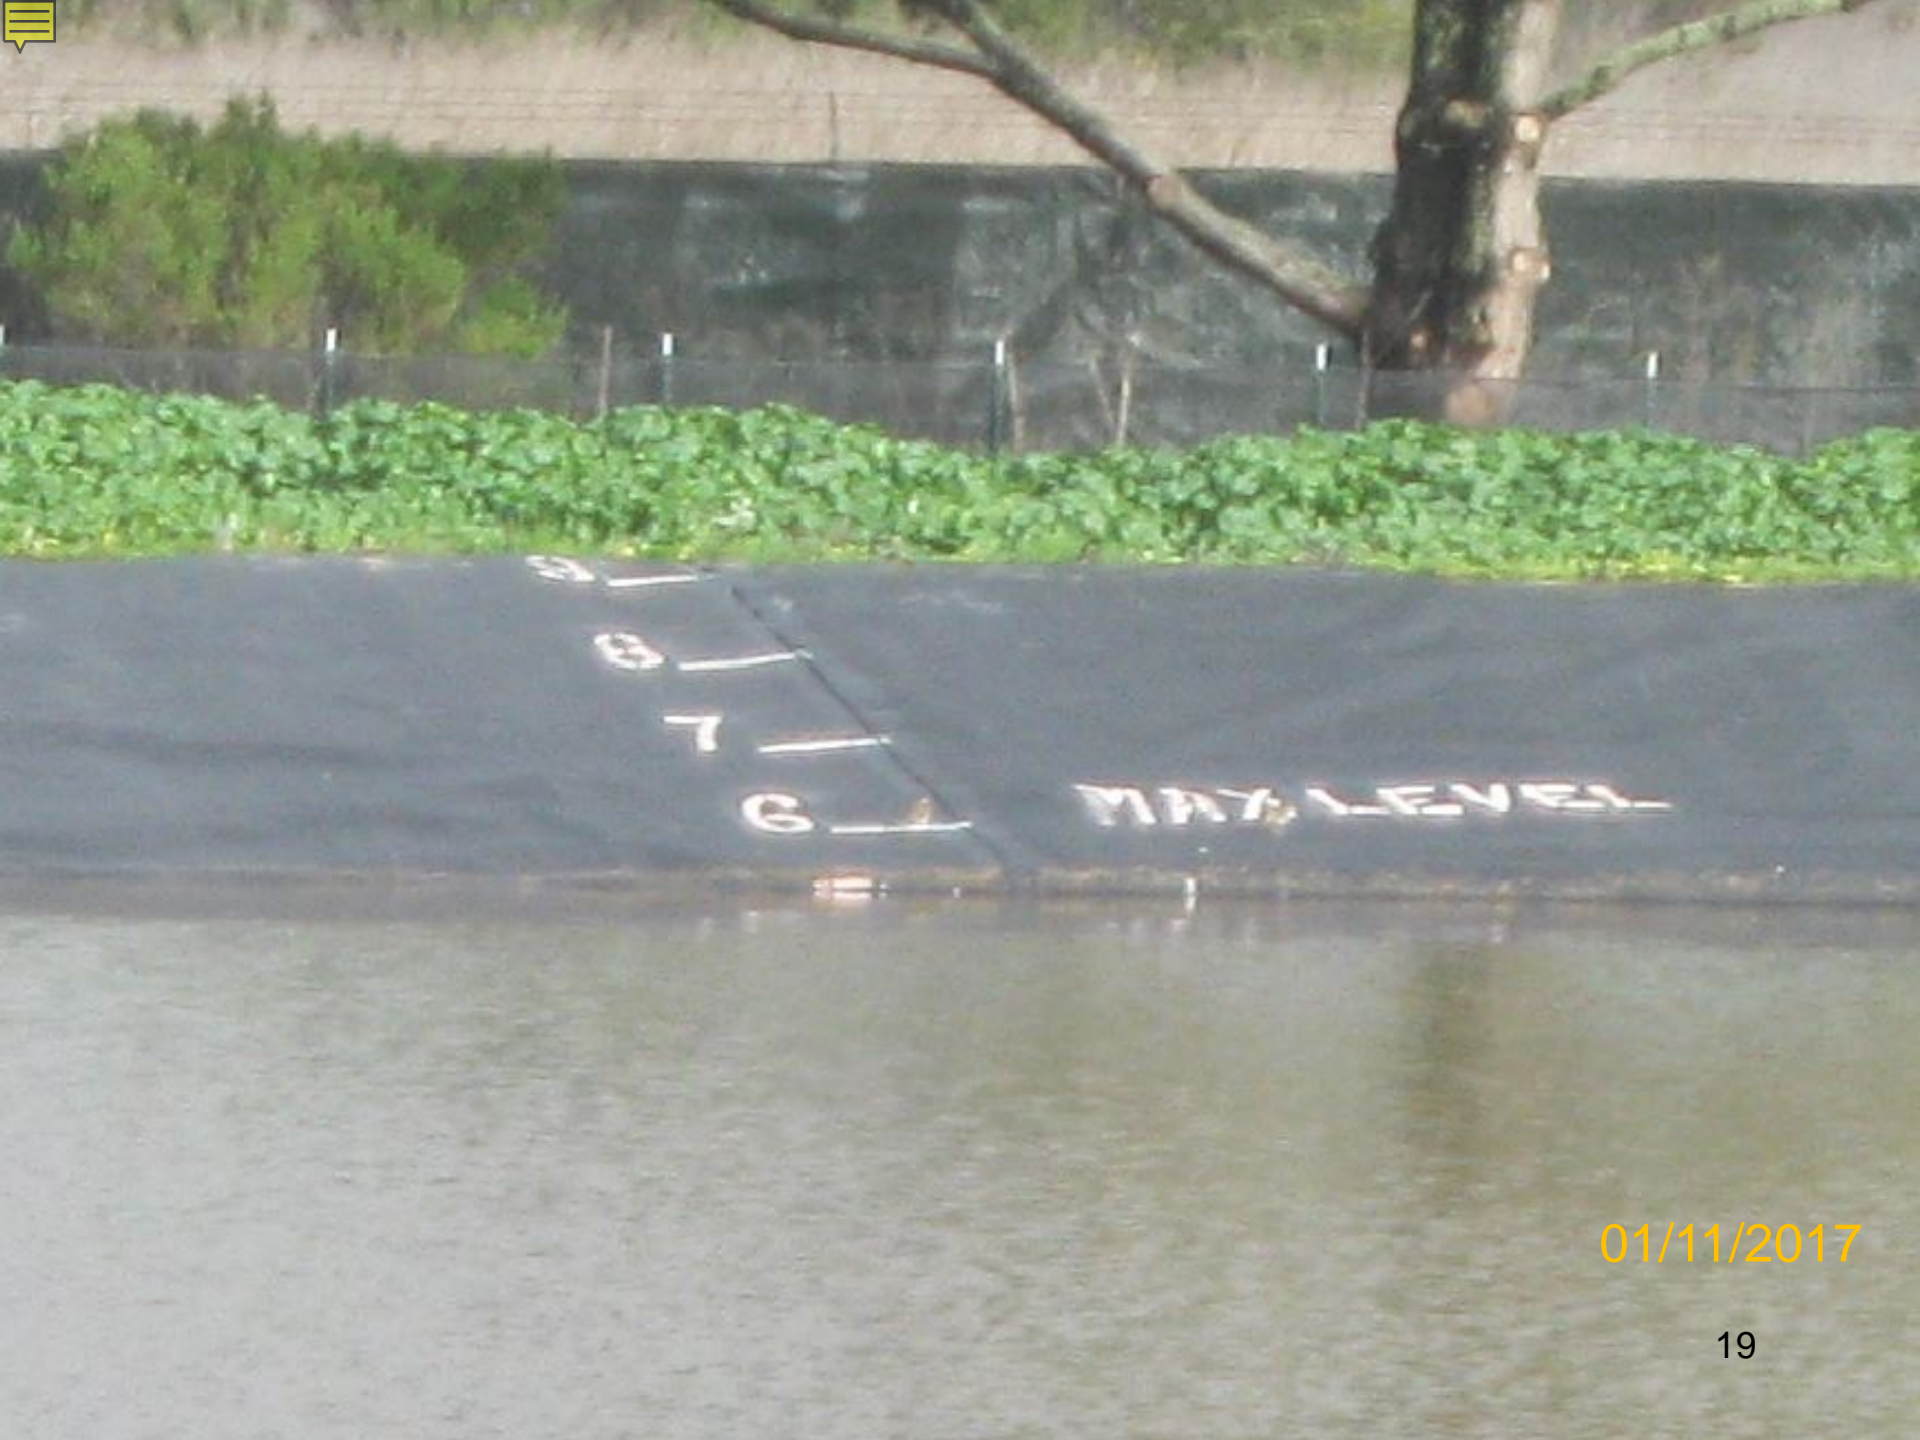
01/11/2017

- **Applies to Surface Impoundment Only**
- **Two Major Design Flaws Identified During January Storms**
- **Flooding Began on January 8, 2017**
 - **Flooding reported to Water Board on January 9, 2017**
 - **Flooding not reported by CCSD until January 11, 2017**

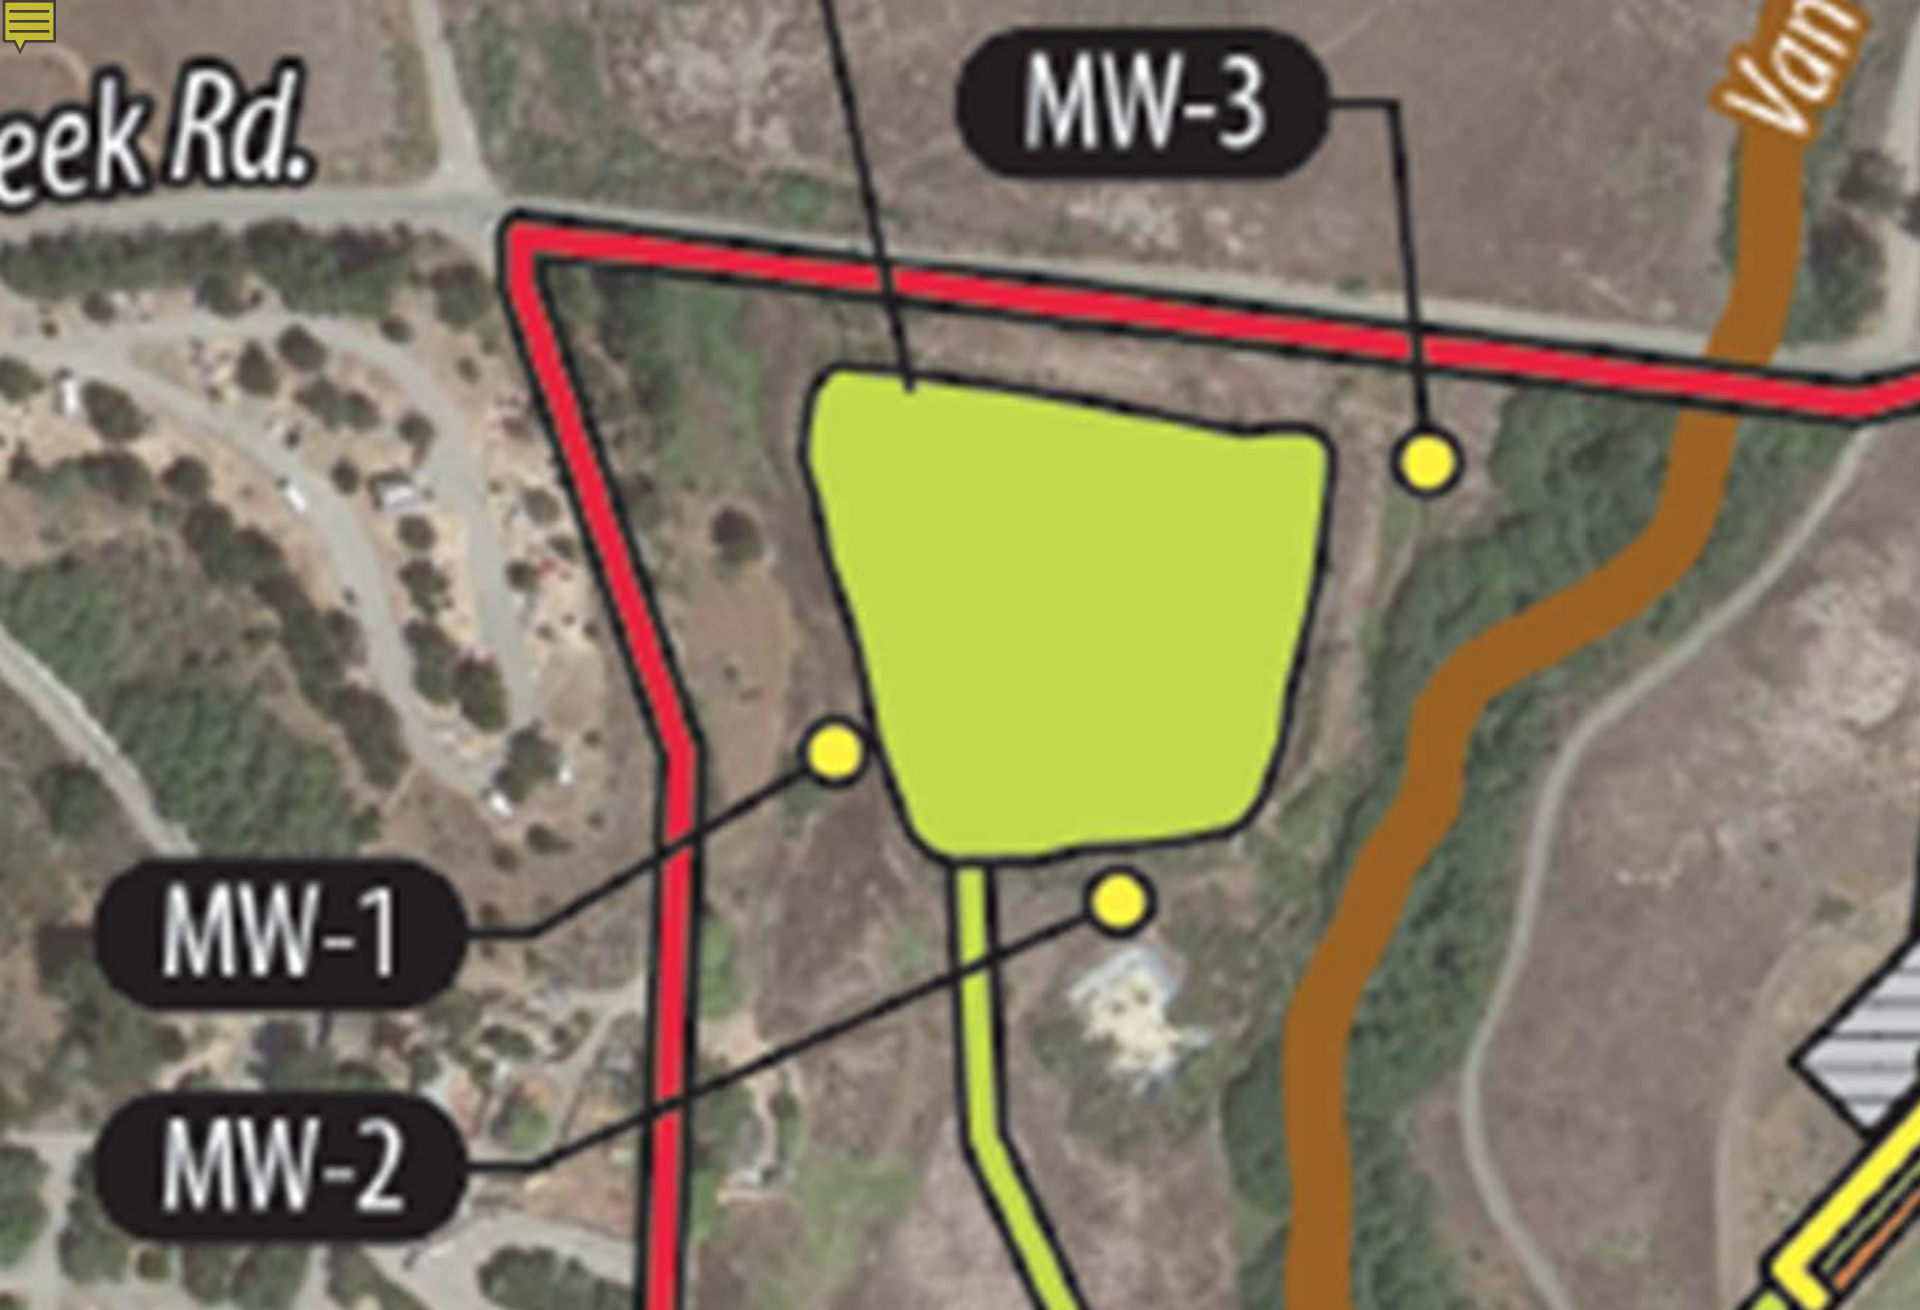
Surface Impoundment Liner System

- **Liquid in the Vadose Zone Monitoring System (VZMS)**
 - **Water detected in VZMS on January 24 through March 7, 2017**

The presence of liquid in the VZMS means either:

- 1) The liner is leaking; or**
- 2) Groundwater has infiltrated into VZMS**

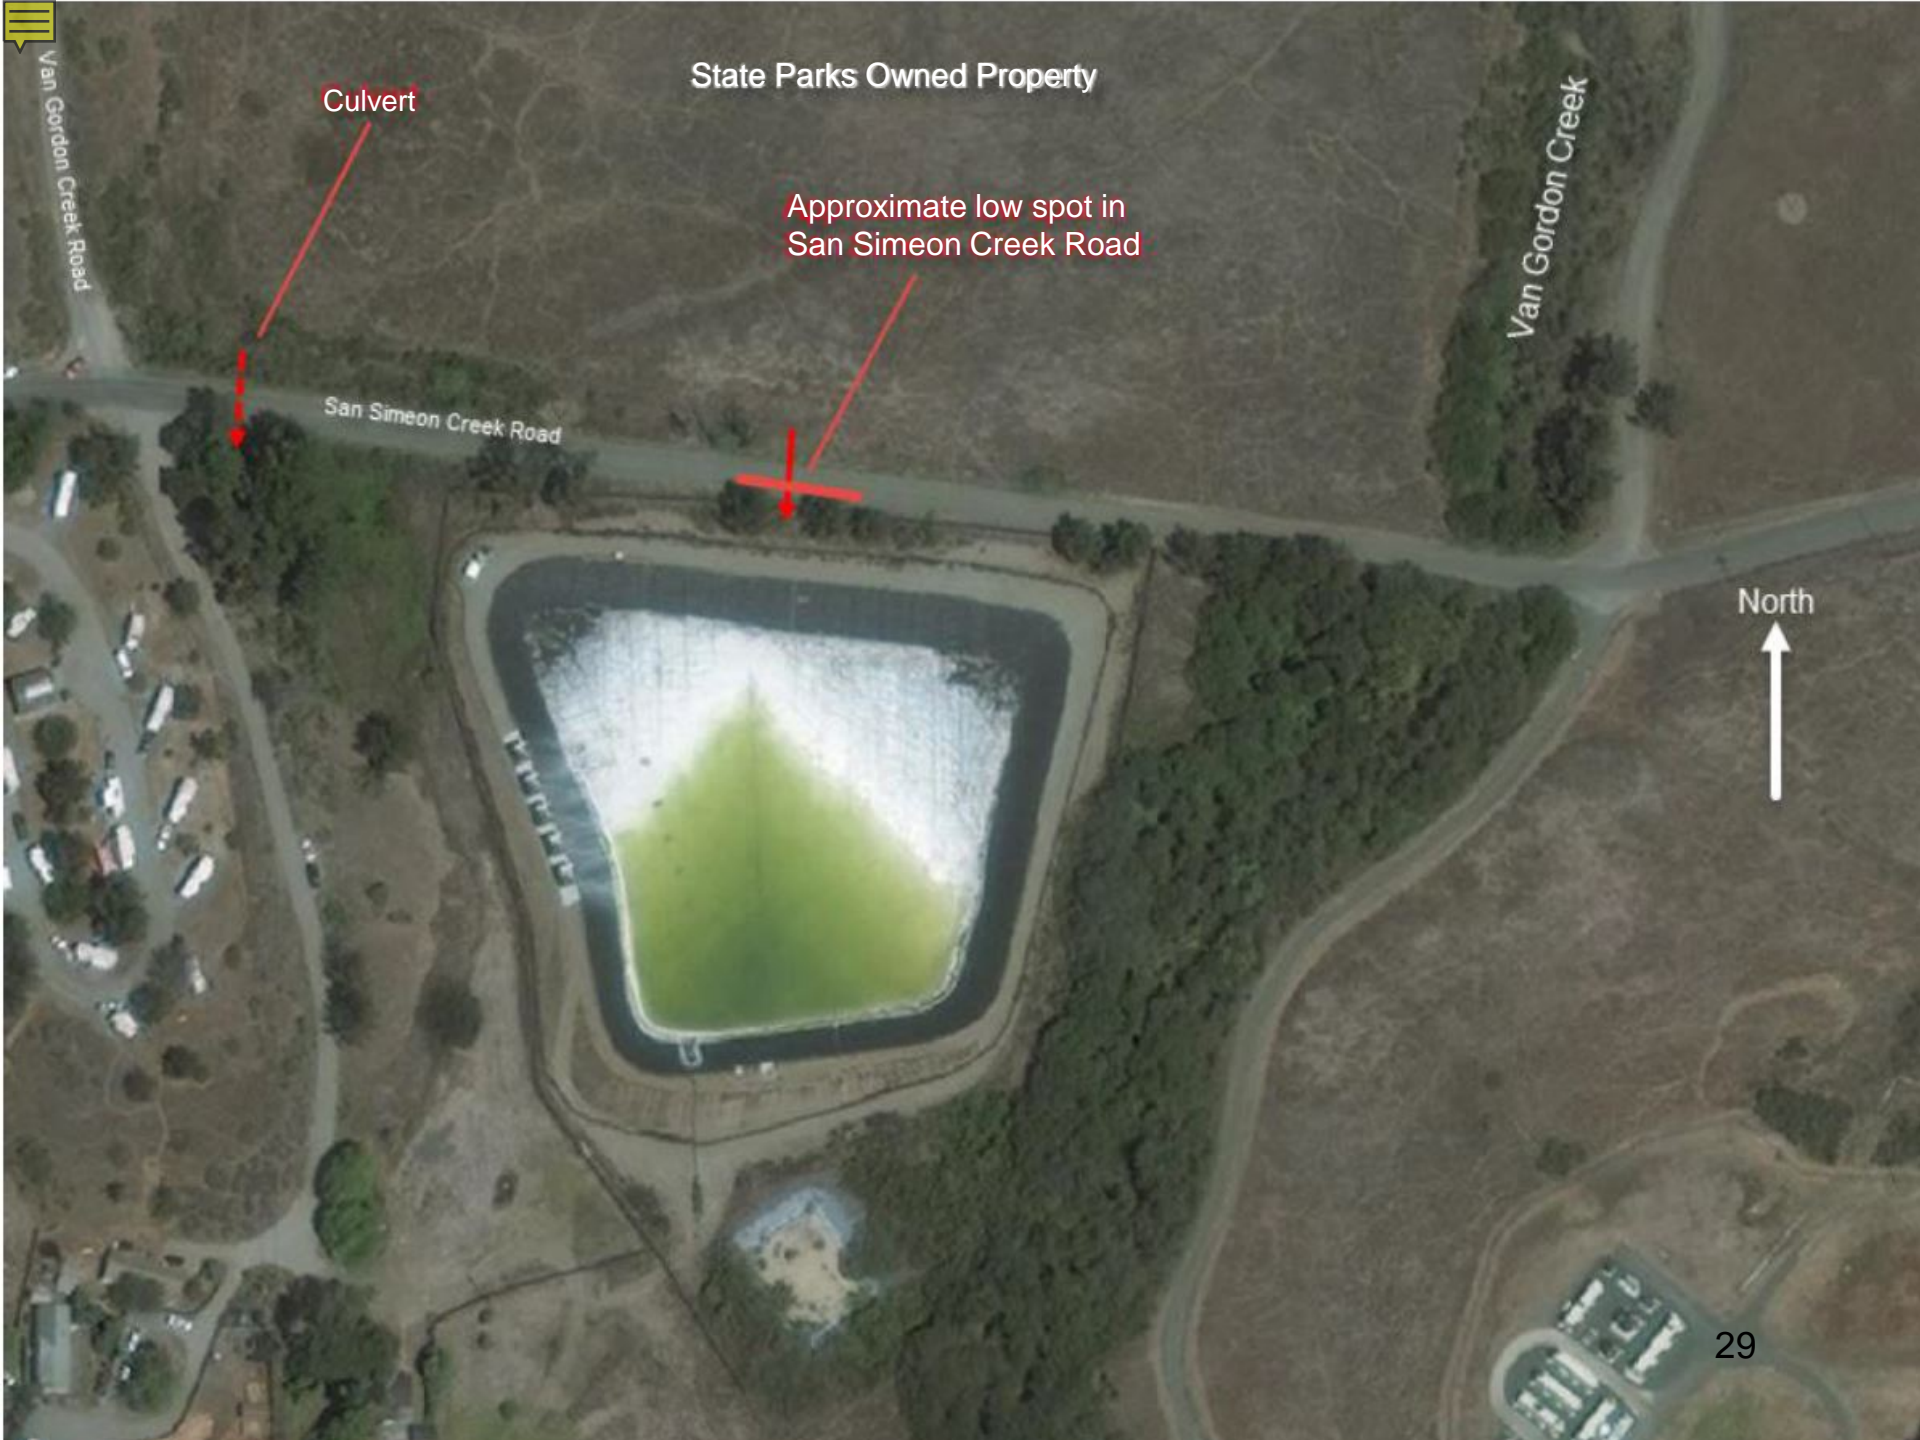
- **Surface Impoundment designed to contain a 1,000-year 24-hour storm event**
 - **Exceeded minimum freeboard on February 5, 2017 (34.2 inches required)**
 - **Design Report states:**
 - “...there is no anticipated stormwater flow into the evaporation pond.”

Culvert

Approximate low spot in San Simeon Creek Road

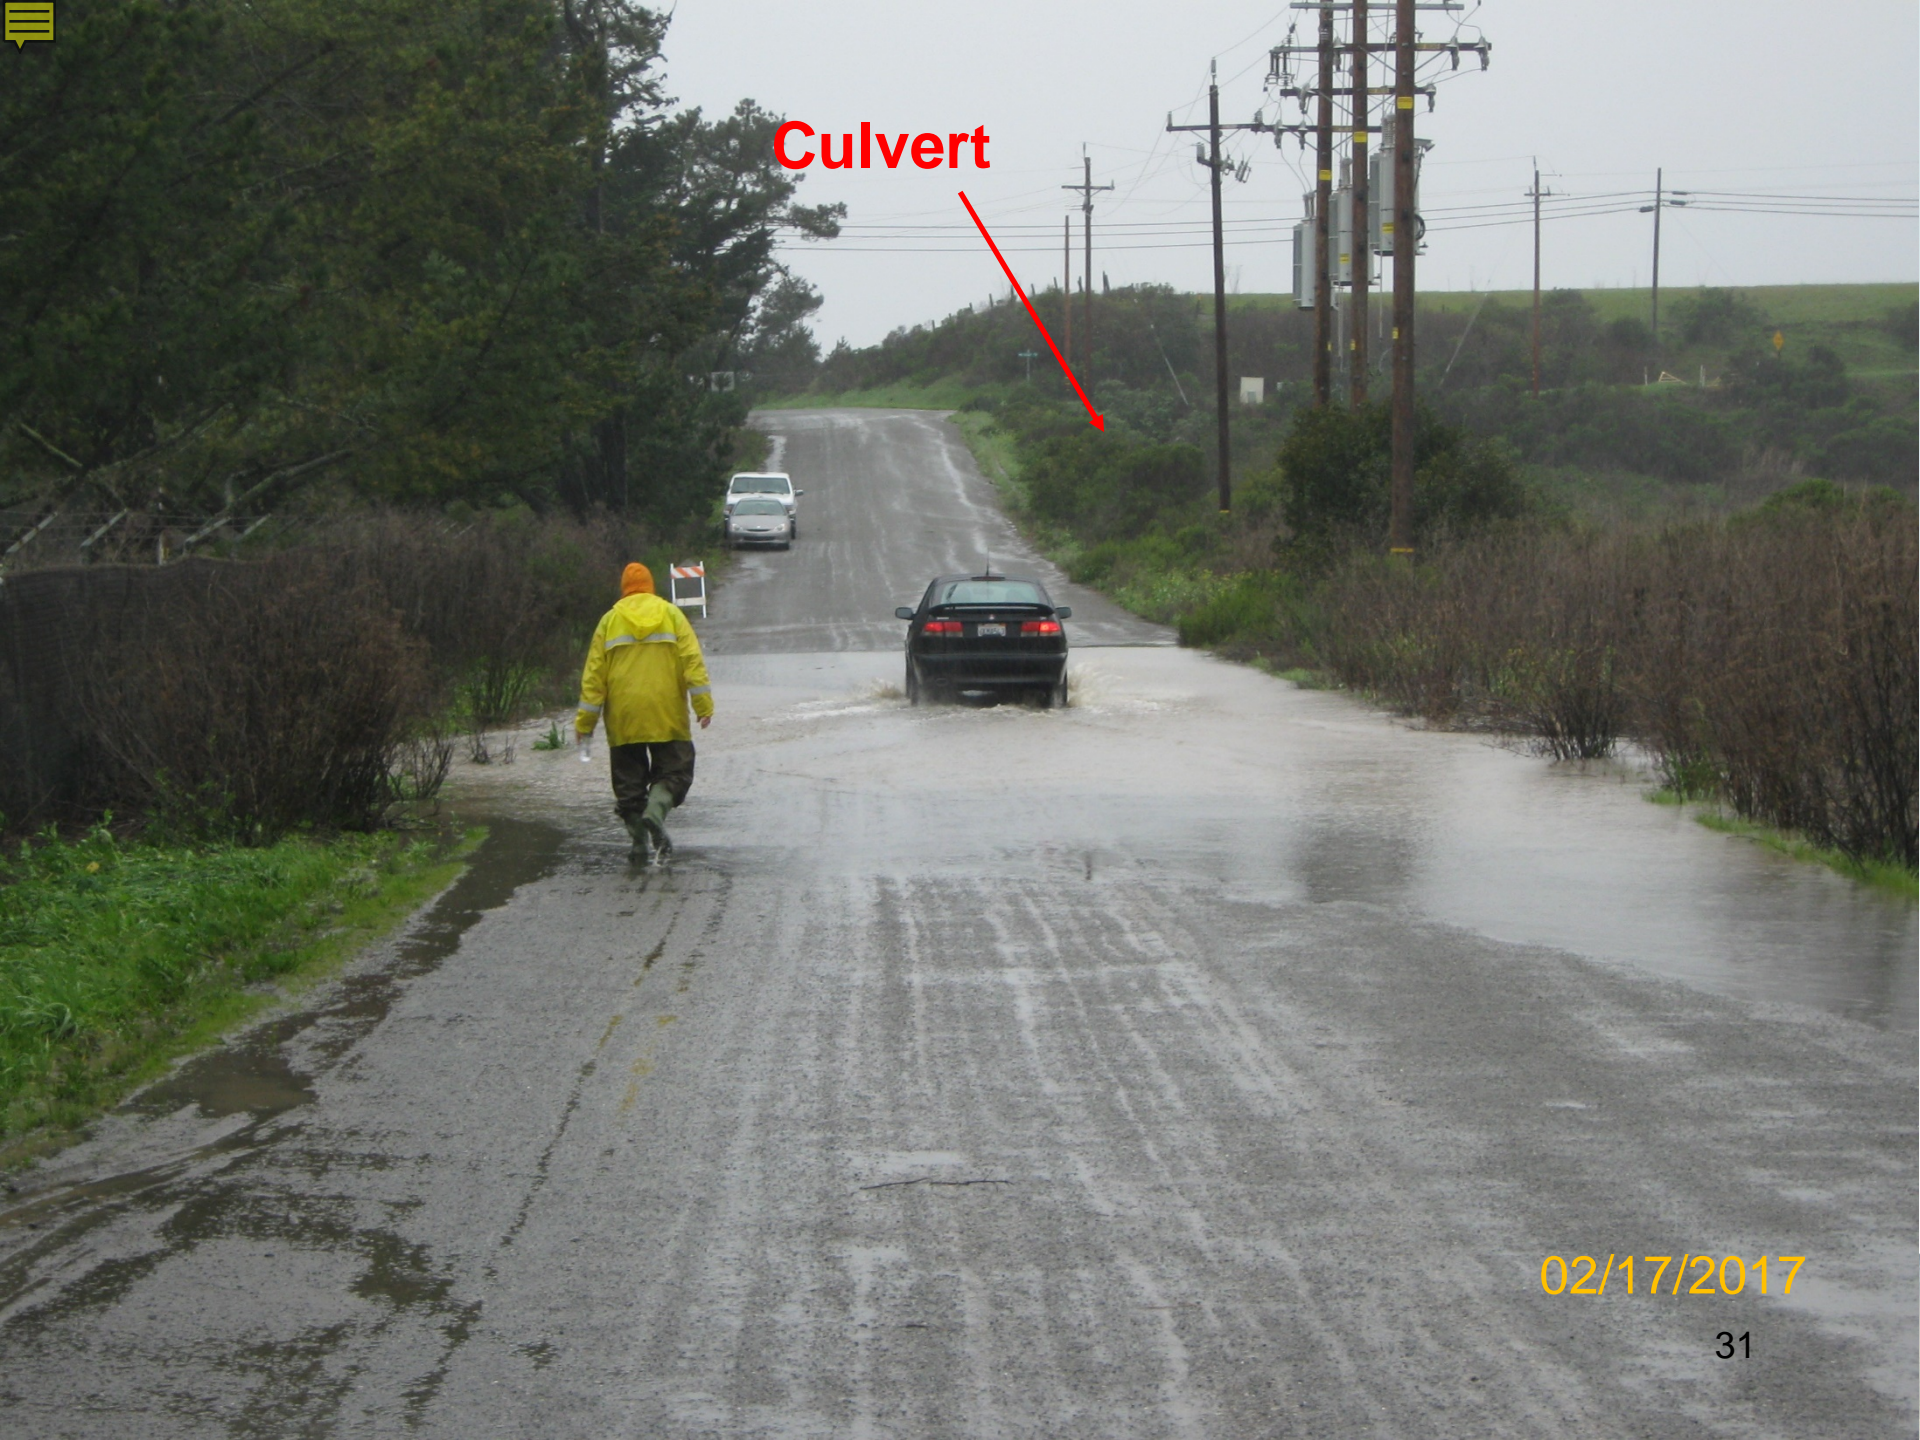
02/17/2017

Culvert

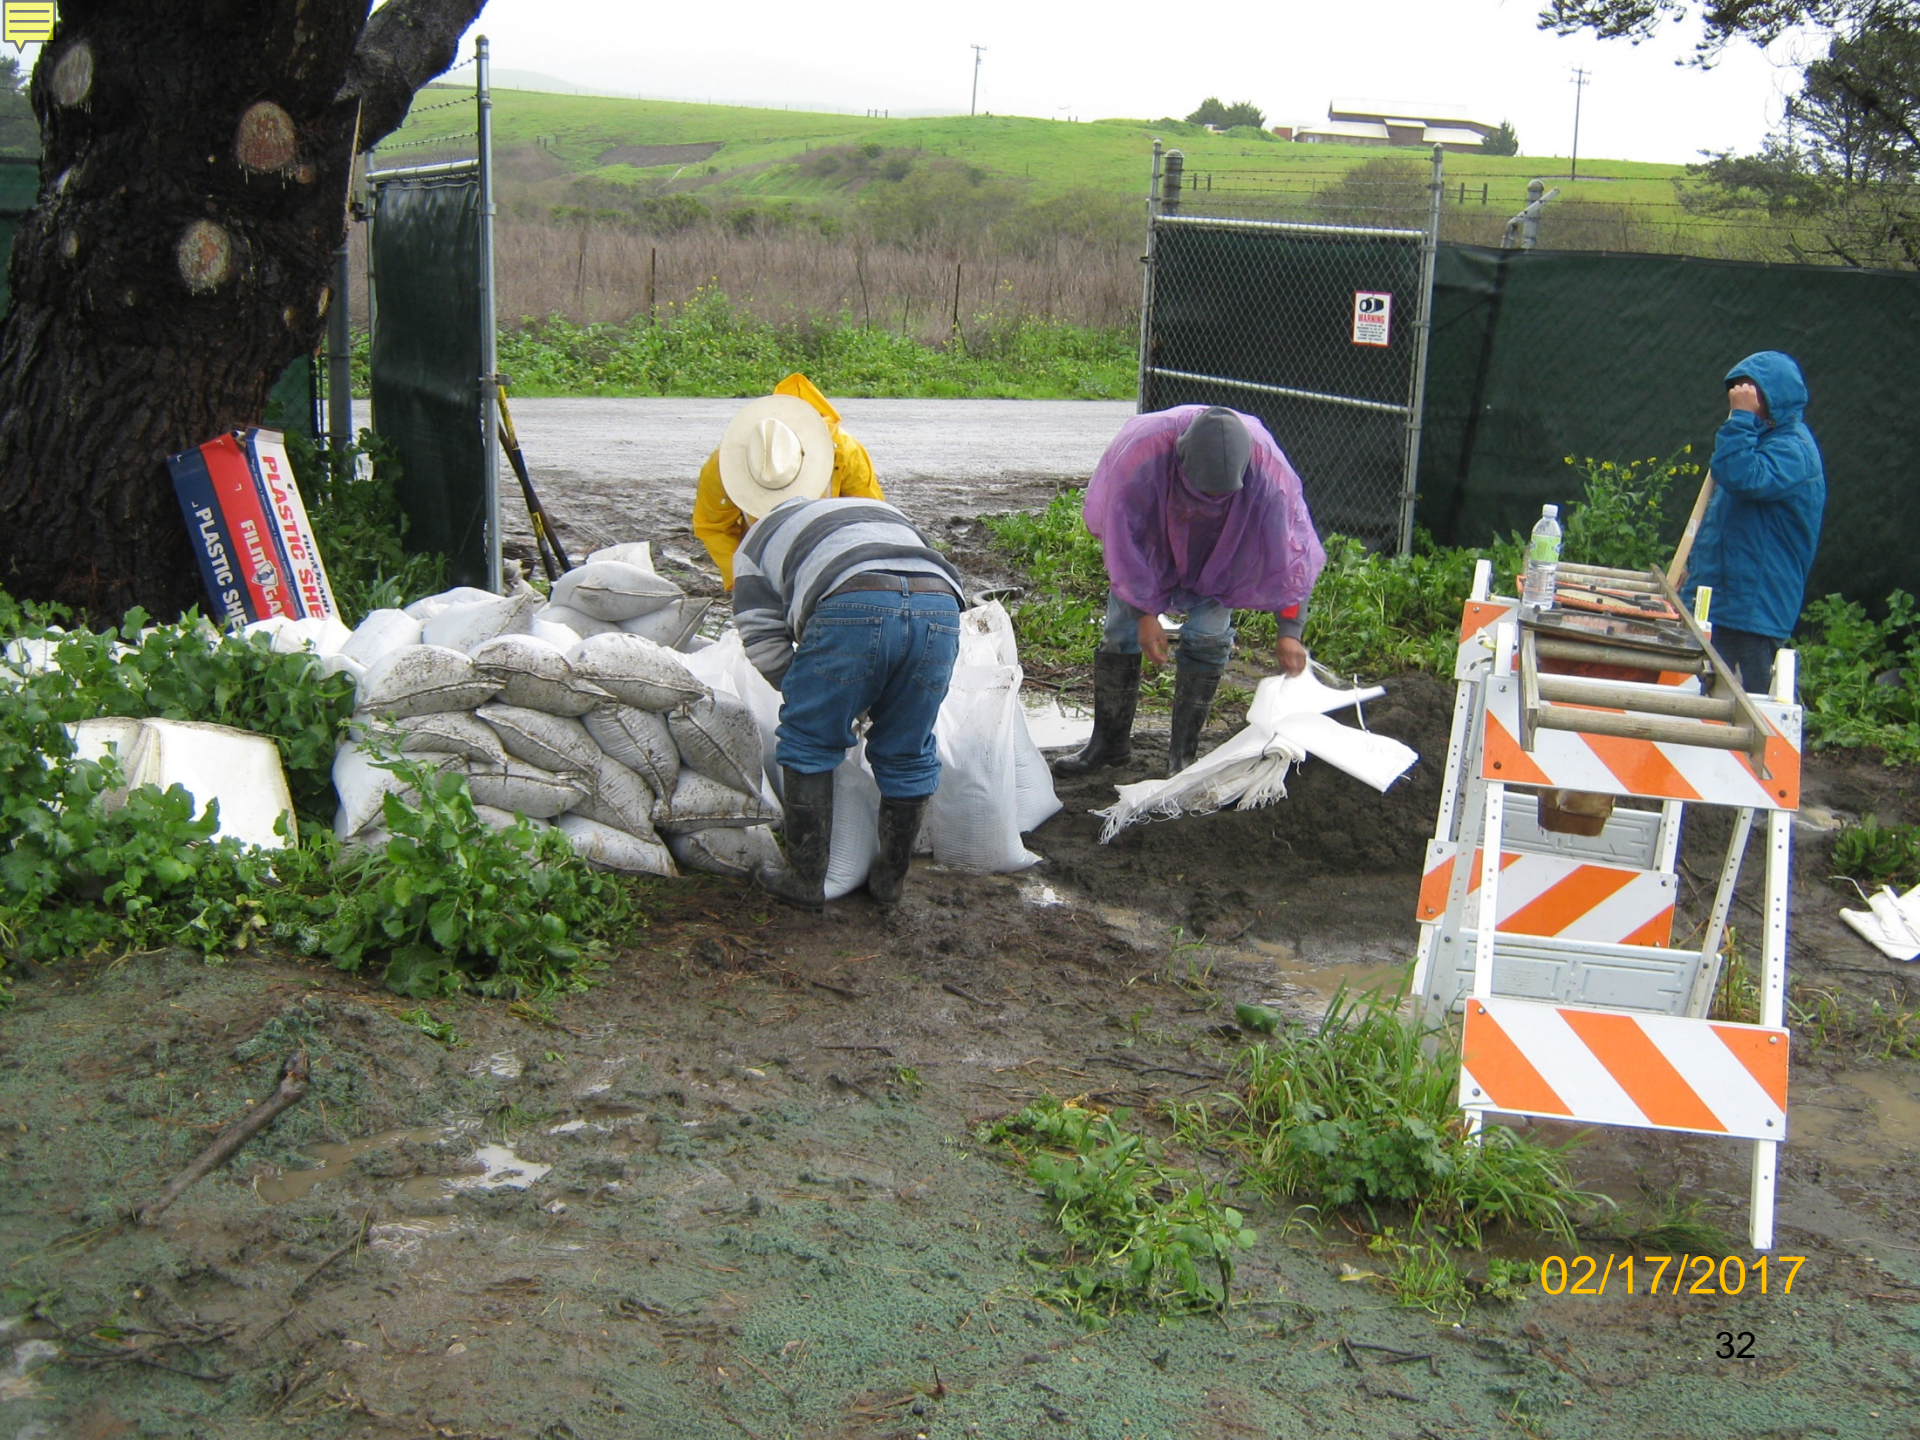
02/17/2017

PLASTIC SHEET
PLASTIC SHEET
PLASTIC SHEET

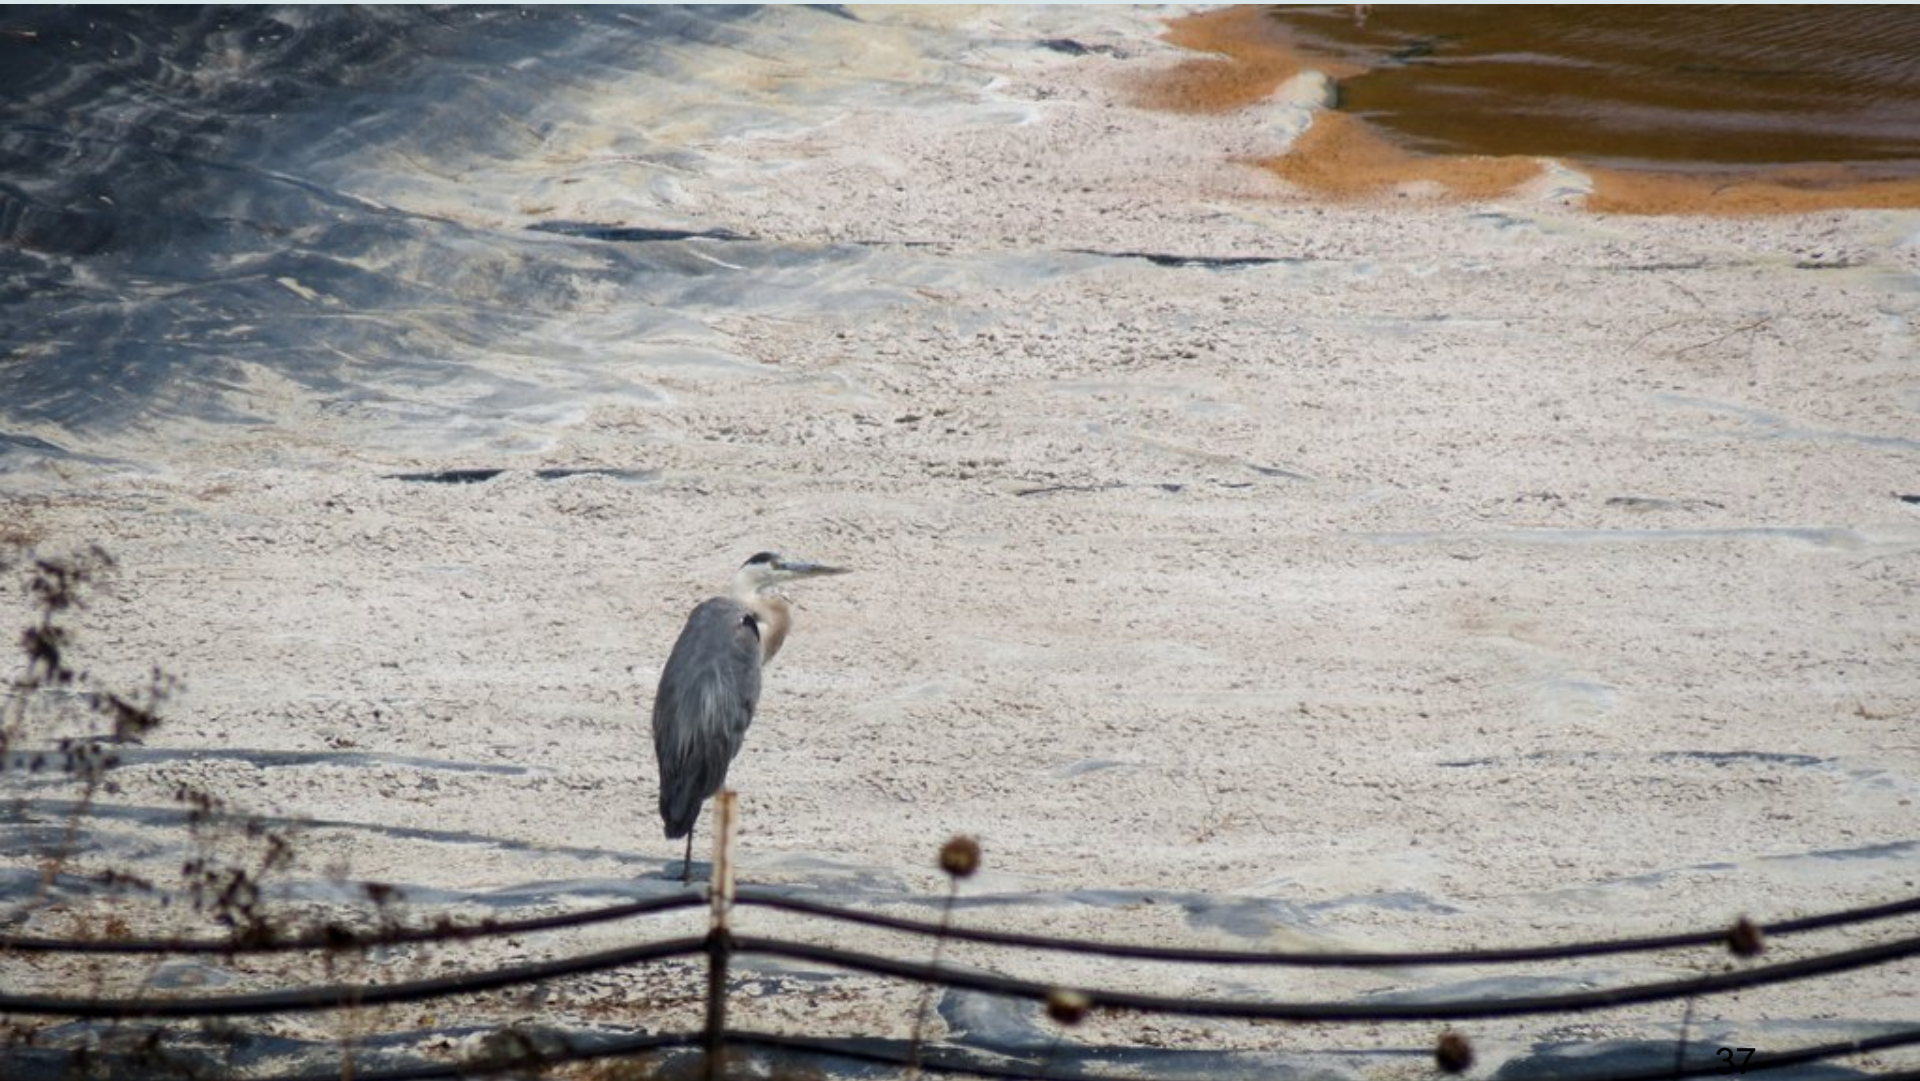
On the Bottom

- **Allowing liquids to evaporate is problematic**
 - Design evaporation rates predict approximately 11 years for liquid removal
 - Pollutant concentrations will increase over time
 - Wildlife attracted to increasingly polluted water
 - Facility would be continuously out of compliance with Title 27

- **Two options for Surface Impoundment:**
 1. **Rehabilitate**
 2. **Discontinue use**
- **CCSD is not contesting the CDO as proposed**
- **CCSD plans to discontinue use**
- **CDO requires workplan within 30 days of adoption**
