PINTO LAKE

RESTORATION PROJECT

FINAL REPORT

Clean Water Act § 319(h) – Nonpoint Source Implementation Grant Program

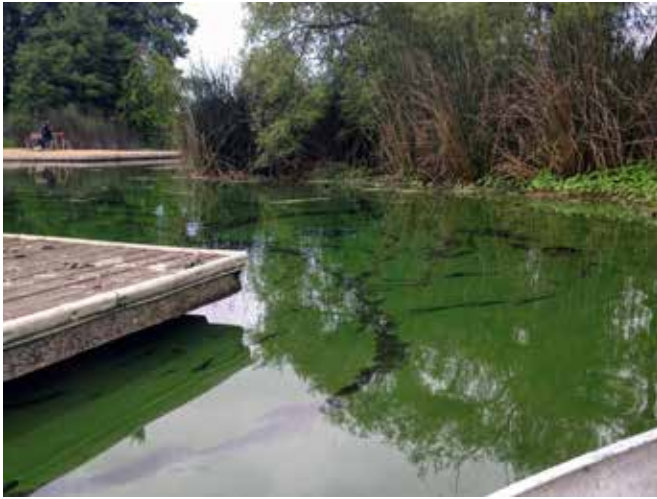
Photo 2 Algal bloom at Pinto Lake City Park Dock, October 26, 2016

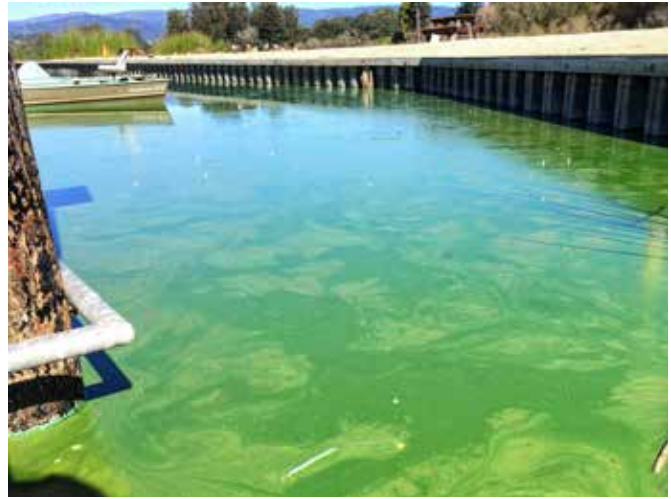
Photo 3 Algal bloom at Pinto Lake City Park Dock, October 26, 2016

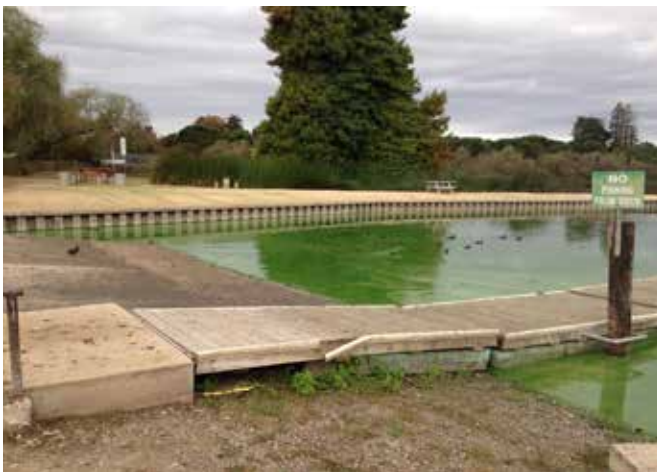
Photo 4 Algal bloom at Pinto Lake City Park Dock, October 27, 2016

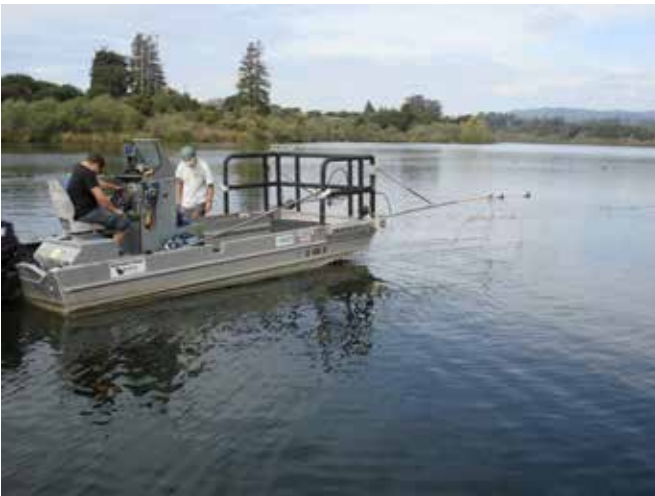
Photo 5 California Department of Fish and Wildlife (CDFW) electrofishing boat used in the carp removal project, March 5, 2014

The City utilized in house staff to research cost, effectiveness, and feasibility of each of the proposed in-lake treatment practices. Through an alternative funding source (State of California Coastal Conservancy Agreement #13-086) the City was able to implement carp removal.

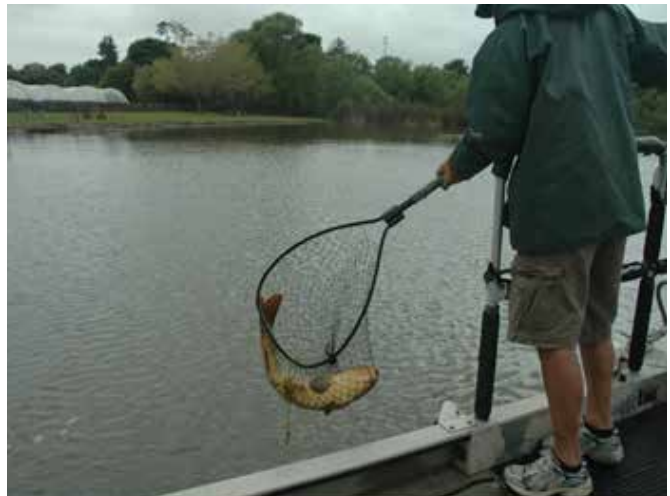
Photo 6 CDFW Biologist removes a carp, an invasive species, from Pinto Lake, March 5, 2014

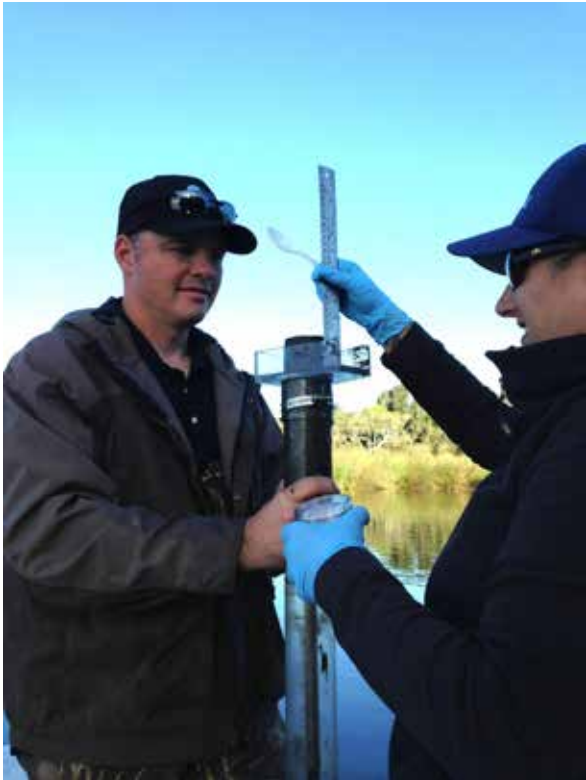
Photo 7 Jackie McCloud (City of Watsonville) and Tadd Barrow (HAB Aquatics Solutions LLC.) collect a sediment core from Pinto Lake, October 21, 2014

The City partnered with HAB Aquatics Solutions, LLC. to collect four sediment cores, in Pinto Lake. These cores provided information on the in-lake available phosphorus sources from the lake's sediment. More detail is provided in the next section.

Sediment constituents were determined at four depths in four sediment core locations. The cores were sectioned at 5 cm intervals to a depth of 20 cm. The alum treatment targeted Mobile-P and labile organic P for inactivation. Mobile-P

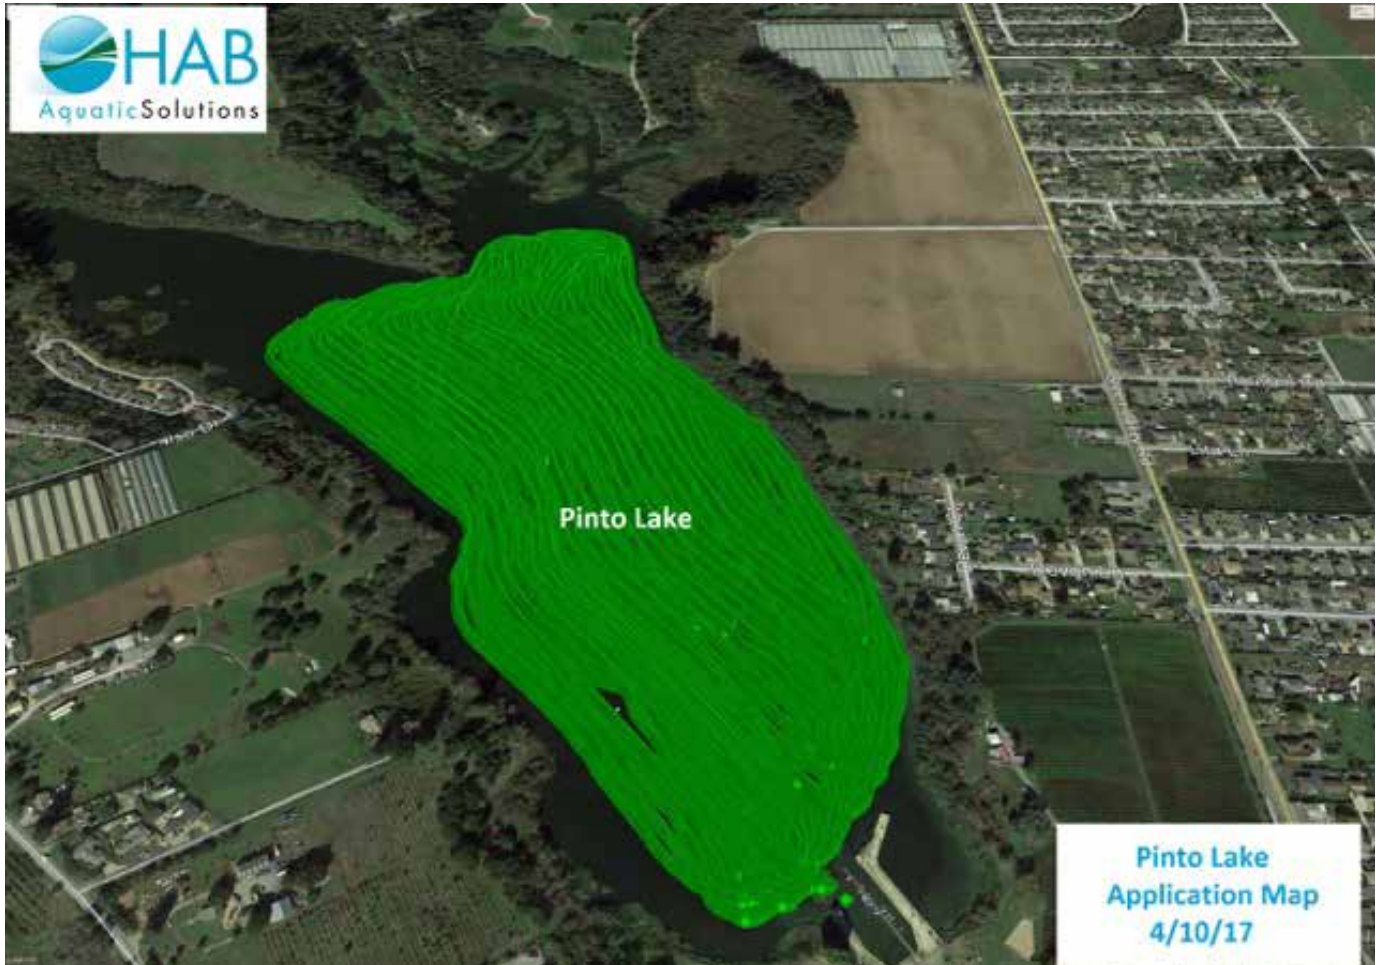
Figure 4 GPS printout of on barge tracking of the alum treatment, HAB Aquatic Solutions LLC.

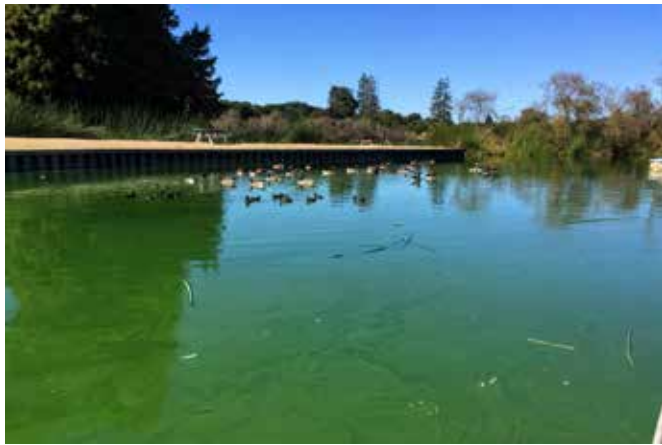
Photo 9 Algal bloom at Pinto Lake City Park Dock, October 26, 2016, before alum treatment

Specifically, for Pinto Lake, the single largest source of phosphorus driving excess production of cyanobacteria leading to cyanotoxin generation is phosphorus recycling from its sediments. Hence, the first in-lake activity is planned for the early spring of 2017 in early March or late February, when the temperature of the water is at or above 5 degrees Celsius. This timing allows for maximizing the direct introduction of aluminum to the sediment, removal of the phosphorus loading from winter and spring external phosphorus inputs to the lake from the watershed, and limits the interference of aquatic plants from allowing the alum to reach the sediments quickly.

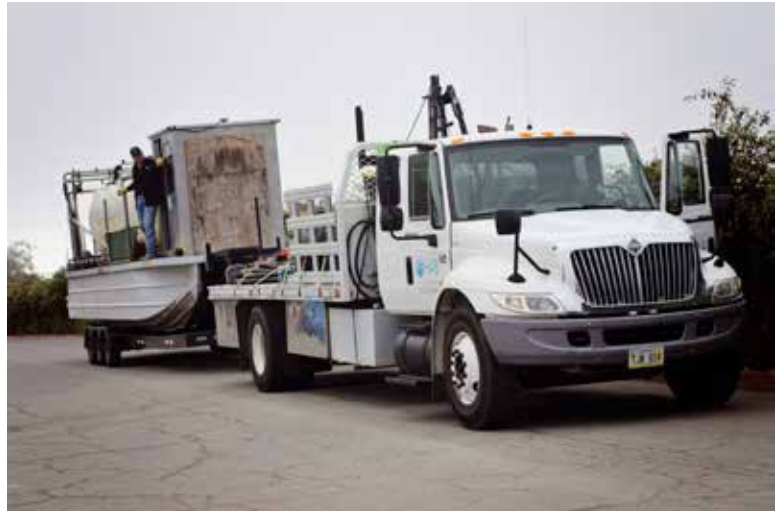
Photo 11 Alum being delivered at Pinto Lake City Park, April 2017
[Photo Credit: Catherine Bosley, HAB Aquatic Solutions, LLC.]

In order to maximize the delivery of aluminum to the lake in an environmentally proven safe process, water treatment grade liquid alum will be simultaneously applied with a pH buffer liquid sodium aluminate. Both compounds are aluminum based and when applied at a 2:1 volumetric ratio of alum:sodium aluminate, the existing pH of the lake water will be maintained. The alum and sodium aluminate will be applied separately, but at the same time, and at the 2:1 ratio just below the water surface. The rate of application will be at a water column concentration of 45.5 mg Al/L. This dose will be controlled by the applicator using computer controlled pumps that account for lake depth and speed of the boat. The lake will be treated in a tracked pattern in one direction and then recovered using a 90-degree travel pattern to ensure complete and total coverage of the lake sediment at a depth of greater than 3 feet. No application of alum will take place in the “fingers” of the lake due to Department of Fish and Wildlife’s concern with any effects on endangered species, such as the Western Pond turtle. Depending upon conditions at the lake at the time of application, it is estimated that the treatment will take two weeks or less. This includes 2 to 4 working days to mobilize and demobilize and 3 to 8 days to conduct the application.

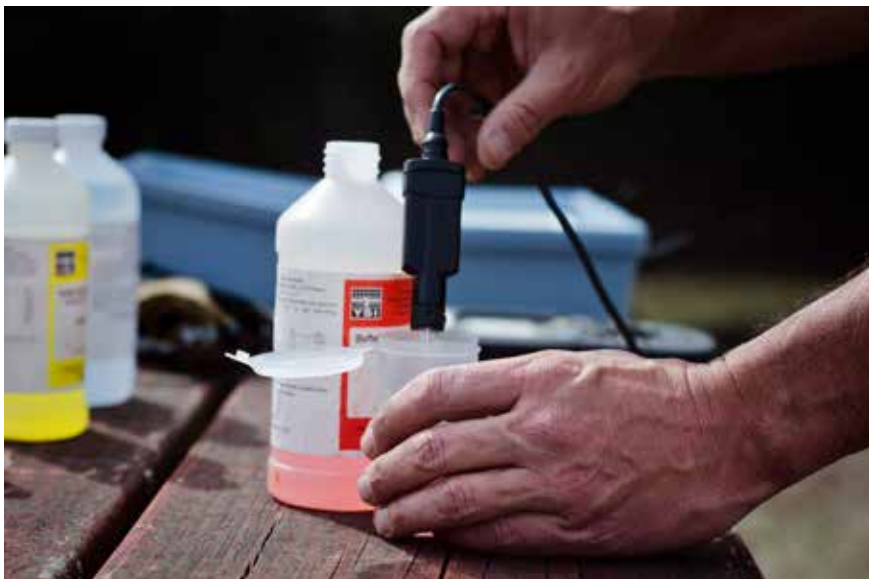
Photo 12 Dr. John Holz (HAB Aquatics Solutions LLC.) calibrating the pH probe, in preparation for alum dosing, April 2017. [Photo Credit: Catherine Bosley, HAB Aquatic Solutions, LLC.]

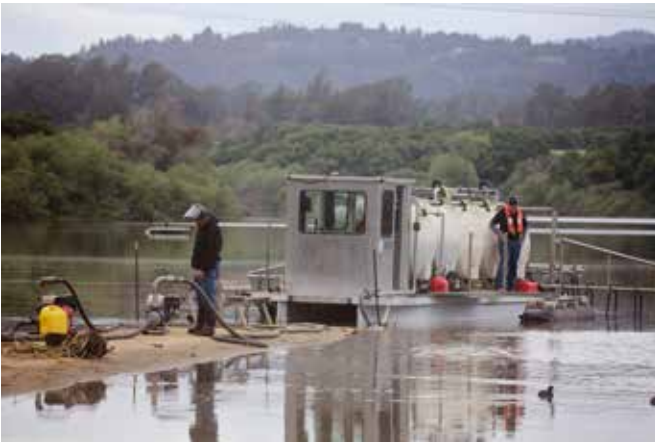
Photo 14 HAB Aquatic Solutions, LLC. staff prepare the barge for alum treatment at Pinto Lake, April 2017 [Credit: Catherine Bosley, HAB Aquatic Solutions, LLC.]

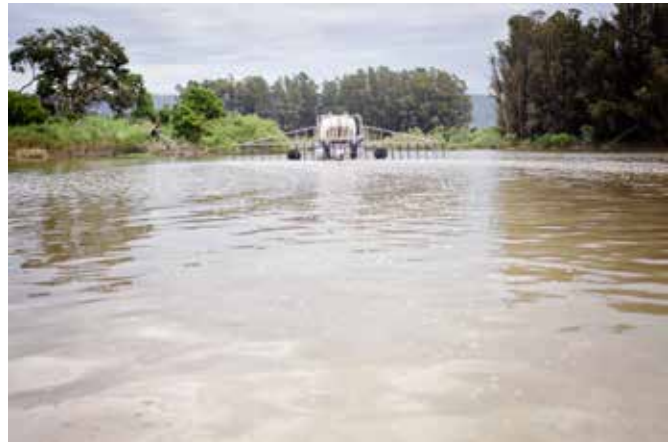
Photo 15 HAB Aquatic Solutions, LLC. barge dosing Pinto Lake with alum, April 2017 [Credit: Catherine Bosley, HAB Aquatic Solutions, LLC.]

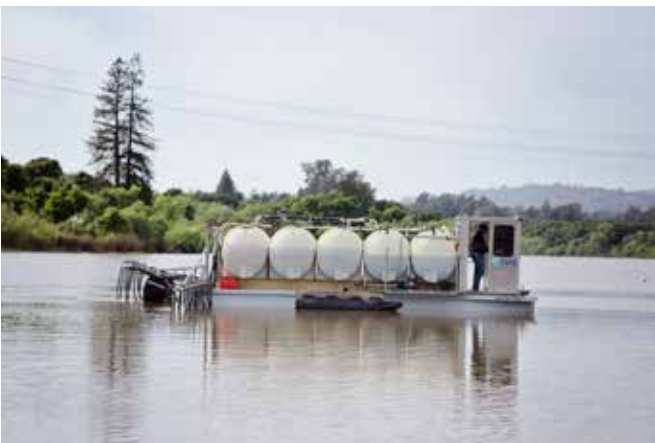
Photo 16 HAB Aquatic Solutions, LLC. barge dosing Pinto Lake with alum, April 2017. [Credit: Catherine Bosley, HAB Aquatic Solutions, LLC.]

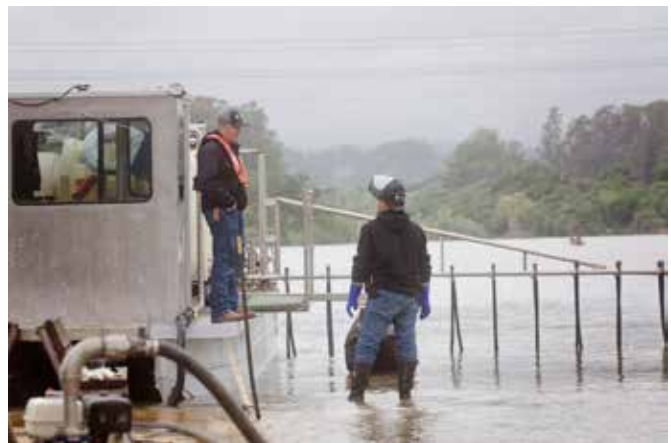
Photo 17 HAB Aquatic Solutions, LLC. staff during alum treatment, April 2017. [Credit: Catherine Bosley, HAB Aquatic Solutions, LLC.]

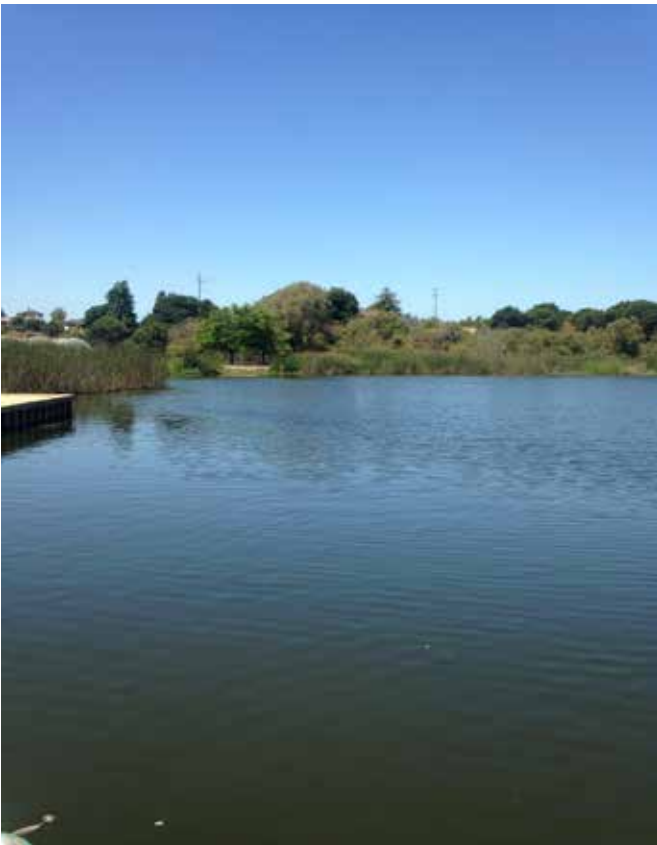
Photo 19 View from the end of Pinto Lake City Park Dock, July 18, 2017, after alum treatment.

Due to the shorter toxic conditions, the City only had to close the lake for approximately three weeks in fall 2017 as opposed to the approximately three months in the previous fall 2016.

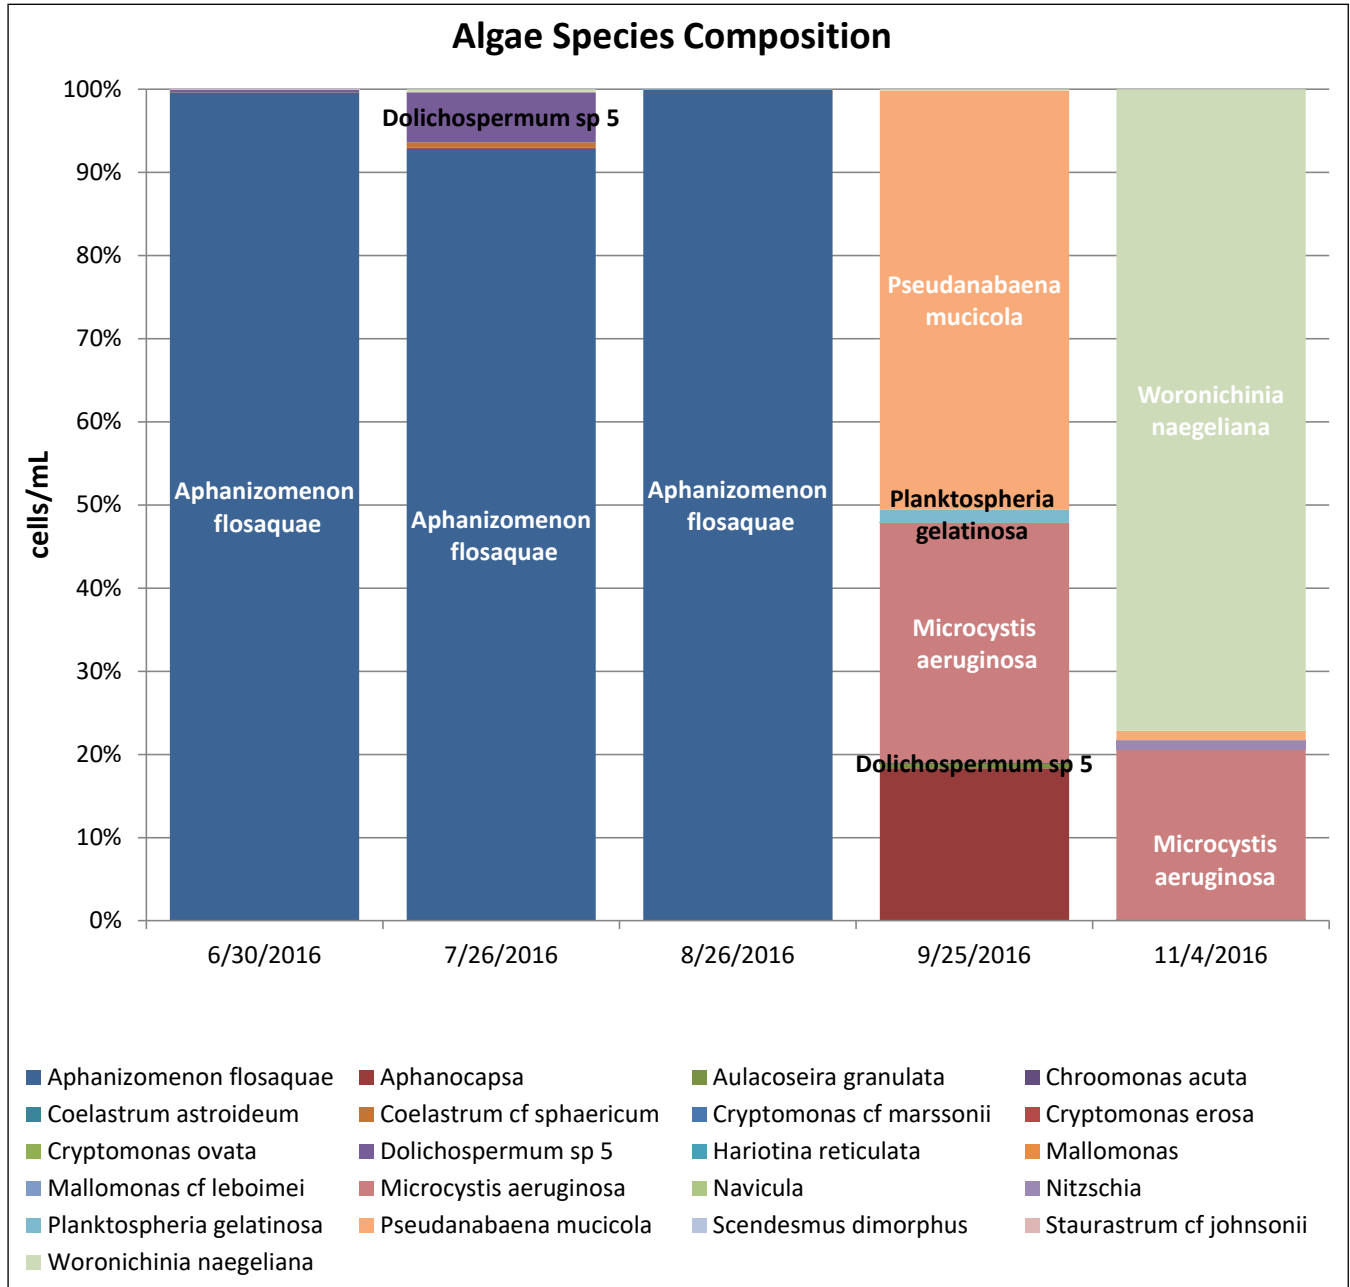
Figure 5 Algal species composition during an active bloom, results analyzed by CSUSM

Usually, the bloom starts in spring, with *Aphanizomenon*, an algae species. The bloom then, commonly, shifts to *Microcystis*, another algae species, in the late summer. Cyanobacteria compositions were analyzed, five times, during a pre-treatment active bloom, by Dr. Rosalina Hristova with California State University San Marcos (CSUSM). CSUSM results below.

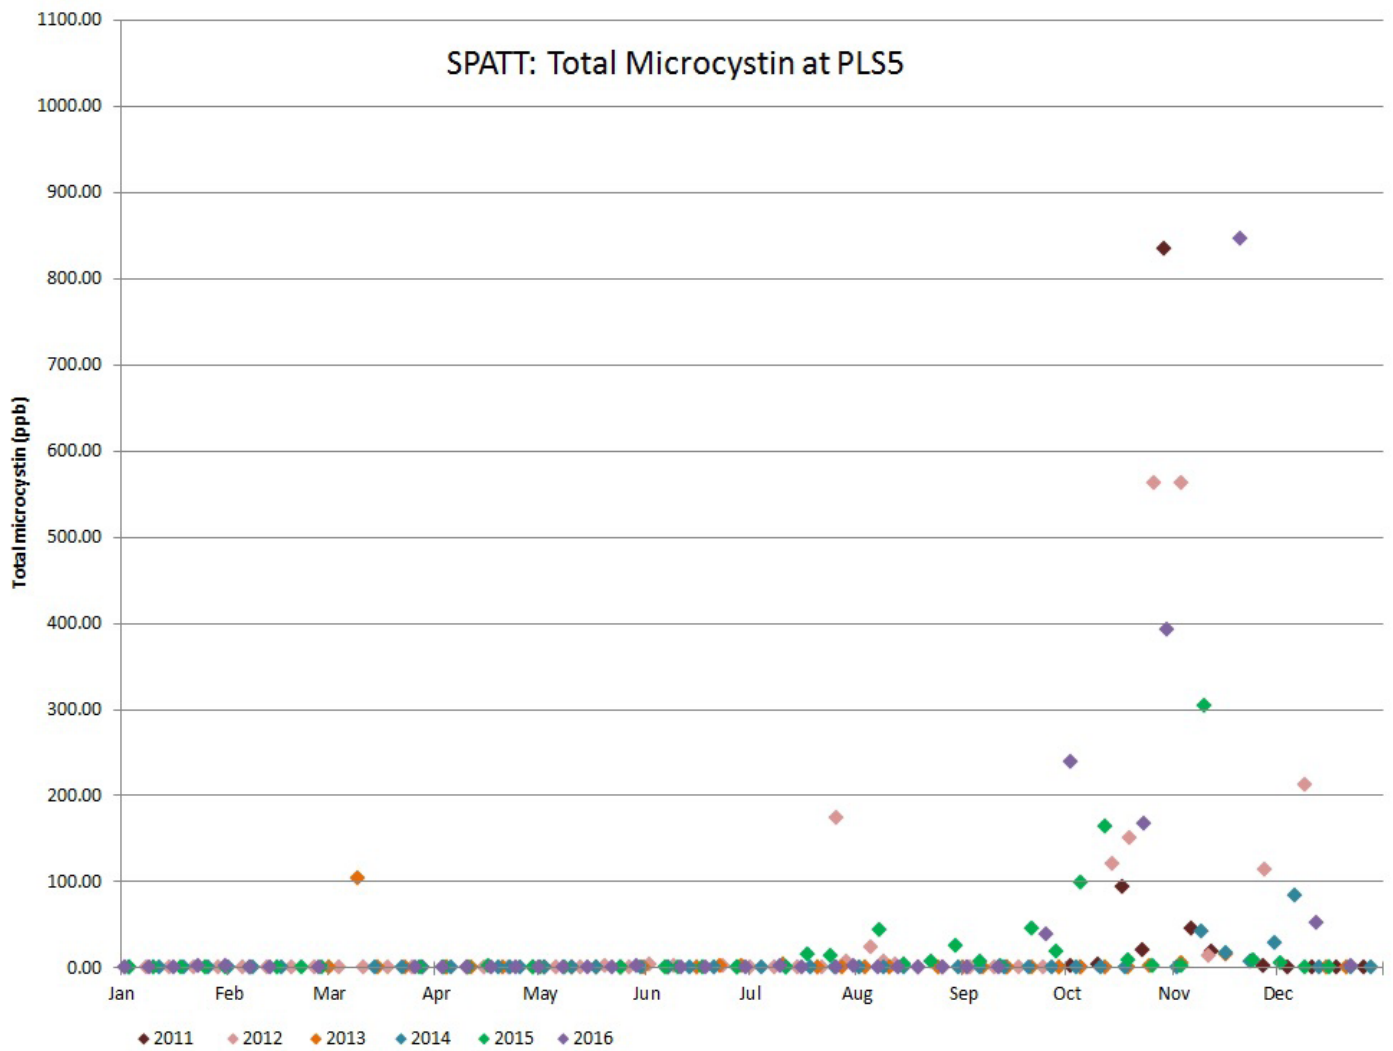
Figure 6 The baseline conditions of the total microcystin at the Pinto Lake City Park Dock, prior to alum treatment.

The bloom’s toxicity, indicated by the toxin, Microcystin, peaks around October or November. Cyanotoxin concentrations are measured weekly by Dr. Raphael Kudela with UCSC. UCSC uses the solid phase adsorption toxin testing (SPATT) technique to analyze cyanotoxins. The pre-treatment results, dating back to 2011, are found in **Figure 6**. Note that there

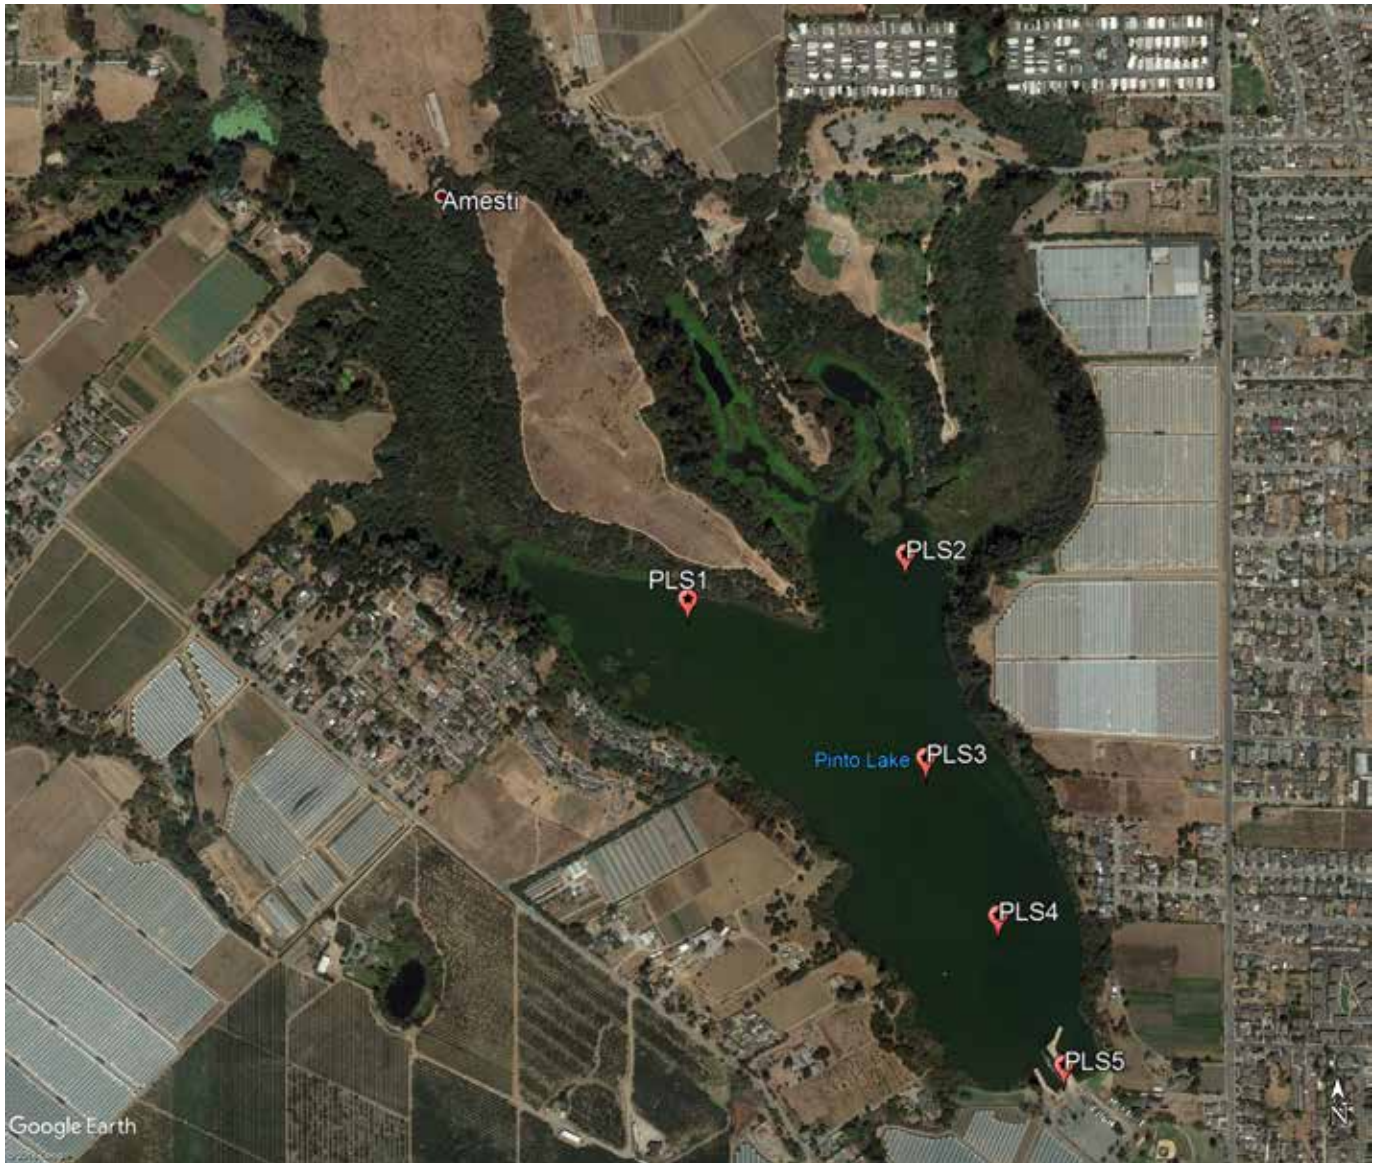
Figure 7 The in-lake monitoring sites of the Pinto Lake Restoration Project

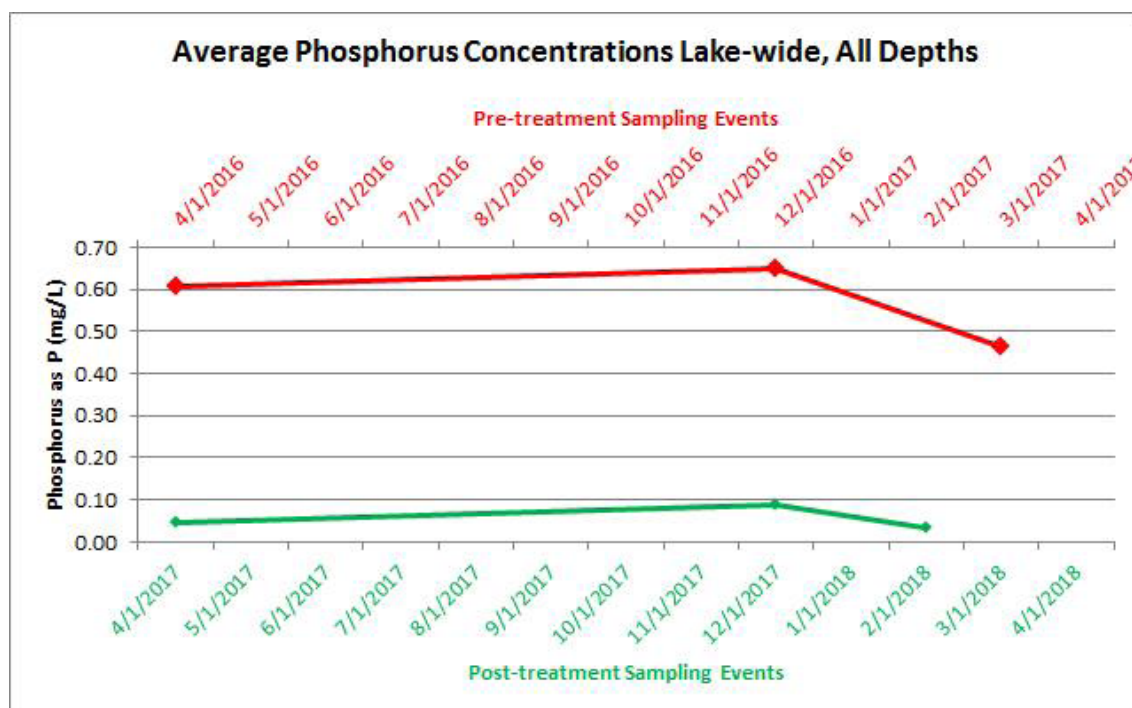
Figure 8 A comparison of the average pre-treatment (red trend) and post-treatment (green trend) phosphorus concentrations lake-wide, at all depths

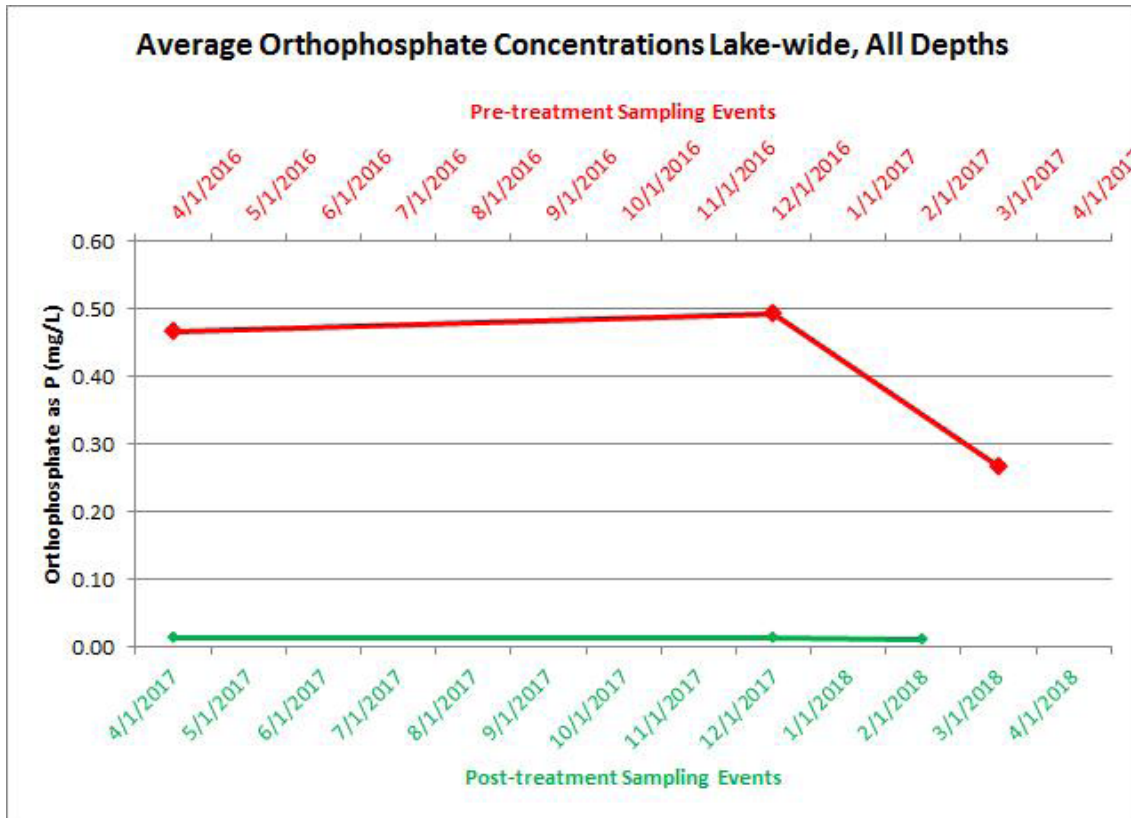
Figure 9 A comparison of the average pre-treatment (red trend) and post-treatment (green trend) orthophosphate concentrations lake-wide, at all depths

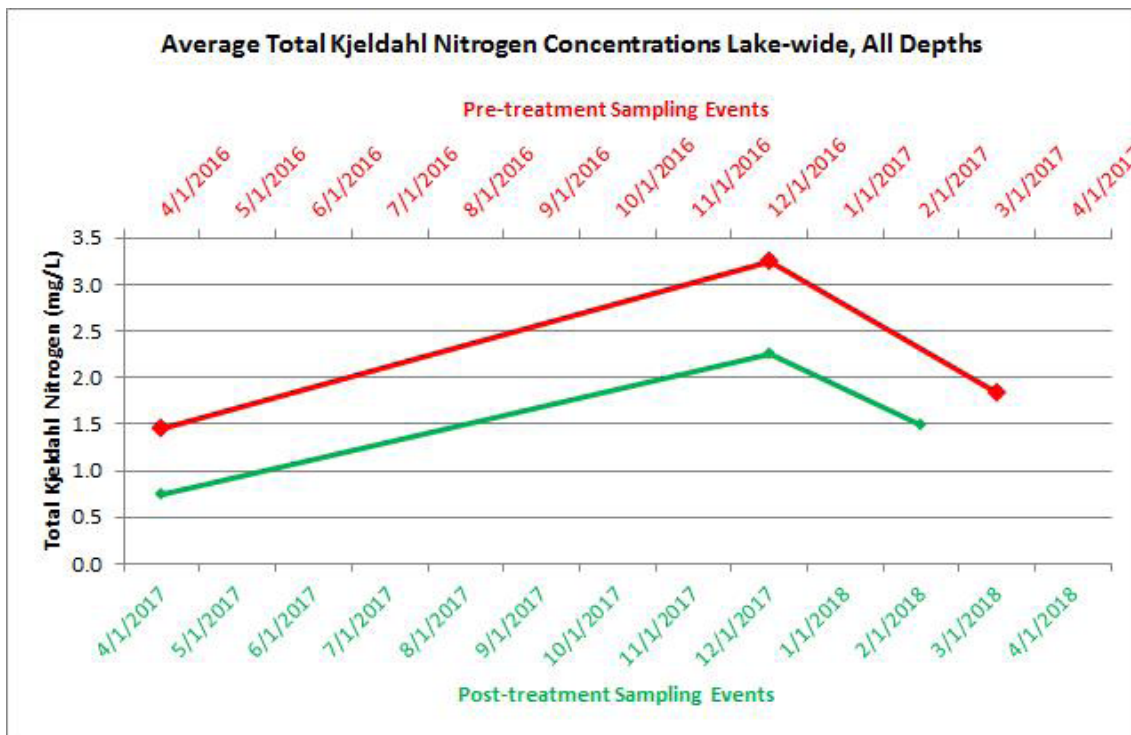
Figure 10 A comparison of the average pre-treatment (red trend) and post-treatment (green trend) orthophosphate concentrations lake-wide, at all depths

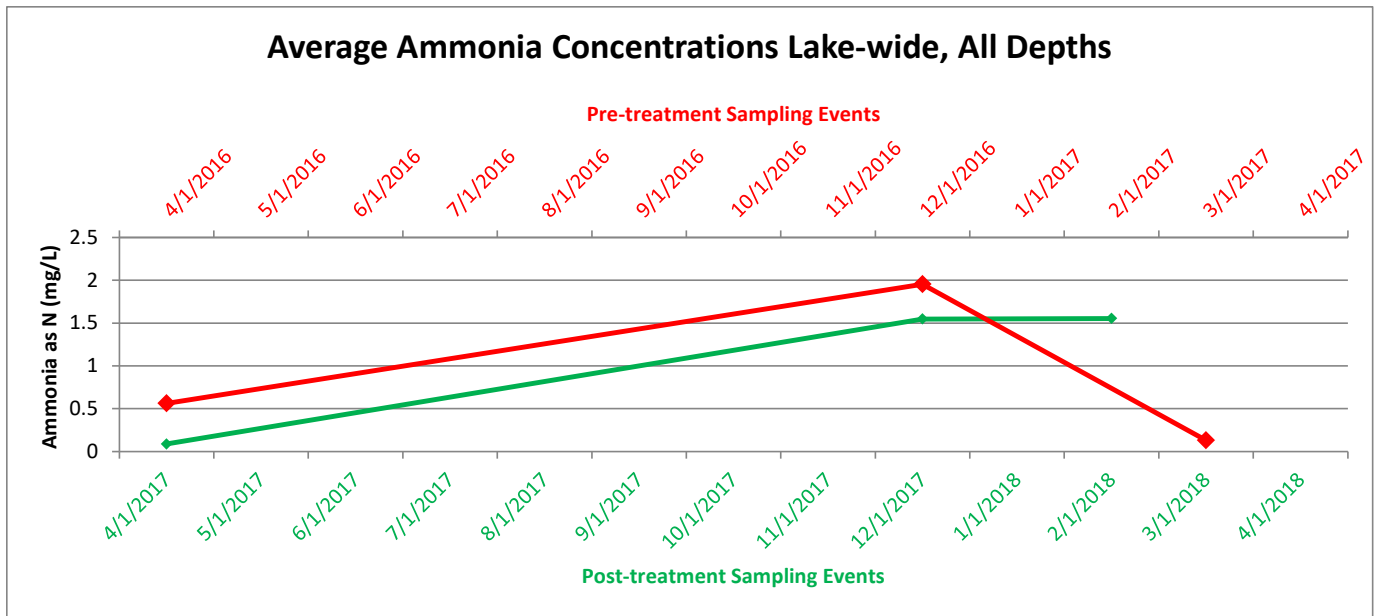
Figure 11 A comparison of the average pre-treatment (red trend) and post-treatment (green trend) ammonia concentrations lake-wide, at all depths

The average ammonia (NH₄⁺) lake-wide percent increase was 20%. The data contributing to this increase can be attributed to the final post-treatment sampling event, where the ammonia concentrations didn't decrease, as seen in the pre-treatment conditions. This could be due to the temporary reduction in available oxygen, following the alum treatment or to seasonal changes in availability of oxygen to the lower part of the lake. The percent change was calculated using the average of all the results from the three pre-treatment sampling events (0.88 mg/L), and the average of all the results from the three post-treatment sampling events (1.06 mg/L). Note that the alum treatment was not intended to reduce ammonia levels.

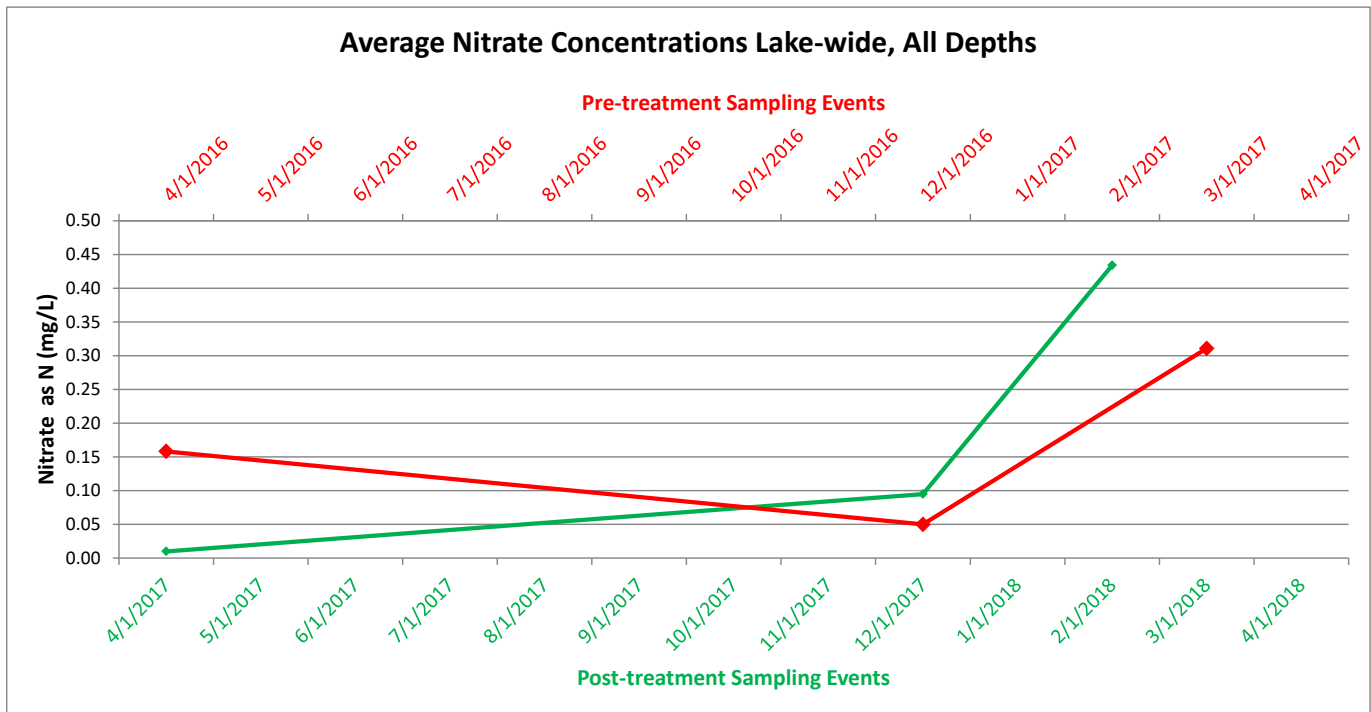
Figure 12 A comparison of the average pre-treatment (red trend) and post-treatment (green trend) nitrate concentrations lake-wide, at all depths

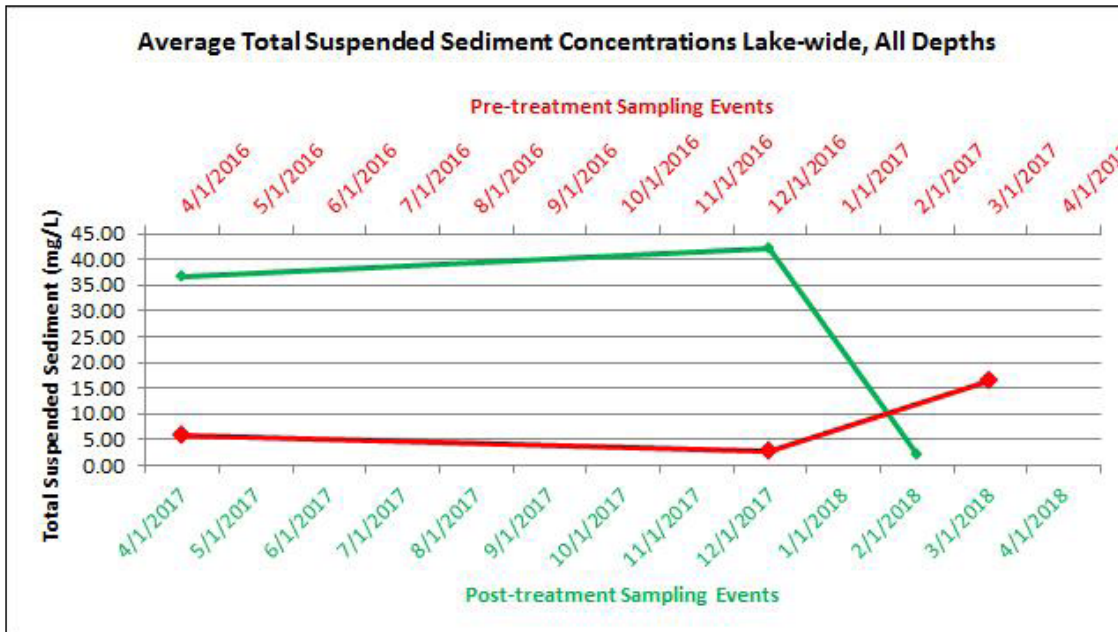
Figure 13 A comparison of the average pre-treatment (red trend) and post-treatment (green trend) TSS concentrations lake-wide, at all depths. Note that 2 data points (PLS3, near bottom and PLS4, near bottom), from the December 5, 2017 sampling event, are excluded from this graphic as samples may have been collected below the sediment-water-interface, resulting in extremely high levels of TSS.

It should be noted that the TSS samples from the pre-treatment monitoring event, on December 5, 2017, may have been collected below the sediment-water-interface, resulting in extremely high levels of TSS at two of the four bottom sites. The interface is often nebulous, and determining the depth for the sample was challenging.

Another potential factor for the unusually high TSS concentrations could be disturbance of the sediment prior to sampling. This may have occurred during deployment of monitoring site buoys and their anchors. This could have also occurred if there were extremely windy conditions, which caused the anchors to drag along the bottom of the lake.

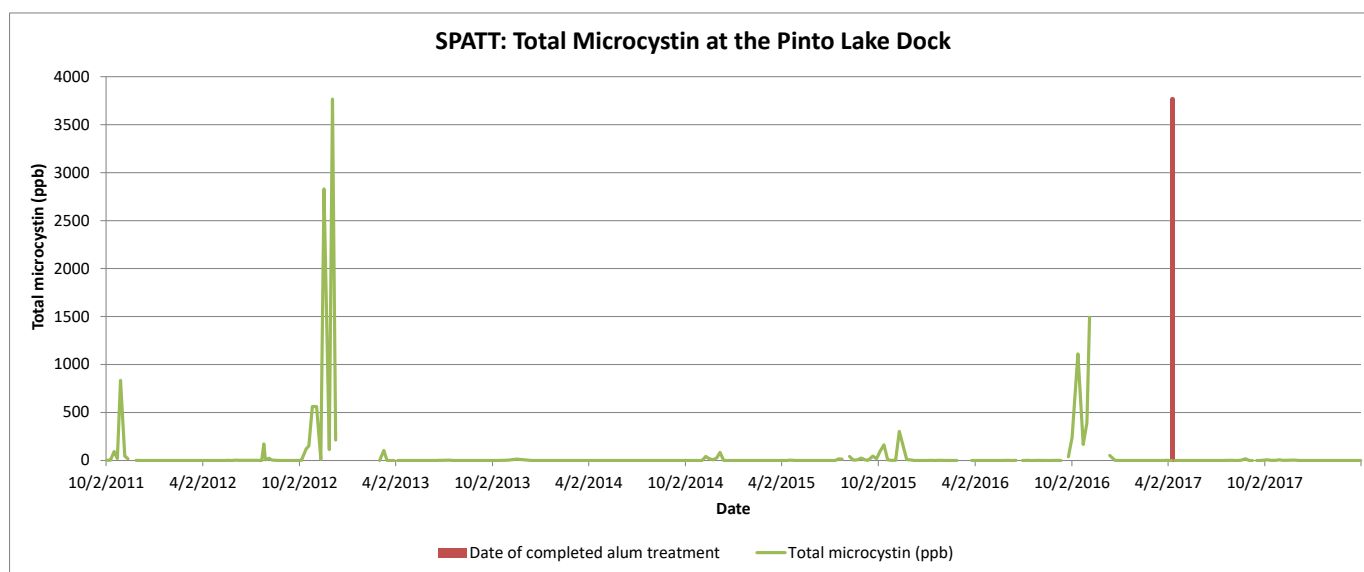
Figure 14 Total microcystin at the Pinto Lake City Dock spanning October 2, 2011 through April 1, 2018. The vertical red line indicates the approximate completion of alum treatment, on April 10, 2017.

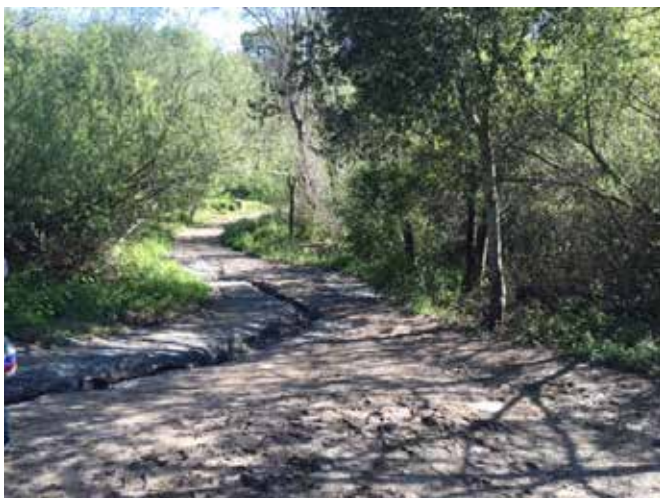
Photo 21 Downcutting observed prior to implementation, on the access road.

The project constructed five (5) rolling dips, forty (40) linear feet of drainage swale, and repaired existing ruts on the road prior to the grading and installation of 950 sq ft of Class II aggregate road base. Prior to the project, there was considerable storm water that flowed down the road during the rainy season, carrying with it sediment from the roadway as well as landslides that were occurring adjacent to the road. The intent of the road improvement practices is to redirect storm water to reduce erosion and sediment inputs into the Amesti mainstem and Pinto Lake. This project was implemented under the Santa Cruz County Partners in Restoration Permit Coordination Program and required coordination with the following permitting agencies: CCRWCQB, CDFW and the Santa Cruz County Master Permit.

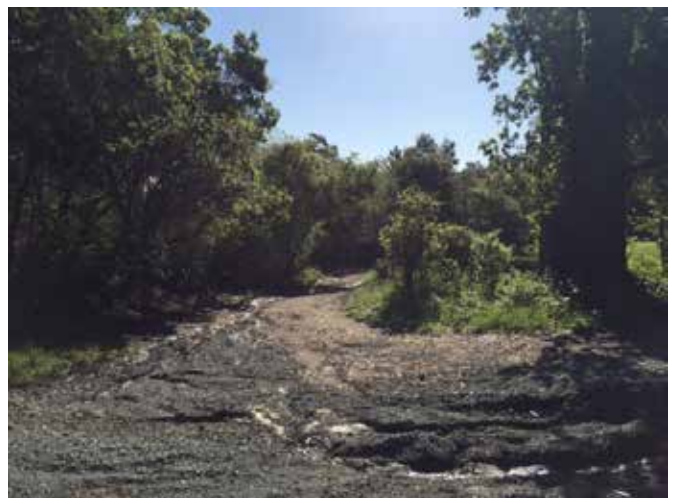
Photo 22 Downcutting and erosion farther up the road from photo 21, on the access road.

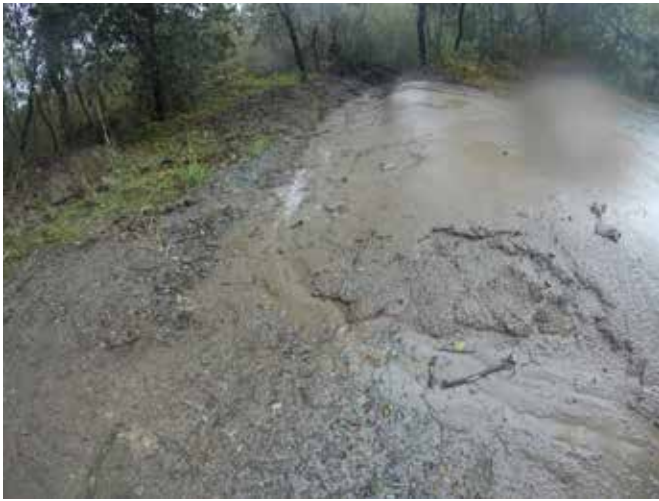
Photo 23 The implemented rolling dips in action, moving water off the access road to inhibit downcutting.

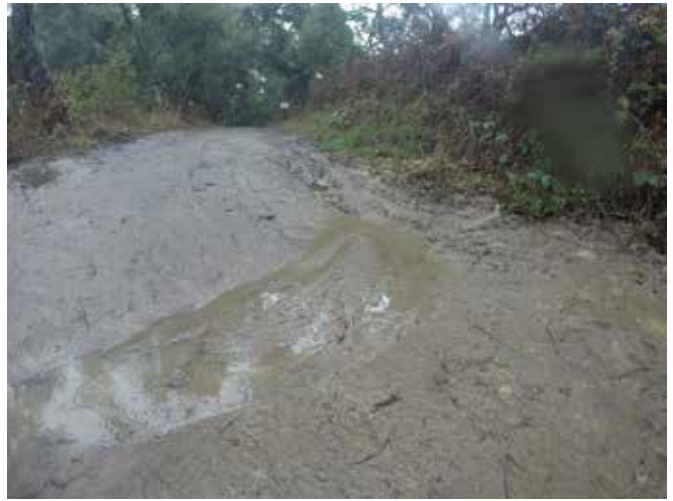
Photo 24 The implemented rolling dips in action, moving water off the access road to inhibit downcutting, October 28, 2016

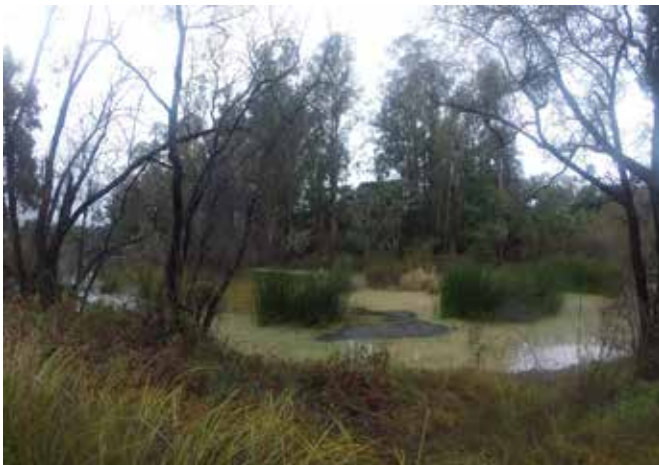
Photo 25 Pinto Lake, at the Amesti Creek tributary, December 2015

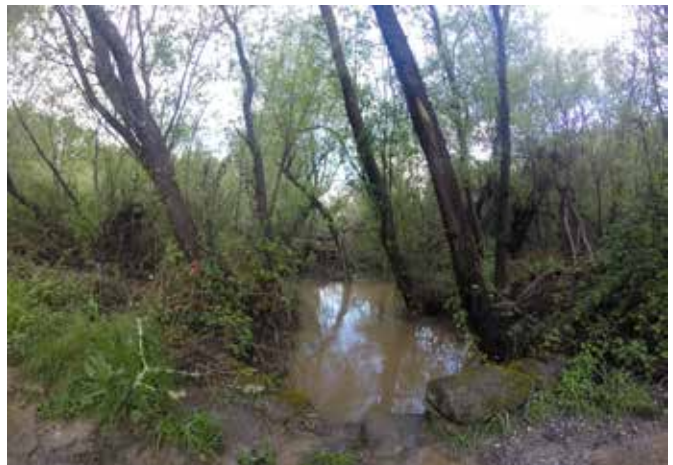
Photo 26 Image 26: Amesti Creek, upstream, March 2016

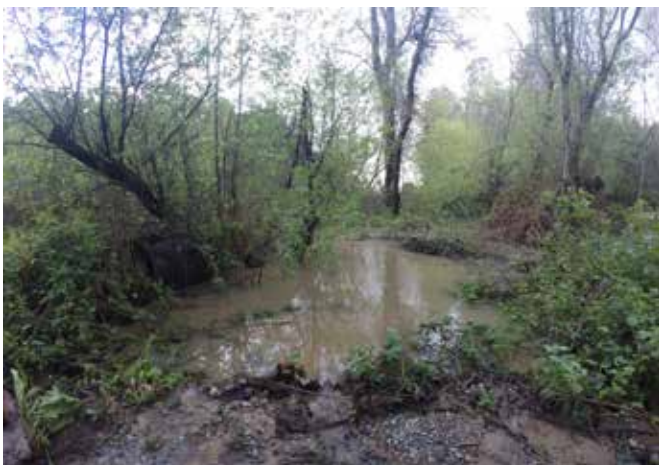
Photo 27 Amesti Creek, downstream, March 2016

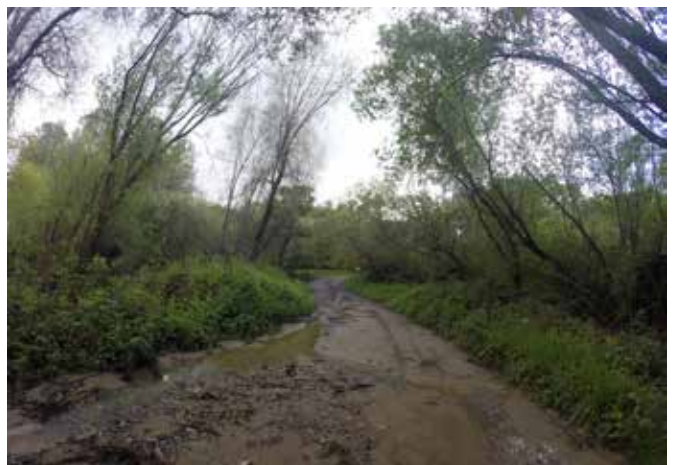
Amesti Creek, a tributary to Pinto Lake, is highly ephemeral and dependent on rainfall. The Creek is crossed by a Pinto Lake County Park access road. This road is prone to erosion resulting in highly sediment-laden stormwater runoff entering the Amesti Creek.

Photo 28 Pinto Lake County Park access road, adjacent to Amesti Creek, March 2016
