PINTO LAKE

RESTORATION PROJECT

FINAL REPORT

Clean Water Act § 319(h) – Nonpoint Source Implementation Grant Program

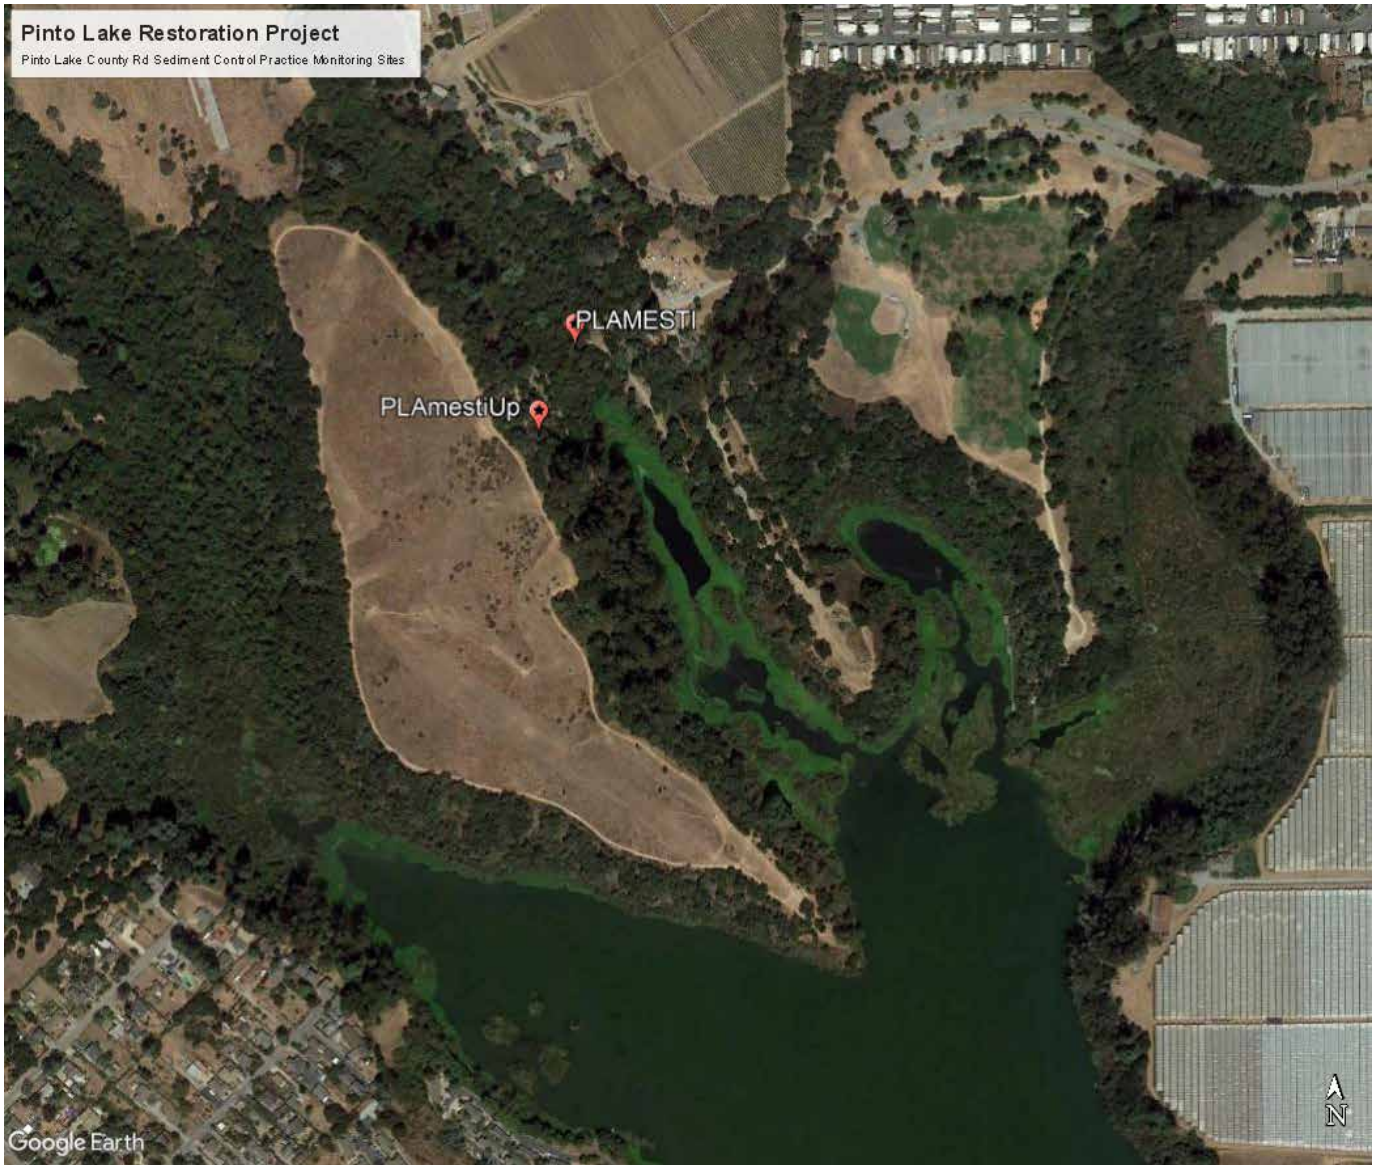
Figure 15 The Pinto Lake County Rd Sediment Control Practice monitoring sites, of the Pinto Lake Restoration Project

After the Rolling Dips were constructed, the intent was to monitor the stormwater runoff entering and exiting the Dips. However, the Dips were 100% successful in diverting runoff into surrounding vegetation, leaving no runoff to exit the Dips into the Amesti Creek. Therefore, samples were taken at a point entering the Dips (PLAmeستيUp) and in the Creek itself (PLAMESTI).

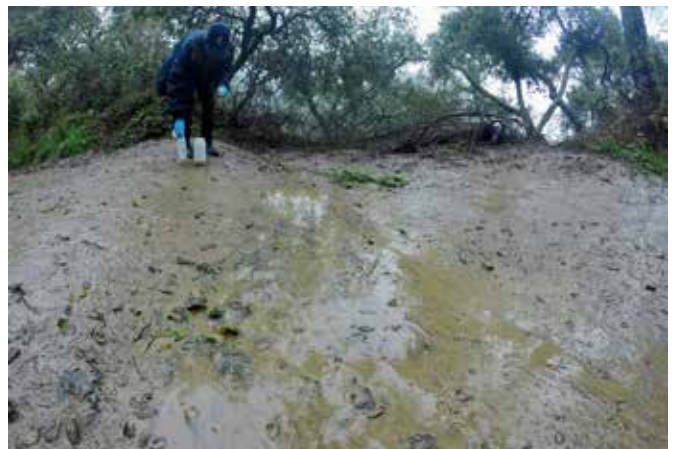
Photo 29 City staff collecting samples from upstream of the Pinto Lake County Rd Sediment Control Practice Rolling Dips, December 2016.

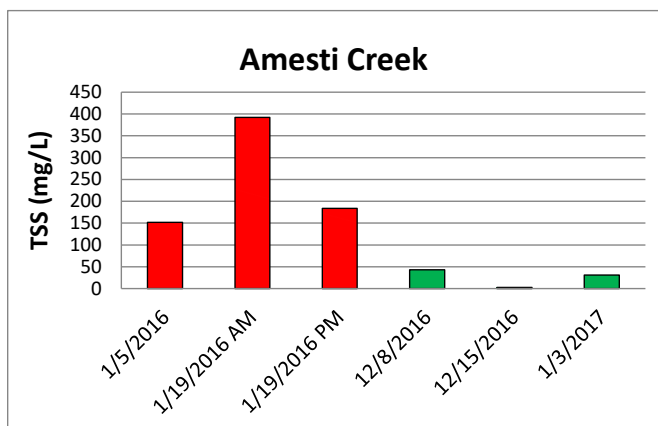
Figure 17 Total suspended sediment concentrations in the Amesti Creek, with the red bars representing the pre-implementation concentrations, and the green bars representing the post-implementation concentrations.

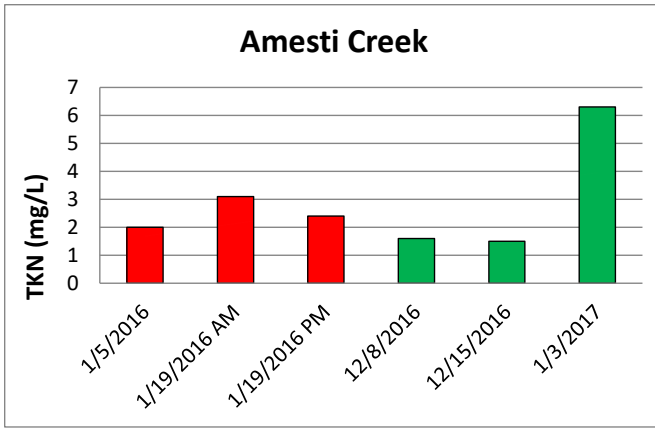
Figure 19 TKN concentrations in the Amesti Creek, with the red bars representing the pre-implementation concentrations, and the green bars representing the post-implementation concentrations.

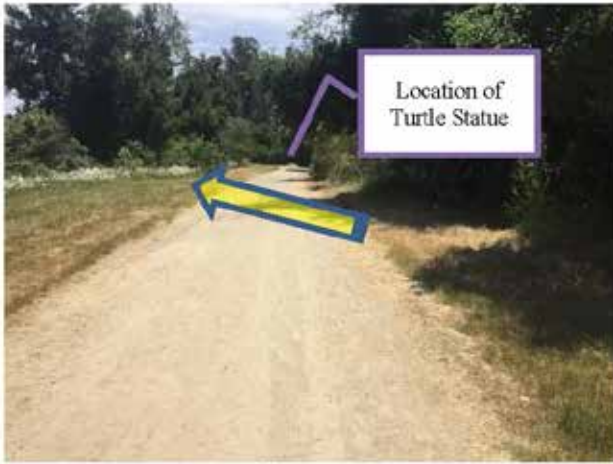
Before Photo:
Approximate reverse grade dip location 1
(Direction: Looking Southwest)

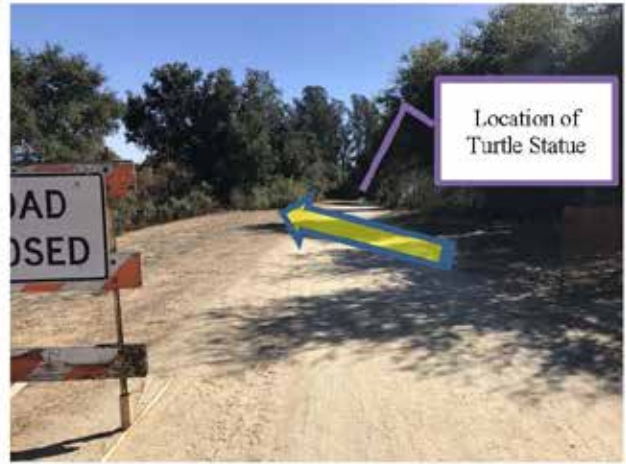
During Photo:
Approximate reverse grade dip location 1
(Direction: Looking Southwest)

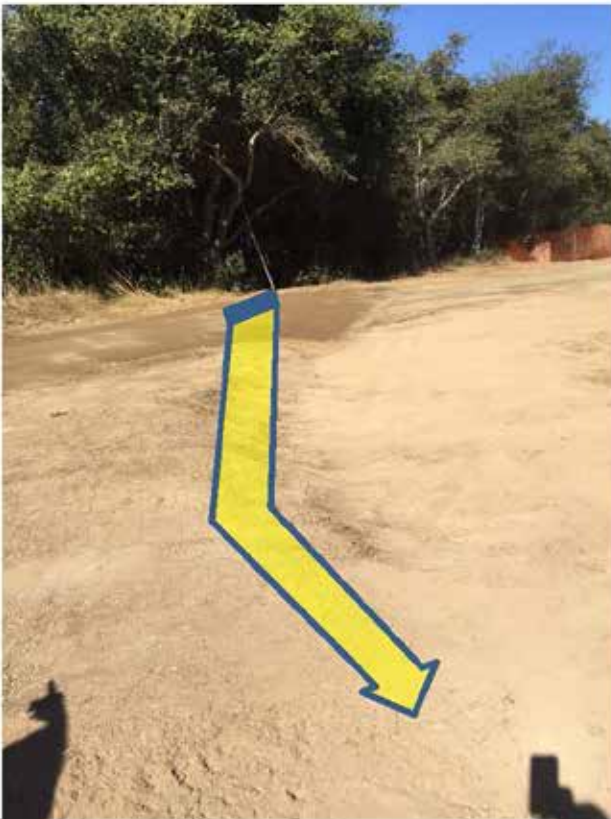
Post Construction Photo:
Reverse grade dip location 1
(Direction: Looking West)

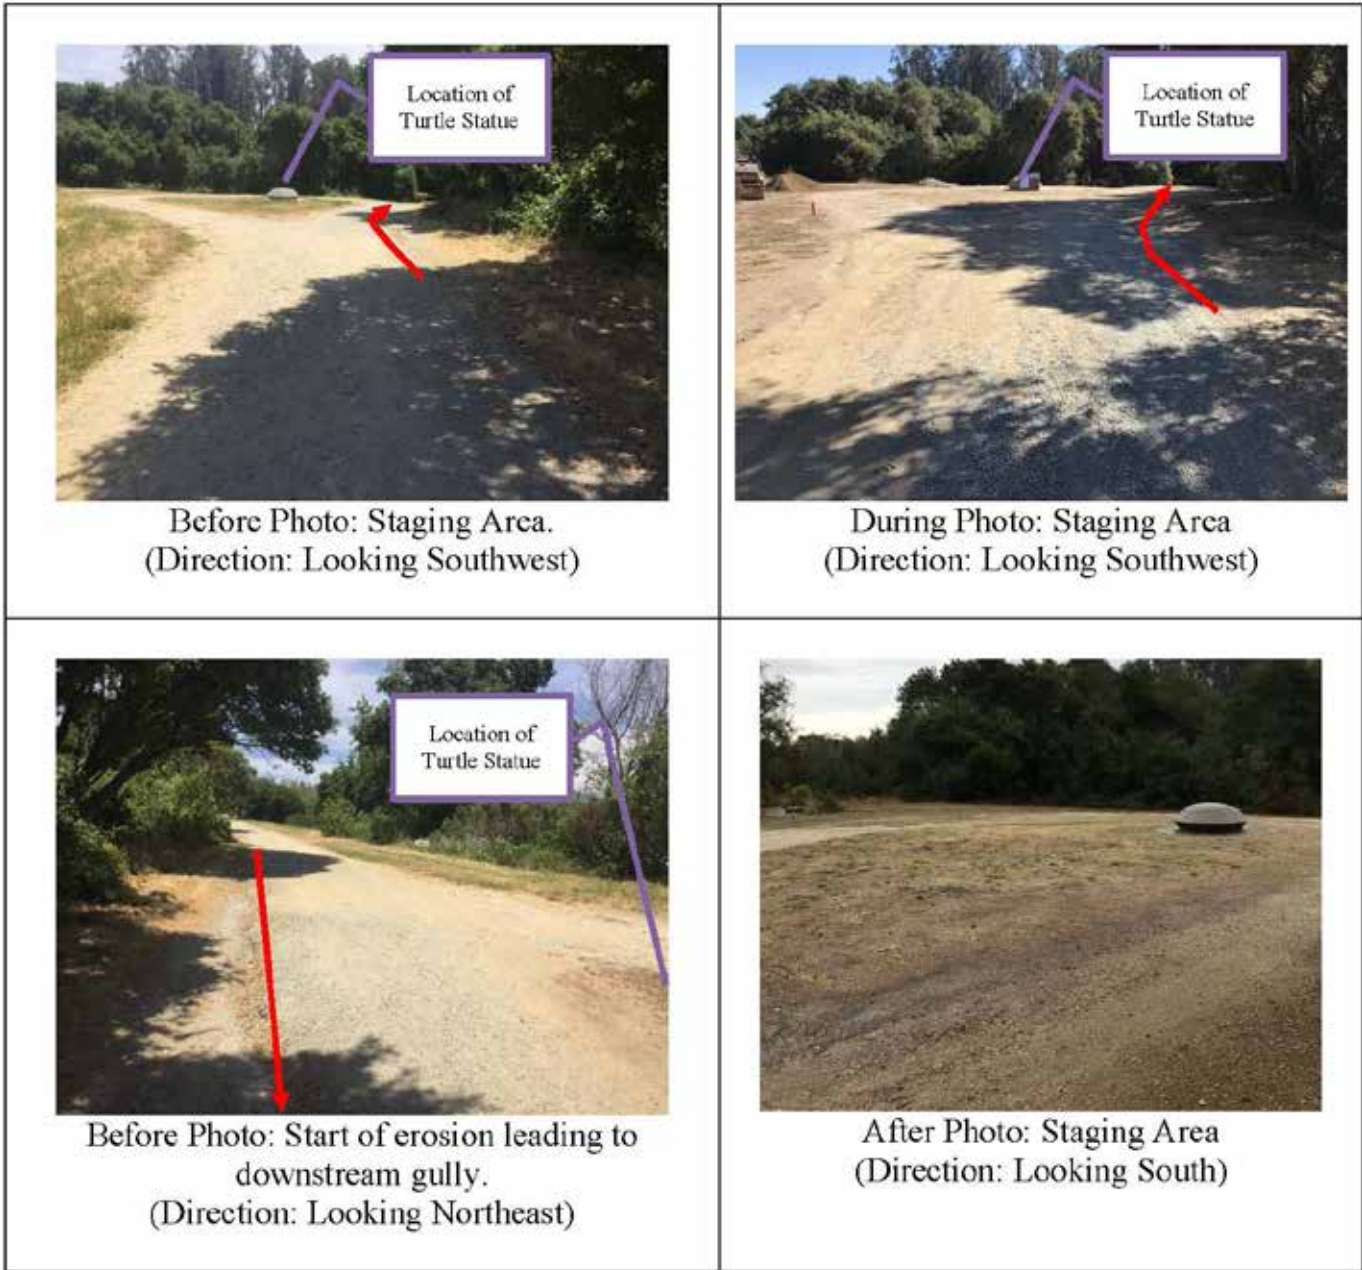
Figure 21 Before and after photos of the Virgin Mary Road Improvement Project, staging area.

The project constructed five (5) rolling dips, forty (40) linear feet of drainage swale, and repaired existing ruts on the road prior to the grading and installation of 950 sq ft of Class II aggregate road base. Prior to the project, there was considerable storm water that flowed down the road during the rainy season, carrying with it sediment from the roadway as well as landslides that were occurring adjacent to the road. The intent of the road improvement practices is to redirect storm water to reduce erosion and sediment inputs into the Amesti mainstem and Pinto Lake. This project was implemented under the Santa Cruz County Partners in Restoration Permit Coordination Program and required coordination with the following permitting agencies: CCRWCQB, CDFW and the Santa Cruz County Master Permit.

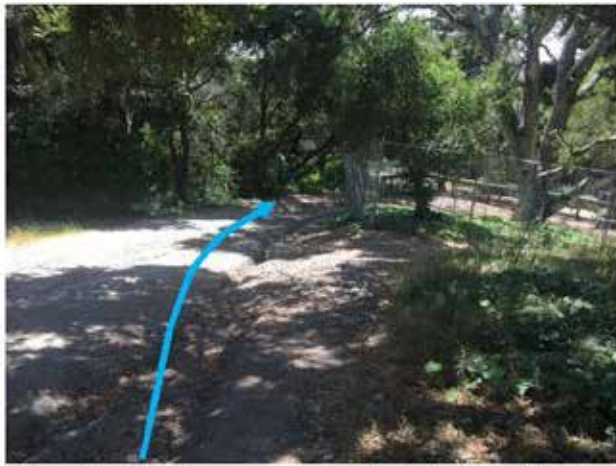
Before Photo: Approximate location of 72 linear feet of drainage swale. Gully can be seen adjacent and to the right of the blue line.
(Direction: Looking West)

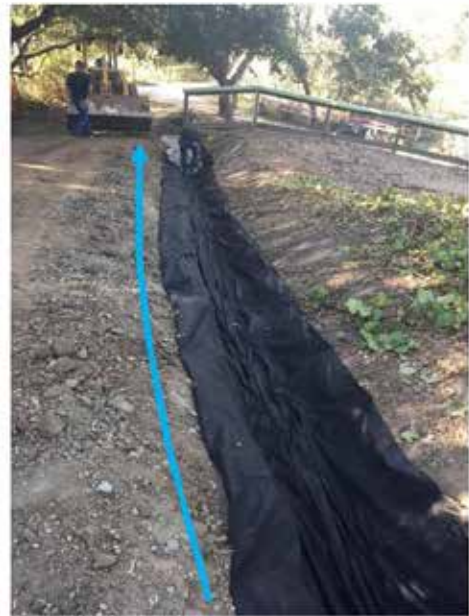
During Photo: Approximate location of 72 linear feet of drainage swale. Gully repair can be seen adjacent and to the right of the blue line.
(Direction: Looking West)

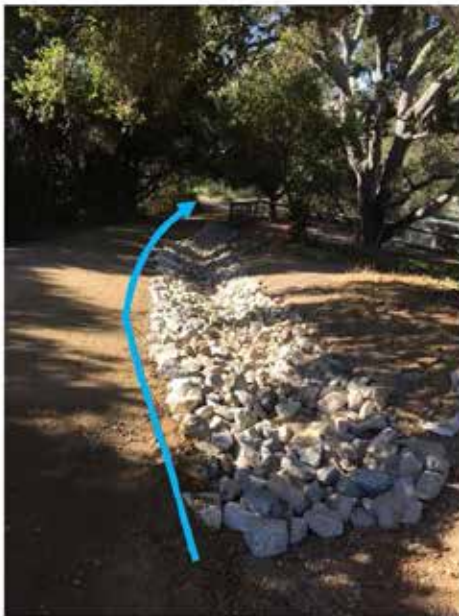
After Photo: Location of 72 linear feet of drainage swale.
(Direction: Looking West)

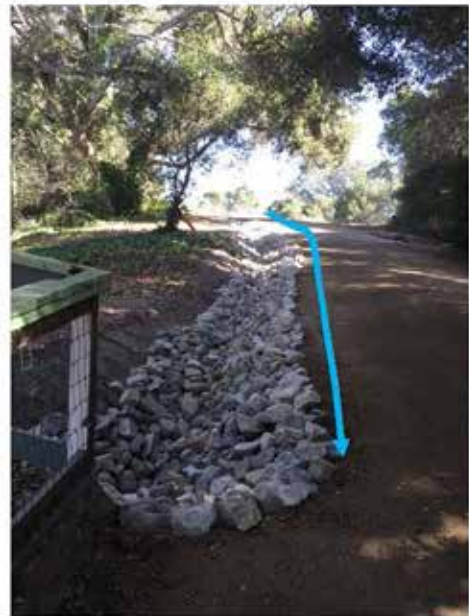
After Photo: Location of 72 linear feet of drainage swale.
(Direction: Looking East)

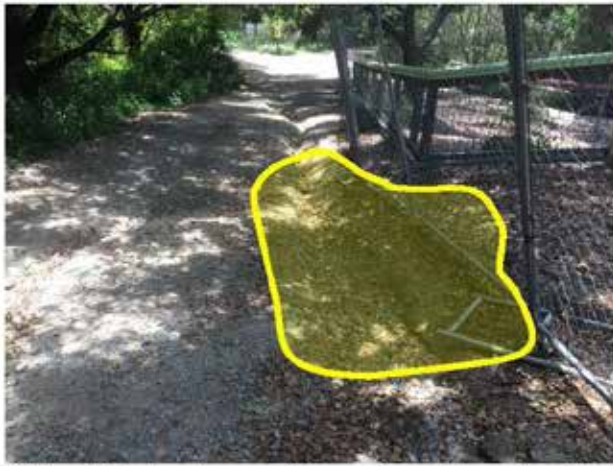
Before Photo: Approximate location of culvert inlet to transport water under the road. Gully can be seen adjacent and to the right of the blue line. (Direction: Looking West)

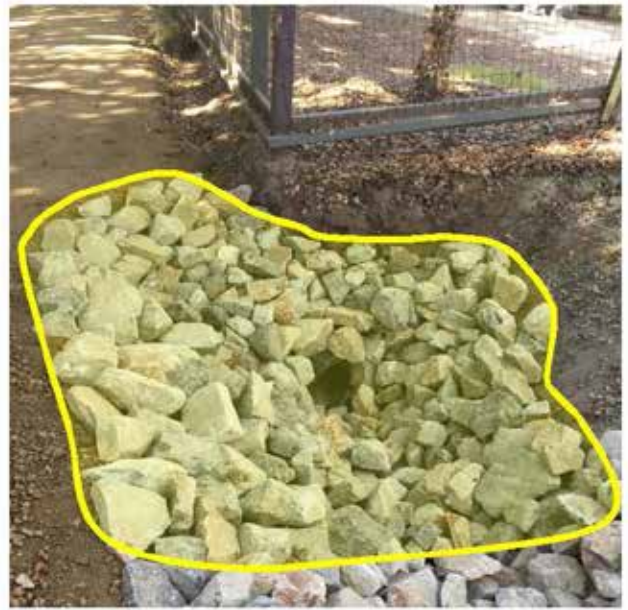
After Photo: Culvert inlet location. (Direction: Looking West)

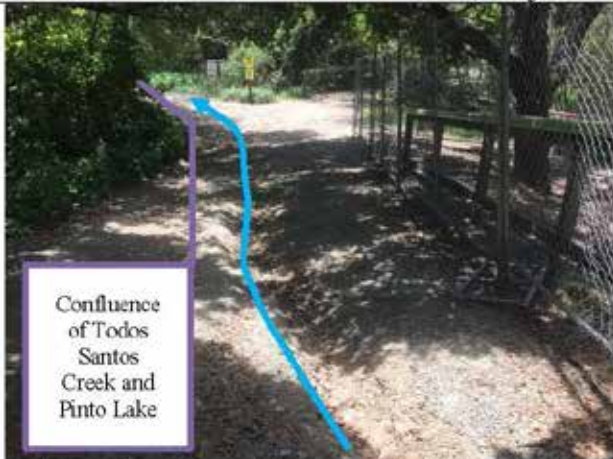
Photo 6: Bottom Section of the Road, Adjacent to Pinto Lake.

Before Photo: Erosion can be seen on bottom section of road before it drains to lake. Gully can be seen adjacent and to the right of the blue line. (Direction: Looking West)

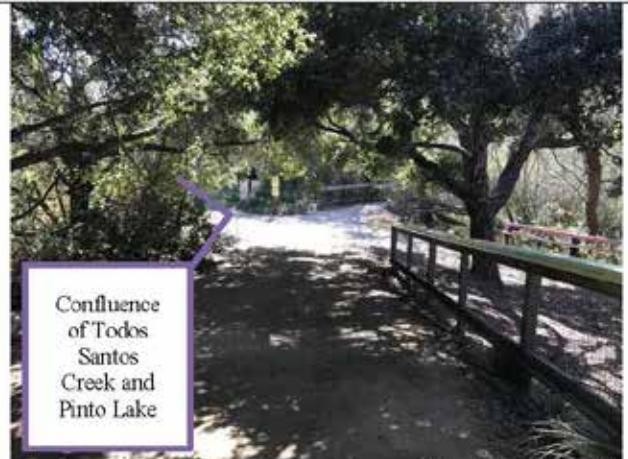
After Photo: Gully has been filled and road has been sloped to address future surface flows. (Direction: Looking West)

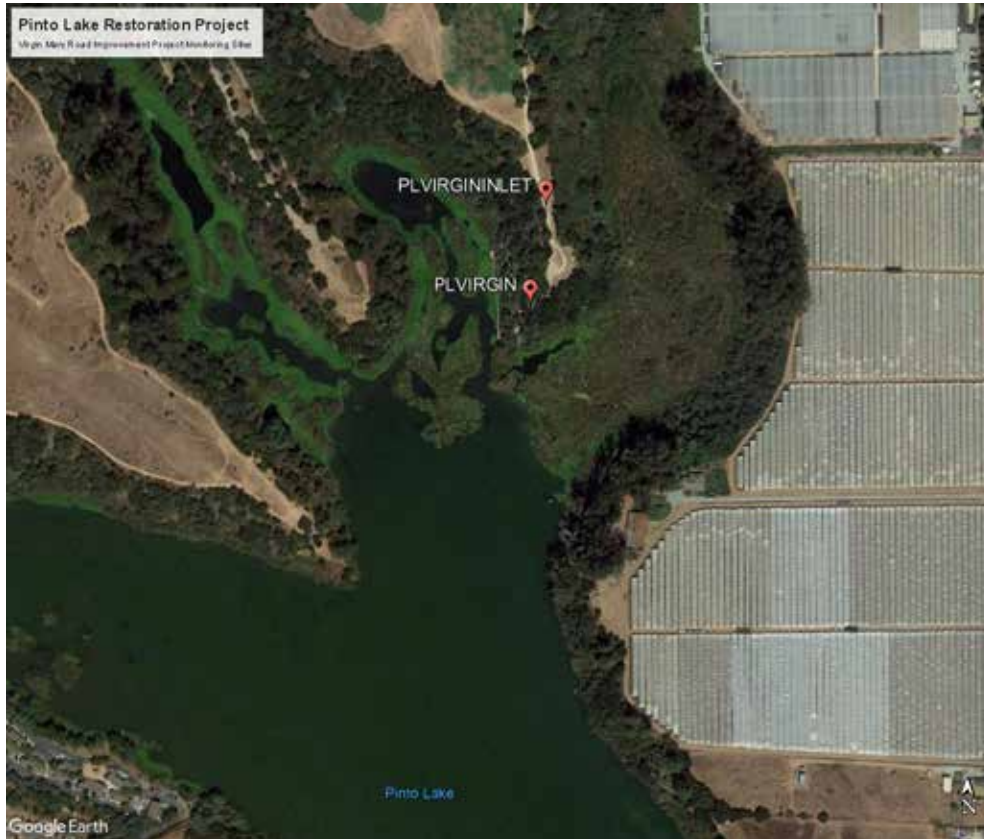
Figure 26 The Virgin Mary Road Improvement Project monitoring sites of the Pinto Lake Restoration Project.

After the rolling dips were constructed, the intent was to monitor the stormwater runoff entering and exiting the dips. However, the dips were 100% successful in diverting runoff into surrounding vegetation, leaving no runoff to exit the Dips (at the PLVIRGINsite) into Pinto Lake. Therefore, samples were taken at a point entering the Dips (PLVIRGININLET).

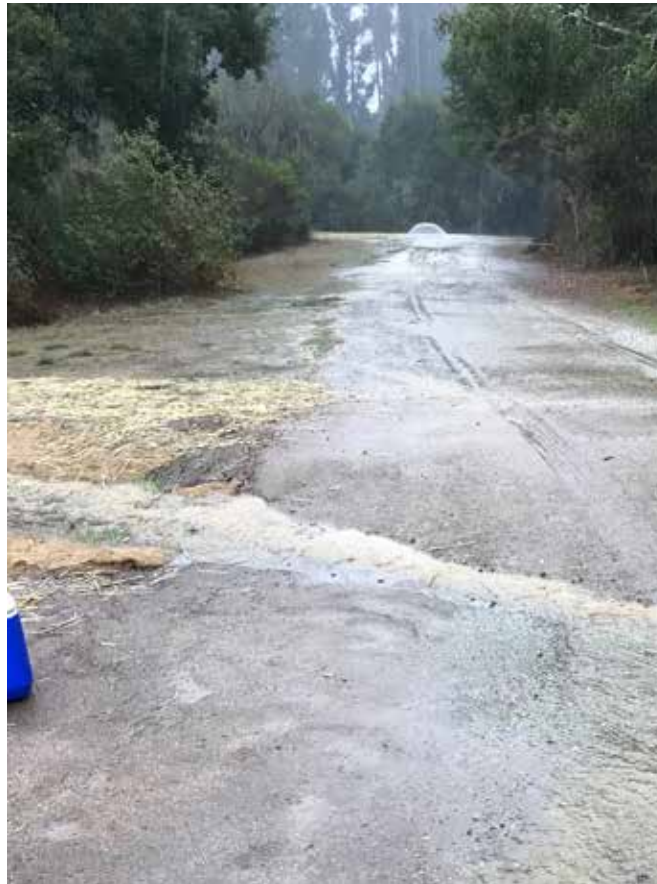
Photo 30 At the first Rolling Dip, on the Virgin Mary Road Improvement Project, during an active storm, November 16, 2017.

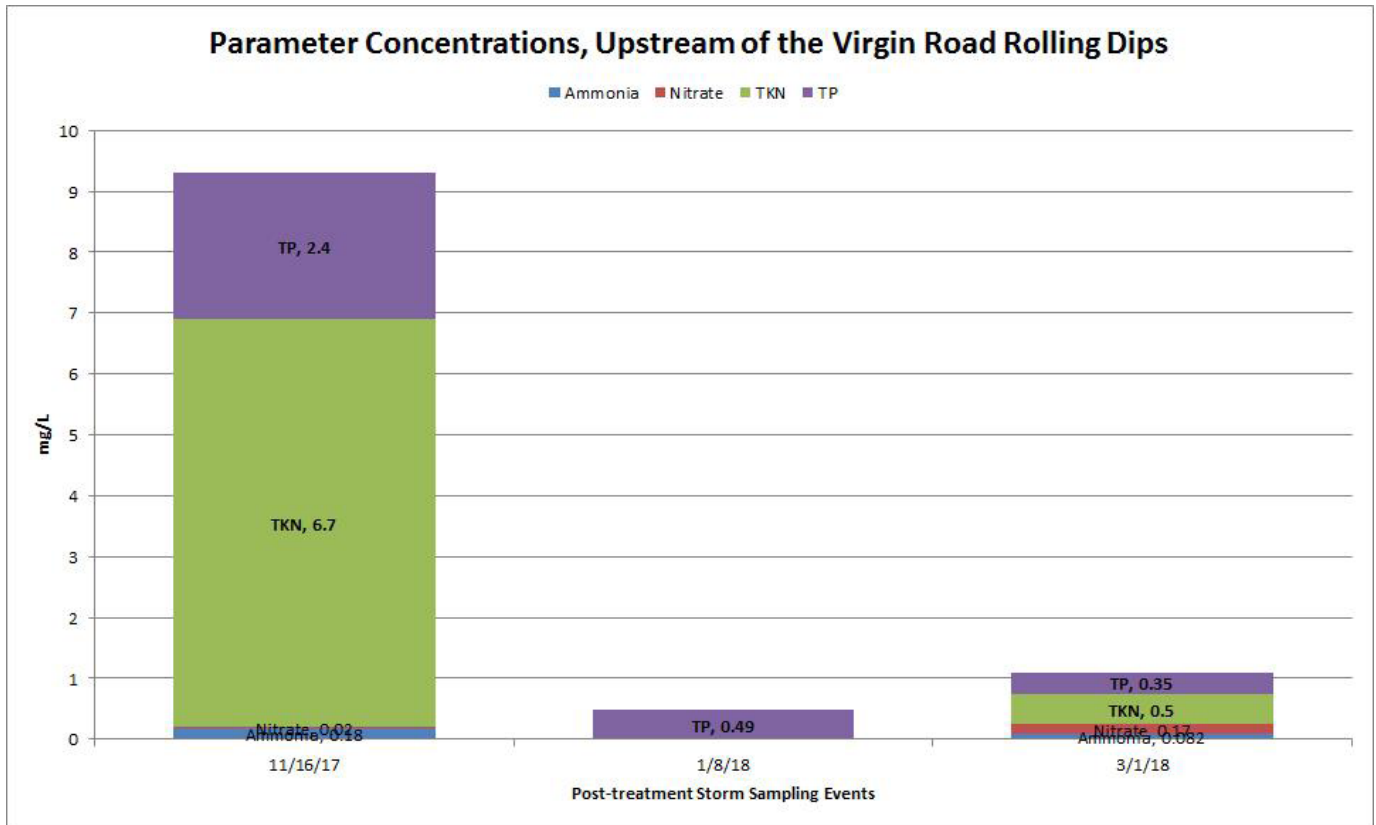
Figure 27 The monitored parameter concentrations upstream of the rolling dips.

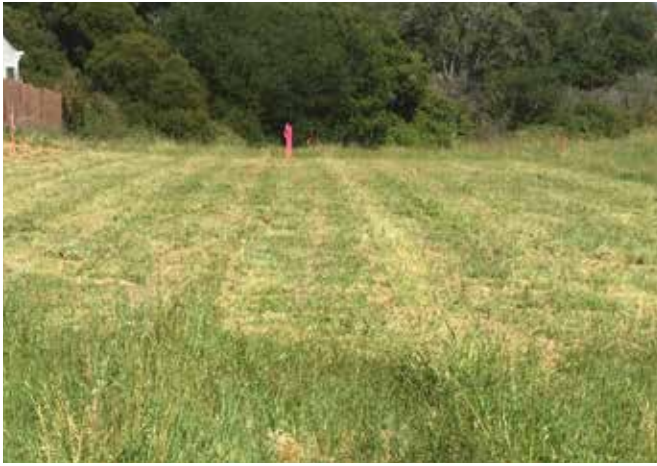
Photo 31 Before photo of location of County Park Pump Track Filter Strip Project. Looking downstream towards the riparian area adjacent to Todos Santos (trees seen in background of photo).

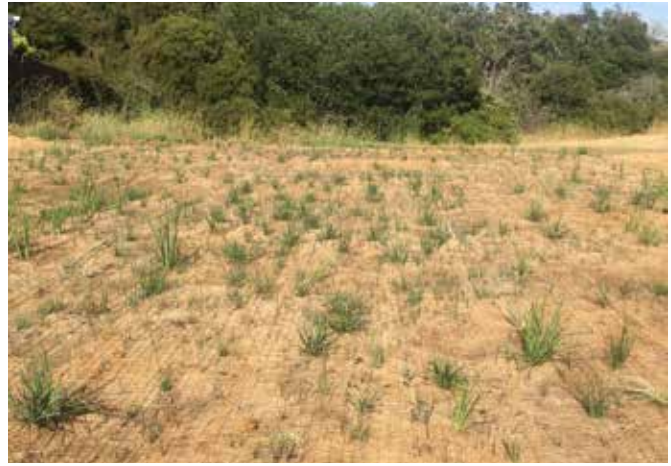
Photo 32 After photo of newly planted County Park Pump Track Filter Strip Project. Looking downstream towards the riparian area adjacent to Todos Santos (trees seen in background of photo).

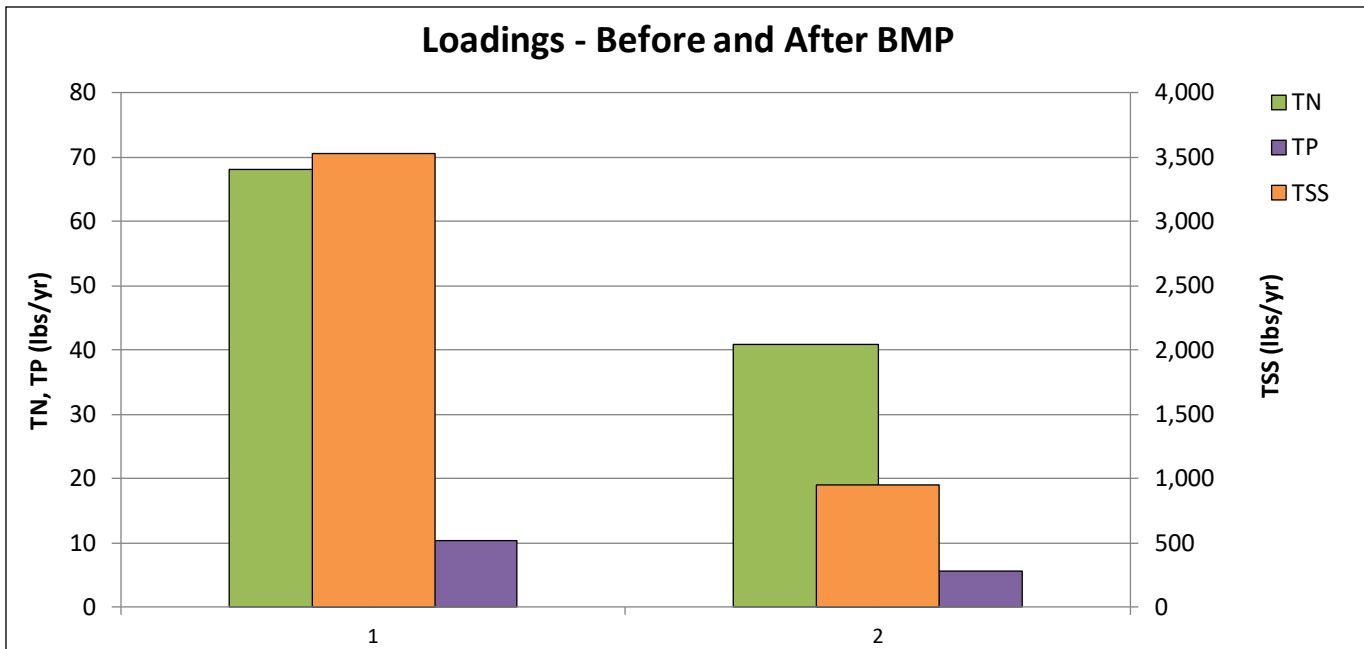
Figure 28 The estimated load reduction before and after the implementation of the County Park Pump Track Filter Strip

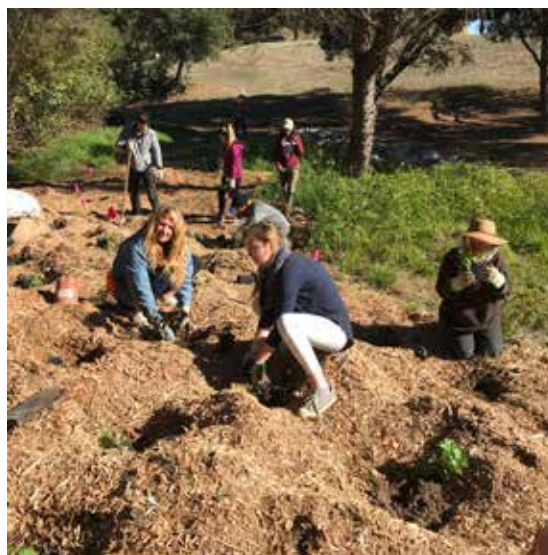
Photo 33 Volunteers helped put over 350 native plants in the ground surrounding the sediment basin at Pinto Lake.

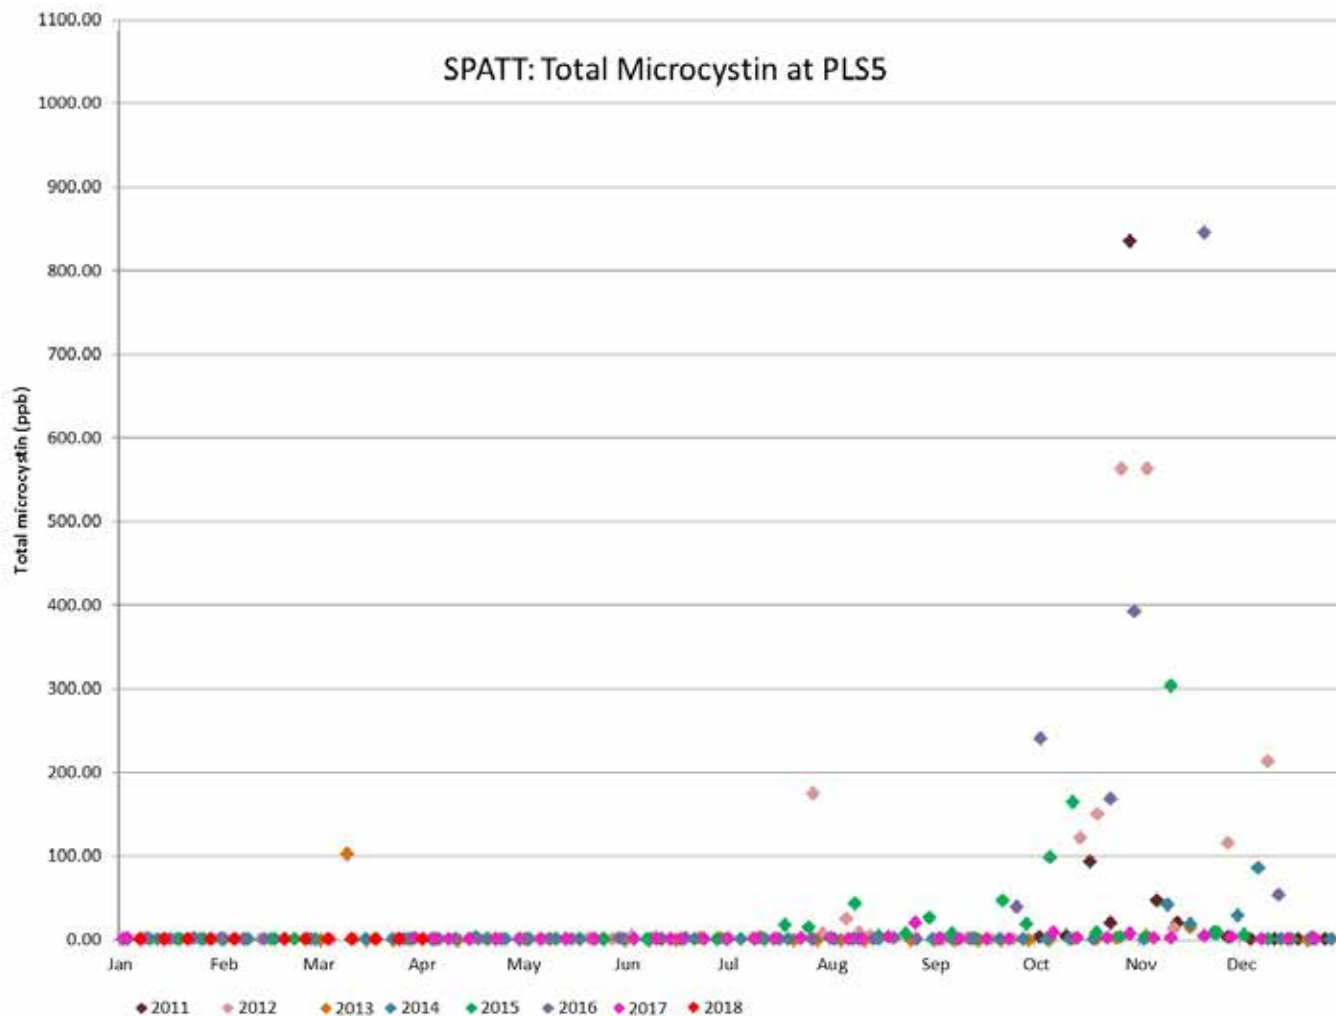
Figure 30 The total microcystin, spanning alum treatment, measured by Raphe Kudela at the Pinto Lake City Park dock (PLS5)
