**OUTLINE OF ATTACHMENTS AND SLIDES
FOR PRESENTATION TO LAHONTON BOARD -MARCH 9, 2017 at 8:30am
DONNER LAKE POLLUTION PROBLEMS
By Emilie Kashtan**

DONNER LAKE POLLUTION PROBLEM

PRESENTED BY EMILIE KASHTAN

MARCH 9, 2017

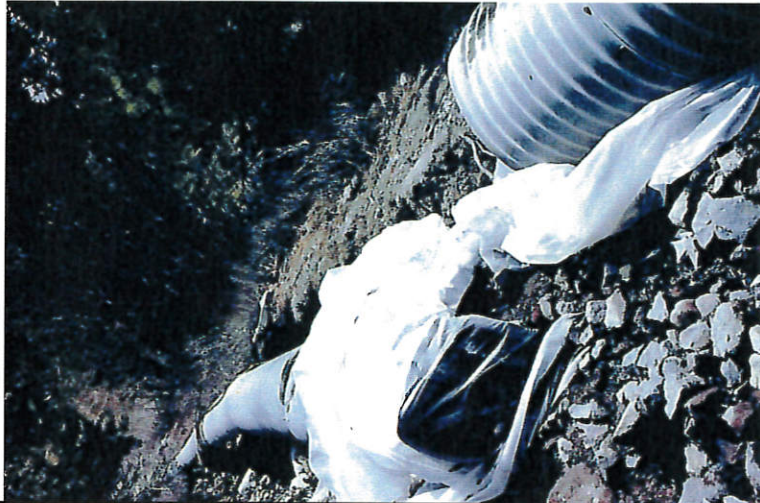
1. COURT IDENTIFIED UNDER ENGINEERED INTERSTATE 80 CULVERTS CAUSING SHEETING DRAINAGE AND EROSION DUE TO THE LACK OF CULVERTS AND MAINTENANCE OF DRAINAGE DITCHES

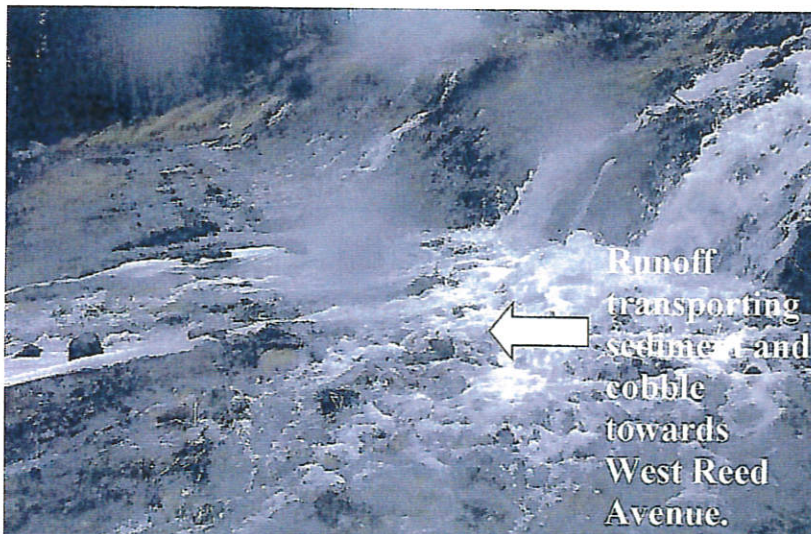
2. A GRADED ROAD ACROSS THE HILLSIDE ON THE MONTANO PROPERTY IN ASSOCIATION WITH THE TRUCKEE DONNER PUD, BOTH SIDE STEPPING TOWN REQUIRED DRAINAGE MITIGATIONS THAT THE TOWN HAS YET TO ENFORCE, POSSIBLY DUE TO A CONFLICT OF INTEREST. CAUSING MASSIVE HILLSIDE SHEETING AND EROSION DUE TO LACK OF DRAINAGE STRUCTURES

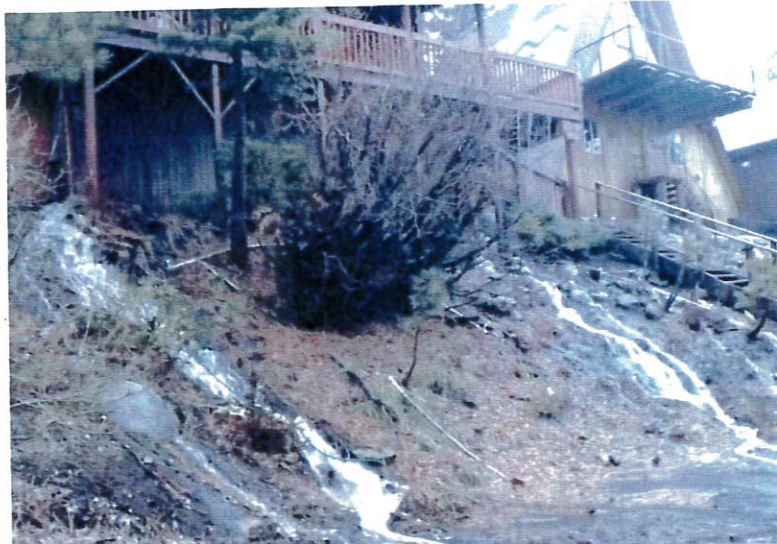
3. THE TOWN OF TRUCKEE FAILING TO MINIMALLY MAINTAIN THEIR PUBLIC RIGHT OF WAY, WEST REED AVENUE'S DRAINAGE DITCHES, CLOGGED UNDER ROAD CULVERTS AND THE ROAD SURFACE, ALL CAUSING EXCALATING PROPERTY DAMAGE, ROAD DISTRUCTION AND FLOODING INTO DONNER LAKE

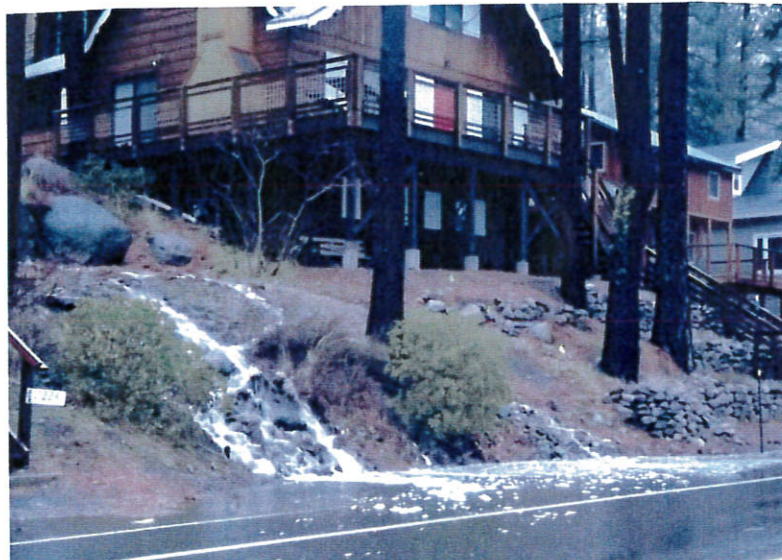
4. THE TOWN'S "DONNER LAKE ROAD BIKE AND DRAINAGE PROJECT " HAS COMPROMISED DRAINAGE IN IN SELF ADMITTED COST CUTTING MEASURES CAUSING SHEETING ACROSS THE ROAD AND INTO DONNER LAKE

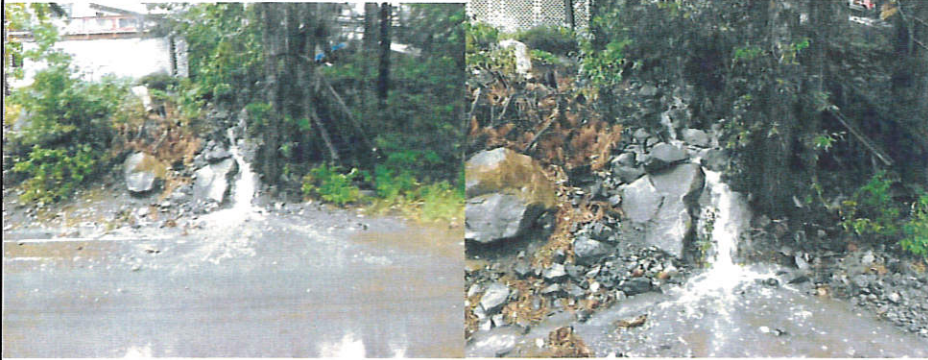
**A simple rain event continues to cause flooding
from the lack of maintained drainage structures on W. Reed Avenue, causing
property erosion and sheeting of unfiltered erosion and drainage sheeting into Donner Lake
July 2016 at 15034 Donner Pass Road**

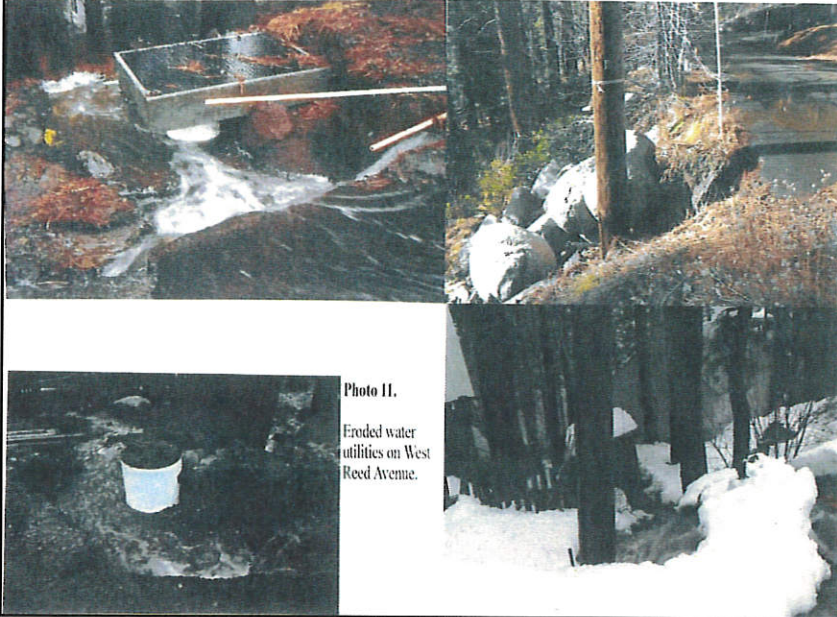
WEST REED EROSION AND FLOODING AROUND UTILITIES DUE TO A LACK OF DRAINAGE DITCHES

Photo 11.
Eroded water utilities on West Reed Avenue.

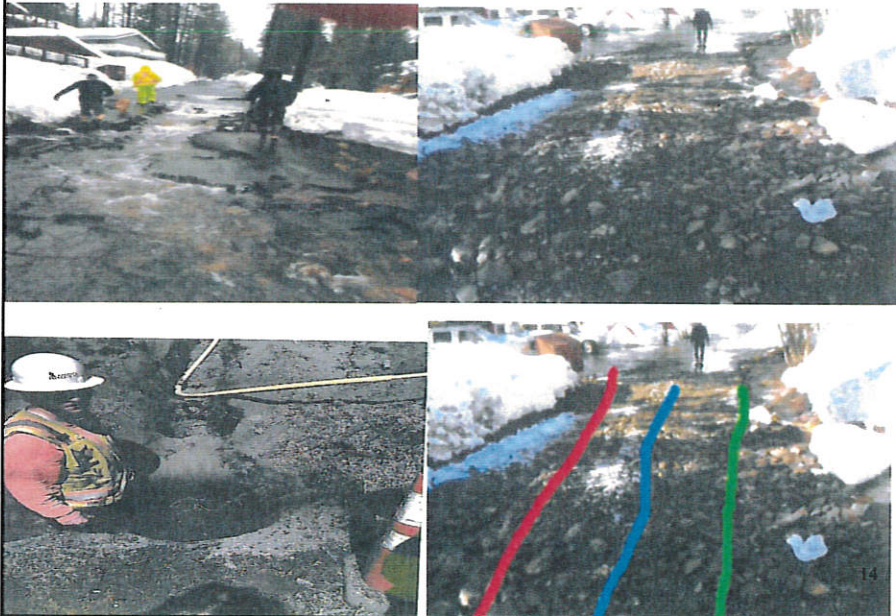
WEST REED AVENUE-THE RESULT OF THE TOWN DIVERTING DRAINAGE OFF DONNER LAKE AND NOT REPAIRING THE PARRELL UNDER ROAD CULVERTS

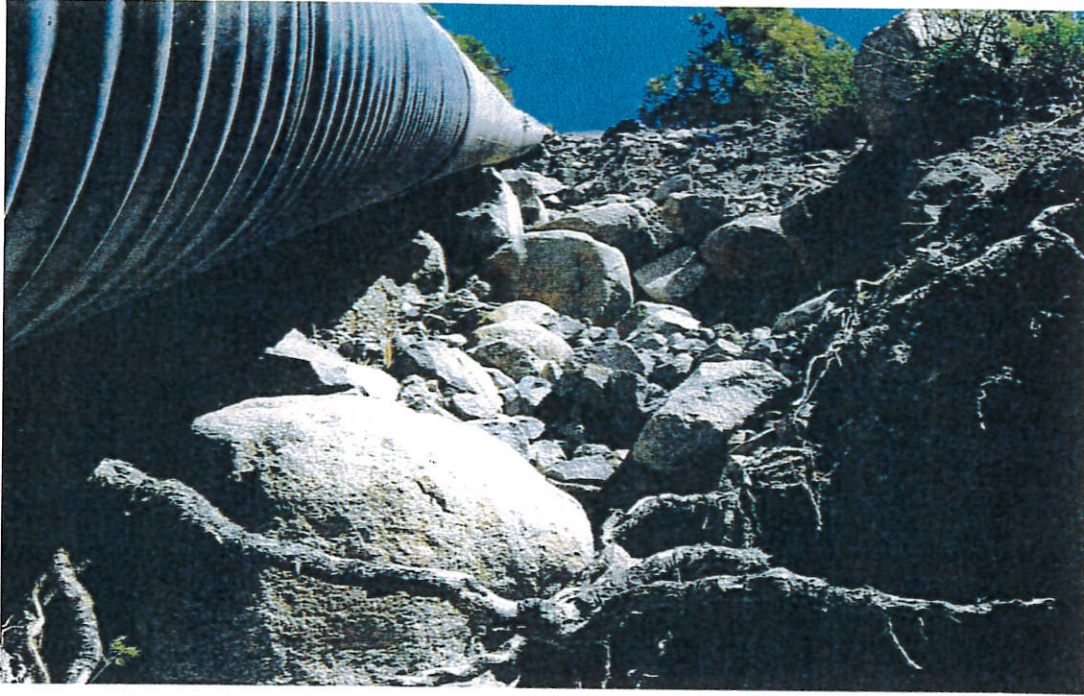
Photo 1. Looking upslope along at the Caltrans culvert on the east end of the hillside above West Reed Avenue. Photo taken June 6, 2006.

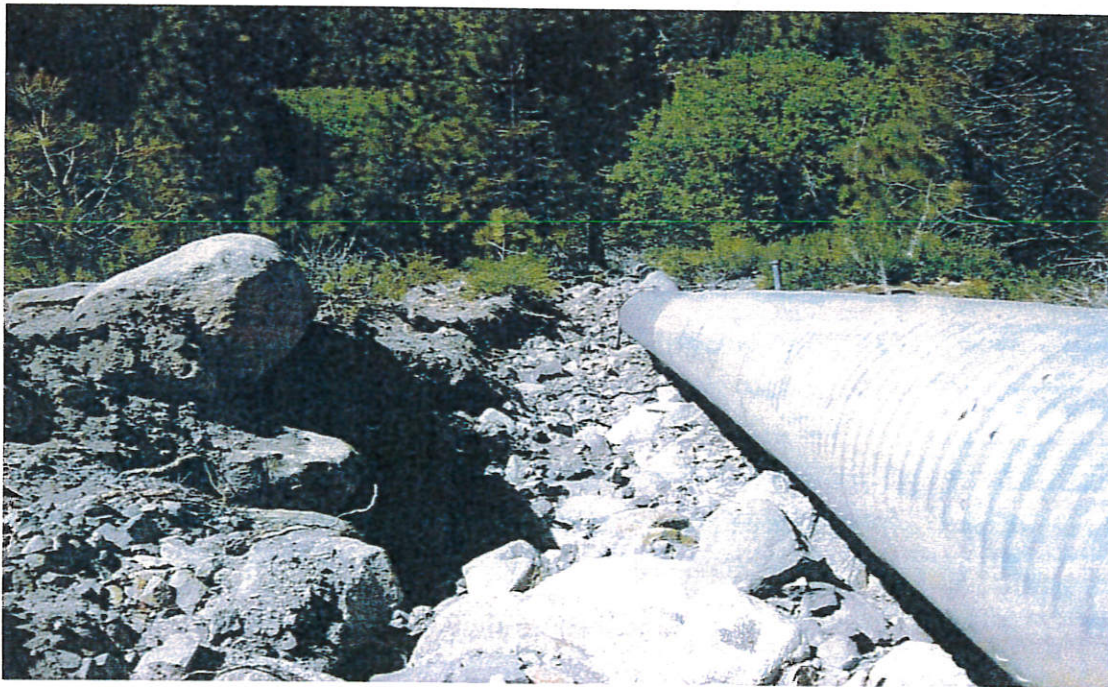
Photo 2. Looking downslope along the culvert where eroded material is being transported down the hillside above West Reed Avenue. Photo taken June 6, 2006.

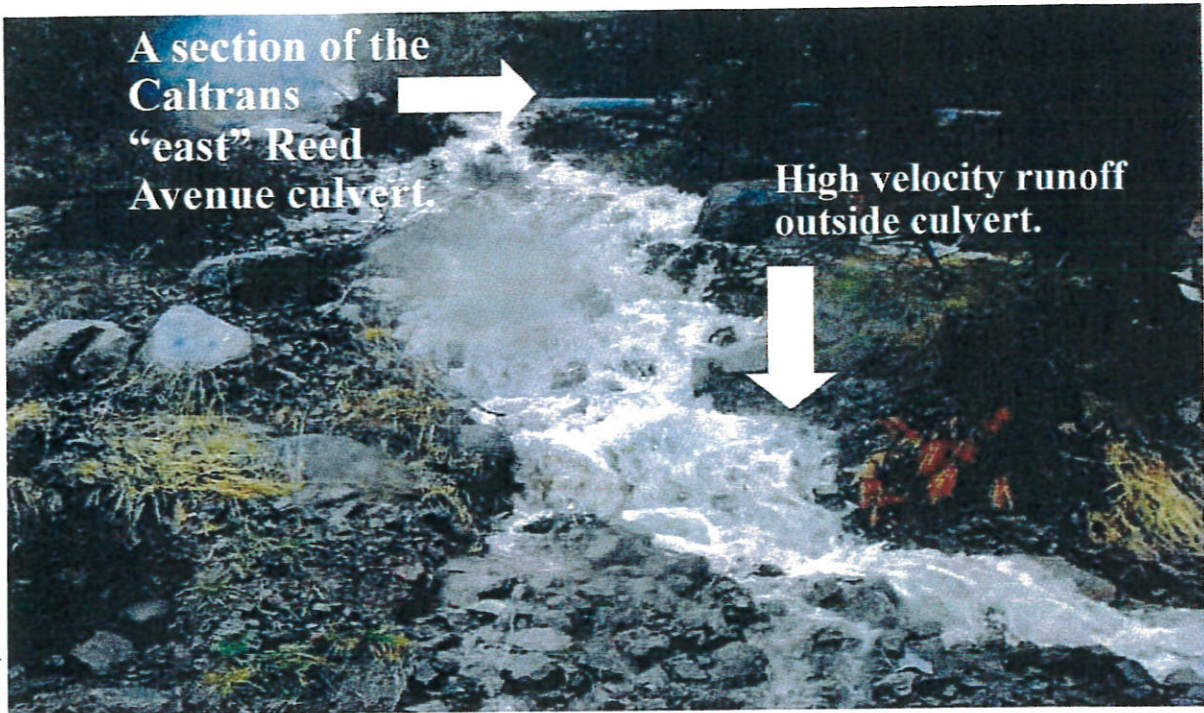
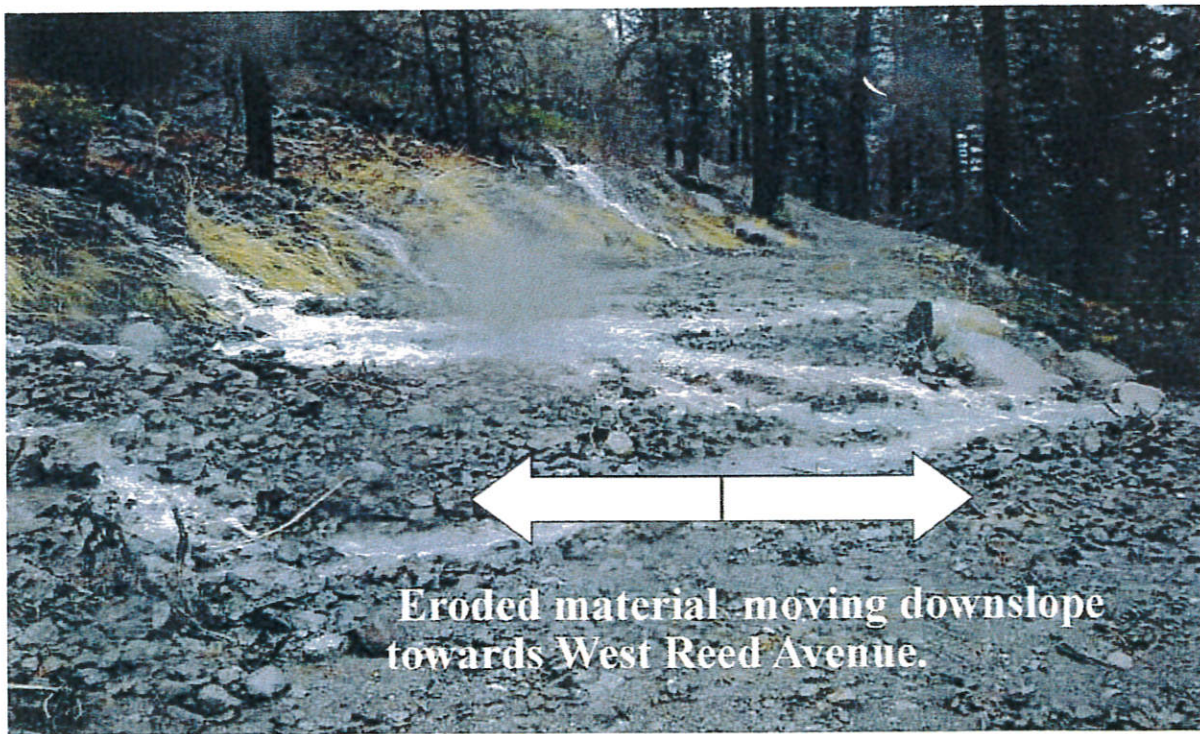
Photos 3 and 4. High velocity runoff outside Caltrans culvert and eroded material being transported downslope. Photo taken December 31, 2005.

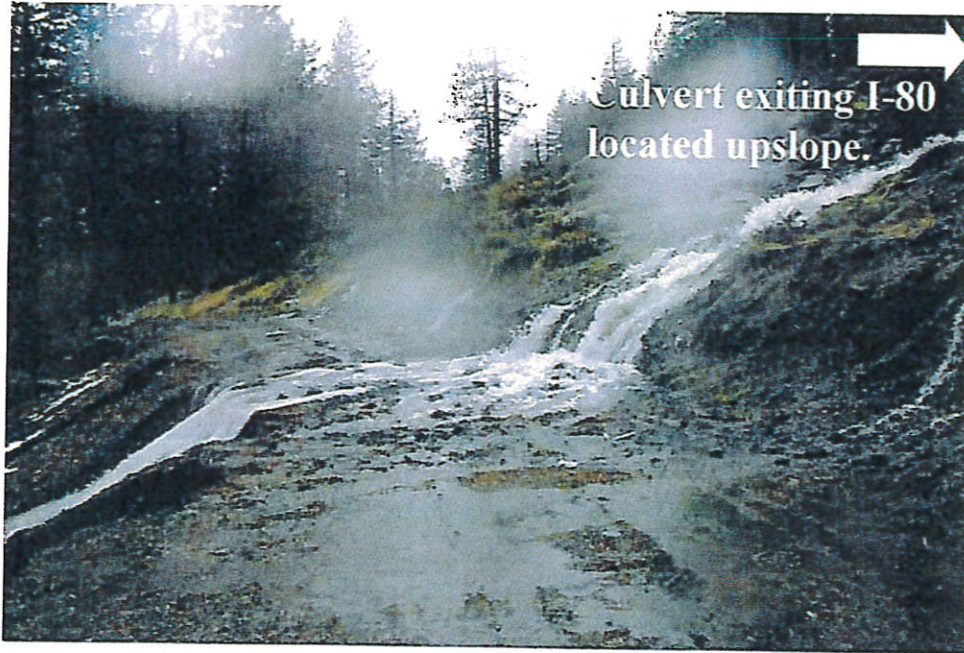
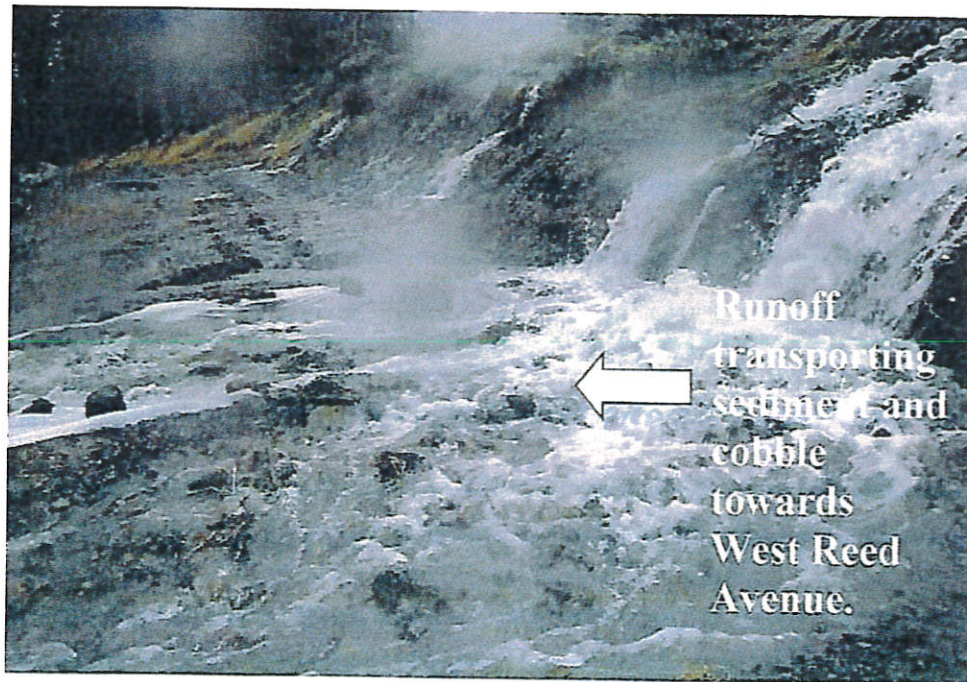
Photos 5 and 6. Culvert runoff from I-80 flowing towards West Reed Avenue. Photos taken December 31, 2005.

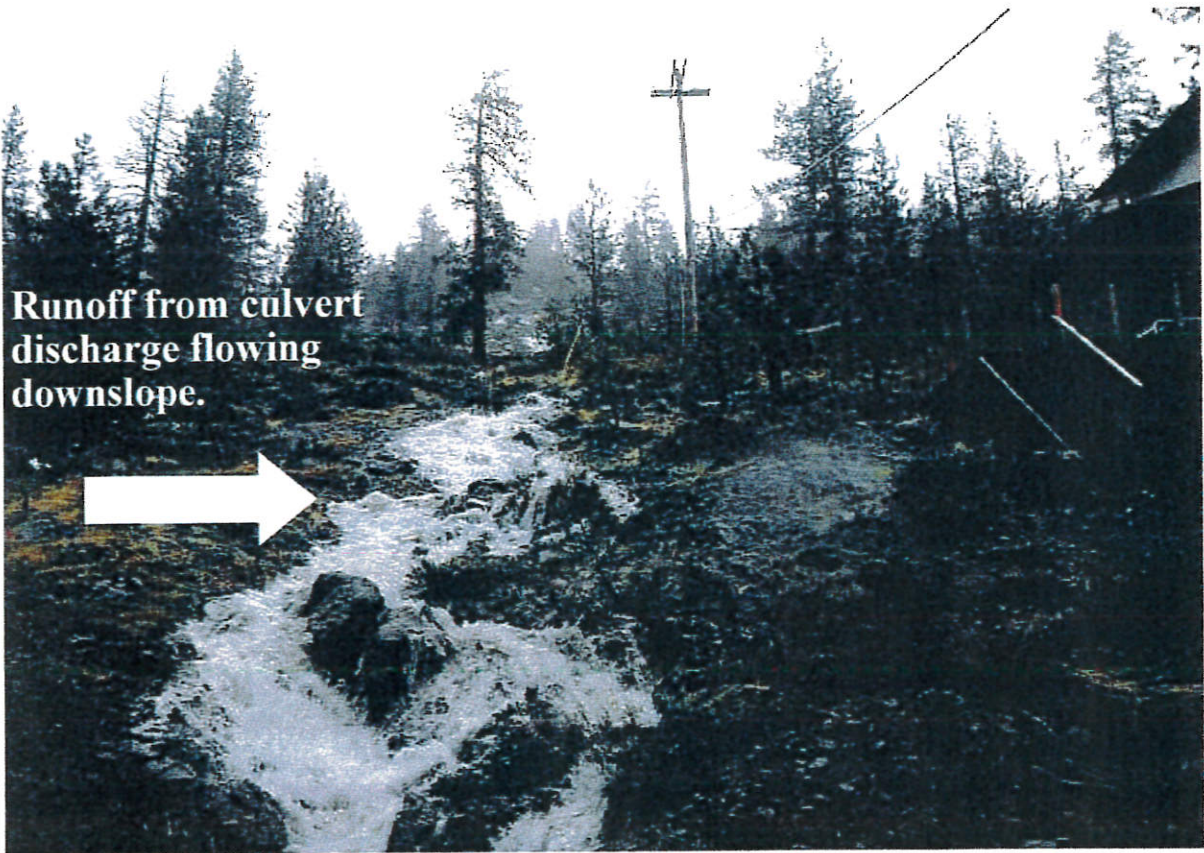
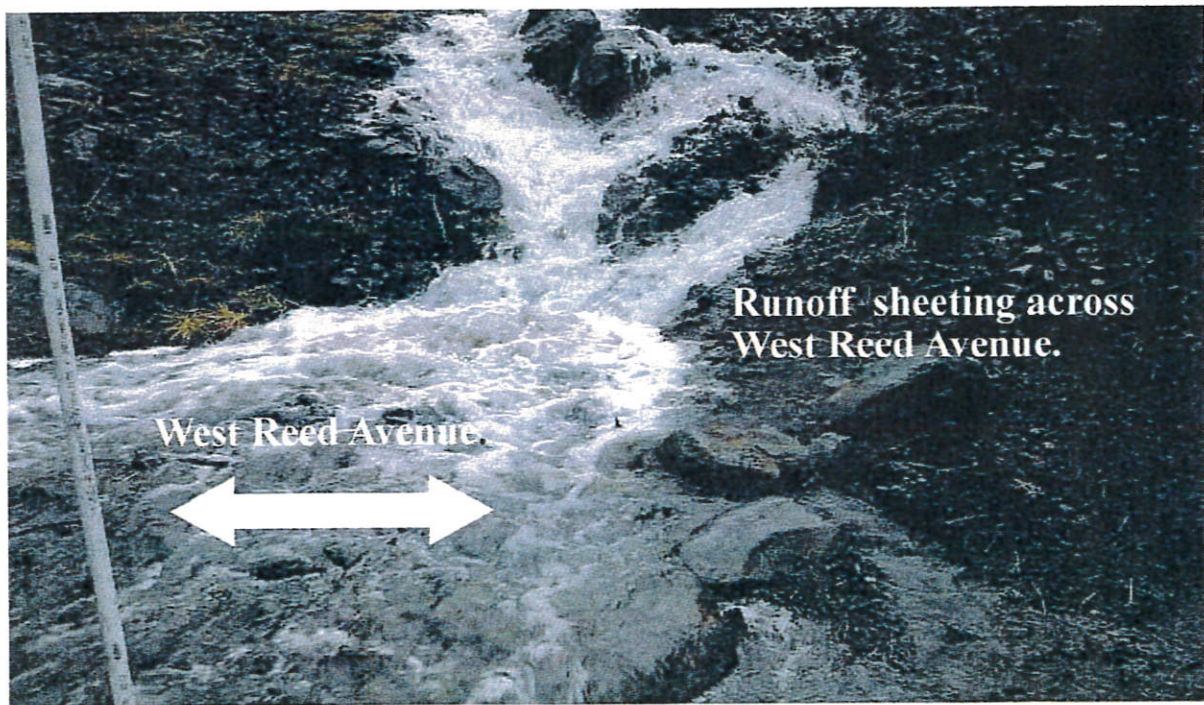
Photos 7 and 8. Runoff discharging from culverts under I-80 moving downslope towards West Reed Avenue. Photos taken December 31, 2005.

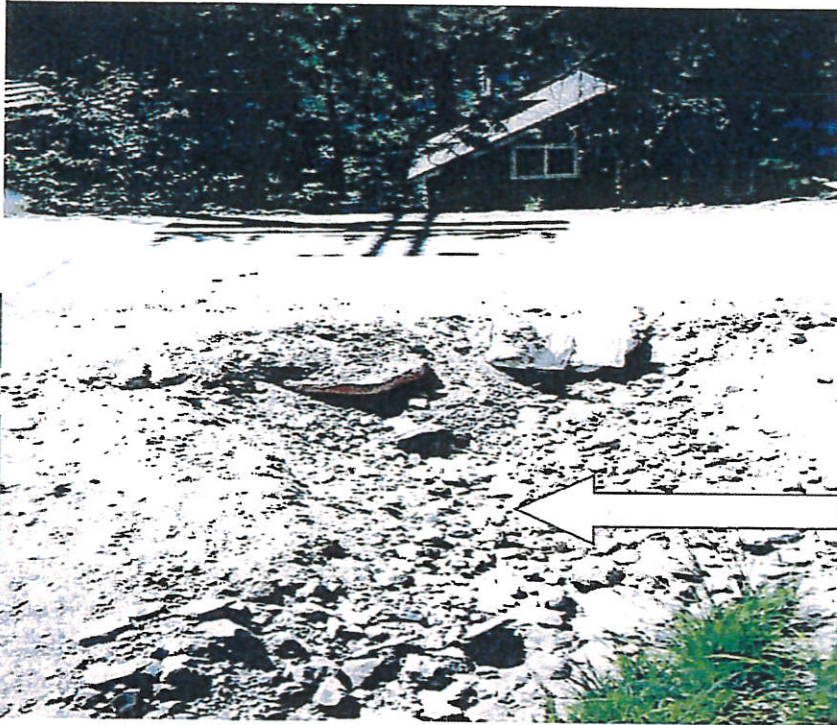
Culverts are clogged and one is completely buried with sediment, cobble, and gravel from uphill erosion.

Photo 9. Culverts on the north shoulder of West Reed Avenue have been clogged by debris transported down the hillside. Photo taken May 29, 2006.

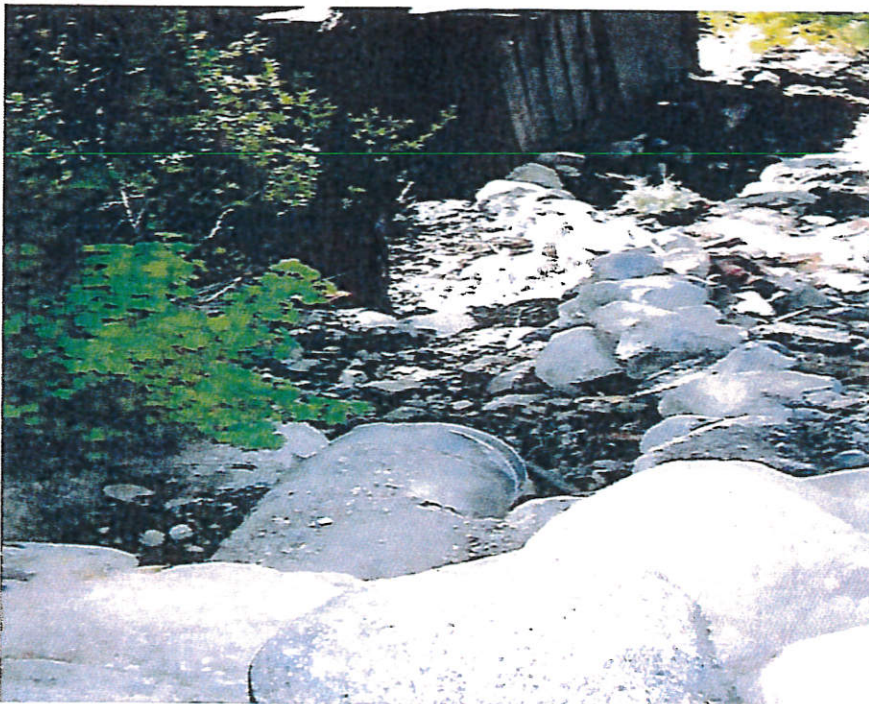
Photo 10. A culvert outfall on the south side of West Reed Avenue does not convey runoff effectively as debris clogs the inlet on the north side of the road. Photo taken May 29, 2006.

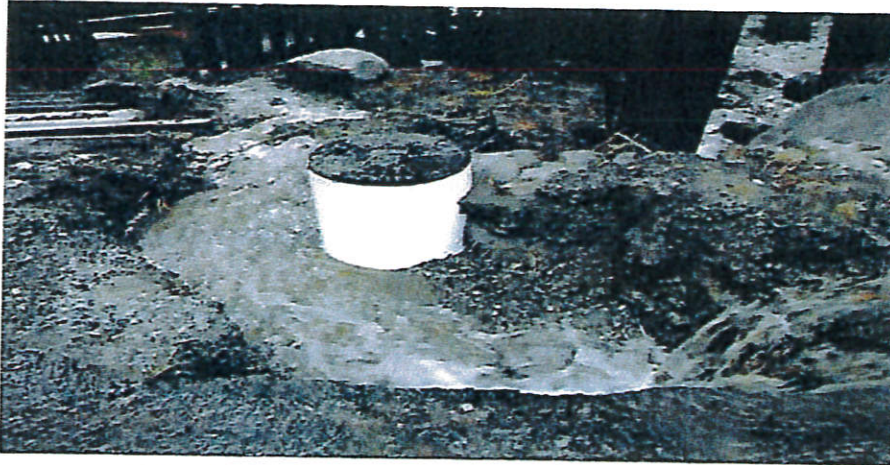
Photo 11.
Eroded water utilities on West Reed Avenue.

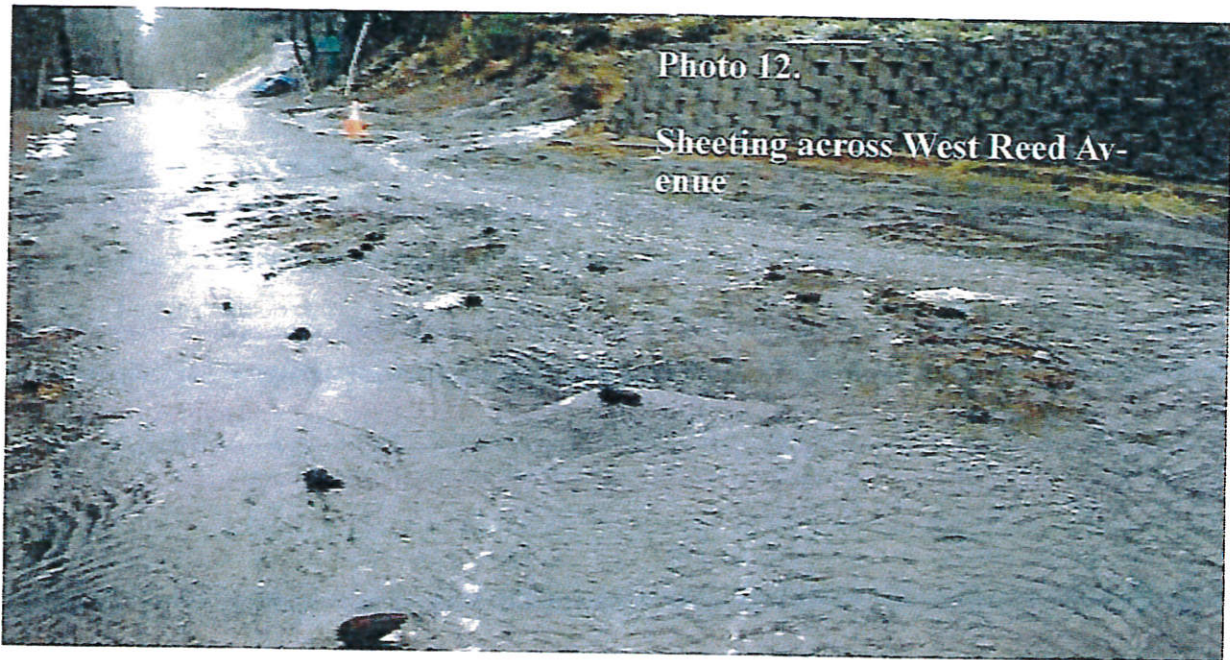
Photo 12.
Sheeting across West Reed Avenue

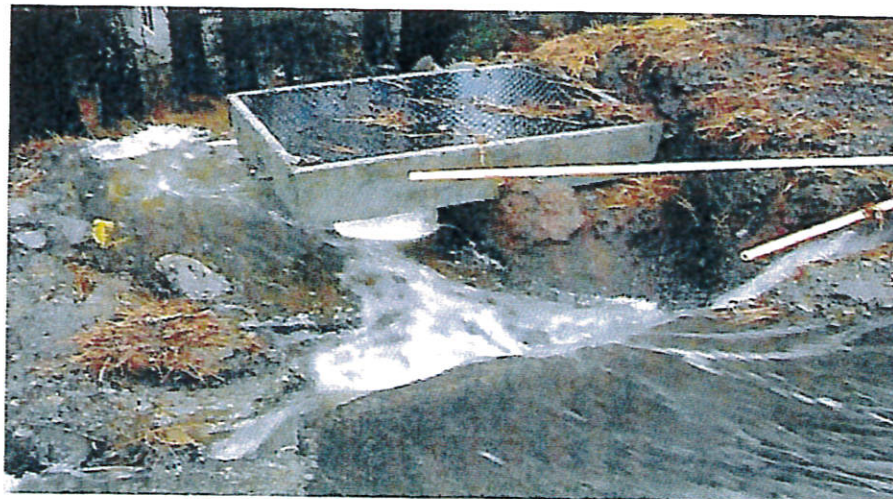
Photo 13.
Eroded water utilities on West Reed Avenue.

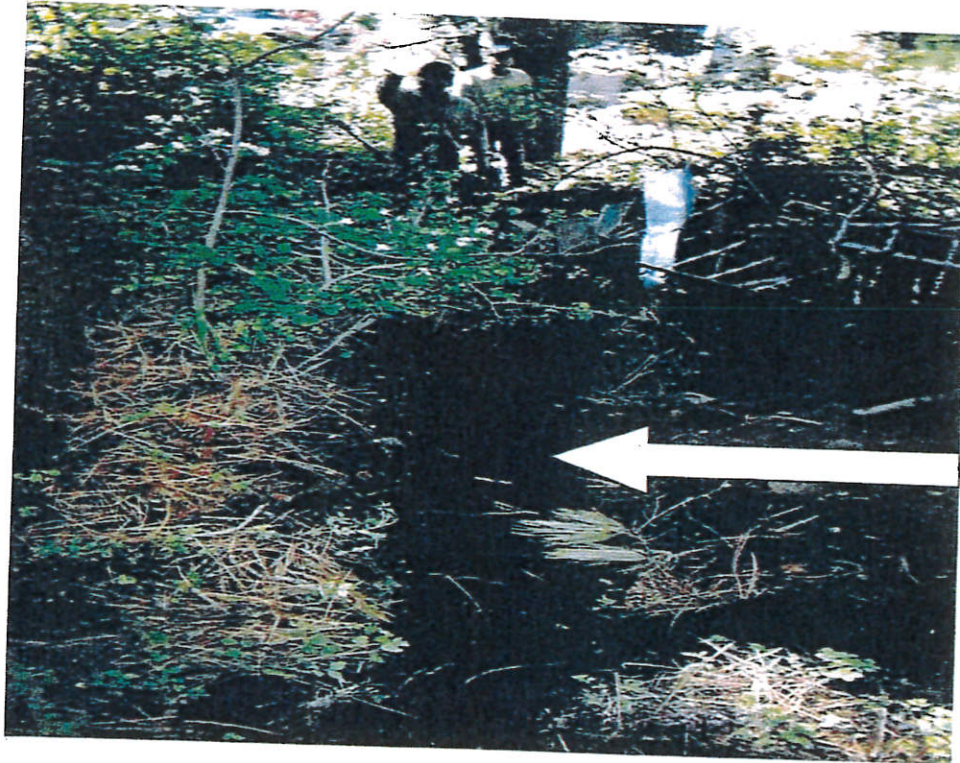
New
Drainage
Ditch.

Photo 14. A new drainage ditch below West Reed Avenue that was being dug on May 29, 2006 to convey runoff to Donner Pass Road.

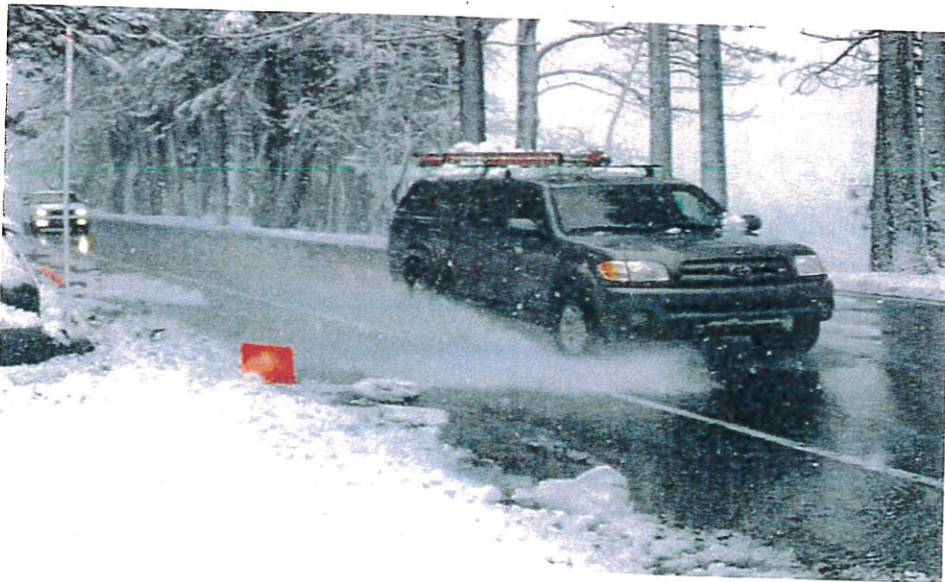
Photo 15. Between the residences of 15214 and 15234 Donner Pass Road runoff was observed sheeting across the road during several of the 2005/2006 rain storms (E. Kashtan, pers. comm. 2006). Vehicles kick up both water and erosion debris that can impact garages.

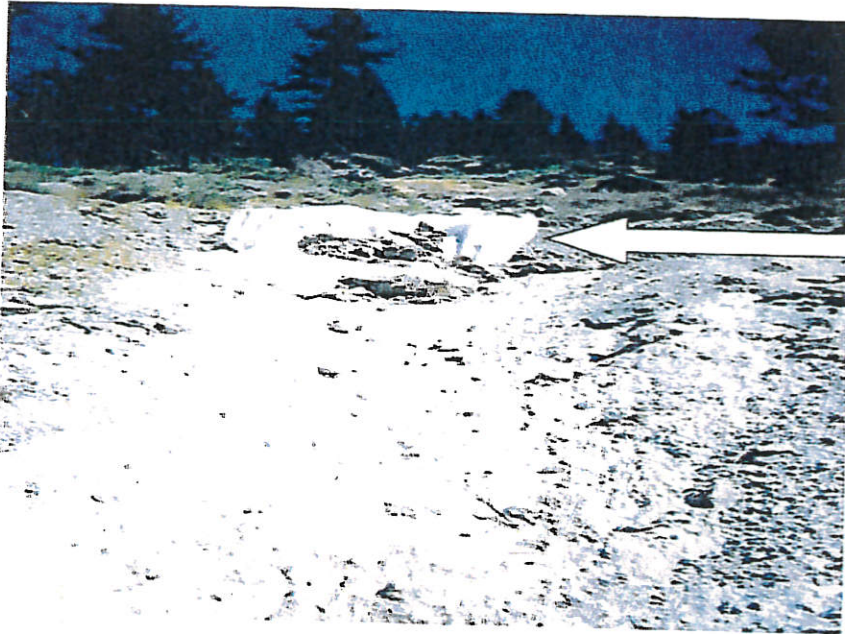
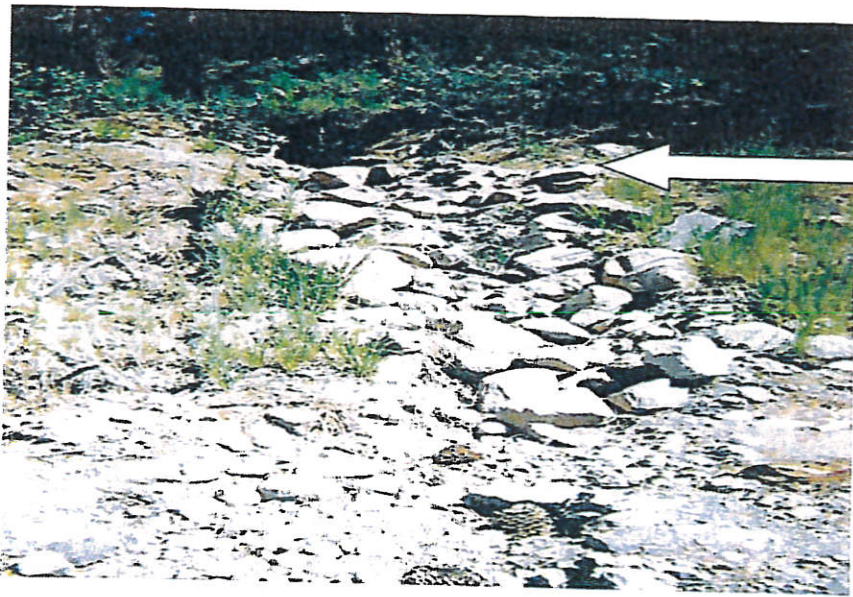
Erosion has occurred on the Cedar Point alignment from I-80 culvert runoff and needs to be repaired and restored.

This drainage channel eroded due to high velocity runoff

Photos 21 and 22. Areas along the Cedar Point Pipeline Alignment that require improvements. Photos taken May 29, 2006.

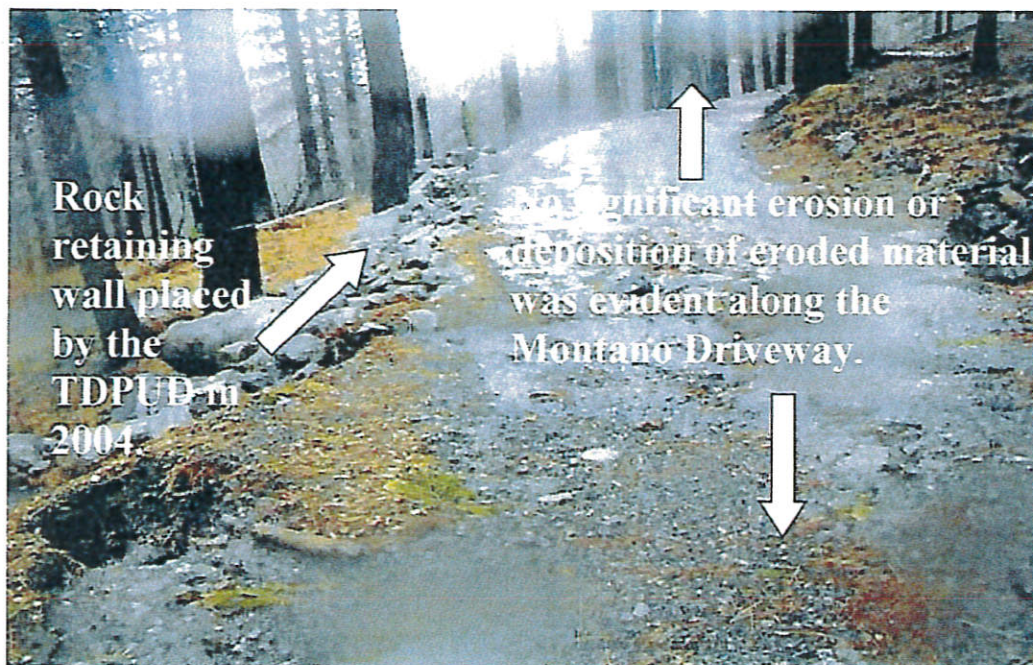
Photo 26. The west end of the TDPUD’s Cedar Point pipeline alignment through the Robert Montano property that is planned for asphalt paving. Photo taken December 31, 2005.

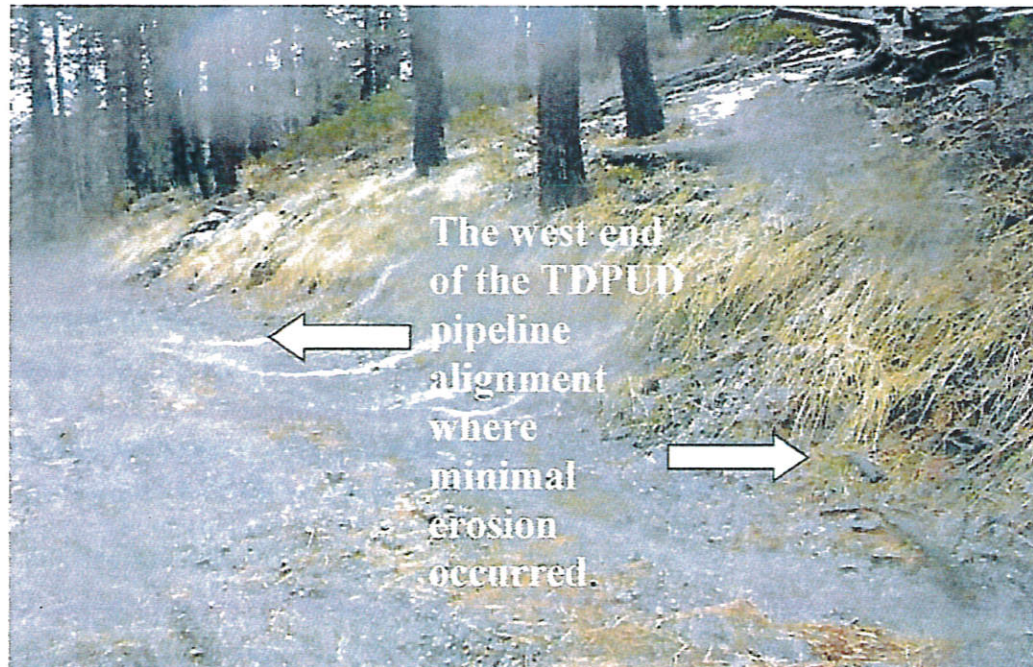
Photo 27. A section of the west end of the TDPUD’s Cedar Point pipeline alignment. No substantial erosion is occurring along the alignment. Photo taken December 31, 2005.

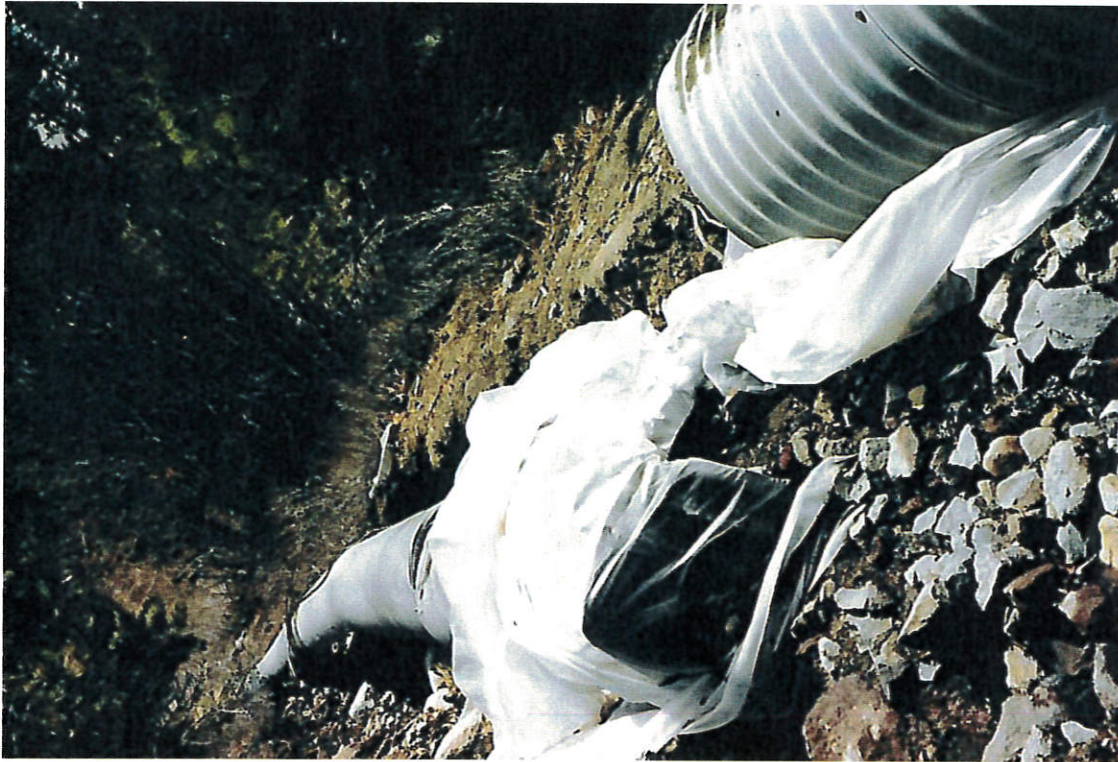
A. INTERSTATE 80 ABOVE GREEN POINT SUBDIVISION

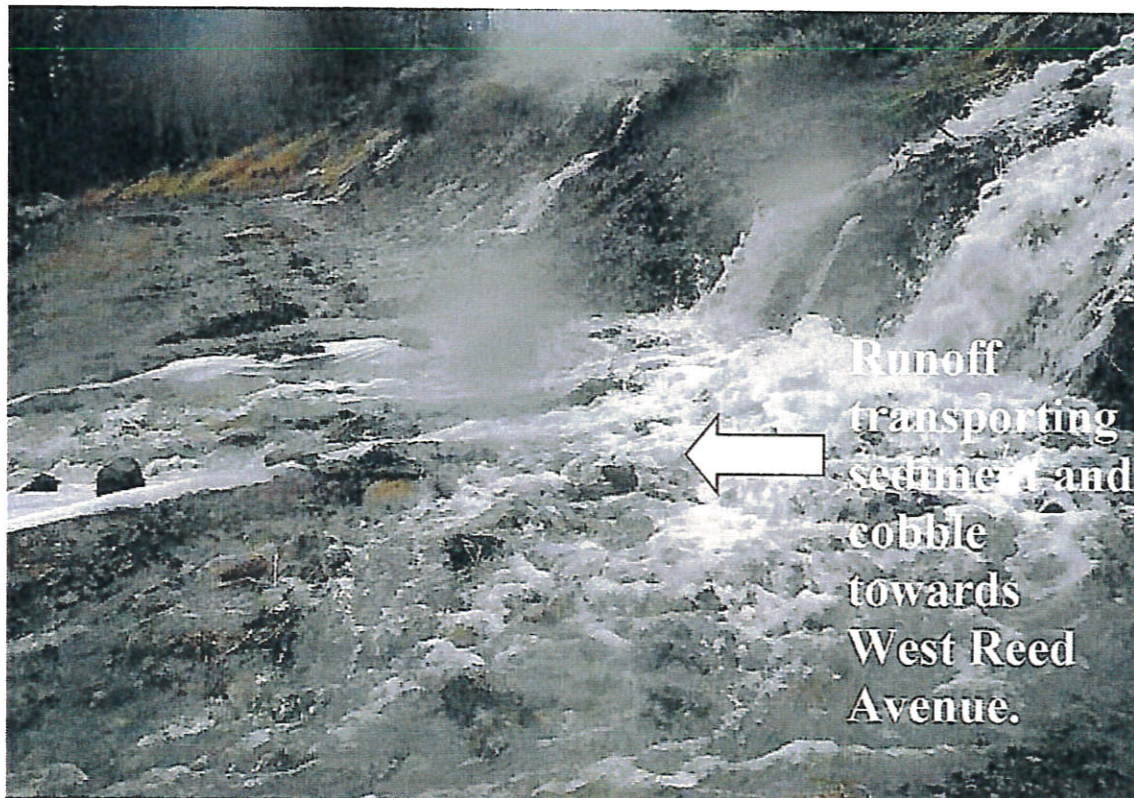
B. A GRADED ROAD ON THE MONTANO PROPERTY

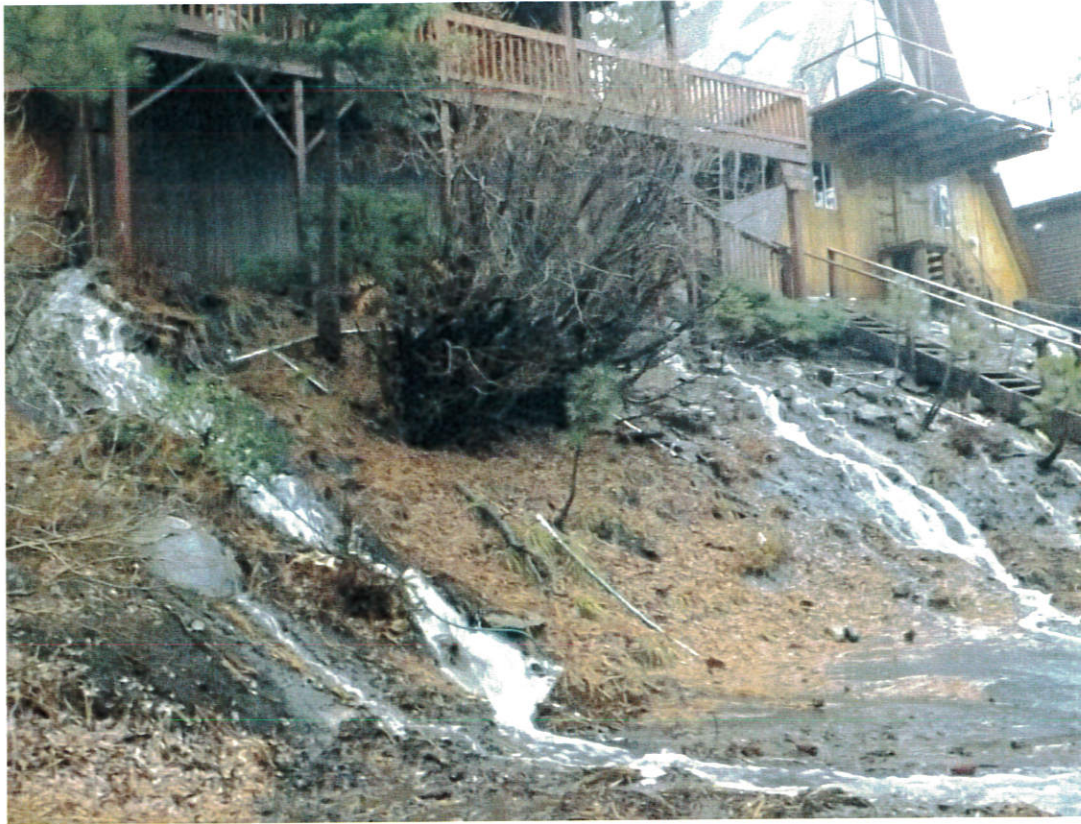
C. WEST REED AVENUE'S LACK OF DRAINAGE STRUCTURES

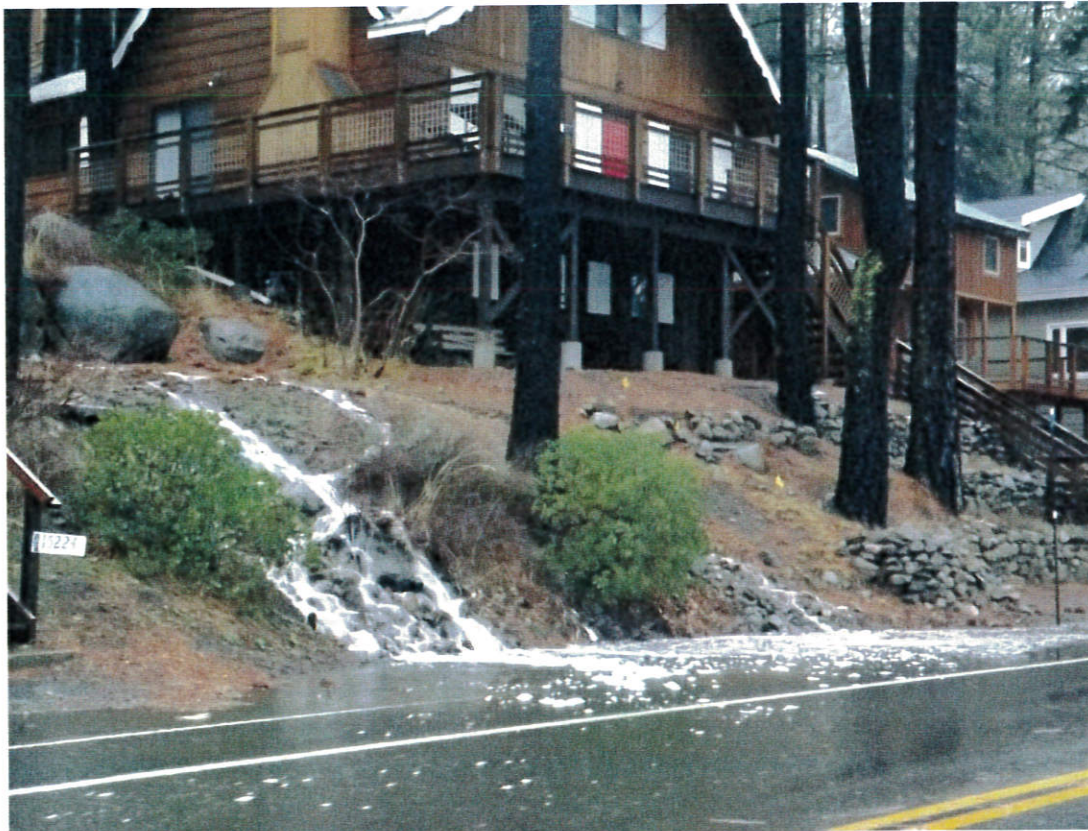
D. DONNER PASS ROAD BIKE AND DRAINAGE PROJECT DEFECTS

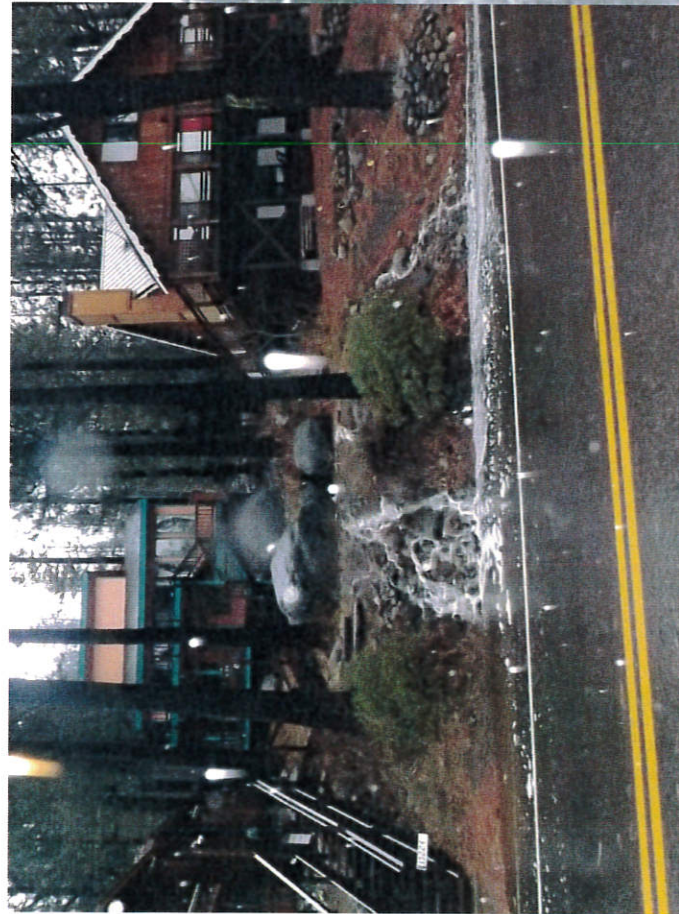
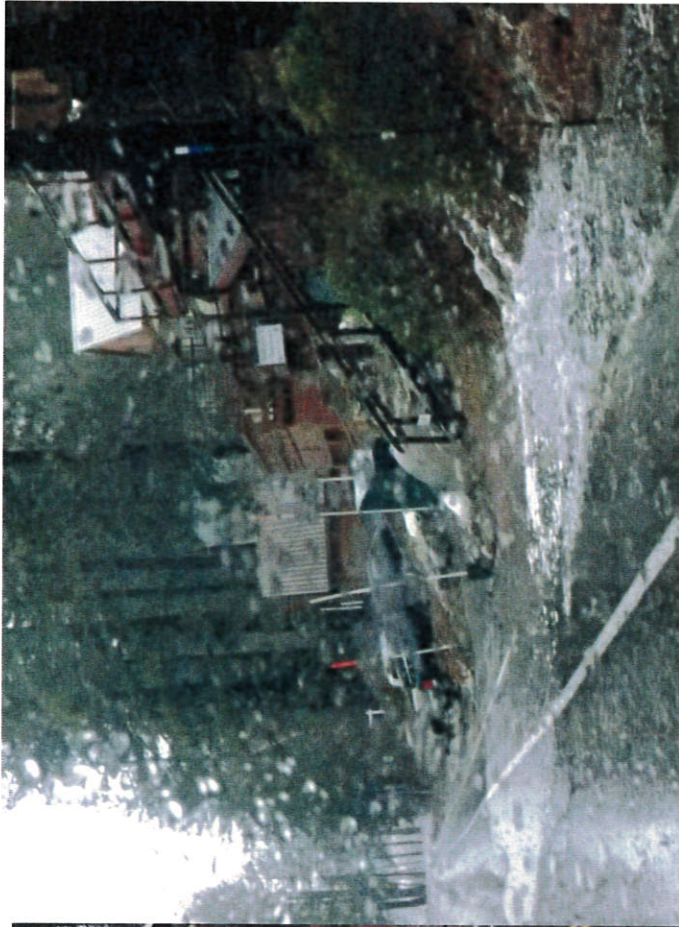
December 8, 2016 at 15224 Donner Pass Road

A simple rain event continues to cause flooding from the lack of maintained drainage structures on W. Reed Avenue with unfiltered erosion and drainage sheeting into Donner Lake
