**OUTLINE OF ATTACHMENTS AND SLIDES
FOR PRESENTATION TO LAHONTON BOARD -MARCH 9, 2017 at 8:30am
DONNER LAKE POLLUTION PROBLEMS
By Emilie Kashtan**

DONNER LAKE POLLUTION PROBLEM

PRESENTED BY EMILIE KASHTAN

MARCH 9, 2017

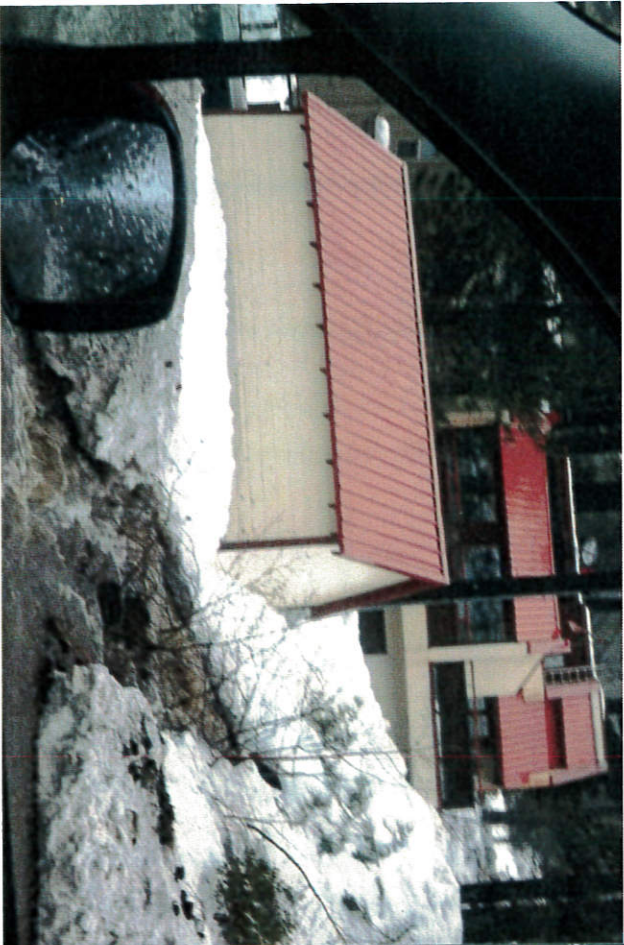
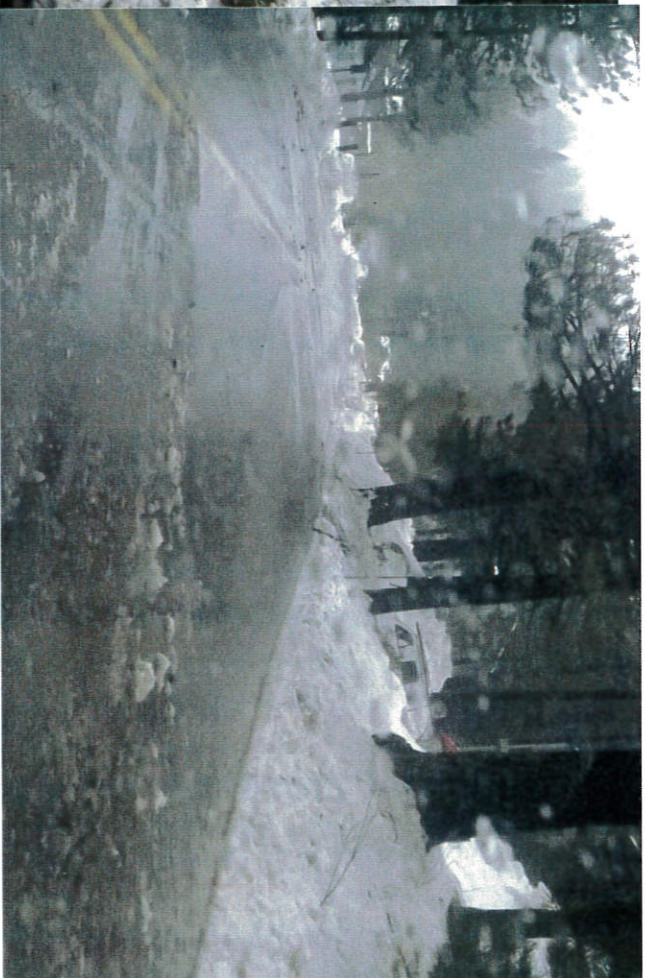
January 2017 at 15446 Donner Pass Road

A simple rain event continues to cause flooding

from the lack of maintained drainage structures on W. Reed Avenue, caused by drainage diversions from Donner Lake Road, with unfiltered erosion and drainage sheeting into Donner Lake

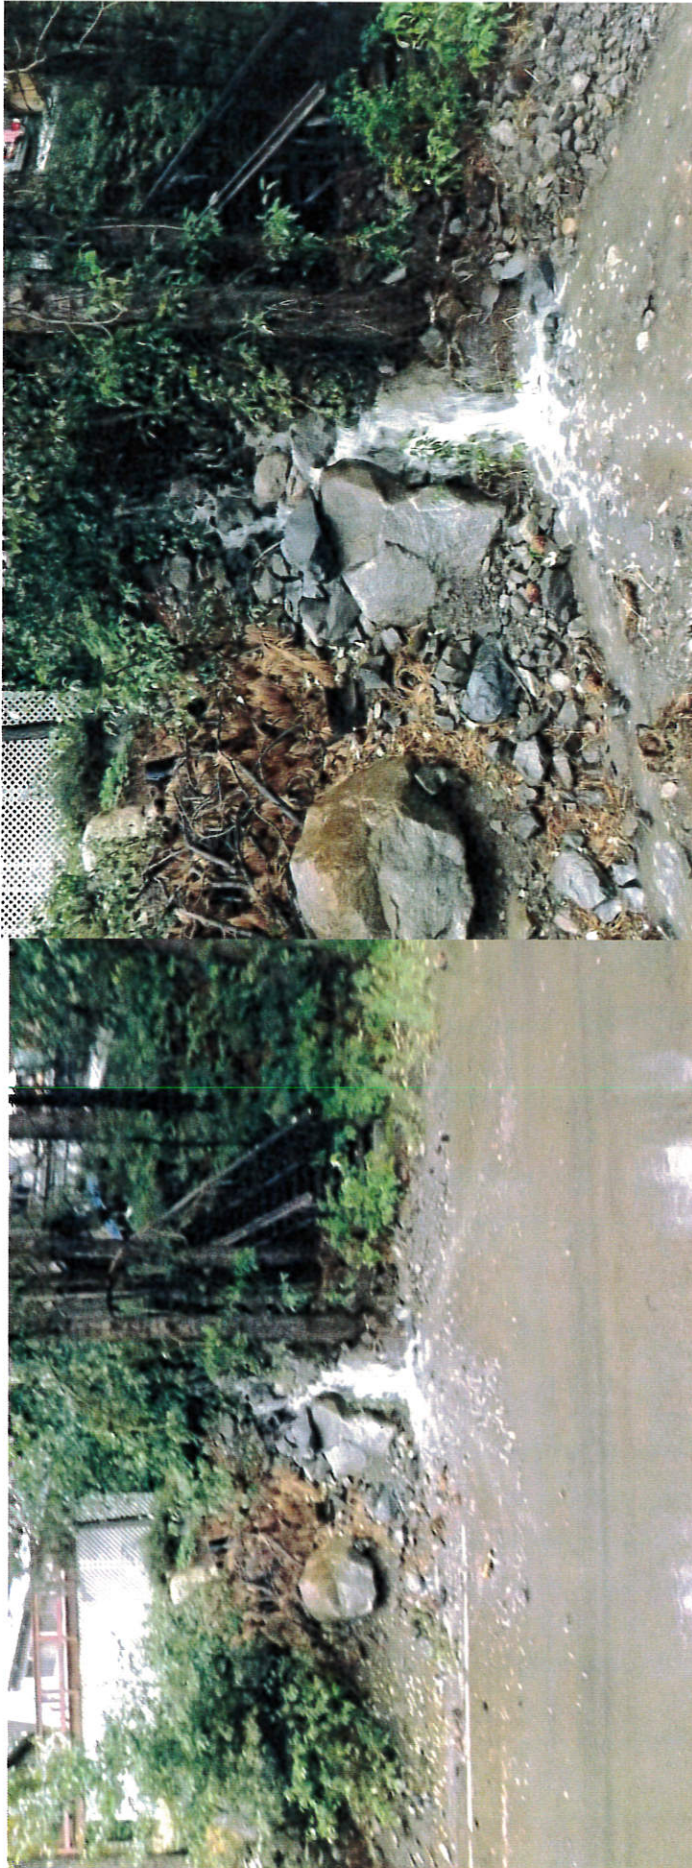
July 2016 at 15034 Donner Pass Road

**A simple rain event continues to cause flooding
from the lack of maintained drainage structures on W. Reed Avenue, causing
property erosion and sheeting of unfiltered erosion and drainage sheeting into Donner Lake**

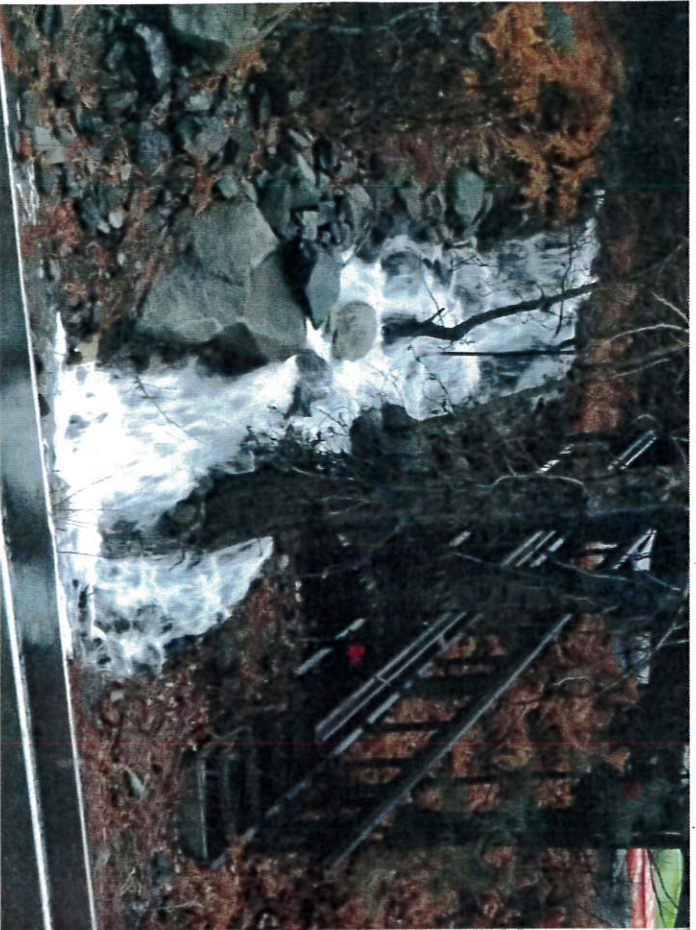
December 2016

Two more simple day rain events, with increased drainage and erosion at 15034 Donner Pass Road causing increased unfiltered erosion, flooding and sheeting Across Donner Pass Road and into Donner Lake, due to a clogged and unmaintained under road culvert on West Reed Avenue

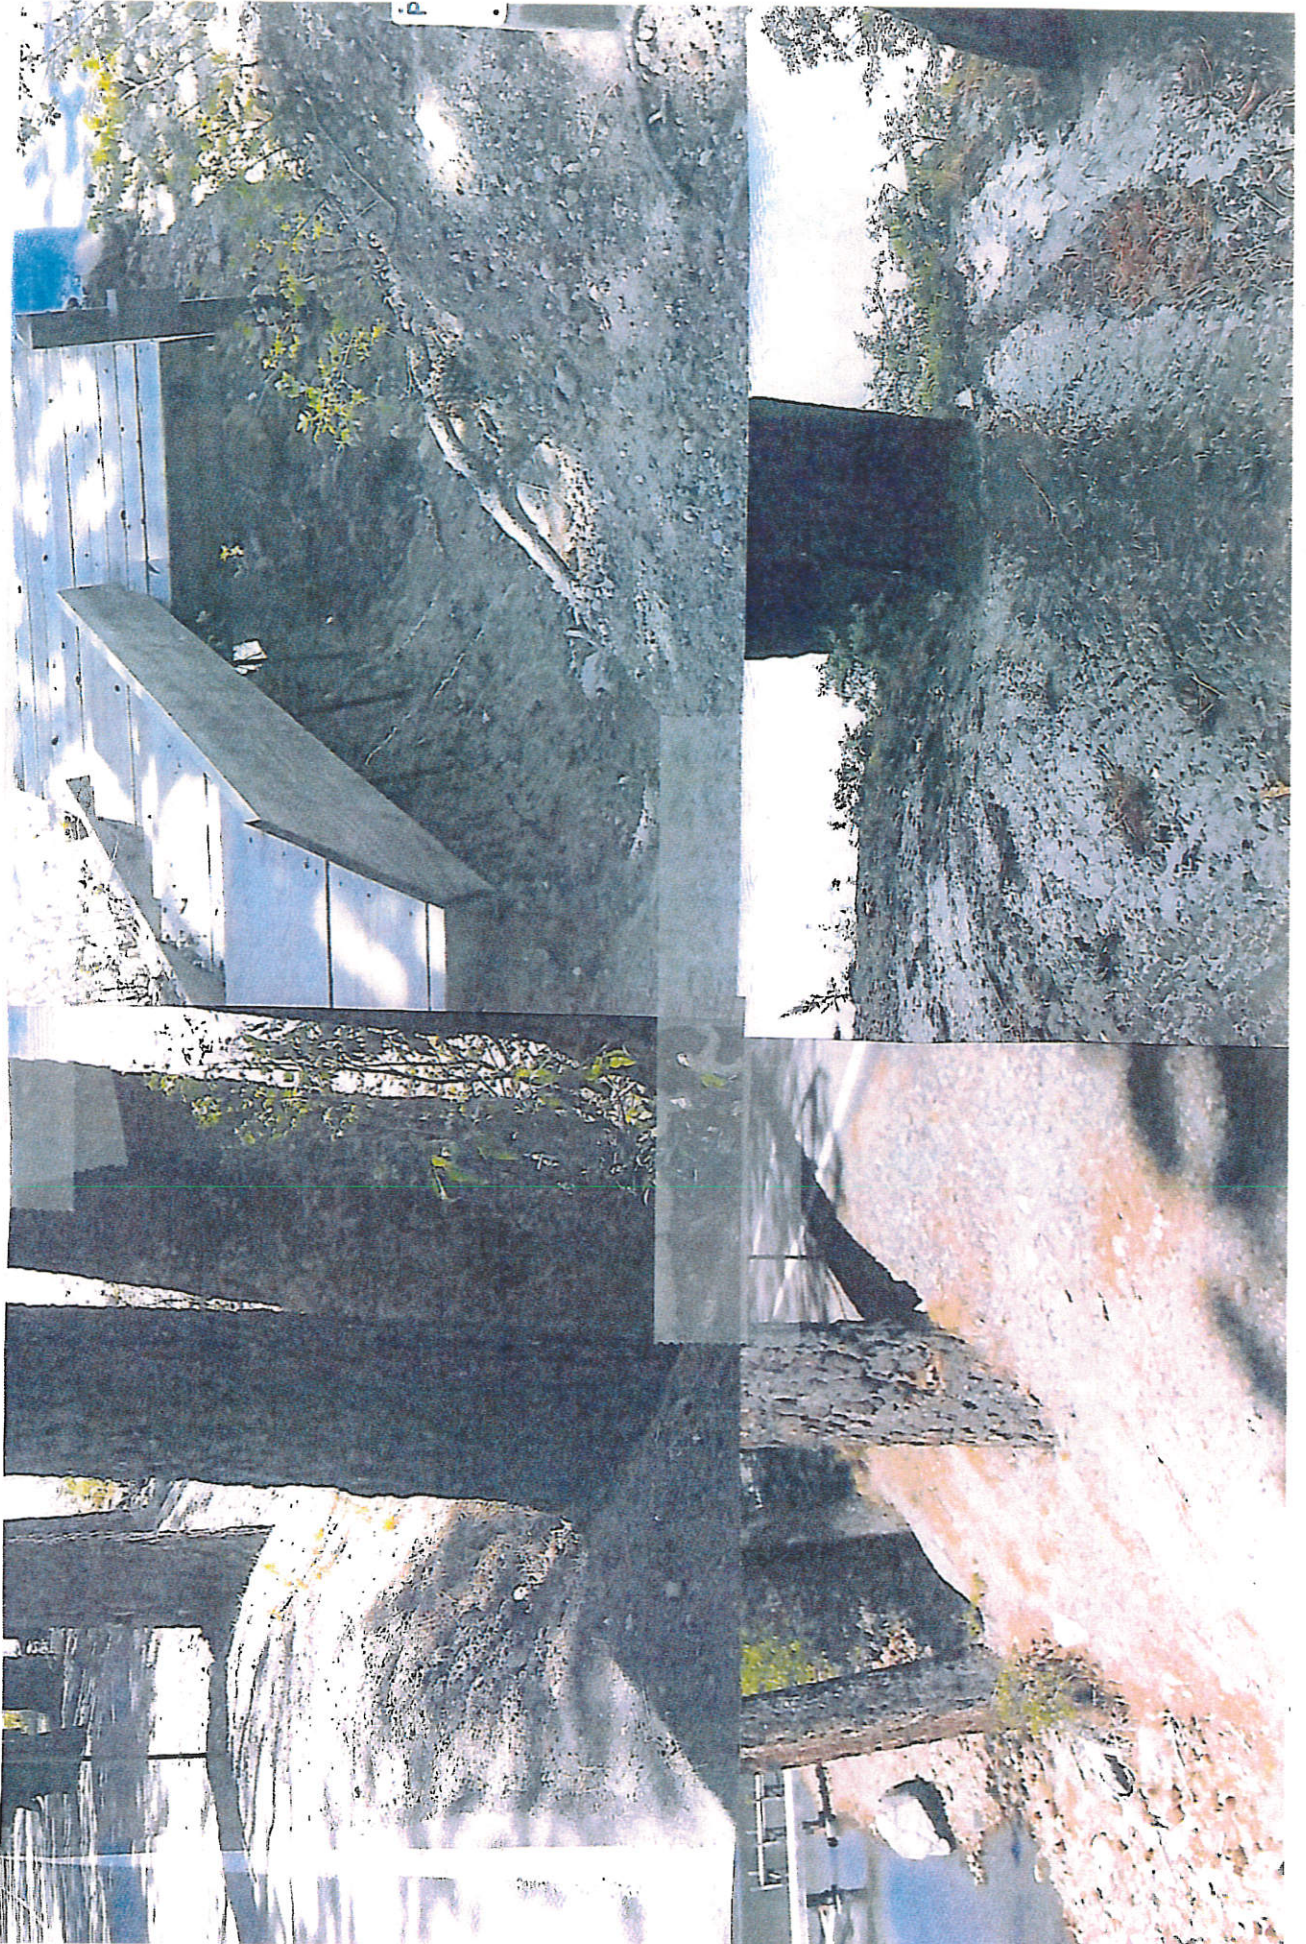
EROSION CAUSED BY SHEETING DRAINAGE ACROSS DONNER PASS ROAD
UNDERMINING DOCKS, TREES AND ROAD SIDE RIGHT OF WAY
