Lahontan Regional Water Quality Control Board

REQUEST FOR COMMENTS - CLEANUP AND ABATEMENT ORDER R6T- 2022- (PROPOSED), REQUIRING SEVEN SPRINGS LIMITED PARTNERSHIP, FOX CAPITAL MANAGEMENT CORPORATION, BOBBY PAGES, INC., AND CONNOLLY DEVELOPMENT, INC TO ASSESS, CLEAN UP AND ABATE WASTE DISCHARGED TO WATERS OF THE STATE PURSUANT TO CALIFORNIA WATER CODE SECTIONS 13267 AND 13304 AT 1024 LAKE TAHOE BOULEVARD AND REGIONAL PERCHLOROETHYLENE GROUNDWATER PLUME, SOUTH LAKE TAHOE, EL DORADO COUNTY

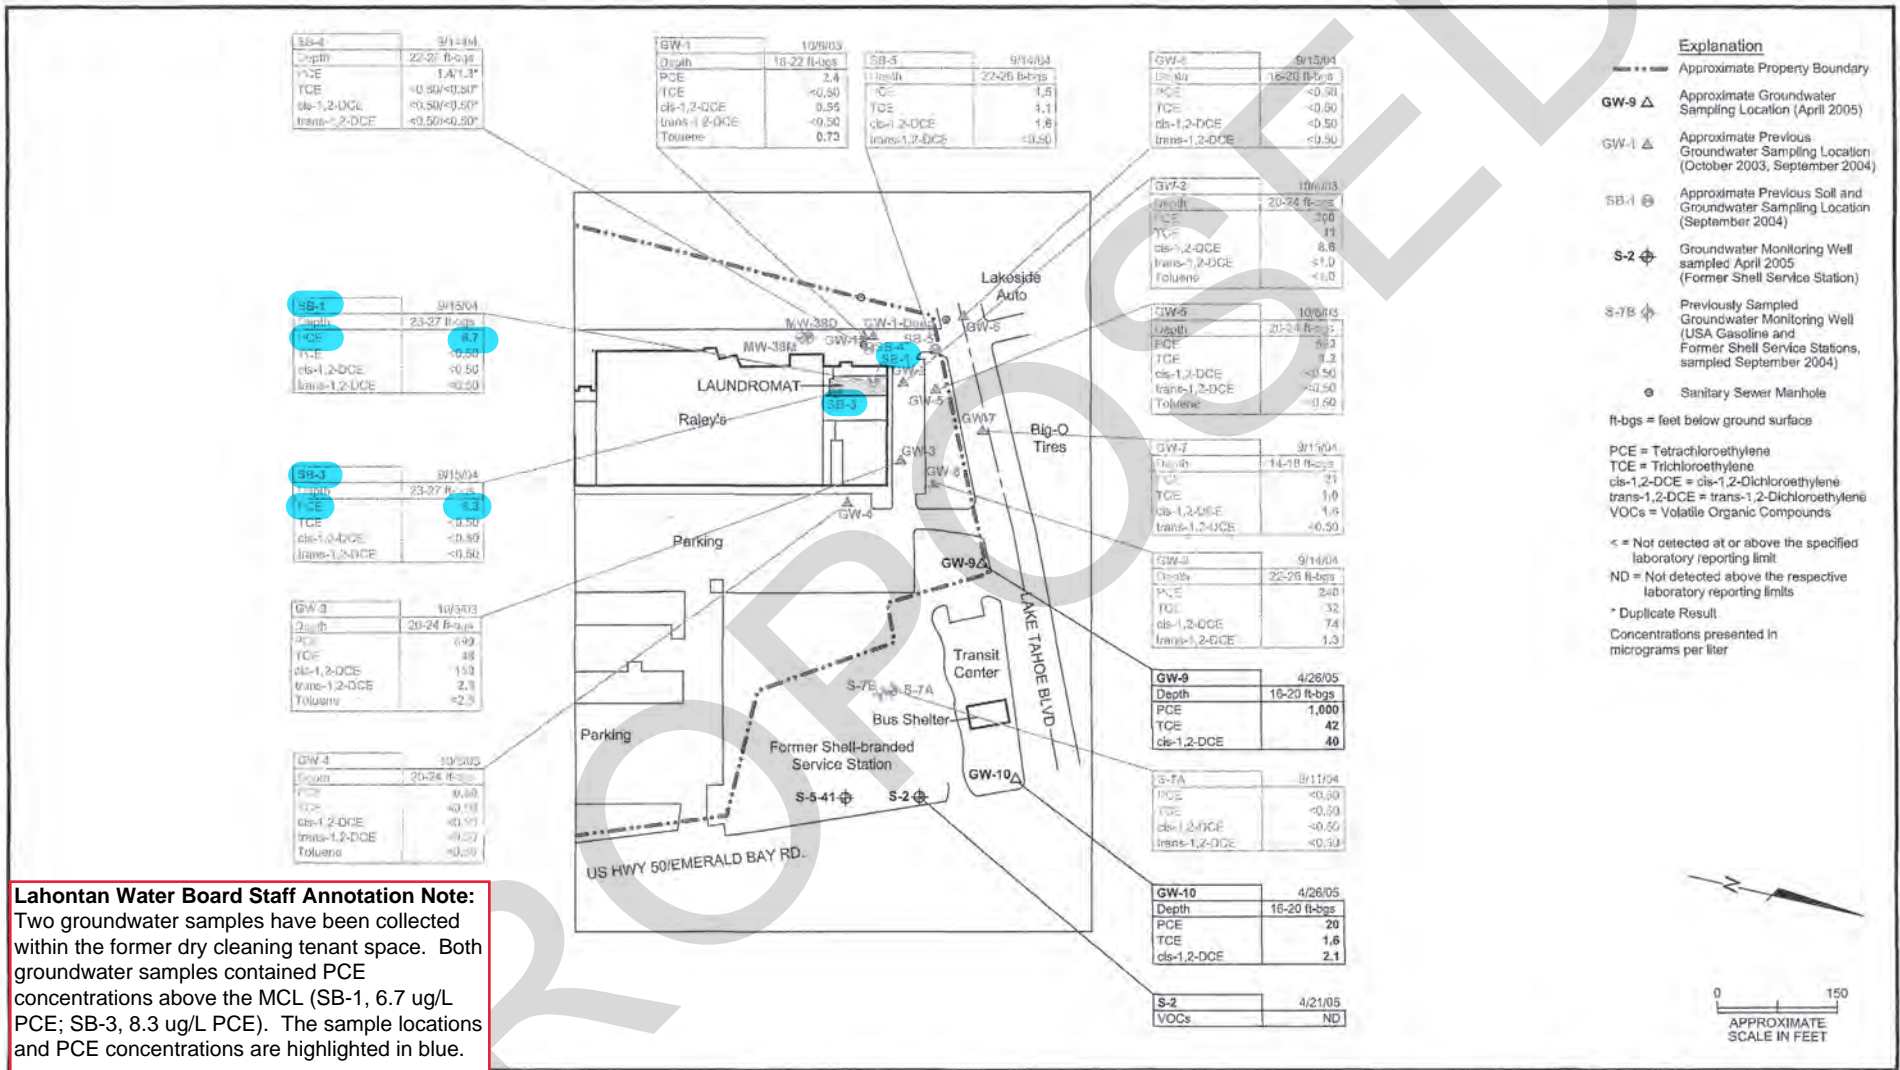
Lahontan Water Board Staff Annotation Note:
 Two groundwater samples have been collected within the former dry cleaning tenant space. Both groundwater samples contained PCE concentrations above the MCL (SB-1, 6.7 ug/L PCE; SB-3, 8.3 ug/L PCE). The sample locations and PCE concentrations are highlighted in blue.

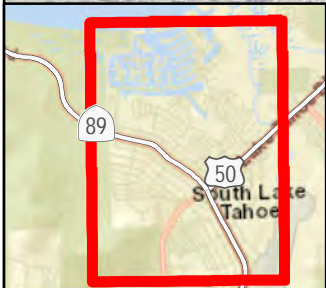
FIGURE 15: PCE ISOCONCENTRATION CONTOURS OF ANALYTICAL RESULTS FROM MIDDLE WATER-BEARING ZONE (2001-2008), COMMENTS ON PROPOSED CLEANUP AND ABATEMENT ORDER NO. R6T-2015-PROP (AR010085)

- Notes:**
- Well status current as of date on figure.
 - PCE Plume estimation initially provided as EVS output and revised as appropriate using professional judgment.
 - EVS plume incorporates singular and multi-depth sampling locations for PCE analytical data collected between January 3, 2017 and November 9, 2020. For locations with multiple sampling events over this time period the maximum concentration between 2018 and November 9, 2020 was used.
 - AECOM 2019/2020 CPT Locations: overall sample depths range between 4 and 131 feet below ground surface (bgs). AECOM 2019/2020 Sonic Locations: overall sample depths range between 5 and 320 feet bgs. Other Historical Multi-Depth Sampling Locations: overall sample depths range between 10 and 74 feet bgs.

- PCE Concentration Contours (dashed where inferred)**
- 5 - 50 µg/L
 - 50 - 100 µg/L
 - 100 - 500 µg/L
 - >500 µg/L

¹⁴ Figure 14 and Figure 15 provide illustration of shallow (Figure 14) and middle zone (Figure 15) groundwater analytical results from investigations conducted from 2001 to 2008 at the Site and nearby sites.

¹⁶ Figure 20 shows the approximate extent of the soil and shallow groundwater cleanup areas at the Site. Figure 15 shows the estimated extent of PCE contamination in middle zone groundwater for investigations conducted between 2001 and 2008 (i.e., prior to remedial implementation). The known extent of groundwater contamination in middle zone groundwater that was not directly addressed by remedial actions implemented for the soil and shallow groundwater cleanup areas can be inferred from Figure 20 and Figure 15.

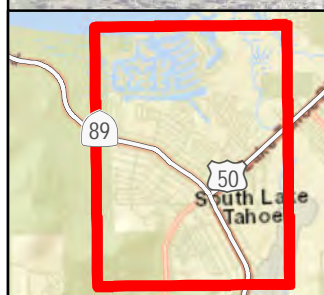
Figure 15
Receptor Inventory
 South "Y" PCE Plume
 South Lake Tahoe, CA

Active Municipal Well	Inactive Private Well	Potential Sensitive Receptor
Destroyed Municipal Well	Inactive/Unknown Private Well	PCE Concentration Contours <i>(dashed where inferred)</i>
Inactive Municipal Well	Active Small Community Well	0.5 - 5 µg/L
Active Private Well <i>(for locations with * see note)</i>	Destroyed Small Community Well	5 - 50 µg/L
Destroyed Private Well	Inactive Small Community Well	50 - 100 µg/L
		100 - 500 µg/L
		>500 µg/L

8. PCE groundwater data are not available to evaluate the potential threat to the receptor identified.
9. See Figure 15 for the estimated lateral extent of 0.5 µg/L iso-contour of the South "Y" Plume.
