February 11, 2016

**Re: Response to Proposed Cleanup and Abatement Order for
Former Lake Tahoe Laundry Works; 1024 Lake Tahoe Boulevard,
South Lake Tahoe, California**

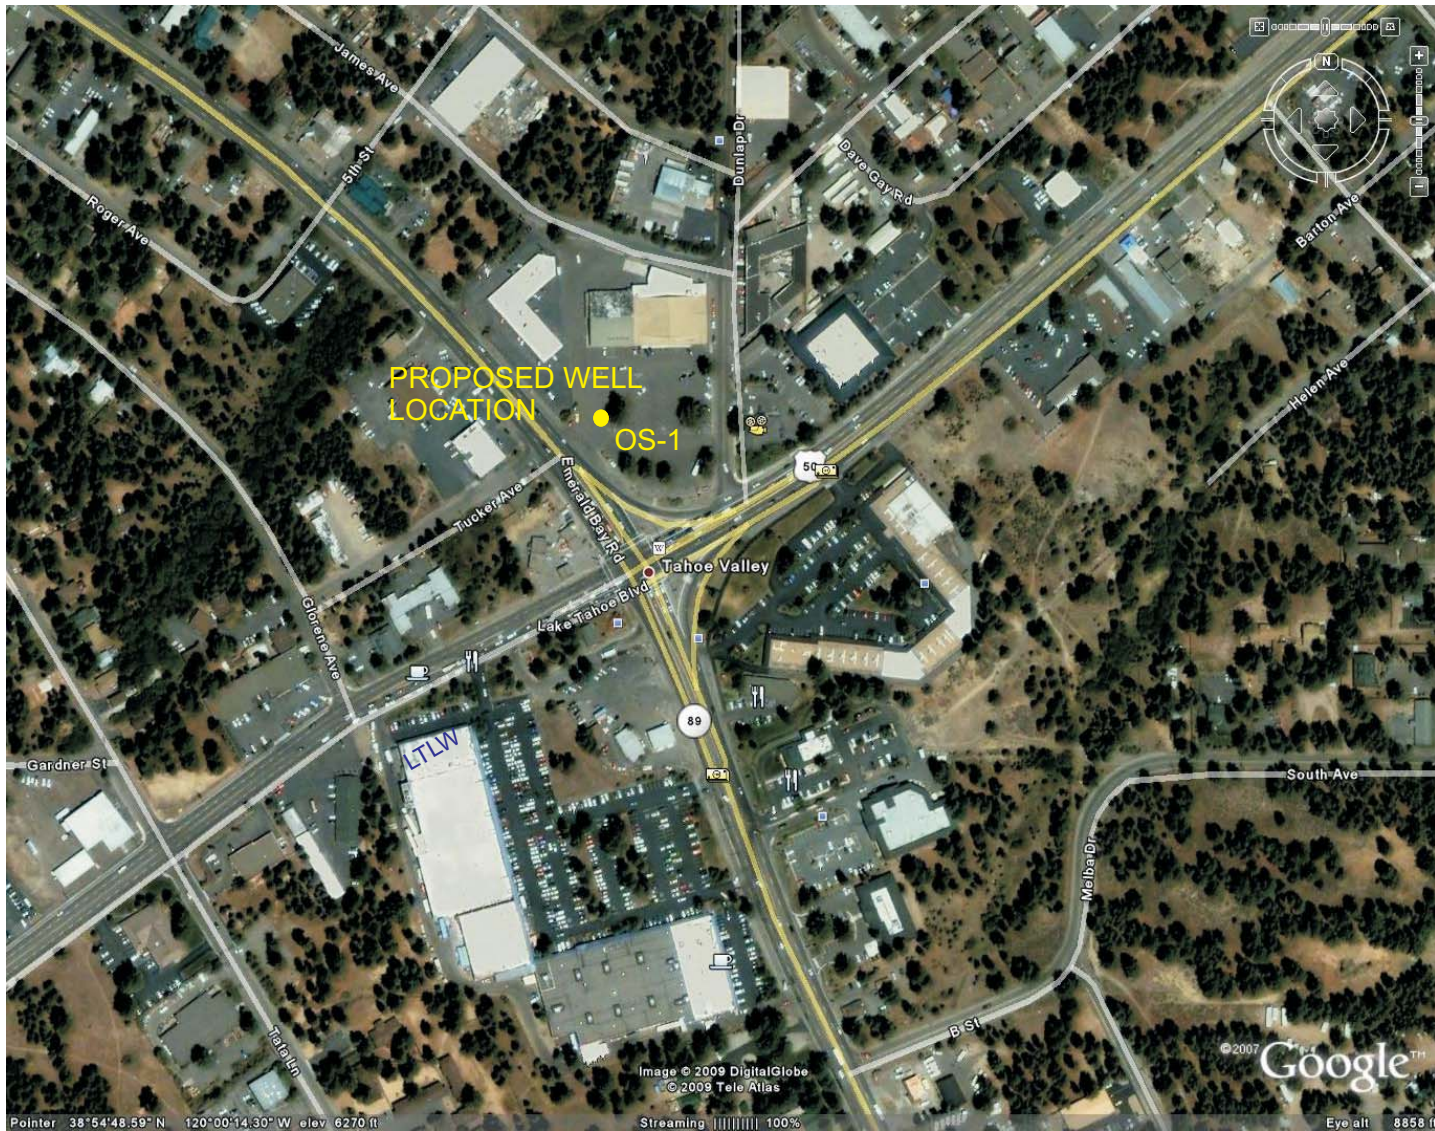
- Figure 1 Off-Site Proposed Groundwater Monitoring Well Plot
Figure 2 Revised Typical SZA Groundwater Monitoring Well Diagram

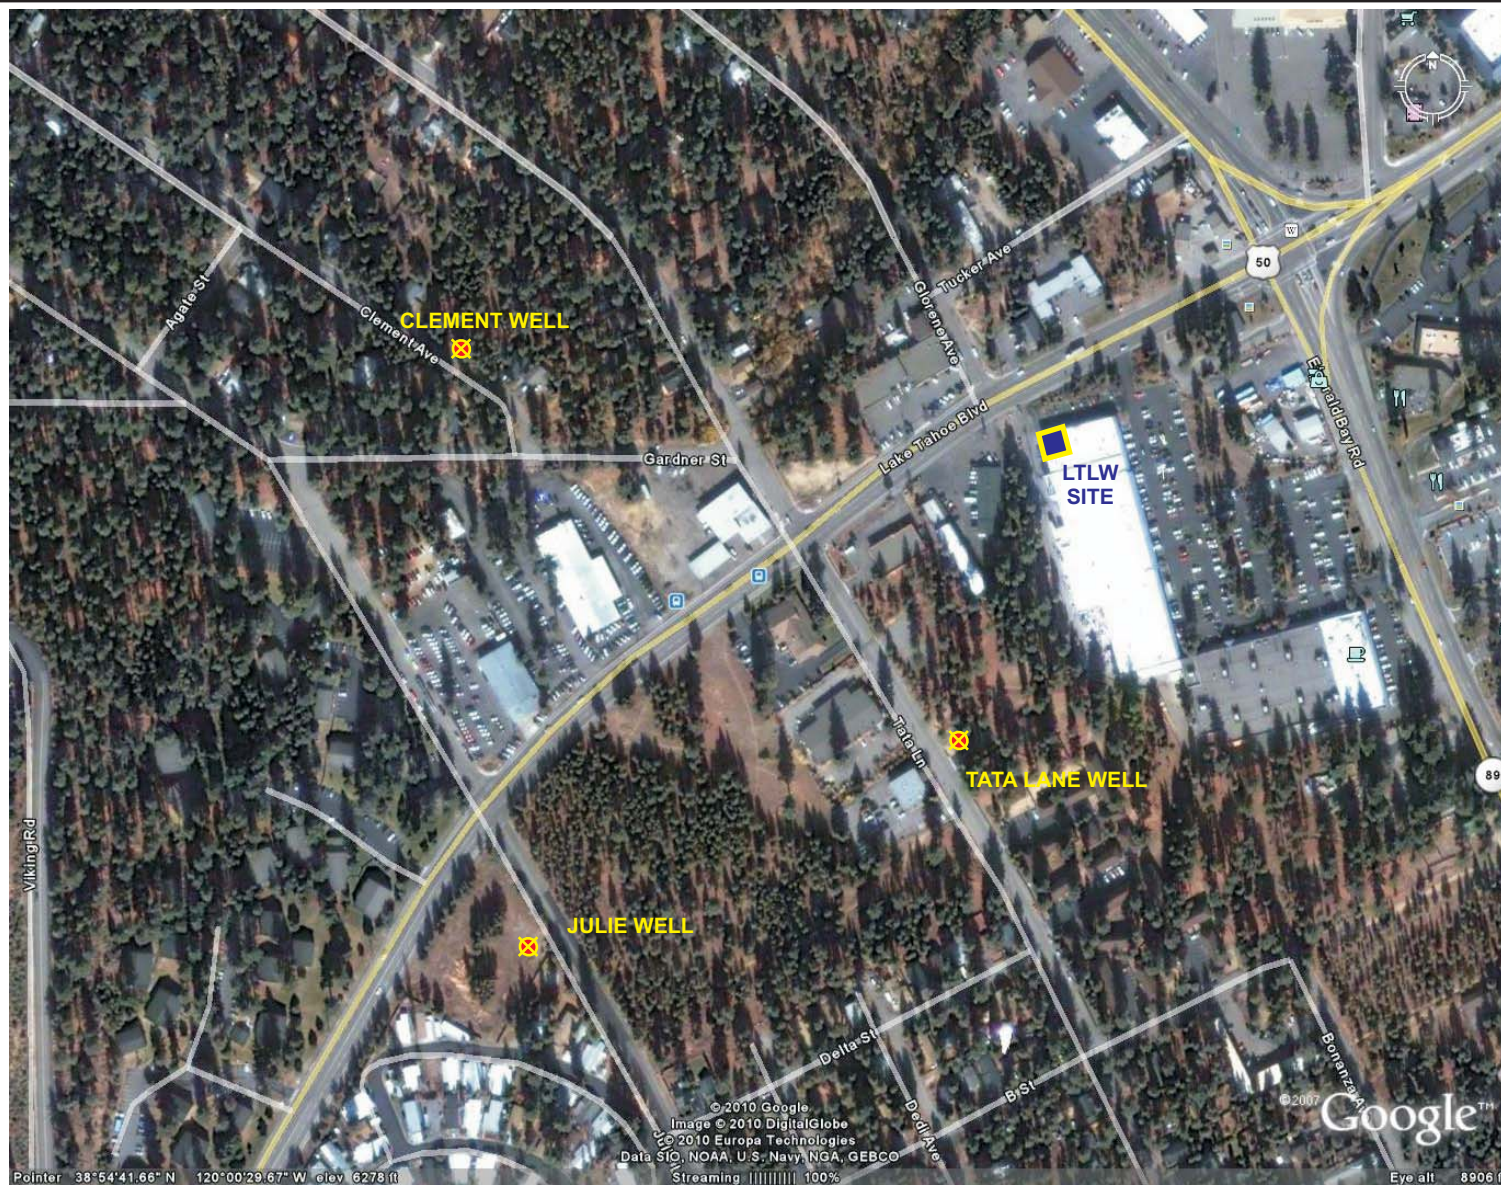
- ⊗ Approximate Location of Water Supply Well
- TATA LANE WELL
- JULIE WELL
- CLEMENT WELL

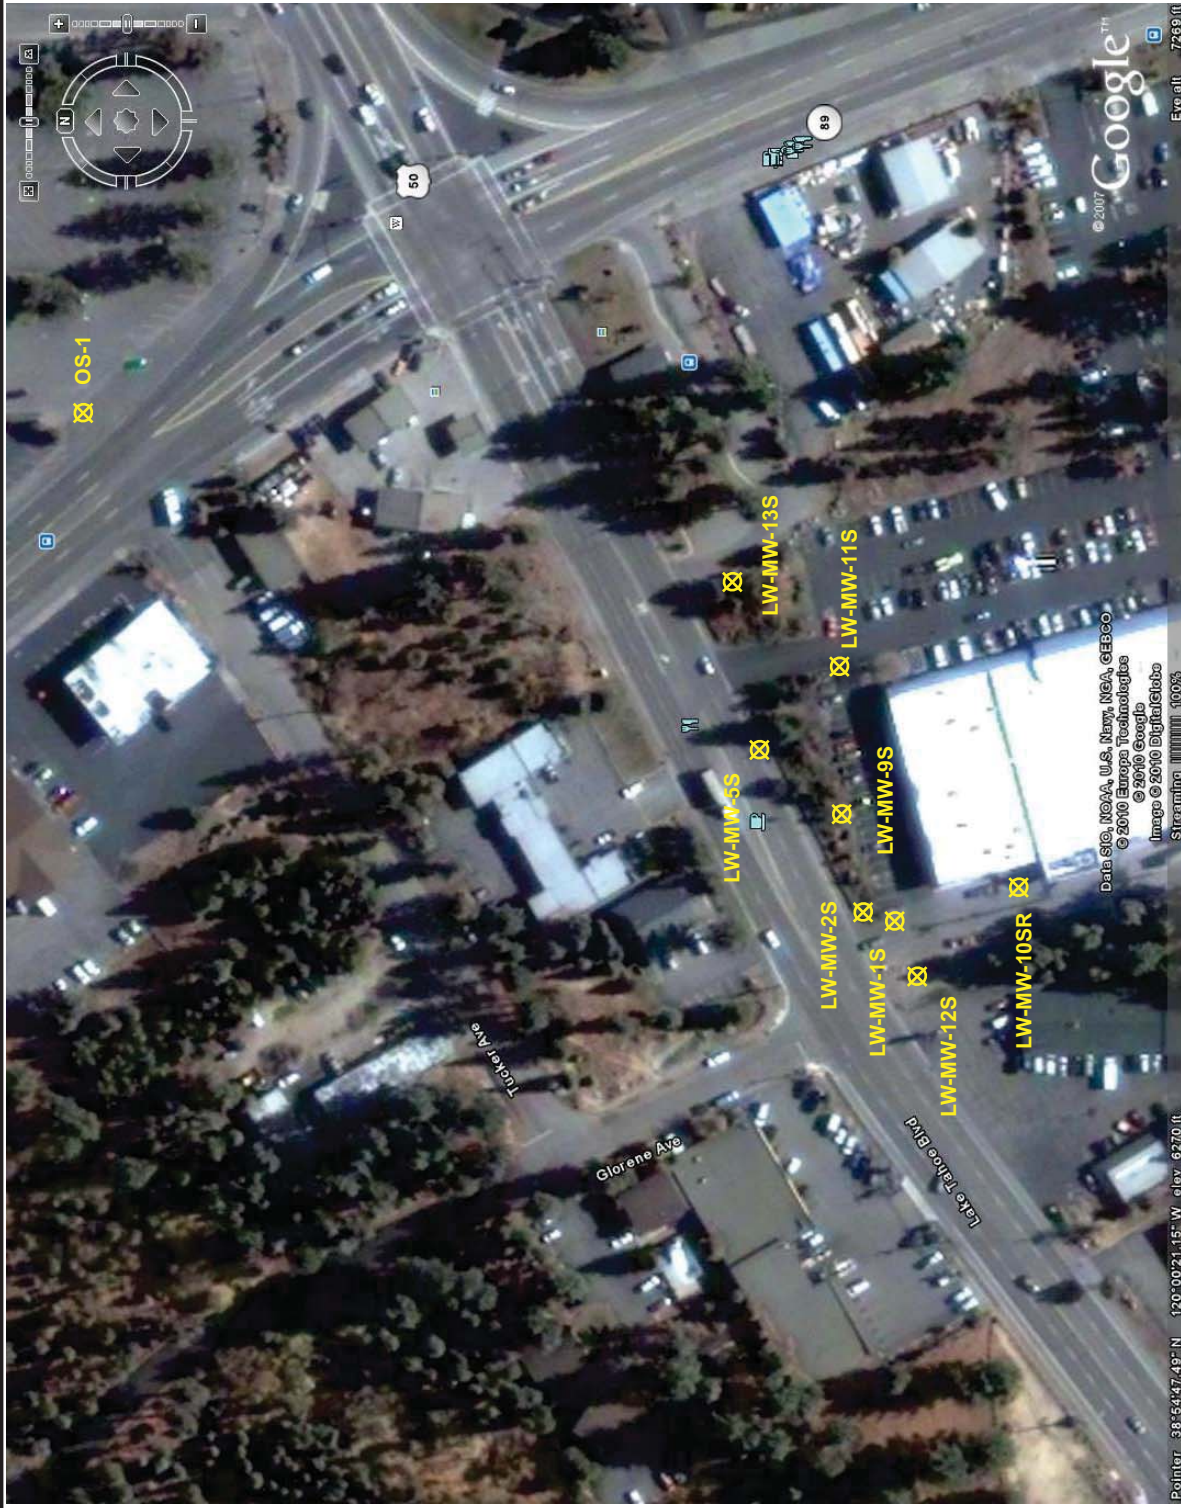
SITE PLAN

**LAKE TAHOE LAUNDRY WORKS
1024 LAKE TAHOE BOULEVARD
SOUTH LAKE TAHOE, CALIFORNIA**
