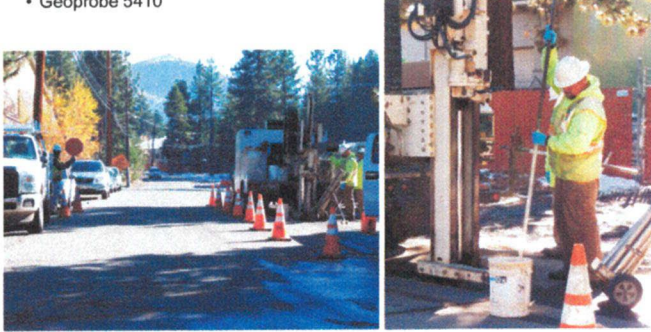
- Advanced 22 borings to 24-40 feet bgs
 - Geoprobe 5410

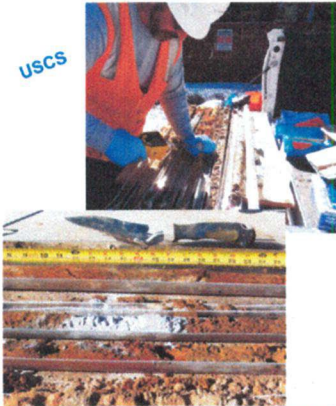
- Identified soil types from cores → coarse-grained
- Weathered granitic rock
- Consistent with alluvium deposits and geologic setting
 - Mostly well-sorted sand with thin silt interbeds

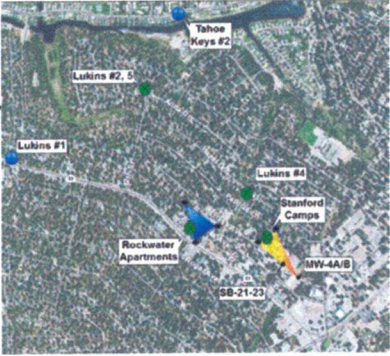
- No specific source(s) identified
- Highest PCE: east end, deeper depth
 - MW-4A: 14 µg/L
 - MW-4B: 150 µg/L
 - SB-21-23: 3 µg/L
- PCE → deeper depths

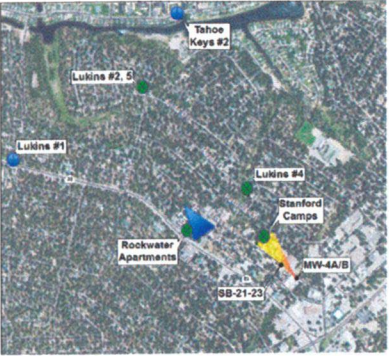
- No PCE connection in GW from west end to east end
- Possible separate PCE sources for each end of the study boundary
- Potential PCE source(s) farther upgradient/cross-gradient than expected
