# Lahontan Regional Water Quality Control Board

### Request for Comments - Proposed Cleanup and Abatement Order Requiring Ramiro Avila to Cleanup and Abate the Discharge and Threatened Discharge of Sediment to Surface Waters of the Antelope Hydrologic Unit– Vicinity of 126th Street East and Nearwood Road, Pearblossom, Los Angeles County, APN 3060-020-043

### NOTICE OF VIOLATION – VICINITY OF 126<sup>TH</sup> STREET EAST AND NEARWOOD ROAD, PEARBLOSSOM, LOS ANGELES COUNTY, APN 3060-020-043

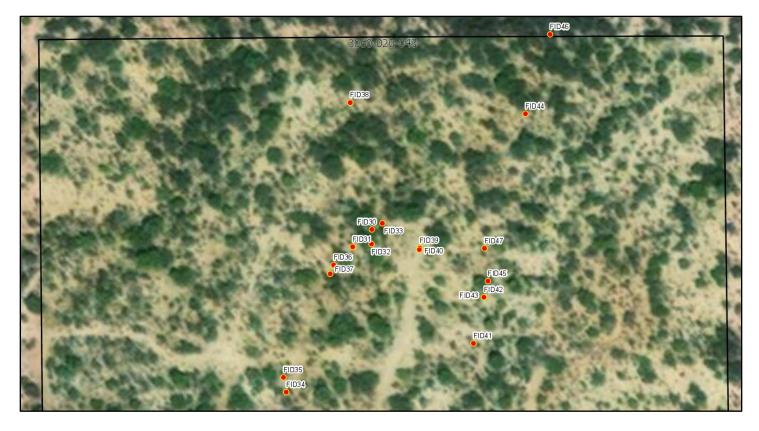
Soil disturbances associated with grading for the western and eastern hoop houses were significant ("Length 2 west" and "Length 2 east") and involved cutting into the banks of the drainages and filling the natural channels to create approximately 77-foot wide and 80-foot wide flat areas for cultivation in the west and east channels, respectively. We estimate that the ravine walls outside the central portion of the channel were cut an average of 7 feet above the final grade. In the each of the drainages stockpiles of soil spoils were located above (FID: 31 and 44) and below each hoop house (FID: 38 and 42) that were not secured to prevent runoff or run-on during a storm event. Cultivation related waste was observed in each drainage (FID: 32 and 43) and on the ridge between the hoop houses (FID: 39) including partially full and empty containers of fertilizer and other chemicals; all containers were stored uncovered and without secondary containment, in a manner not protective of wildlife or the environment.
