2017 Bottom Barrier Monitoring Report

Prepared Pursuant to
California Regional Water Quality Control Board
Lahontan Region Board Order No. R6T-2014-0059

**Prepared for the Tahoe Keys Property Owners
Association**

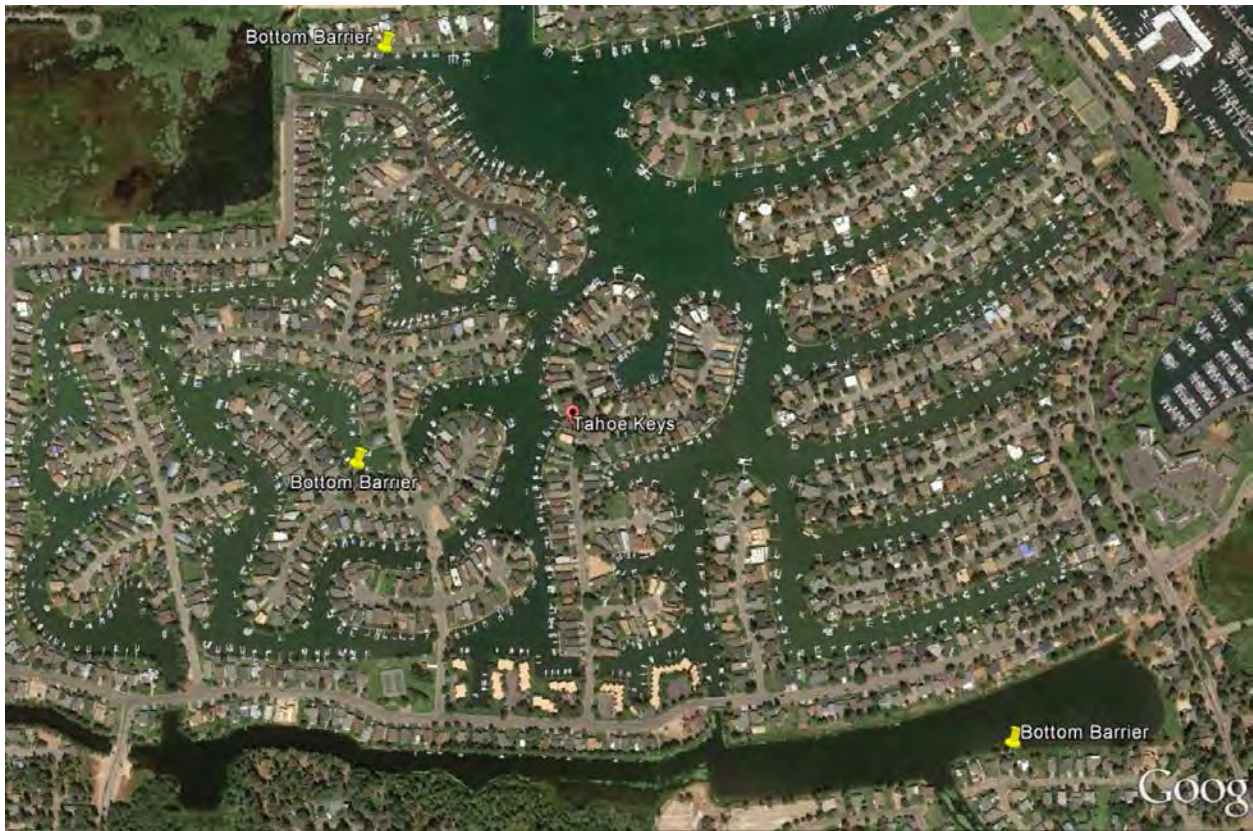
Figure 1. Location of 2017 Bottom Barriers

In 2017, the Tahoe Keys Property Owners Association (TKPOA) conducted another season of its bottom barrier program for homeowners. Barriers were supplied by the Tahoe Resource Conservation District (TRCD) free of charge for three (3) homeowners at the locations shown on Figure 1. Prior to the summer season, the WQD and ACD Staff held a town hall forum which focused on the TKPOA's Barrier Program. The topics covered were the AIS Program, bottom barriers, the process to get them, installation and removal along with the required monitoring and paperwork. Local diving companies were invited, and several attended, in order to discuss cost estimates for installation, extraction and maintenance.
