Non-Chemical Combination Control Methods Test Summary Report for the Tahoe Keys Property Owners Association

Final
May 15, 2018

TAHOE KEYS INTEGRATED
MANAGEMENT PLAN

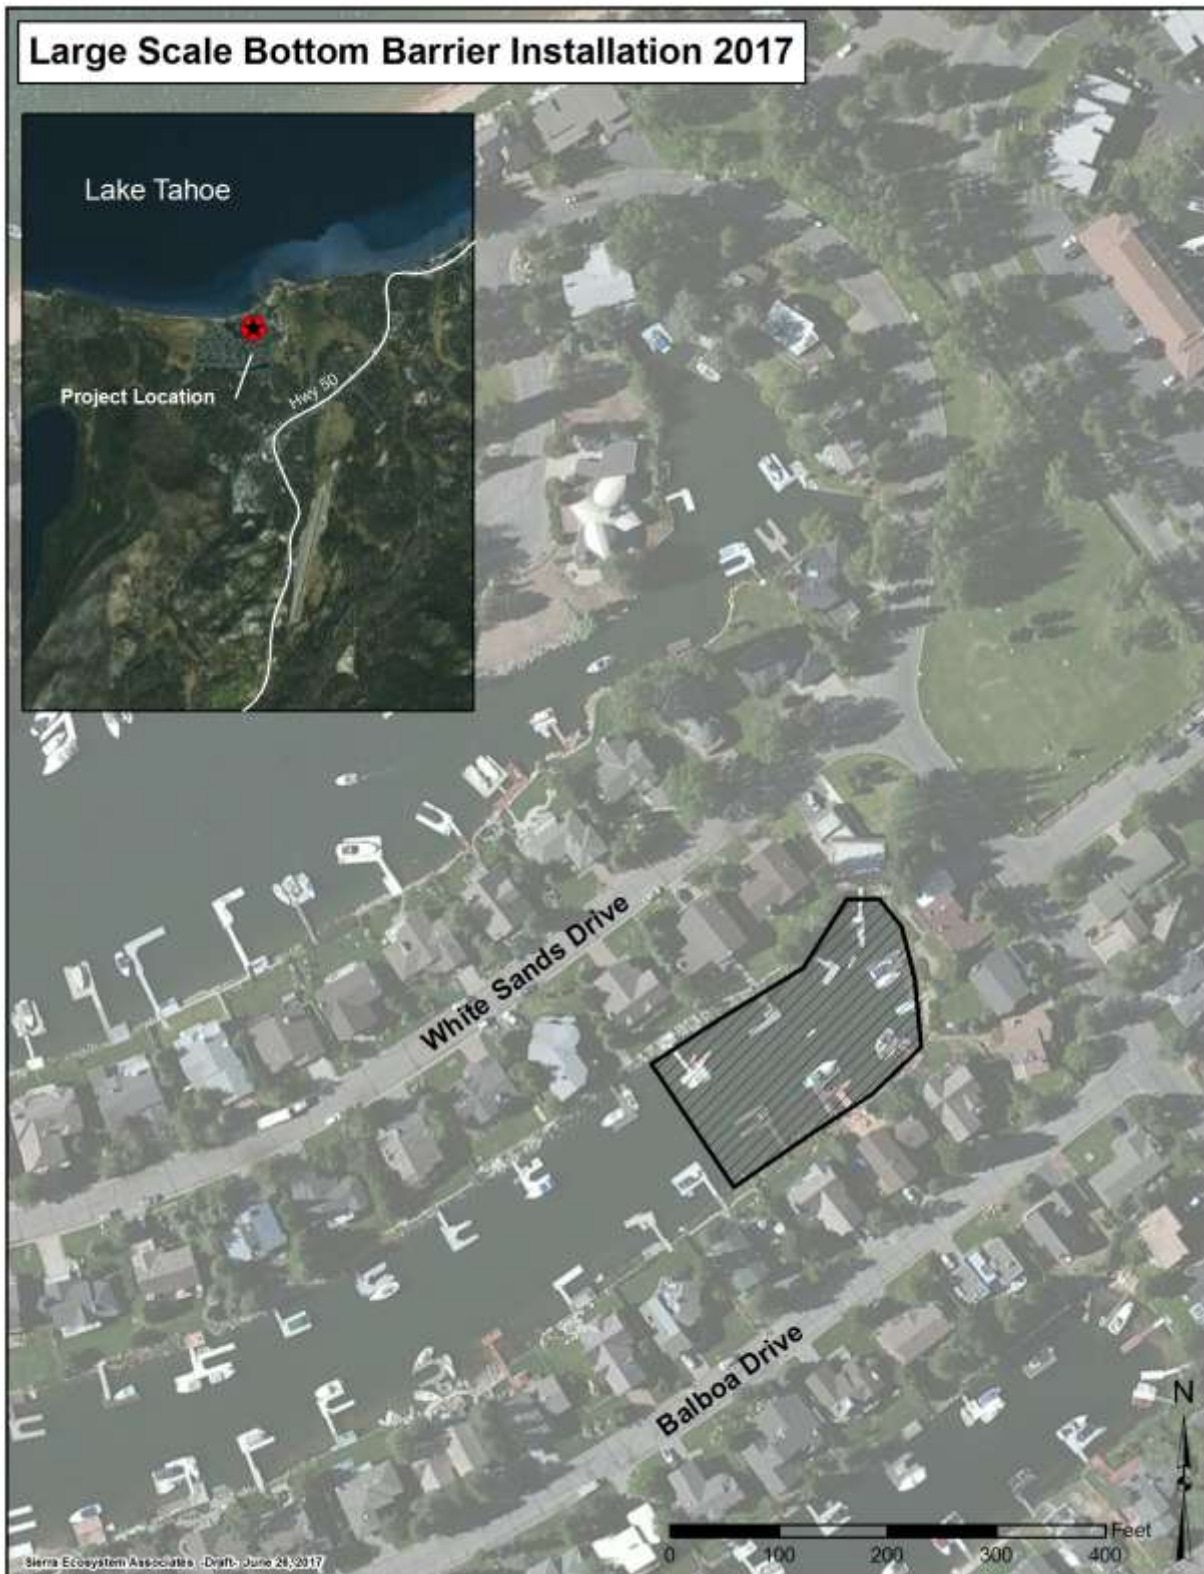
Figure 1. Large Scale Bottom Barrier Installation 2017

(due to the high cost of diving labor to install and remove barriers). The barriers were placed by Hiuga Diving Company between White Sands and Balboa Drives (Figure 1) starting July 7th and took approximately one week to install.

The divers installed the barriers by rolling them out along the channel bottom and securing them in place with rebar u-stakes. Where stakes could not be used due to bottom sediment conditions, sand bags were used instead. The barriers were overlapped to help minimize growth of macrophytes between the barriers.

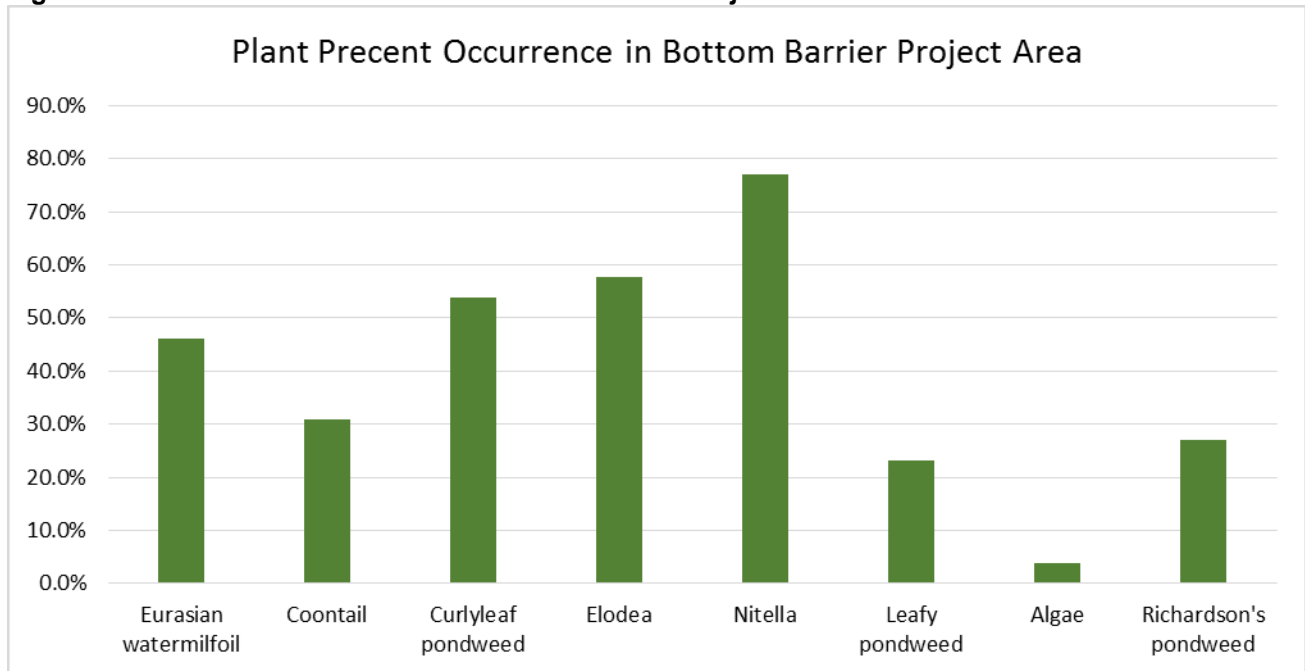
Figure 2. Plant Percent Occurrence in Bottom Barrier Project Area

Monitoring was conducted prior to installation that consisted of turbidity and plant point sampling within the project area in addition to hydroacoustic monitoring. Unfortunately, there was an error with the scanning system and no map was generated. The plant survey showed that curlyleaf pondweed was somewhat more present than Eurasian watermilfoil (54% coverage compared to 46% coverage, respectively). There was also a high coverage of nitella (77%), a multicellular algae, and native elodea (58%), as can be seen in Figure 2.
