FIGURE 5-5
CHROMIUM RESULTS FOR SECOND QUARTER 2018
GROUNDWATER MONITORING AND DOMESTIC WELL
SAMPLING AND MAXIMUM COMPOSITE PLUME
OUTLINE IN UPPER AQUIFER

SECOND QUARTER 2018 GROUNDWATER MONITORING
 REPORT AND DOMESTIC WELL RESULTS
 SITE-WIDE GROUNDWATER MONITORING PROGRAM

PACIFIC GAS AND ELECTRIC COMPANY
 HINKLEY COMPRESSOR STATION
 HINKLEY, CALIFORNIA

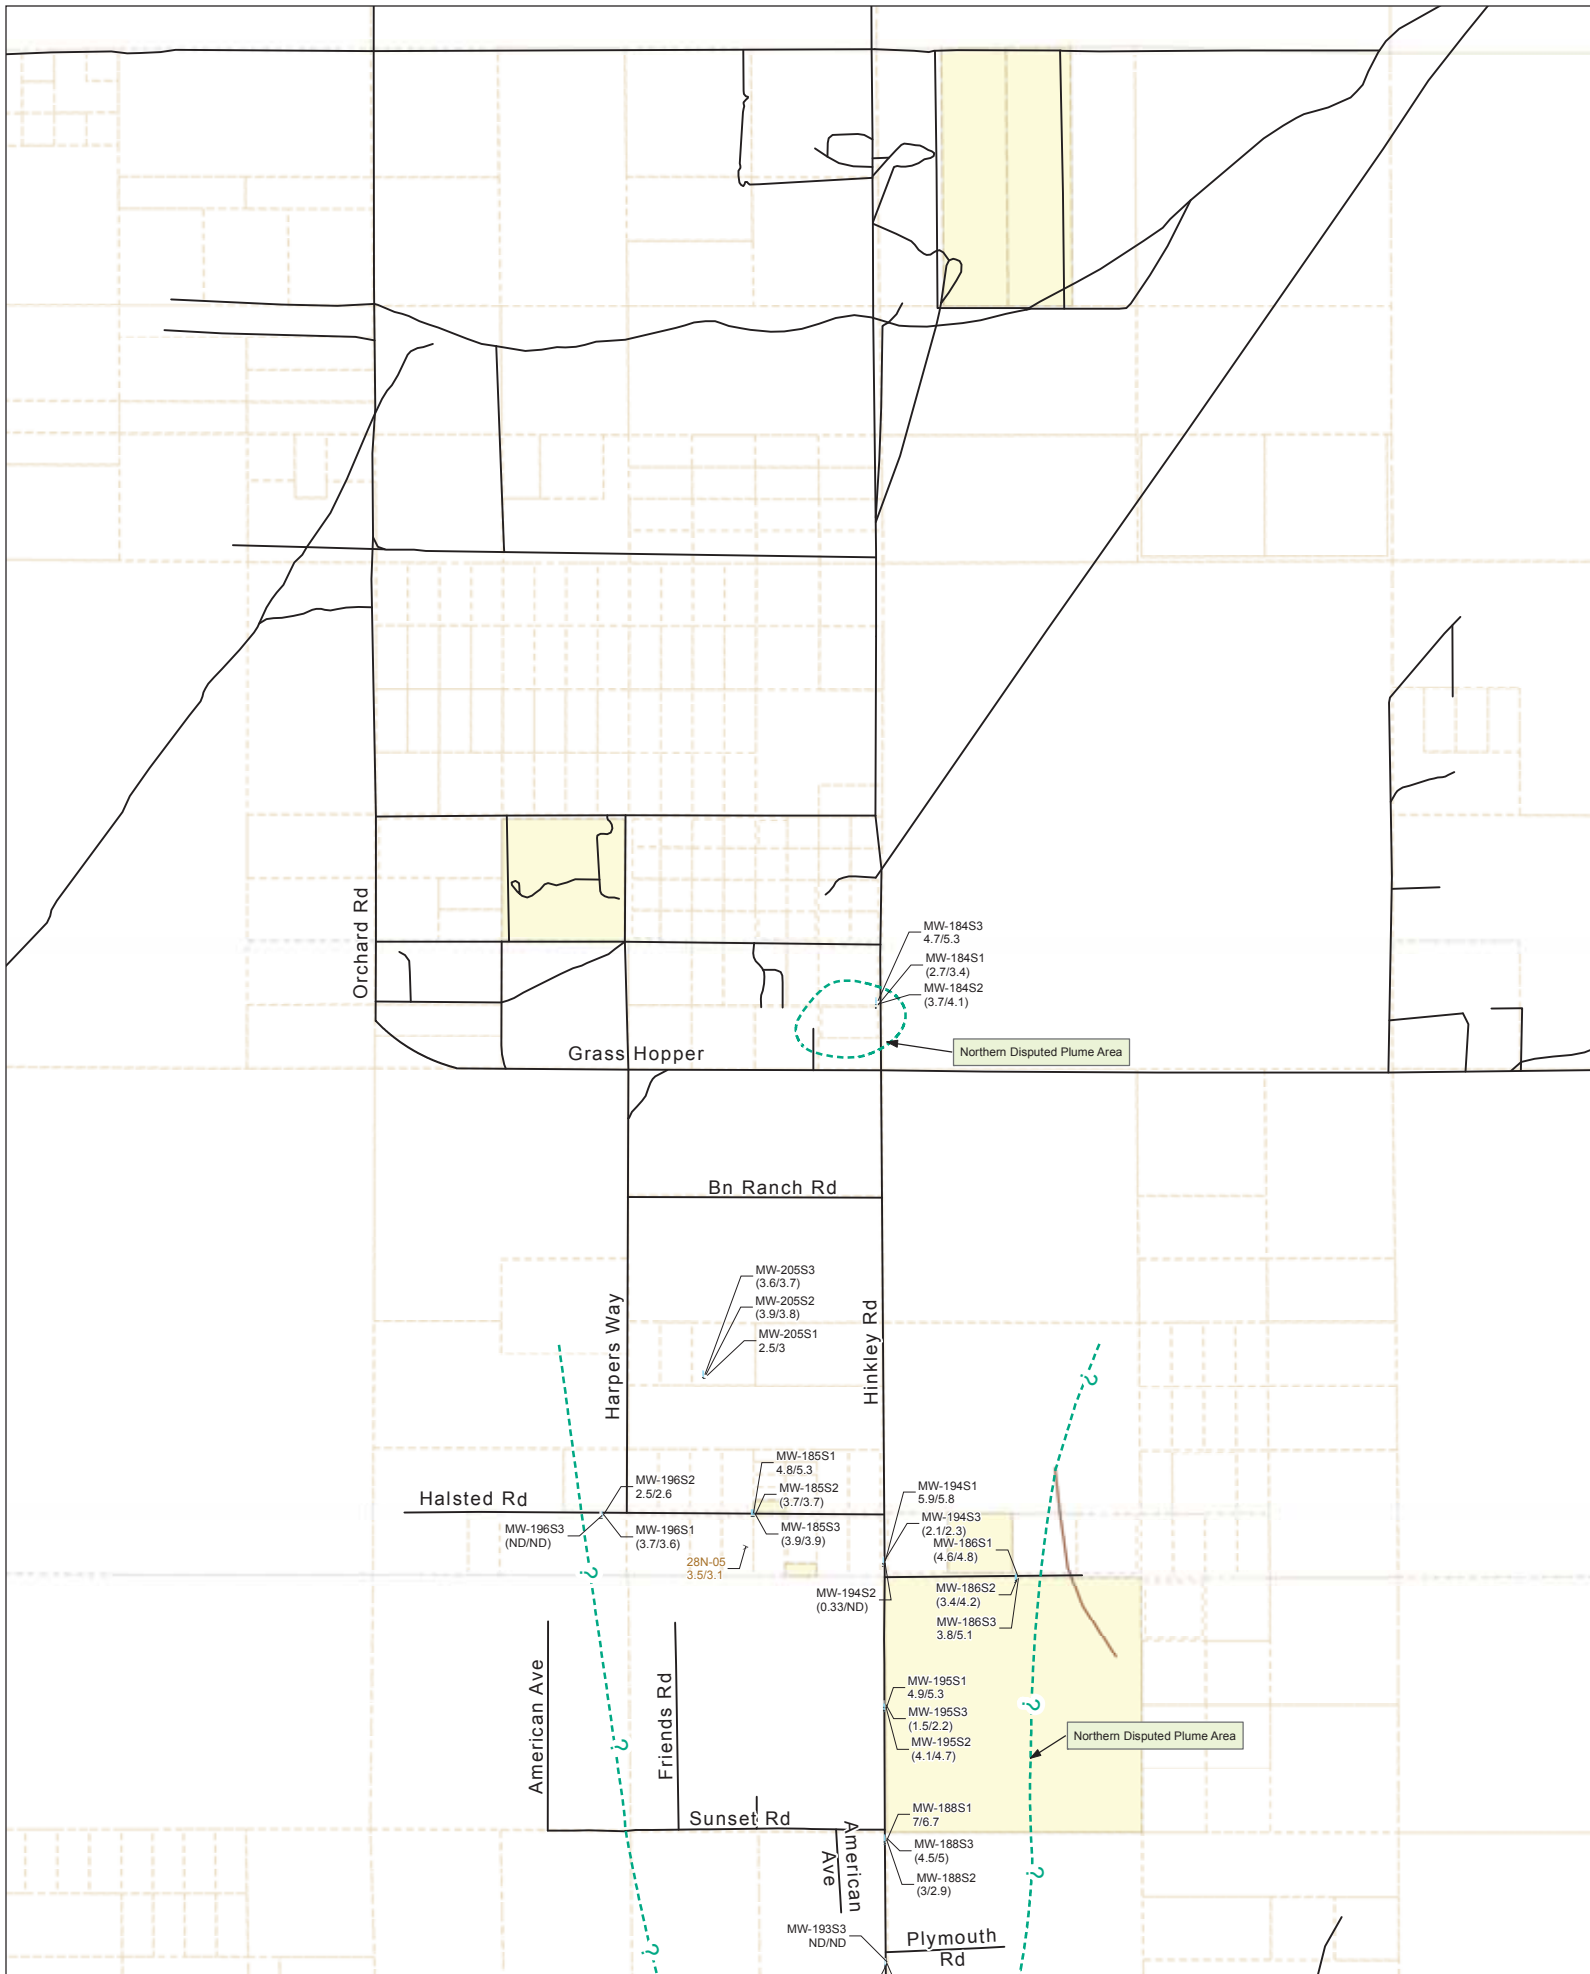
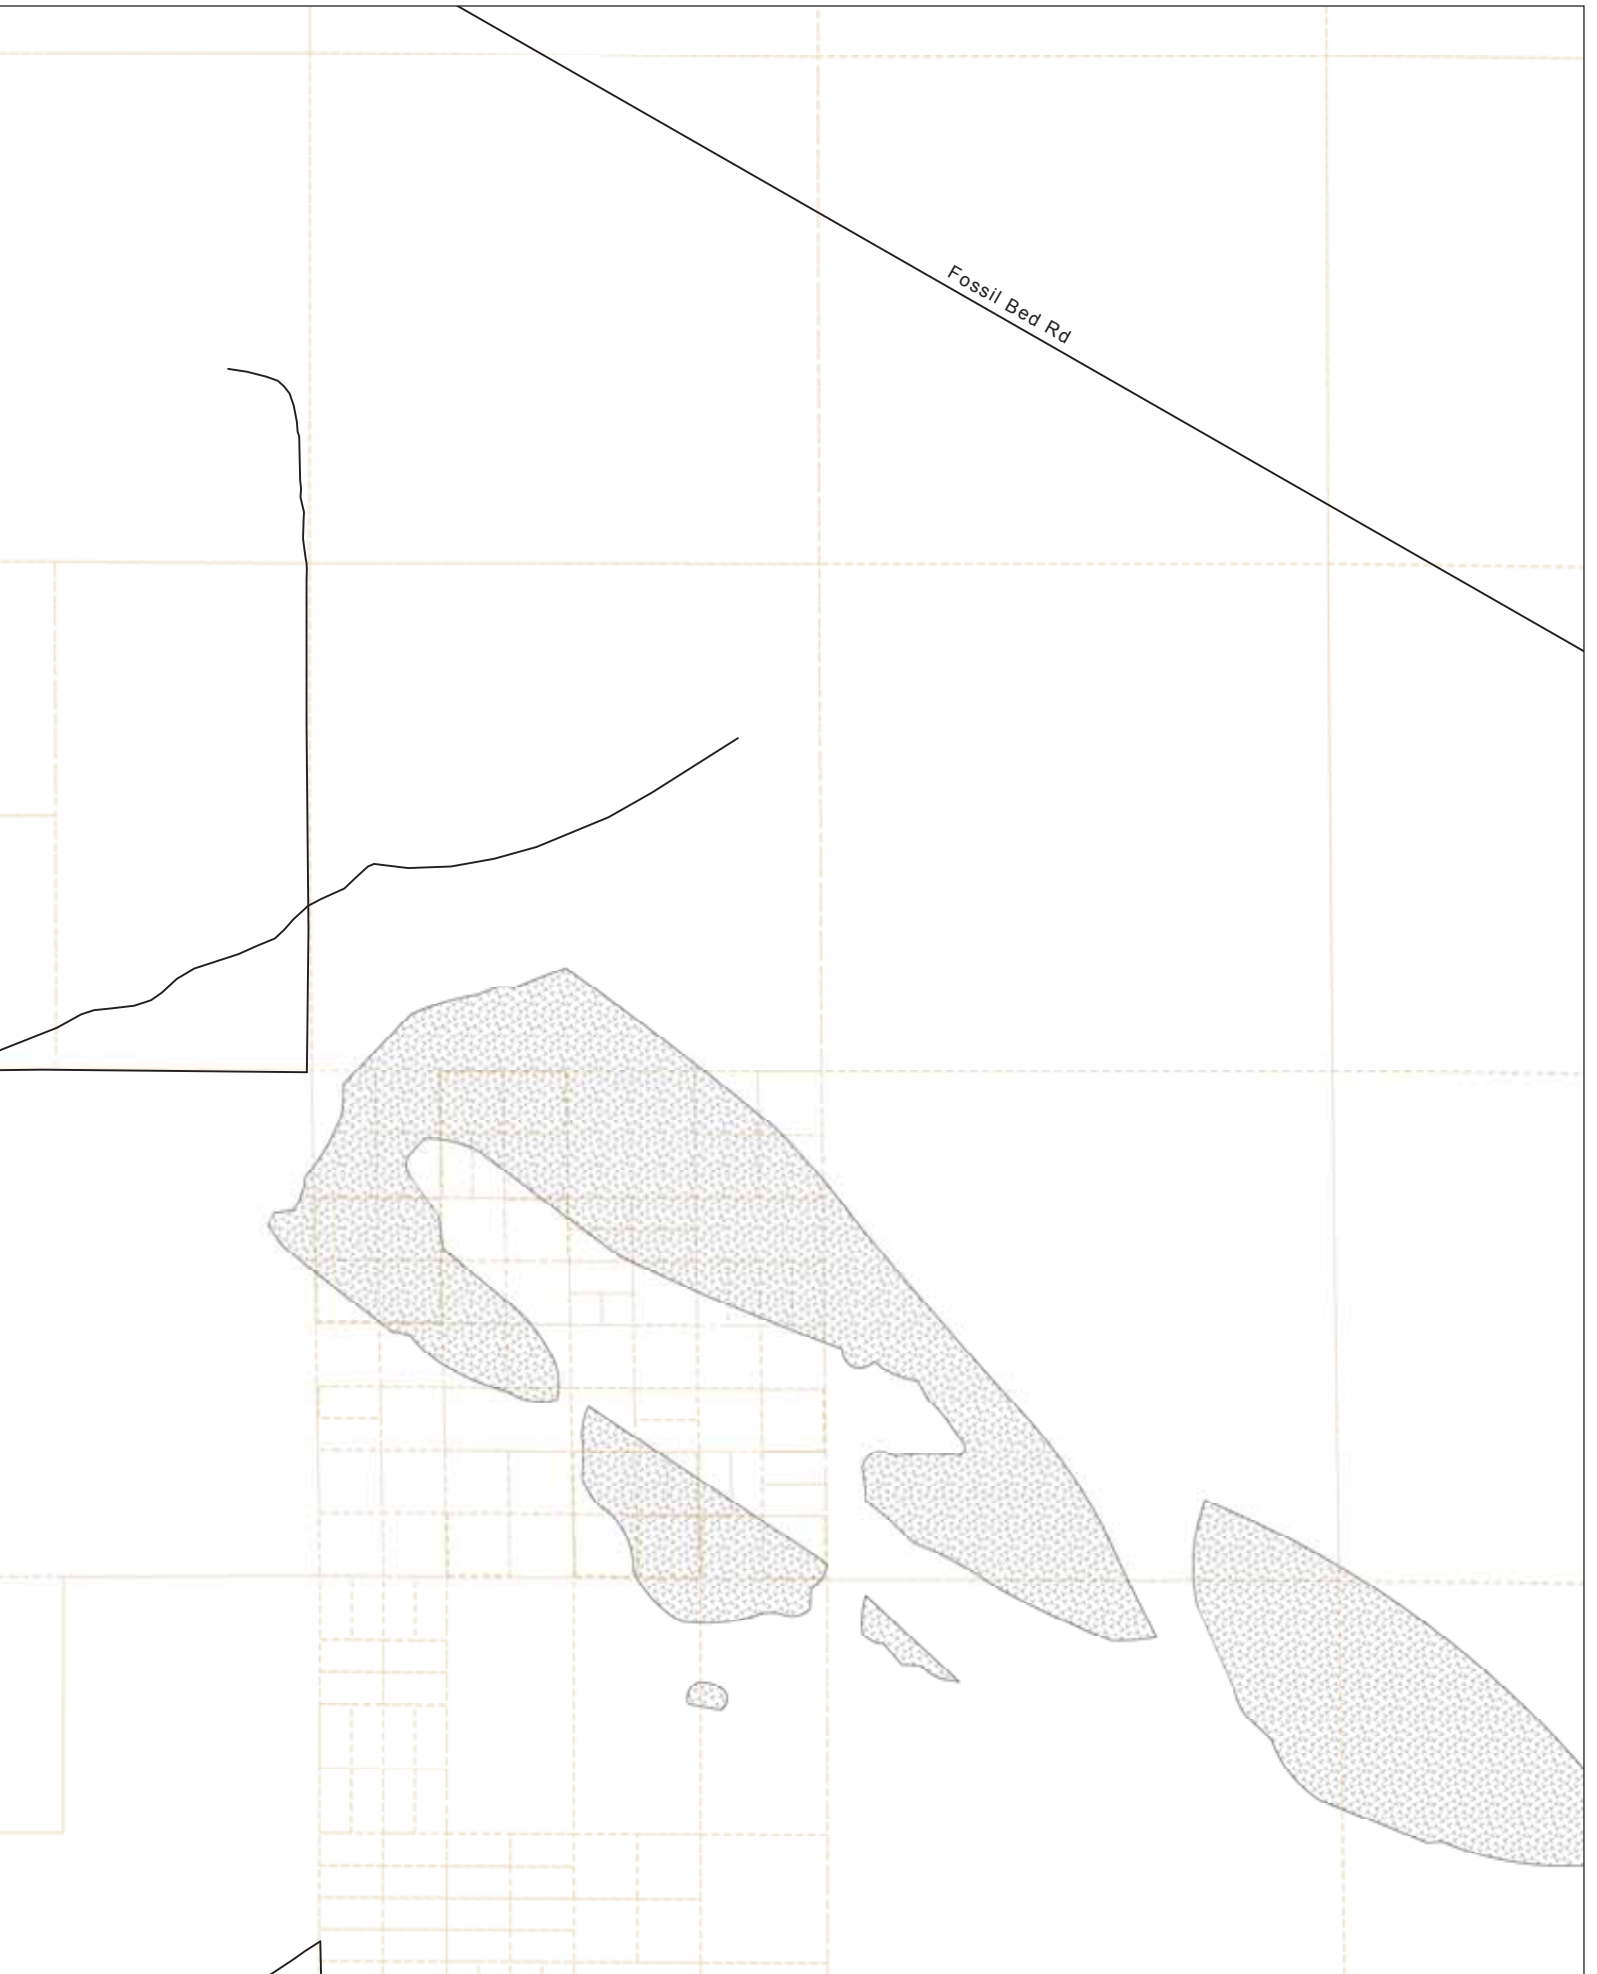
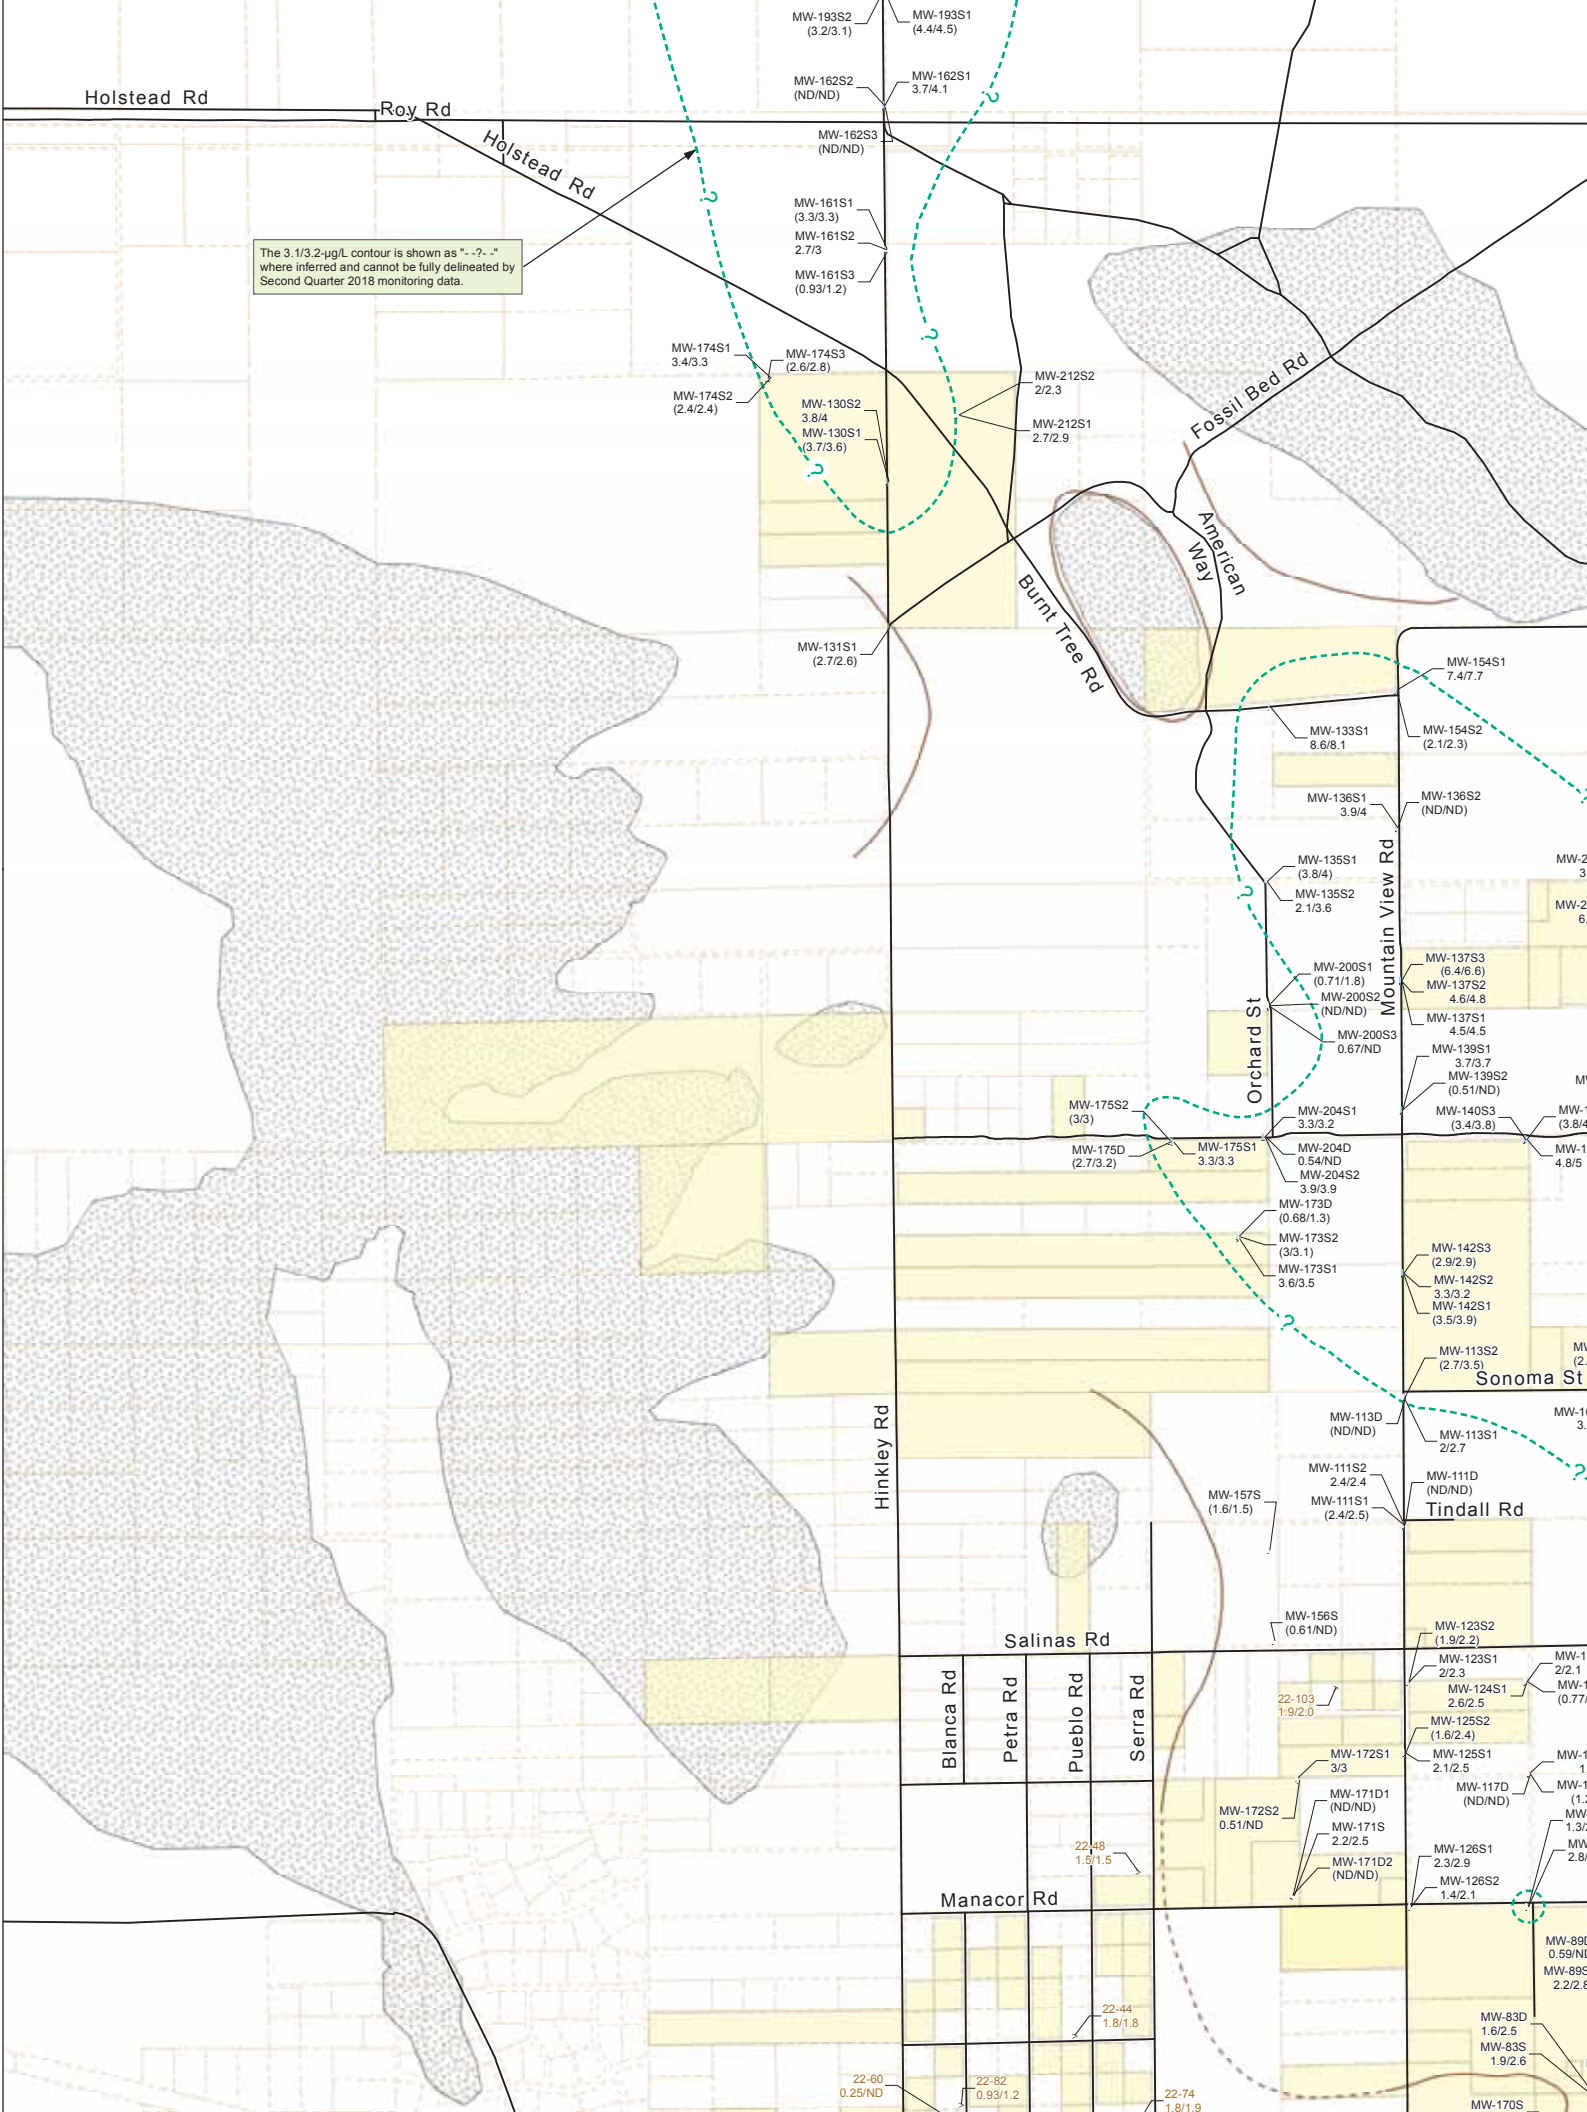
The 3.1/3.2-µg/L contour is shown as "-.-.-" where inferred and cannot be fully delineated by Second Quarter 2018 monitoring data.

MW-177D Well ID
1.6/1.8 Cr(VI)/Cr(T) concentrations in µg/L; maximum of primary and duplicate samples during Second Quarter 2018 sampling. Data in parentheses are from previous reporting period. See Table E-1 for sample dates.

- The concentration contours are based on Second Quarter 2018 chromium results for the groundwater monitoring wells. Figures 5-1 and 5-2. Results for domestic wells (brown-colored labels) were not used for chromium plume contouring. Control Board's Cleanup and Abatement Order dated November 4, 2015 (Water Board 2015).

- Chromium plume contours in the general area south of Highway 58, were developed using a larger set of monitoring wells from the Northwest Freshwater Injection Projects (Arcadis 2018). Select wells from that program are shown here.
