April 2, 2014

Jemellee Cruz
Flood Maintenance Division
County of Los Angeles Department of Public Works
900 South Fremont Avenue
Alhambra, CA 91803

SUBJECT: WATER QUALITY MONITORING AND ANALYSIS RESULTS FOR THE SAN GABRIEL FEASIBILITY STUDY WORK PLAN, LOS ANGELES COUNTY, CALIFORNIA.

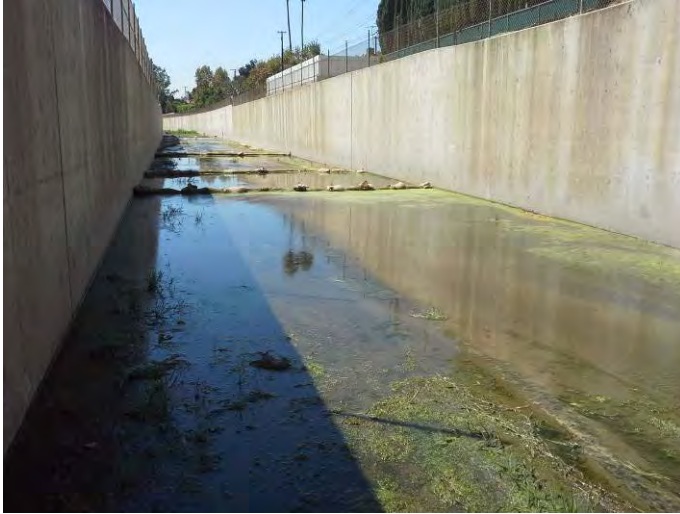
Photo 1:

Photo was taken facing southeast looking at the downstream water quality sampling station at Site 98 Walnut Creek.
GPS 34.07973,-117.86073.

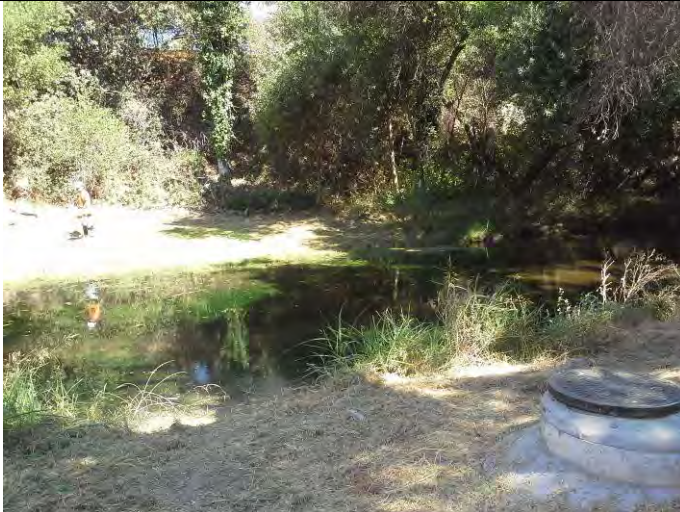
Photo 2:

Photo was taken facing north looking at the midpoint water quality sampling station at Site 98 Walnut Creek.
GPS 34.0776,-117.86065.

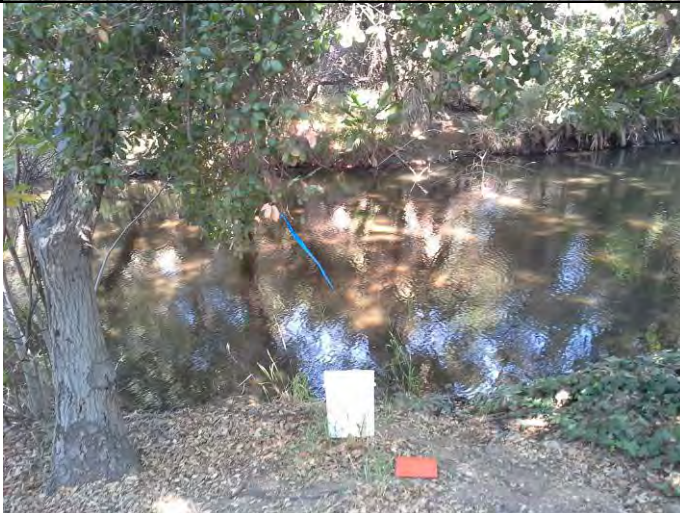
Photo 3:

Photo was taken facing north looking at the upstream water quality sampling station at Site 98 Walnut Creek.
GPS 34.07967, -117.86053.

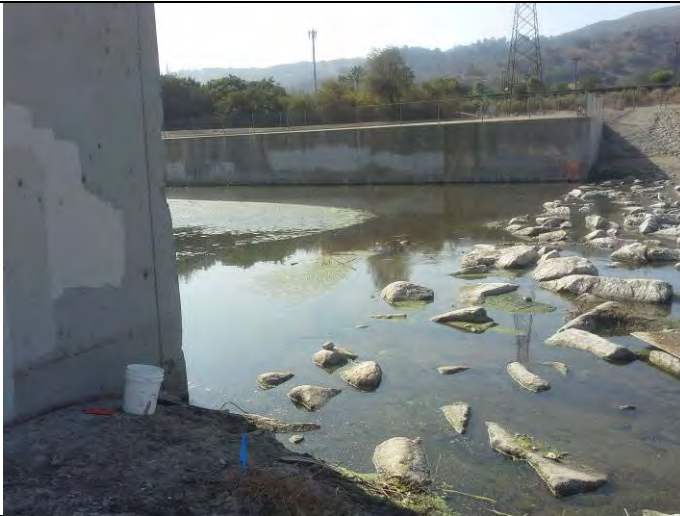
Photo 4:

Photo was taken facing south looking at the upstream sampling station at Site 42 San Jose Creek. GPS 34.03282,-118.00579.

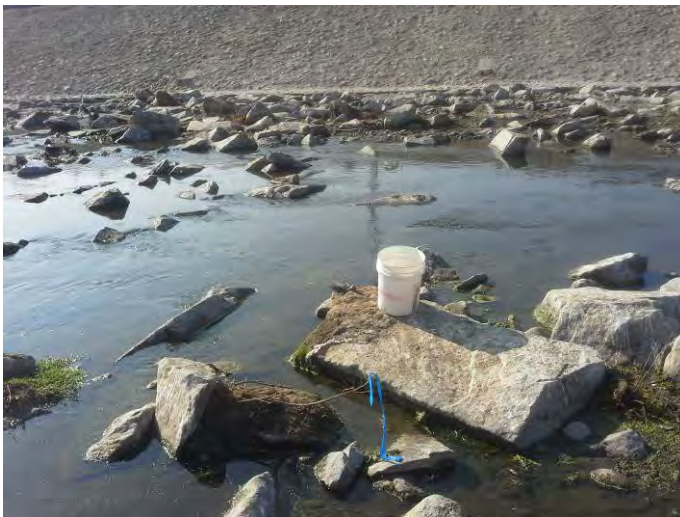
Photo 5:

Photo was taken facing south looking at the midpoint sampling station at Site 42 San Jose Creek. GPS 34.03259, -118.00758.

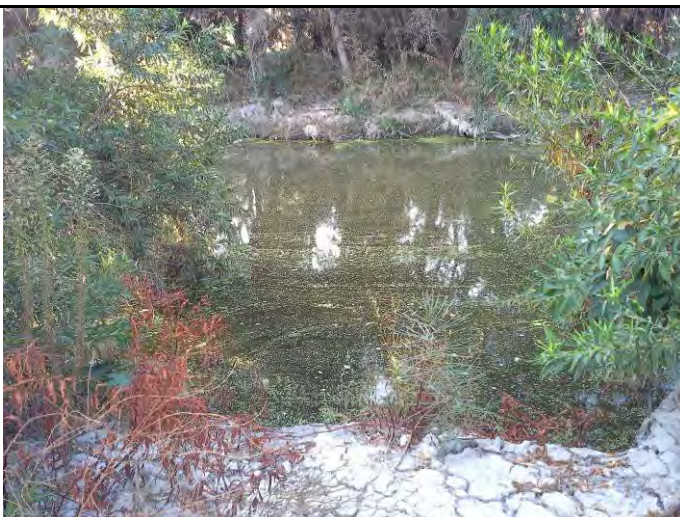
Photo 6:

Photo was taken facing south looking at the downstream sampling station at Site 42 San Jose Creek. GPS 34.03237,-11800930.

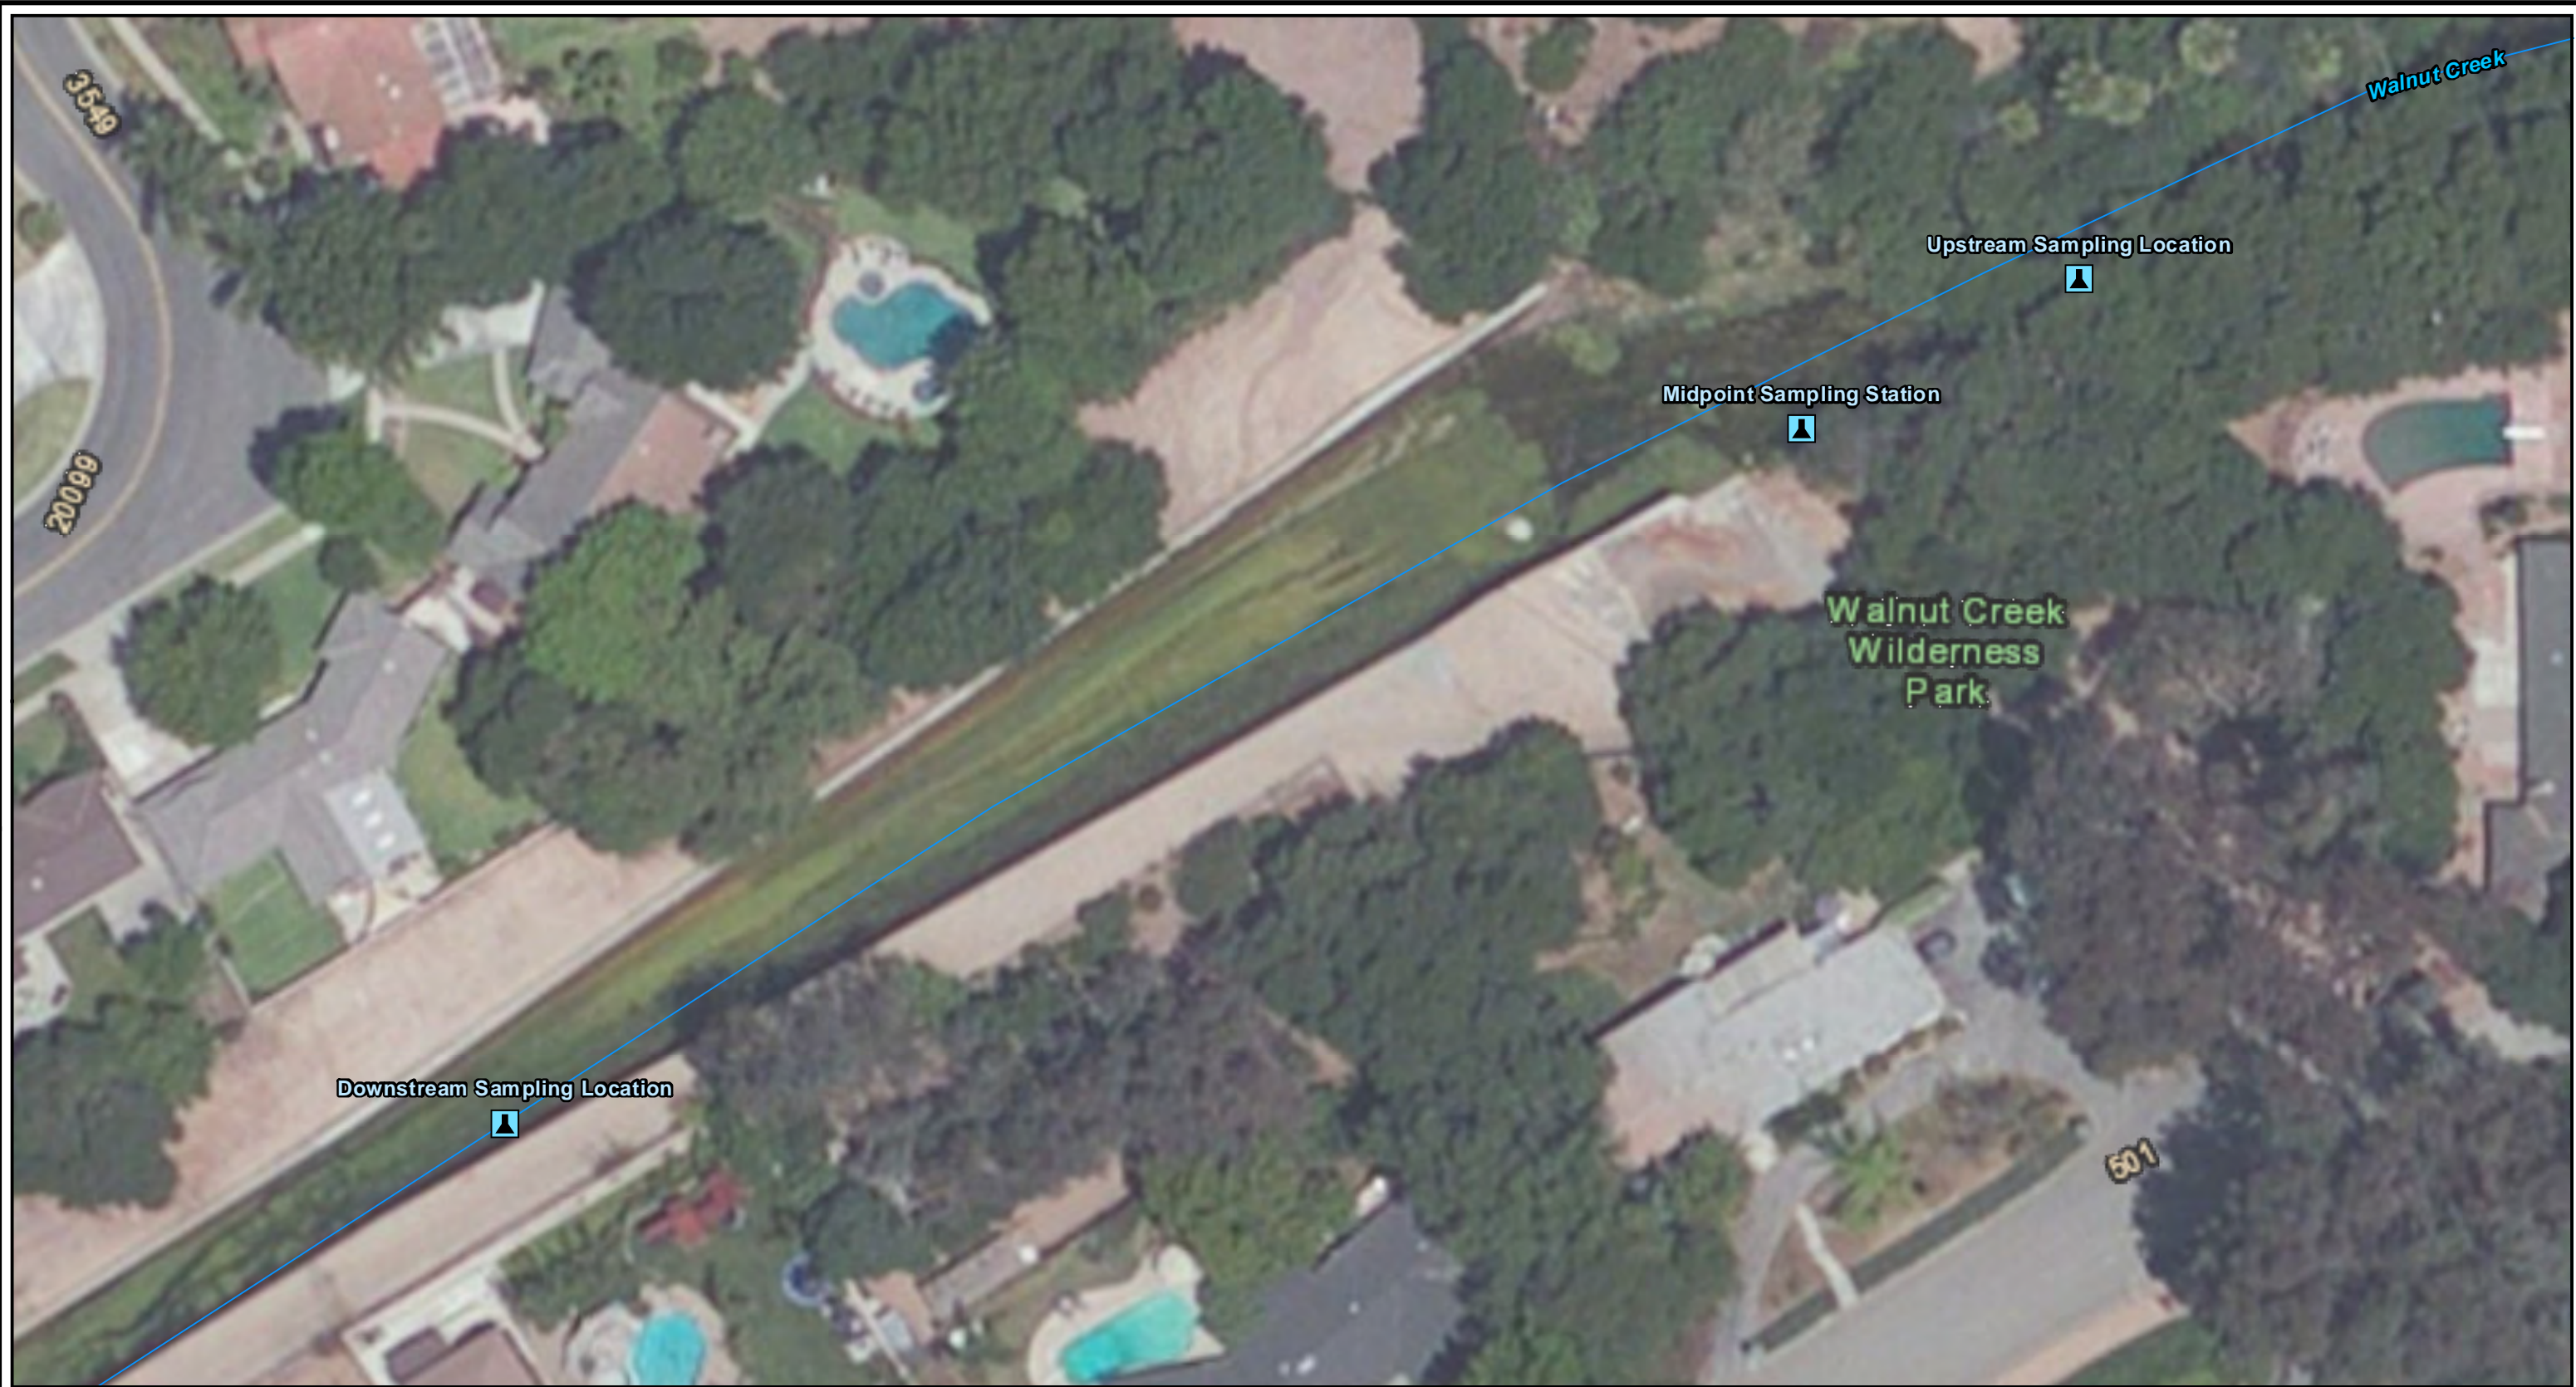
Water Quality Sampling Station Locations Map

Inlet Walnut Creek

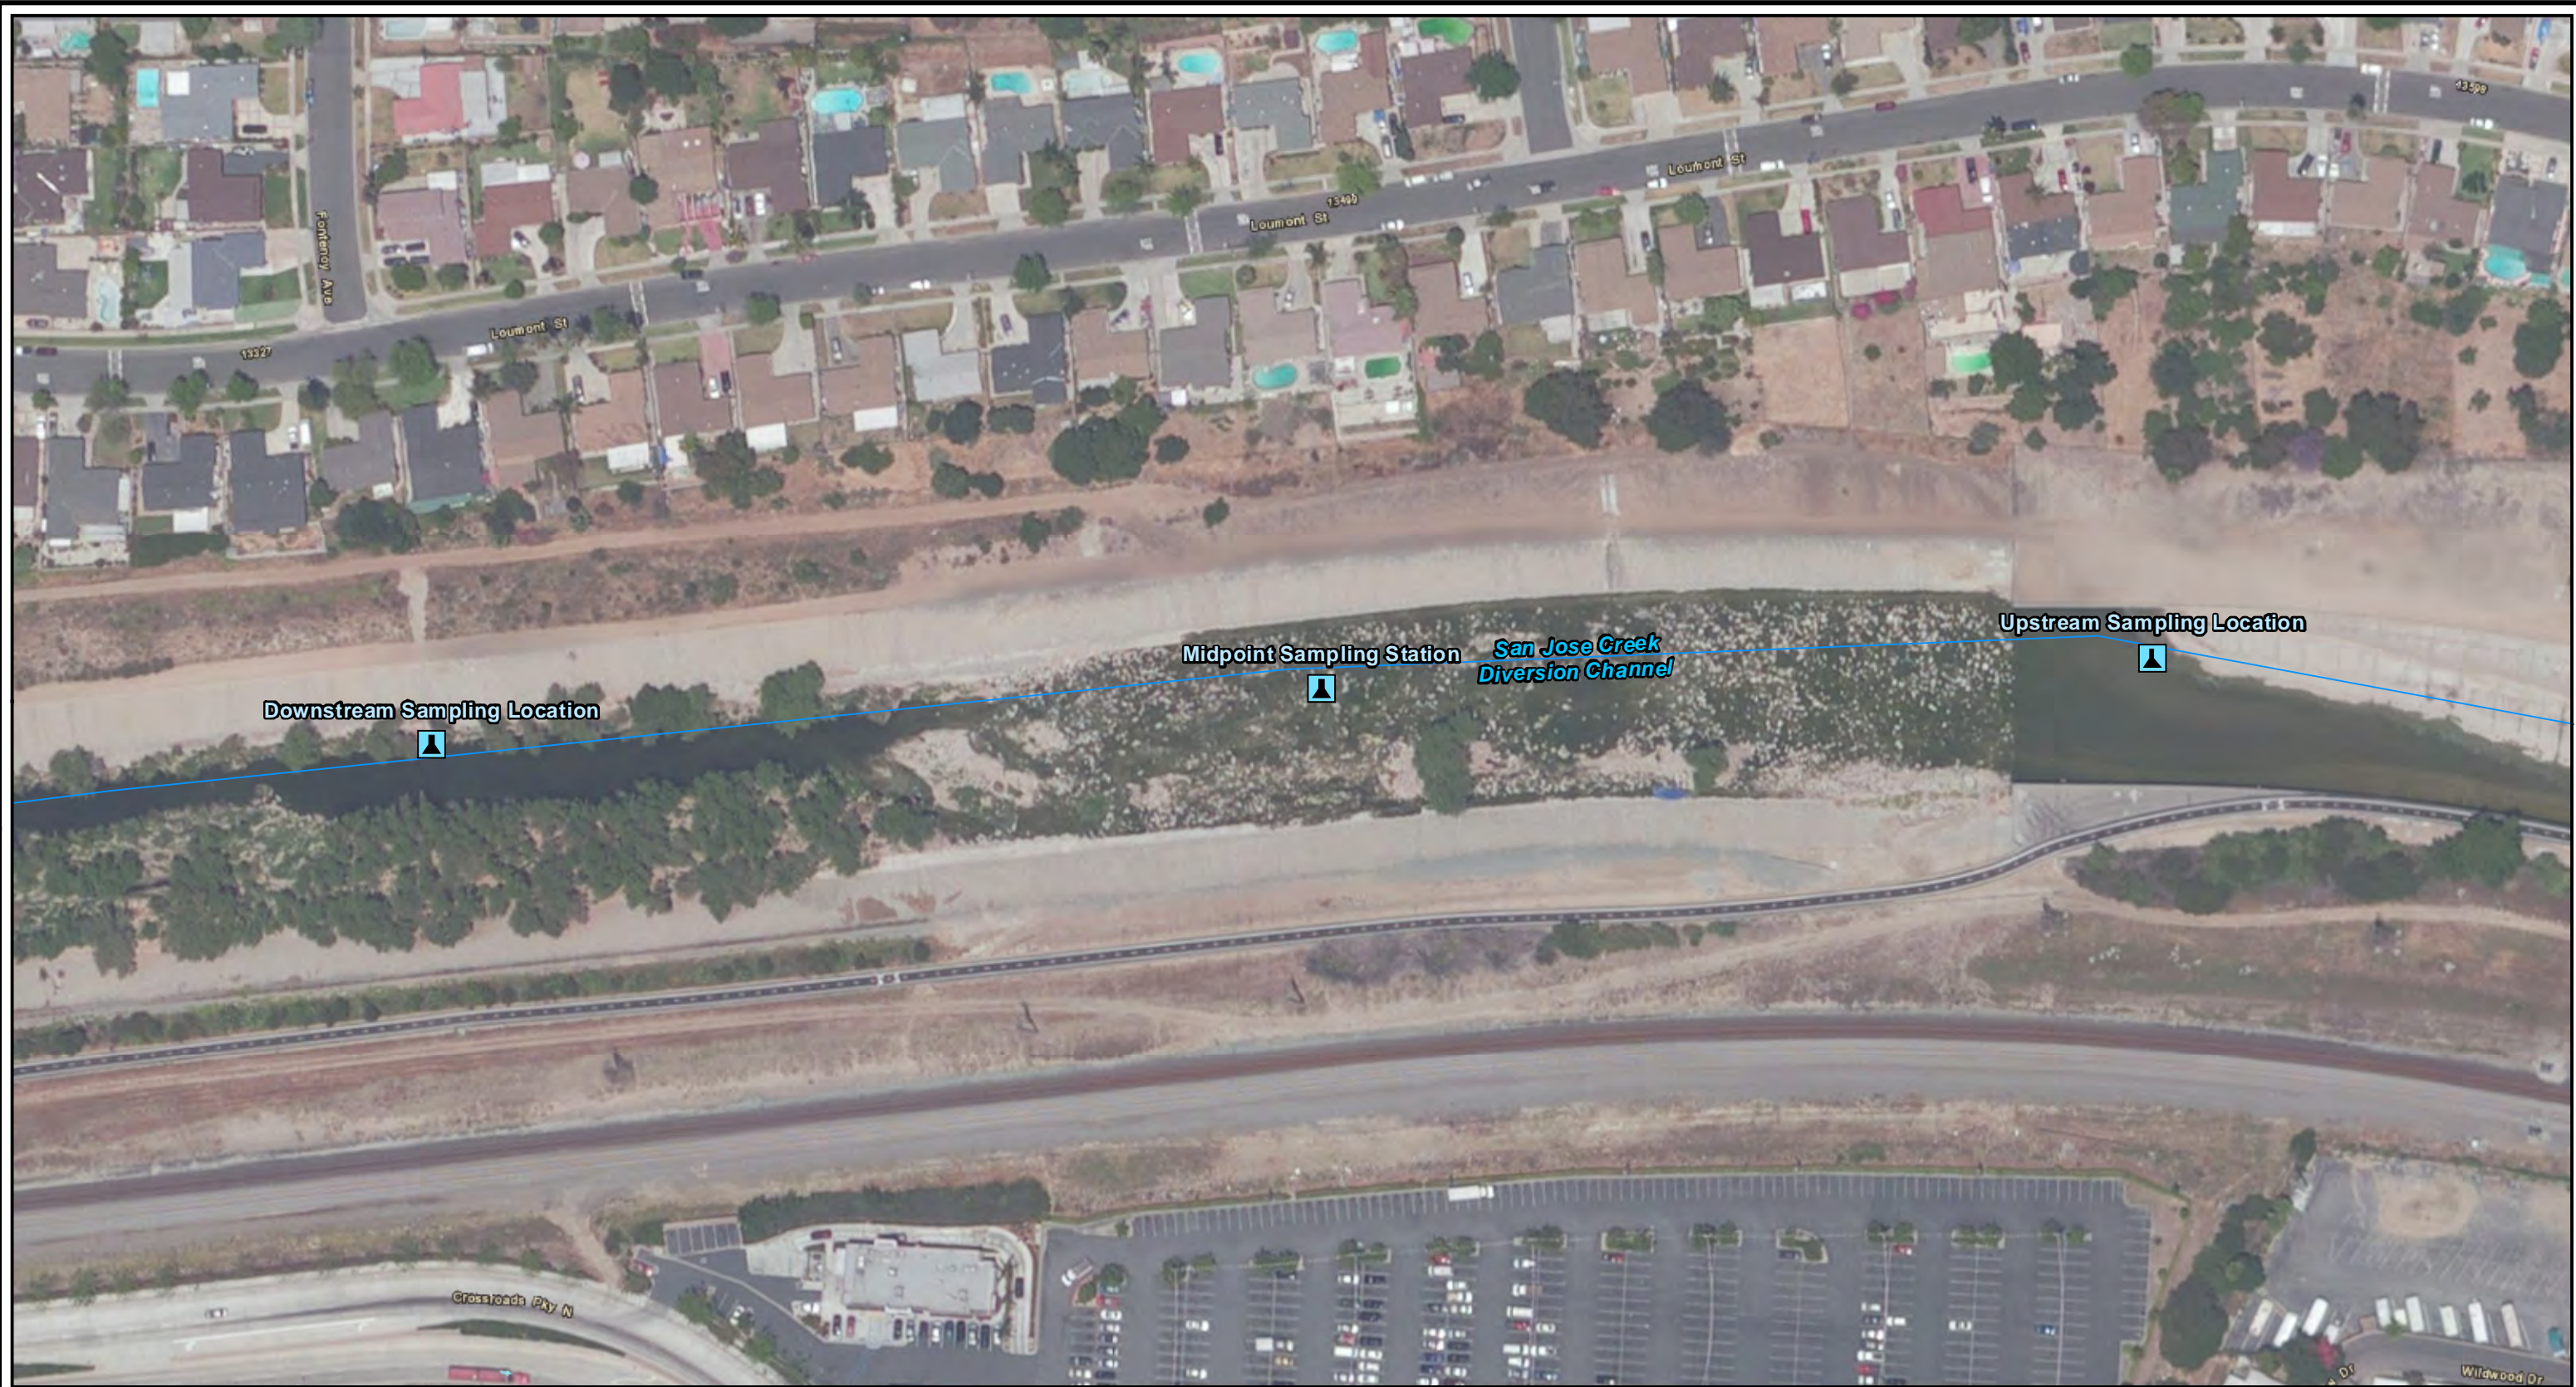
Water Quality Sampling Station Locations Map

San Jose Creek
