**VENTURA COUNTY AGRICULTURAL
IRRIGATED LANDS GROUP (VCAILG)**

Water Quality Management Plan

DRAFT

LARRY WALKER ASSOCIATES

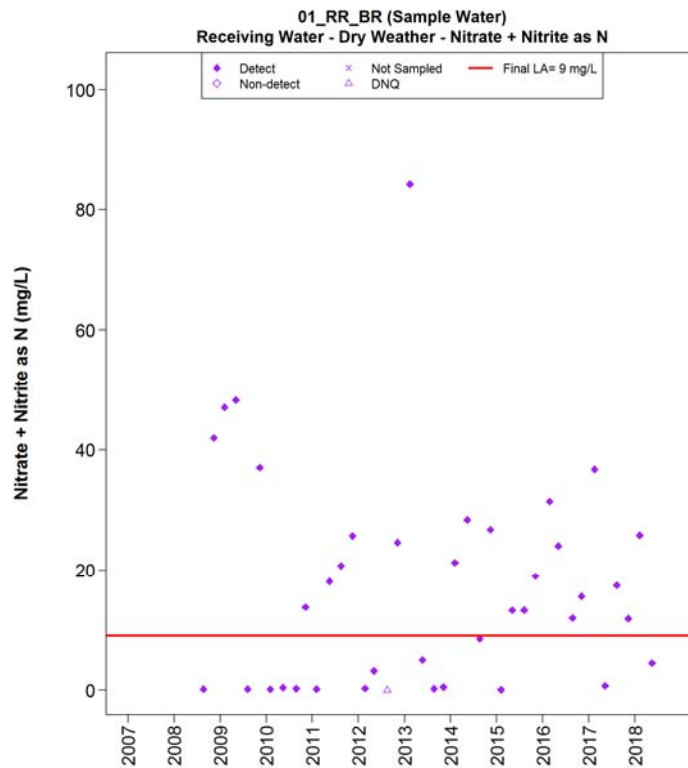
Figure 25. Dry Weather Nitrate-N + Nitrite-N Concentrations at TMDL LA Site 01_RR_BR

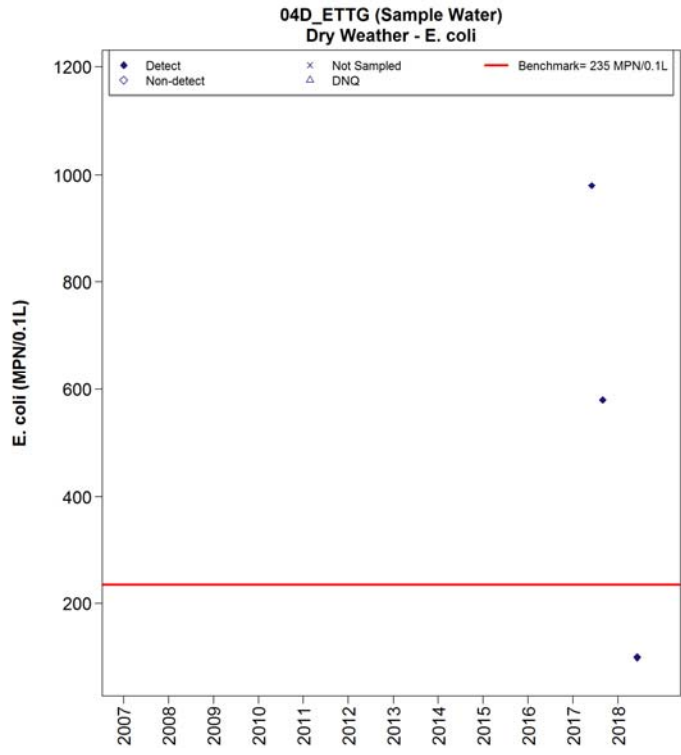
Figure 36. Dry Weather E. coli Concentrations at Waiver Benchmark Site 04D_ETTG

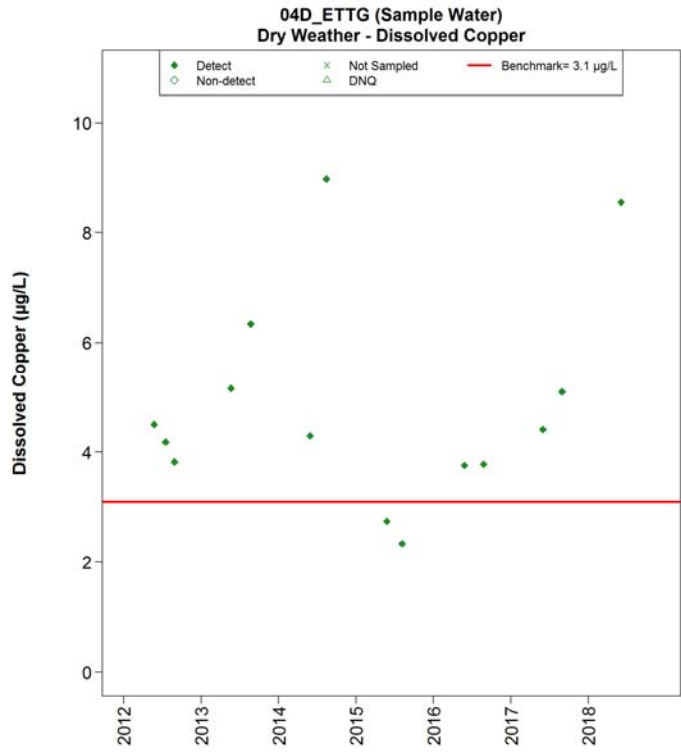
Figure 38. Dry Weather Dissolved Copper Concentrations at Waiver Benchmark Site 04D_ETTG

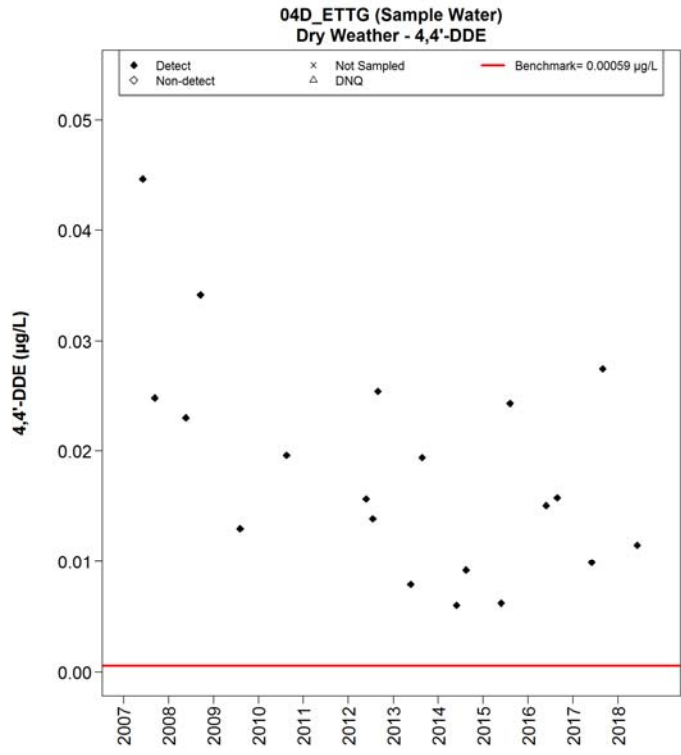
Figure 40. Dry Weather DDE Concentrations at Waiver Benchmark Site 04D_ETT

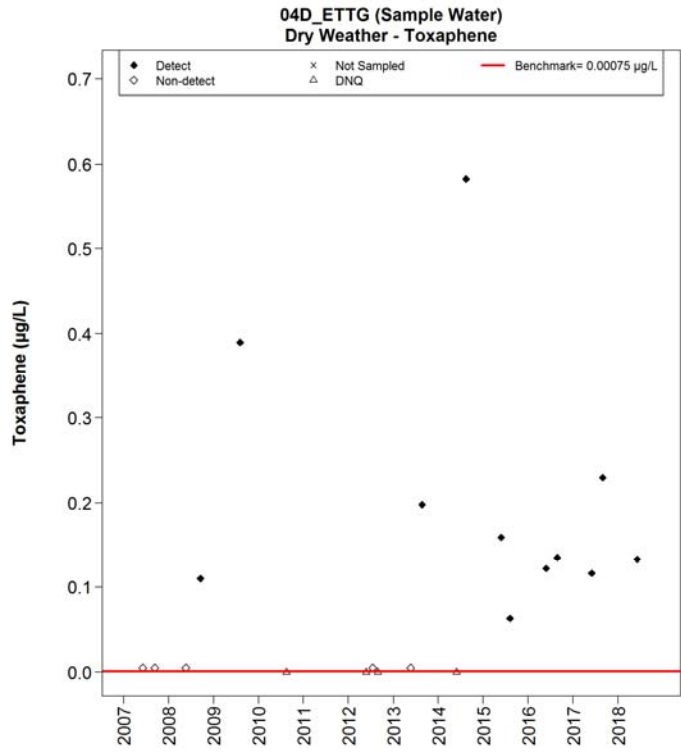
Figure 42. Dry Weather Toxaphene Concentrations at Waiver Benchmark Site 04D_ETTG

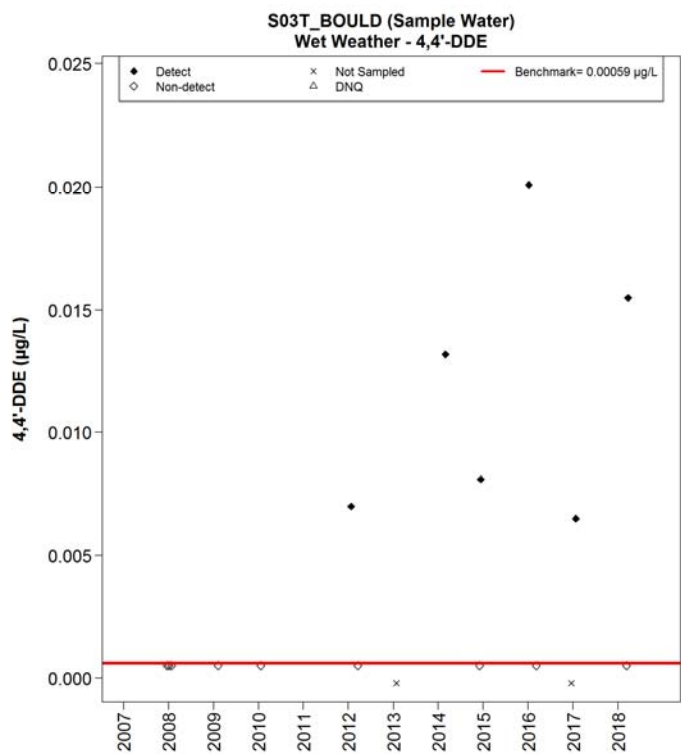
Figure 186. Wet Weather DDE Concentrations at Waiver Benchmark Site S03T_BOULD

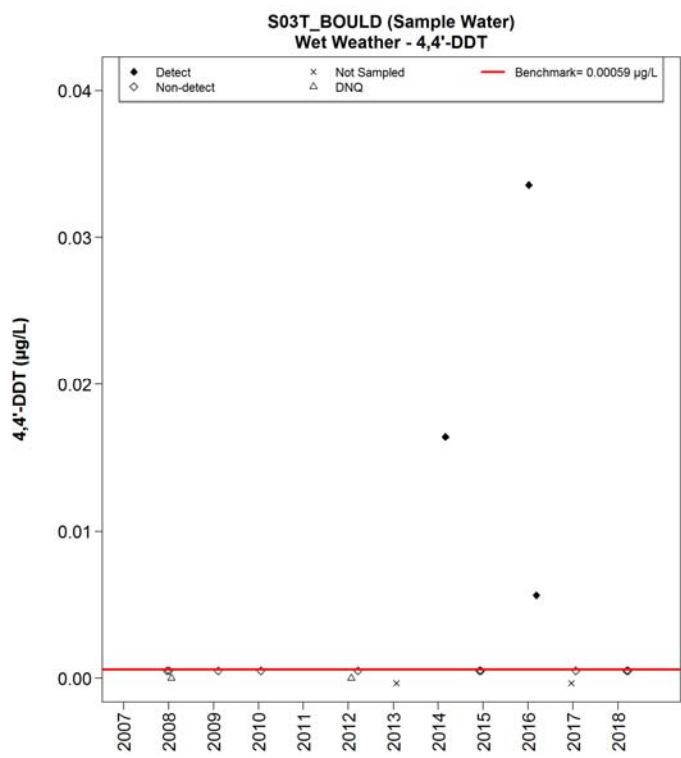
Figure 187. Wet Weather DDT Concentrations at Waiver Benchmark Site S03T_BOULD

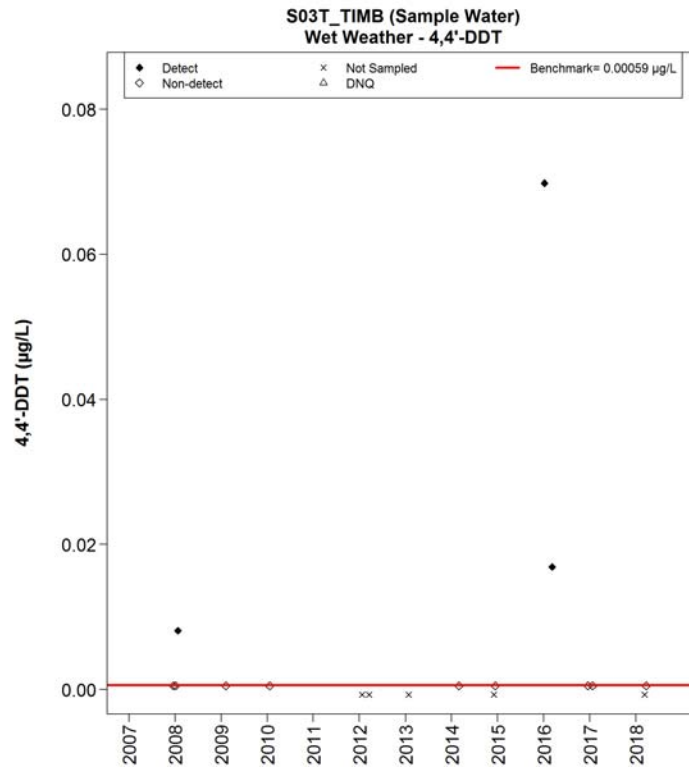
Figure 198. Wet Weather DDT Concentrations at Waiver Benchmark Site S03T_TIMB

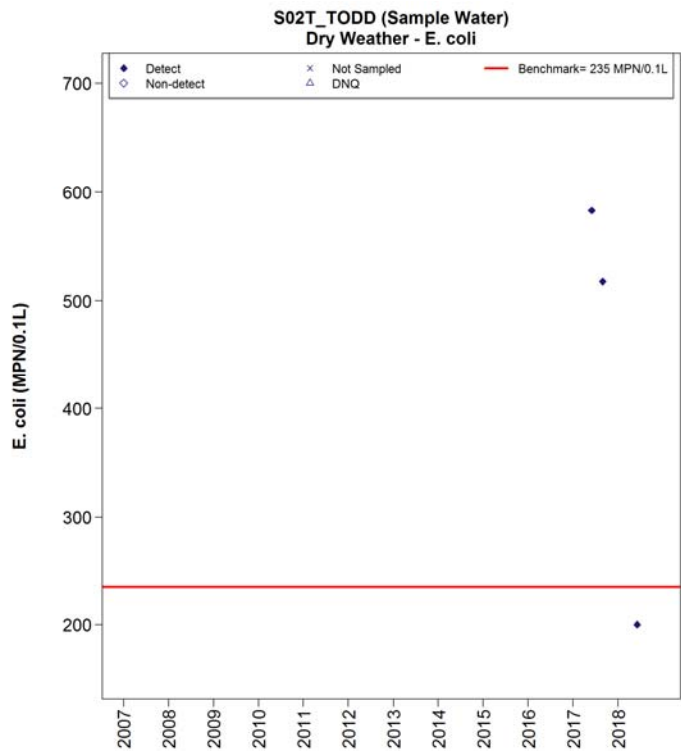
Figure 200. Dry Weather *E. coli* Concentrations at Waiver Benchmark Site S02T_TODD

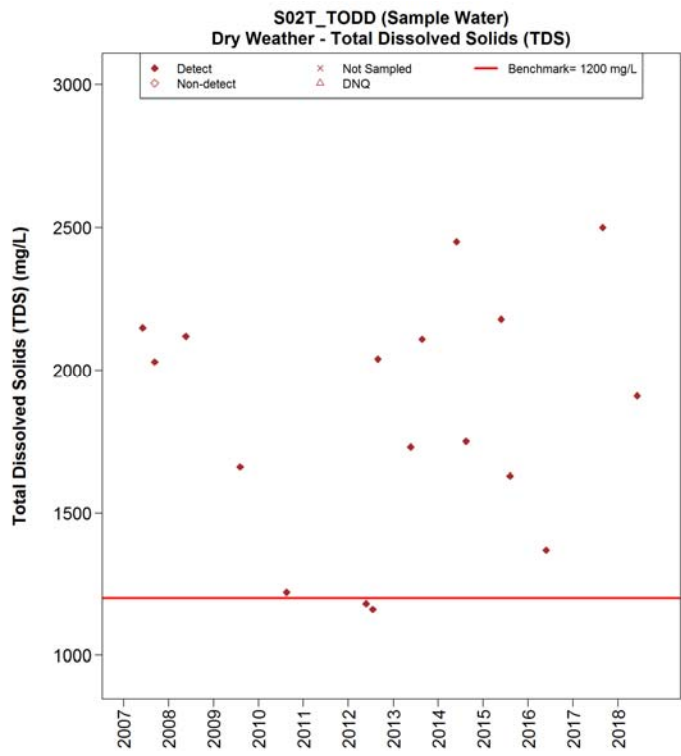
Figure 202. Dry Weather Total Dissolved Solids Concentrations at Waiver Benchmark Site S02T_TODD

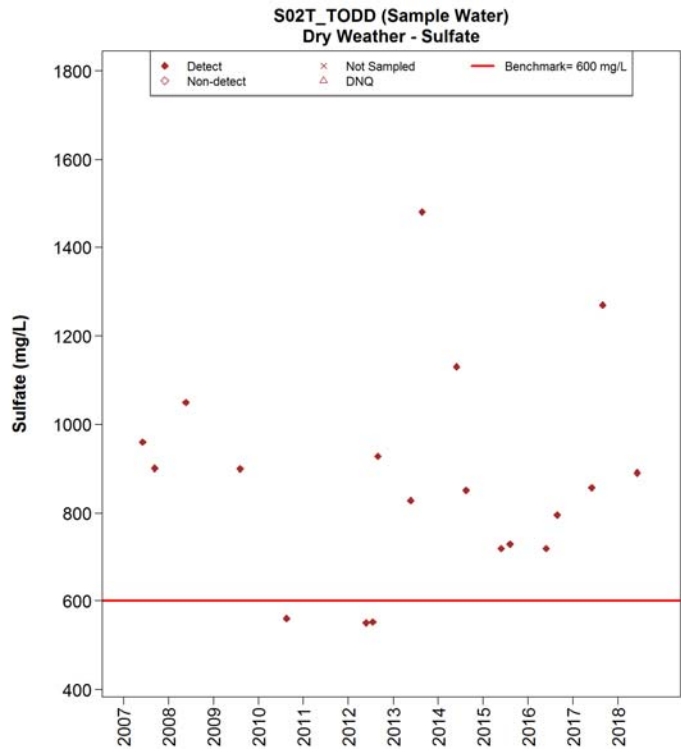
Figure 203. Dry Weather Sulfate Concentrations at Waiver Benchmark Site S02T_TODD

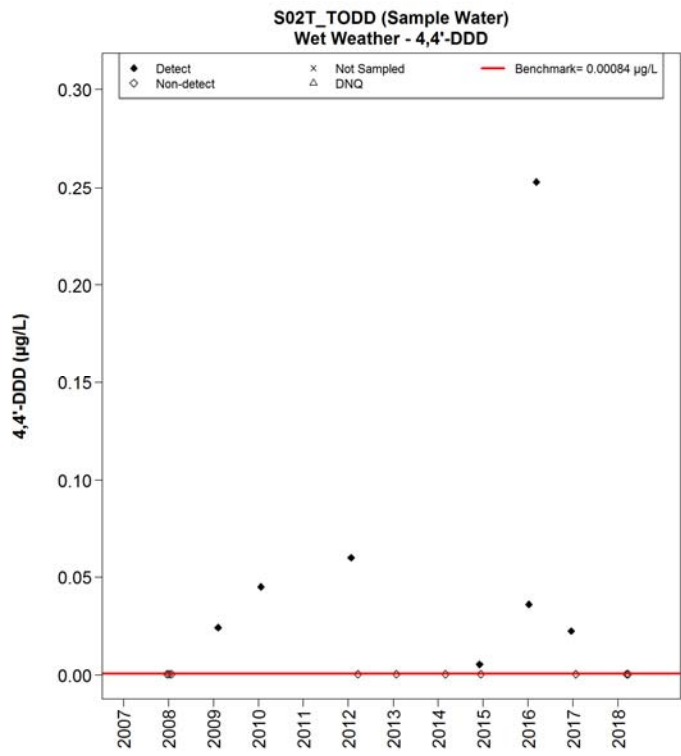
Figure 204. Wet Weather DDD Concentrations at Waiver Benchmark Site S02T_TODD
