**BURIED DRUM INVESTIGATION
REPORT**

**Sierra Pacific Industries
Arcata Division Sawmill
2593 New Navy Base Road
Arcata, California**

March 15, 2004

MFG Project No. 030229.15

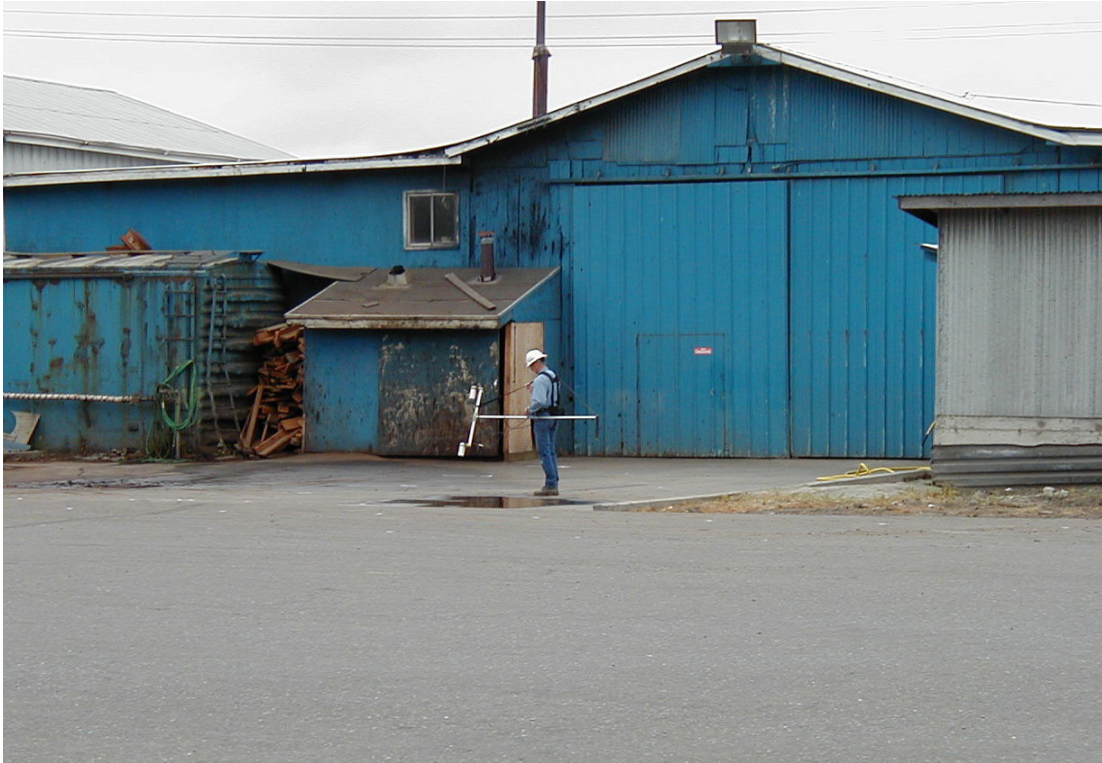
Photograph 1 – Magnetometer Survey.

NORCAL performed the initial geophysical survey using a magnetometer. The magnetometer measures variations in the earth's magnetic field caused by geologic units or buried objects comprised of ferrous material, such as underground storage tanks, drums and metal debris. A magnetic reading was obtained at each grid node and recorded on a data logger. The data obtained during this survey was then downloaded to a notebook computer and analyzed using an appropriate software package to produce a vertical magnetic gradient contour map. The vertical magnetic gradient contour map was used to identify the areas where magnetic anomalies were present. Prior to further evaluation, the immediate vicinity of each detected anomaly was inspected for miscellaneous surface features and surface debris that may have generated a false-positive reading. A copy of the contour map is presented in Appendix B.

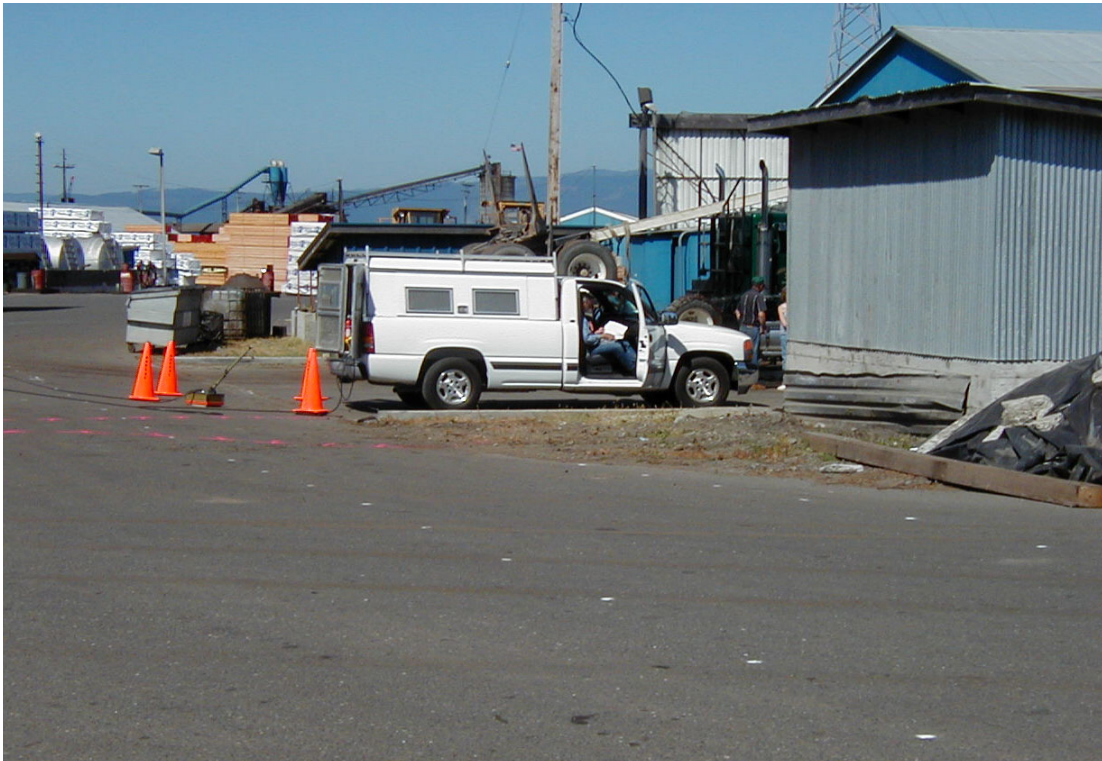
Photograph 2 – Ground Penetrating Radar Survey.

The GPR survey method provides a high resolution, cross-sectional image showing variations in the electrical properties of the subsurface material. GPR operates by repeatedly radiating an electromagnetic pulse into the ground from a transducer (antenna) as it is moved along the surface. Since rock and soil are transparent to electromagnetic energy, the radar signal propagates downward into the ground until it encounters a change in electrical permittivity (ability of a material to hold a charge when an electrical field is applied), such as a metallic object. When the signal encounters a metallic object, the electromagnetic energy is reflected back to the surface and detected by the transducer (antenna). The reflected signal is then printed as a cross-sectional image and interpreted by a geophysicist.

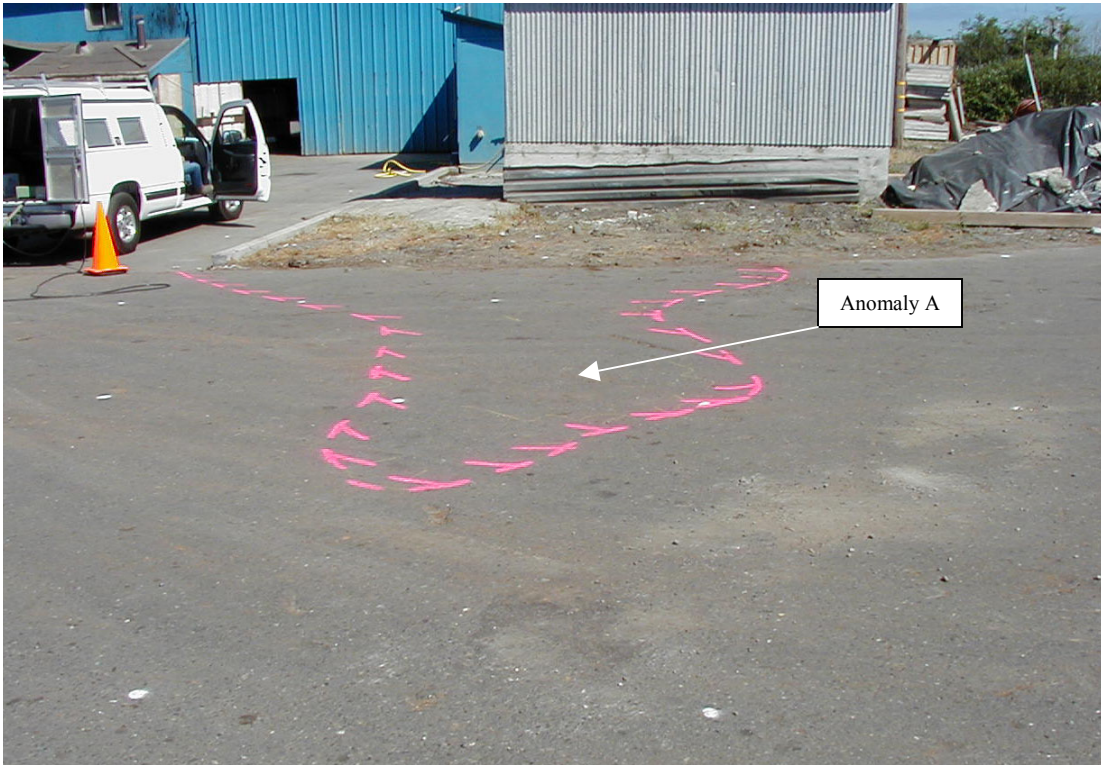
Photograph 3 – Shows Anomaly A outlined in pink spray paint.

- Anomaly A – suspected to be a single massive object or multiple smaller objects located close together. The top of the object(s) was estimated to be approximately 3 to 4 feet bgl. The width of the object(s) was estimated to be approximately 4 feet.
- Anomaly B – suspected to be a small object. The width of the object was estimated to be approximately 2 feet and was visible in the GPR image obtained along the northeast-southwest transect. The object was not visible along the northwest-southeast transect suggesting that the object was linear. The top of the object was estimated to be 2 to 3 feet bgl.
- Anomaly C – the top of the object was estimated to be approximately 4 feet bgl; the signal was faint along both the northeast-southwest and northwest-southeast transects.
- Anomaly D – suspected to be a small object at a shallow depth, likely immediately beneath the asphalt pavement.

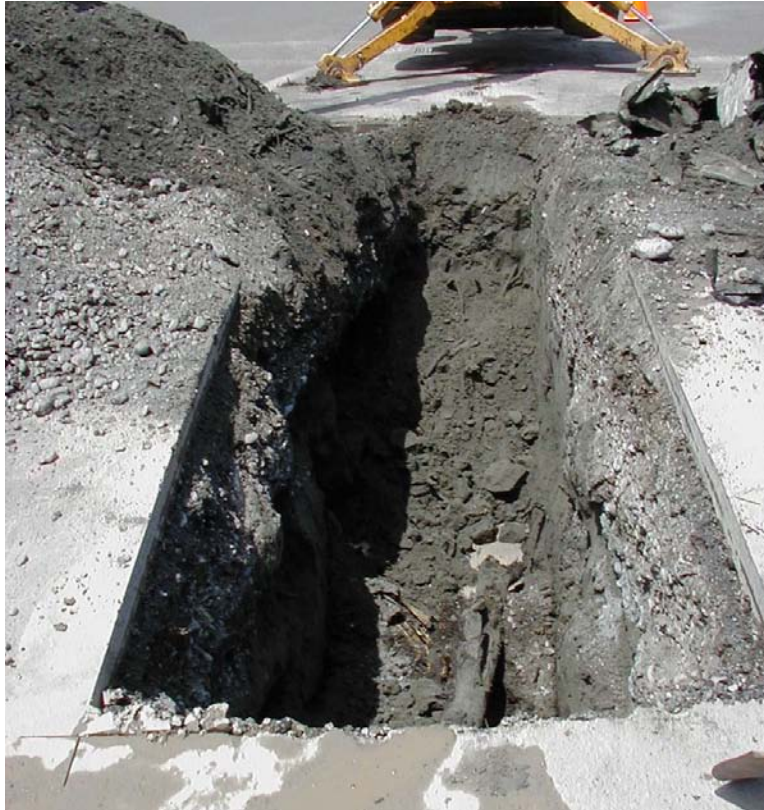
Photograph 5 – Shows the limited excavation at Anomaly A.

- Anomaly A – several sections of degraded, corrugated sheet metal of varying size were removed from the excavation along with lesser amounts of other miscellaneous metal debris, such as wiring, metal cables and tin cans. No other metal debris was visible in the excavation.

Immediately following the completion of investigation activities on July 22, 2003, Foss backfilled the excavations to surrounding grade with soil that was removed from each location. The backfilled soil was compacted in-place using the backhoe bucket. SPI personnel will complete the site restoration activities by capping each excavation with asphalt pavement.

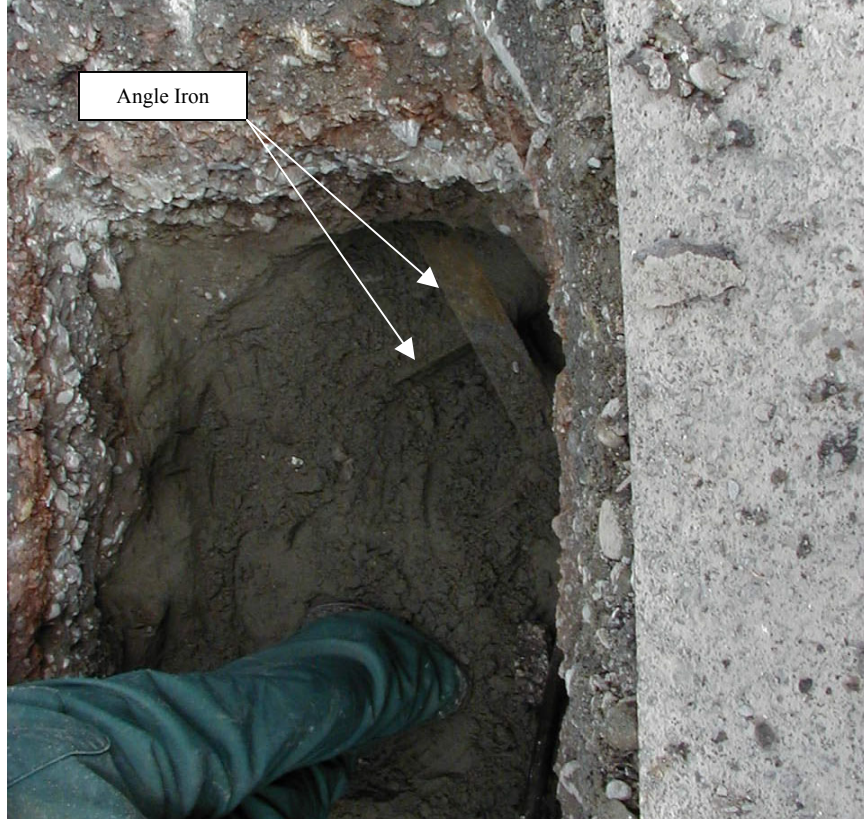
Photograph 7 – Shows angle iron along north (top) side of the excavation at Anomaly B.

- Anomaly B – two pieces of narrow angle iron of unknown length and a degraded saw blade were uncovered; however, the objects were left in place because they extended beyond the excavation sidewalls and could not be removed with the backhoe bucket. No other metal debris was visible in the excavation.

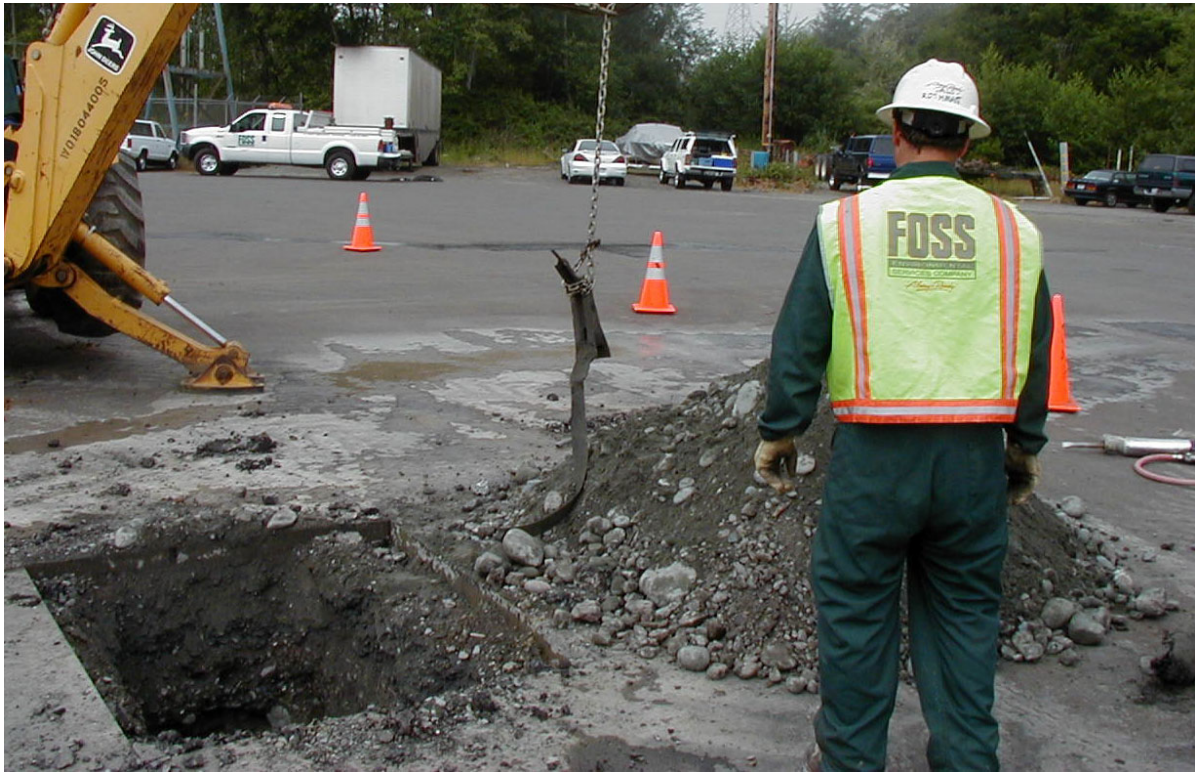
Photograph 9 – Shows the limited excavation at Anomaly C.

- Anomaly C – miscellaneous metal debris, including steel plates, piping, metal cables, wiring and a truck axle, was removed from the excavation. No other metal debris was visible in the excavation.

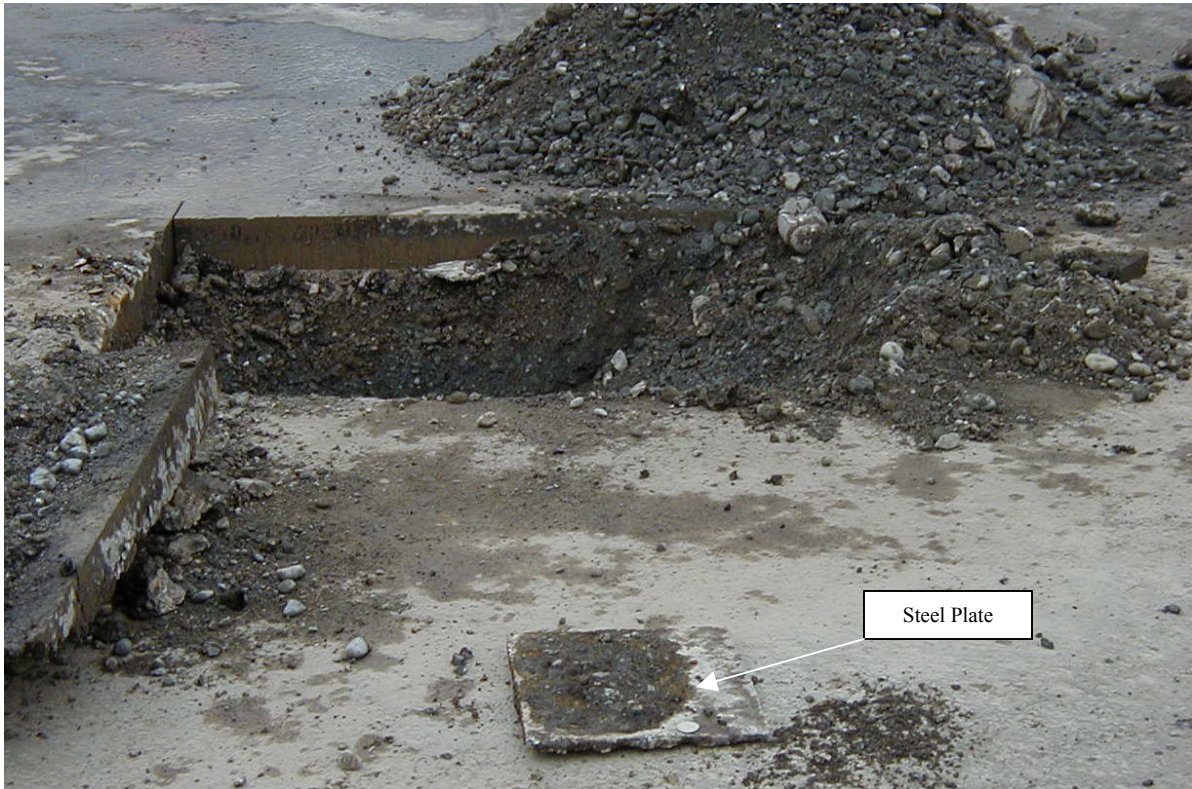
Photograph 11 – Shows the limited excavation at Anomaly D and the steel plate removed from the excavation.

- Anomaly D – a single steel plate was discovered at shallow depth and was removed from the excavation. No other metal debris was visible in the excavation.
