FACILITY INSPECTION REPORT

INSPECTION DATE: 10/28/05

FACILITY: Carlsbad Municipal Golf Course

Construction Storm Water Inspection-10/28/05
Carlsbad Municipal Golf Course, WDID# 937C337203
Carlsbad, San Diego County

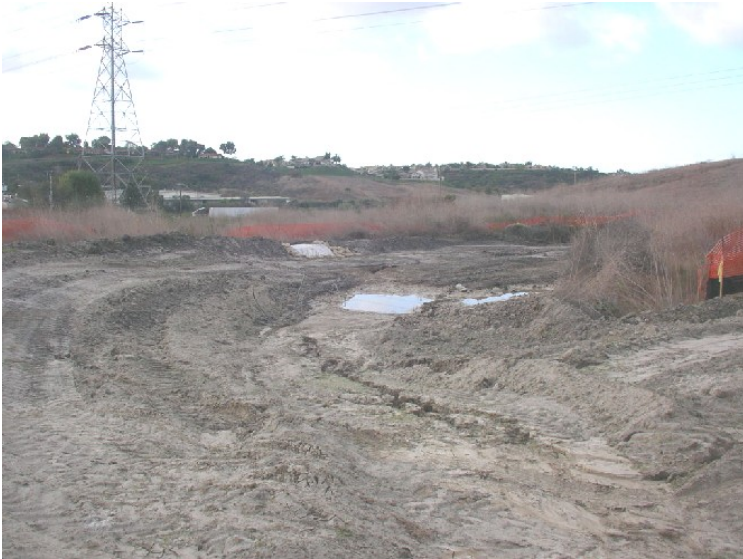
- New silt fence has been installed along the entire perimeter (Photo 2)
- Sediment traps have been sized and constructed in inactive areas (Photo 1). Sediment traps have been designed/sized and will be installed prior to rain events.

Photo 1
Example of Sediment Trap (Facing South)

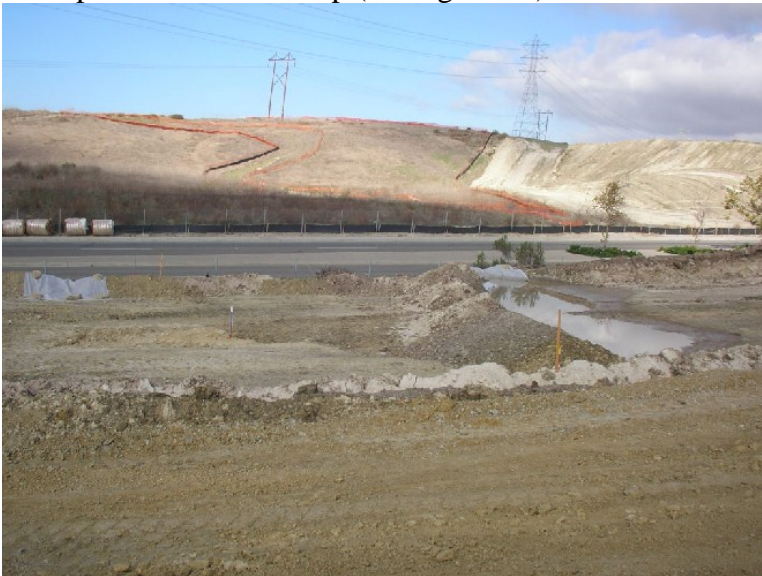
Photo 2
Example of New Silt Fence on Perimeter (Facing East on College)

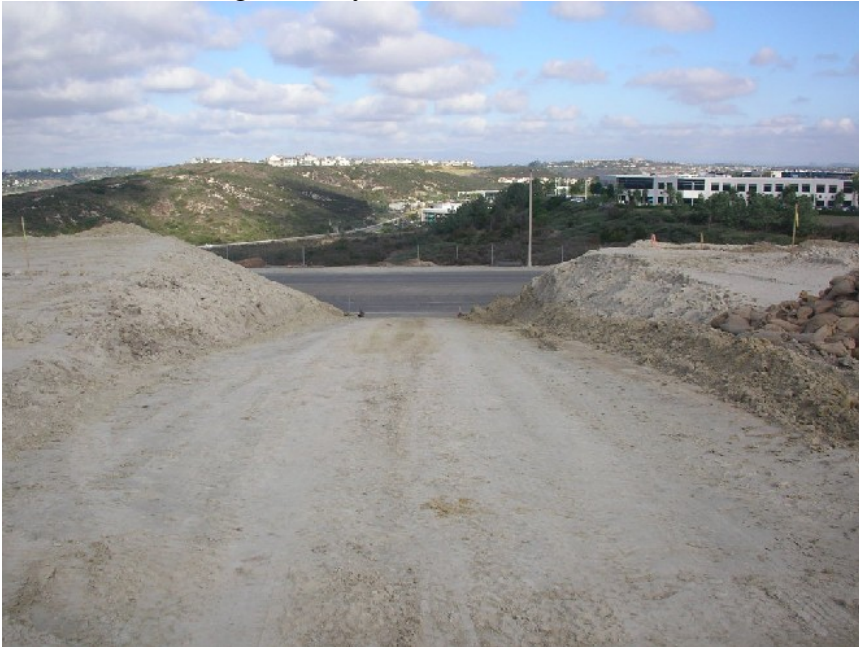
- Additional erosion and sediment control BMPs were being installed at the site at the time of the inspection.
- Straw erosion control blankets were being installed on some exterior slopes. Additional straw blankets and other erosion control BMPs will be available to cover all exterior slopes prior to rain events (Photo 3).

Photo 3
Example Of Exterior Slopes & Roadways Needing BMPs as Part of Action Plan (Facing West on College Ave)

- Provided the City maintains existing BMPs and implements their weather triggered action plan, the site should have adequate BMPs to reduce/eliminate further discharges of sediment.
- Additional stockpiled BMPs are needed on site to ensure implementation during rain events.
