Tijuana Slough NWR

Tijuana Slough National Wildlife Refuge

Tijuana River Mouth Over Time

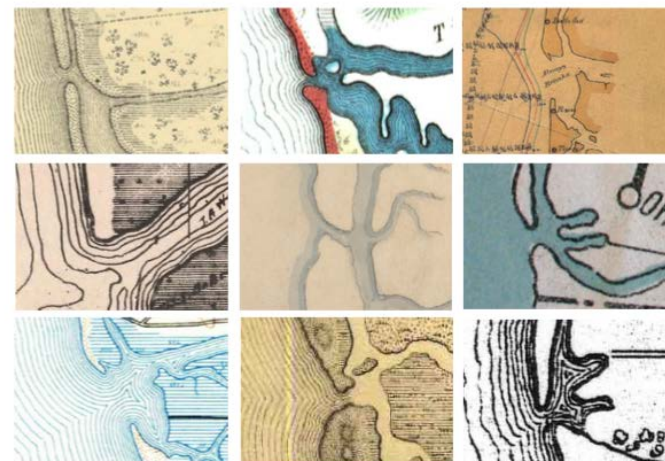
Table XX1883. We analyzed the depiction of the Tijuana estuary inlet in 57 unique historical (1849-1960) cartographic sources. The inlet was classified as "open" if a source suggested that some ocean water could enter the estuary, even if there was closure in the intertidal. All but two of the unique historical (1849-1960) cartographic sources reviewed for this project depict the Tijuana estuary with an open inlet. One 1935 map shows the estuary with a closed inlet, and one shows the inlet in an ambiguous state. Bold font is used for maps that were likely drawn from direct observations/surveys of the Tijuana estuary.

Inlet condition	
O	open
C	closed
A	ambiguous

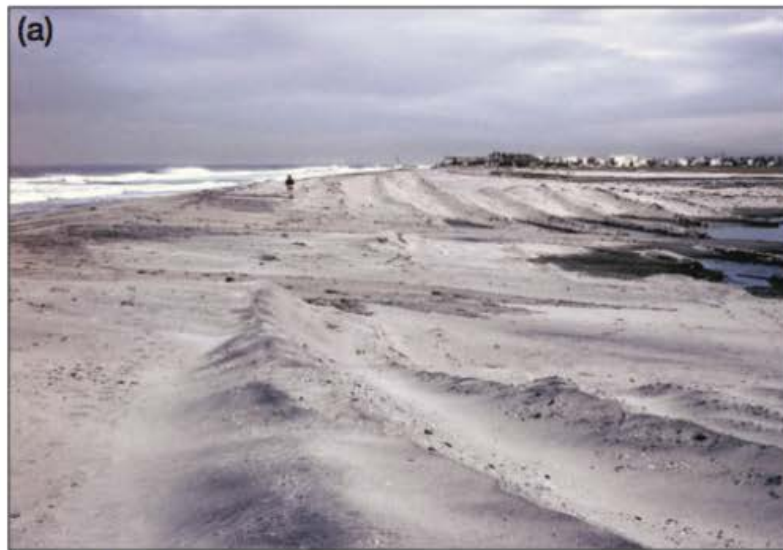
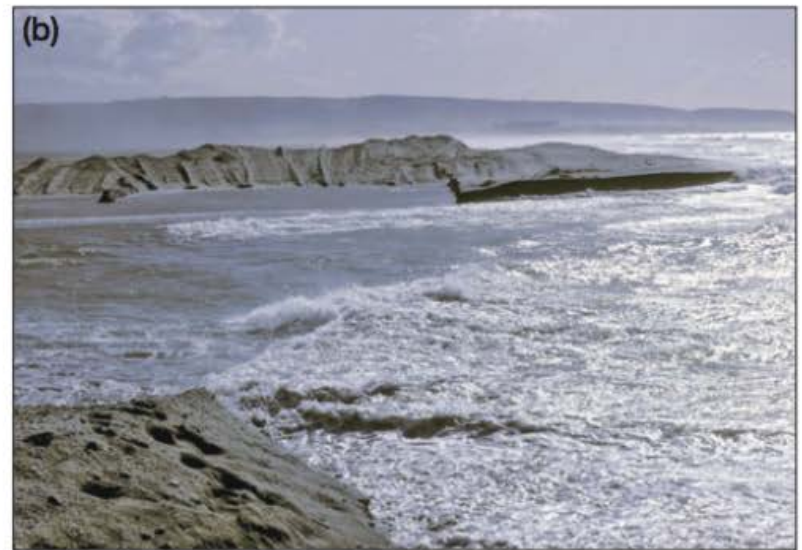
Figure 5. The mouth of the Tijuana Estuary (a) closed in April 1984 and remained closed until sand was dredged from the channels and replaced on the dunes, and bulldozers reopened it (b) in December 1984.

Tijuana Estuary Mouth Closure 1982 – 1983 El Nino

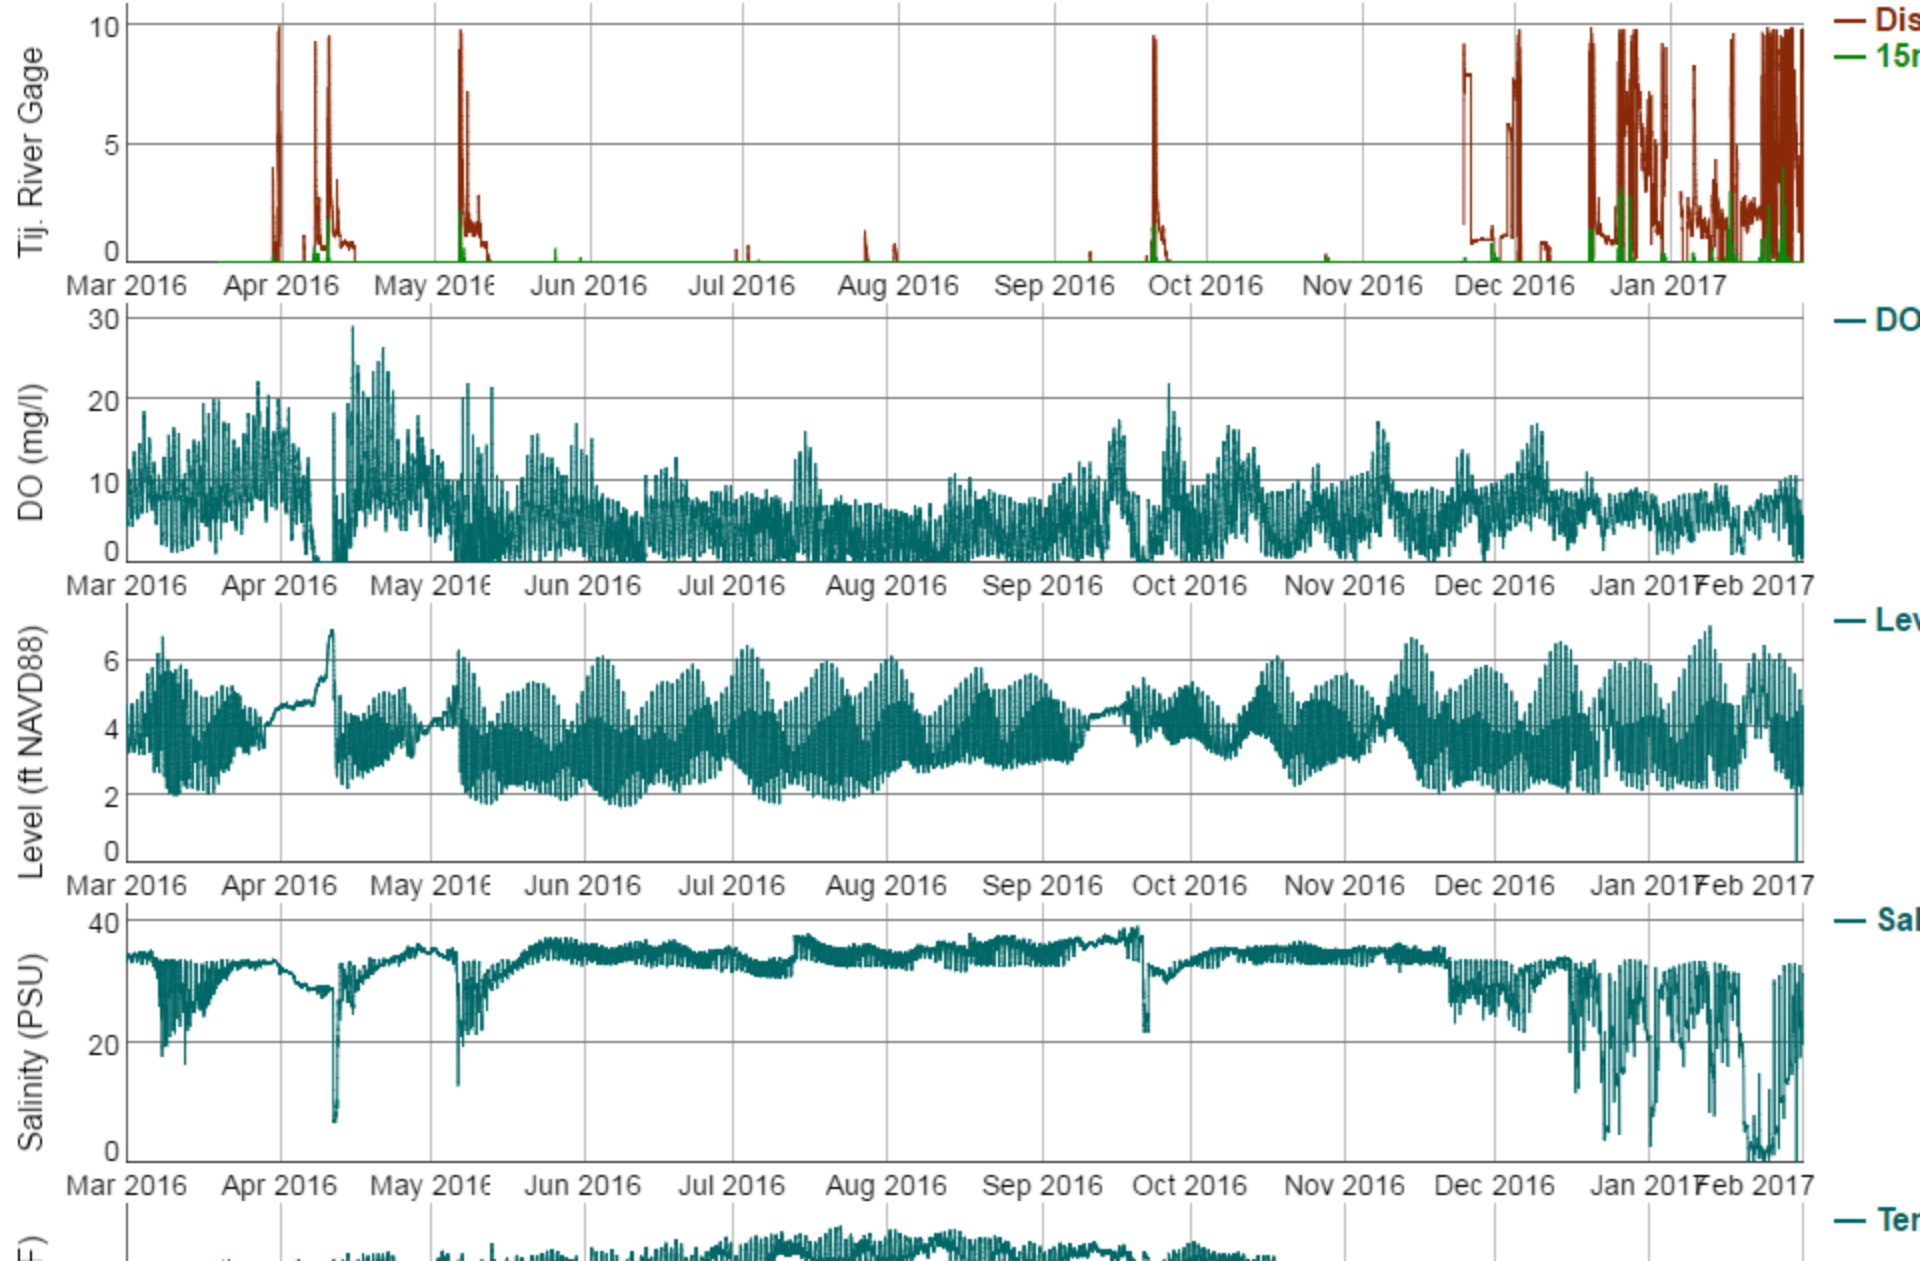
TRNERR Oneonta Slough station water quality with IBWC river gage data

All data is preliminary and has not undergone any QA/QC procedures (please see links below for further information)

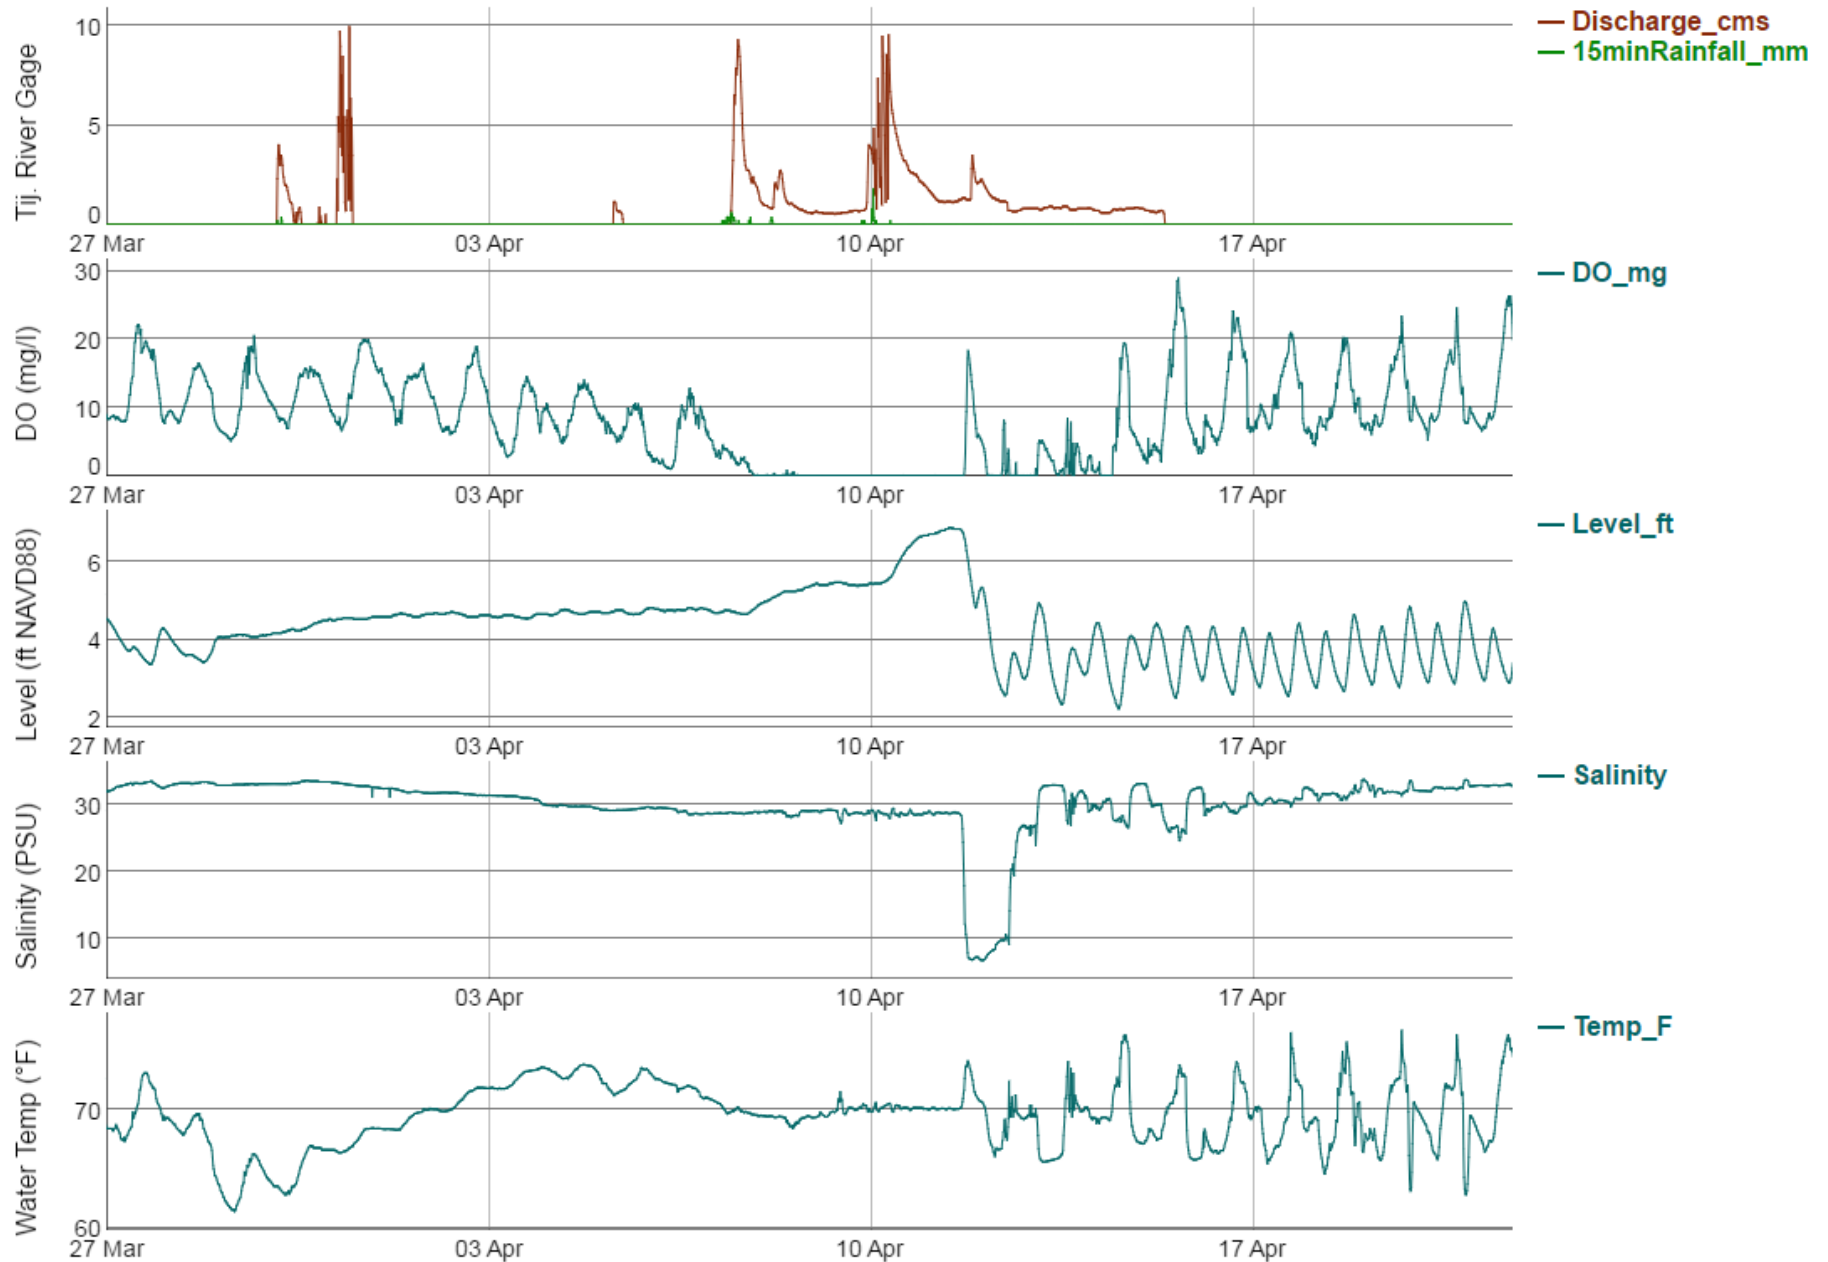
TRNERR Oneonta Slough station water quality with IBWC river gage data

All data is preliminary and has not undergone any QAQC procedures (please see links below for further information)

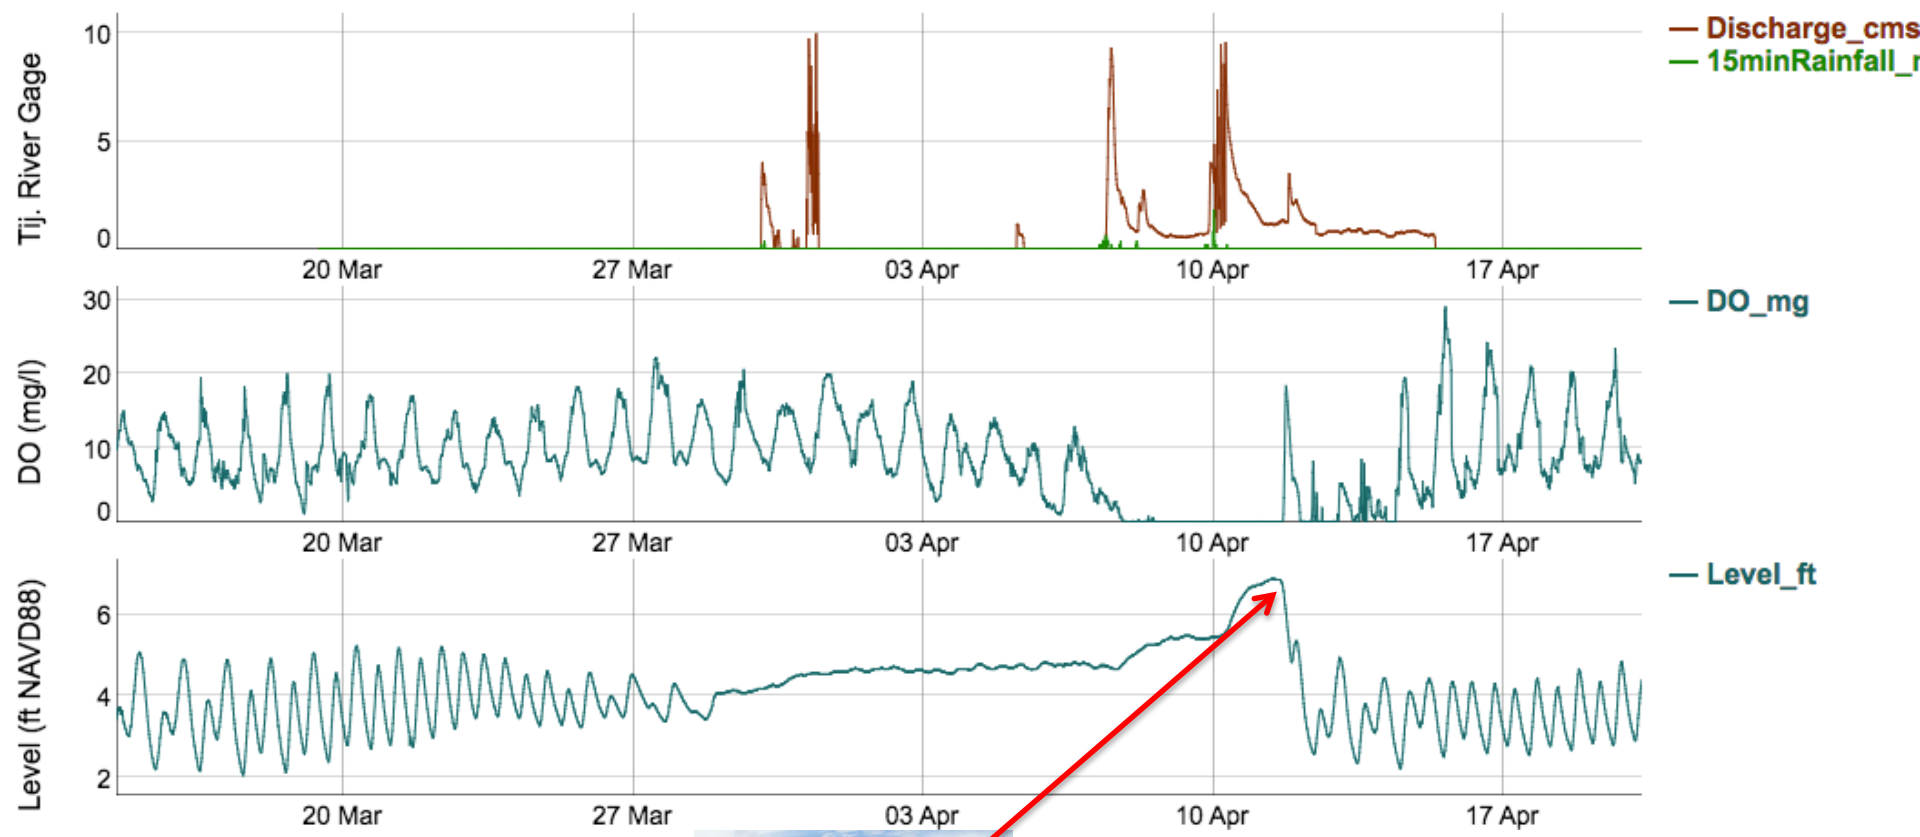
TRNERR Oneonta Slough station water quality with IBWC river gage data

All data is preliminary and has not undergone any QA/QC procedures (please see links below for further information)

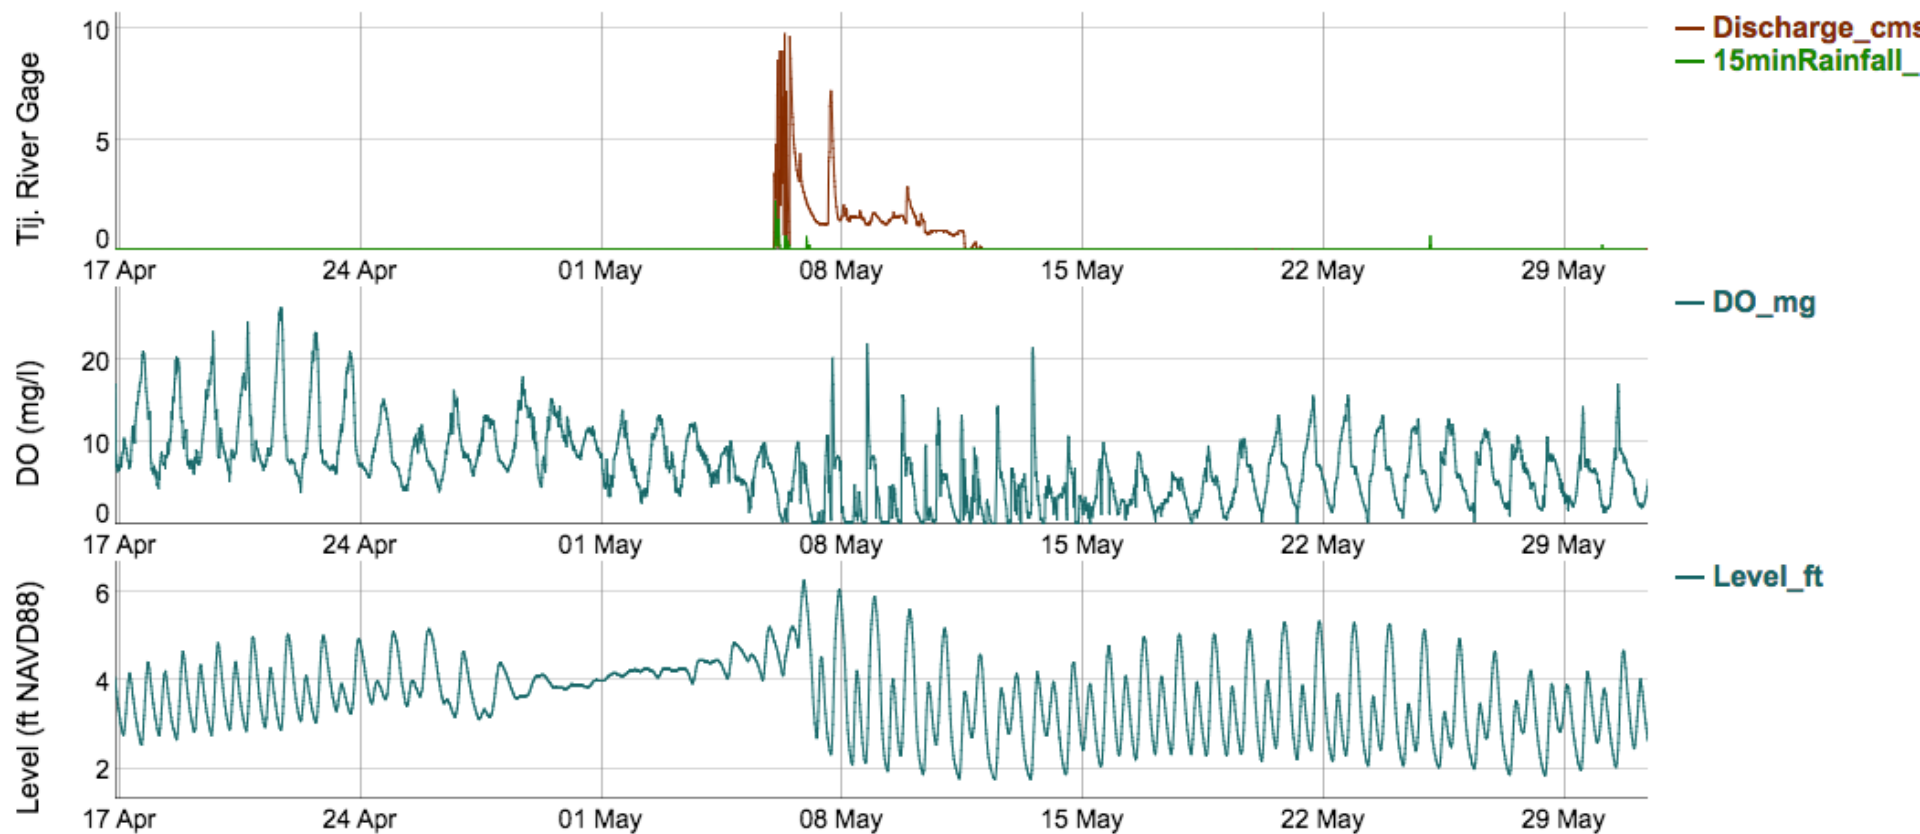
TRNERR Oneonta Slough station water quality with IBWC river gage data

All data is preliminary and has not undergone any QA/QC procedures (please see links below for further information)

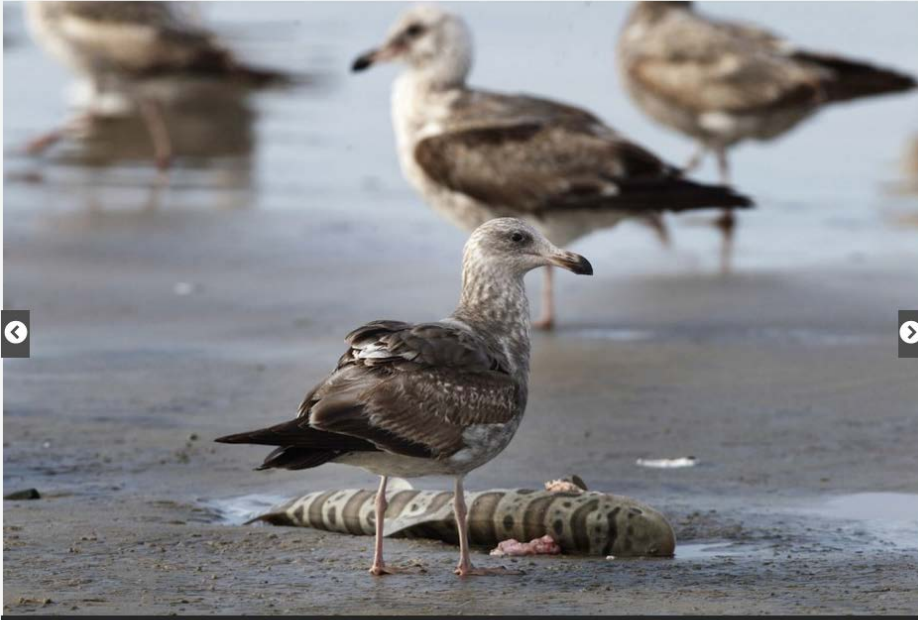
Sea gulls ate the remains of a leopard shark killed when the estuary was closed off from the ocean. — John Gibbins / San Diego Union-Tribune

El Niño conditions pushed enough sand into the mouth of the Tijuana River south of Imperial Beach to close off the flow of the river to the ocean. With the weekend rains water from the closed off estuary was backing up into Imperial Beach streets, forcing an emergency opening of the river mouth with heavy equipment Monday afternoon. After the water receded it became apparent that the oxygen depleted waters had been fatal to many leopard sharks, mollusks and other species that inhabit the area.

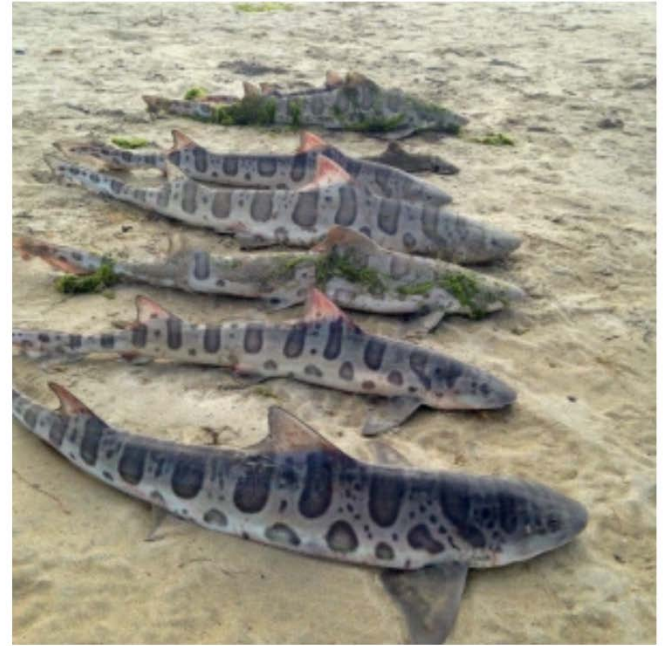
Dozens of leopard sharks died near the mouth of the Tijuana River. (Serge Dedina)

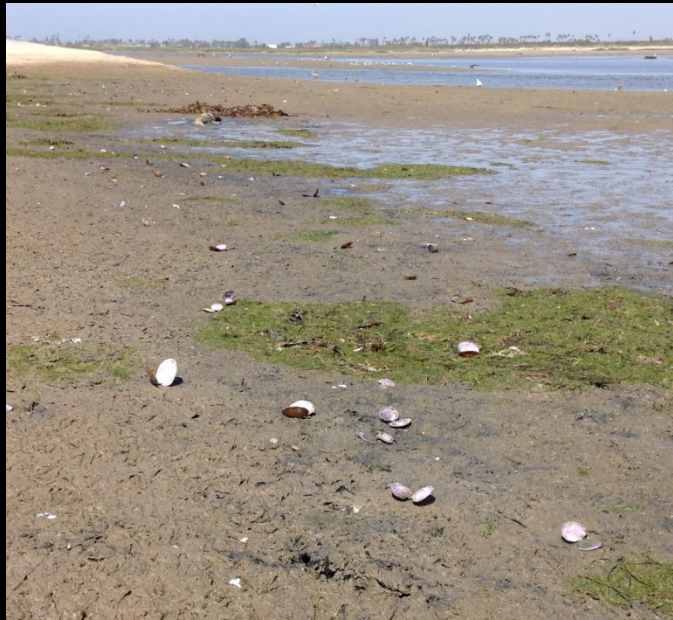
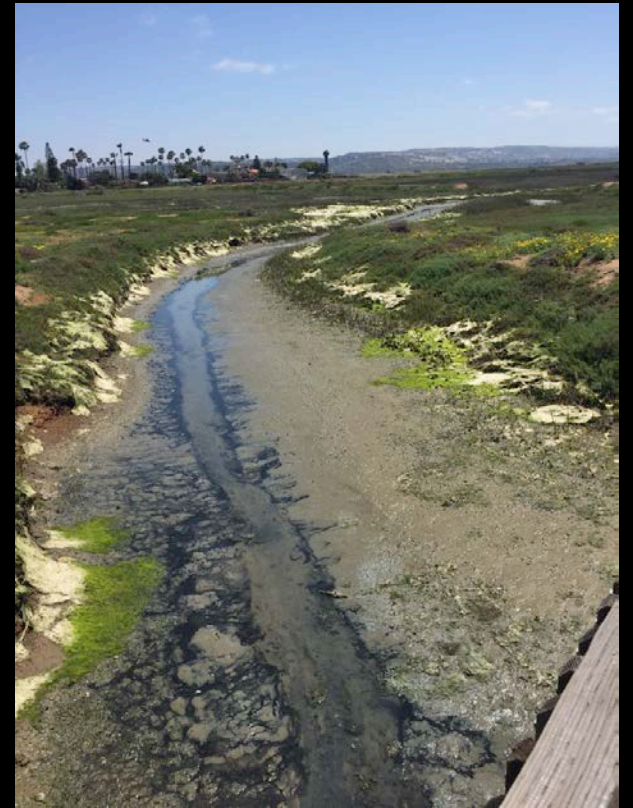
Anoxic Creek Bottom & Wrack
