RE: NOTICE OF VIOLATION NO. R9-2008-0025 & REQUIRED TECHNICAL REPORT

NOTICE OF VIOLATION
NO. R9-2008-0025

Subject Site: Sky Ranch in the City of Santee

FACILITY INSPECTION REPORT

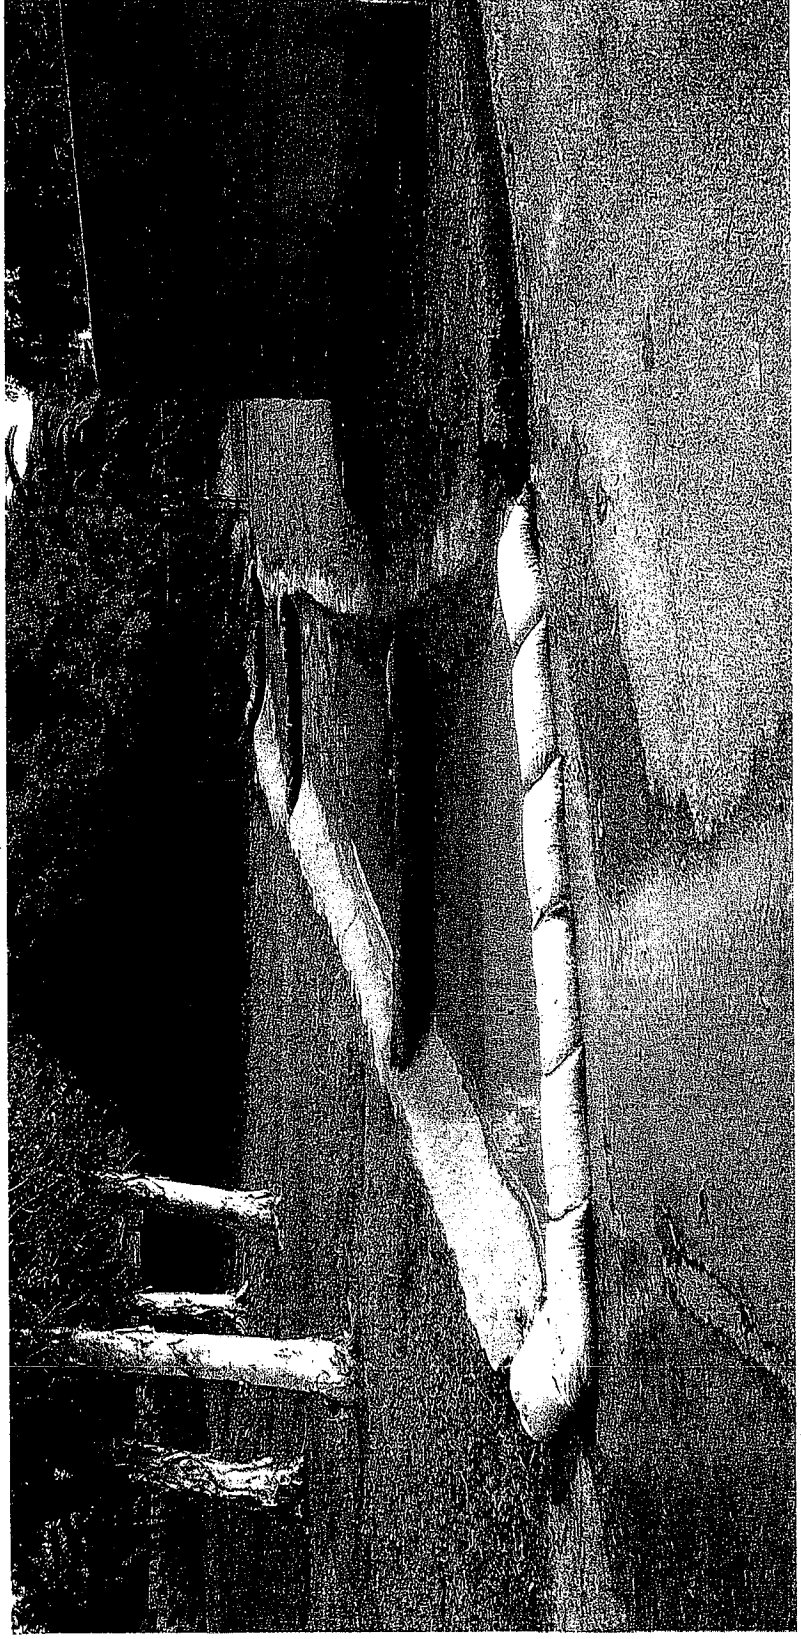
Image IMG P0337 WDID #9 37C336088;
Taken by Dat Quach, RWQCB-SD, between 0930 and 1200 on 01-30-
2008

Site: Pepper Drive School
Location: Marlinda Road, San Diego County
Image shows: Water laden with sediment discharged from drainage
channel to parking lot of Pepper Drive School.

1. A plan to immediately cleanup the waste and abate all effects of the discharge of waste into the parking lot of Pepper Drive School, Marlinda Way, and Pepper Drive, and drainage channels along Graves Avenue.
2. Copies of all work orders, progress report, and any documents related to cleanup sediments at Pepper Drive School and the sediment on Marlinda Way and Pepper Drive.
3. Copies of all work orders, progress report, and any documents related including receipts for erosion control related to erosion and sediment control at the Sky Ranch project.

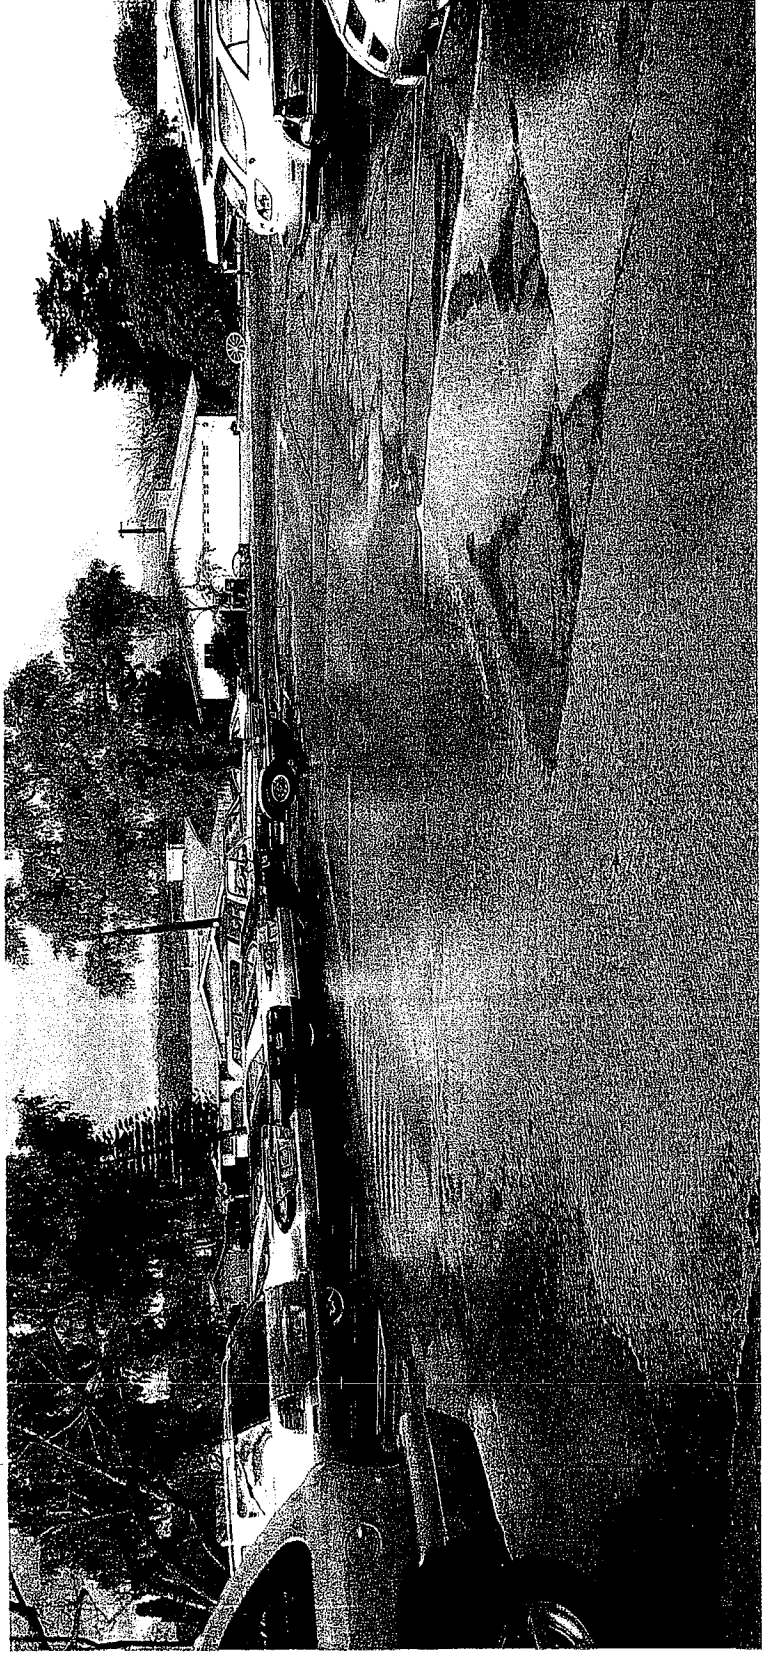
Image IMG P0338 WDID #9 37C3336088;
Taken by Dat Quach, RWQCB-SD, between 0930 and 1200 on
01-30-2008

Image shows: Water laden with sediment discharged from
drainage channel crossing parking lot of Pepper Drive School.

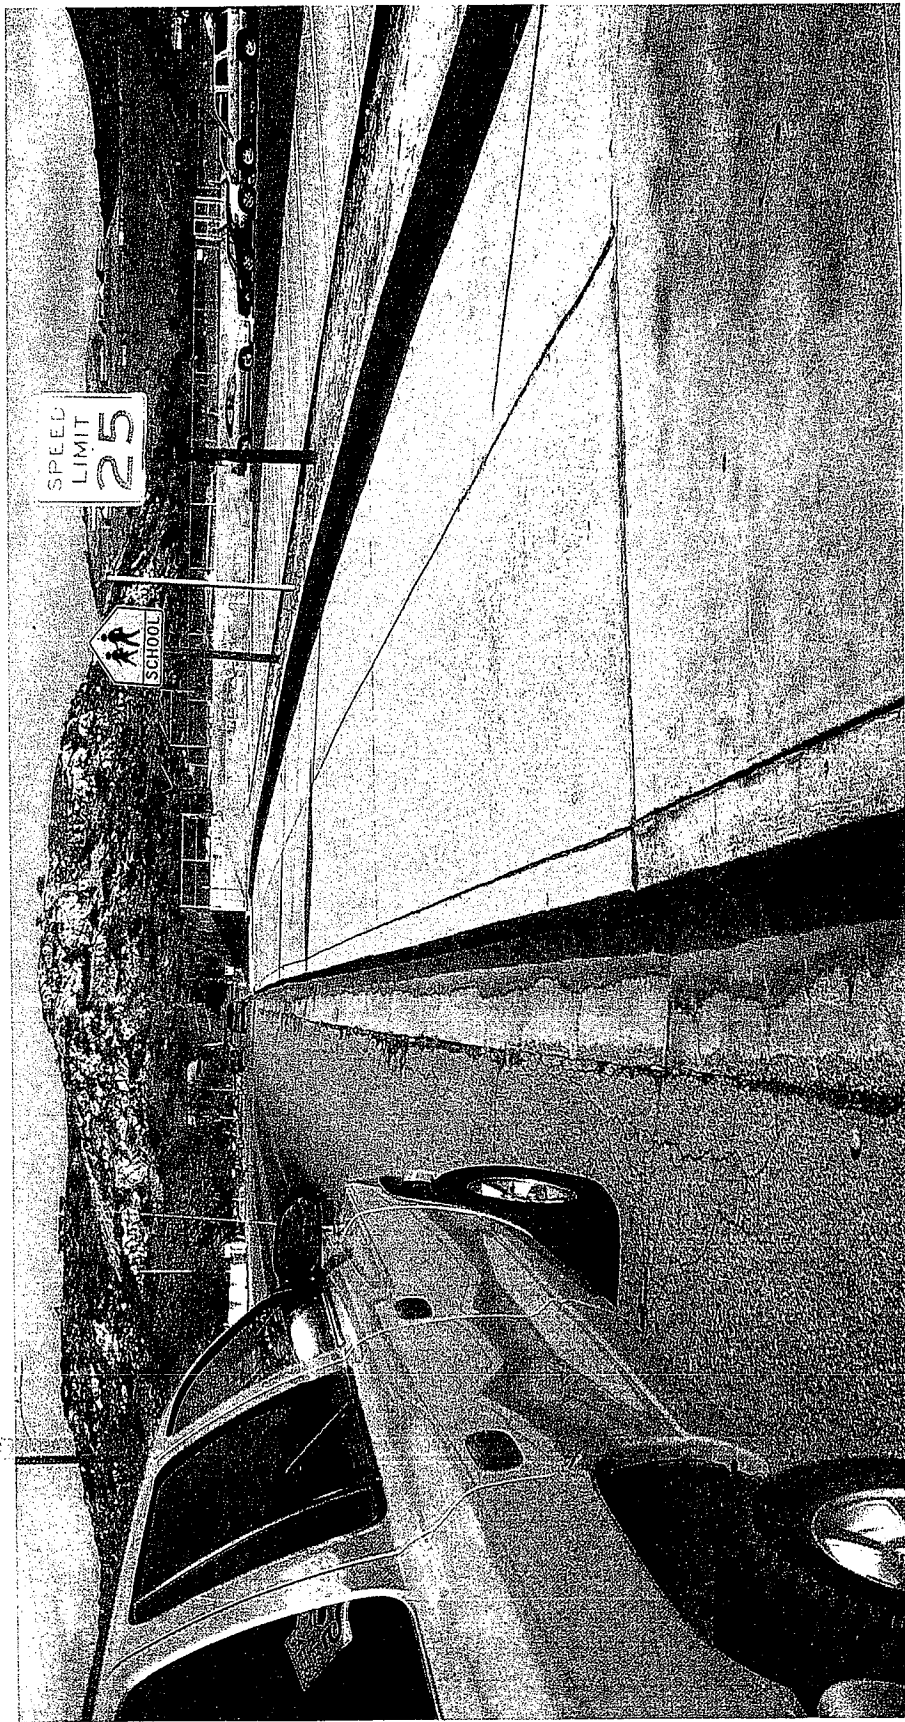
Image IMG P0336 WDID #9 37C336088;
Taken by Dat Quach, RWQCB-SD, between 0930 and 1200 on 01-30-
2008

Site: Corner of Marlinda and Pepper Drive
Location: Marlinda Road, San Diego County
Image shows: Water laden with sediment flowed south on Marlinda road.

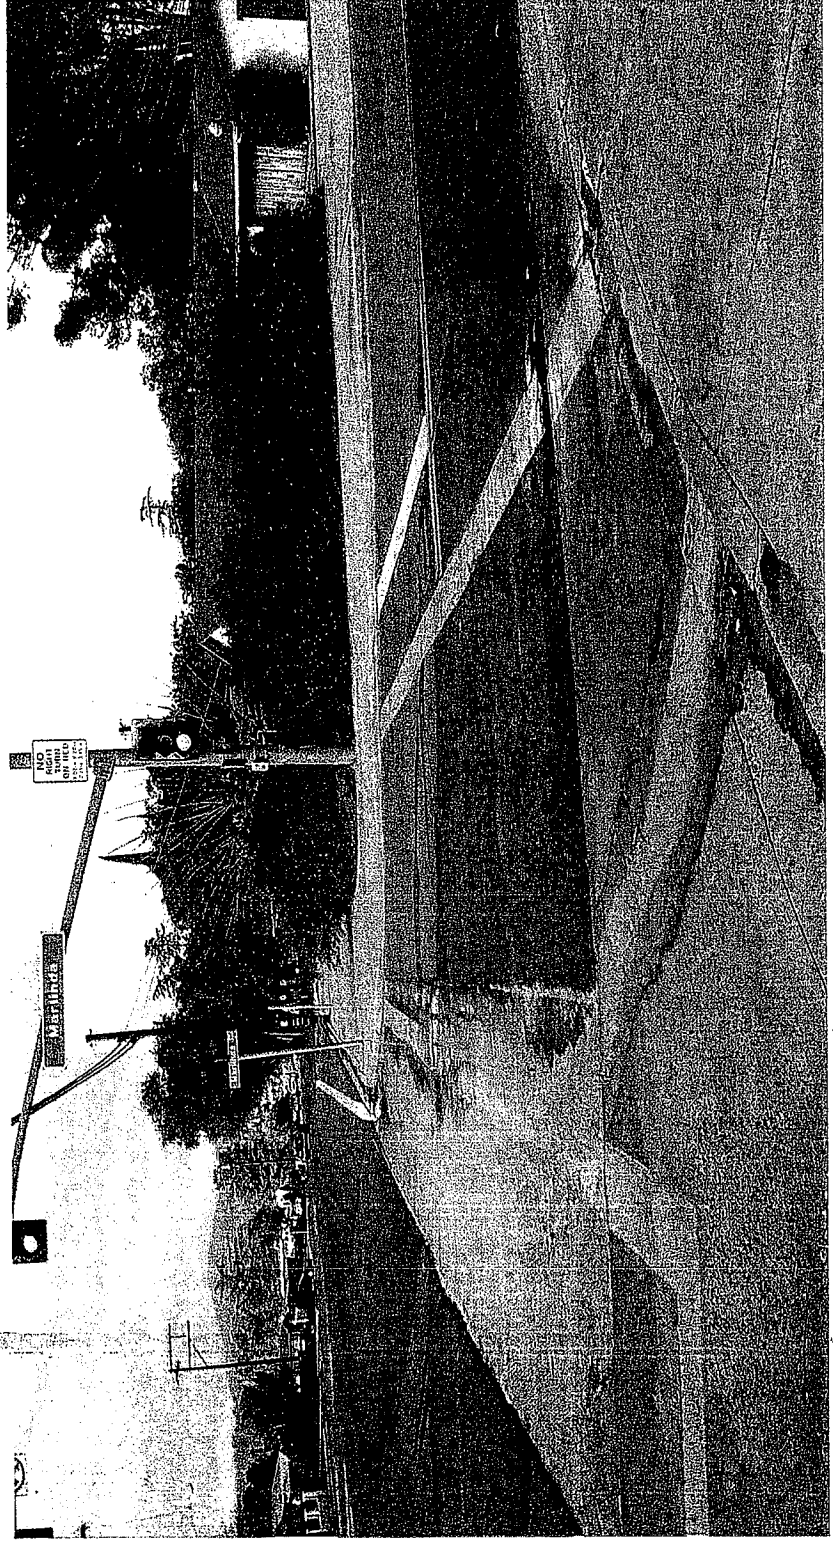
Image IMG P0333 WDID #9 37C336088;
Taken by Dat Quach, RWQCB-SD, between 0930 and 1200 on 01-30-
2008

Image shows: Water laden with sediment crossing Marlinda to flow west
on Pepper Drive.

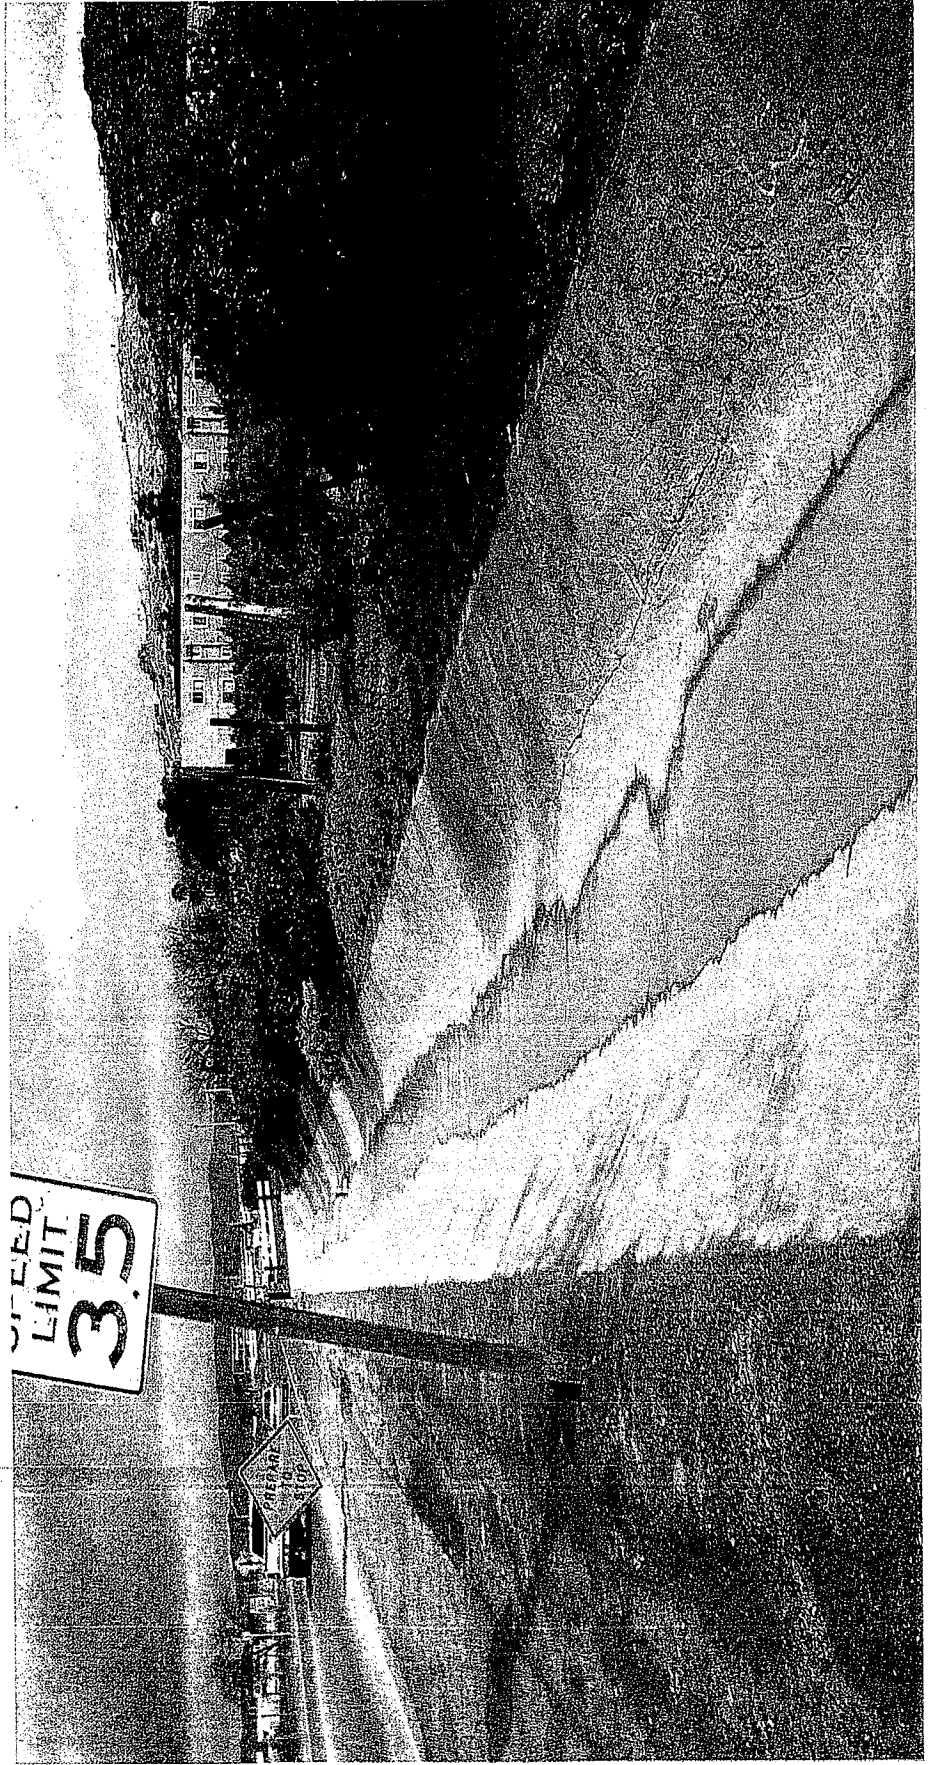
Image IMG P0346 WDID #9 37C336088;
Taken by Dat Quach, RWQCB-SD, between 0930 and 1200 on 01-30-
2008

Site: Graves street
Location: Graves street, San Diego County
Image shows: Water laden with sediment flowed north in a drainage
channel along Graves street.

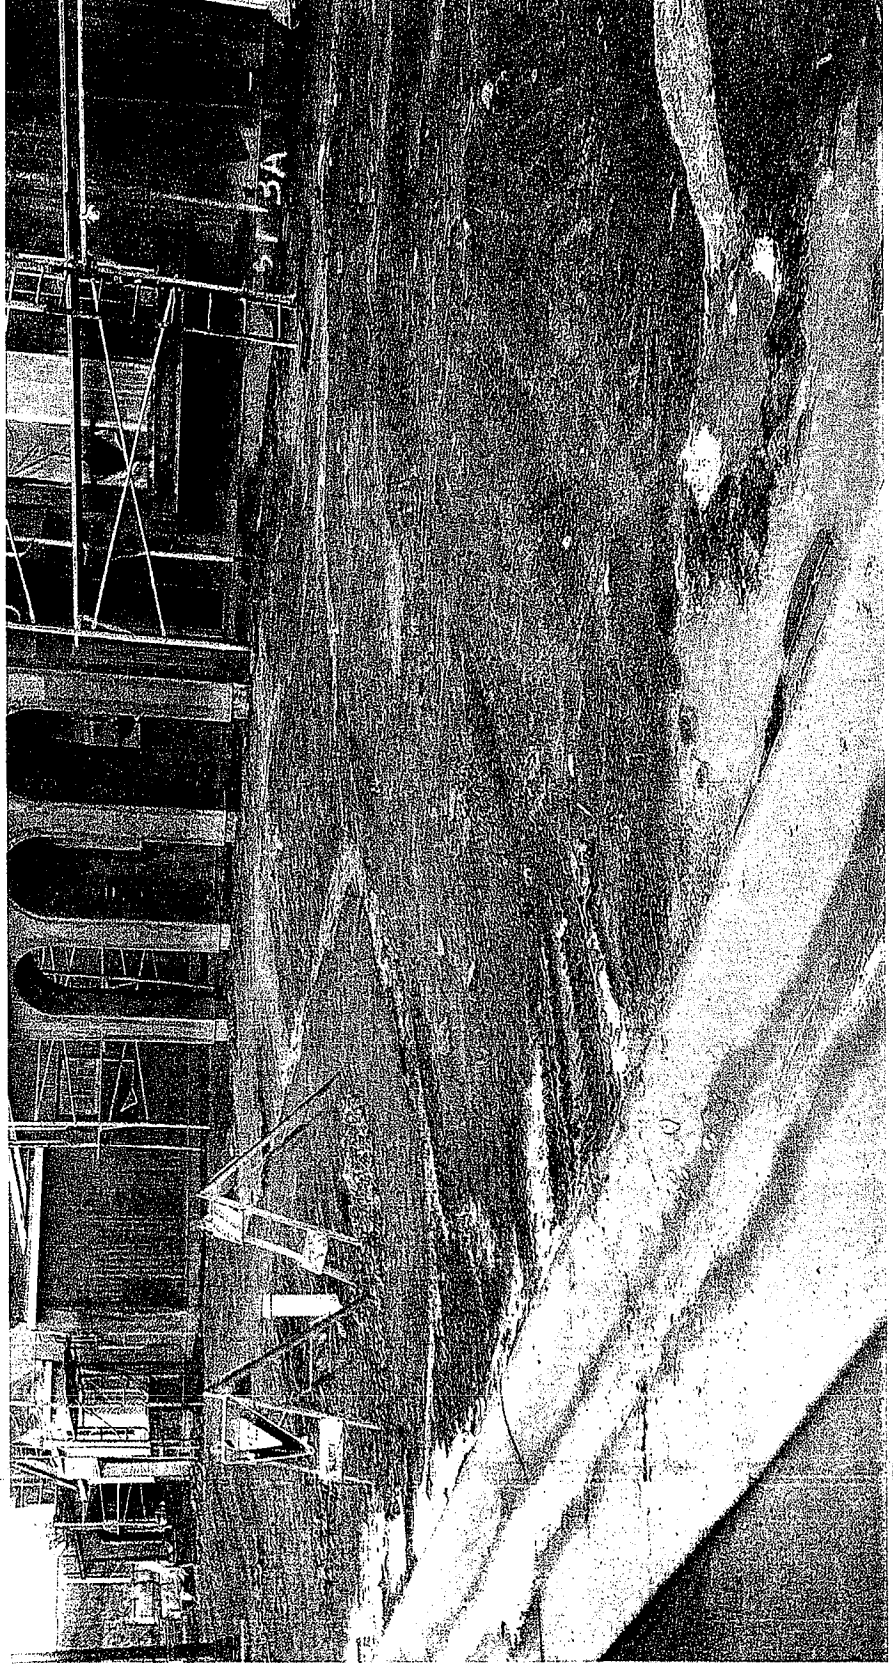
Image IMG P0348 WDID #9 37C336088;
Taken by Dat Quach, RWQCB-SD, between 0930 and 1200 on
01-30-2008
Site: Crest View
Location: Sky Ranch, San Diego County
Image shows: No BMPs along the curb and at front entrance.
Showed evidence that sediment and stucco material discharged
to street.

4. The inspection of the site showed that the construction site lacking the BMP for entrance protection at the active construction lots, lacking the BMP of some slopes between the construction lots, and lacking the BMP along the curbs of the active construction lots. The above violation was shown in photograph No. IMG P 0348, and 0351 of the FIR.

- a. An effective and appropriate combination of sediment and erosion controls on all disturbed areas;
 - b. Specific BMPs to prevent the discharge of sediment, and sediment-laden water off site.
