**SUBJECT: Notice of Violation No. R9-2013-0055, Order No. 97-40, Waste Discharge Requirements for Closure and Post-Closure Maintenance for the Class I Waste Management Containment Cell, Omar Rendering Facility, Otay Mesa Ventures II, L.L.C, and Cleanup and Abatement Order No. R9-2003-0080, Otay Mesa Ventures II, L.L.C. for the Former Omar Rendering Facility, San Diego County**

# NOTICE OF VIOLATION

## No. R9-2013-0055

# Landfill Inspection Report

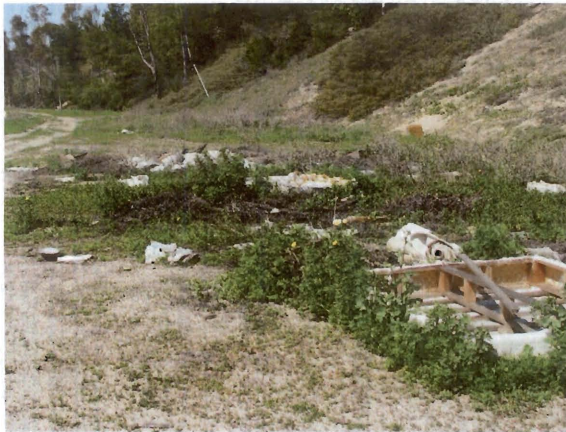
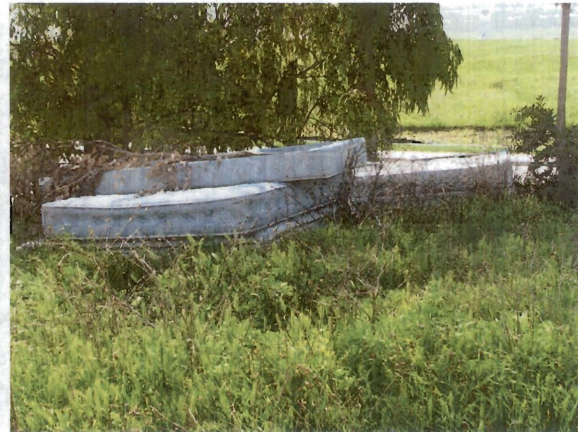
Prohibition A.3 of Cleanup and Abatement Order No. R9-2003-0080 specifies that discharges of any wastes to land or waters of the State are prohibited unless the discharge is permitted by issuance of Waste Discharge Requirements. During a site inspection conducted on March 12, 2013, several mattresses, tires, etc. have been illegally dumped on the property. The discharge of these items to the property is not permitted under this Cleanup and Abatement Order and these items need to be removed.

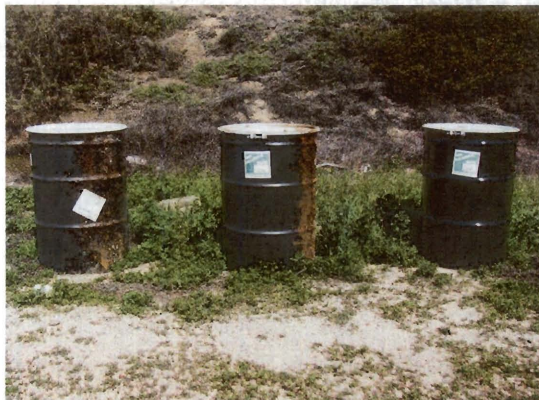
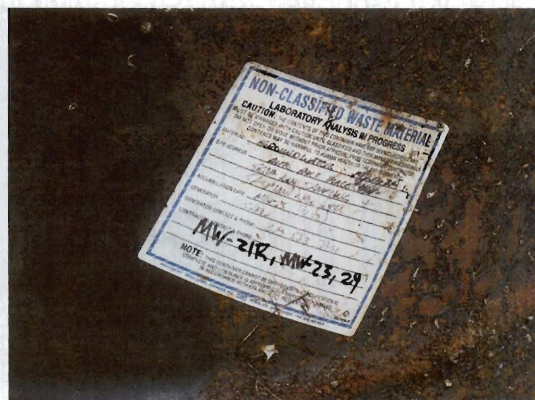
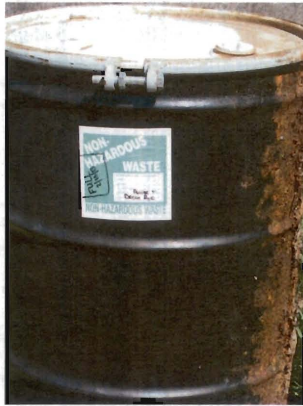
Prohibition A.4 states that the management and discharge of contaminated soils and groundwater shall not violate applicable federal, State and local regulations or requirements. During a site inspection on March 12, 2013, the San Diego Water Board noted that three drums of “purge/decon” water were being stored at the site. The oldest drum was dated January 2012 and contained purge water from monitoring wells MW21R, MW23, and MW24. The other two drums were dated February 13, 2013. The storage of drums is not a permitted activity under Order No. R9-2003-0080. The drums need to be disposed of properly.

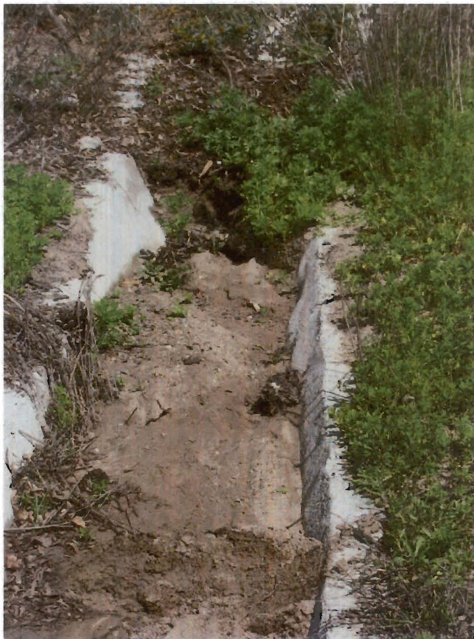
Site Maintenance Directive E.1.c requires the Discharger to perform semi-annual inspections of the site and report any significant findings with regard to drainage facilities. During the site inspection, the drainage structure for the site was clogged with soil. This soil needs to be removed to ensure proper operation of the drainage structure.

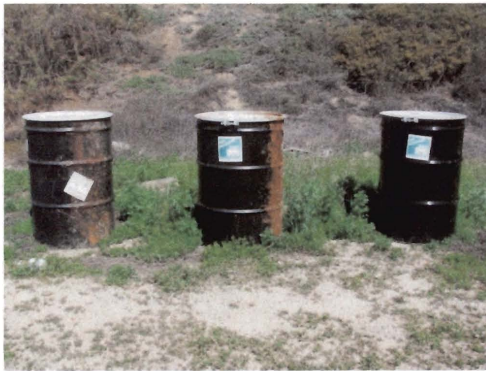
Three drums of groundwater were found in the northeastern corner of the property. Photos show closeups of two of the barrel labels. One was labeled a groundwater for MW-21R, MW-23 and MW-24, dated January 4, 2012. The label from the middle drum indicated that it contained purge and decon water and was labeled as full on February 13, 2013. San Diego Water Board staff also noted that illegal dumping had taken place on the site. See attached photos of mattresses, a tire, broken toilet and other debris.

Three drums containing groundwater.

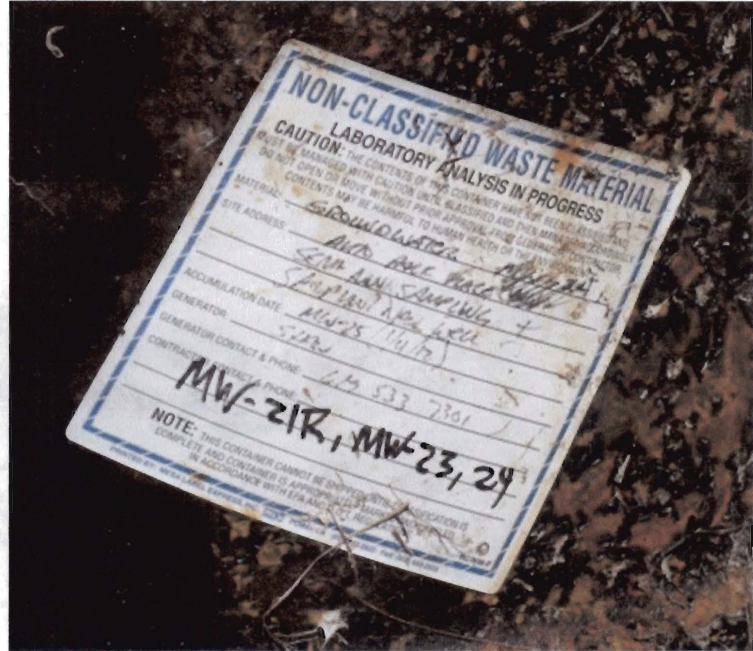
Closeup of label from left drum dated January 4, 2012.

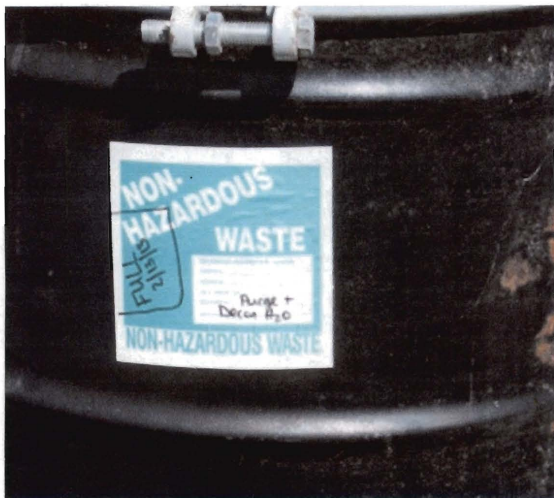
Label from middle drum dated February 13, 2013.

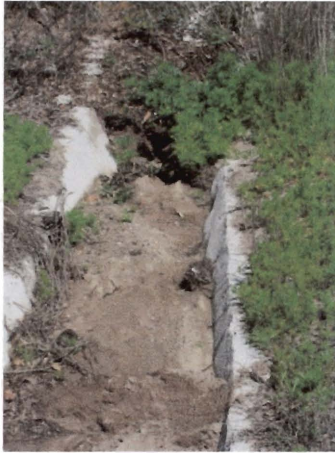
Inadequate maintenance of site drainage.

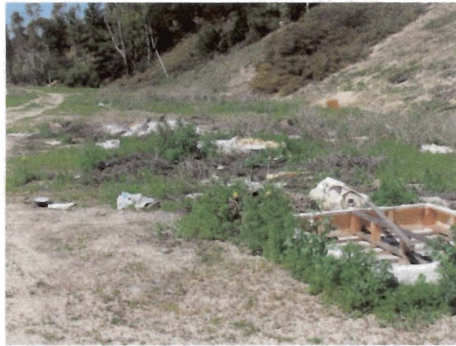
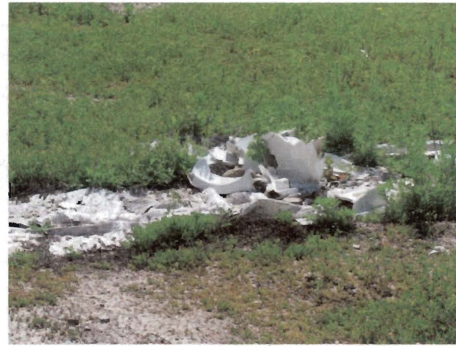
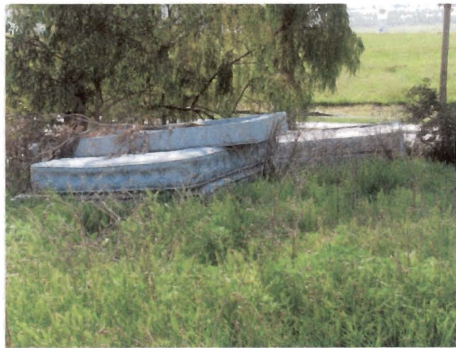
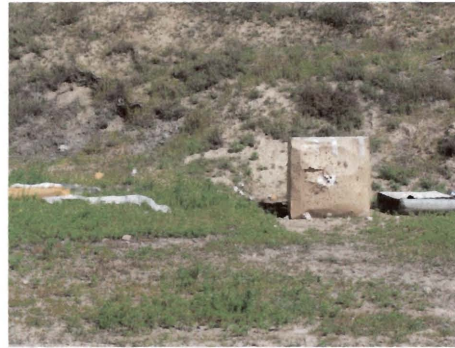
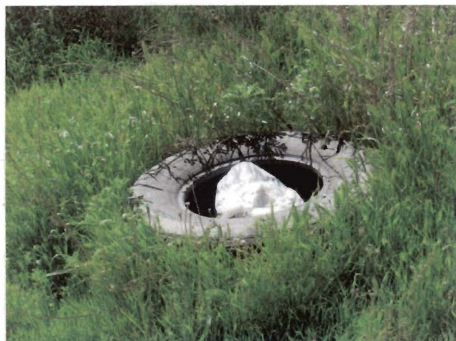
Illegal dumping.
