Re: San Diego Shipyard Sediment Site – Final Cleanup and Abatement Completion Report  
(Place ID 794466; Order No. R9-2013-0093)

# FINAL CLEANUP AND ABATEMENT COMPLETION REPORT SAN DIEGO SHIPYARD SEDIMENT SITE

Cleanup and Abatement Order No. R9-2012-0024

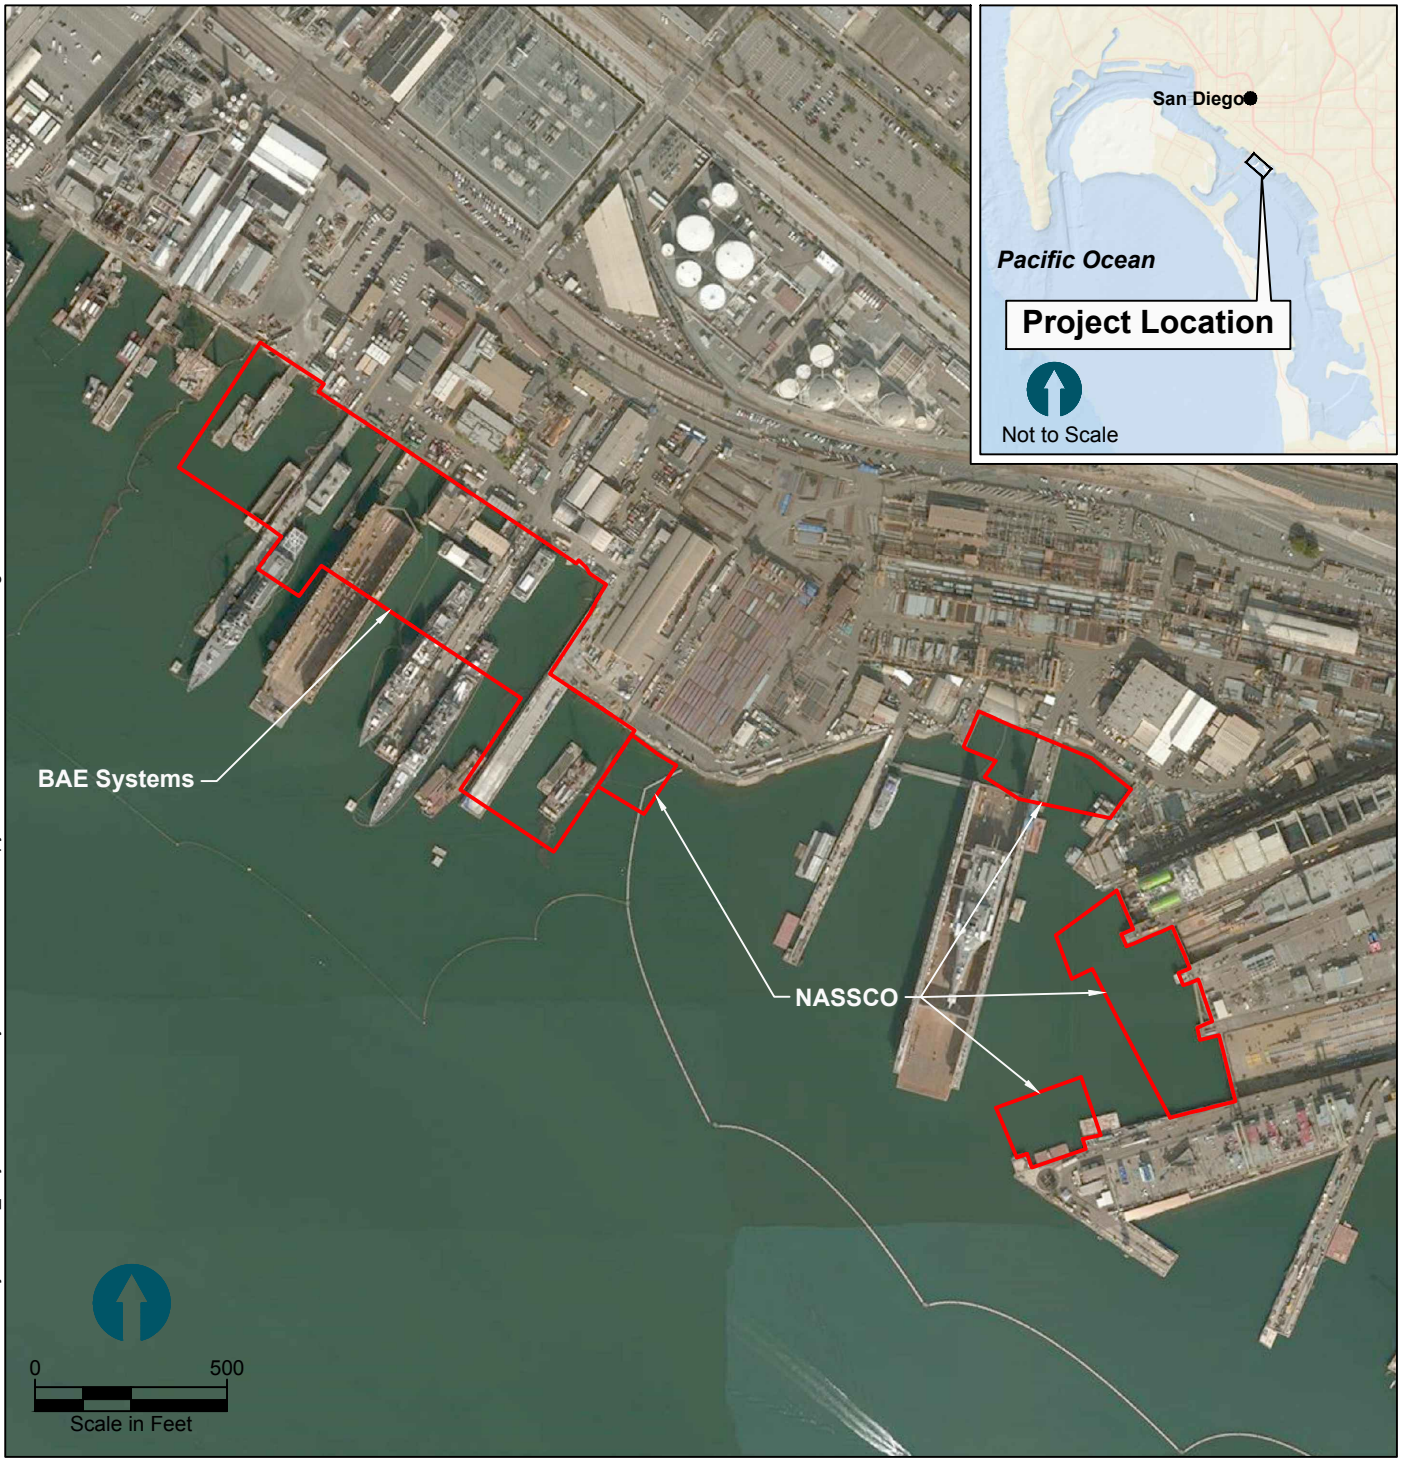
L:\AutoCAD Project Files\Projects\0994-SD Bay Environmental\SD Shipyard\0994-RP-189 VIC\_SITES.dwg FIG 1

The San Diego Shipyard Sediment Site encompasses waters adjacent to two adjoining, active shipyard facilities in San Diego Bay—the South Shipyard (leased by National Steel and Shipbuilding Company Shipyard Facility [NASSCO]) and the North Shipyard (leased by BAE Systems San Diego Ship Repair Facility [BAE Systems]). In March 2012, the Water Board issued a CAO for remediation of marine sediments containing elevated chemical concentrations within the San Diego Shipyard Sediment Site. Figure 1 depicts the location of the site and delineates both the North and South shipyards.
