**NORTH SHIPYARD REMEDIAL ACTION PLAN IMPLEMENTATION
REPORT
SAN DIEGO SHIPYARD SEDIMENT SITE – NORTH SHIPYARD**

BAE Systems San Diego Ship Repair

Anchor QEA, LLC

July 2016

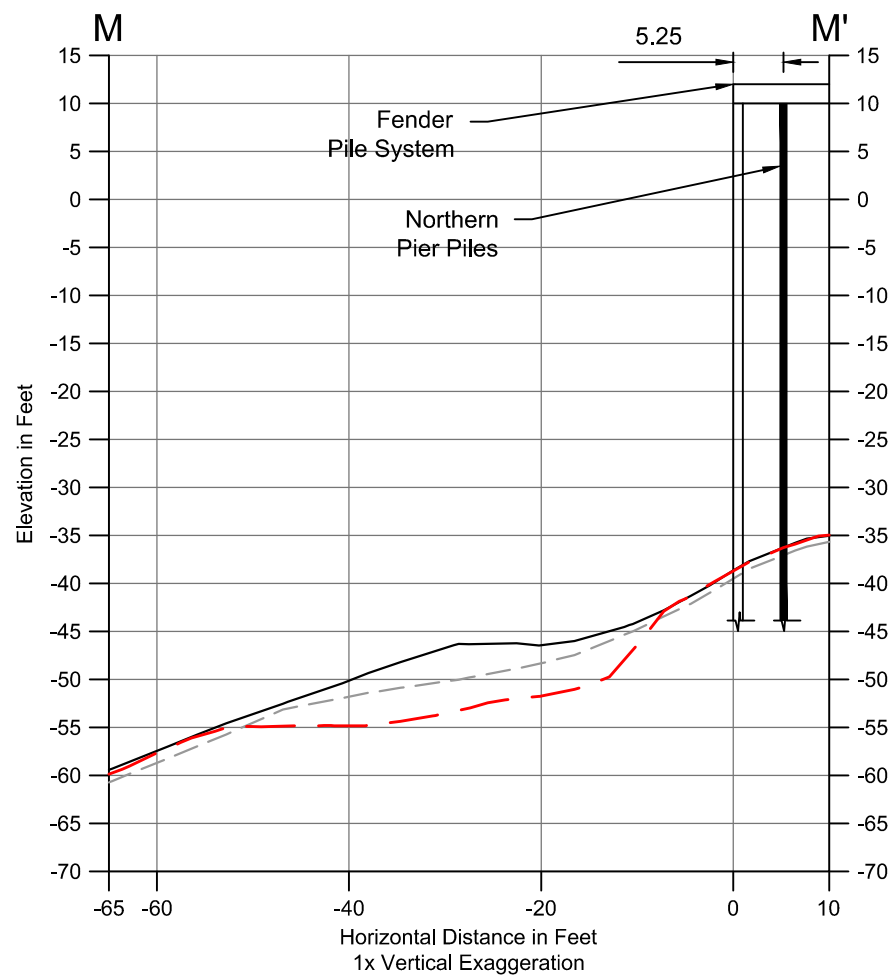
post-spill bathymetry is graphically depicted to generate an elevation isopach, included in Figure 13e. The green shading identified those areas where the post-spill survey is equal to or deeper than the pre-spill conditions (i.e., no effect of leakage is evident), and the yellow to red areas are where the post-spill survey is higher than the pre-spill conditions. The area in which the spill occurred is observed adjacent to Pier 3 North, where more than 1 foot of bathymetric rise (presumed spilled material) is observed on the isopach.

As shown, no significant bathymetric variations signifying the presence of additional spilled material are observed between the pre- and post-spill surfaces along the scow haul route (extending from Pier 3 North to the offloading location). The elevation differences are between 0.5 to -0.5 foot, indicating equipment tolerances and/or minor, random changes in the sediment surface over the years. Thus, there is no evidence of any additional spillage on the route of the spill scow to the offloading location.

The Engineer compared the post-spill bathymetric survey with the bathymetric survey data obtained prior to the leakage event along the Scow 3002 haul route (the pre-spill bathymetric survey data included various bathymetric surveys obtained during the remedial action as well as historic bathymetric survey information). The comparison of pre-spill to
