Central Sierra Environmental Resource Center
Box 396 • Twain Harte, CA 95383 • (209) 586-7440 • FAX (209) 586-4986

April 14, 2010

Gaylon Lee - Forest Activities Program Manager
State Water Resources Control Board
1001 I Street, 15th Floor
Sacramento, CA 95814

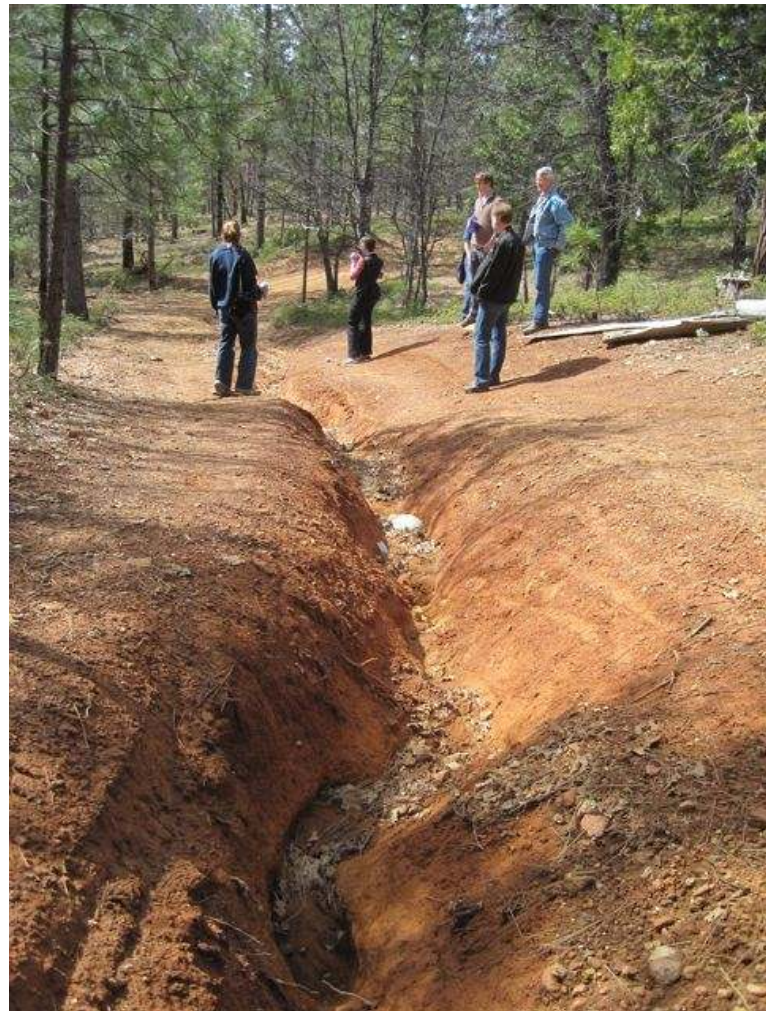
This major rut has been discharging sediment into a nearby creek for many years. Further up the road a number of boulders were placed to prevent through use. Nothing has been done to block use on the lower portion of the road. Nothing has been done to halt erosion pouring off the road into a nearby creek.

Instead, Forest officials recently gave legal approval to off-road-vehicle use on a steep, rutted user-created ORV route that parallels this road and adds even more sediment discharge into the stream. ORV tracks are visible on this adjacent road as shown in the photo.

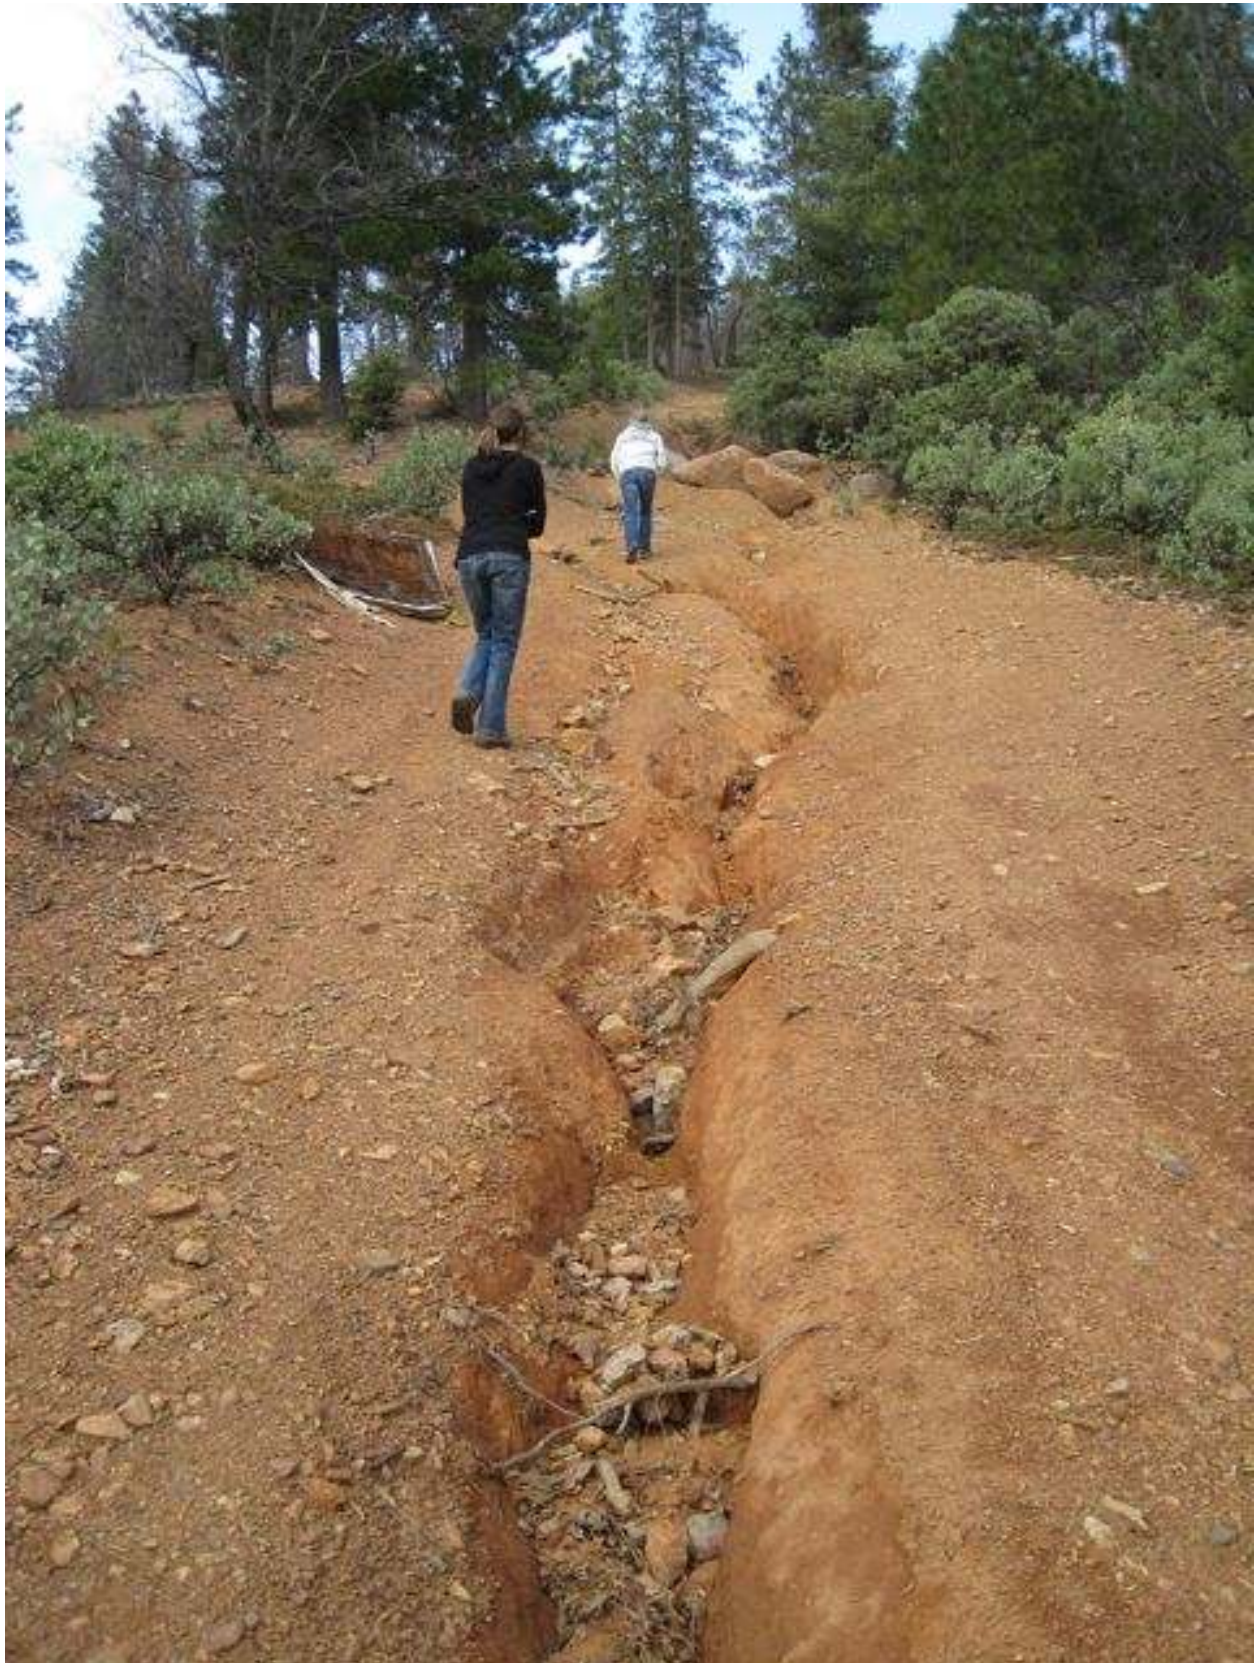
This photo shows the Stanislaus Forest road upslope from the first photo.

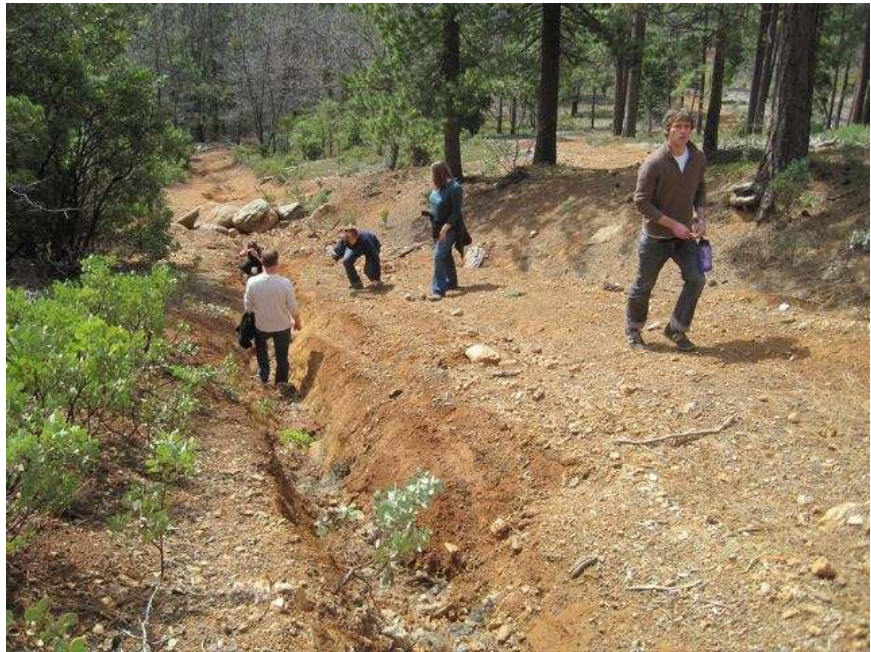
Still further up the hillside, the rut is so deep that it nearly comes up to the waist of the person standing in the rut.

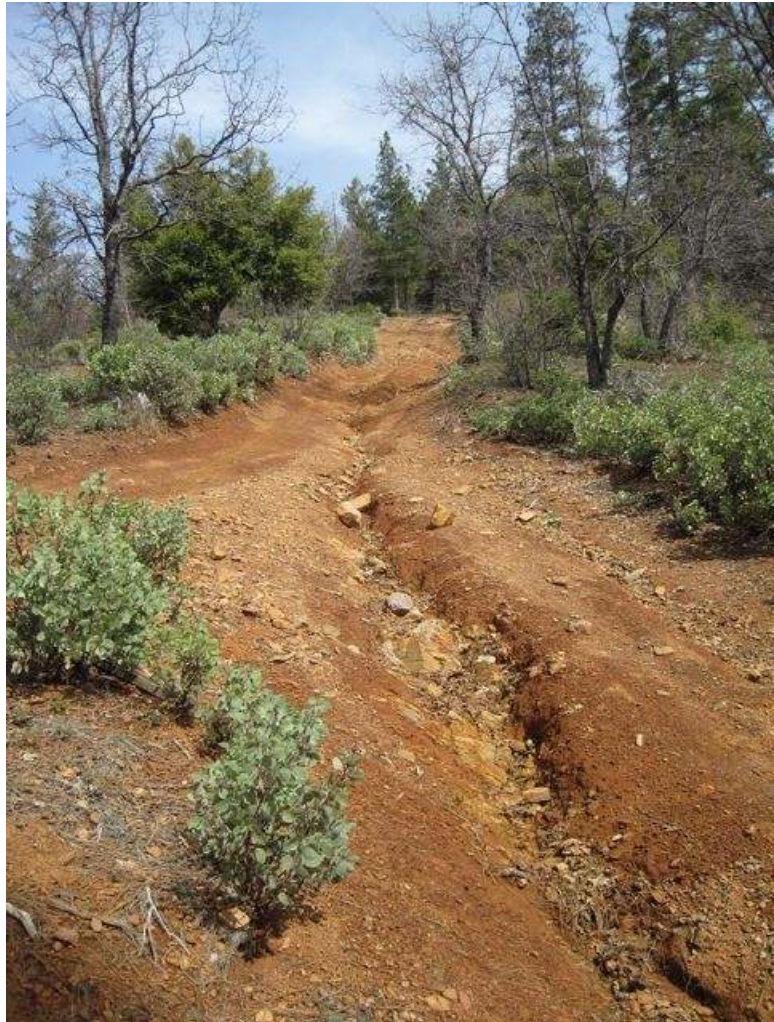
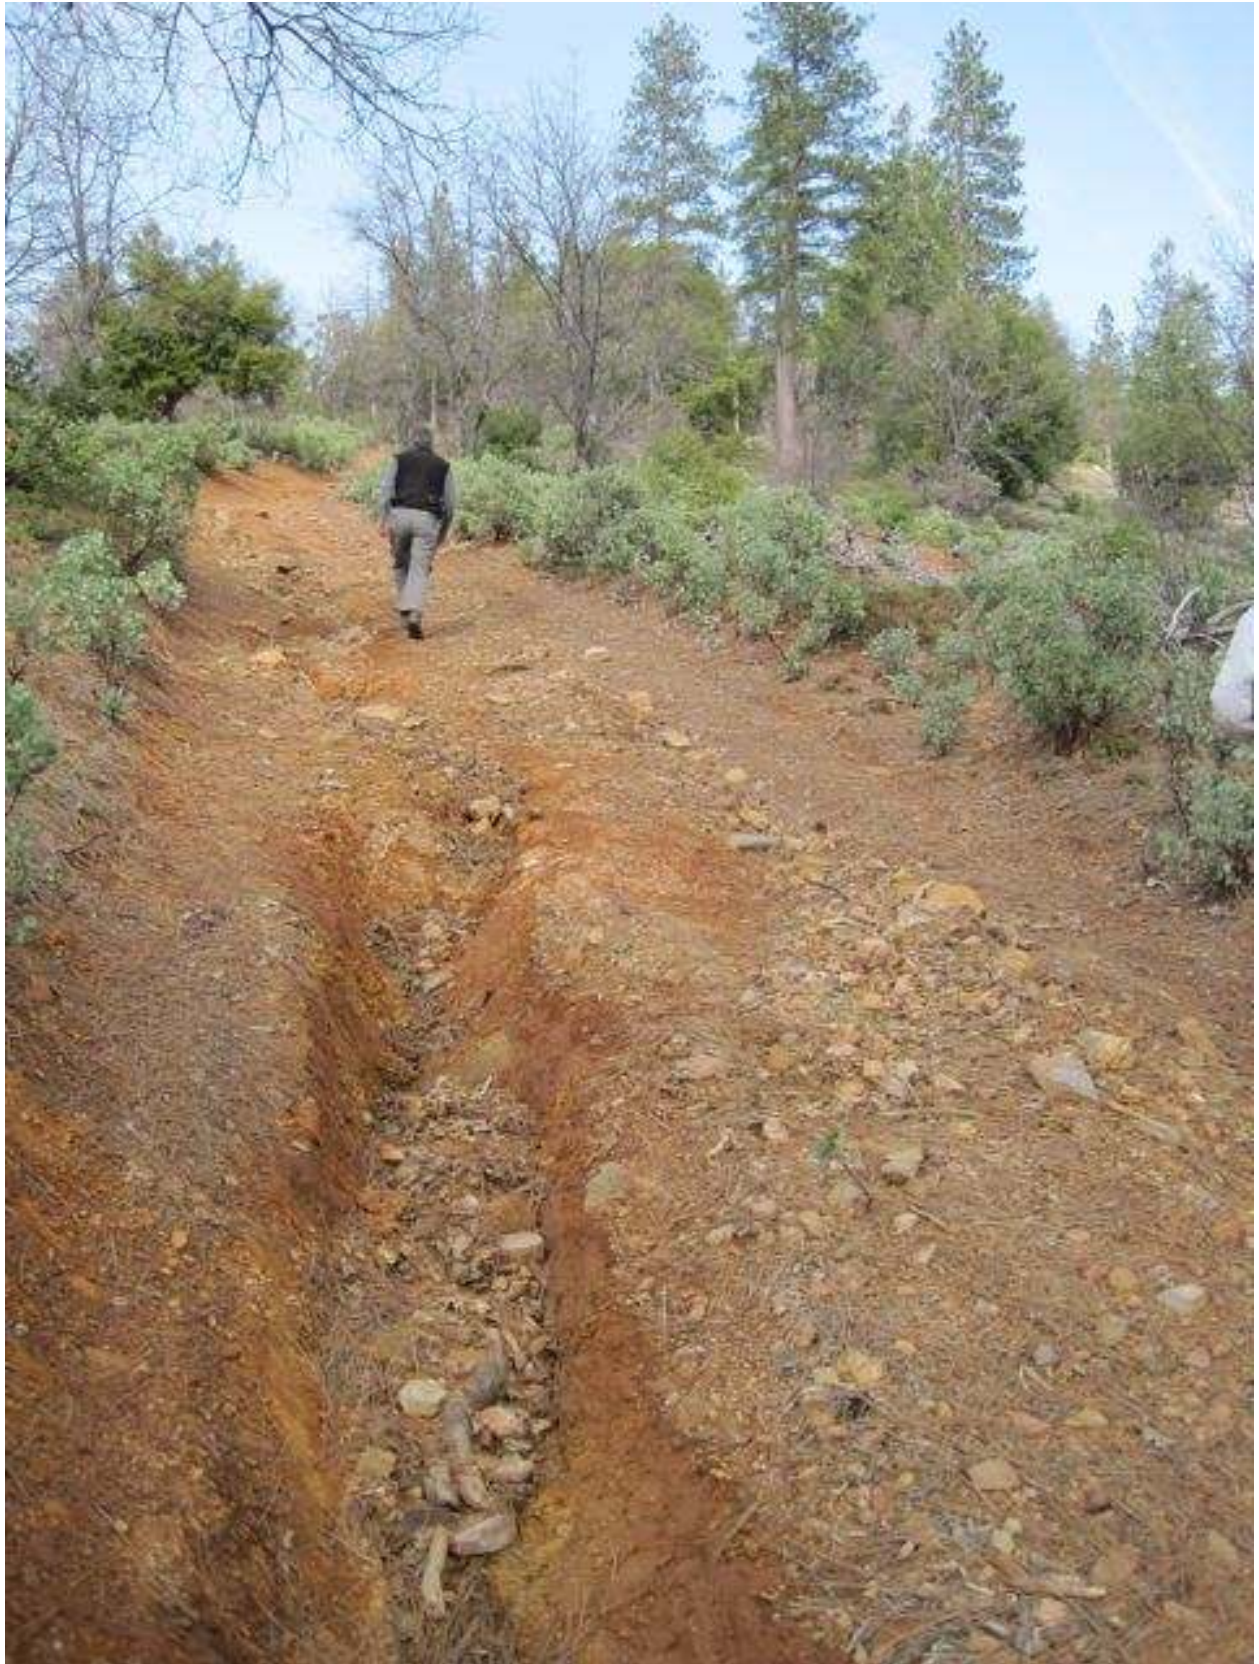
At the upper end of this fork of the rut, the "road" connects to the off-road-vehicle route, which continues even further up the slope.

The picture on the following page shows the rut up on the off-road-vehicle route.

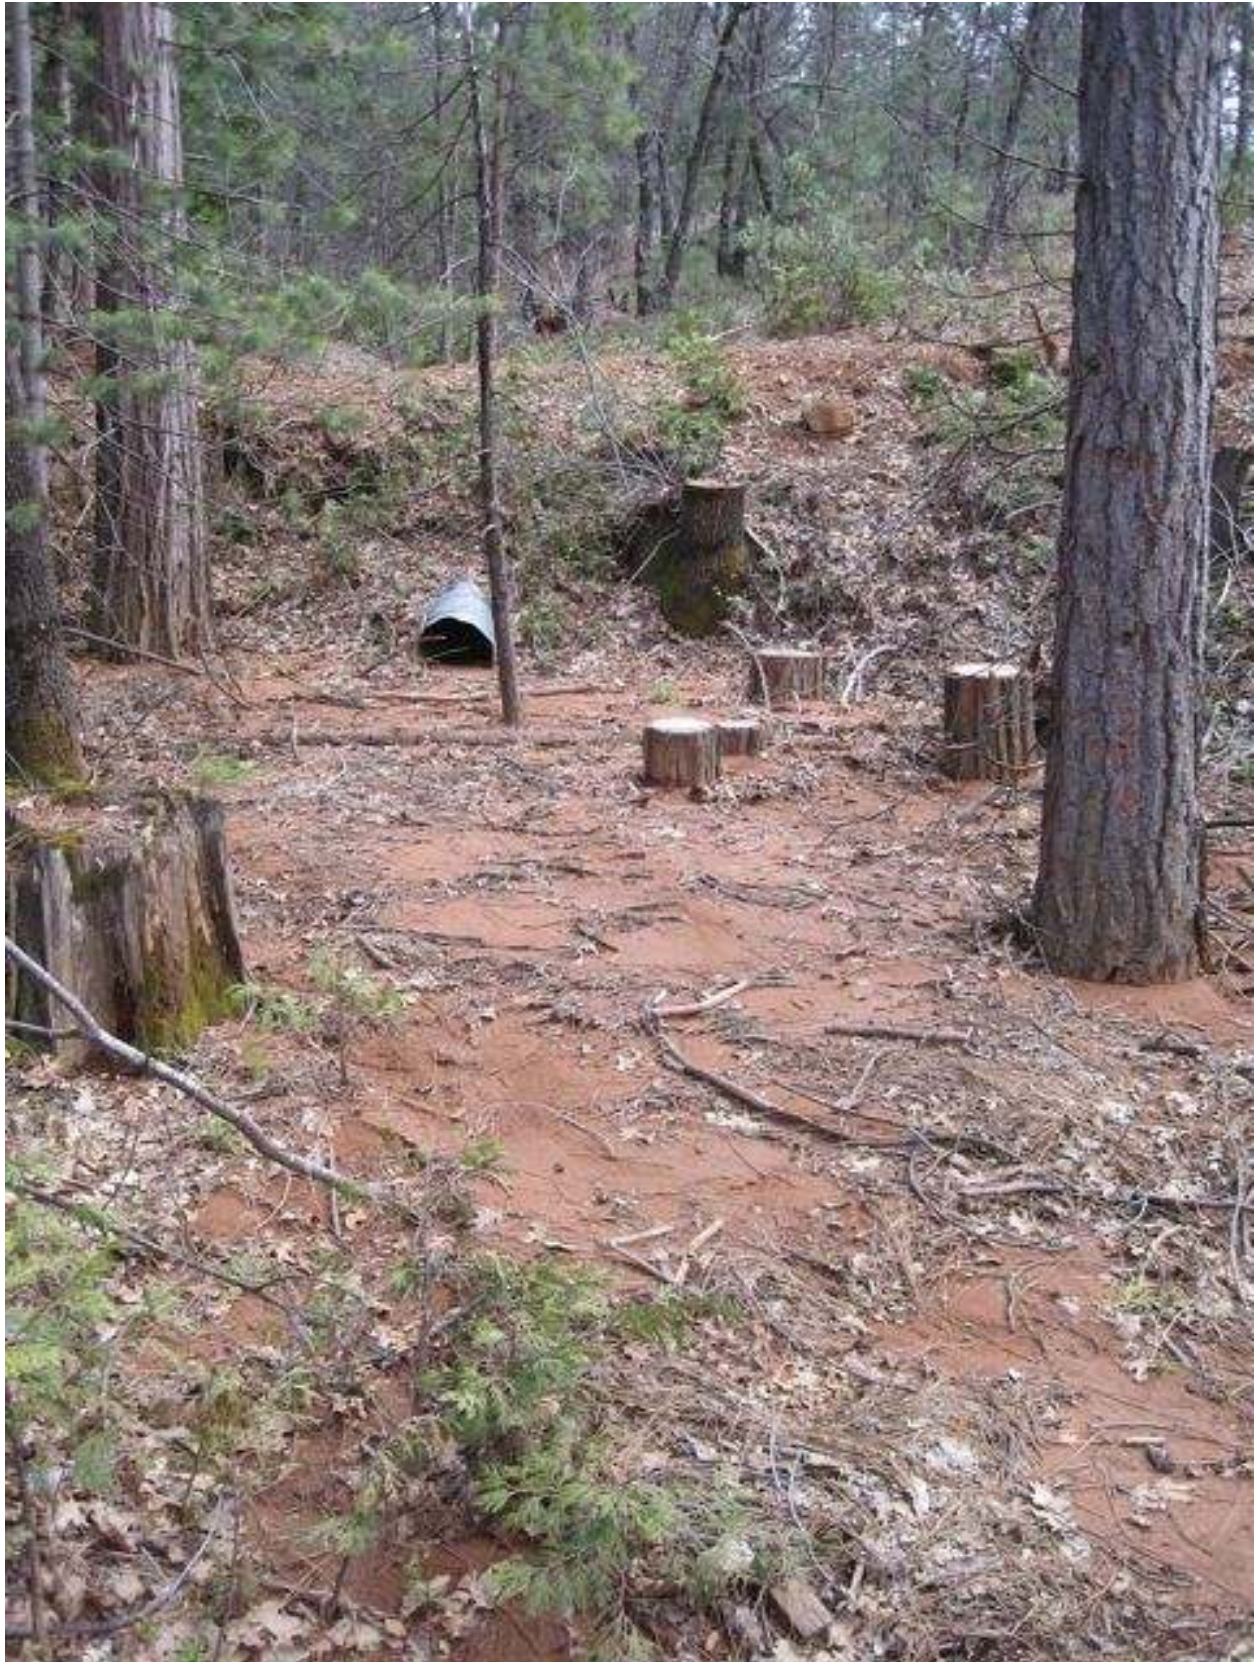
And here is where the sediment discharges into a creek that is now clogged with silt.

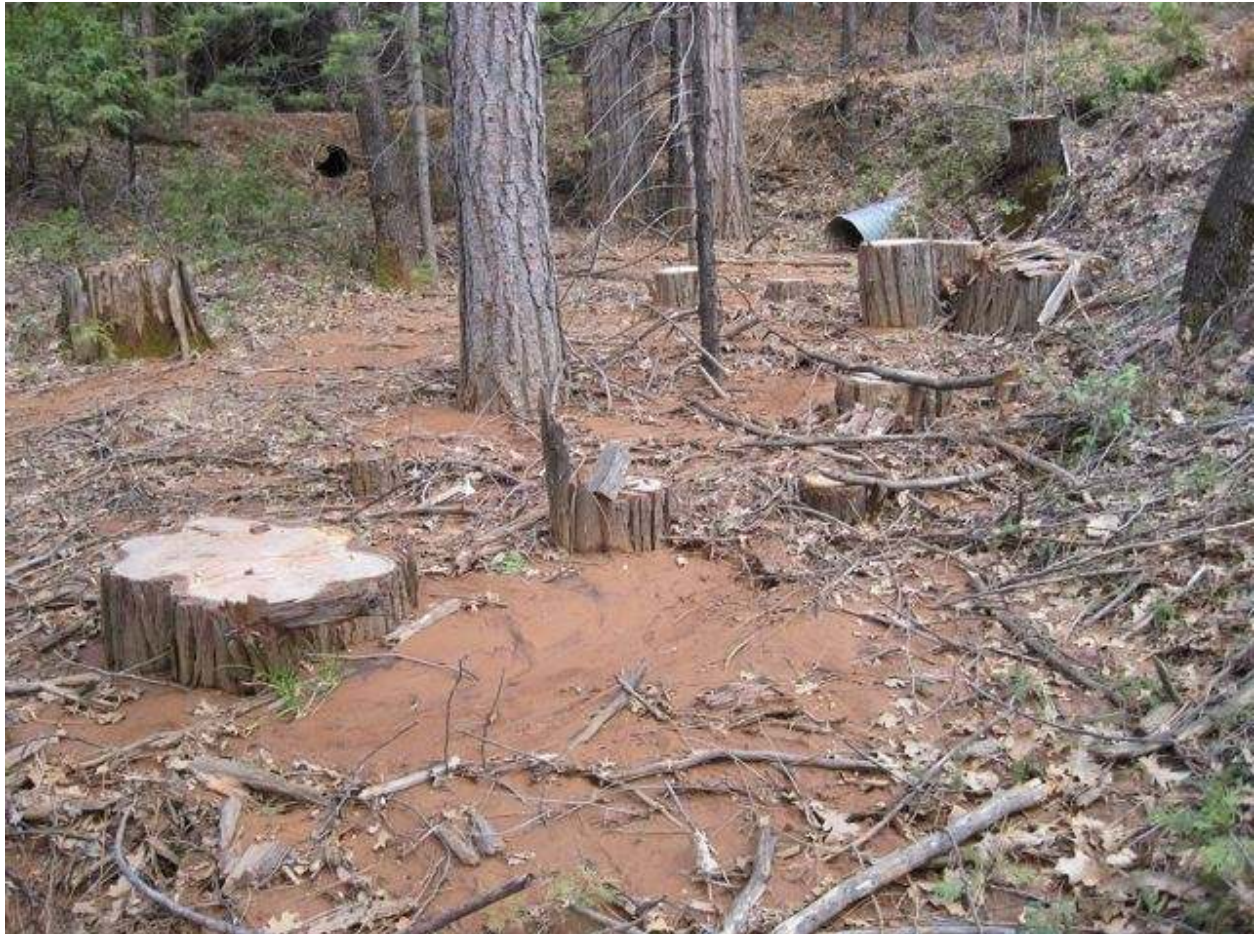
During the thinning fuels reduction logging project done two years ago, the Forest Service had crews cut down the cedars in the drainage that were killed by the deep sediment burying them with silt. There was no action taken to make any effort to halt the sediment from continuing to wash into the stream drainage.

CSERC has a video of staff digging in this specific creek drainage. Fresh sediment deposits of at least 16" in depth are easily dug down into with a shovel.

At the lower end of this sediment settling area, directly behind where this photo was taken, water was flowing from beneath the sediment and continued downstream.

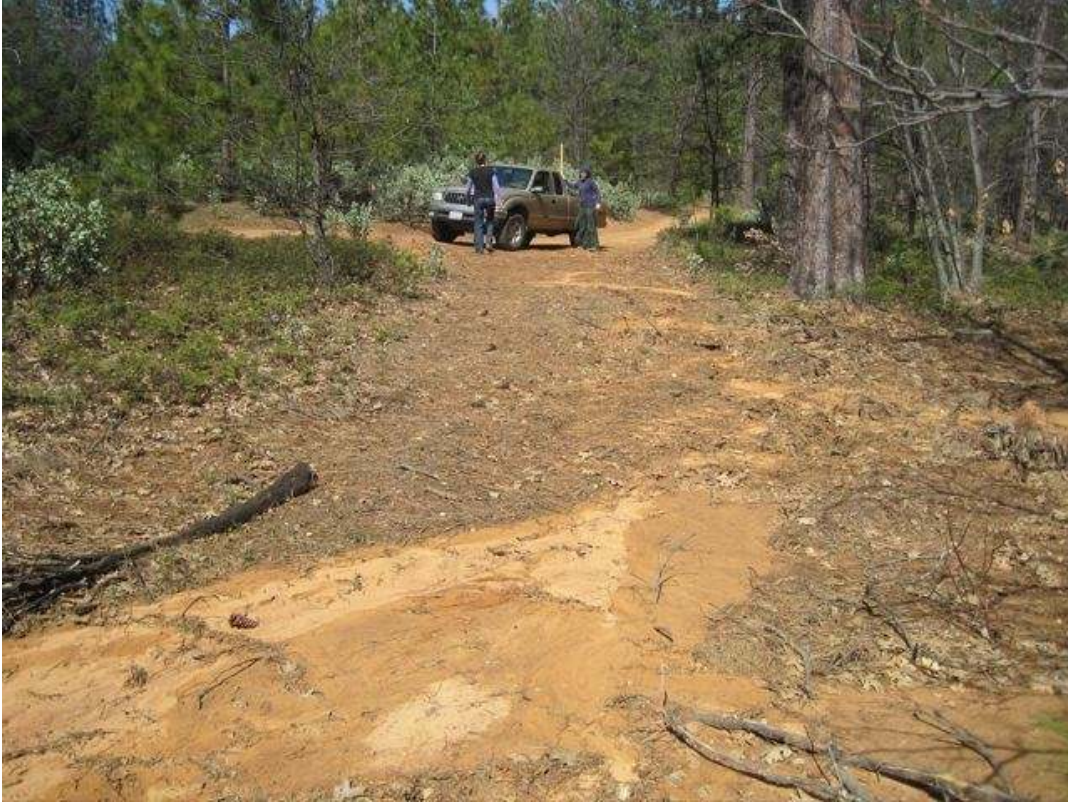
In the same general area as the above road and ORV route discharge problems, this forest road had multiple locations where sediment washed off the road. In the top photo, the photograph is taken approximately 60 feet from the road at a settling area where sediment concentrated in a low spot.

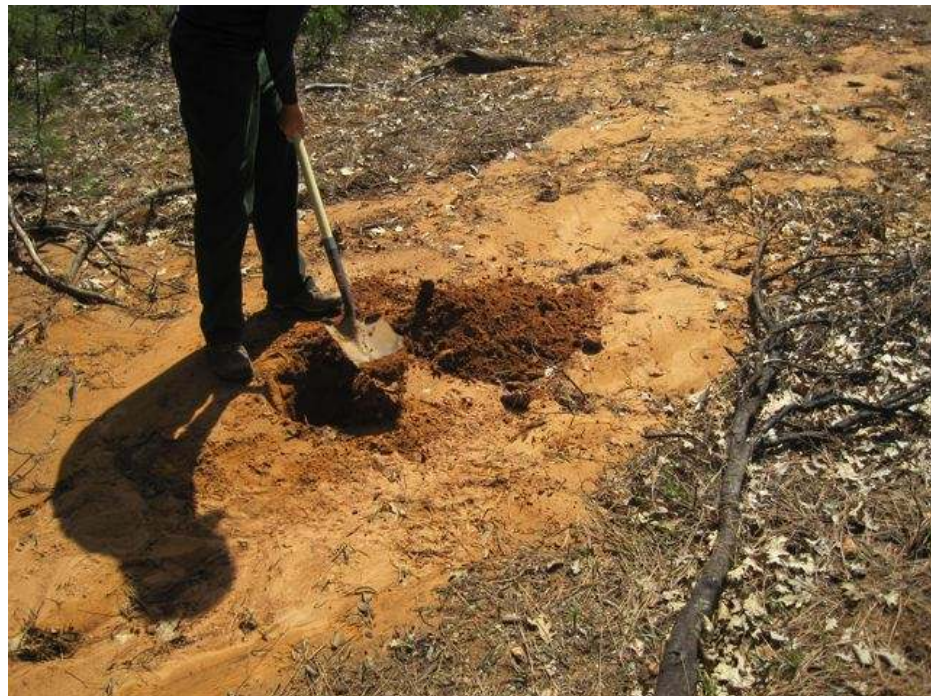
This photo shows the silt washed off the road that accumulated at roughly 12" in depth at this spot in the forest. However, the sediment flow was visible all the way to a stream over 100' downslope.
