Improving Chorro Creek Watershed – Reducing Nitrate and Dissolved Oxygen

REPORTING WATERSHED IMPROVEMENT

Based on Multiple Lines of Evidence (Option 2b)

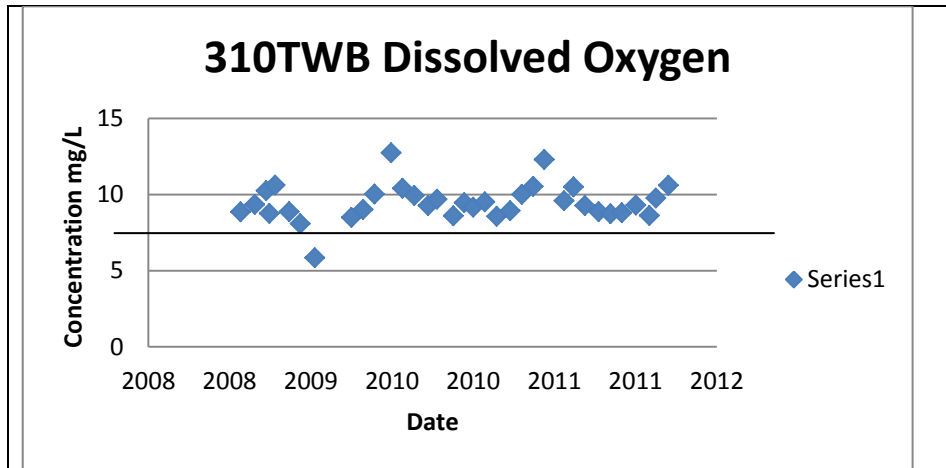
Figure 1 – Dissolved Oxygen Concentration at 310-TWB, 2008 – 2011, Routine Monthly Sampling (CCAMP)

The Chorro Creek dissolved oxygen listing was removed from the 303(d) list in 2010 because data analysis showed that Chorro Creek was meeting the Basin Plan objective of 7.0 milligrams per liter (mg/L) and was therefore protective of the cold freshwater habitat beneficial use (COLD).

When the TMDL was established, dissolved oxygen concentrations in the lower reaches of Chorro Creek were not within the range protective of cold freshwater habitat as described in the Central Coast Water Board's Water Quality Control Plan (Basin Plan). The initial dissolved oxygen listing was based on five out of ten samples being below the water quality objective of 7.0 mg/L dissolved oxygen. Since the initial listing, more than one hundred additional samples have been collected and analyzed by the Water Board's Central Coast Ambient Monitoring Program (CCAMP). Out of 111 samples collected at the most downstream site (310-TWB), only nine had dissolved oxygen below 7.0 mg/L. Additional monitoring by MBNEP at the same site showed that only two of 67 samples were below 7.0 mg/L. Overall, these data meet the COLD beneficial use water quality objective and are sufficient justification to remove the dissolved oxygen Clean Water Act section 303(d) listing for Chorro Creek. Chorro Creek was "delisted" for dissolved oxygen in 2010. Because CWA Section 319(h) funds had been used in Chorro Creek, the delisting met USEPA requirements for a Section 319(h) Success Story. The story is posted on USEPA's website at http://water.epa.gov/polwaste/nps/success319/ca_chorro.cfm

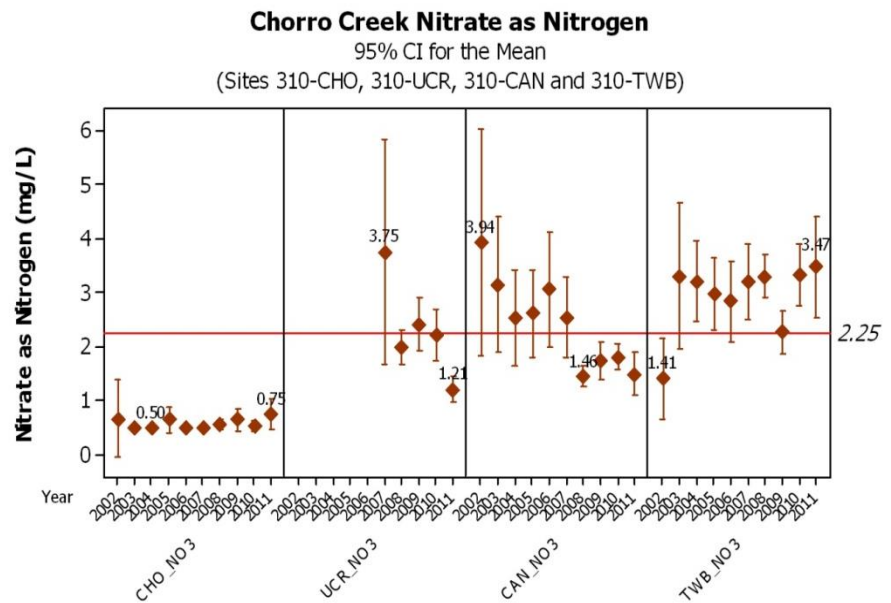
Figure 2 – Chorro Creek Mean Nitrate Levels

The graph below (Figure 2) is from the MBNEP's 2011 Data Summary Report, showing nitrate data collected by the MBNEP's monitoring program from 2002 through 2011 at four Chorro Creek sites, 310-CHO, 310-UCR, 310-CAN and 310-TWB. Site names include the hydrologic unit (310) and a three-letter tag indicating the location. Data was collected using screening level nitrate test kits. Sites 310-UCR, 310-CAN and 310-TWB are all downstream of the CMC waste water treatment plant. The two sites immediately downstream, 310-UCR and 310-CAN, show a reduction in mean nitrate levels following the treatment plant upgrade in

2007. Site 310-TWB does not show the same reduction, indicating other nitrate sources. All sites are well below the drinking water standard of 10 mg/L nitrate as N, but 310-TWB remains above the screening level of 2.25 mg/L and above the TMDL target.

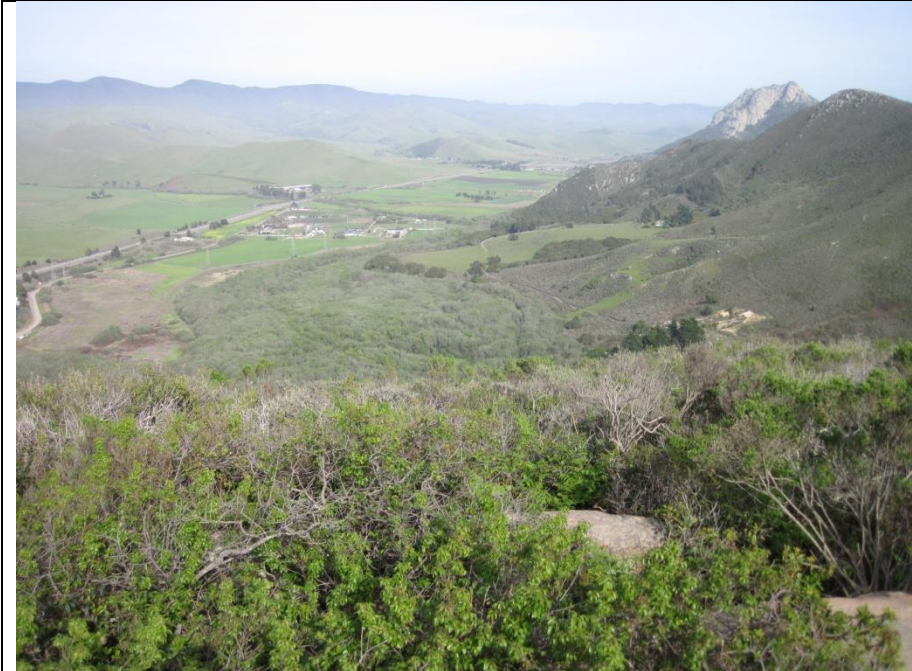
Figure 4: Chorro Flats, 2011 (MBNEP)

The Chorro Flats Enhancement Project, located in the lower watershed just upstream of the TWB monitoring site, was constructed in 1997 to reconnect Chorro Creek with its historical floodplain, thereby allowing sediment to be deposited there instead of in the bay. The project's other benefits include increasing the riparian corridor to provide shading to Chorro Creek and providing 83 acres of restored wetland and wildlife habitat. Land acquisition was funded through Proposition 111 and State Coastal Conservancy funds; project design, implementation, monitoring and maintenance have been funded with State Coastal Conservancy and USEPA 319(h) funds. The cost of the entire project was approximately \$2.3 million.

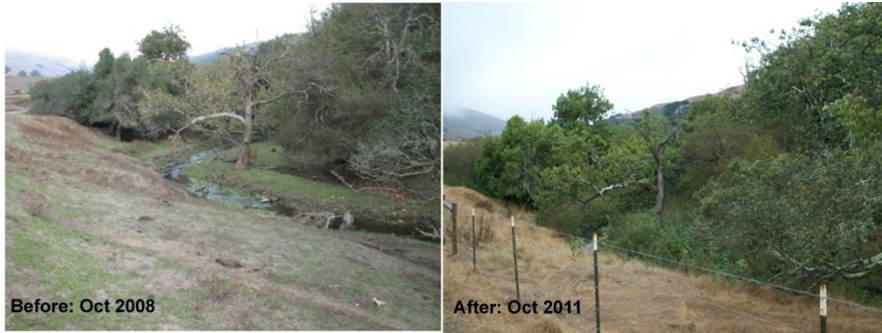
Figure 5: San Luisito Creek, Before and After (MBNEP)

Riparian fencing projects to limit or prevent cattle access to creeks have been completed on sections of several Chorro Creek tributaries (San Bernardo, San Luisito, Dairy, Pennington, Walters and Chumash creeks). The intent of the projects is to reduce fecal coliform and nutrient loading to creeks, to protect creek banks and riparian vegetation, and to improve habitat for fish and wildlife. Projects have been funded with a mixture of state and federal grants, settlement funds and cost-sharing by landowners.

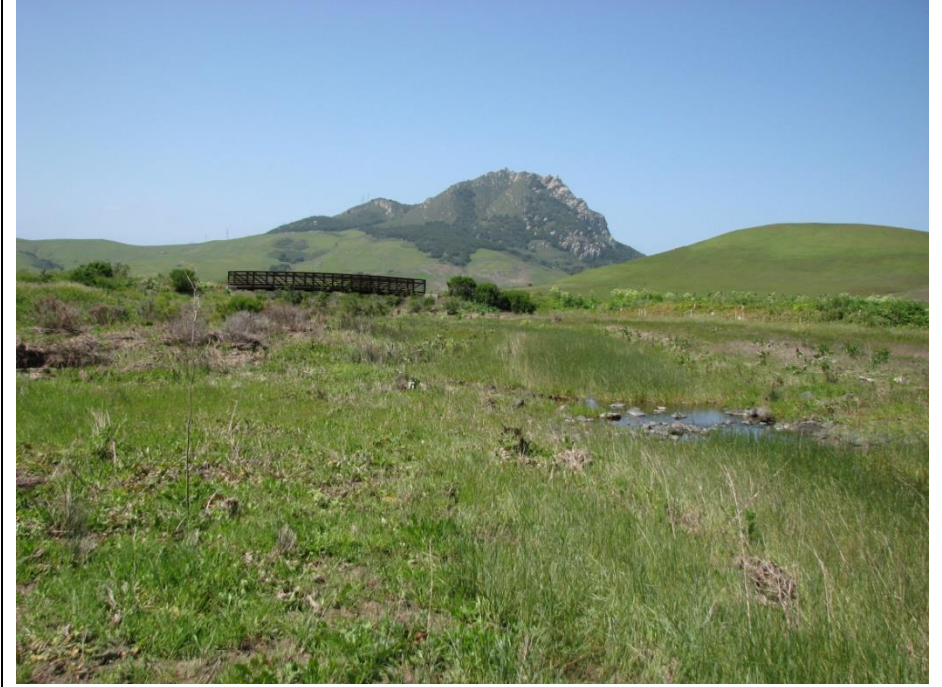
Figure 6: Walters Creek Restoration, 2011, After Three Years (MBNEP)

Walters Creek had been straightened and bermed during World War II. As a result, the channel was deeply incised and dominated by non-native vegetation. The restoration project, funded through a combination of state and private funds, removed the berms, re-established a creek meander, connected the channel to its floodplain, and planted native riparian vegetation. The project cost approximately \$125,000 and was completed in 2008. MBNEP conducts bird surveys, macroinvertebrate bioassessments and monitors vegetation at the restoration site, in order to track changes in habitat diversity over time.

By restoring meanders to a straightened channel and removing berms, the Walters project is reducing erosion at the source and enhancing habitat.
