SHR-253

OBSERVATION:

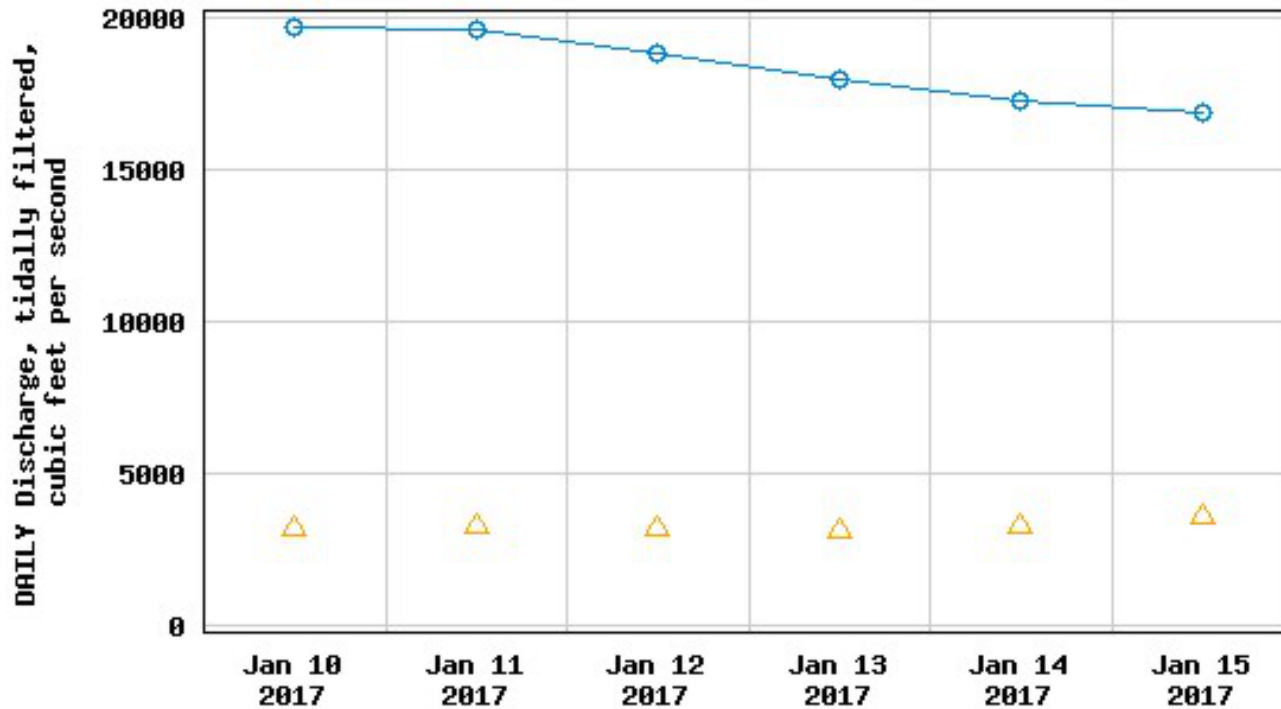
USGS 11447830 SUTTER SLOUGH A COURTLAND CA

Discharge, tidally filtered, cubic feet per second

Most recent instantaneous value: 20900 02-11-2017 10:00 PST

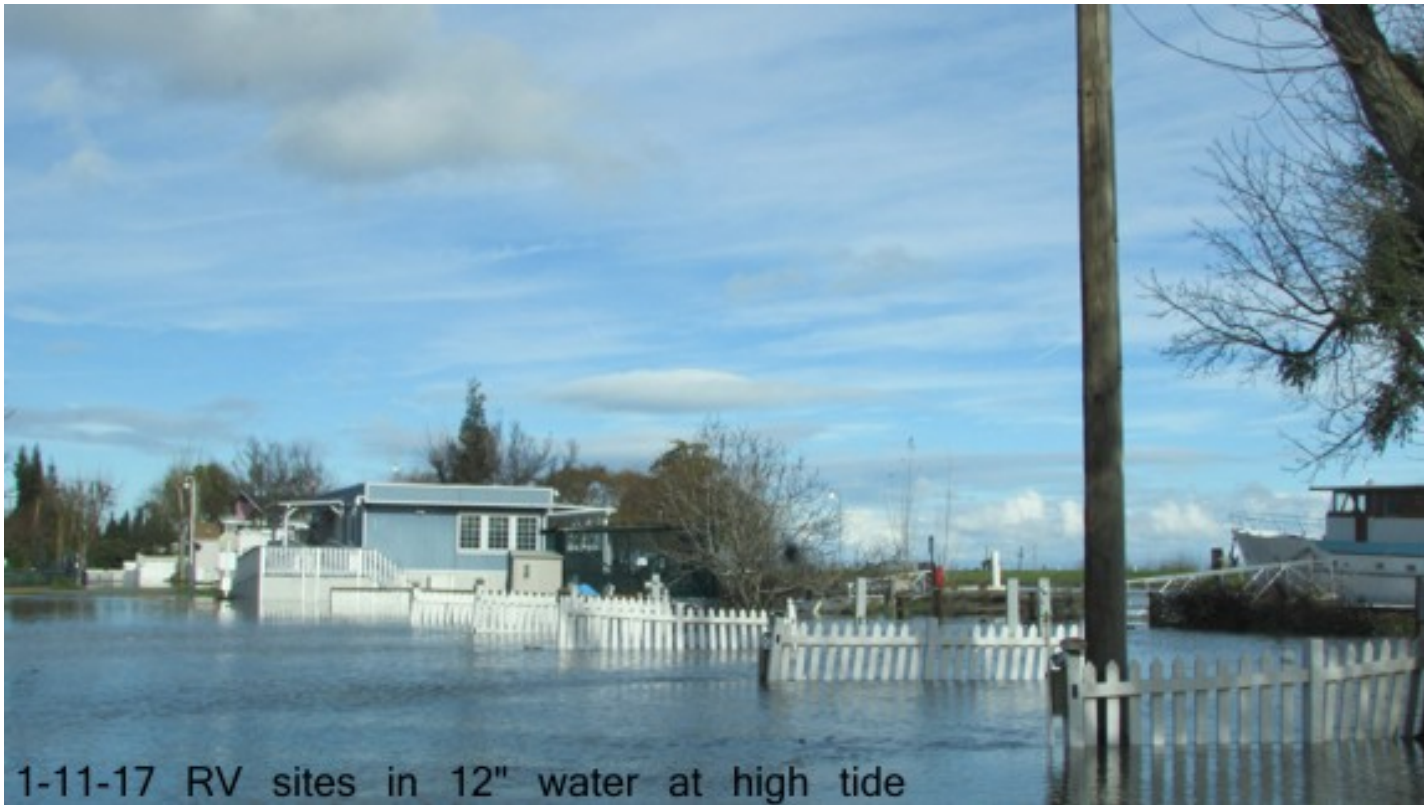
1-11-17 RV sites in 12" water at high tide

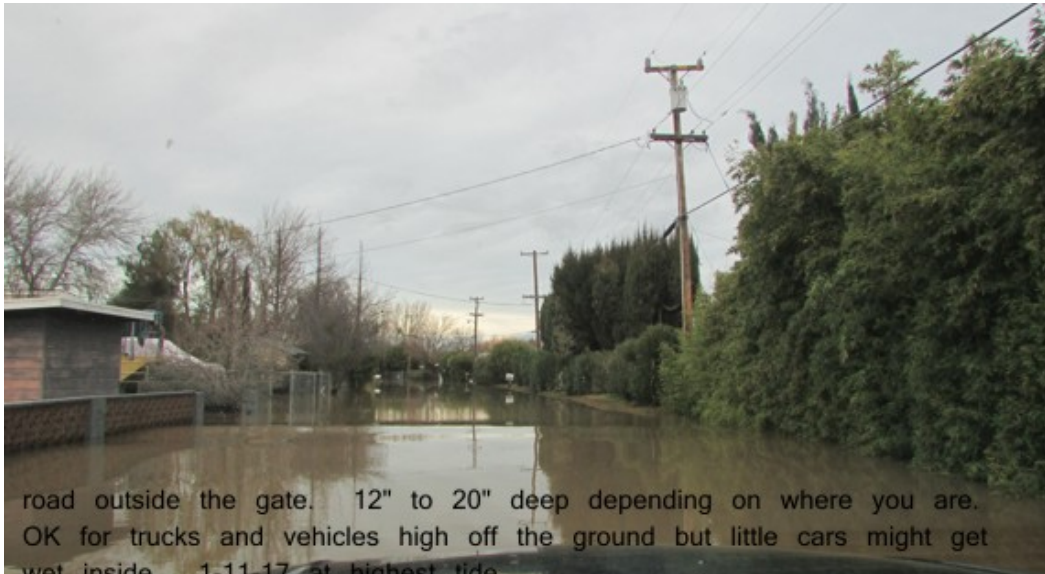
road outside the gate. 12" to 20" deep depending on where you are. OK for trucks and vehicles high off the ground but little cars might get wet inside. 1-11-17 at highest tide

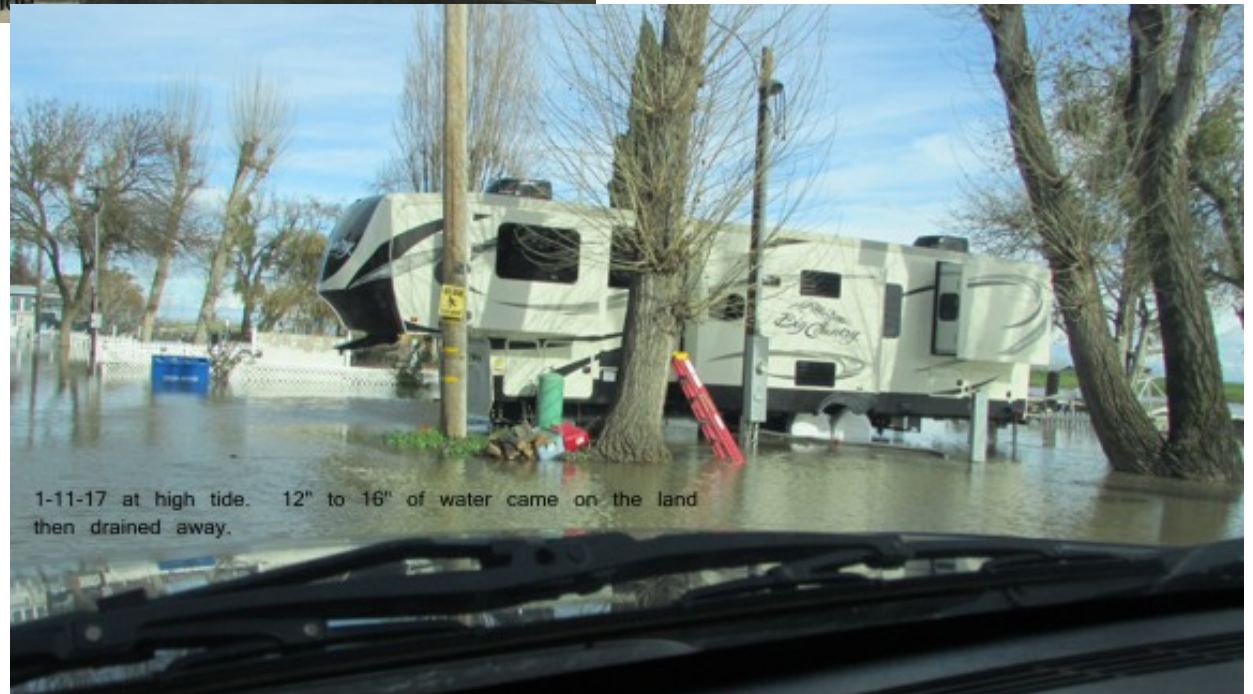
1-11-17 at high tide. 12" to 16" of water came on the land then drained away.

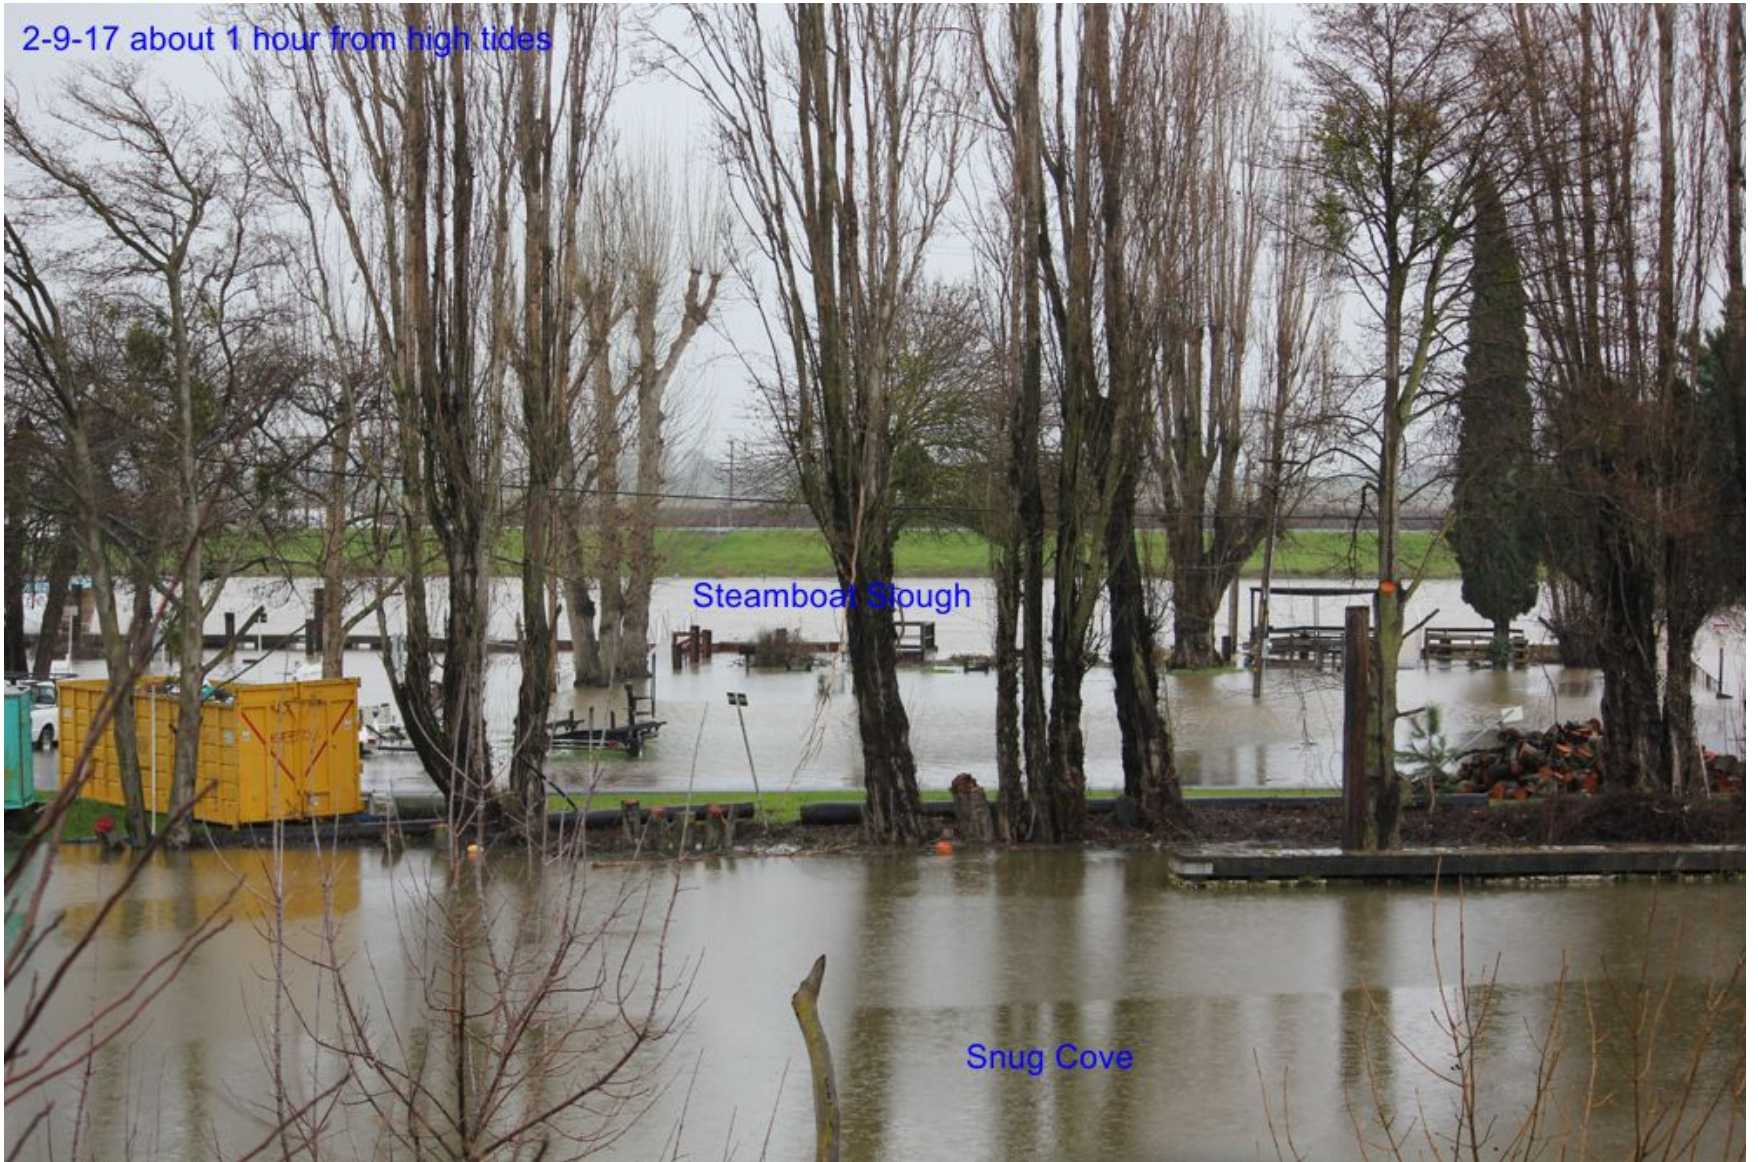
2-9-17 about 1 hour from high tides

Steamboat Slough

Snug Cove

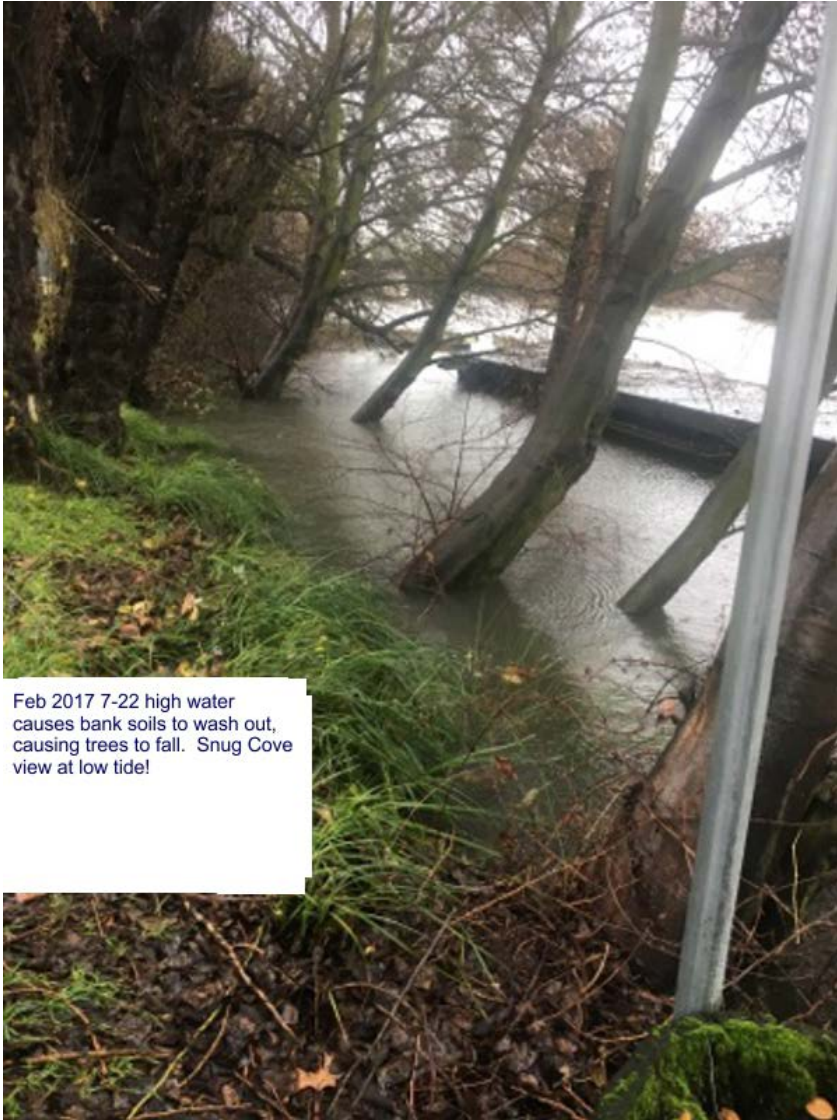
Feb 2017 7-22 high water causes bank soils to wash out, causing trees to fall. Snug Cove view at low tide!

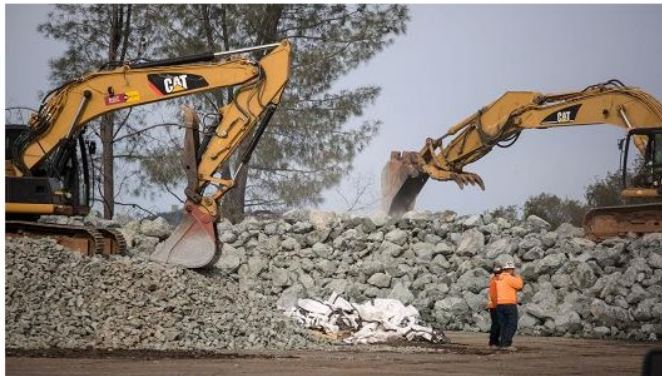
Heavy equipment moving rocks for use in an attempt to repair damaged spillway at Lake Oroville Dam in Oroville, Calif., on Feb. 13, 2017.
