# ASSESSMENT OF FISH MORTALITY OBSERVED IN THE SAN JOAQUIN RIVER NEAR STOCKTON IN MAY 2007

CITY OF STOCKTON

October 2007

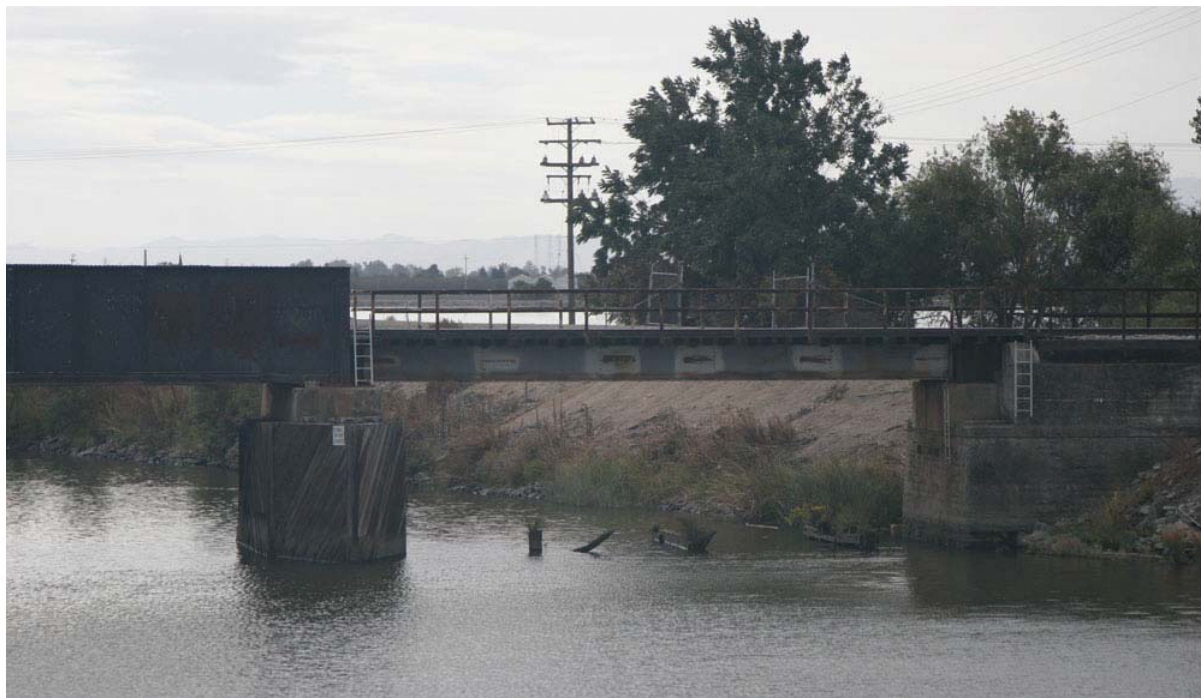
The supports for the railroad bridge and remnant supports located under the railroad bridge (**Figure 2**), create hydraulic breaks in the river, which often harbor piscivorous fish, such as striped bass (*Morone saxatilis*), largemouth bass (*Micropterus salmoides*), smallmouth bass (*Micropterus dolomieu*), catfish (*Ictalurus* spp.) and Sacramento pikeminnow (*Ptychocheilus grandis*). These fish are opportunistic ambush predators that will hold in the low-velocity water near cover and prey upon smaller fish as they pass by. Anecdotal information (e.g., from fishermen and RWCF staff) indicates that the San Joaquin River immediately upstream, downstream, and underneath the railroad bridge is a popular fishing spot for these game fish, especially during the spring months, when striped bass are relatively abundant in the lower San Joaquin River.

Figure 2. Railroad bridge located upstream of the RWCF. Note the bridge supports and remnant supports underneath the bridge, which provide holding habitat for piscivorous fish.

Furthermore, the NRS (2007) report indicates that the tags from the lost fish were located in a relatively concentrated area immediately upstream, downstream, and underneath the railroad bridge. Had the fish died of the potential causes listed in Table 1, the tags would likely have been spread over a larger area. Furthermore, had the fish been killed as a result of elevated concentration of toxic compounds discharged from the RWCF, the tags likely would have been distributed upstream and downstream of the RWCF outfall. The high concentration of tags scattered around the bridge, coupled with the fact that no dead fish were observed, provides evidence supporting the idea that the tagged chinook salmon were simply eaten by predators that were holding near the railroad bridge and the tags were defecated at this predatory fish holding site.

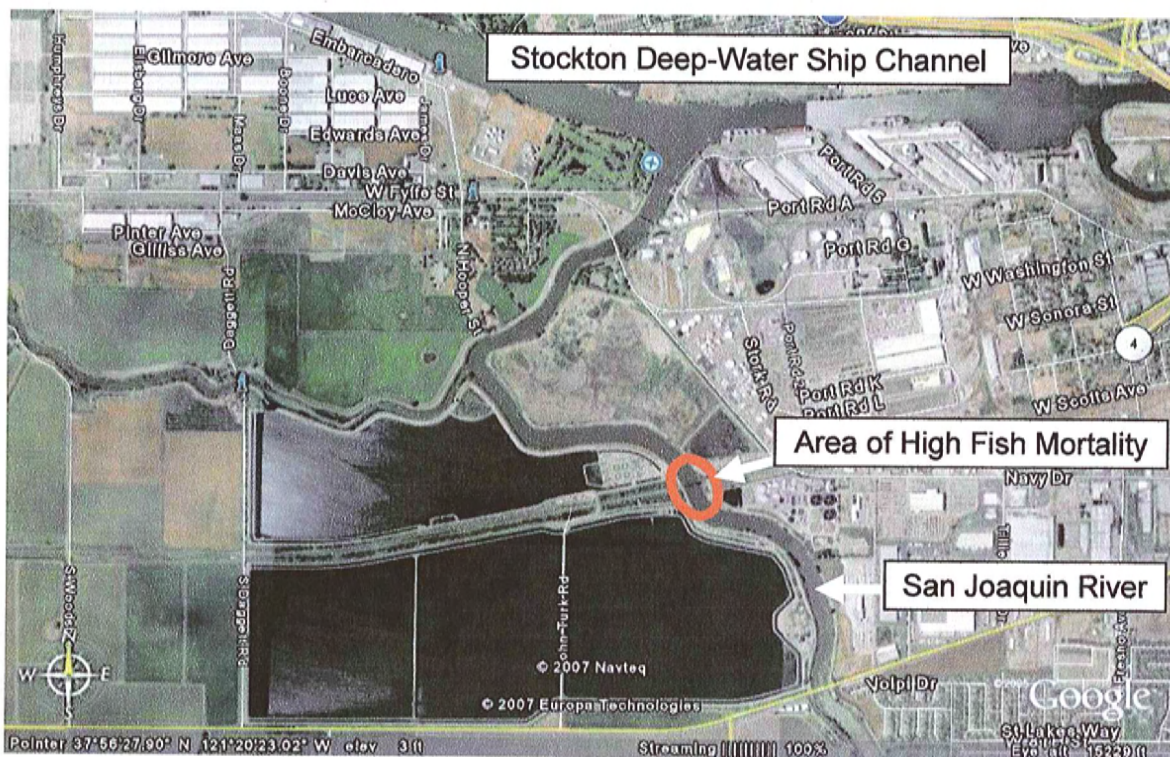
Late last week, while performing mobile telemetry monitoring in the San Joaquin River near Stockton, I located a high number of acoustic transmitters at a very small, localized site approximately 0.75 miles downstream of the Highway 4 bridge, 1.7 miles upstream of the Stockton Deep Water Ship Channel, and adjacent to a railroad bridge and the Stockton waste water treatment facilities (Figure 2).

Figure 2. Location of high mortality among juvenile acoustic-tagged Chinook salmon.
