OPENING AND CLOSING STATUS OF THE BIG SUR RIVER MOUTH, MONTEREY COUNTY, CA

Based on Photographic Interpretation during Selected Years, 1972-2010

David H. Dettman

Prepared for the Center for Biological Diversity, San Francisco, CA

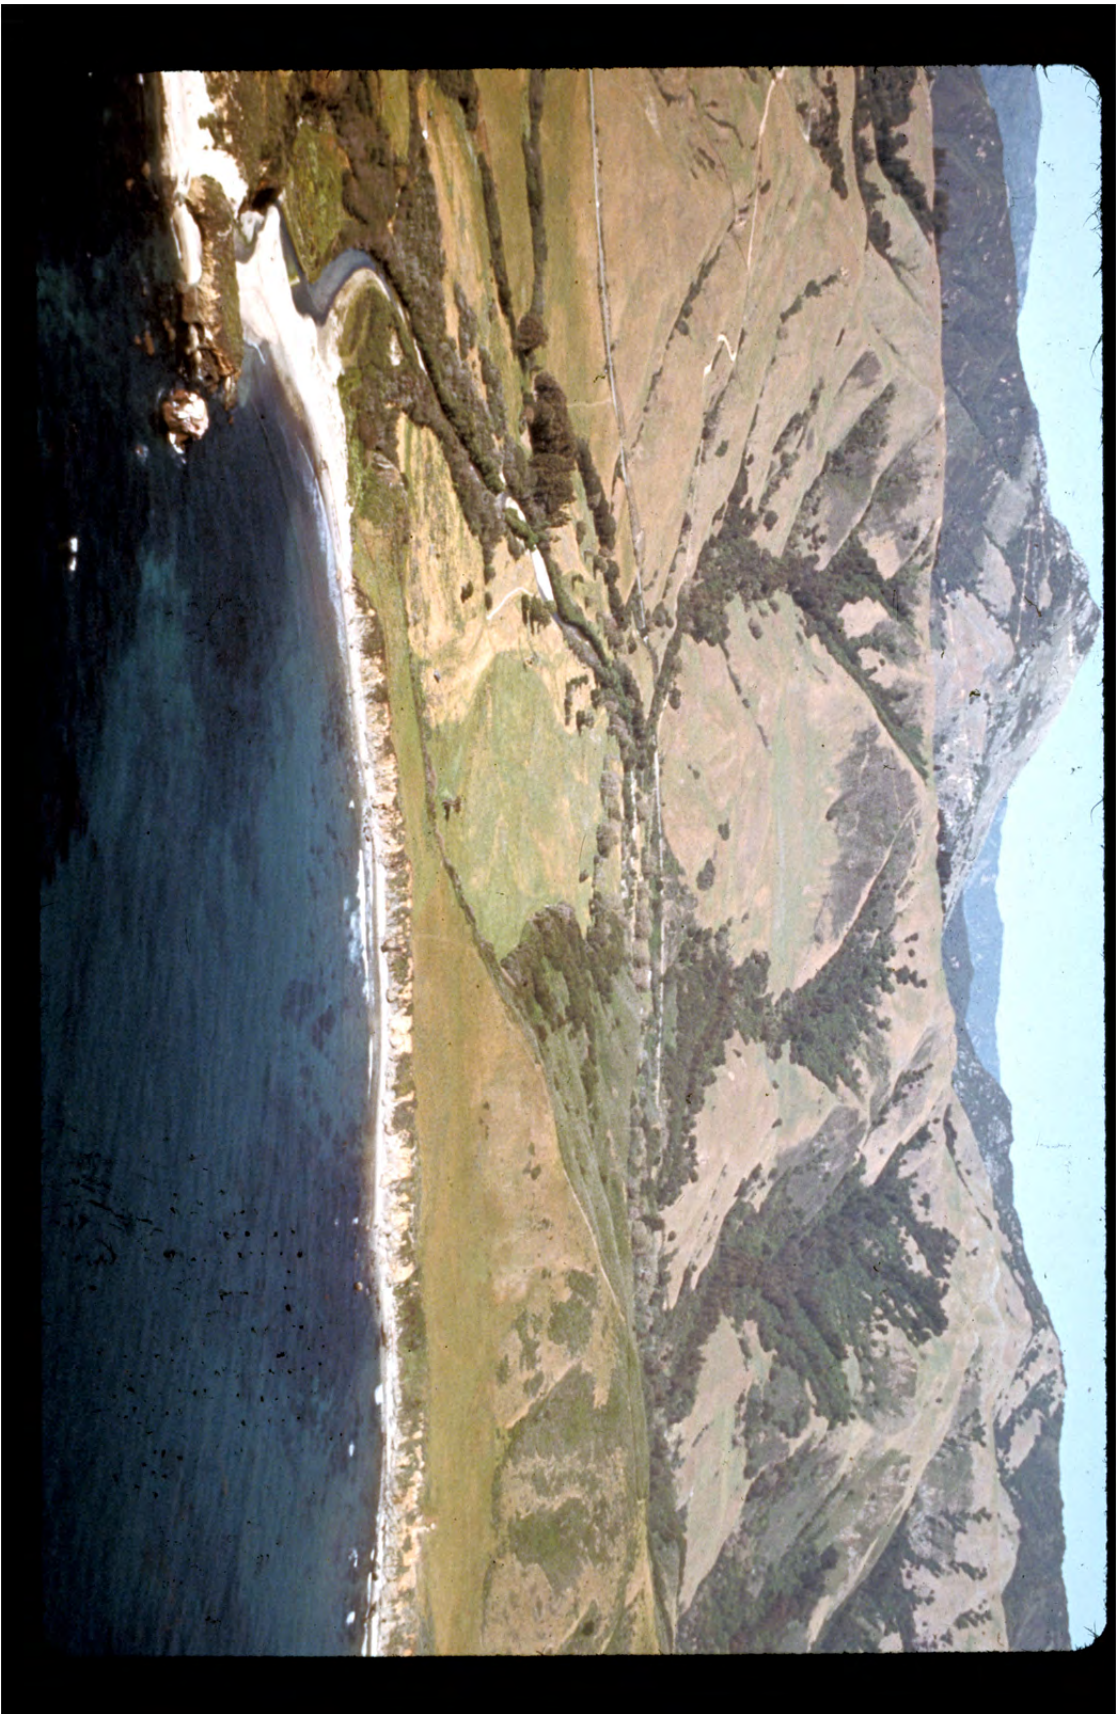
Photo 1: Big Sur Lagoon and River mouth, 1972, date unknown, but probably late March or April, based on green grass on hill slopes.

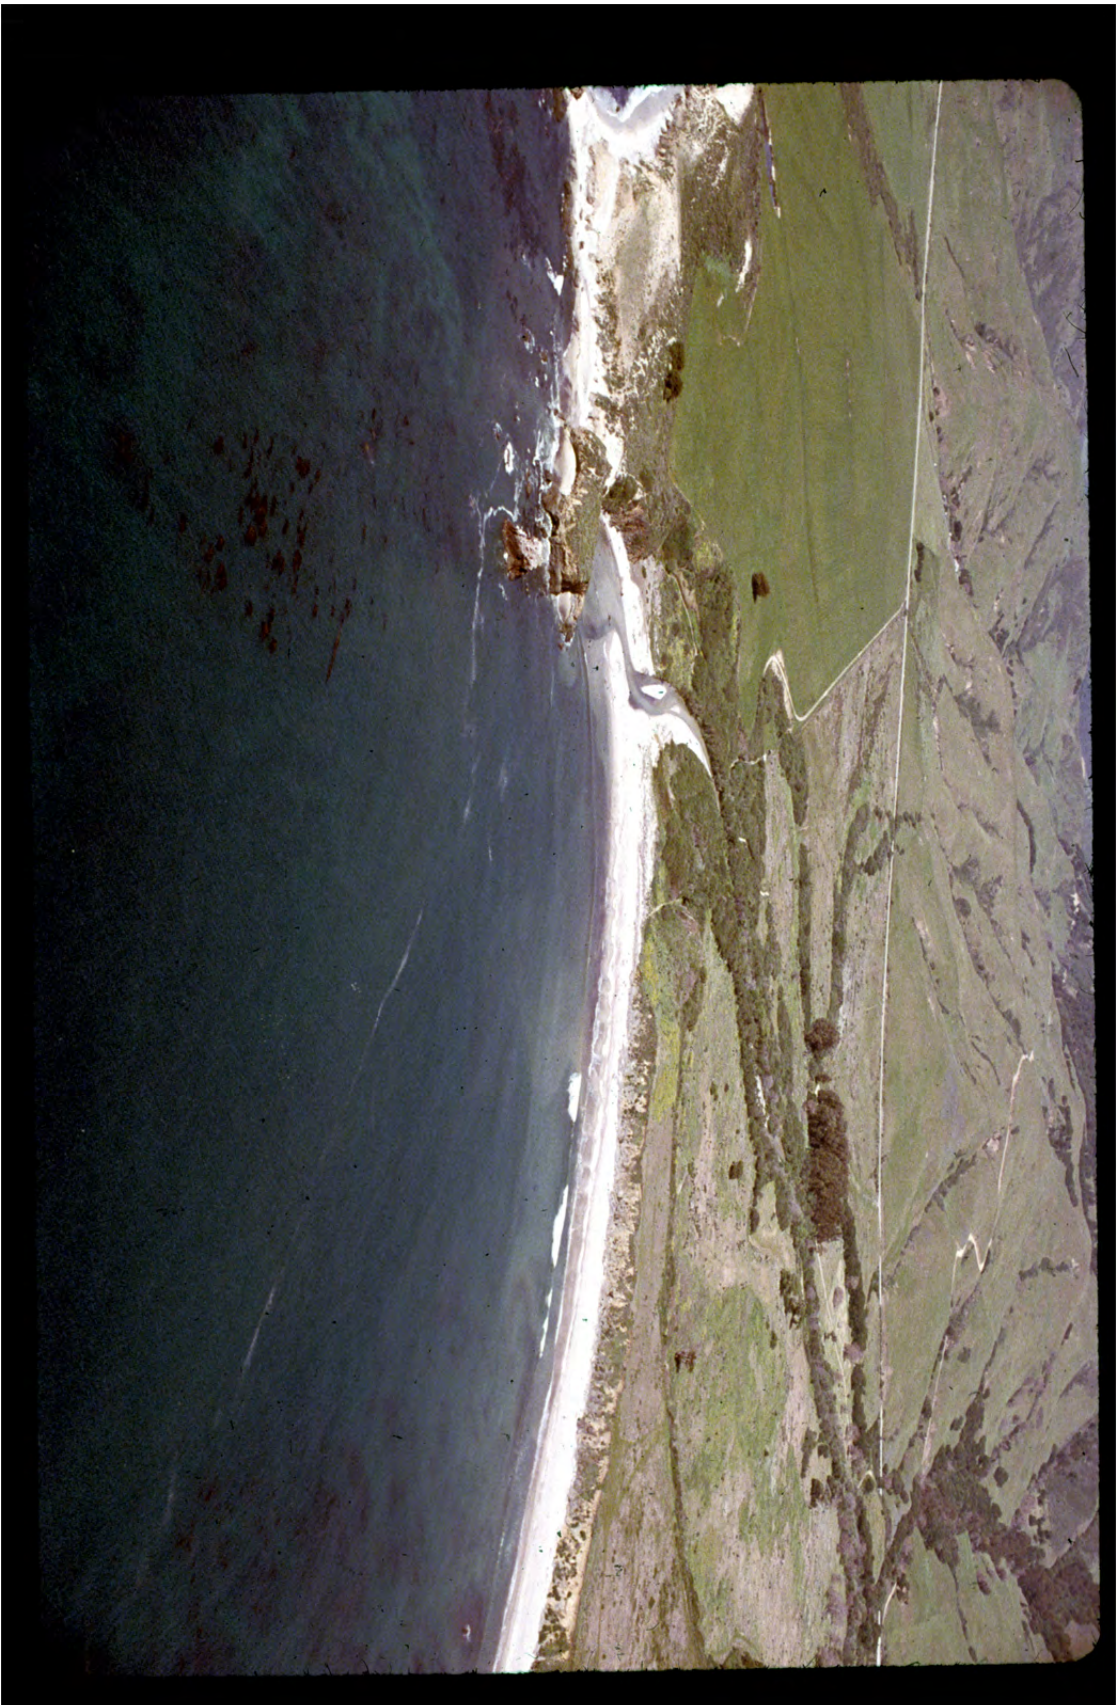
Photo 2: Big Sur Lagoon and River mouth, April 30, 1979. Source: Copyright (C) 2002-2011 Kenneth & Gabrielle Adelman, California Coastal Records Project, www.Californiacoastline.org

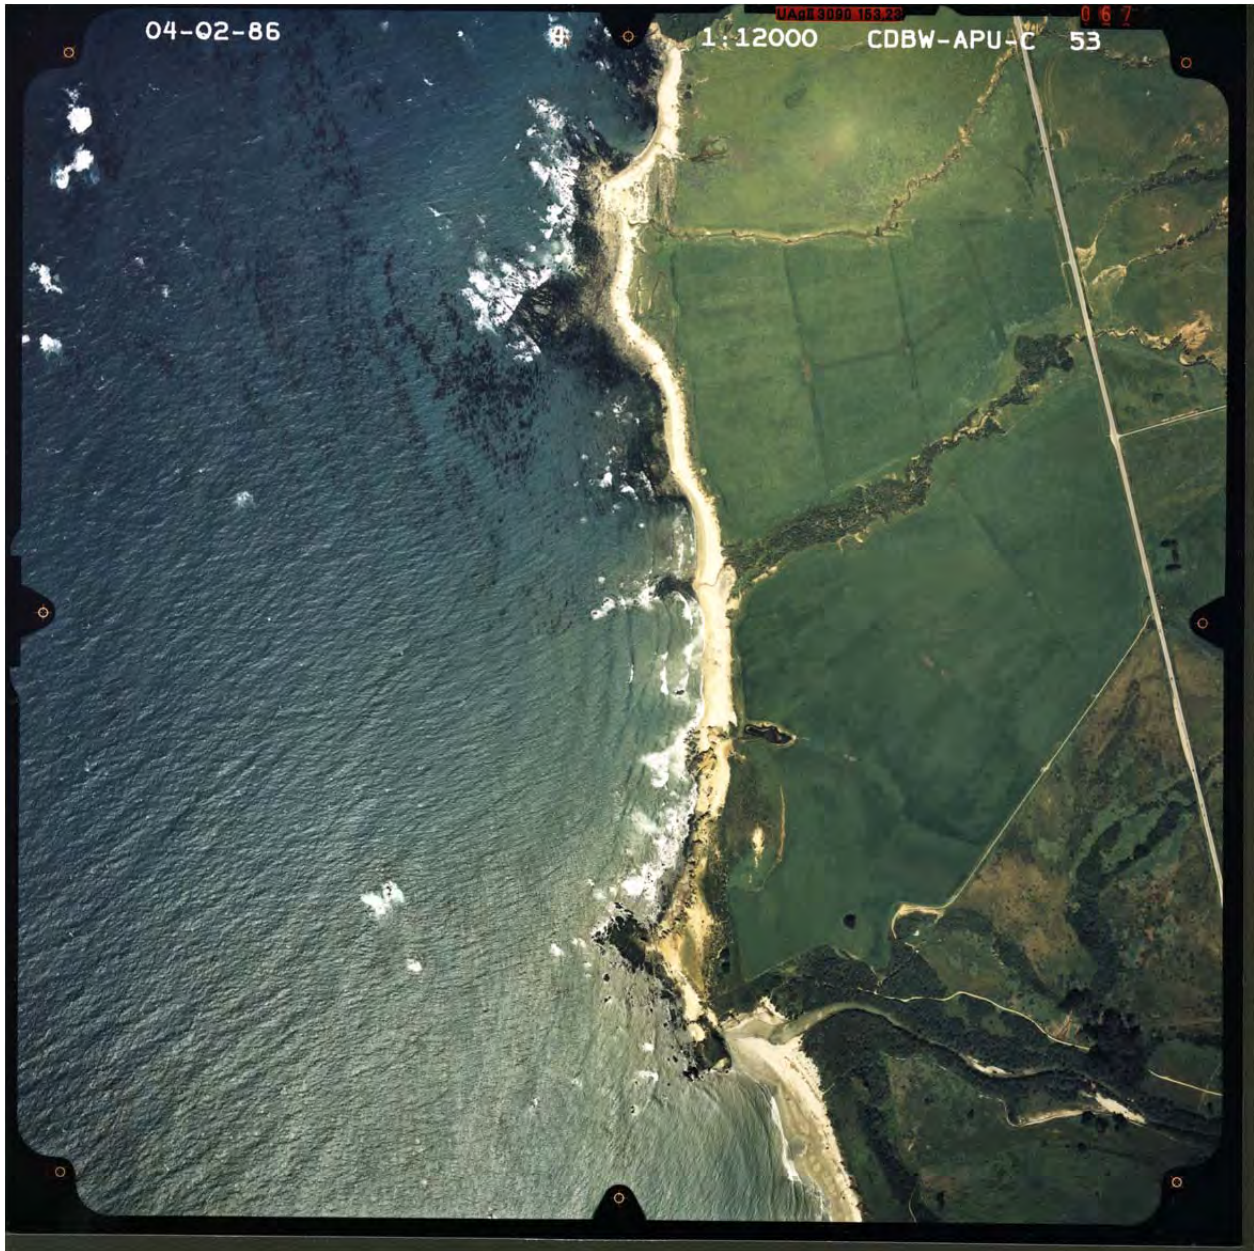
Photo 3: Big Sur Lagoon and River mouth, April 2, 1986. Source: Copyright (C) 2002-2011 Kenneth & Gabrielle Adelman, California Coastal Records Project, www.Californiacoastline.org

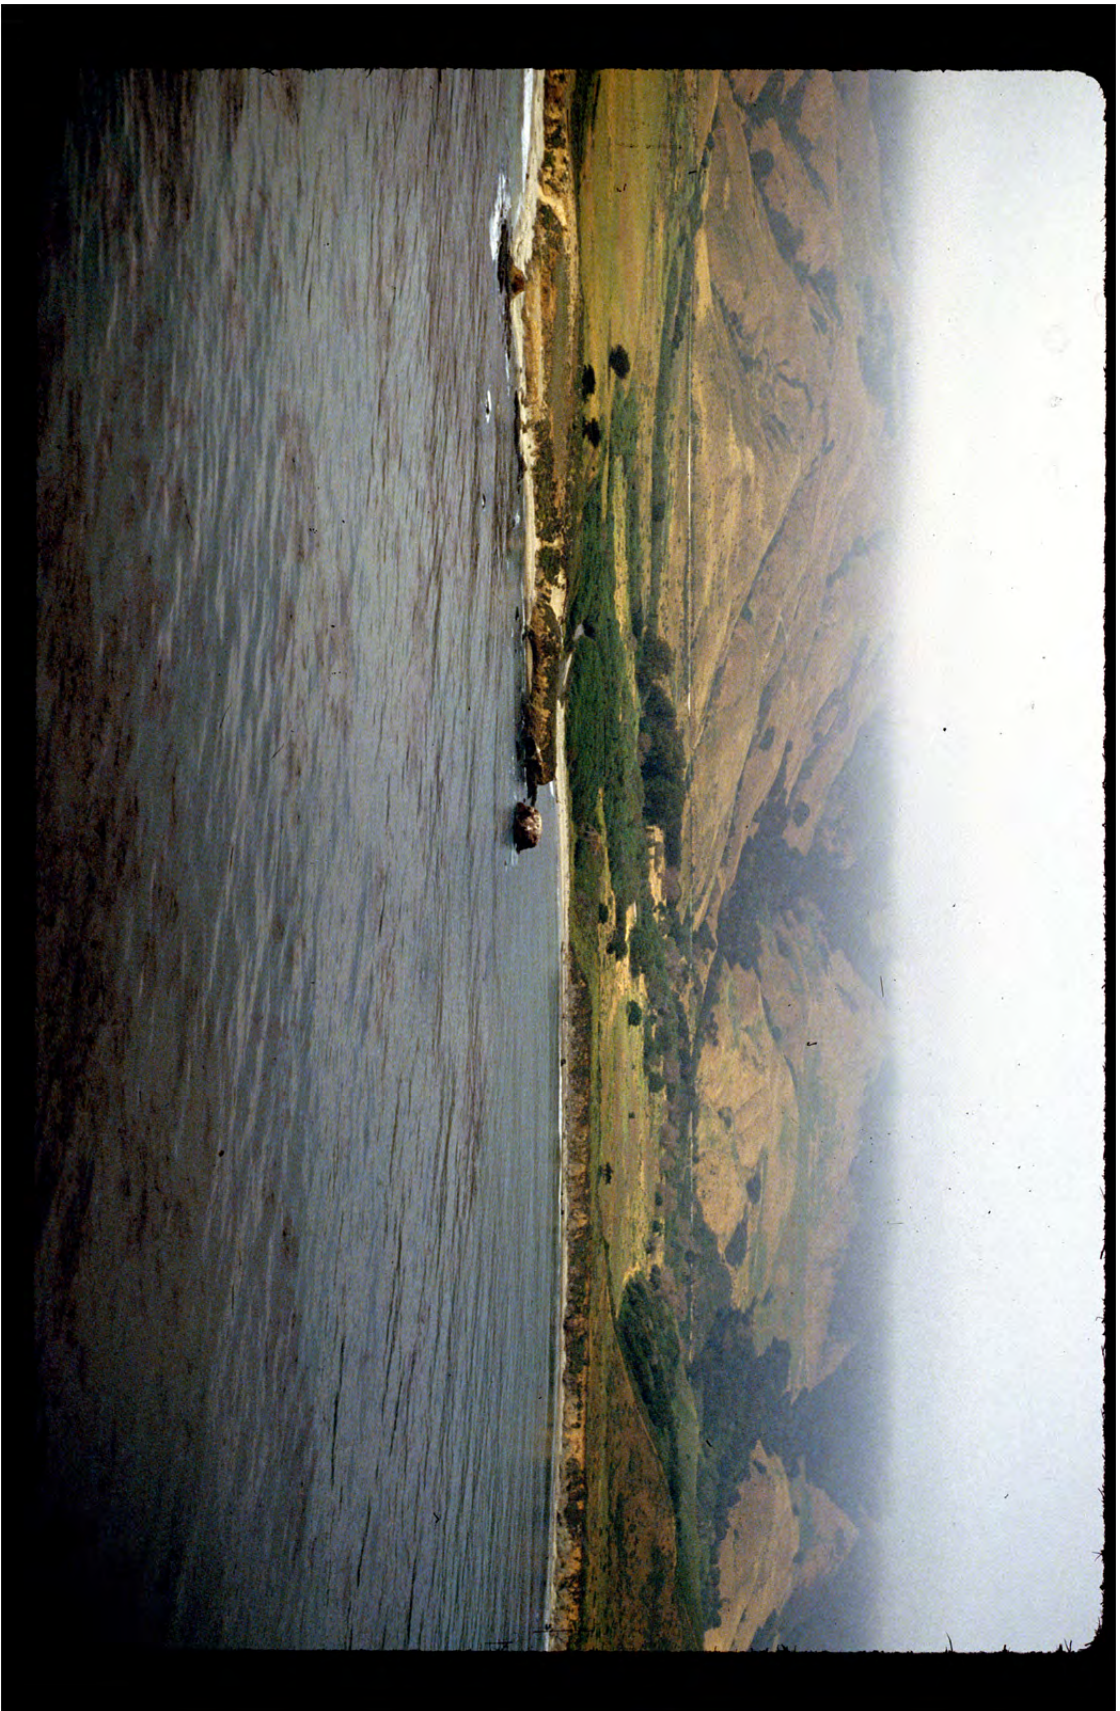
Results and Interpretation of Photos – Sixteen images were available for interpretation, covering selected years between 1972 and 2010. (**Table 1**) The detail and orientation of the outlet in two photos, 1987[**Photo 4**] and 1994[**Photo 7**], were not discernable due to low resolution or out-of-view and could not be used to definitively determine status of the outlet. In the remaining 14 photos the geographic details of a wetted outlet channel, or water flowing along the northern bedrock headland were clearly visible, or not.

Photo 4: Big Sur Lagoon and River mouth, June 1987. Source: Copyright (C) 2002-2011 Kenneth & Gabrielle Adelman, California Coastal Records Project, www.Californiacoastline.org

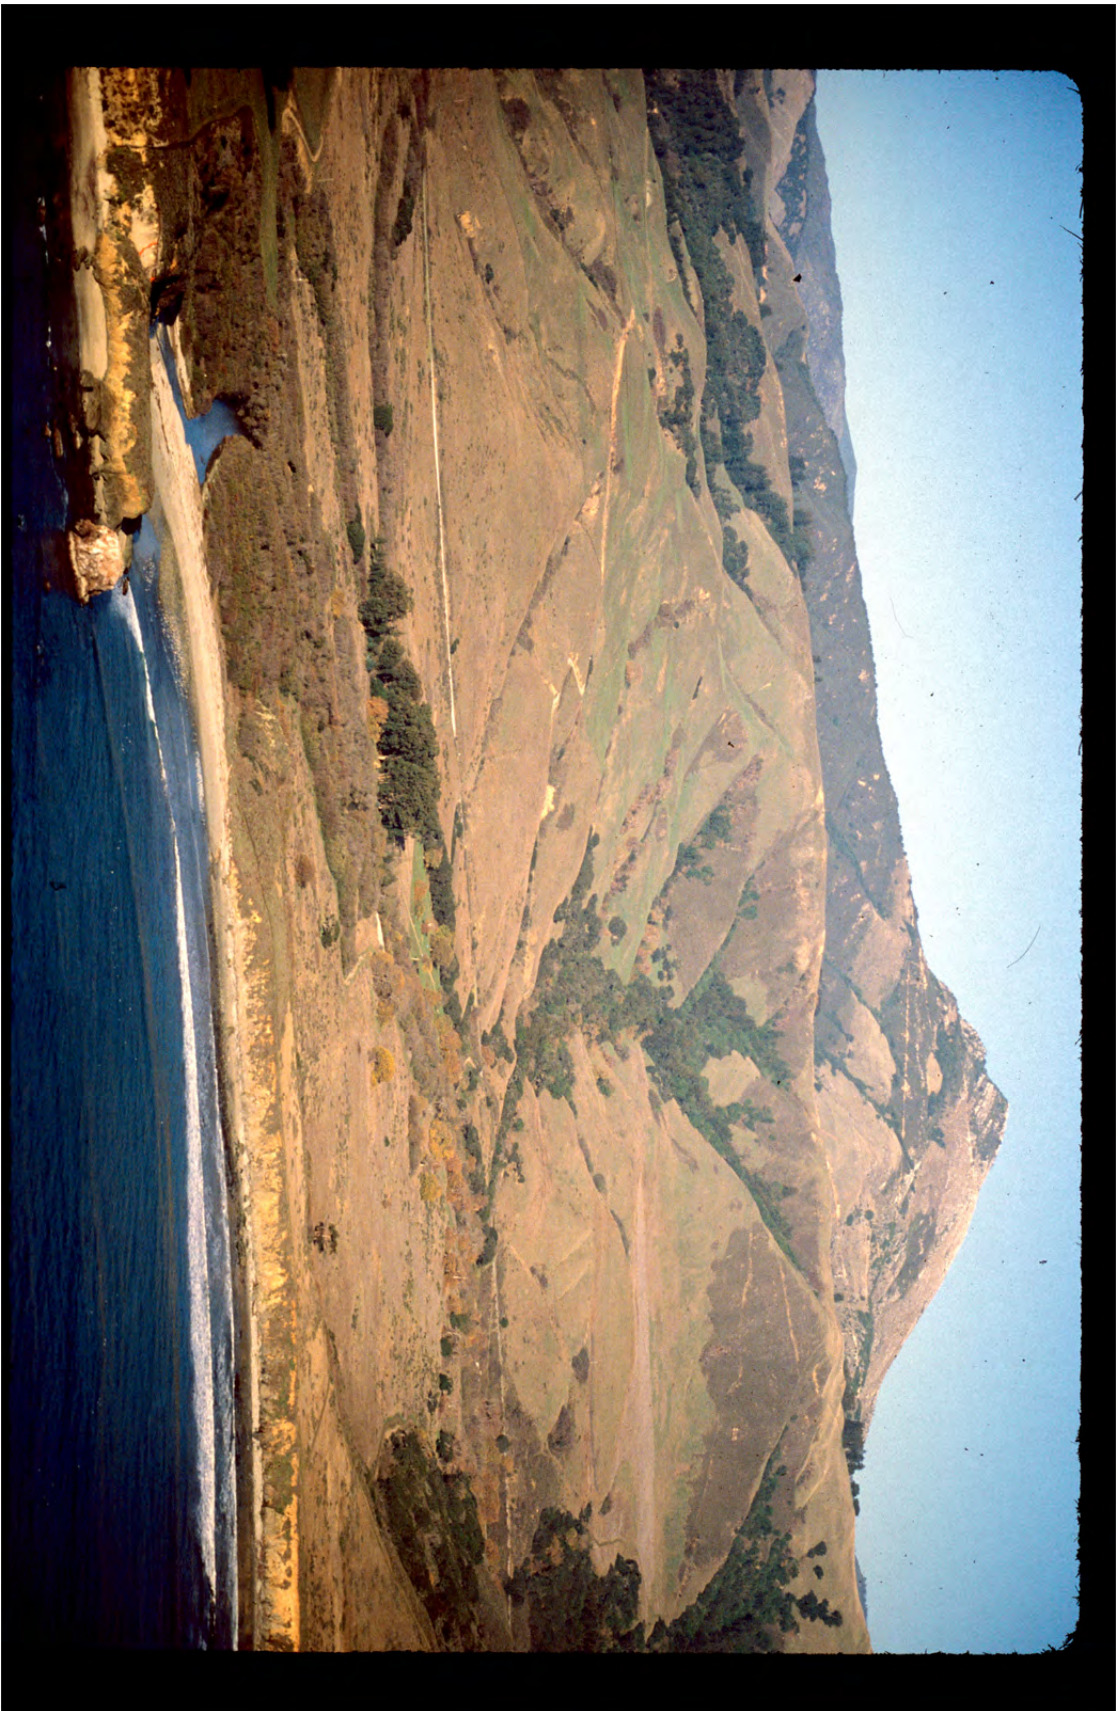
Photo 5: Big Sur Lagoon and River mouth, June 1989. Source: Copyright (C) 2002-2011 Kenneth & Gabrielle Adelman, California Coastal Records Project, www.Californiacoastline.org

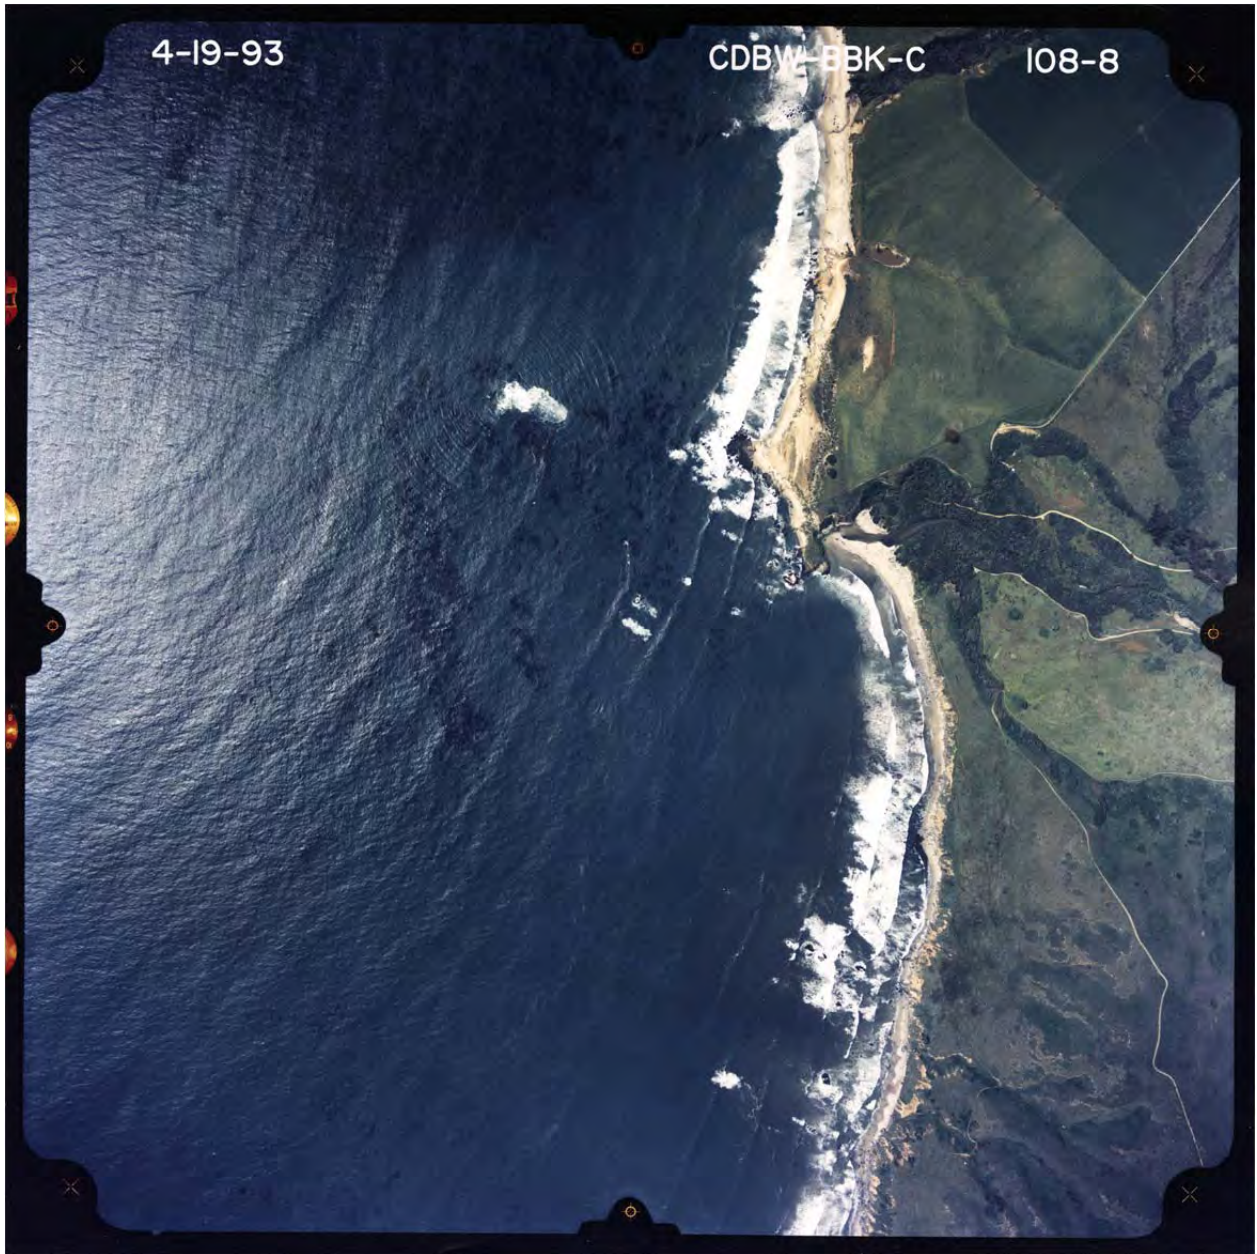
Photo 6: Big Sur Lagoon and River mouth, April 1993. Source: Copyright (C) 2002-2011 Kenneth & Gabrielle Adelman, California Coastal Records Project, www.Californiacoastline.org

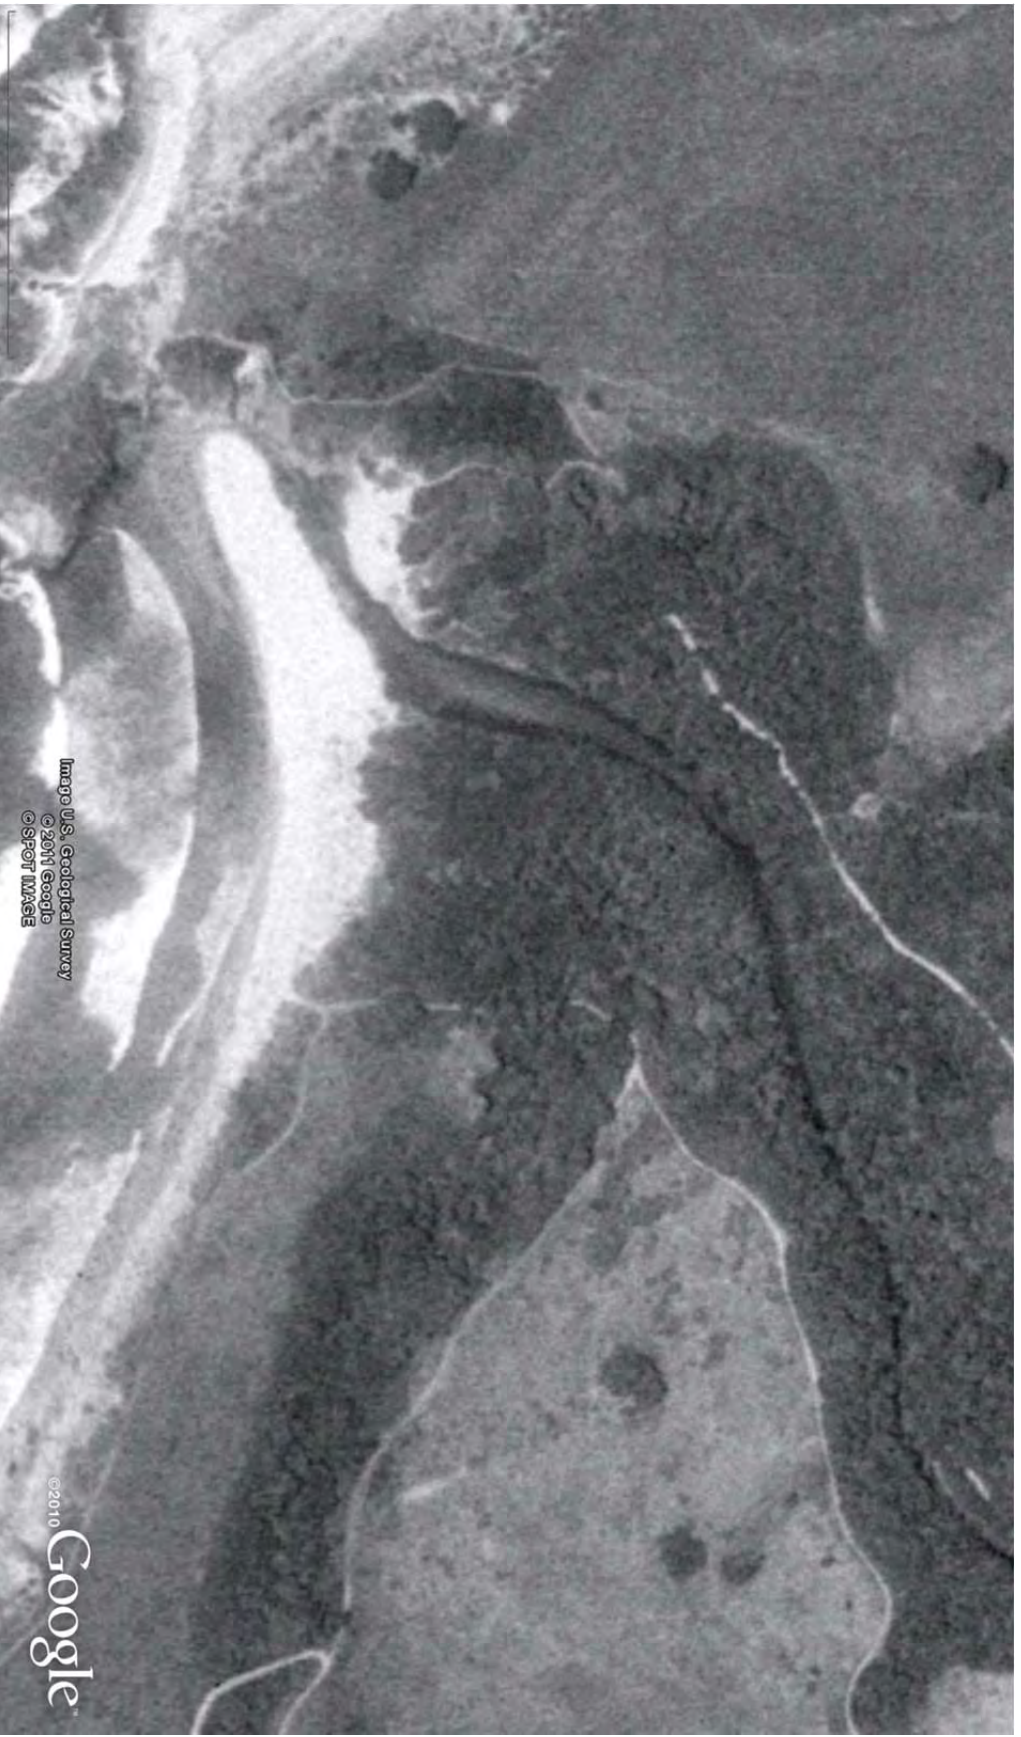
Photo 7: Big Sur Lagoon and River mouth, May 12, 1994. Source: Google EarthPro Imagery, © 2011Google

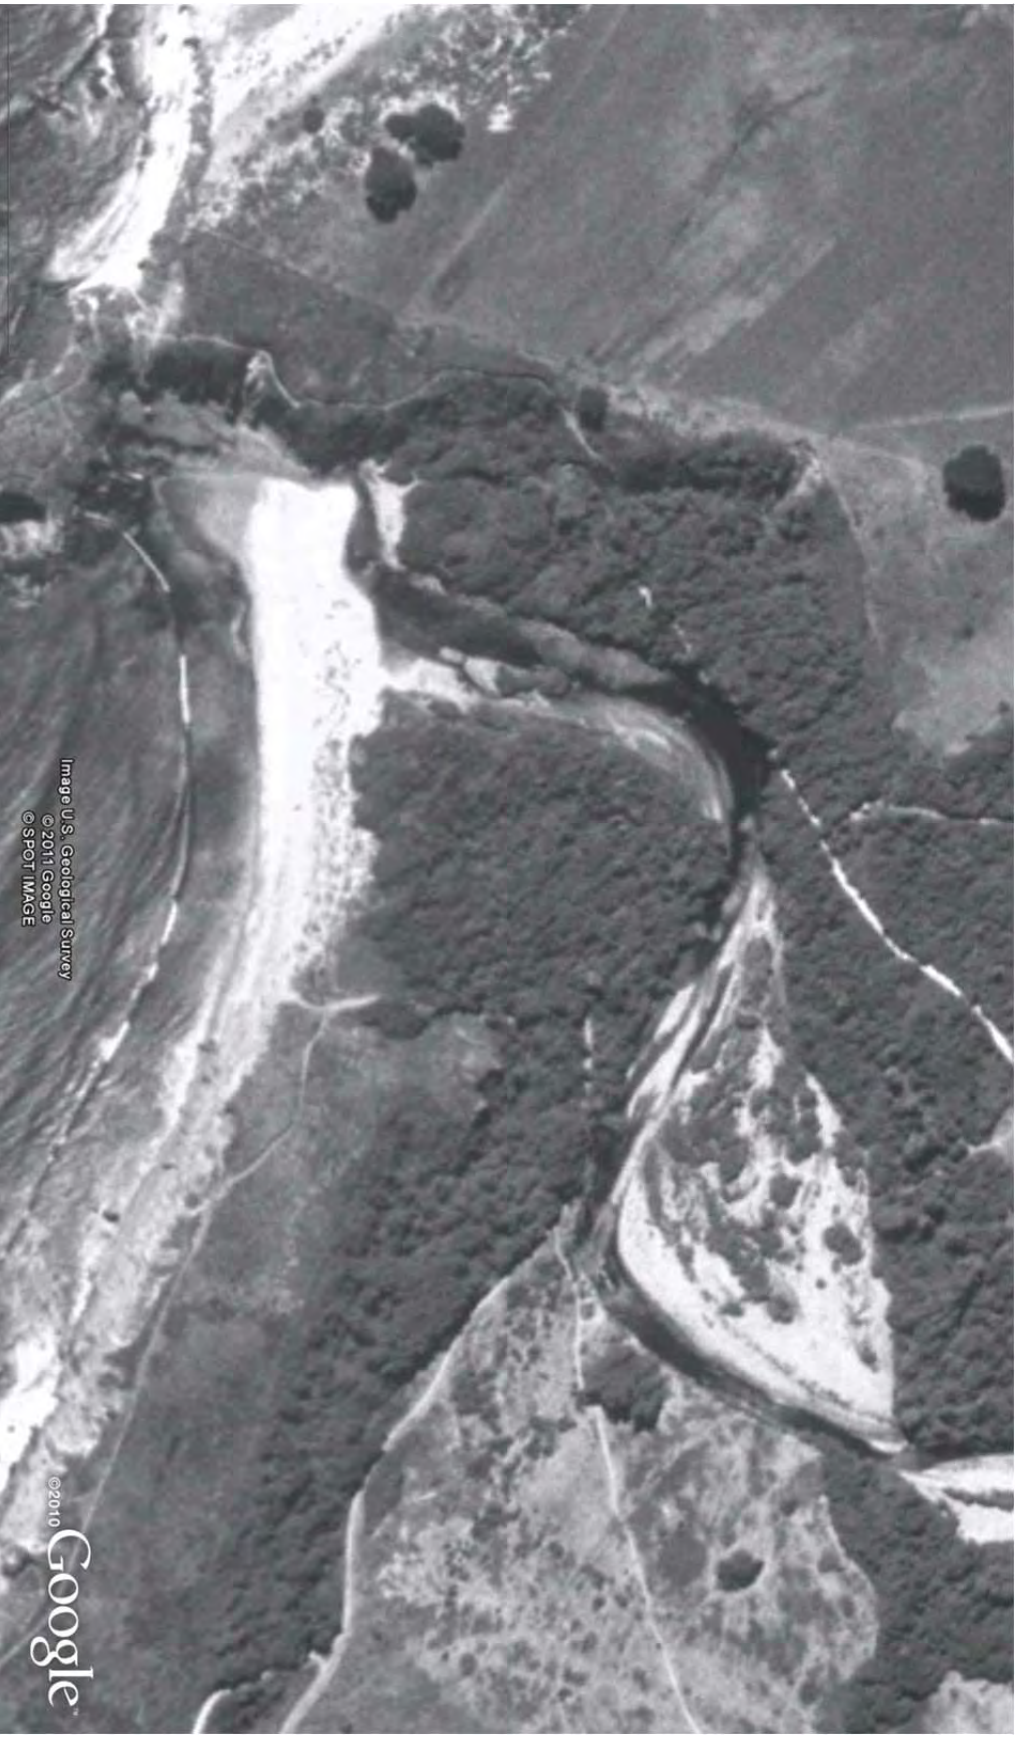
Photo 8: Big Sur Lagoon and River mouth, June 7, 2002. Source: Google EarthPro Imagery, © 2011 Google

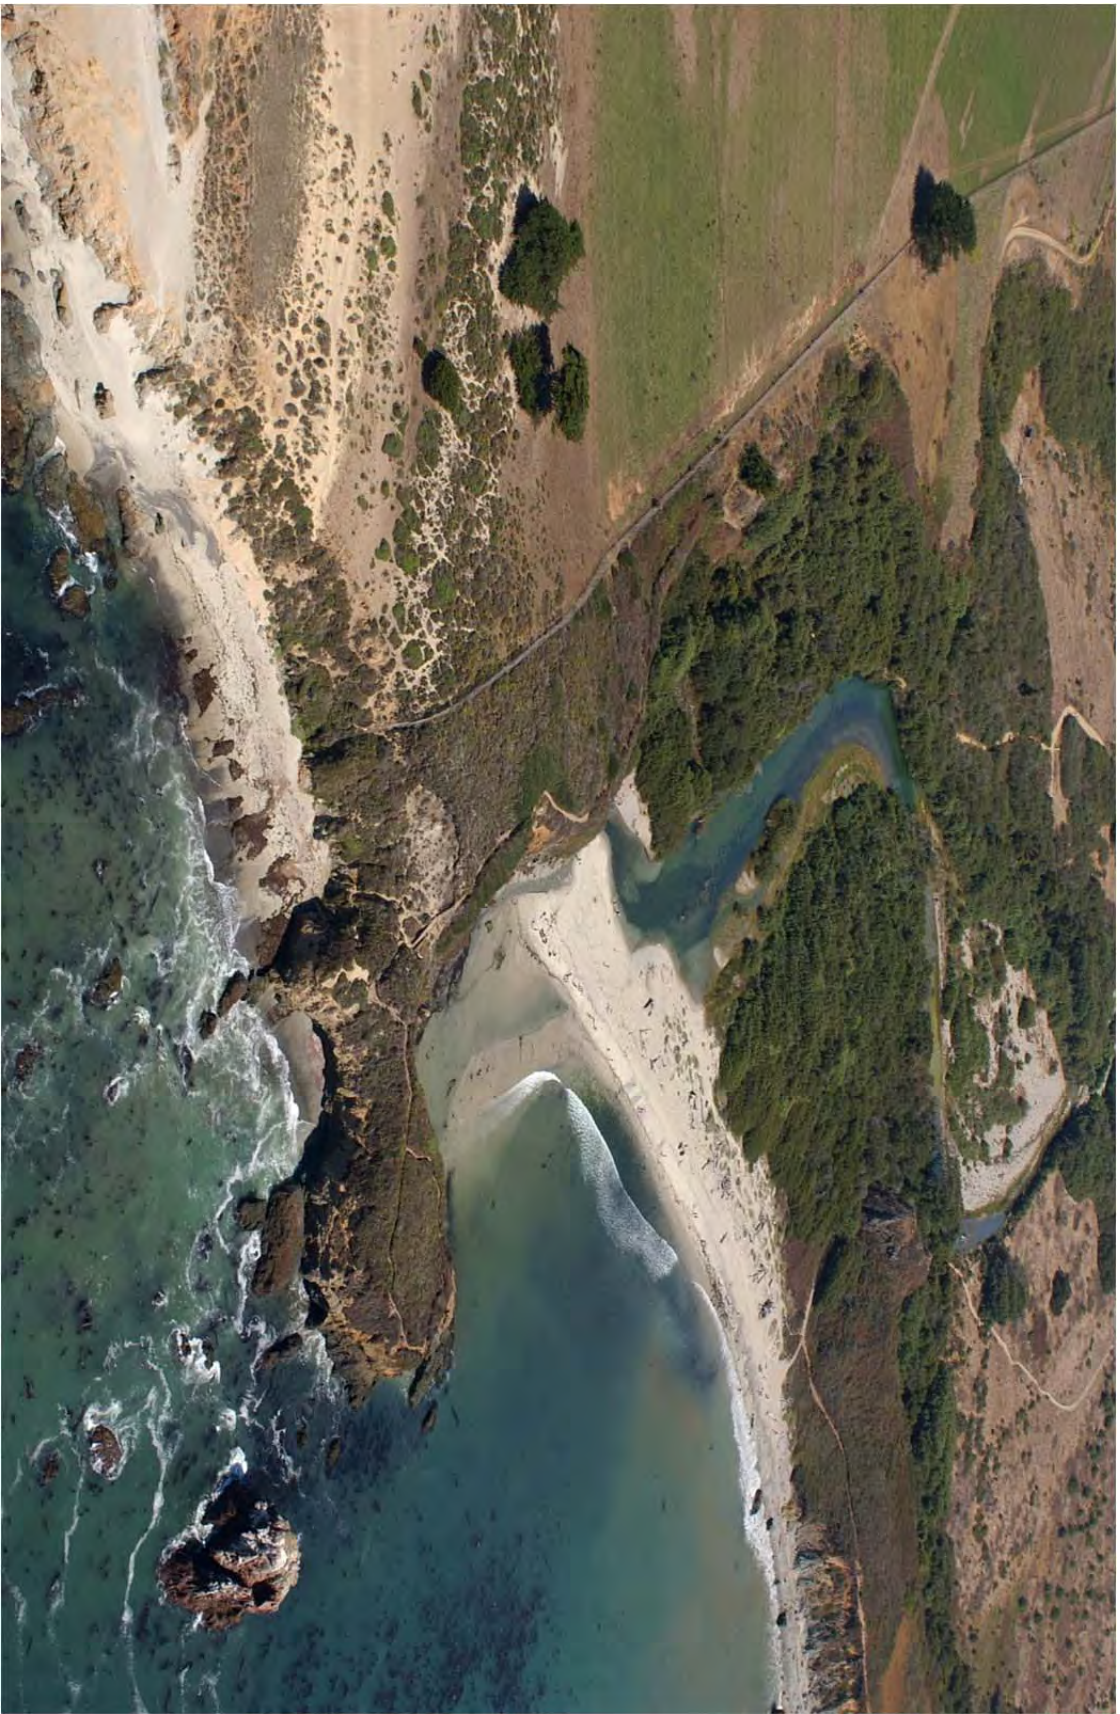
Photo 9: Big Sur Lagoon and River mouth, September 2, 2002 @ 10:24 hours. Source: Copyright (C) 2002-2011 Kenneth & Gabrielle Adelman, California Coastal Records Project, www.Californiacoastline.org

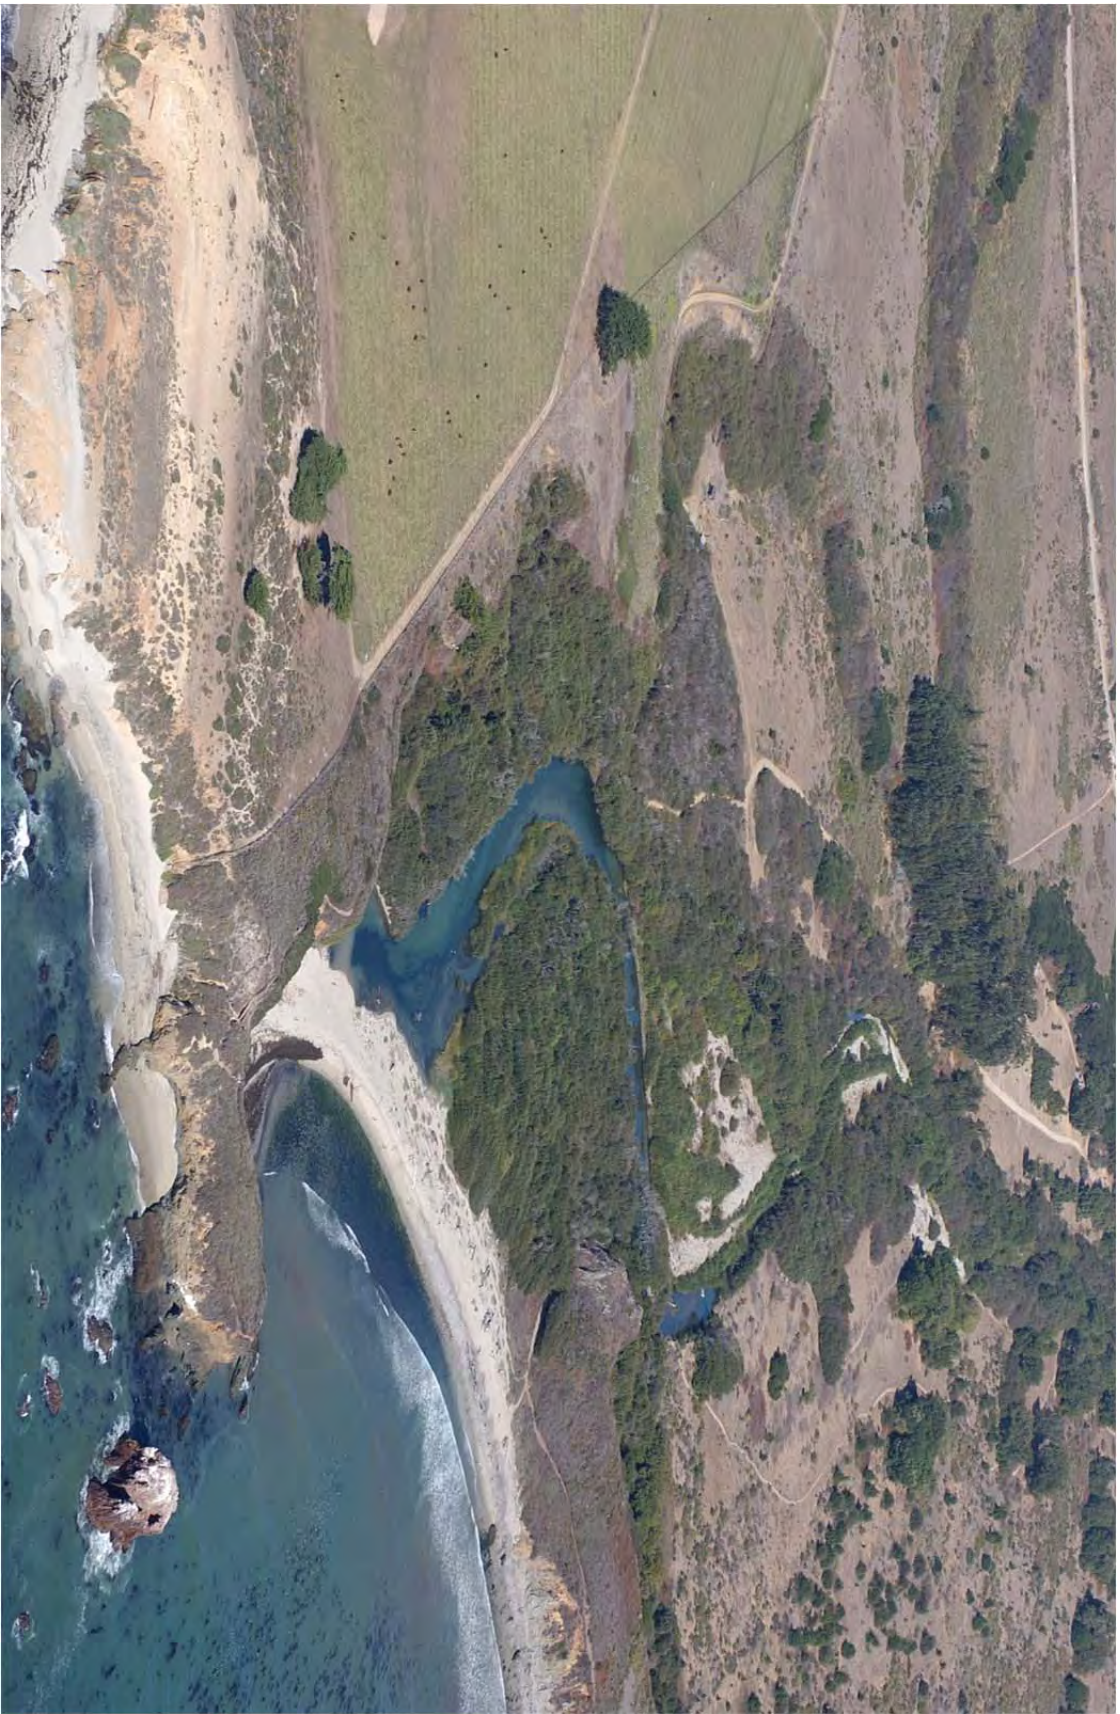
The lagoon was open in all of the photos except October 2004. Review of the daily discharge records at USGS Gage 11143000 showed that lagoon outlet was usually open, when 7-day long discharge at the USGS gage was greater than 8 to 12 cfs, but on October 11, 2004, the mouth was closed when discharge at the gage ranged from 10-12 cfs. Based on this photographic interpretation, I estimate that flows ranging above ~10 to 15 cfs are needed to maintain an open channel outlet with consistent flow between the Lagoon and the Pacific Ocean.

Photo 10: Big Sur Lagoon and River mouth, October 11, 2004 @ 13:35 hours. Source: Copyright (C) 2002-2011 Kenneth & Gabrielle Adelman, California Coastal Records Project, www.Californiacoastline.org

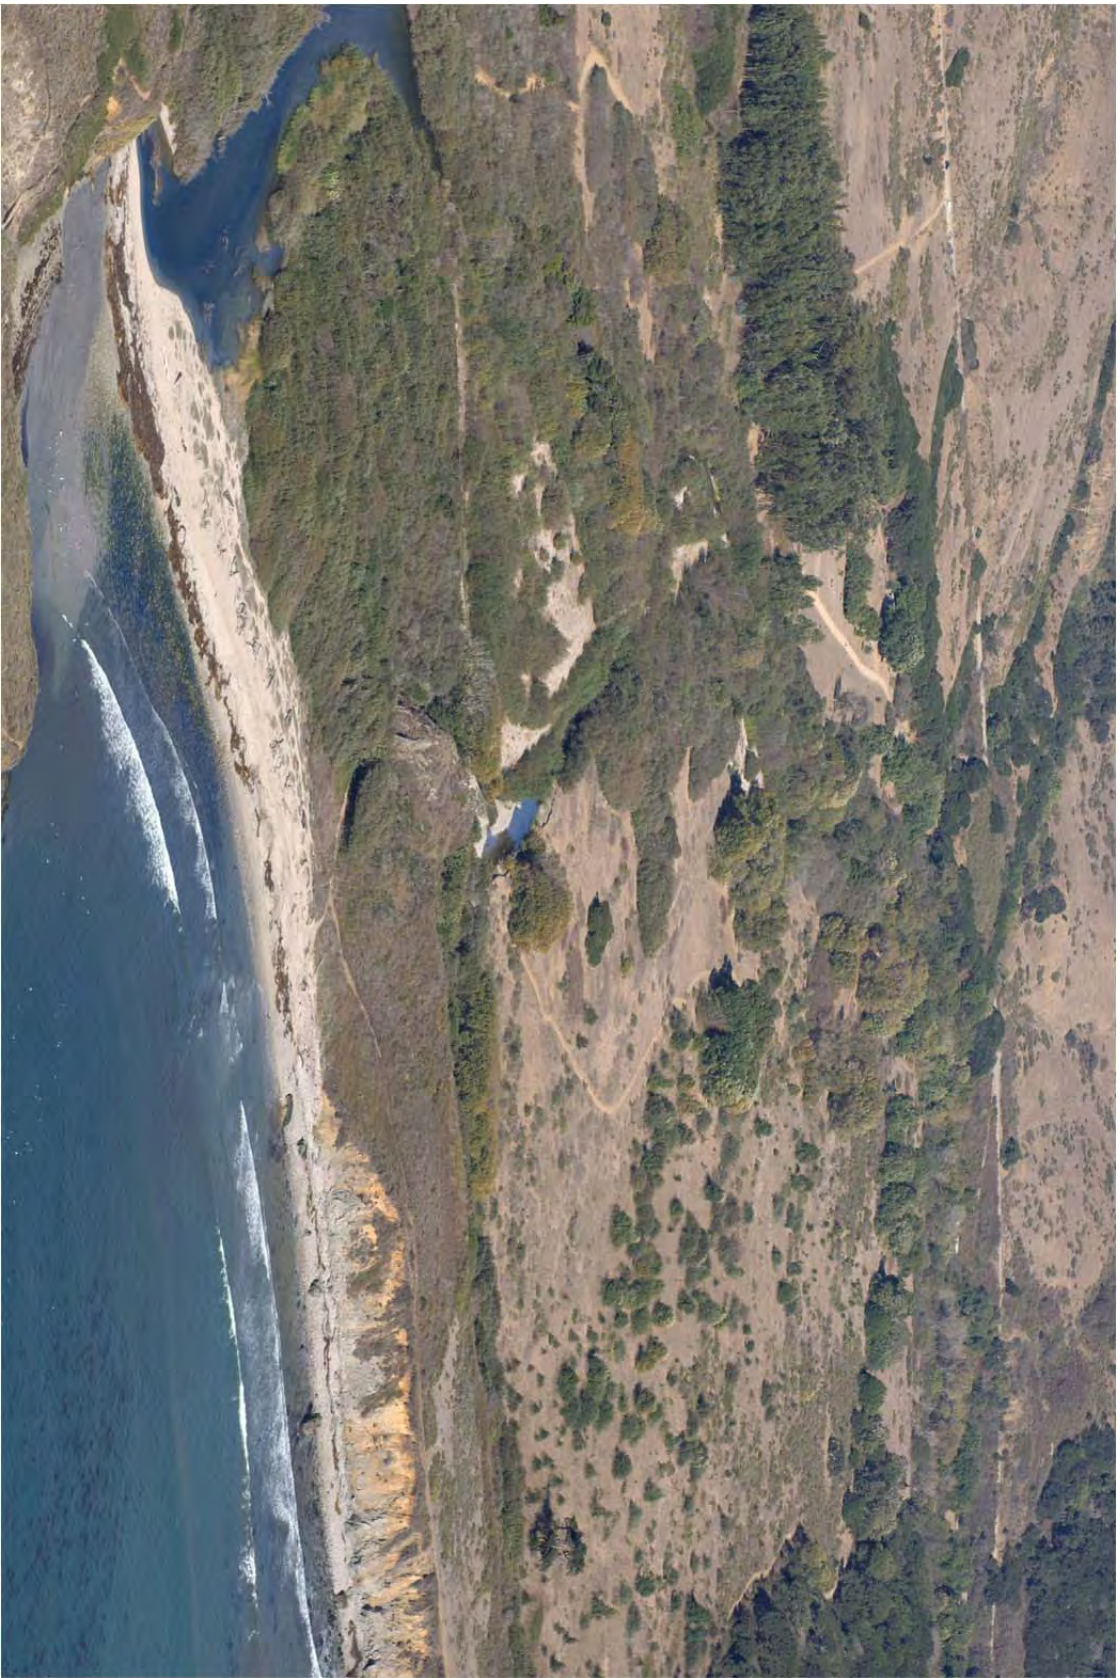
Photo 11: Big Sur Lagoon and River mouth, October 28, 2005 @ 13:56 hours. Source: Copyright (C) 2002-2011 Kenneth & Gabrielle Adelman, California Coastal Records Project, www.Californiaoastline.org

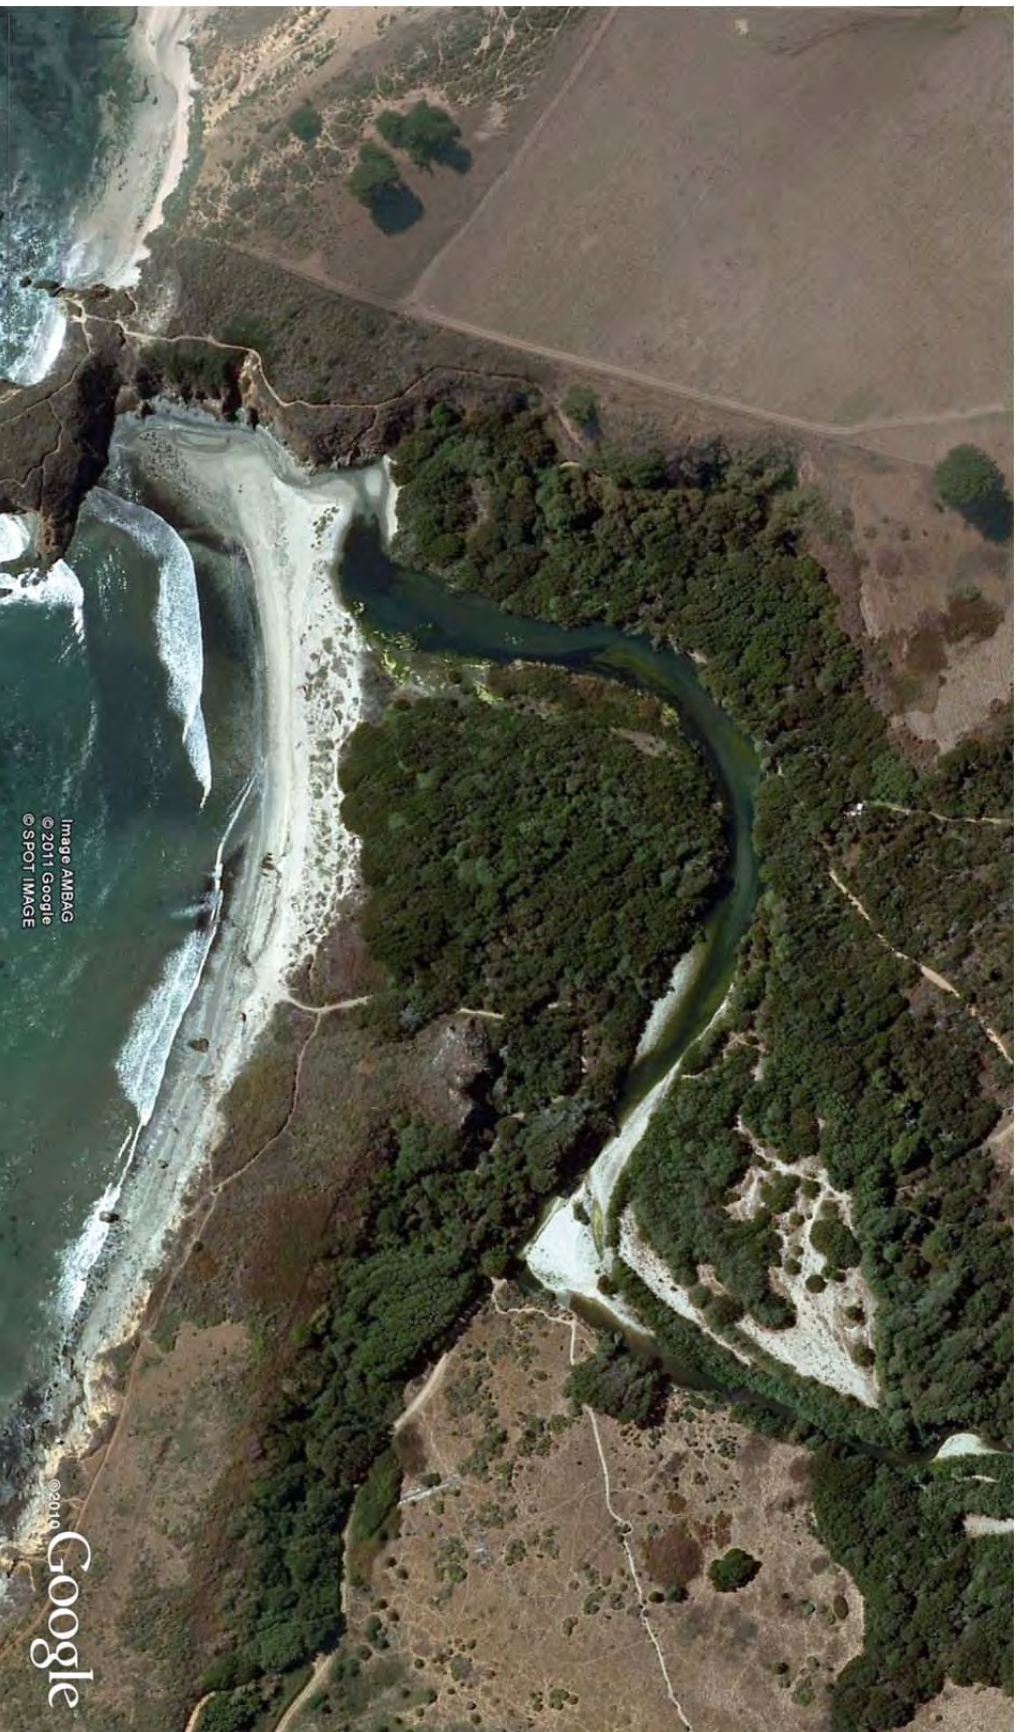
Photo 12: Big Sur Lagoon and River mouth, July 27, 2007. Source: Google EarthPro Imagery, © 2011 Google
