OPENING AND CLOSING STATUS OF THE BIG SUR RIVER MOUTH, MONTEREY COUNTY, CA

Based on Photographic Interpretation during Selected Years, 1972-2010

David H. Dettman

Prepared for the Center for Biological Diversity, San Francisco, CA

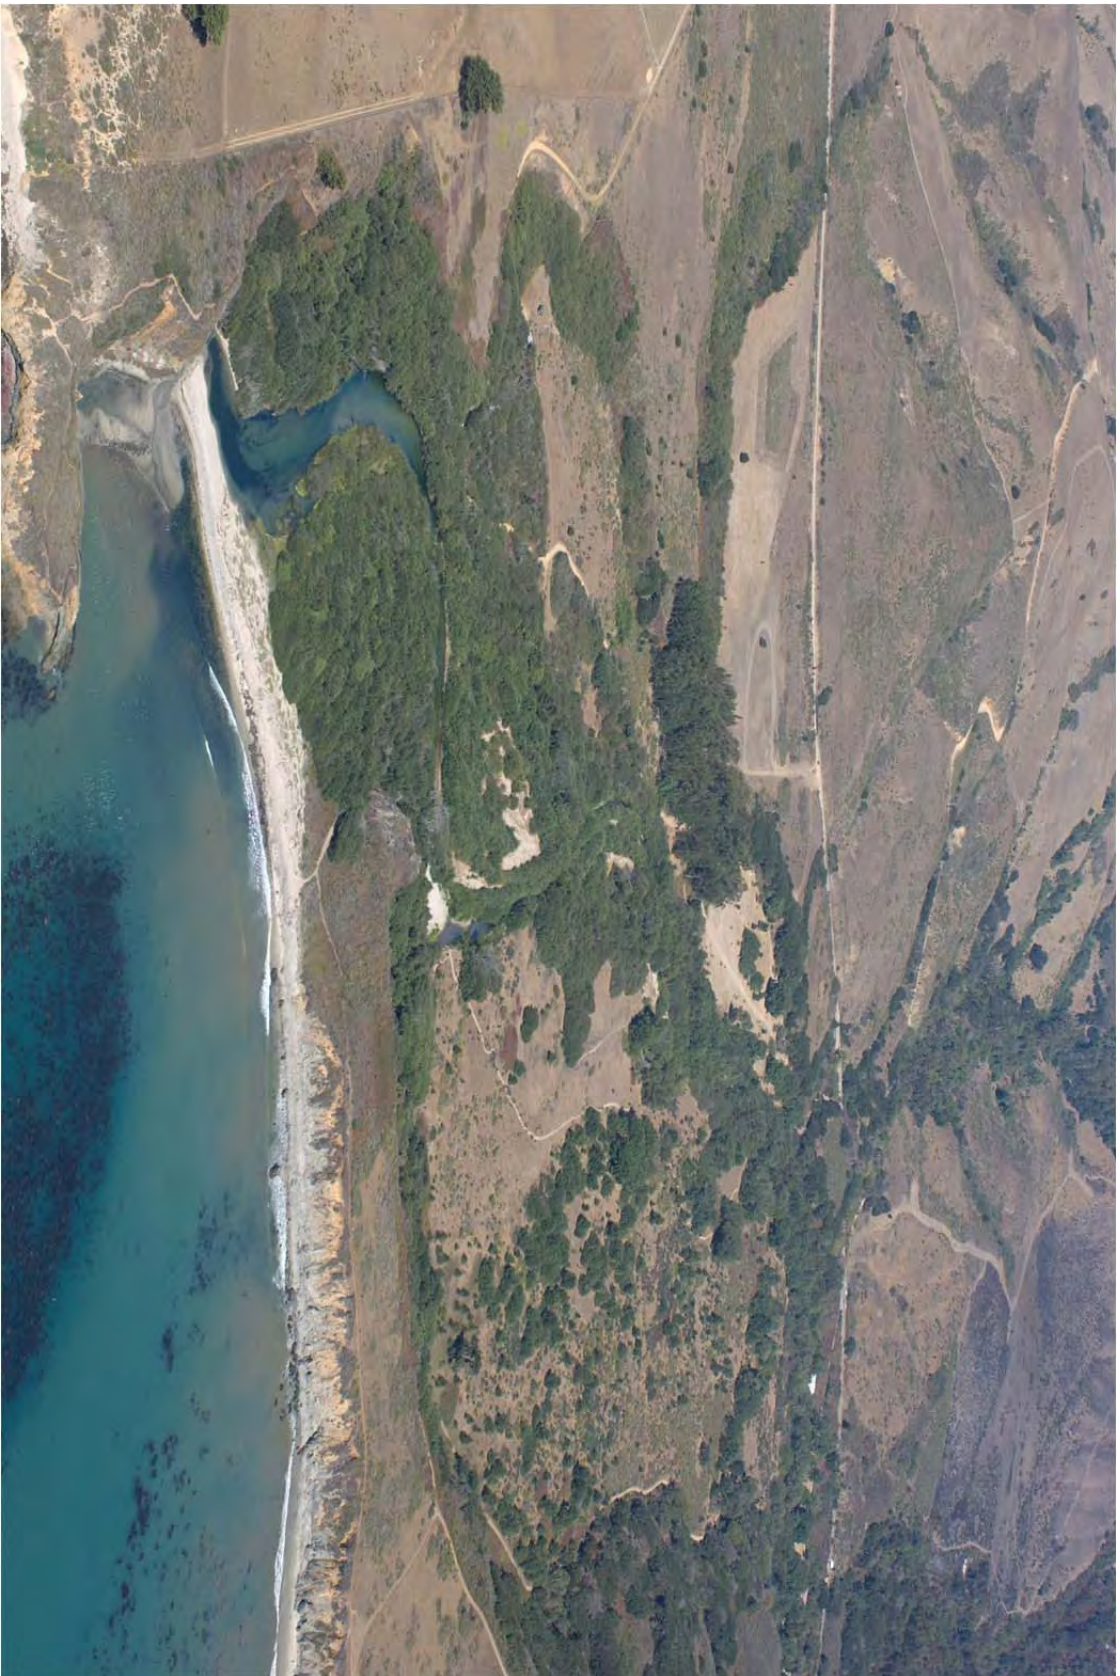
Photo 13: Big Sur Lagoon and River mouth, September 23, 2008 @ 13:42 hours. Source: Copyright (C) 2002-2011 Kenneth & Gabrielle Adelman, California Coastal Records Project, www.Californiacoastline.org

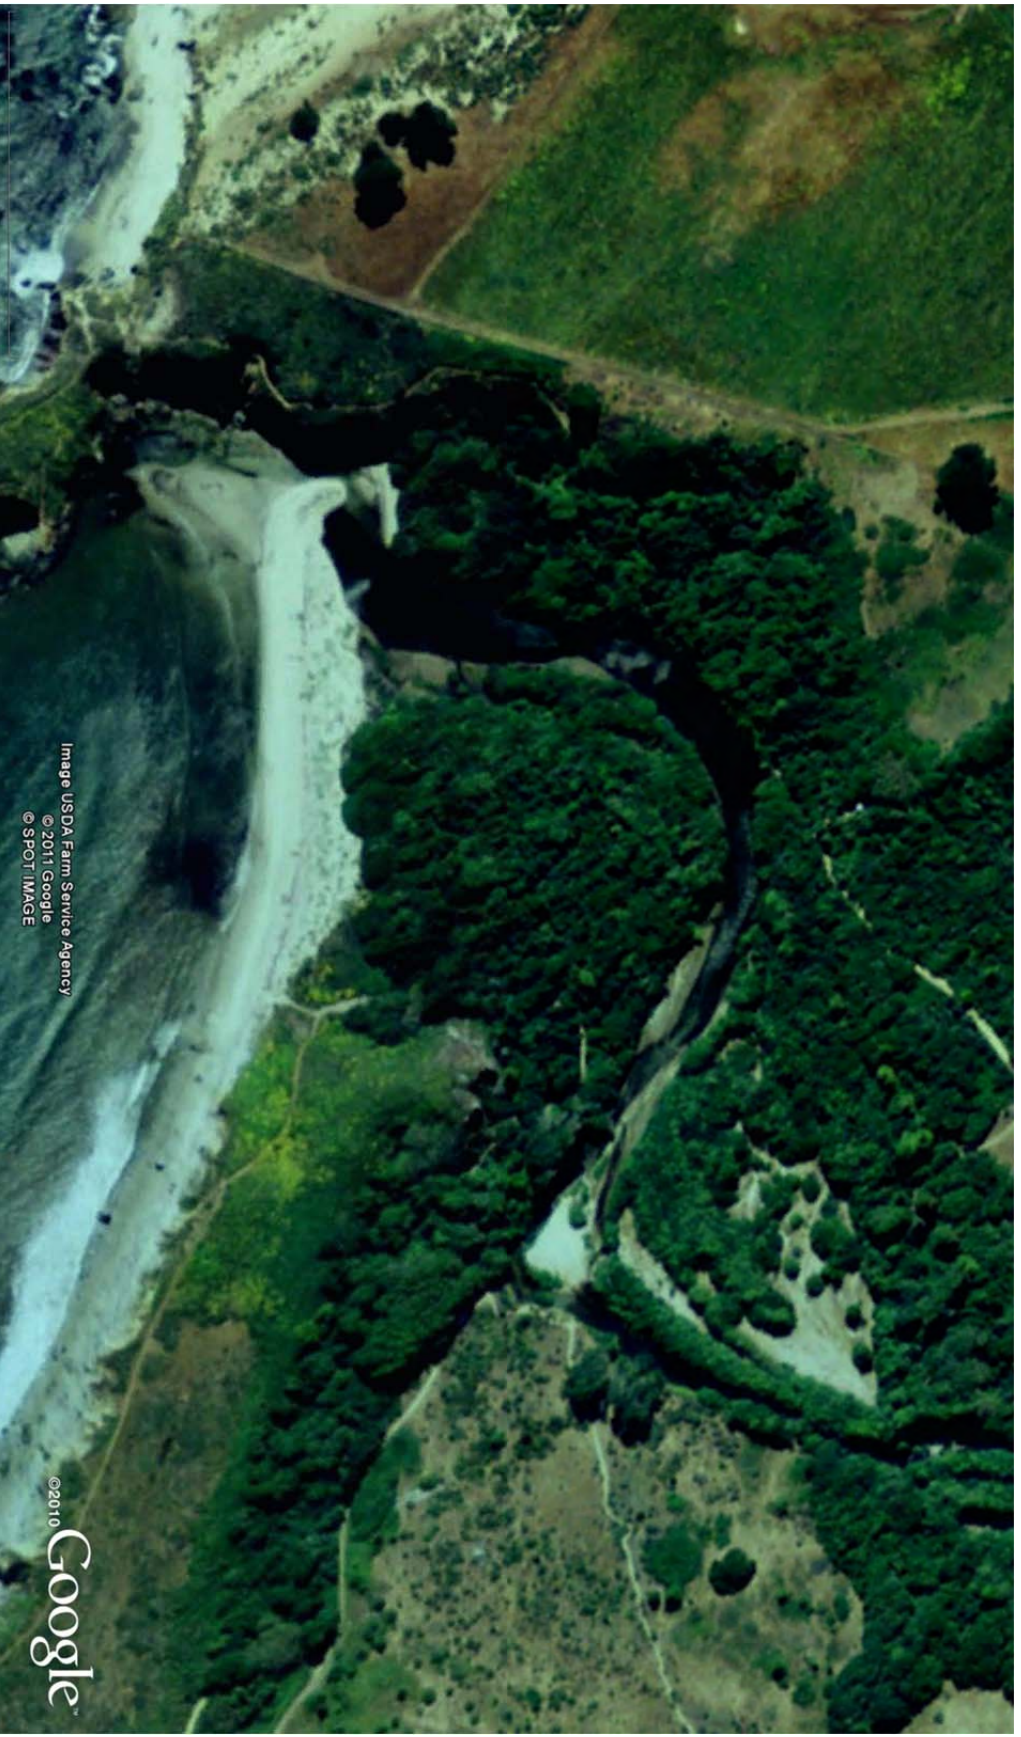
Photo 14: Big Sur Lagoon and River mouth, May 24, 2009. Source: Google EarthPro Imagery, © 2011 Google

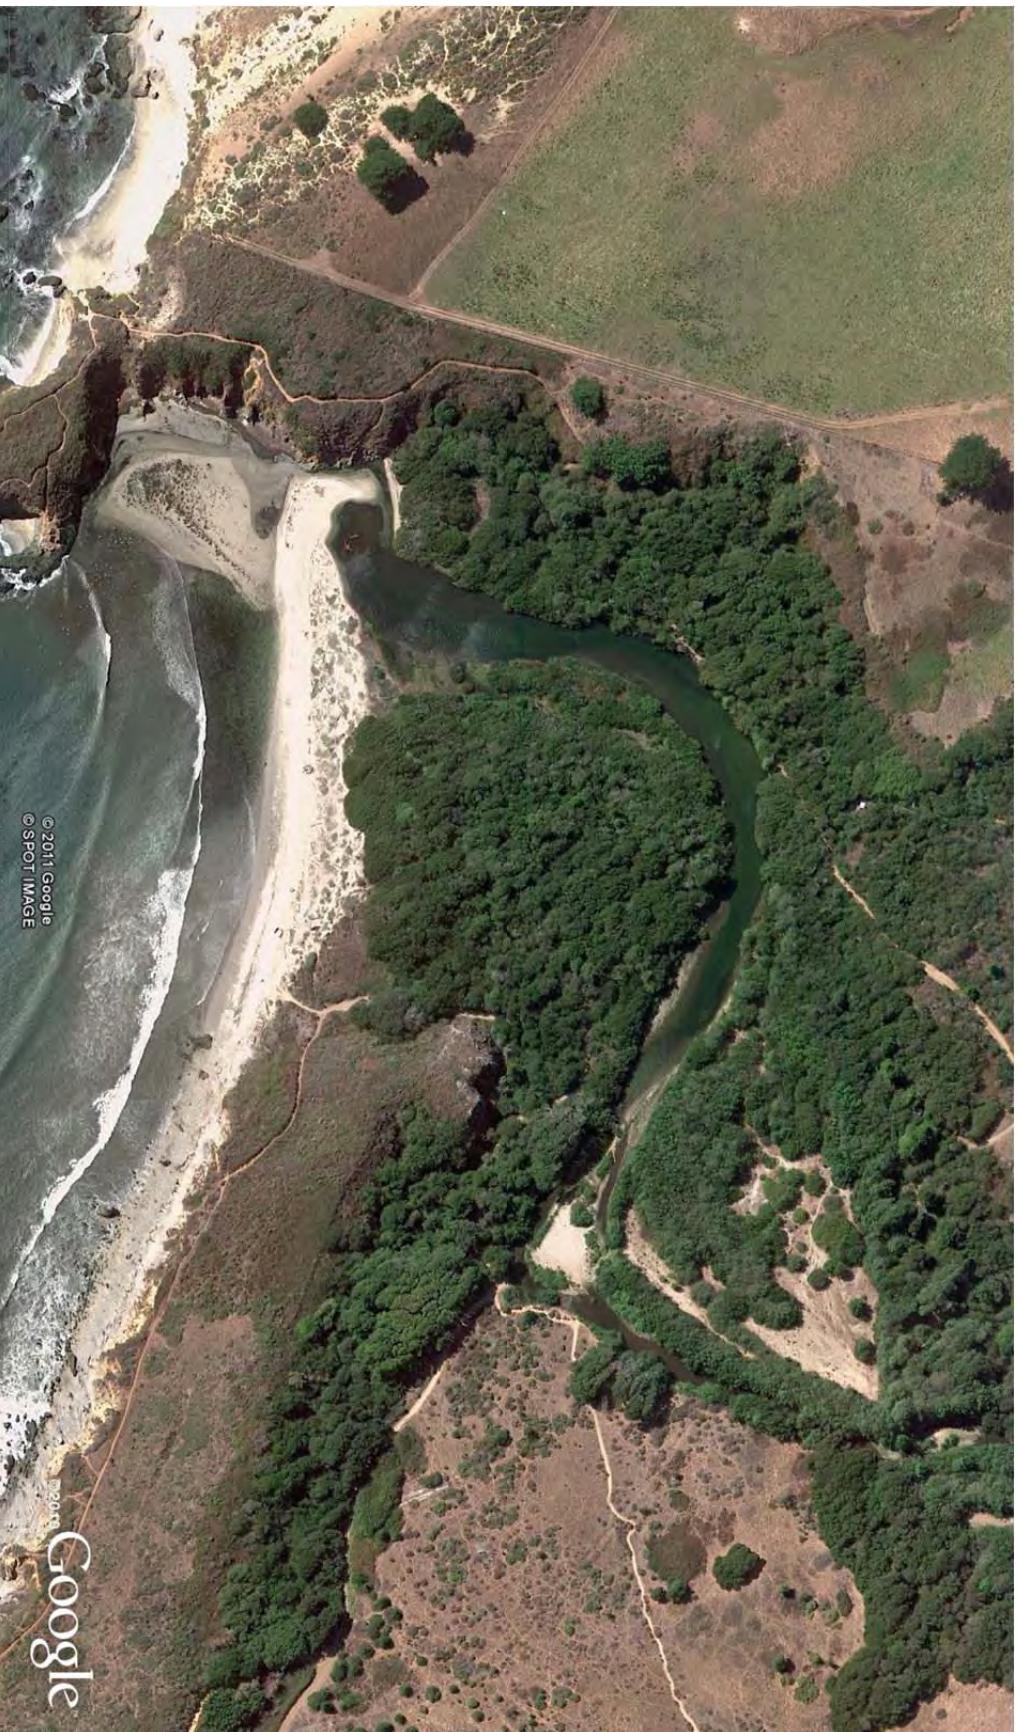
Photo 15: Big Sur Lagoon and River mouth, September 29, 2009. Source: Google EarthPro Imagery, © 2011 Google

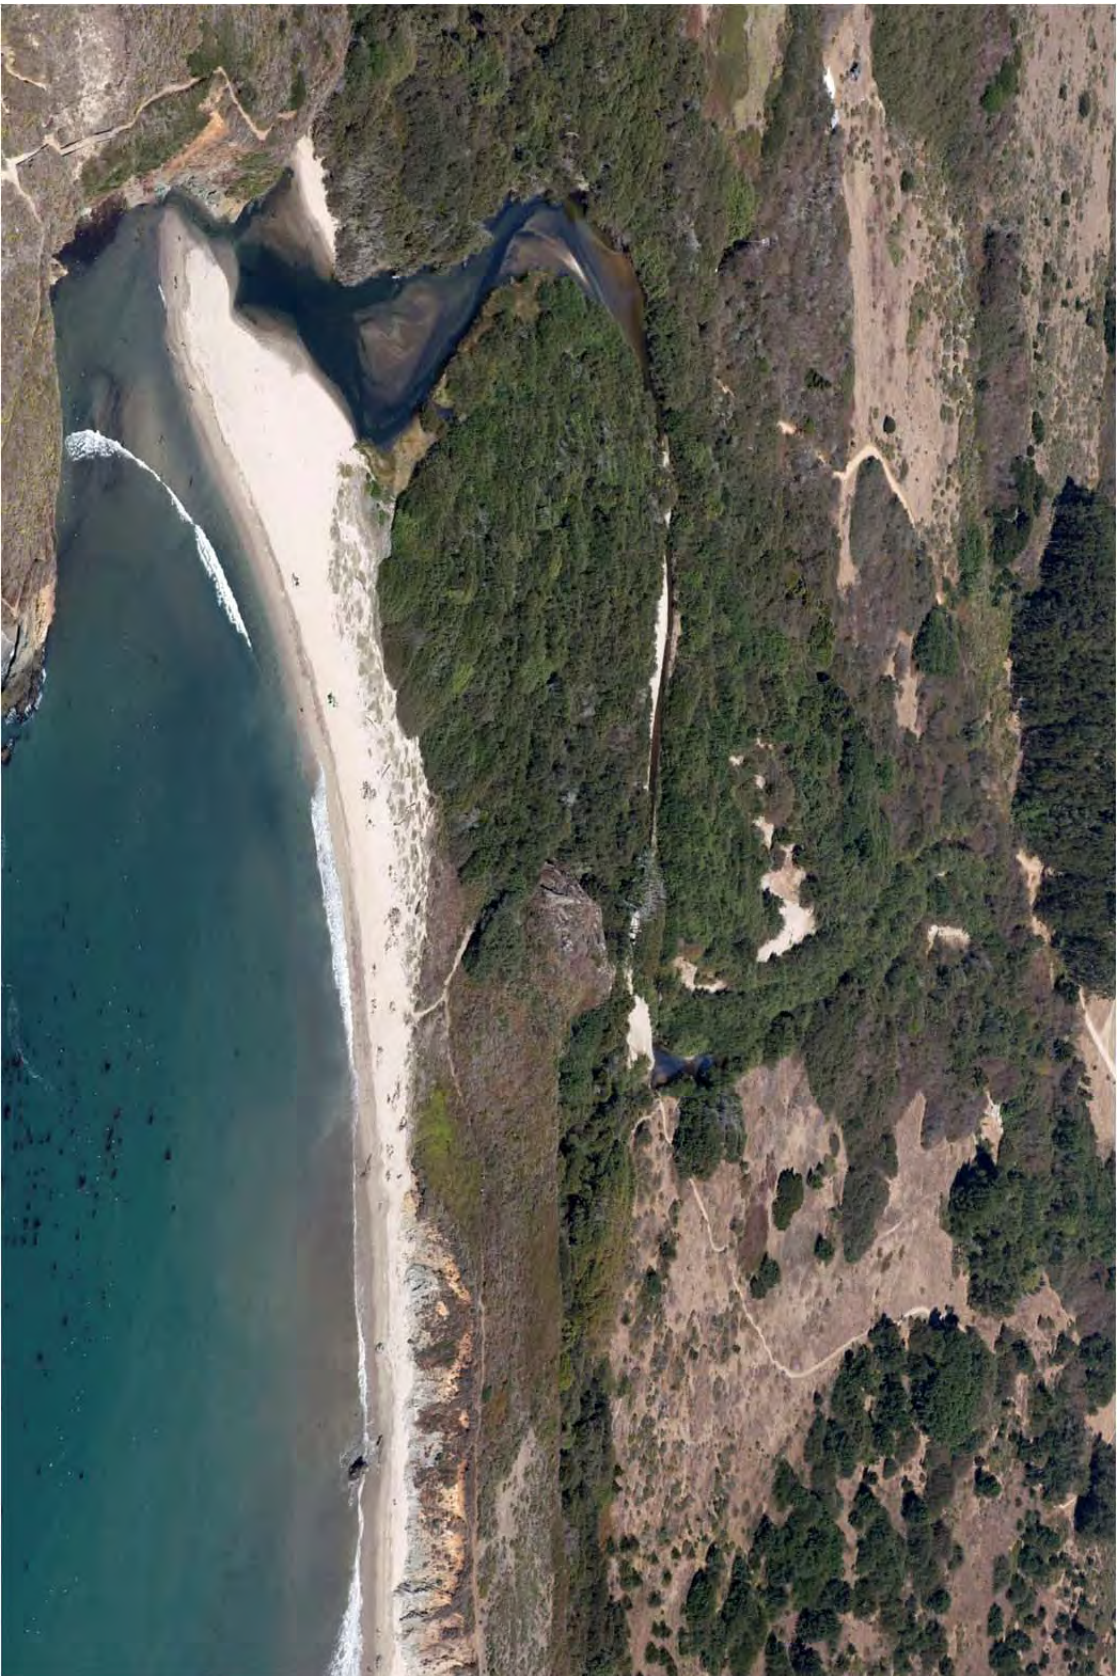
Photo 16: Big Sur Lagoon and River mouth, September 24, 2010 @ 13:07 hours. Source: Copyright (C) 2002-2011 Kenneth & Gabrielle Adelman, California Coastal Records Project, www.Californiacoastline.org
