Re: October 1, 2016 Progress Report for Marble Mountain Ranch required under
Cleanup and Abatement Order R1-2016-0031 and Draft Order WR 2017-00XX-
DWR, issued on August 30, 2016

Marble Mountain Ranch Quarterly Progress Report
September 30, 2016
Page 5 of 5

TECHNICAL MEMORANDUM**Sediment Delivery Potential from Failures on the Stanshaw Creek Diversion Ditch**

WATER QUALITY SAMPLING PLAN
Marble Mountain Ranch

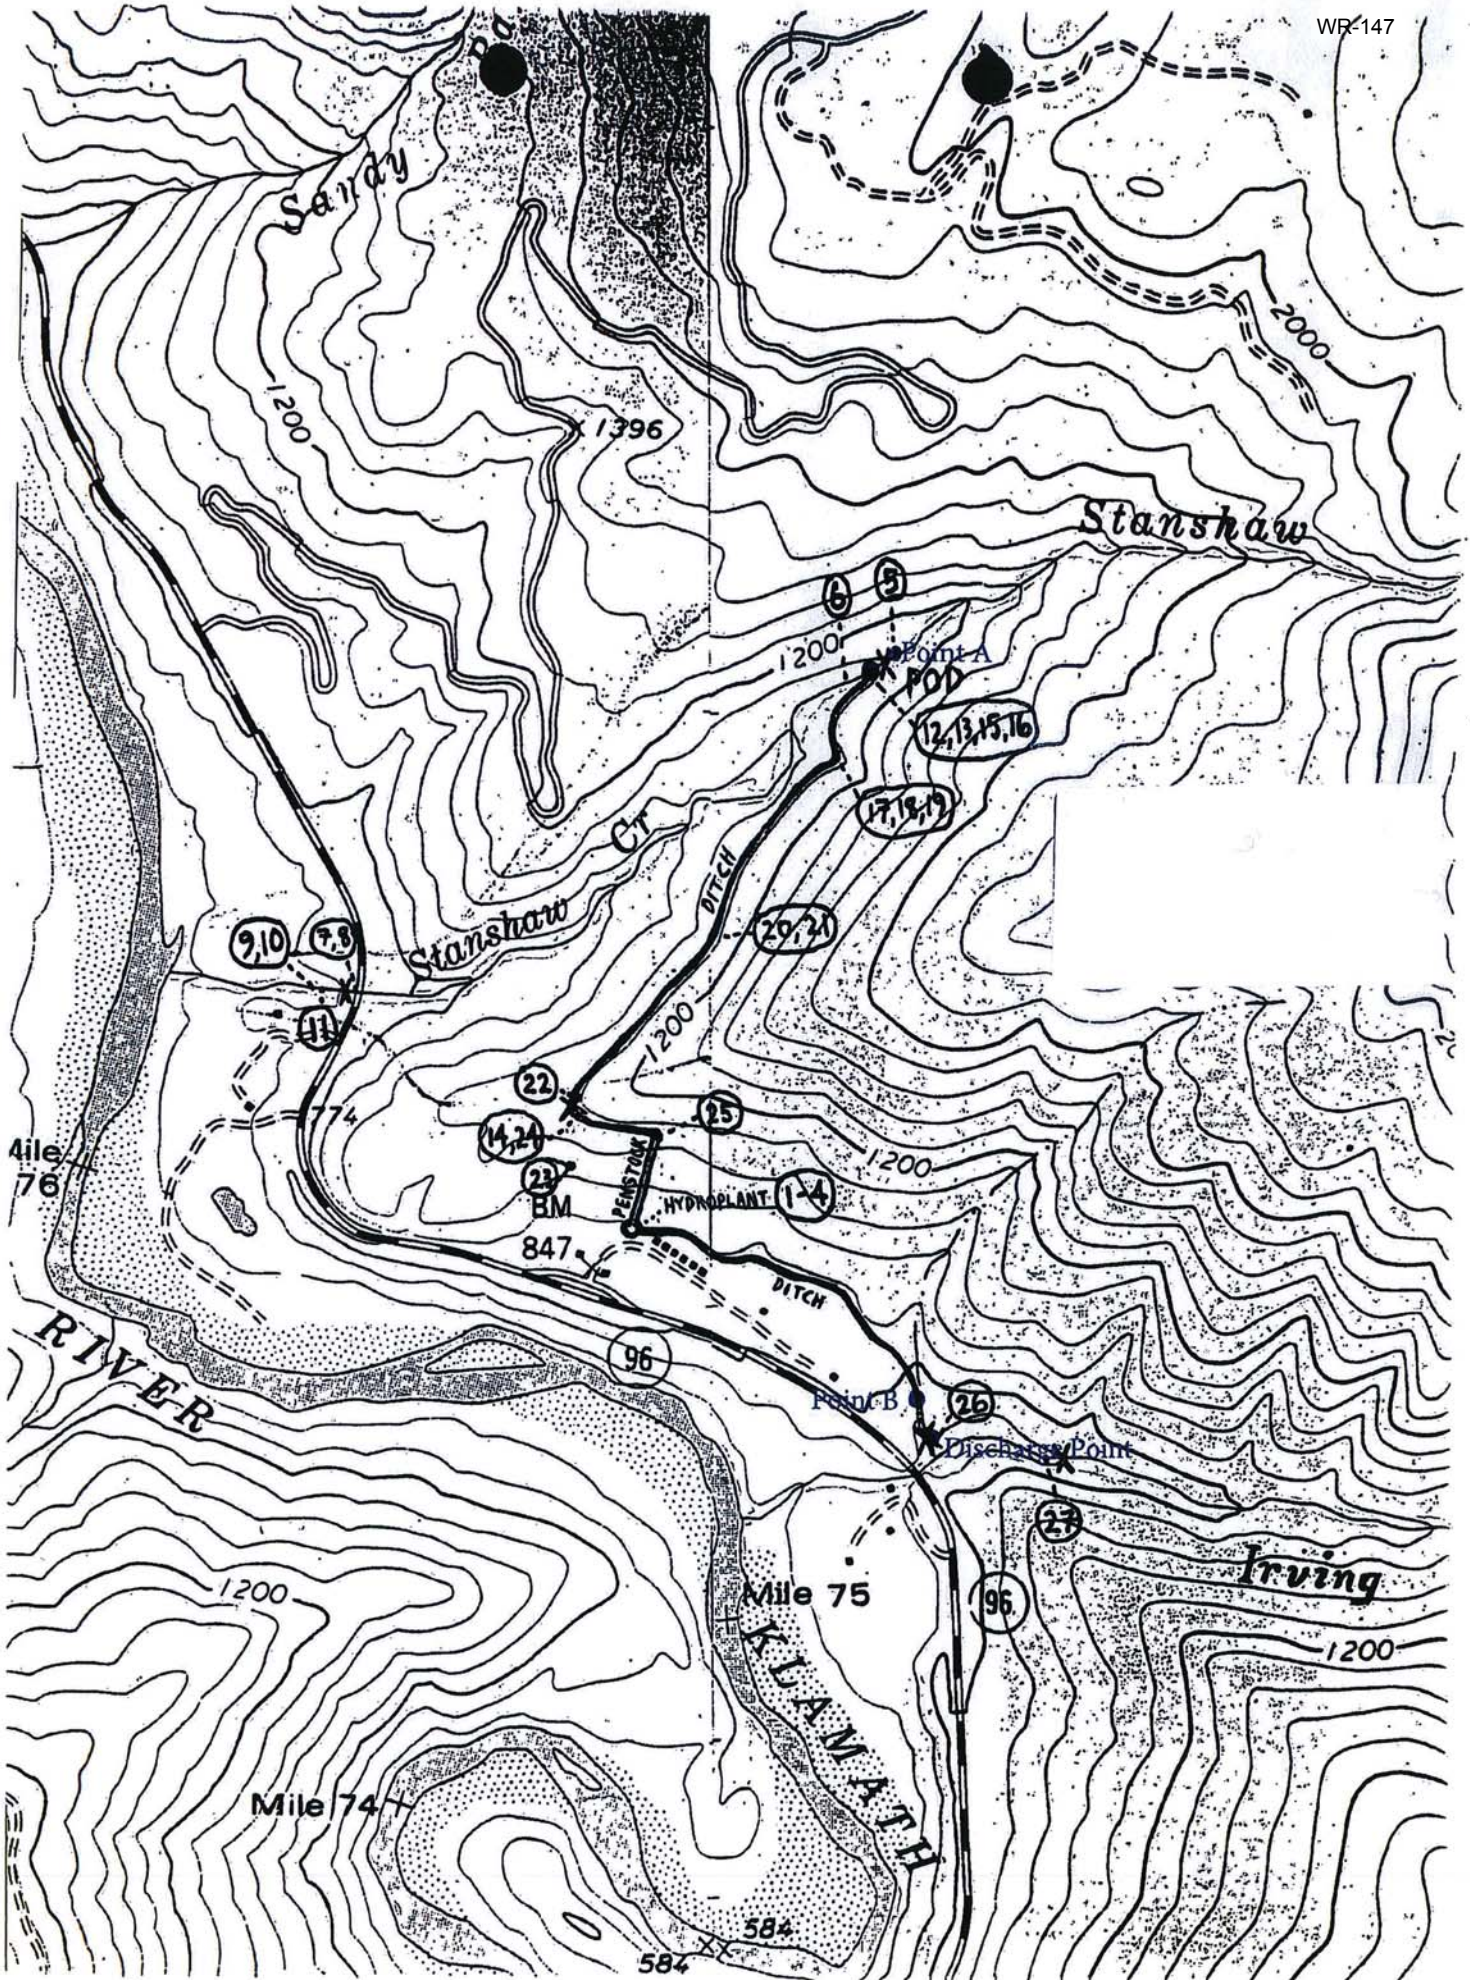
Appendix A. Map of discharge locations, sampling site locations, and adjacent receiving water

Marble Mountain Ranch has a single discharge point. That discharge point is only active when water is being diverted and used for hydroelectric power generation. Discharge is made to an unnamed tributary of Irving Creek. The map attached in Appendix A identifies the discharge point from Marble Mountain Ranch to the unnamed tributary to Irving Creek as "Discharge Point".

In addition to the single discharge point, the map attached in Appendix A also shows all monitoring points that will be used under this Plan. The first monitoring point is located just above the point of diversion in Stanshaw Creek and labeled on the map in Appendix A as "Point A". The second monitoring point is located near the discharge point to the unnamed tributary to Irving Creek. The second monitoring point is labeled on the map in Appendix A as "Point B".
