North Coast Regional Water Quality Control Board

Subject: **Notice of Violation No. 2 and Response to August 26, 2016 Letter Regarding 13267/Cleanup and Abatement Order No. R1-2016-0031 (CAO) Requirements**

File: Douglas and Heidi Cole, Marble Mountain Ranch, 92520 Highway 96, Somes Bar; Siskiyou County APN 026-290-200, Klamath River Watershed, WDID No. 1A15024NSI

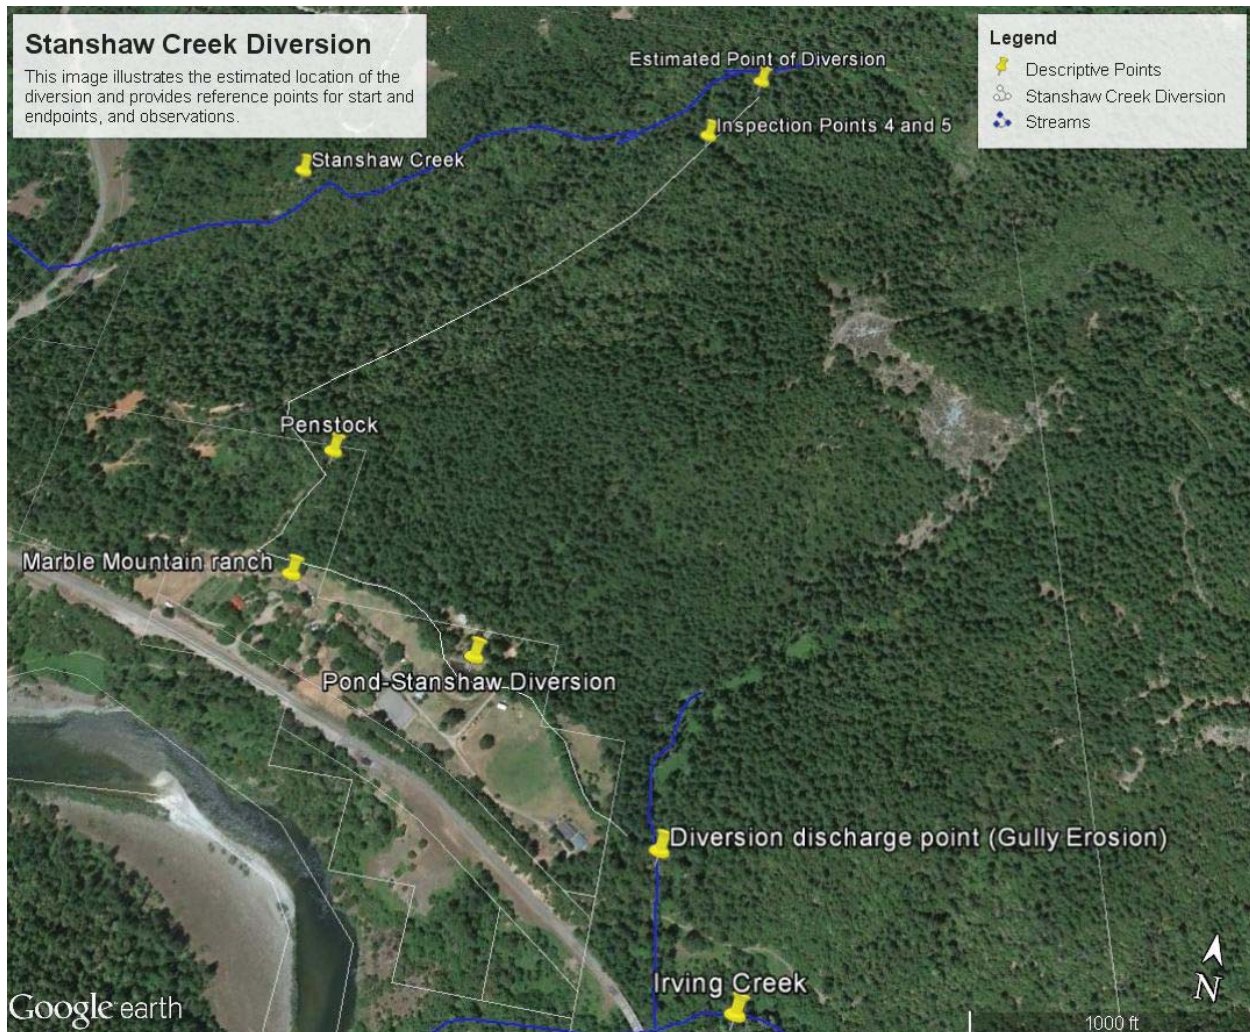
Image 1- shows an overview of the Stanshaw Diversion route and Marble Mountain Ranch. The locations identified are estimated based upon visual observation of the area during the inspection and through subsequent comparison with existing 6/6/2013 Google Earth Pro imagery, Arcview GIS topographic maps, and historic maps of the diversion.

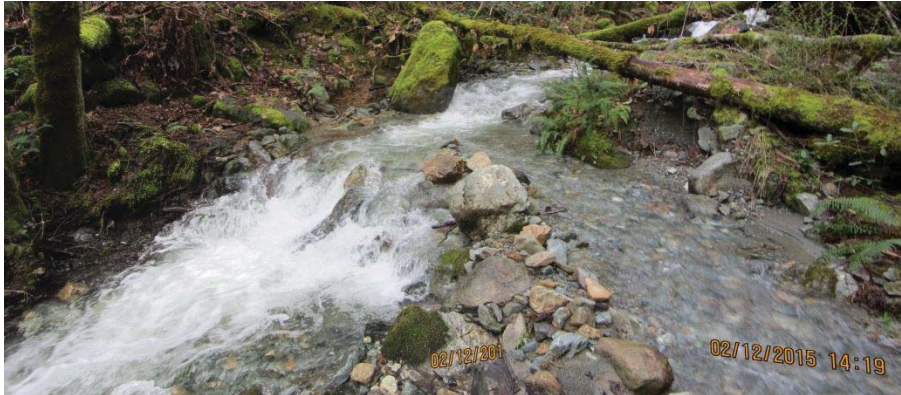
Image 3- shows Point 1, the Point of Diversion. The Stanshaw Diversion flows toward the lower right corner of this image. It appears the rock and cobble diversion structure fails episodically and likely requires periodic modification as Stanshaw Creek's flows change, in order to maintain a diverted flow. (Photos 8459, 8460 and 8461 stitched)

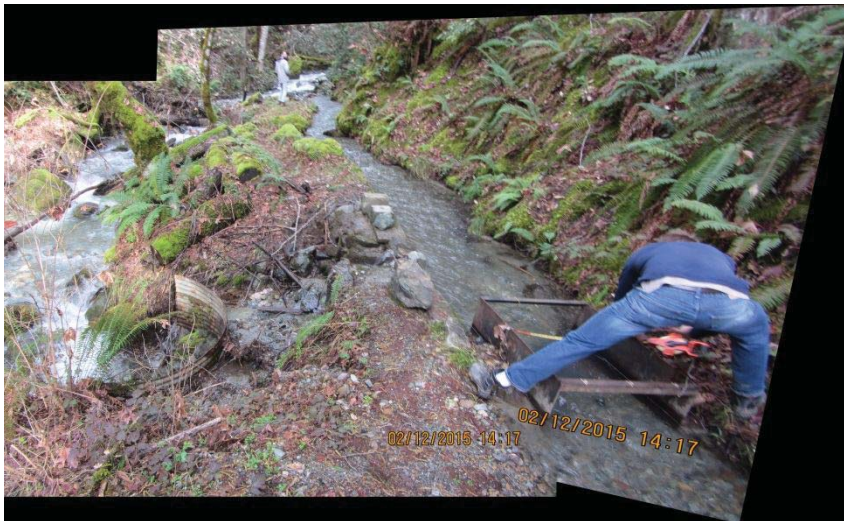
Image 4- shows Point 2, a failure along the outboard berm, approximately 70 feet downstream of Point 1, allowing some of the water in the ditch to flow down to Stanshaw Creek, potentially resulting in erosion and sediment transport. This location appears to have failed repeatedly in the past. The instream flume in the Ditch just downstream of this failure is used to measure flows entering the diversion. (Photo 8454 and 8455)

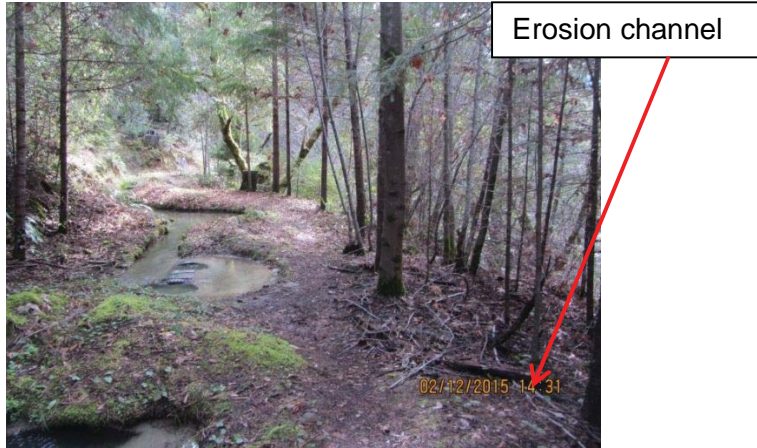
Image 5- shows Point 3, a tank or railroad tank car buried in the ditch channel, likely intended to trap sediment. The tank car is full of sediment. Water flowing in the ditch appears to have overtopped the outboard berm at this location and caused some erosion on the slopes below. (Photo 8467)

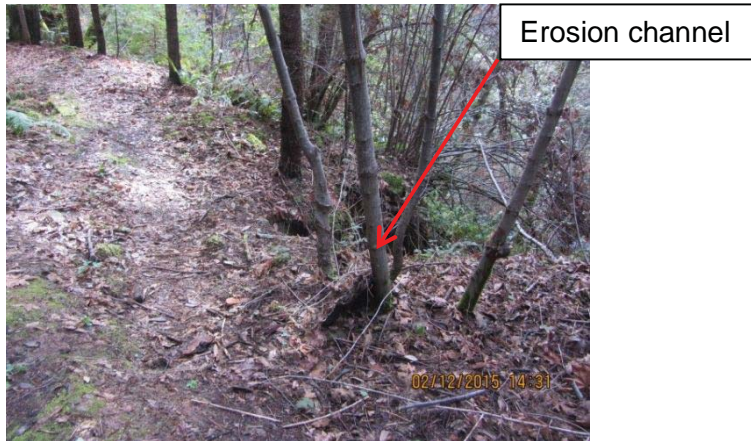
Image 6- shows the erosion channel downslope of Point 3.

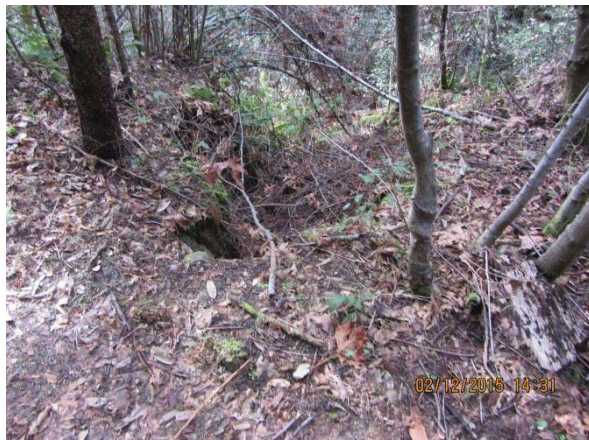
Image 7- shows the erosion channel downslope of Point 3. The void is visible here in the foreground; the erosion extends downslope an unknown distance.

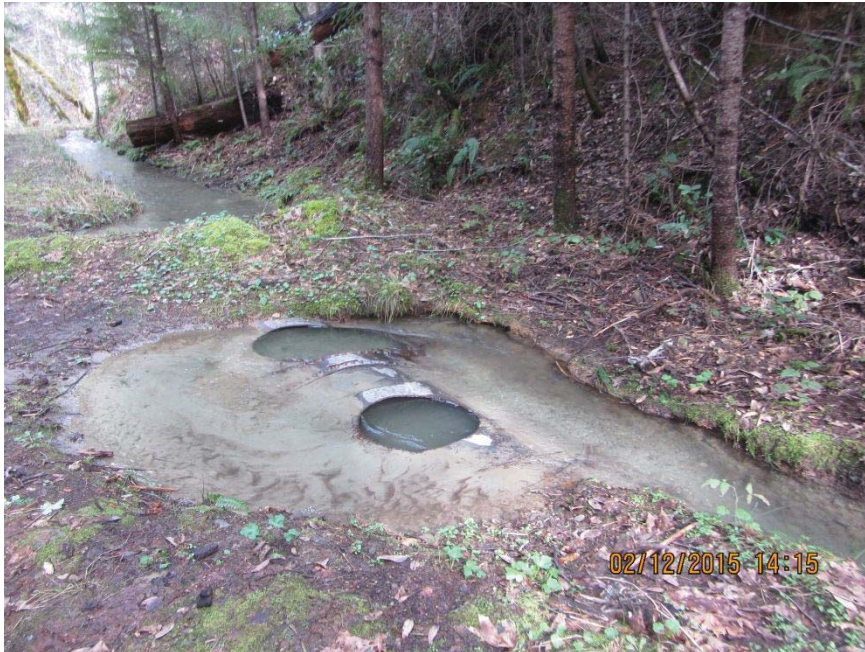
Image 8- at Point 3, shows a closer view of the buried tank car with stored sediments visible. (Photo 8450)

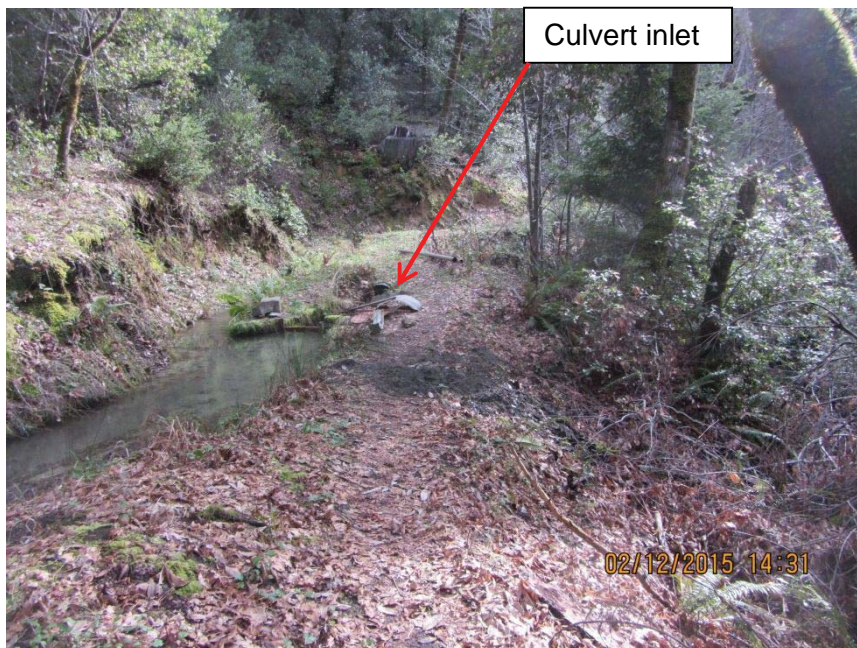
Image 9- at Point 4, shows the partial diversion of the ditch into an unnamed tributary to Stanshaw Creek through the inlet of a 12-inch culvert, before the diversion ditch is routed across the stream in a lined ditch. The culvert is shotgunned, which appears to have caused significant instream erosion in the downslope channel. The stream above the crossing is 3-4 feet wide at bankfull width; the eroded stream channel below the diversion crossing is 12-14 feet wide, and does not appear stable. At this location, I also observed muddy soils in the berm adjacent to the ditch, indicating that seepage from the ditch is saturating surrounding soils, which may lead to catastrophic failure of the ditch. (Photo 8441)

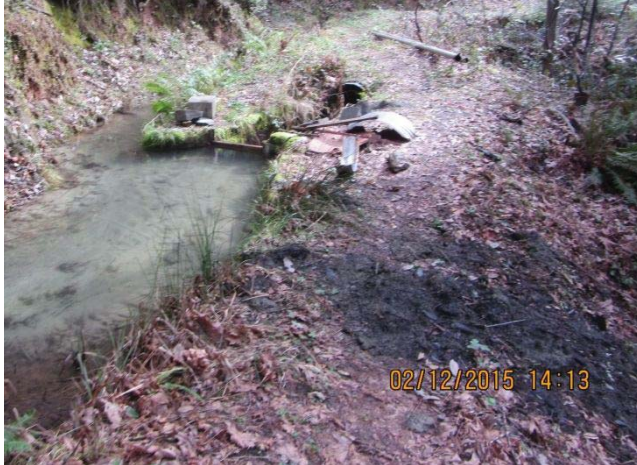
Image 10- at Point 4, shows a closer look at the seepage in the berm; note the muddy soils in the foreground. (Photo 8441 cropped)

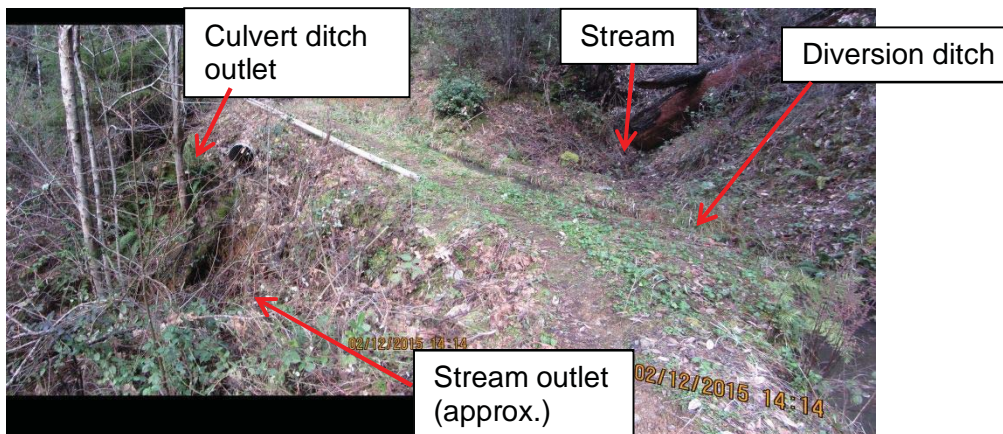
Image 9- at Point 5, shows the shotgunned 12-inch ditch culvert outlet, diversion ditch and native stream channel flowing under the diversion ditch. (Photos 8442, 8443, 8444, 8445 composite)

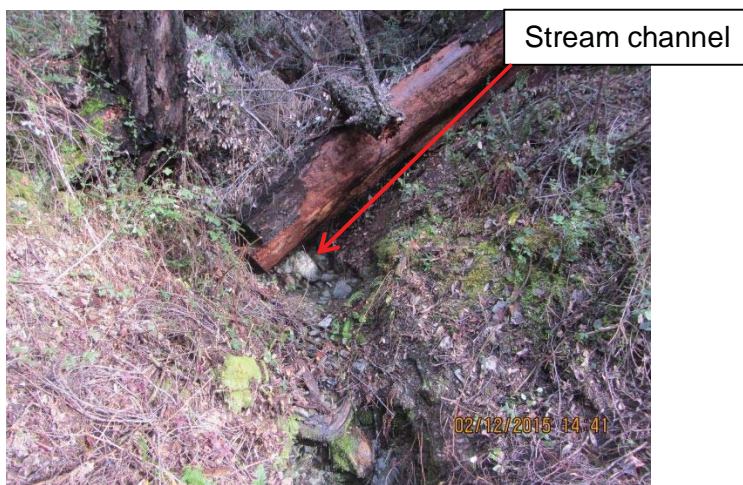
Image 10- shows the unnamed stream channel above Points 4 and 5; the upslope active bankfull stream channel width is approximately 3-4 feet.

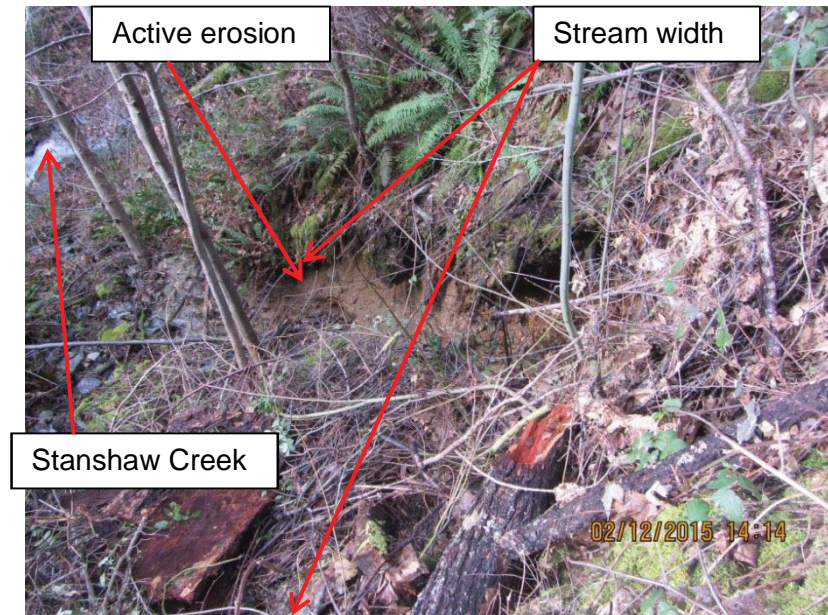
Image 11- shows the unnamed stream channel downstream of Point 5, and the erosion caused by water draining from the shotgunned culvert. Stanshaw Creek can be seen a short distance downslope. I conservatively estimate that this site has delivered 150-300yds³ of sediment and debris to Stanshaw Creek over the life of the Diversion. (Photo 8478)

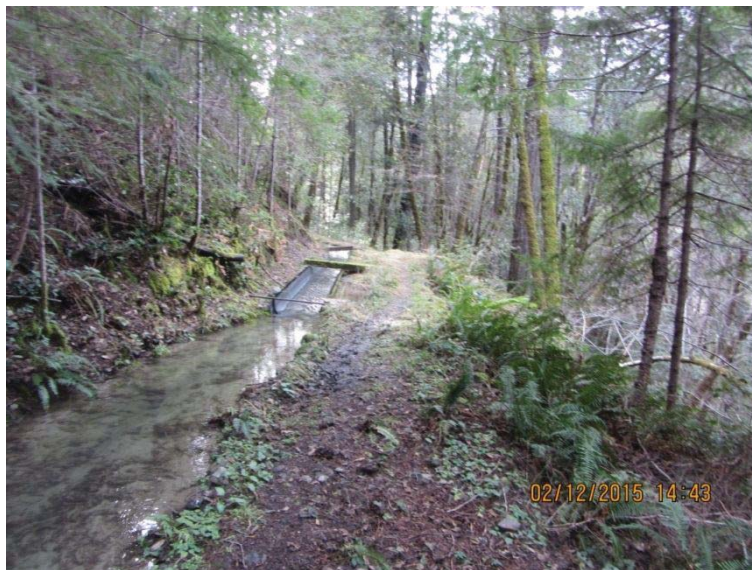
Image 12- shows Point 6, where the diversion channel is full, leaving no freeboard should it rain or the ditch receive a bank slump upstream. It appears the outboard berm may have failed in this area in the past, and at present is seeping, indicating that a portion of the berm may be saturated. Stanshaw Creek is within 200 feet; any failure here likely results in direct delivery of sediment and erosional debris. The flume section visible in the photo appears to have been installed to remedy previous ditch failures and/or to prevent future failures.

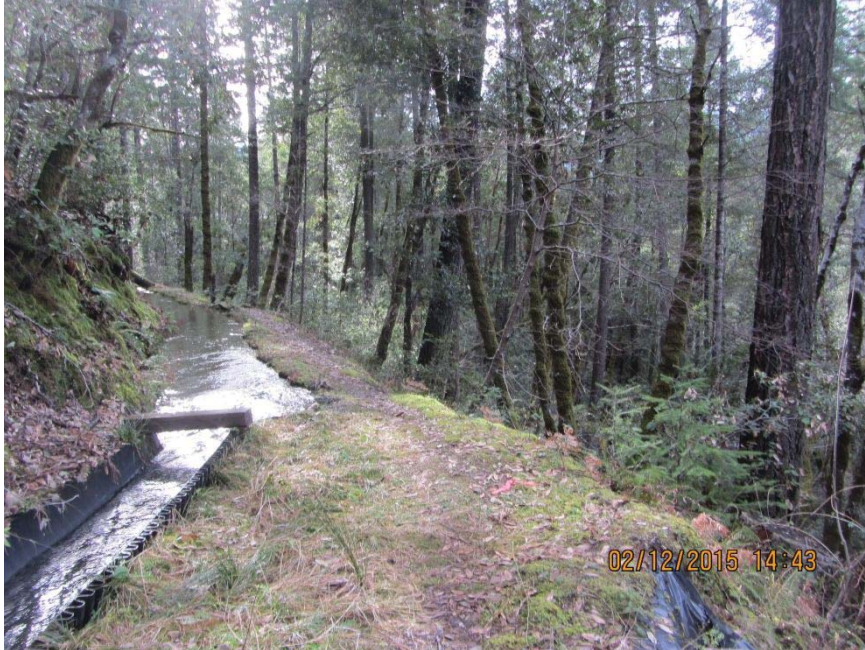
Image 13- point 7, shows the end of the flume in the previous photo; note the black plastic sheeting on the outboard slope face, and the low outboard berm as the diversion ditch exits the flume. The lack of freeboard creates a high potential for overtopping and erosion. The presence of the pipe section and plastic sheeting in the area suggests that the berm or underlying slope in this area has likely failed in the past. (Photo 8483)

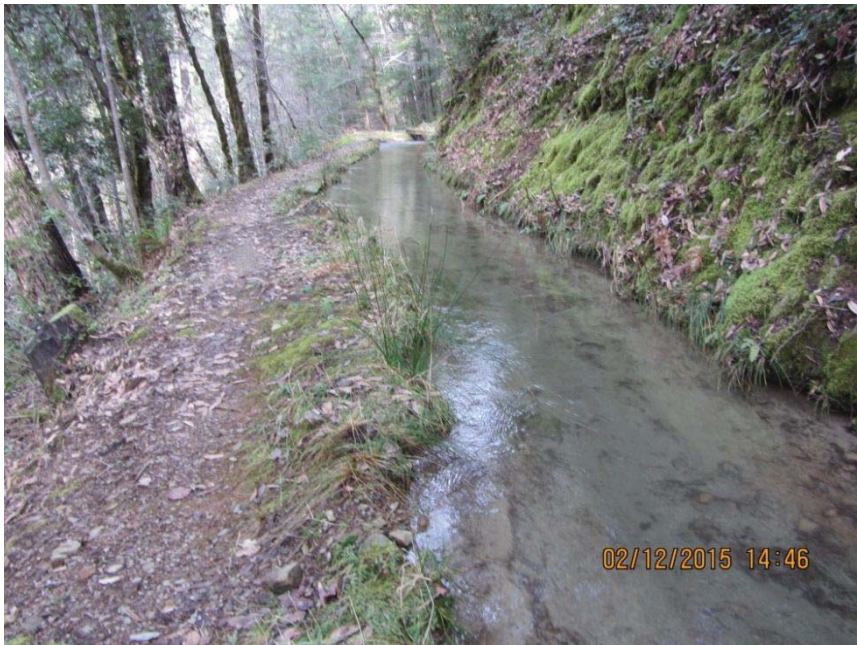
Image 14- shows point 8, an approximately 150-foot section of the channel downstream of Point 7, where the low berm and full ditch likely creates a high potential for berm or slope failure, erosion, and sediment transport downslope. I observed concrete blocks at various locations along the outboard edge of the berm throughout this segment, likely to rebuild or reinforce berm sections. (Photo 8486)

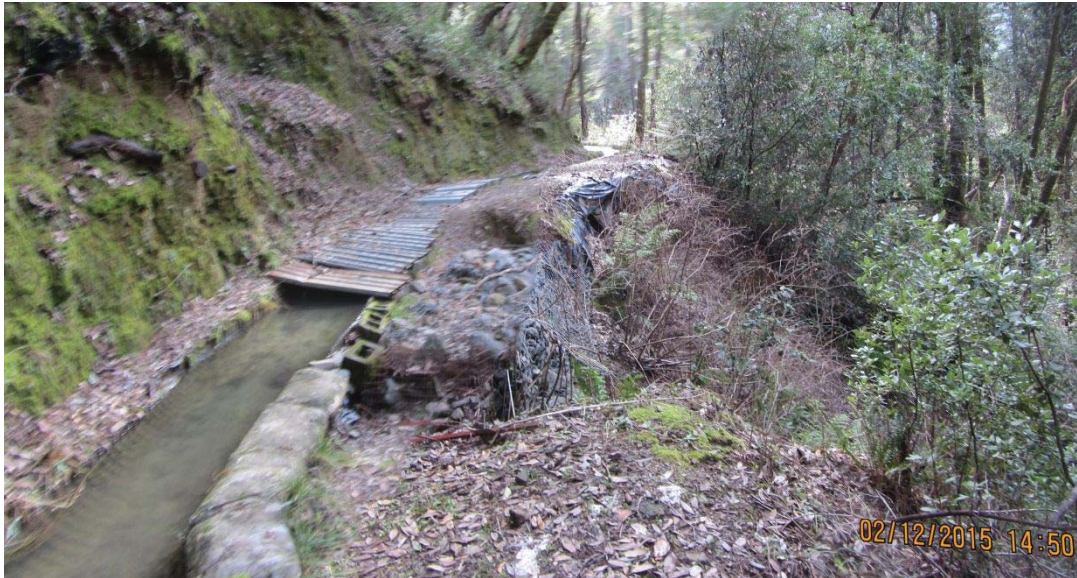
Image 15- shows Point 9, a significant failure point, likely caused by a cut bank slump filling the diversion channel and diverting the stream flow. Note the cut bank slump above and the erosion void downslope. This failure likely accelerated erosion on lower slopes and into the nearby streams. (Photo 8490 and 8491 composite)

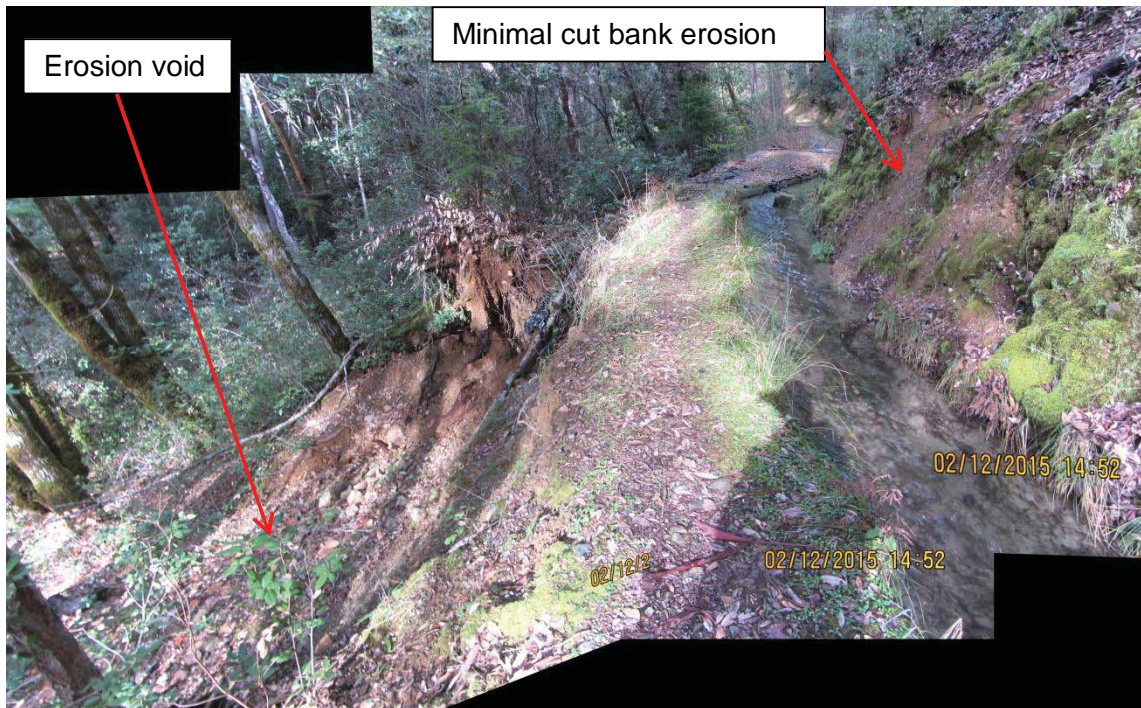
Image 16- Point 10 is an area of concern that includes an erosional channel likely formed by a berm failure and active erosion visible on the cut bank. I observed active cut bank erosion on many of the upper slopes above the diversion ditch and expect that bank slumps have and are contributing significantly to ditch failures. (Photos 8495, 8496, 8497, and 8498 composite image).

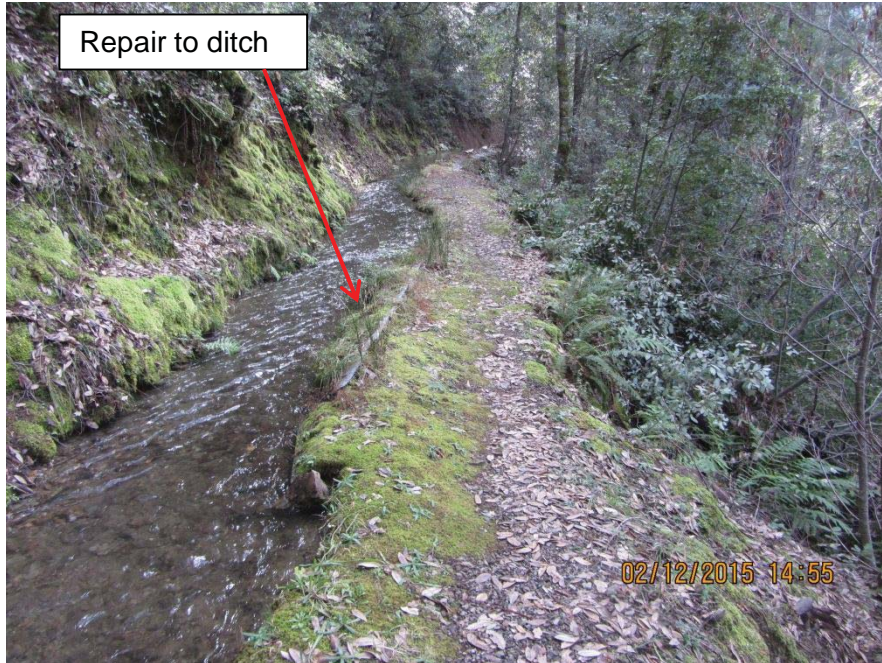
Image 17- Point 11 is another 150-200 feet of ditch with a low freeboard and evidence of past failures; this ditch segment leads to a section of ditch subject to a recent bank failure. I observed erosion scars on the lower slopes that are now overgrown with ferns and small shrubs. (Photo 8499)

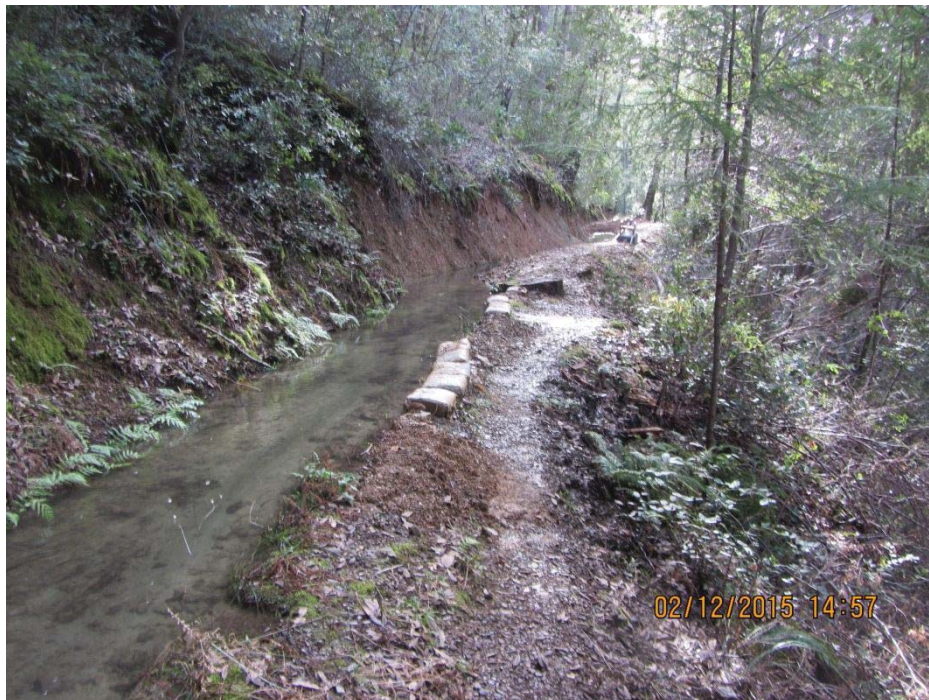
Image 18- Point 12 shows evidence of a recent bank failure that caused water to overtop the outboard berm and erode slopes below the ditch. The outboard ditch shows signs of seepage throughout this length. Note the sand bags and fresh soils along the outboard berm, indicating recent repairs. Also, note the 50-75 foot section of the cut bank with exposed soils. (Photo 8503)

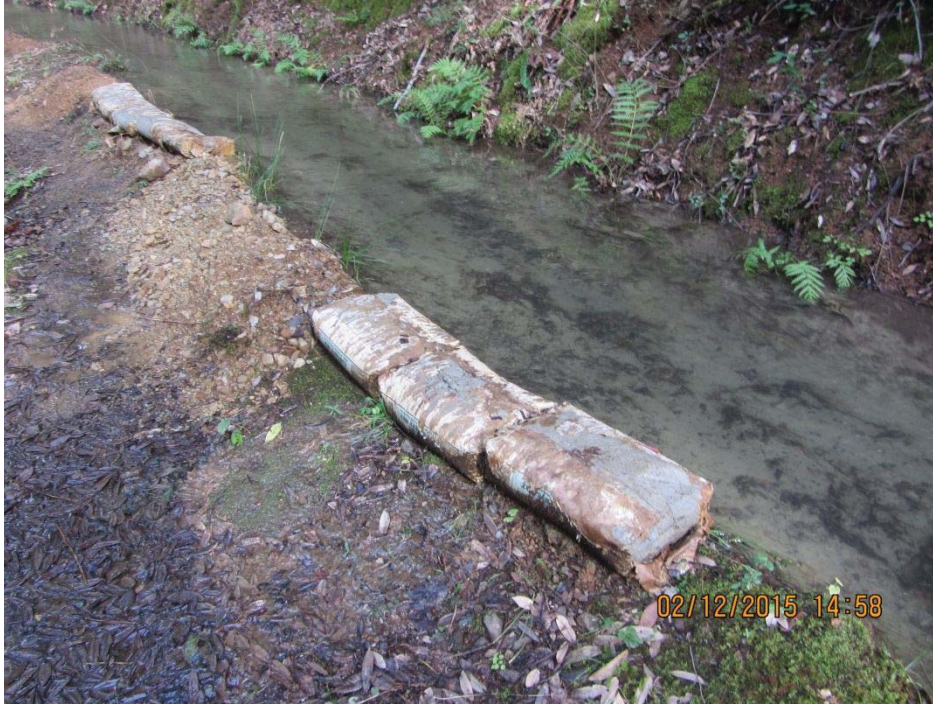
Image 19- Point 12, closer view of berm repair made with ready crete concrete sacks and soils. Note the saturated soils along the outboard berm where water is seeping. (Photo 8510)

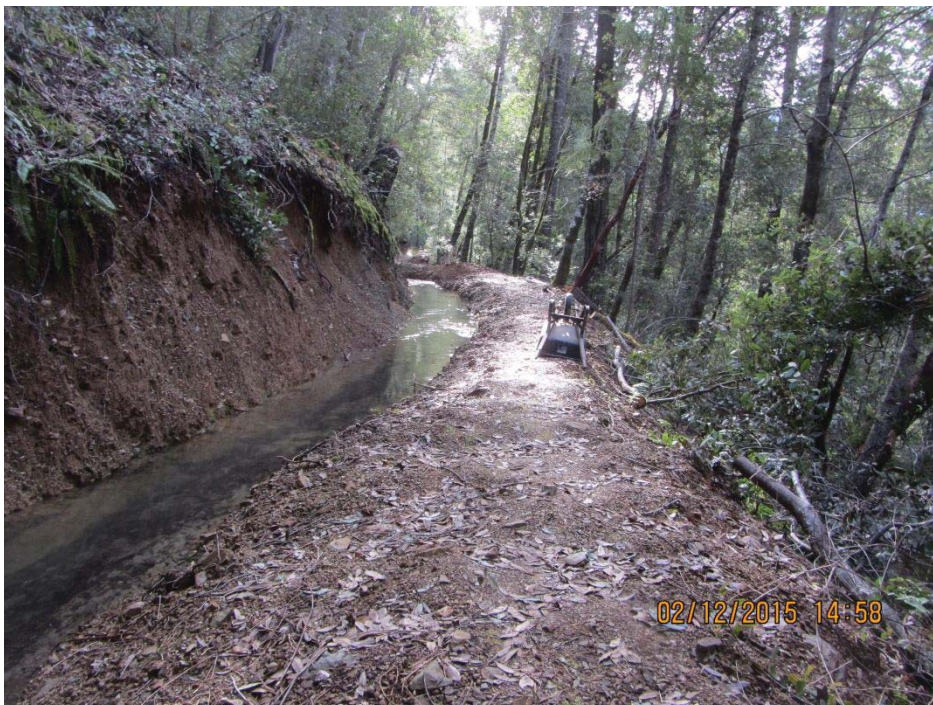
Image 20- Point 13 shows a large continuous cut bank slump that extends for approximately 220 feet. Based on my observations, it appears the cut bank slumped along this stretch over this past winter, delivering approximately 10 yds³ of sediment into the ditch, blocking the channel, and causing water to overtop the berm

and erode the lower slopes. Cut banks are often chronic sources of erosion, delivering additional sediment to streams and ditches each year.

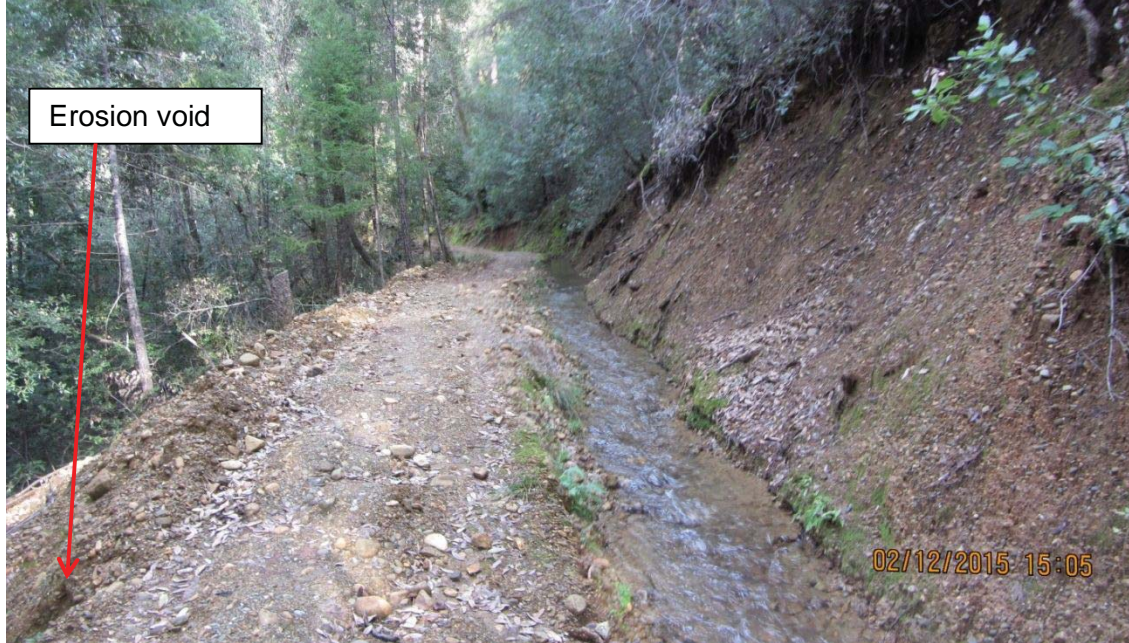
Image 21- Point 14, a cut bank that appears to have slumped in the recent past, causing water to overtop the berm and erode the berm and lower slopes. (Photo 8520 and 8521 composite)

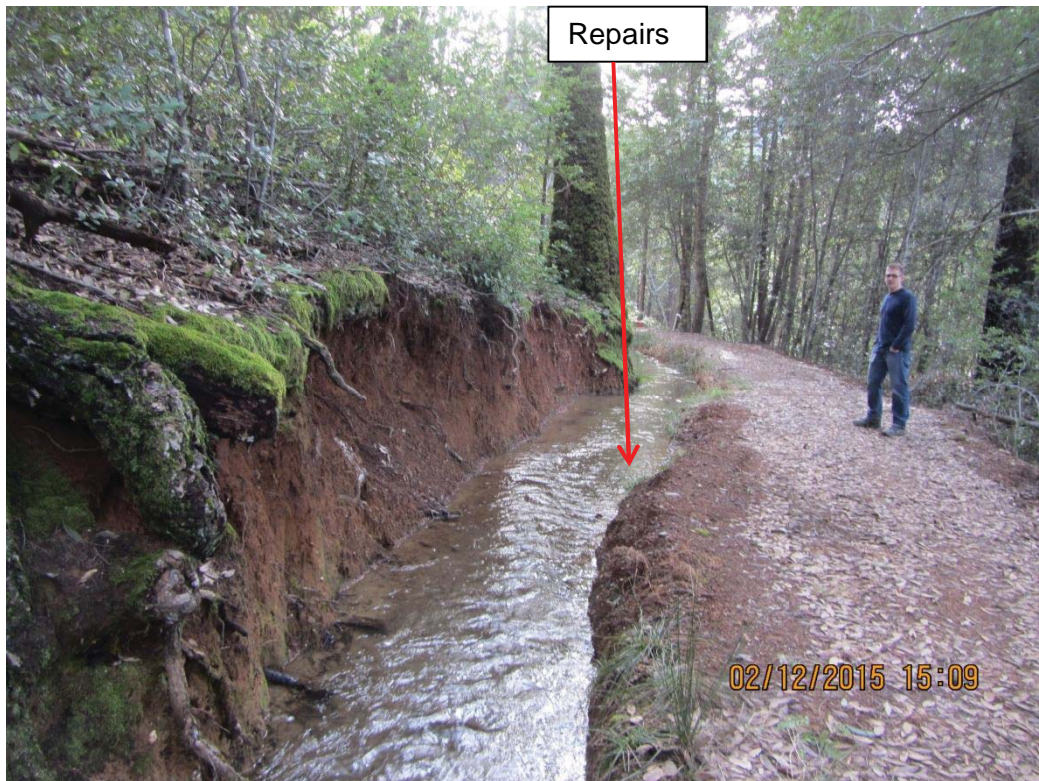
Image 22- Point 15 shows an active cut bank slump, and evidence of recent repairs to the ditch and berm. (Photo 8523)

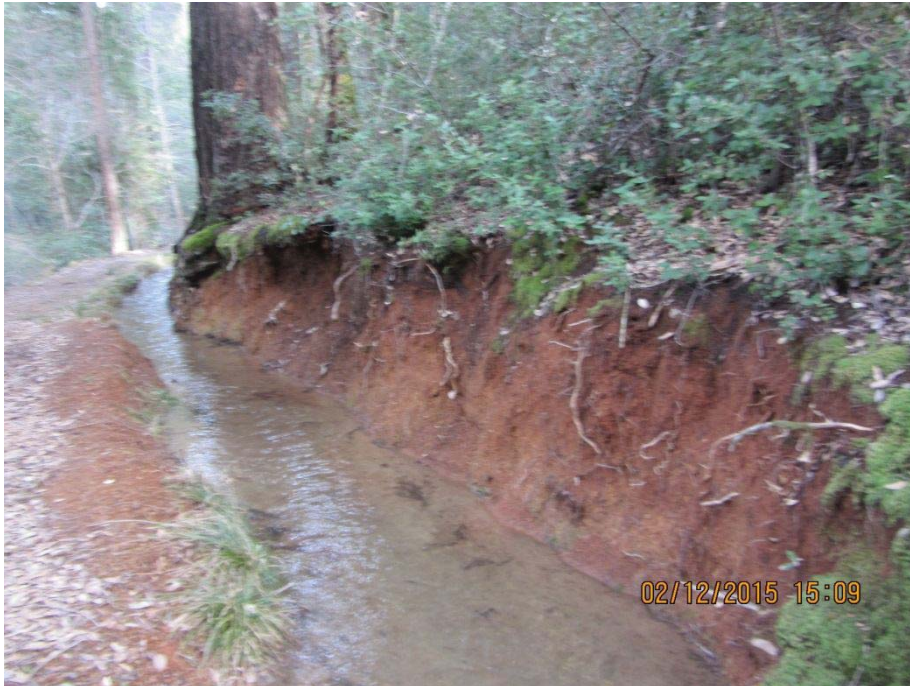
Image 23- Point 16, another cut bank that has a high risk of failure. Note the steep, near vertical slope of this cut bank, which indicates that the bank is still likely to erode. The roots hanging out of the cut bank are indicators of the erosion that has occurred. Most cut banks are originally constructed in a planar form with no visible roots protruding. Over time the cut bank erodes, exposing the roots, and leaving an indicator as to the amount of soil that has eroded or slumped. (Photo 8525)

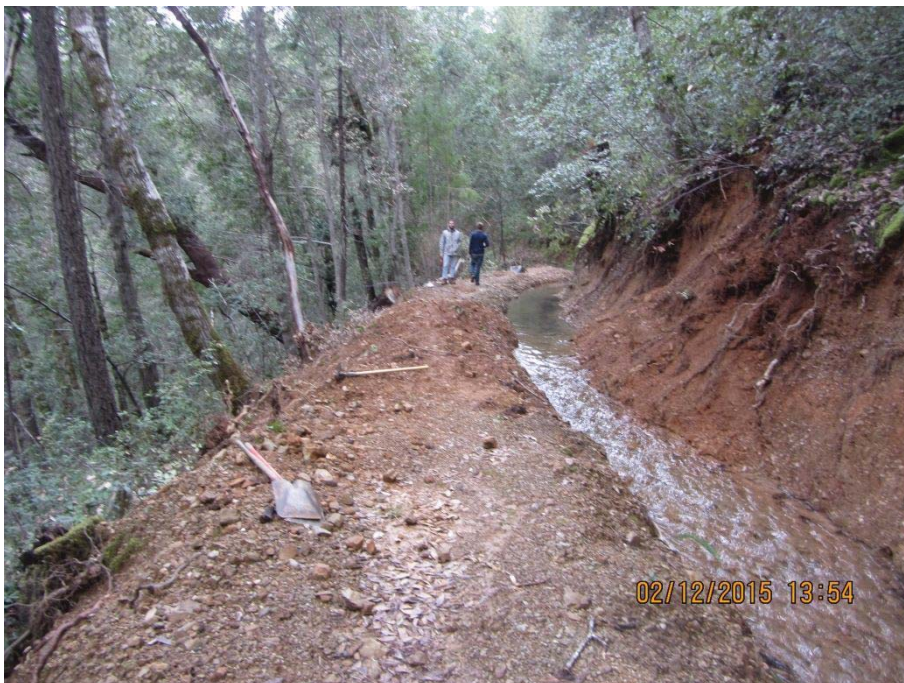
Image 24- Point 17 shows a segment of channel with an active cut bank slump and evidence of recent repairs to the outboard berm.

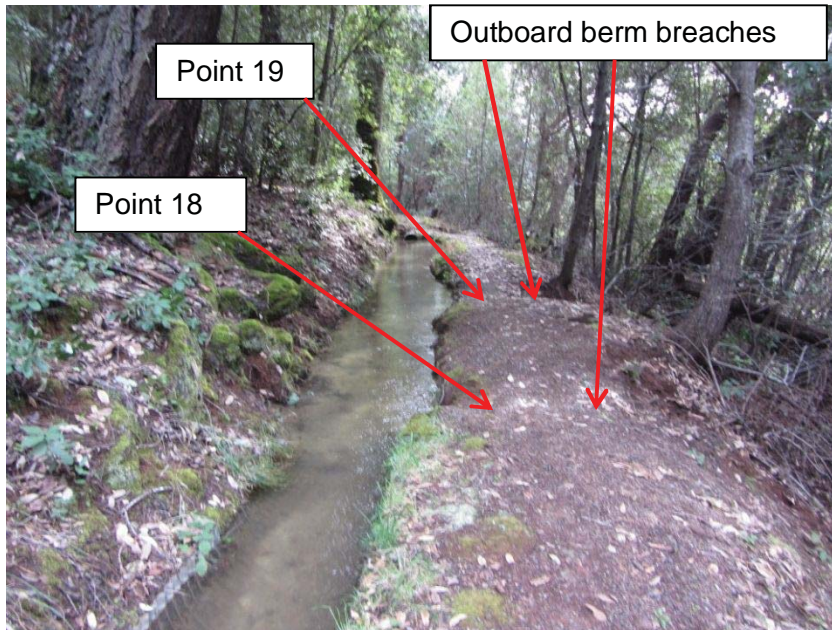
Image 25- shows two locations, points 18 and 19, where the outboard berm has apparently breached in the past, resulting in gully erosion on lower slopes. The failure at Point 19 resulted in the formation of a gully channel for a long distance down the slope, and may have contributed a significant sediment load to the Klamath River and possibly Stanshaw Creek. I did not follow the gully all the way down the slope, but did see an erosion channel from the lower road.

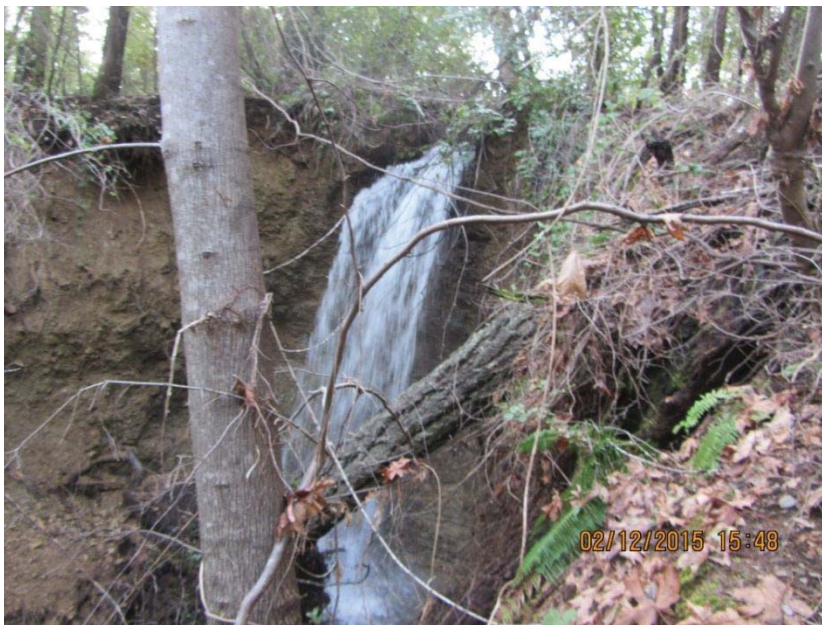
Image 26- Point 20 is the headcut upslope from Irving Creek. This is where tailwater from the Stanshaw Diversion is discharged to an unnamed stream, tributary to Irving Creek. This area is actively eroding. Several trees appear to have fallen recently through erosion of their root masses. I estimate that the headcut erosion has delivered between 1500-2200 yds³ of sediment to the Irving Creek watershed. (Photo 8529)

Outflows to Irving Creek have created a significant active erosional feature, representing a chronic source of sediment discharges into Irving Creek. Point source discharges of sediment-laden waters associated with ditch containment failures and chronic sediment discharges from the Irving Creek outfall occur without authorization from applicable federal, state, and local agencies, including the Regional Water Board. This Order requires investigation and cleanup in compliance with the Water Code, the Water Quality Control Plan for the North Coast Region (Basin Plan), and other applicable Regional Water Board plans, policies, and regulations.

- c. The diversion ditch outfall discharges onto a steep slope with an abrupt drop into a short unnamed tributary to Irving Creek. This discharge causes significant slope erosion and chronic delivery of substantial volumes of sediment into Irving Creek and the Klamath River.
