Exhibit 36

Discharger NOV Response

Subject: PIN: SM-828060:wchiu

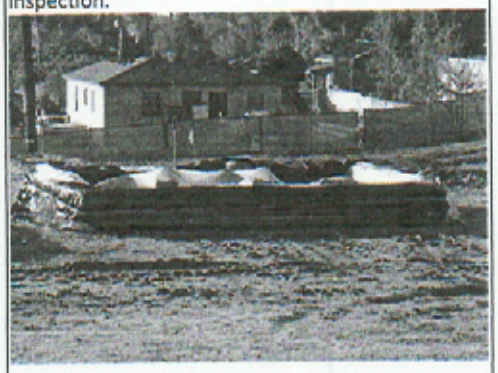
Are temporary concrete washout facilities designated and being used?	✓			Washouts were covered at the time of the inspection.

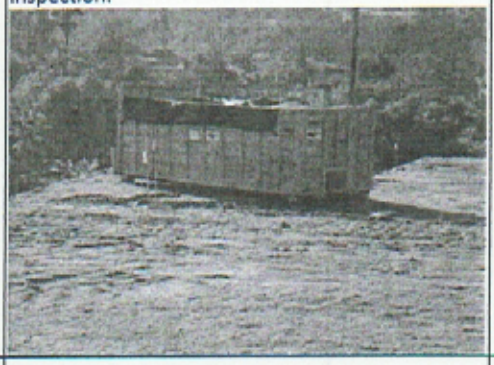
Are trash receptacles provided in the Contractor's yard, field trailer areas, and at locations where workers congregate for lunch and break periods?	✓				No
Are waste management receptacles free of leaks?	✓				No
Are the contents of waste management receptacles properly protected from contact with storm water or from being dislodged by winds?	✓			Trash bins were covered at the time of the inspection.

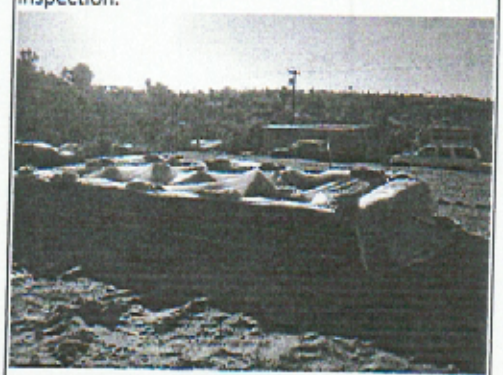
Are temporary storm water containment facilities free of spills and rainwater?	✓				No
Are temporary storm water containment facilities bagged/boxed materials covered?	✓				No
Are temporary concrete washout facilities designated and being used?	✓			Washouts were covered at the time of the inspection.

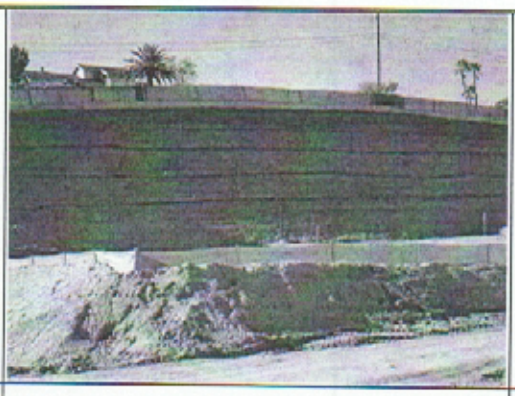
Are fiber rolls installed and maintained on required slopes in accordance with the details, functional and maintained?	✓

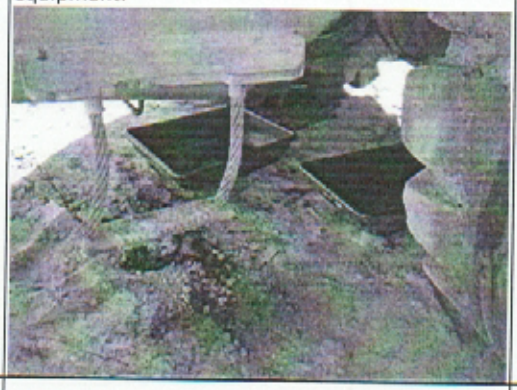
Are vehicle and equipment fueling, cleaning and maintenance activities performed on an impermeable surface in dedicated areas?		✓			No
If no, are drip pans used?	✓			Drip pans were in place under all inactive equipment.
