Los Angeles Regional Water Quality Control Board

November 6, 2012

NOTICE OF VIOLATION – CITY OF COMPTON, CITY OF COMPTON COLLECTION SYSTEM – COMPTON, CALIFORNIA (ORDER NOS. 2006-0003-DWQ AND 2008-0002-EXEC)

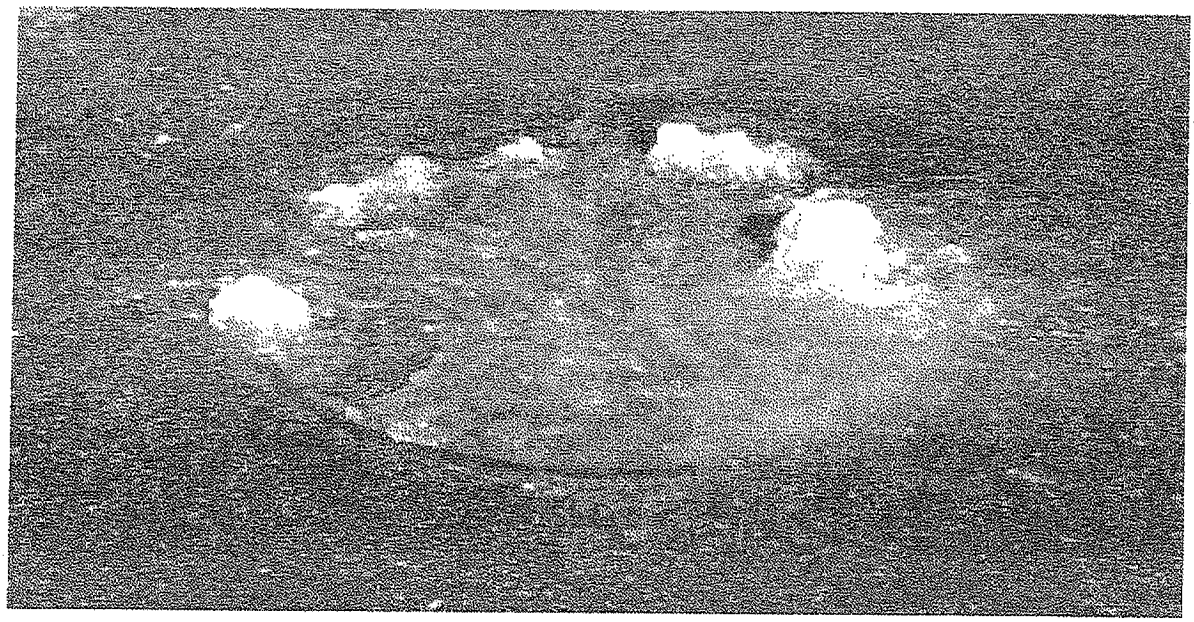
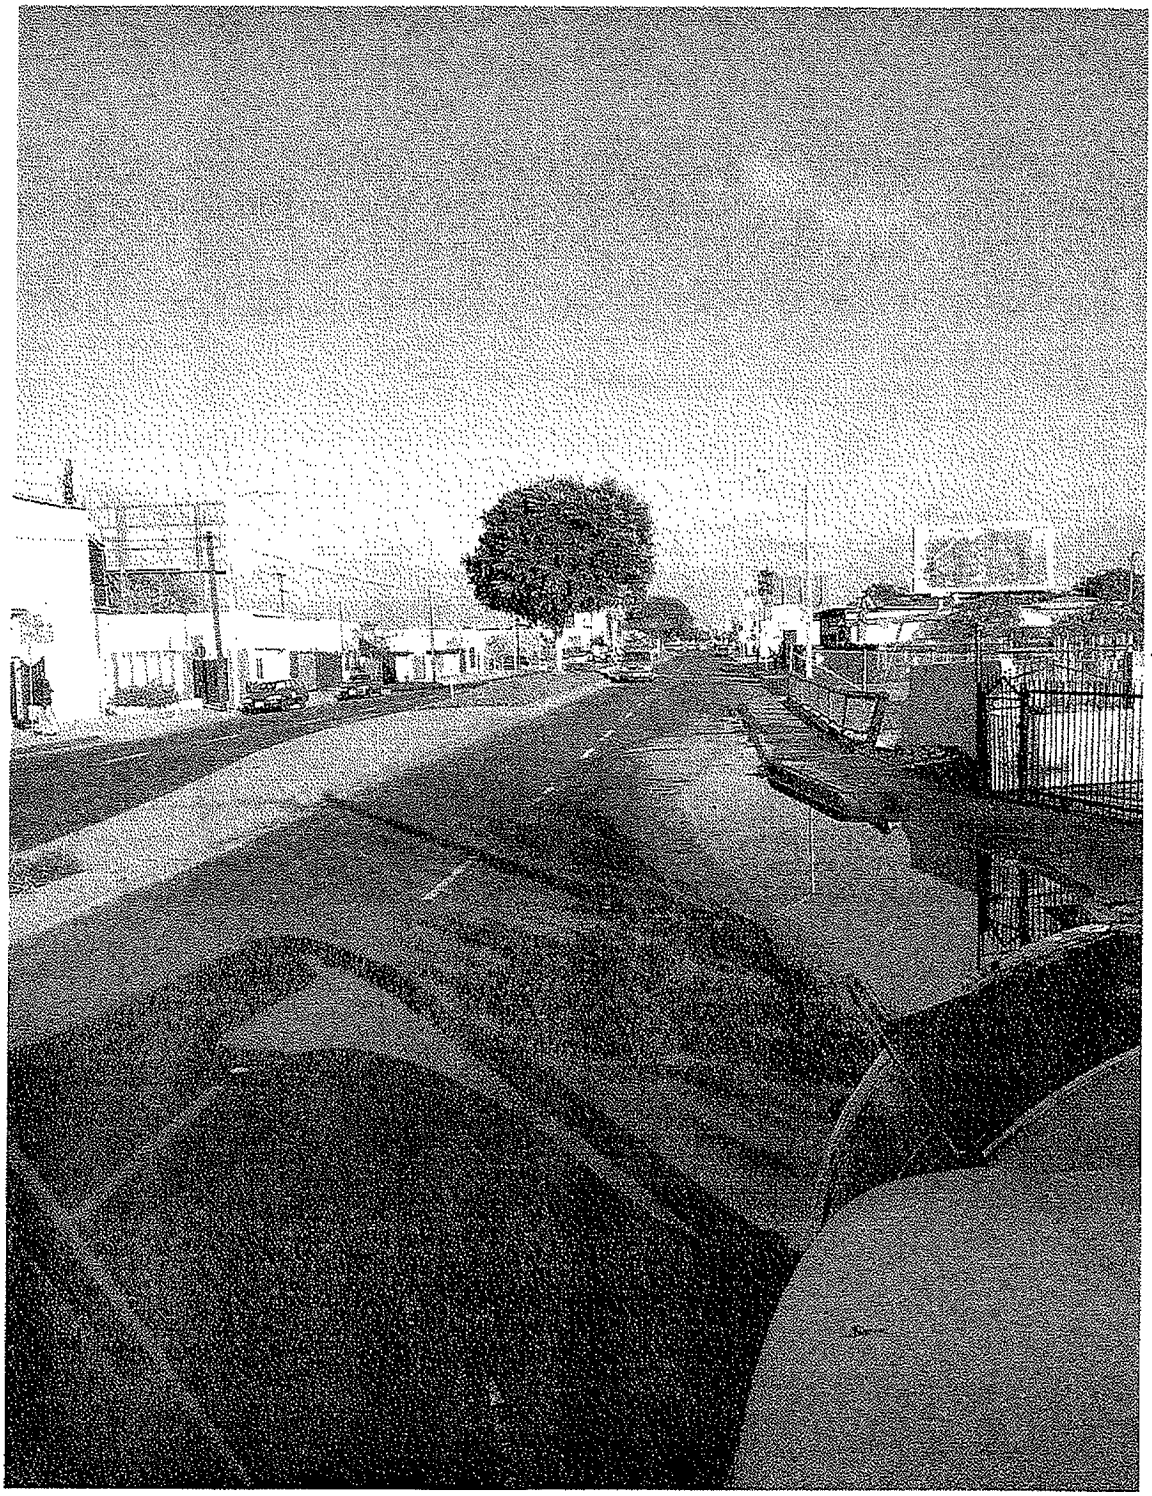
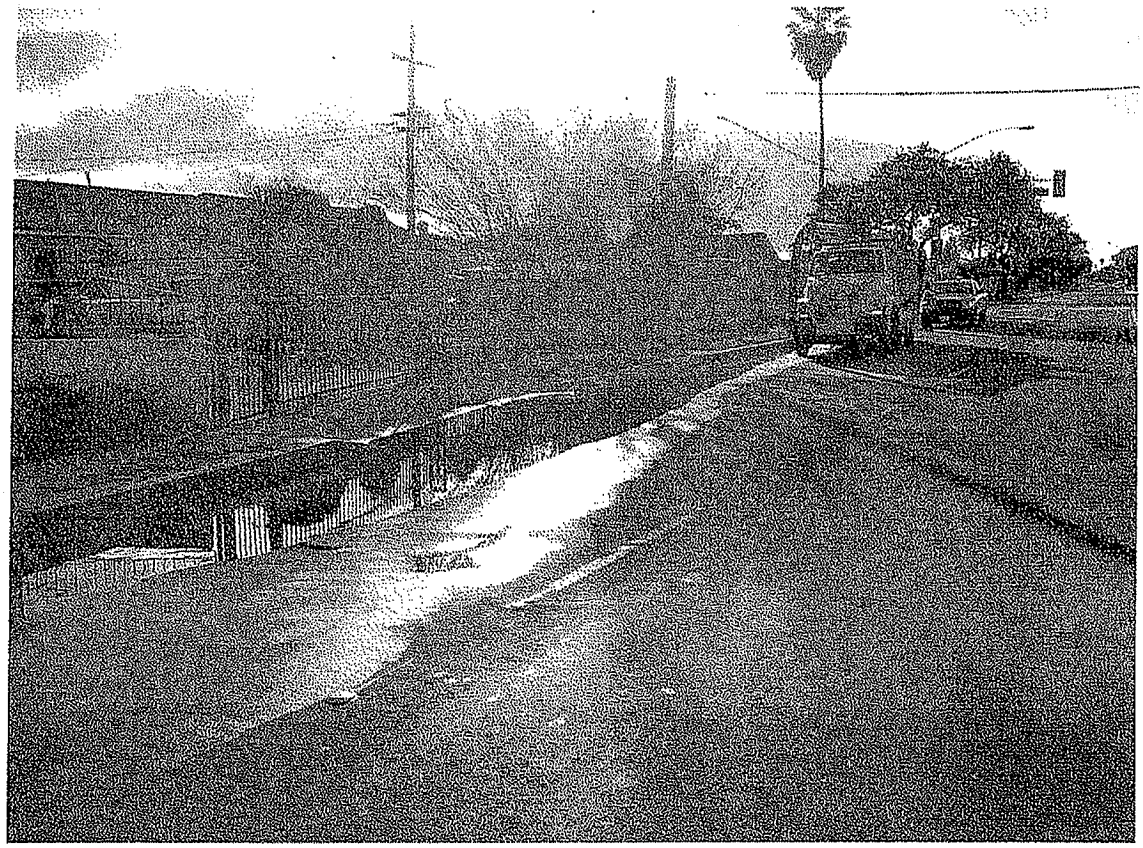
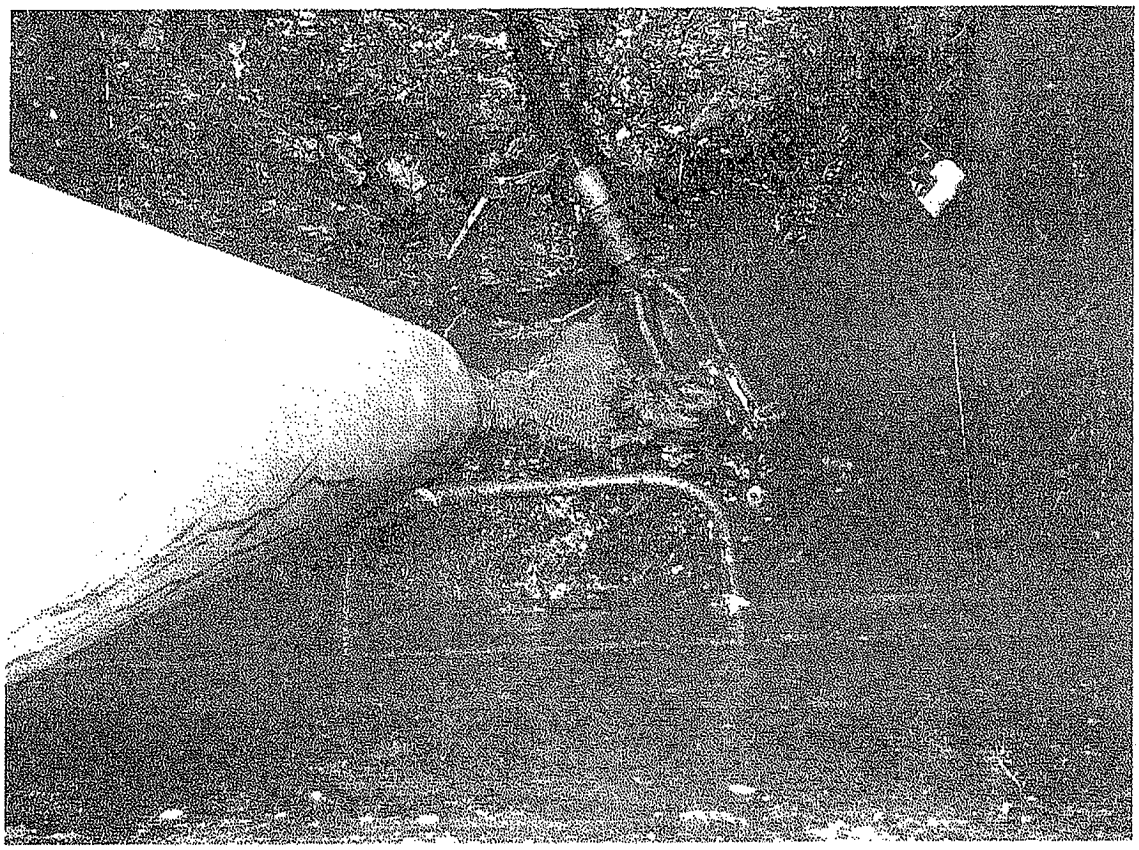
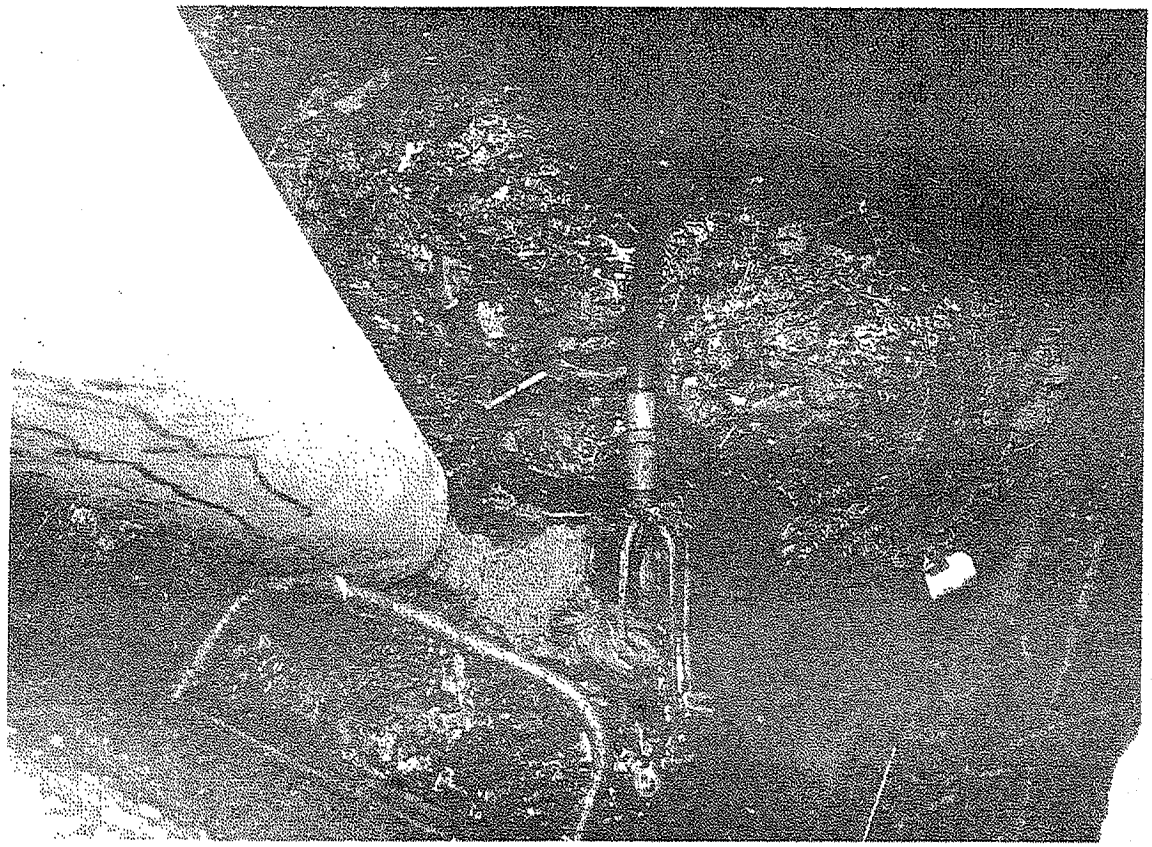
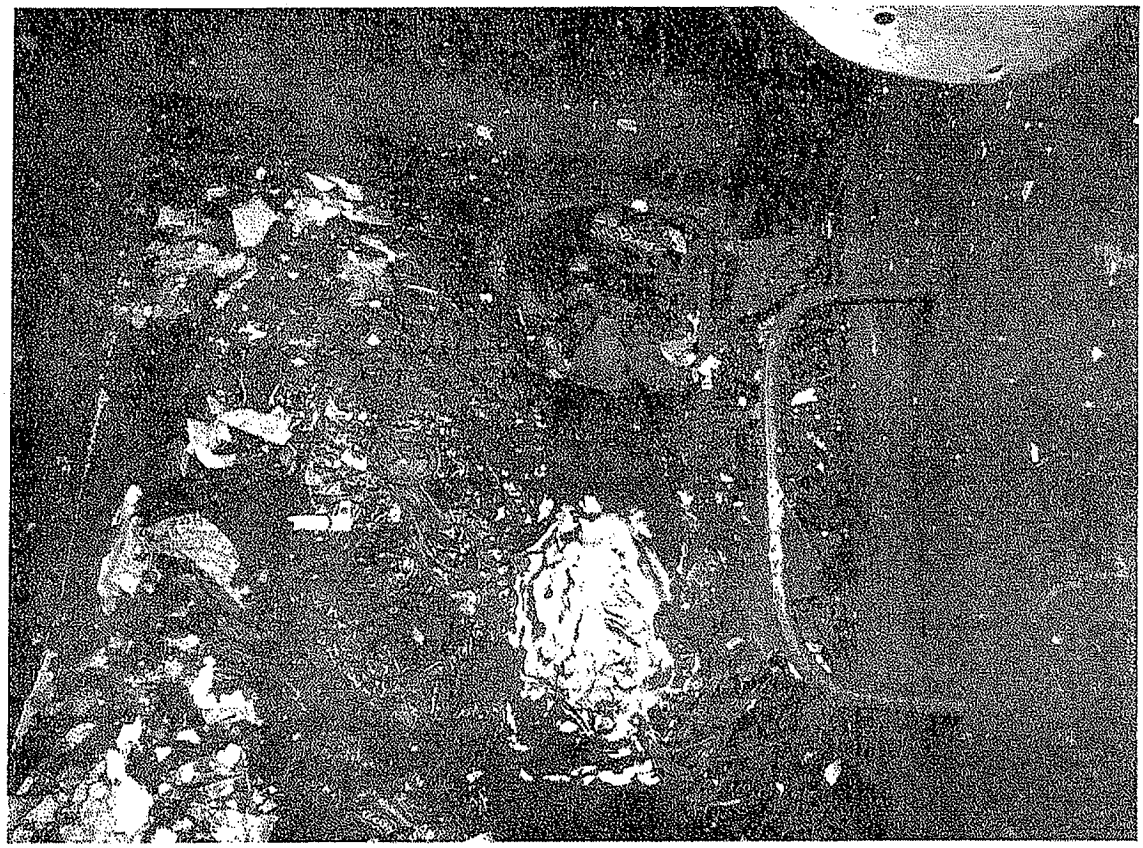
Attachments # 3 - Spill Area Photos

8. Total volume of raw sewage that reached surface waters is estimated at 4,500 gallons. – see attachment #3
9. The discharge was caused by a heavy accumulation of solid grease in the 8" inch VCP located at the 1300 Block of W. Rosecrans Ave (manhole # 1-5-115) downstream of multiple major grease producing entities.
