**INTERNAL MEMO**  
**CALIFORNIA REGIONAL WATER QUALITY CONTROL BOARD**  
**895 Aerovista Place, Suite 101, San Luis Obispo, CA 93401**

**SUBJECT: Assessment of Sediment Conditions and Possible Impacts to Beneficial Uses from Sediment on the Kelegian and Pierson Properties**

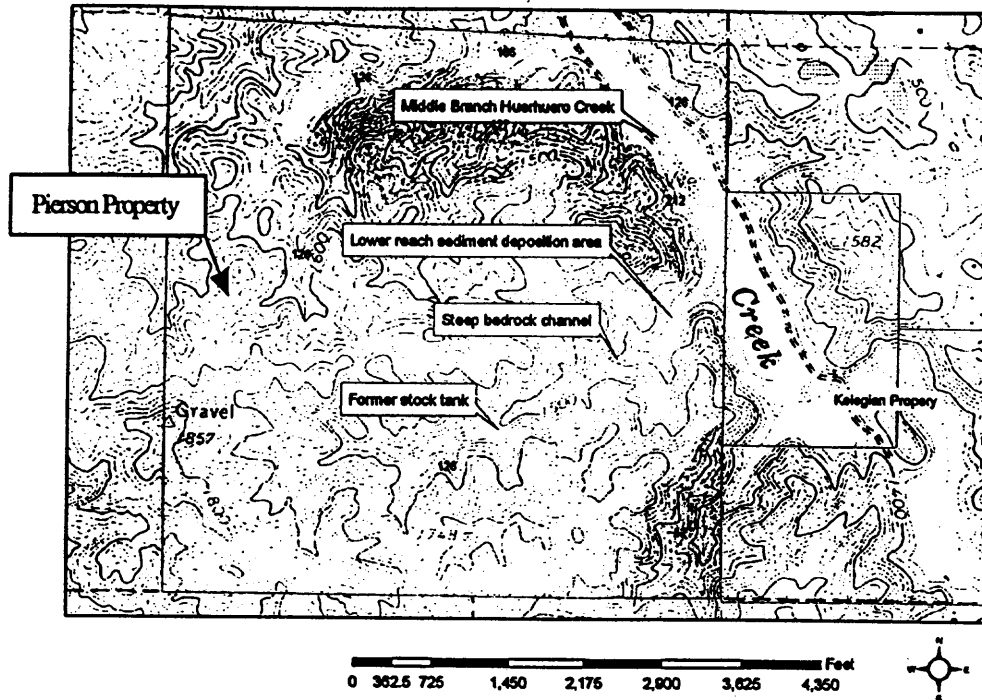
Figure 1 Pierson property showing soil units with 7.5-minute quad background (Soil Map Units on the map correspond to Soil Map Units in Table 1)

I evaluated portions of an unnamed tributary to the Middle Branch of Huerhuero Creek (see Figure 1). Sediment deposits were noted in the lower reach, two small side channels and in an area of a former stock tank. The soils in the grubbed area are primarily Cieneba coarse

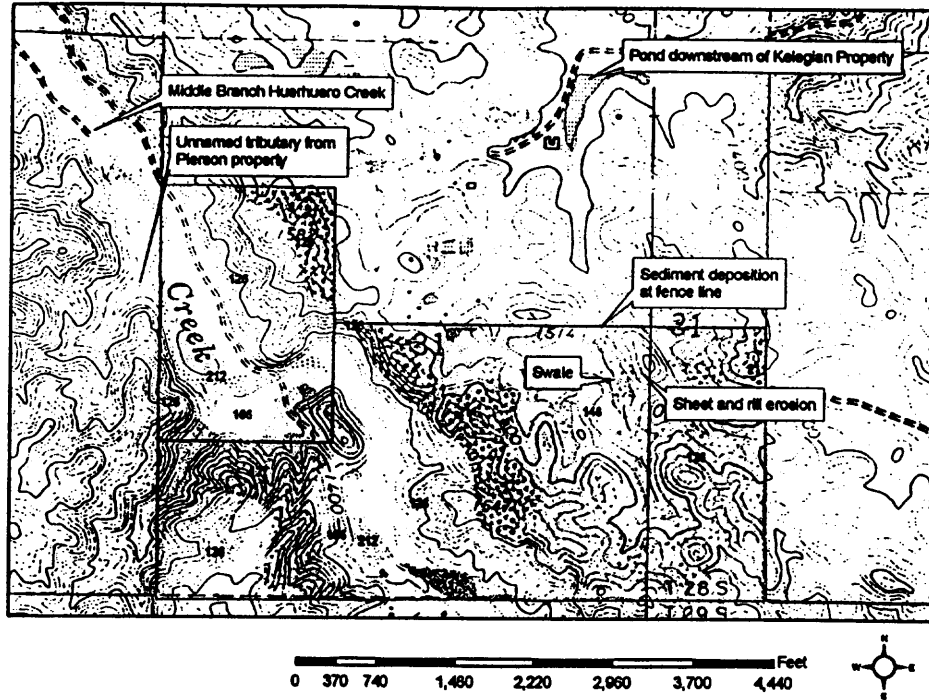
Figure 10 Kelegian property showing soil units with 7.5-minute quad background (Soil Map Units on the map correspond to Soil Map Units in Table 2)
