INTERNAL MEMO
CALIFORNIA REGIONAL WATER QUALITY CONTROL BOARD
895 Aerovista Place, Suite 101, San Luis Obispo, CA 93401

SUBJECT: Assessment of Sediment Conditions and Possible Impacts to Beneficial Uses from Sediment on the Kelegian and Pierson Properties

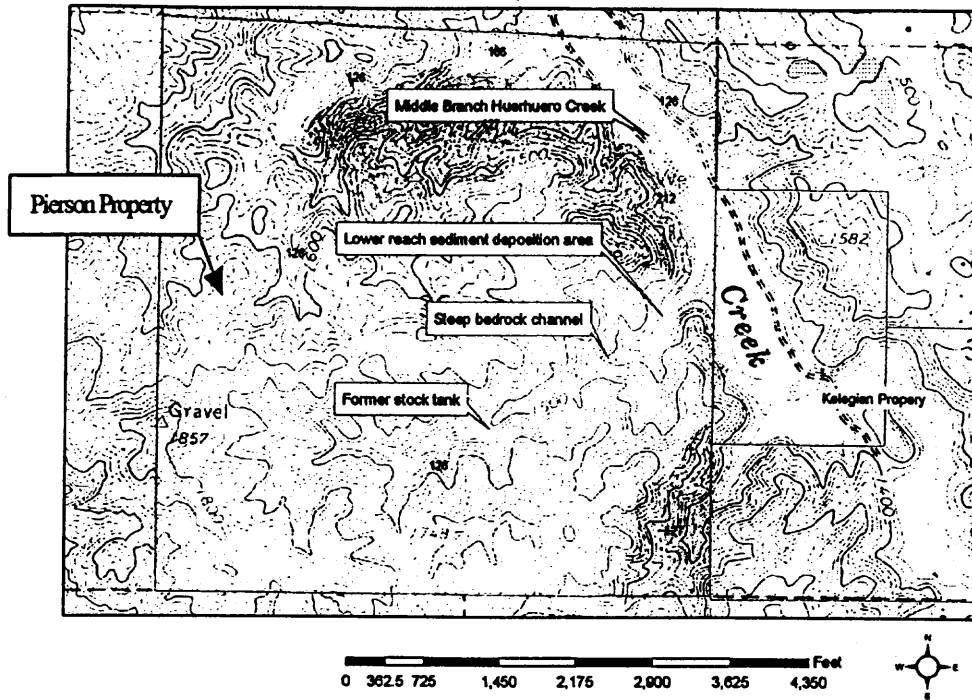
Figure 1 Pierson property showing soil units with 7.5-minute quad background (Soil Map Units on the map correspond to Soil Map Units in Table 1)

I evaluated portions of an unnamed tributary to the Middle Branch of Huerhuero Creek (see Figure 1). Sediment deposits were noted in the lower reach, two small side channels and in an area of a former stock tank. The soils in the grubbed area are primarily Cieneba coarse

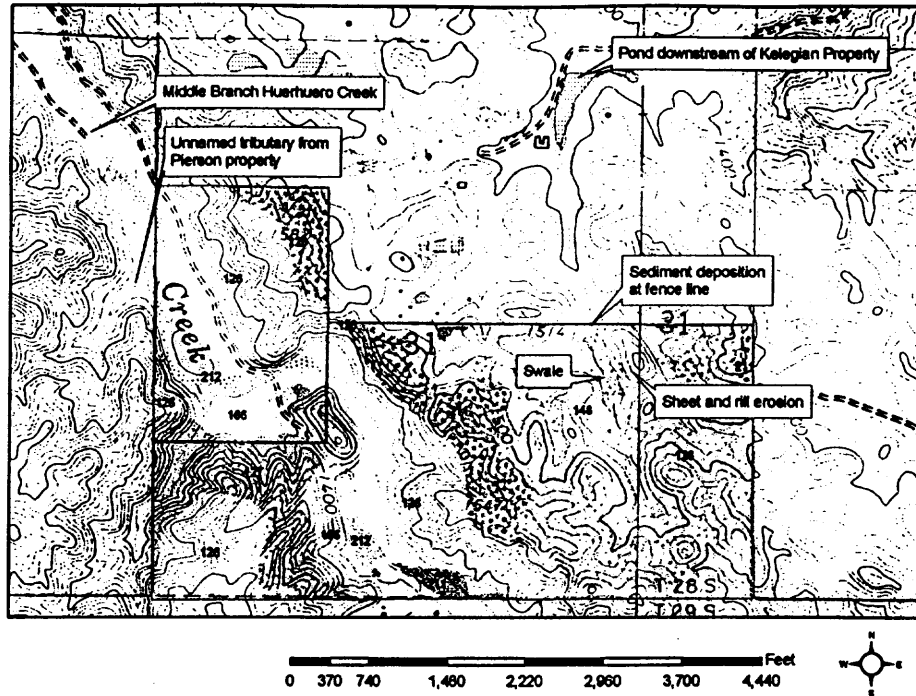
Figure 10 Kelegian property showing soil units with 7.5-minute quad background (Soil Map Units on the map correspond to Soil Map Units in Table 2)
