RE: Erosion Control Review of property east of Santa Margarita, near Highway 58

INTERNAL MEMO
CALIFORNIA REGIONAL WATER QUALITY CONTROL BOARD
895 Aerovista Place, Suite 101, San Luis Obispo, CA 93401

SUBJECT: Assessment of Sediment Conditions and Possible Impacts to Beneficial Uses from Sediment on the Kelegian and Pierson Properties

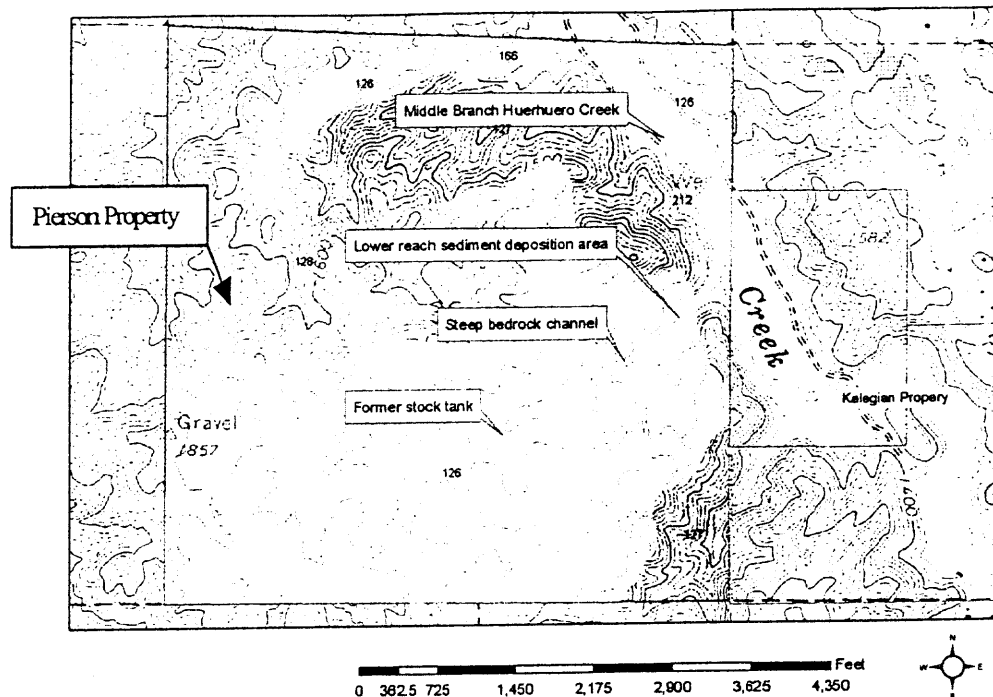
Figure 1 Pierson property showing soil units with 7.5-minute quad background (Soil Map Units on the map correspond to Soil Map Units in Table 1)

I evaluated portions of an unnamed tributary to the Middle Branch of Huerhuero Creek (see Figure 1). Sediment deposits were noted in the lower reach, two small side channels and in an area of a former stock tank. The soils in the grubbed area are primarily Cieneba coarse

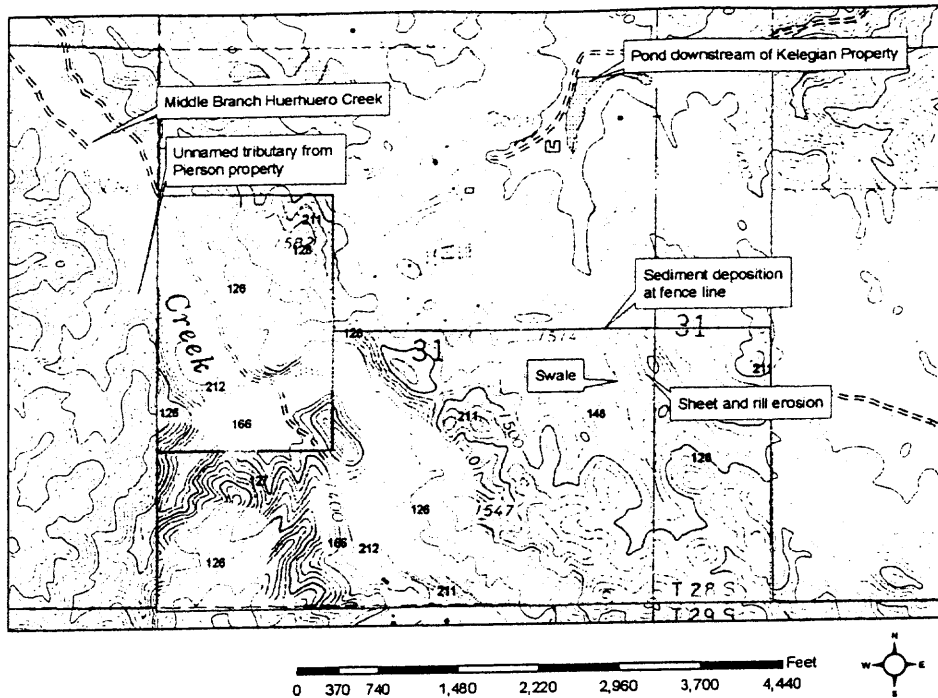
Figure 10 Kelegian property showing soil units with 7.5-minute quad background (Soil Map Units on the map correspond to Soil Map Units in Table 2)
