Re: City of Monterey Municipal Separate Storm Sewer System (MS4) Compliance Audit Report

**MUNICIPAL SEPARATE STORM  
SEWER SYSTEM (MS4)  
COMPLIANCE INSPECTION**

**EVALUATION CONDUCTED:  
September 21–22, 2009**

**CITY OF MONTEREY, CALIFORNIA**

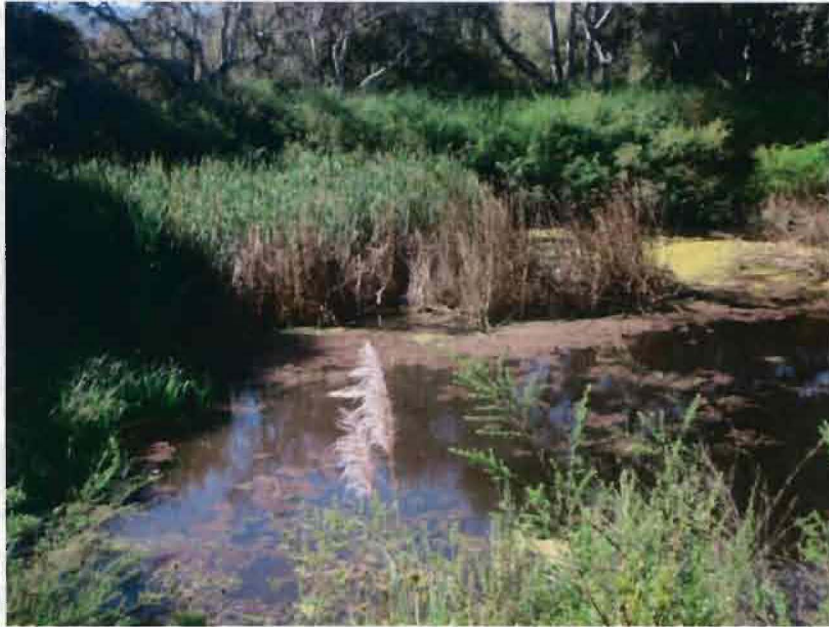
**Photograph 35. Wilson Road Detention Pond.**

The City has three public detention ponds that were built in the 1980s for the Ryan Ranch commercial development and have also been used as regional detention facilities (see attached Photographs 35, 36 and 37). Two of the three ponds recently received maintenance, which included clearing vegetation and dredging accumulated sediment. At the Highway 68 detention facility, an extended length of the upstream drainage channel (i.e., ¼ to ½ mile) had been extensively dredged to remove sediment and create a free-flowing drainage pathway to the detention basin (see attached Photographs 38 and 39). Whether the drainage channel was an existing conveyance channel or waterway and would have required coverage under Clean Water Act (CWA) section 404 and/or 401 was unclear. See Photograph 40 for a view of the same channel upstream of the dredging activity.

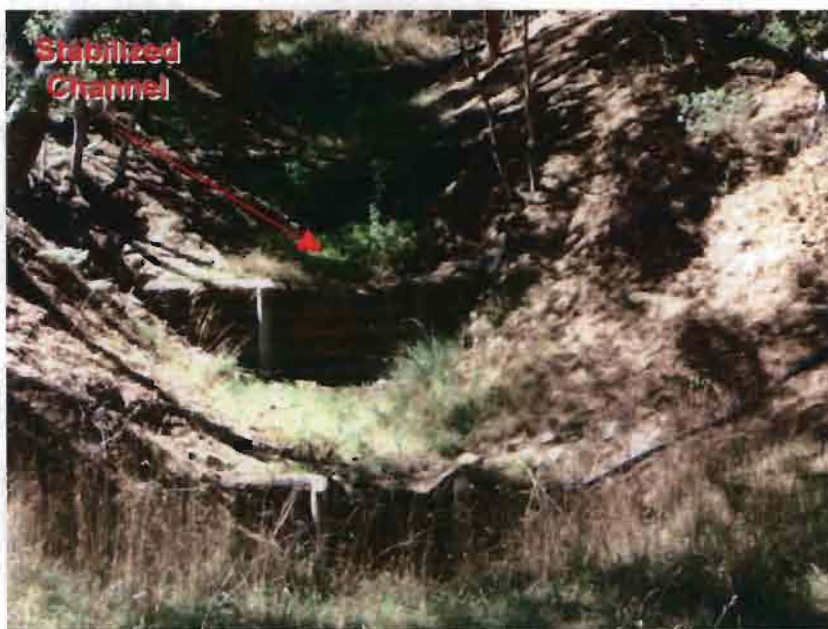
In other locations, the City had conducted and was continuing to conduct stream channel modifications to prevent erosion and the subsequent contribution of sediment to the Monterey Bay. These efforts included excavation and bank stabilization activities (see attached Photographs 41 and 42). Whether these projects required §404 or §401 permit coverage was unclear, and it did not appear that the City had fully considered the potential CWA §404 and/or §401 coverage requirement for such projects.

**Photograph 41. Drainage channel restoration near Crandall Creek.**

*Whether the City has misinterpreted its authority to alter local streams or natural drainages and has acted in violation with §404 of the CWA was unclear. The EPA Inspection Team recommends that the City ensure that all applicable permits (e.g., CWA §404 and/or §401) are obtained prior to conducting work in or around waterways, wetlands, or areas that might be designated as such.*

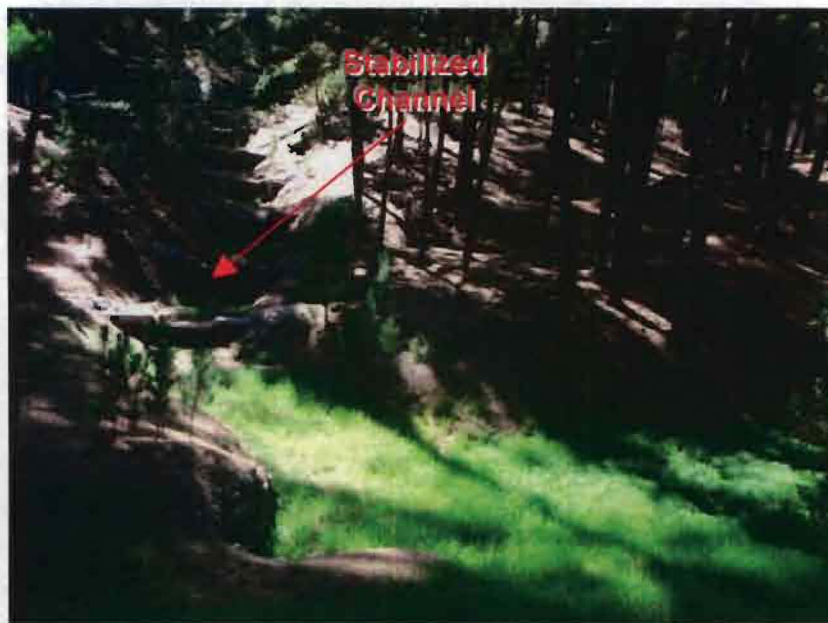
**Photograph 42. Drainage channel restoration near upstream end of Windmere Creek.**
