**Biological Resources Damage Assessment
Within Murrieta Creek in Relation to the
Temecula Valley Regional Water Reclamation Facility
December 25, 2009 Sewage Spill**

City of Temecula, Riverside County, California
USGS – Murrieta and Temecula topographic quadrangles
Township 8 South, Range 3 West

Shay Lawrey
Ecologist / Regulatory Specialist
Prepared on January 05, 2010
Updated, revised and finalized on January 25, 2010

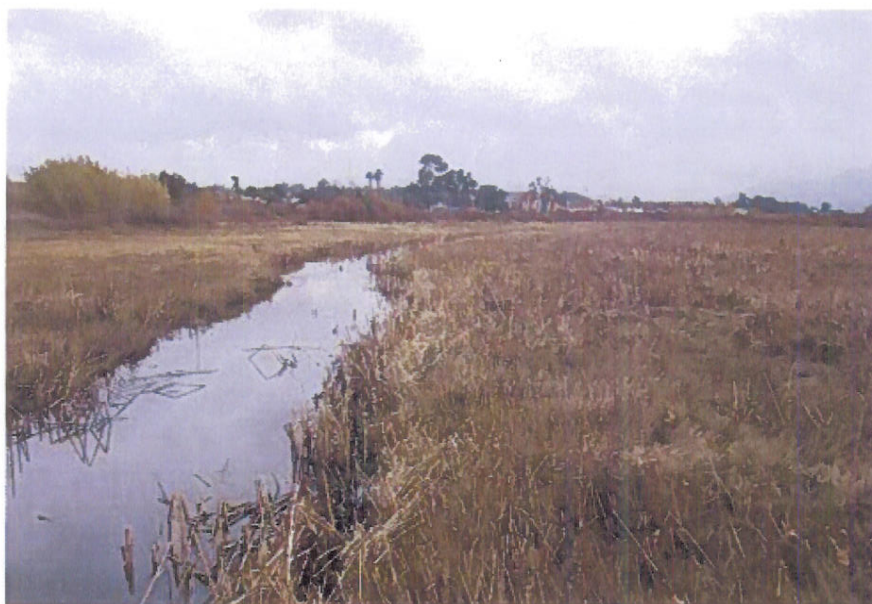
Photo 5. Standing 100 feet downstream of Via Montezuma Road showing conditions of pooled water on the west side of Murrieta Creek.

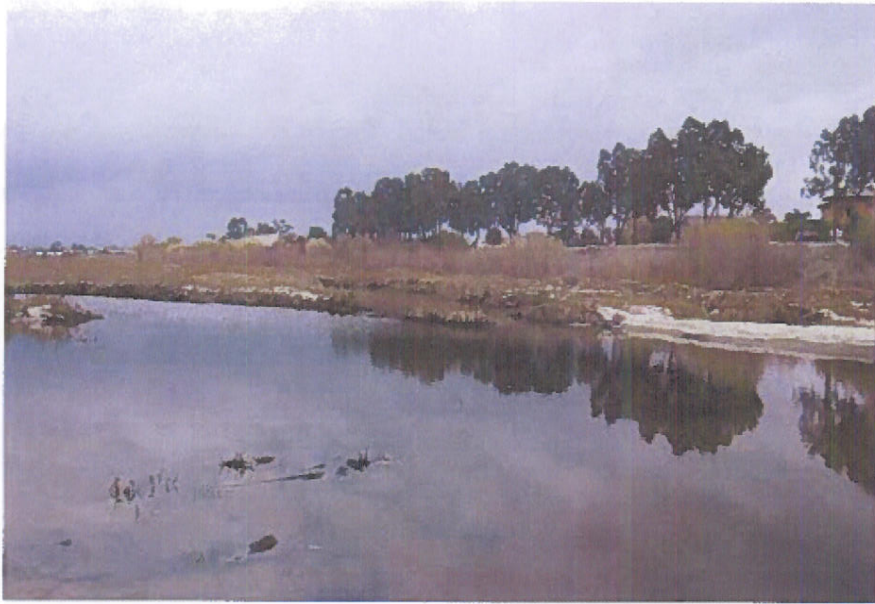
Photo 6. Standing mid-section of the survey area between Via Montezuma Road and Rancho California Road, looking downstream towards the Rancho California bridge crossing over Murrieta Creek.

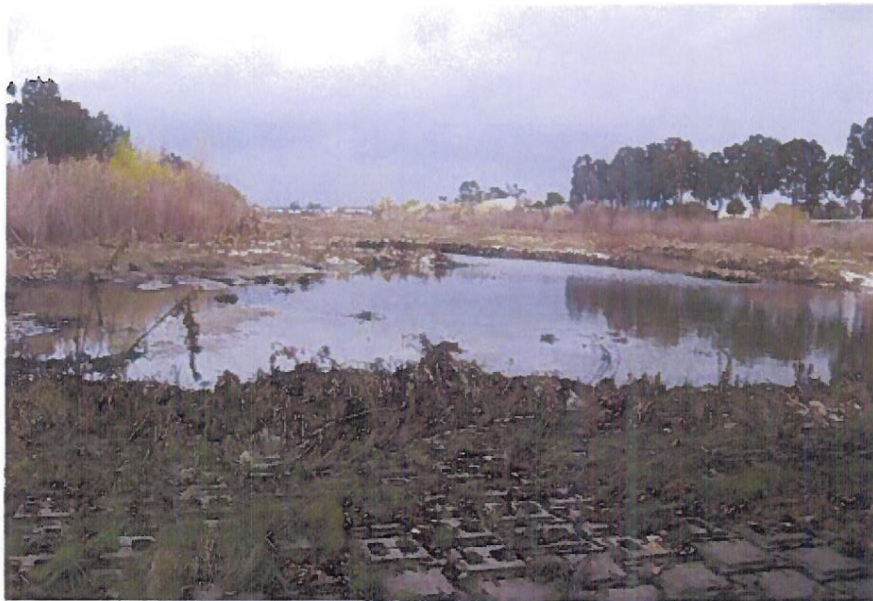
Photo 7. Standing upstream of the Rancho California bridge crossing looking upstream at Murrieta Creek.

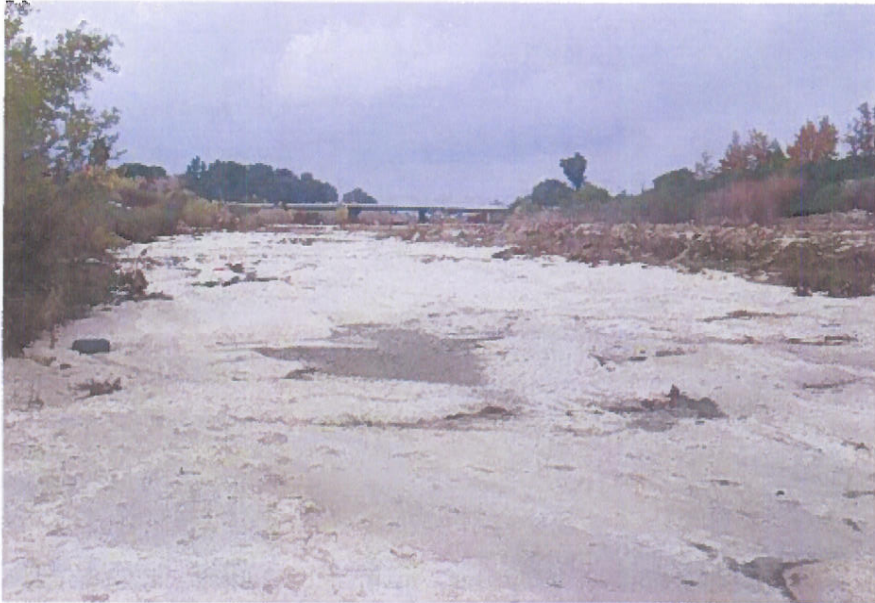
Photo 8. Standing under the Rancho California bridge crossing looking upstream at Murrieta Creek.

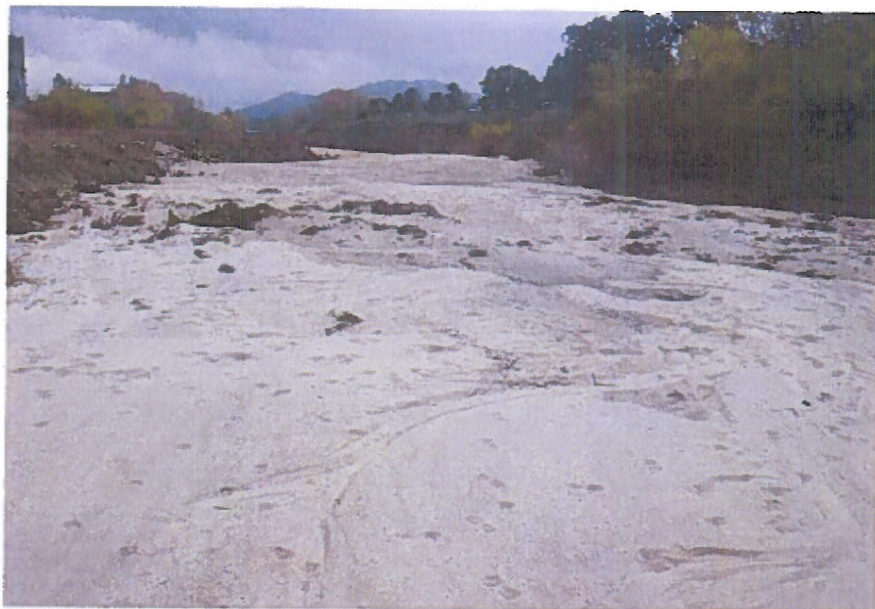
Photo 10. Photo showing dry creek conditions downstream of the Rancho California Road bridge crossing looking upstream towards the bridge.
