International Boundary and Water Commission  
United States and Mexico

Report of Transboundary Bypass Flows into the Tijuana  
River

Minute 320 Binational Technical Team

Final Report

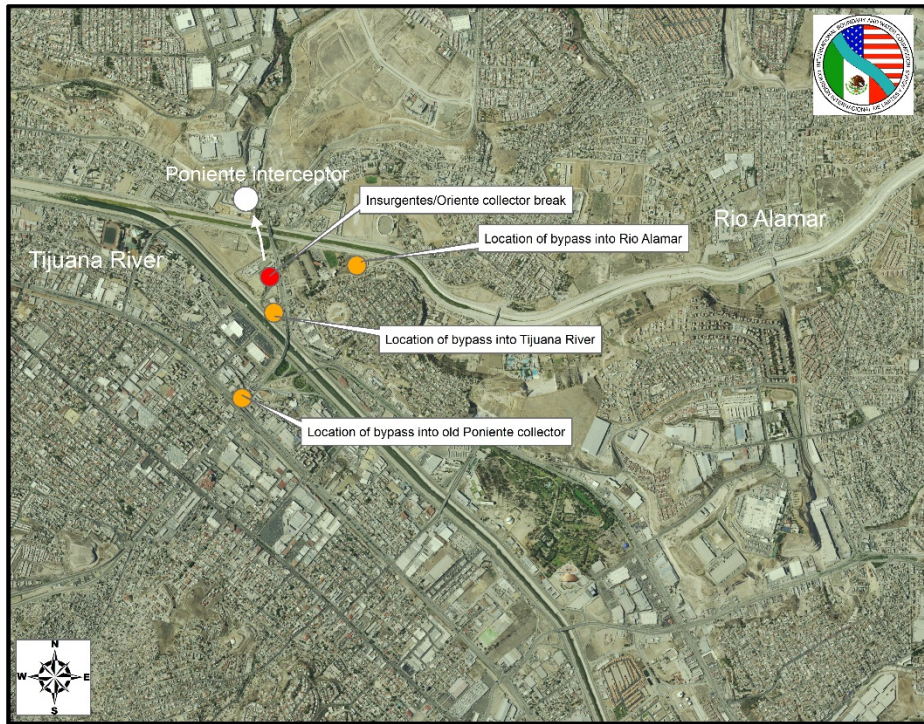
Figure 2 Location of 2017 collector break

On March 1, Roberto Espinosa reported to USIBWC additional details made known at the meeting. On February 1, 2017, there was a collapse of the 48-inch diameter *Insurgentes/Oriente* Collector in the vicinity of the confluence of the Alamar River and Tijuana River. Emergency repairs were undertaken but they were compounded by rain, abandoned underground structures, the failure of a new bus shelter, and overhead and buried power lines. Base flow in the collector was diverted to other pipes, however peak flows were diverted to the river. The nature of the repairs and the expansion of the civil footprint led to a protracted period of repair. The repair work was completed on February 23, 2017. CESPT confirmed their failure to notify the MXIBWC of the emergency work and bypassing of wastewater flows to the river, for that reason, MXIBWC could not provide an estimate for the volume of bypassed wastewater. CESPT also noted that the failure points to the problem of aging infrastructure. CESPT spent \$5 million pesos (MXN), approximately \$260,000 (USD) on repairs, and estimates a need for replacement of approximately two km of 42-inch diameter collectors in the vicinity which will cost around \$28 million MXN, approximately \$1.5 million USD. An additional seven km of pipeline installed in the 1980s are in critical condition and in need of replacement. The Mexican Section stated that they will be coordinating with the State of Baja California to improve CESPT's notification and coordination process.

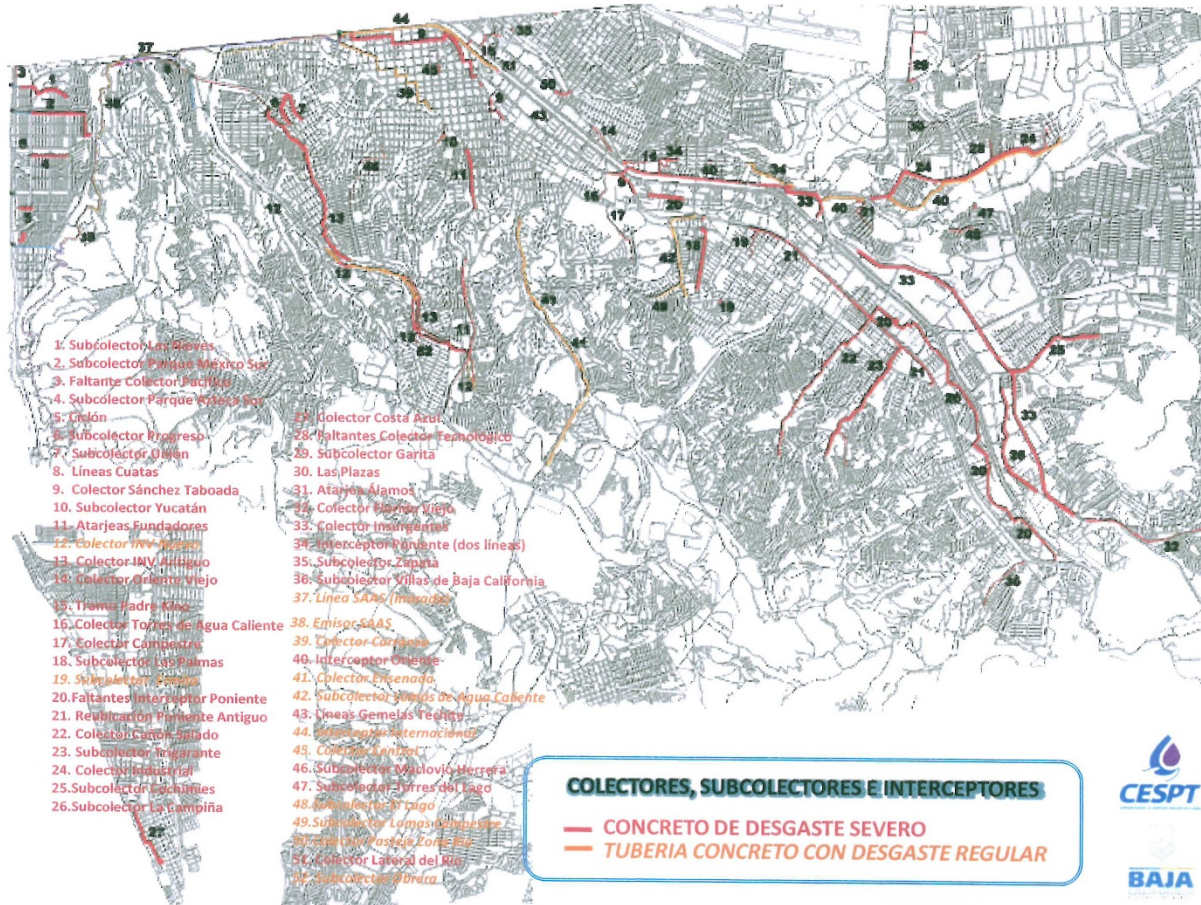
Figure 9 Location map of critical collectors

CESPT noted that they have a 2012 master plan for infrastructure improvements however it needs to be updated as Tijuana has grown significantly. A CESPT consultant will provide the updated 2012 plan with actions and a schedule. CESPT is working with CONAGUA and the governor of Baja California to financially assist in replacing some of the wastewater lines. The following are a location map and two tables showing the immediate needs and near term needs for Tijuana sewerage:

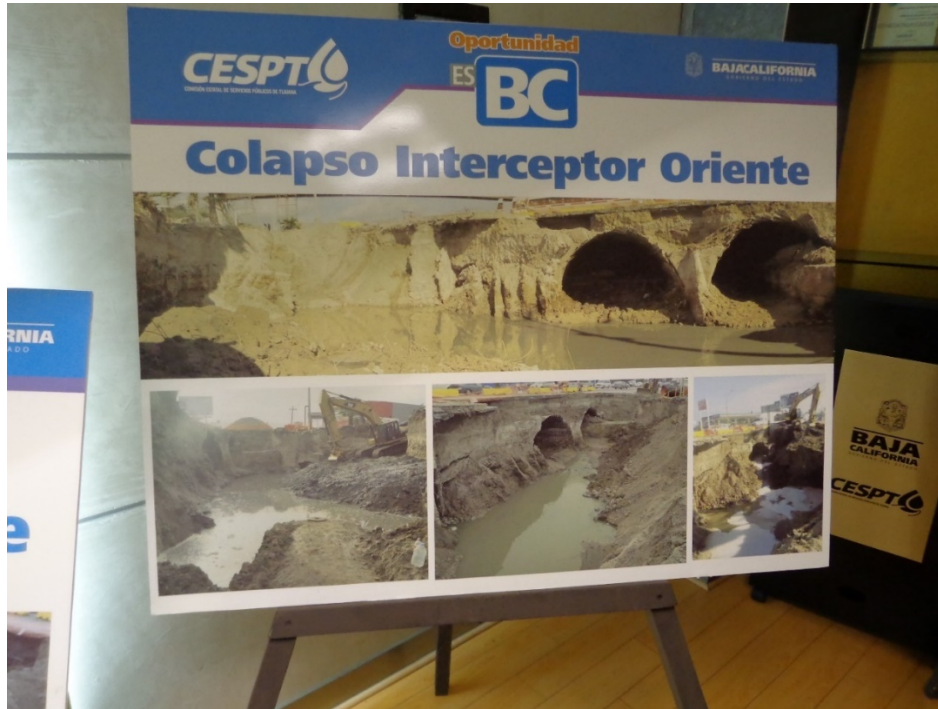
Photographs displayed during the March 9, 2017 meeting at CESPT offices are shown below:

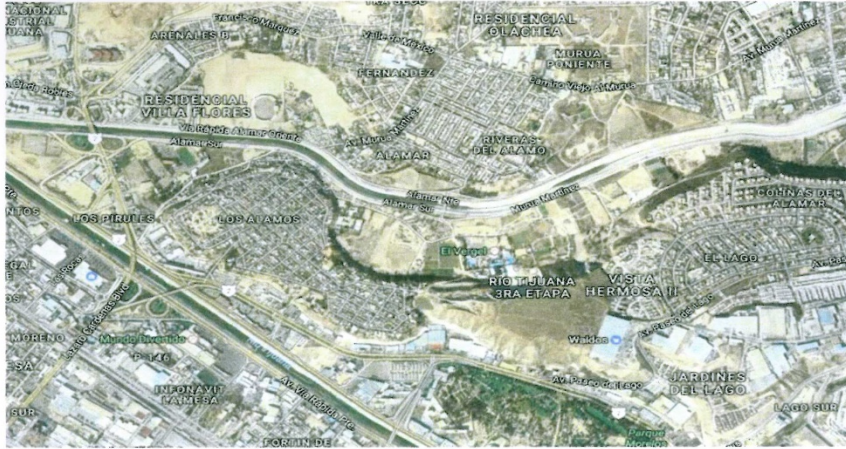
<p>EL 17 DE ENERO, COMO PARTE DE LOS TRABAJOS PRELIMINARES A LA REPOSICION DE LA TUBERIA COLAPSADA DEL COLECTOR INSURGENTES, SE INSTALO BY-PASS DE PCV DE 6" PARA ENCAUZAR EL FLUJO REMANENTE HACIA EL INTERCEPTOR ORIENTE</p>
