NOTICE OF VIOLATION
No. R9-2016-0032

Facility: Murrieta Creek
Inspection Date: 1/7/2016

Attachment 2
to
January 7, 2016
Facility Inspection Report
for
Murrieta Creek Construction Site

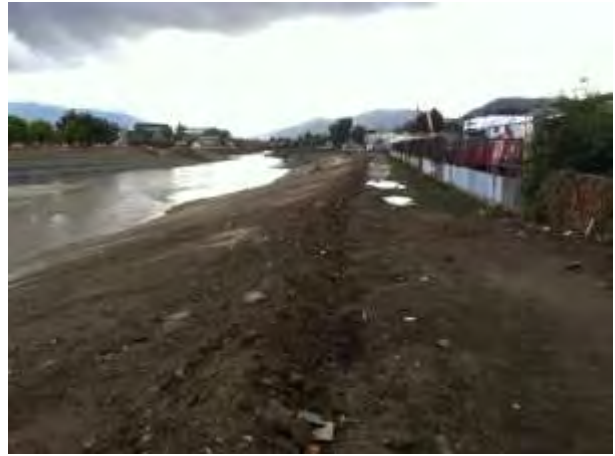
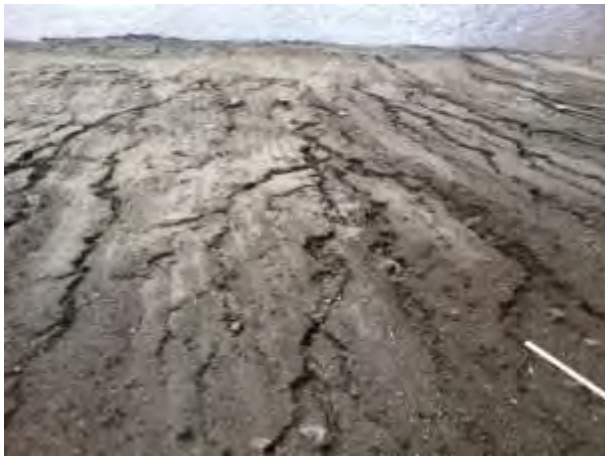
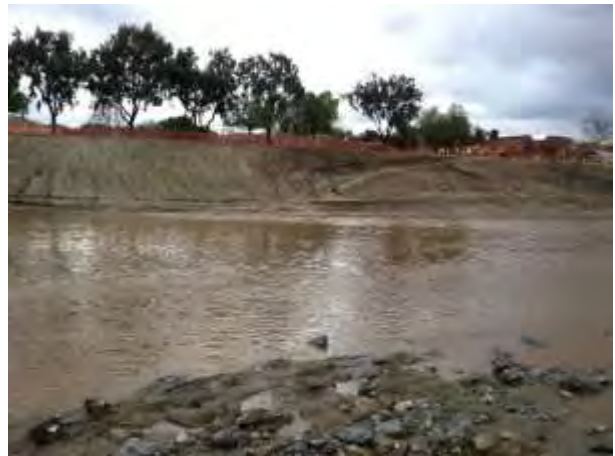
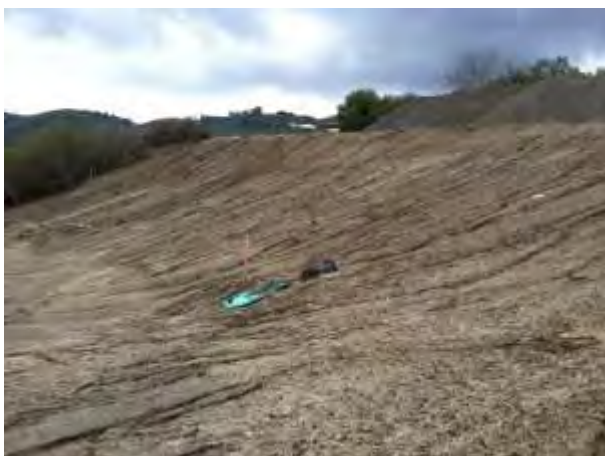
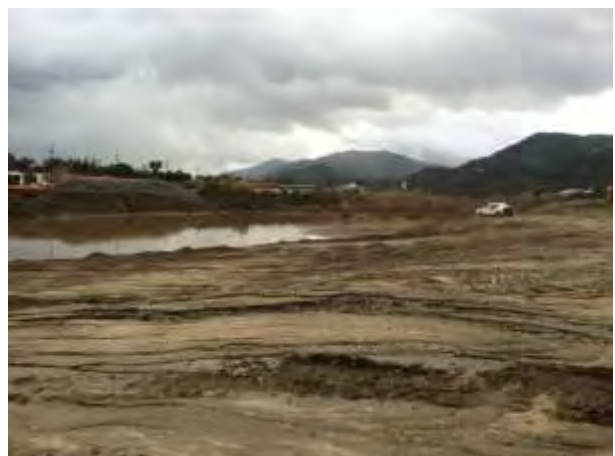
- b. **Observation:** During the January 7, 2016 inspection, the San Diego Water Board inspectors observed slopes throughout the site without linear sediment controls along the face and/or grade breaks of exposed slopes. See attached January 7, 2016 Facility Inspection Report Photos 1 through 11.

3. Risk Level 2 construction sites are required to apply linear sediment controls along the toe of the slope, face of the slope, and at the grade breaks of exposed slopes to comply with sheet flow lengths given in Table 1 of Attachment D to the CGP (i.e. every 20 feet for 0-25% slopes, every 15 feet for 25-50% slopes, and every 10 feet for slopes over 50%). San Diego Water Board inspectors did not observe any slopes within the site with linear sediment controls on the face of the slopes, or appropriate linear controls at the grade breaks of exposed slopes (see Photos 1 through 6).

Photos 1 through 6 show examples of slopes throughout the site that lacked evidence of erosion control BMPs, appropriate linear sediment controls at the grade breaks and face of slopes. Photos 1 and 2 show linear, uncompacted, earthen berms without soil stabilization, which are subject to erosion. Photos 3 through 5 show evidence of significant rilling and sediment transport.

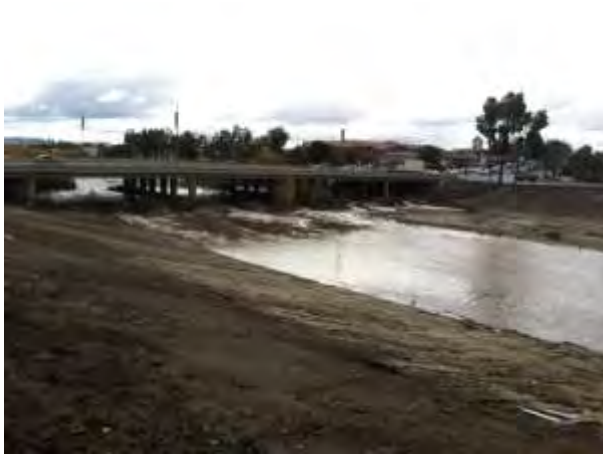
Photos 7 through 10 show examples of areas where there was inadequate implementation of controls to manage run-on to the site and runoff within the site. Photo 7 shows the upstream boundary of the site where Murrieta Creek flows run-on to the site and there is no obvious evidence controls have been implemented to manage the run-on to the site. Photo 8 shows the opposite bank where gullies have formed as a result of run-on to the site and lack of controls to manage runoff within the site. Photo 9 shows a location where a tributary is flowing under a silt fence installed for perimeter control with no evidence of controls to manage the run-on and runoff through the site. Photo 10 is downstream of Photo 9 and shows the gully erosion that has been caused as a result of the lack of run-on controls and runoff controls within the site.

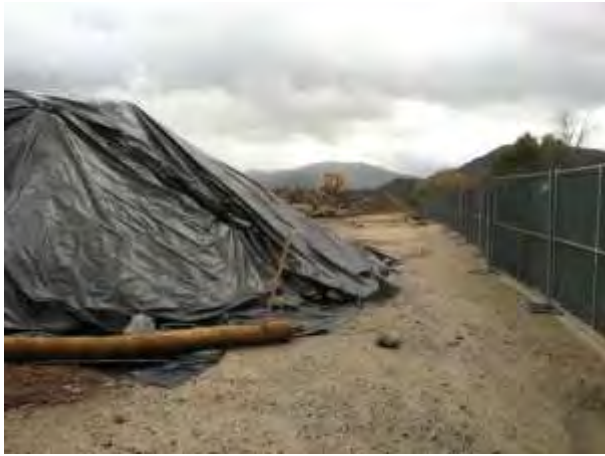
- c. **Observation:** During the January 7, 2016 inspection, the San Diego Water Board inspectors observed stockpiles without adequate berm or containment. See attached January 7, 2016 Facility Inspection Report Photos 12 and 13.

5. Risk Level 2 construction sites are required to cover and berm loose stockpiled construction materials and contain and securely protect stockpiled waste material from wind and rain at all times unless actively being used. San Diego Water Board inspectors observed at least one stockpile of loose construction material with an inadequate berm (see Photo 12), and at least one stockpile of waste material without adequate containment (Photo 13).

Photos 12 and 13 show stockpiles observed without adequate implementation of good housekeeping measures required for Risk Level 2 construction sites. Photo 12 shows loose stockpiled construction materials that are not actively being used without a berm that completely surrounds the stockpile. Photo 13 shows a waste material stockpile lacking measures to contain and securely protect the waste material (i.e. scrap metal) from wind and rain at all times.

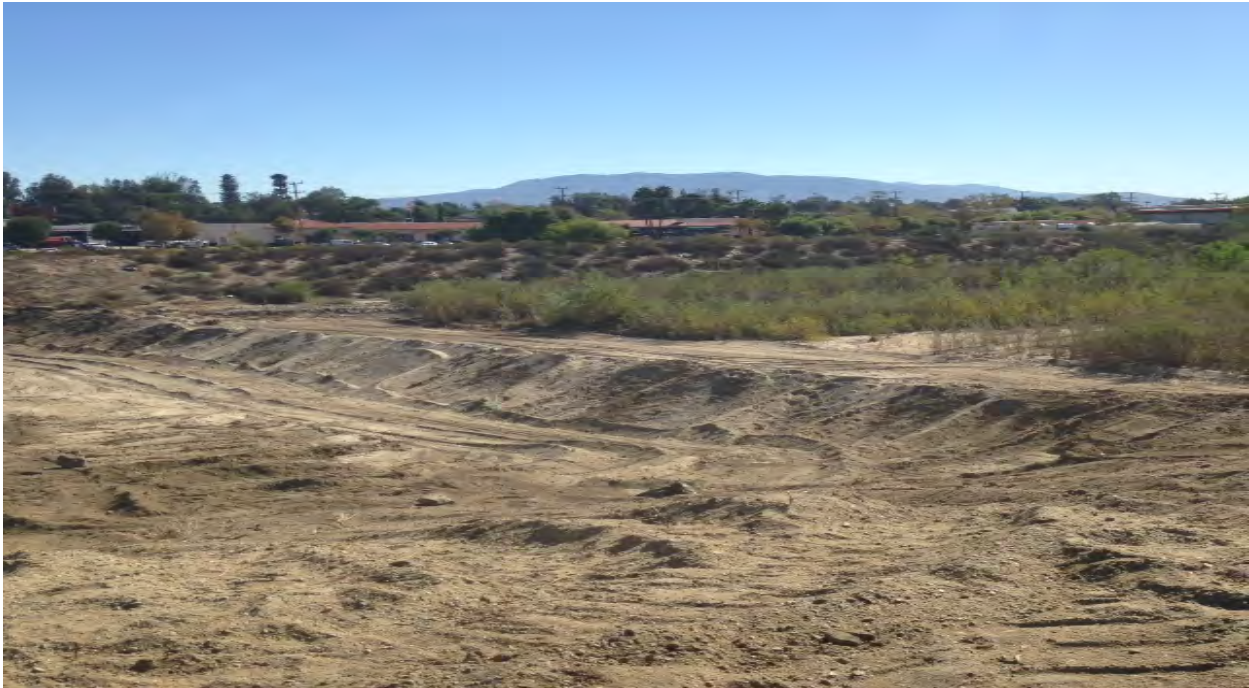
Earthen Berm: 4' Tall X 12' Wide X Bank to Bank Berm placed at the Downstream End of project for Run-off Control.

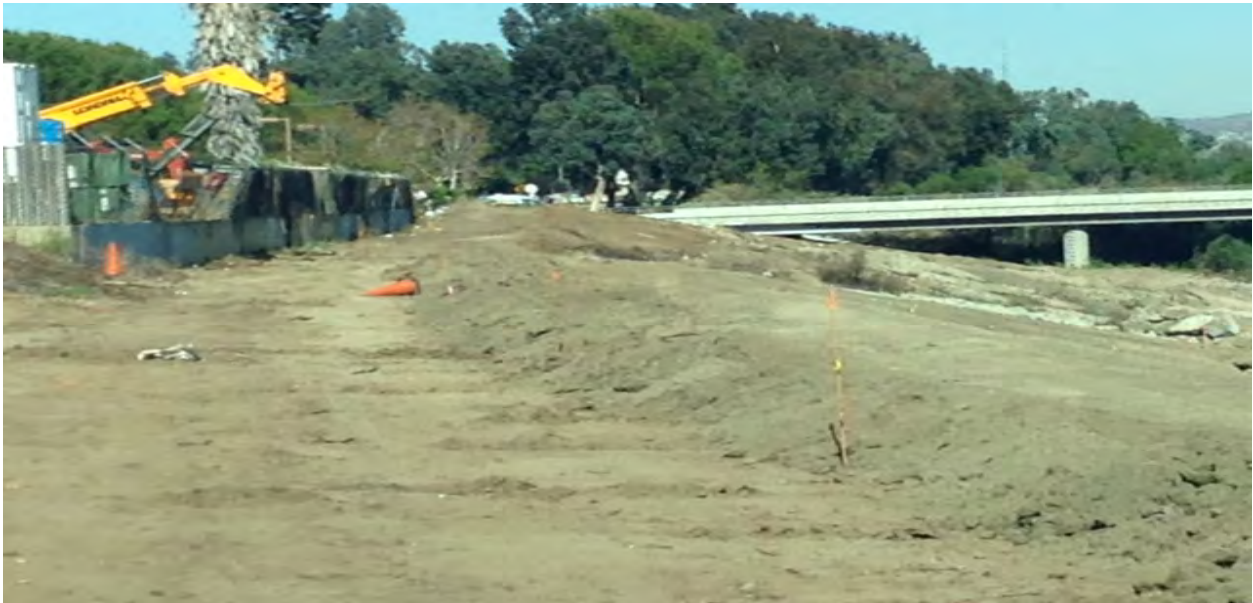
Earthen berms are placed on top of embankments in non-active parts of the creek as part of the run-on protection. North end of the project near Rancho California Rd. This portion of the project from Sta. 107+00 to 102+00 is to be cleared only. OHL has requested US Army Corp to review the current condition and provide contour grading plans as well as any recommended BMPs.

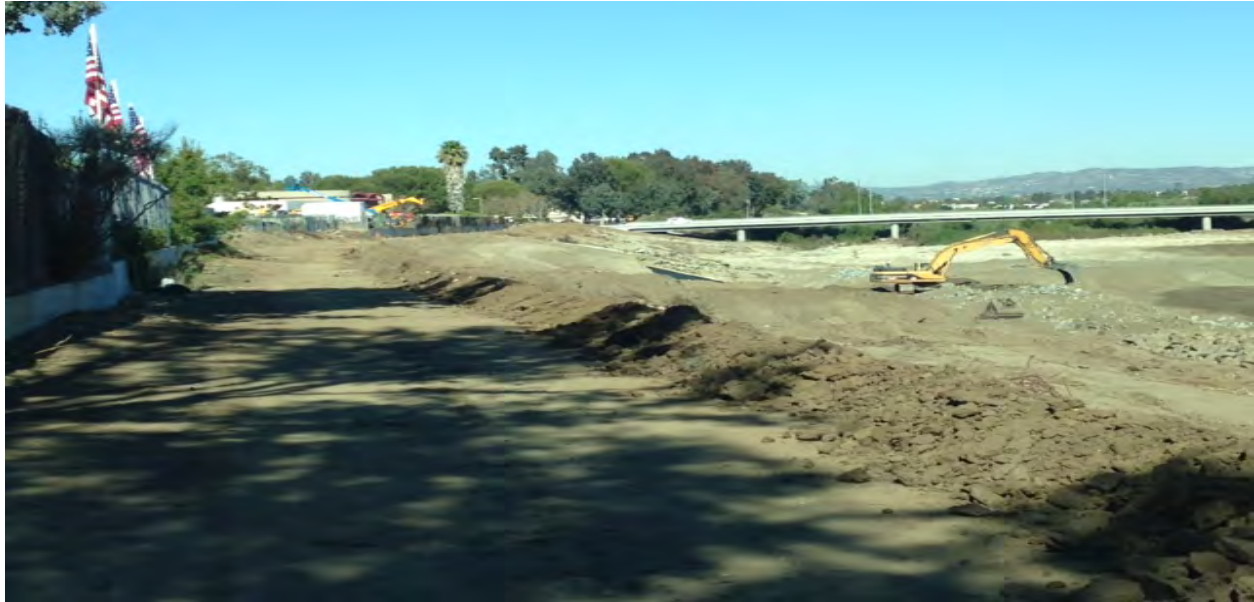
Picture shows riprap being installed as part of the permanent slope protection from Sta. 102+00 to 98+00. The earthen berm on top along the access road is a part of the temp. run-on control.

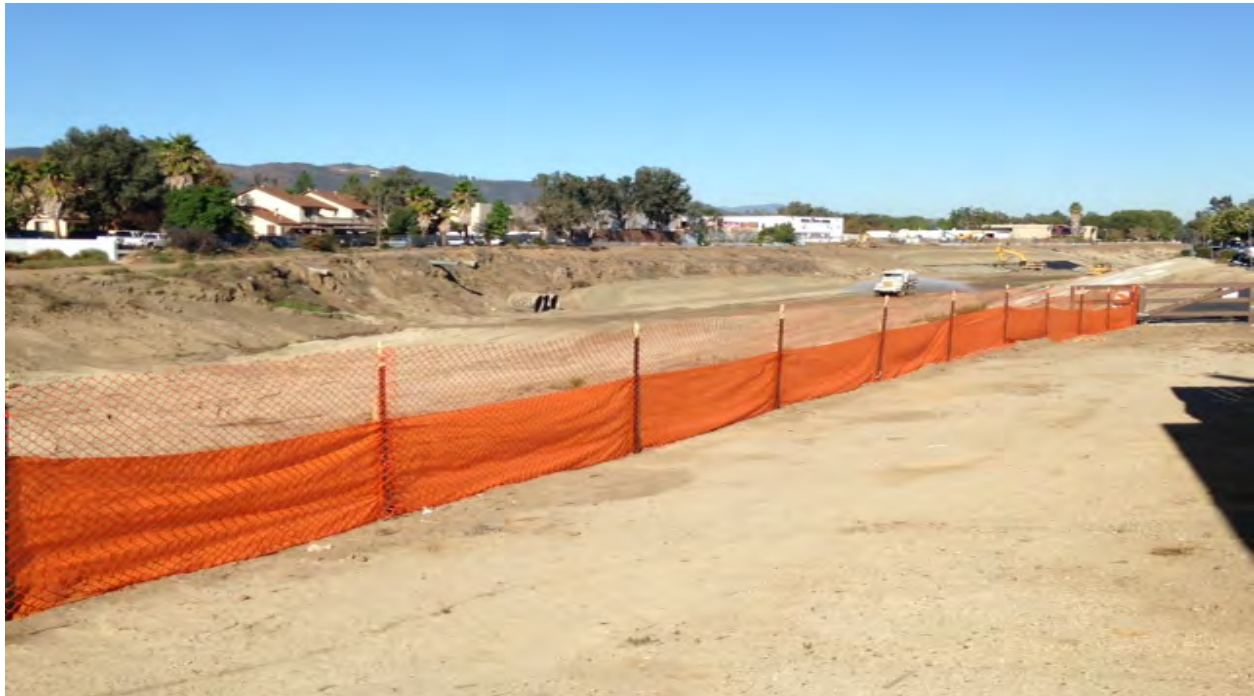
This is along the eastside of the creek approx. 1,500 ft downstream of the Rancho California Rd. OC. Silt fence is in place as part of the run-on control.

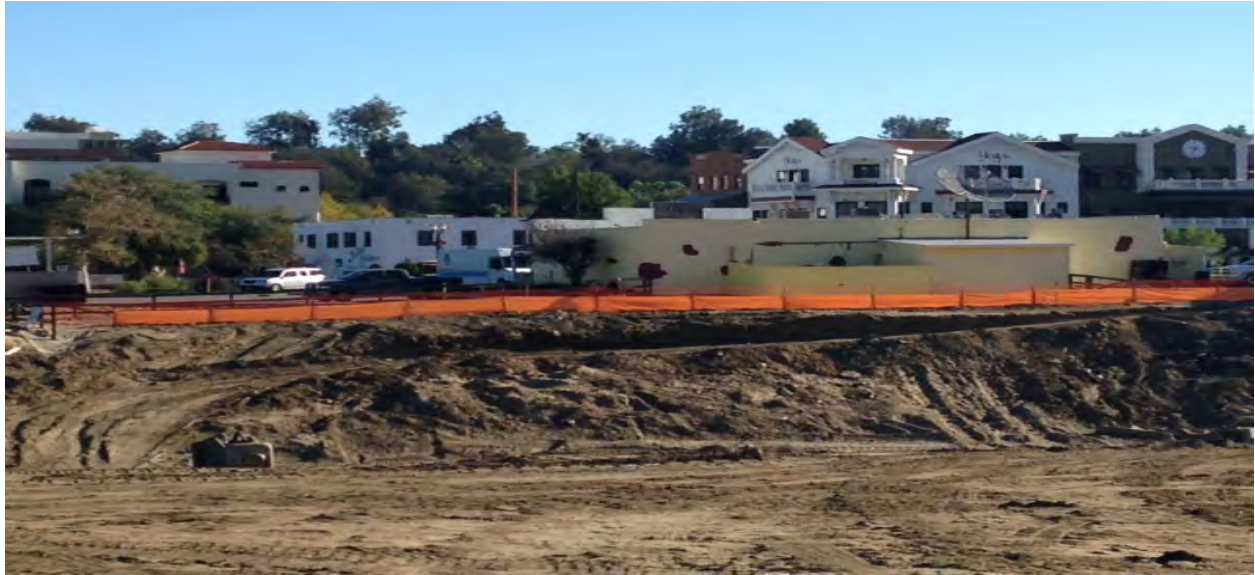
Eastside bank at Approx. Sta. 84+00 to 78+00. Silt fence in place for run-on control.

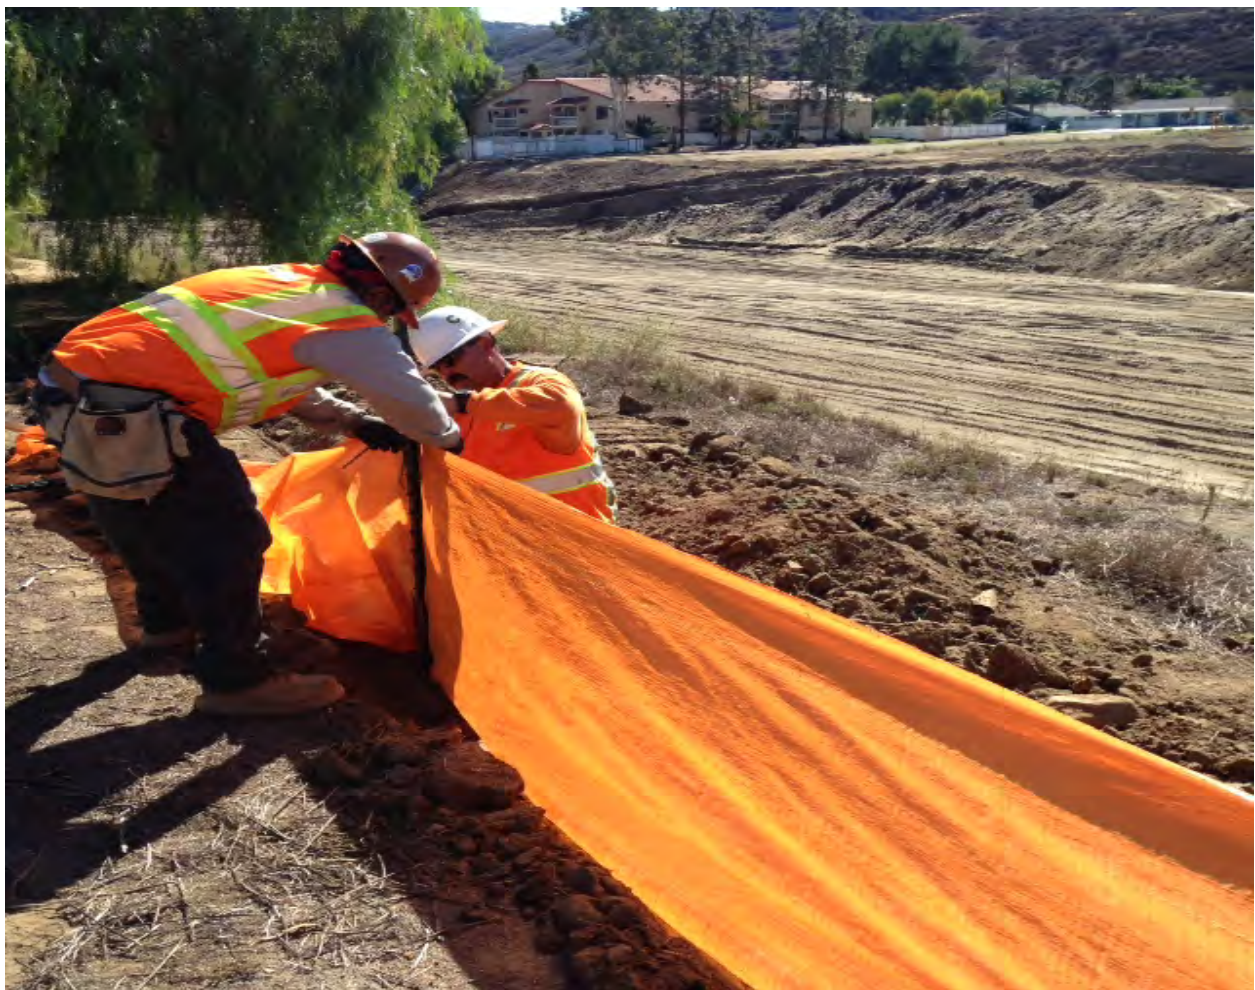
Crews installing additional silt fence along east bank Approx. Sta. 78+00 to 72+00.

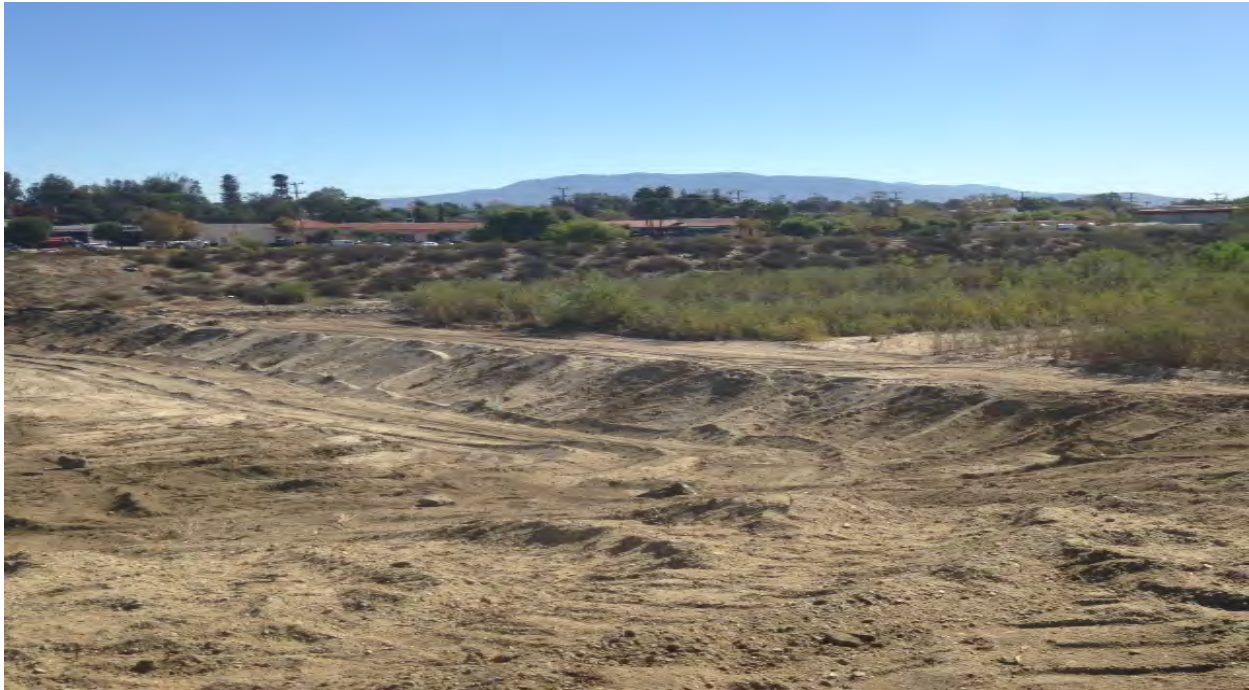
Earthen Berm: 4' Tall X 12' Wide X Bank to Bank Berm placed at the Downstream End of project for Run-off Control.

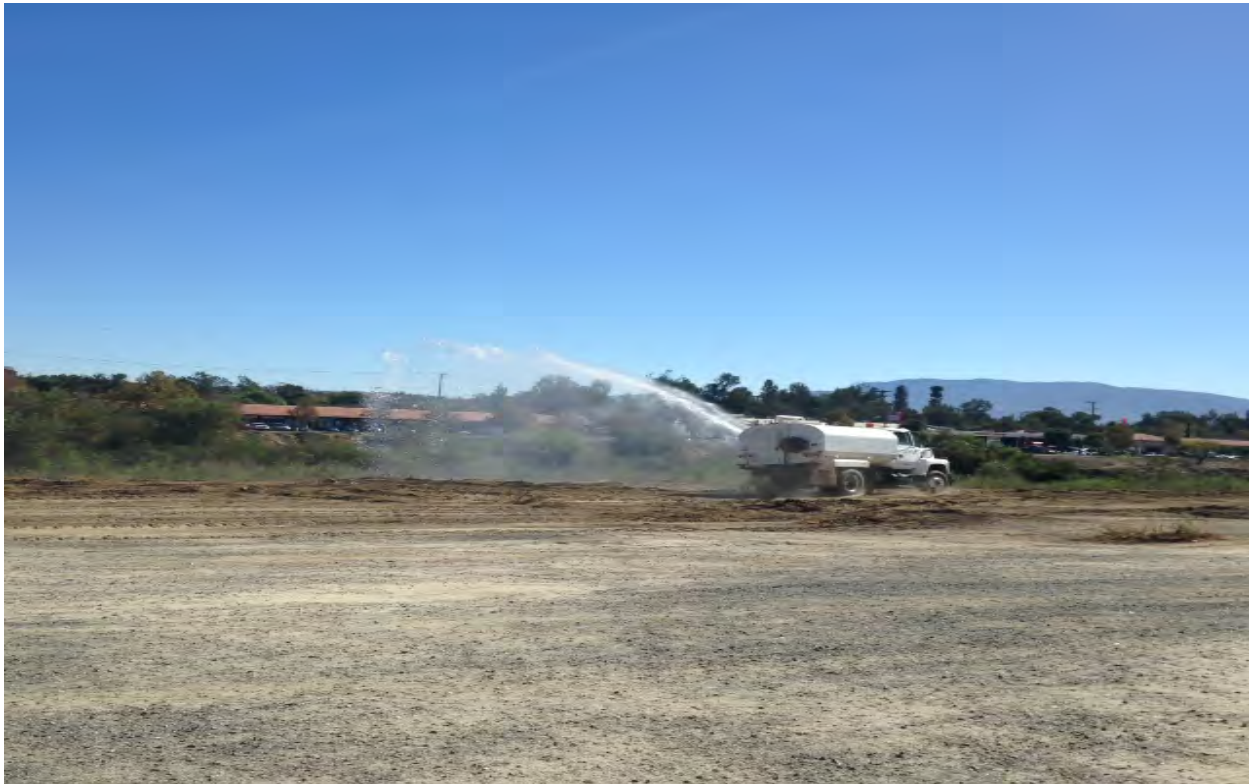
Dust Control: Fulltime Water trucks (2-3 each 4,000Gal Capacity) are being used to keep dust down.

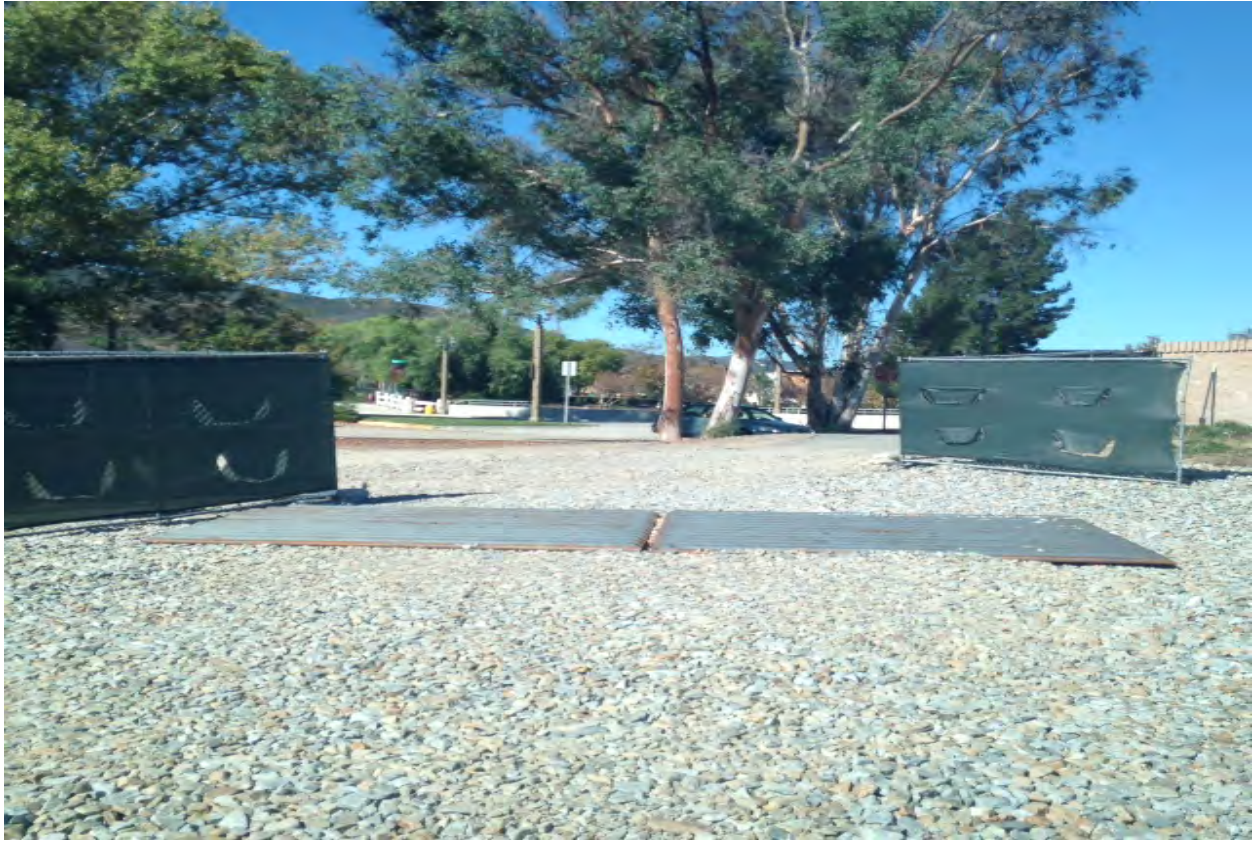
Construction Entrance: Picture of one of our exits (currently not being used) at the south end of project

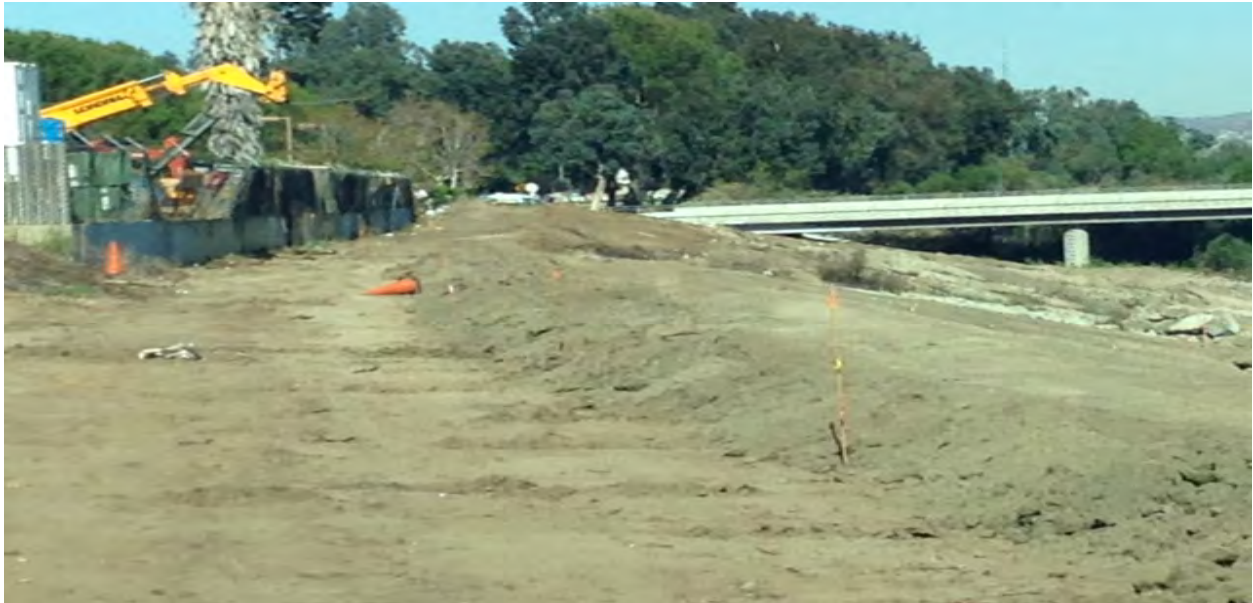
Earthen berms are placed on top of embankments in non-active parts of the creek as part of the run-on protection. North end of the project near Rancho California Rd. This portion of the project from Sta. 107+00 to 102+00 is to be cleared only. OHL has requested US Army Corp to review the current condition and provide contour grading plans as well as any recommended BMPs.

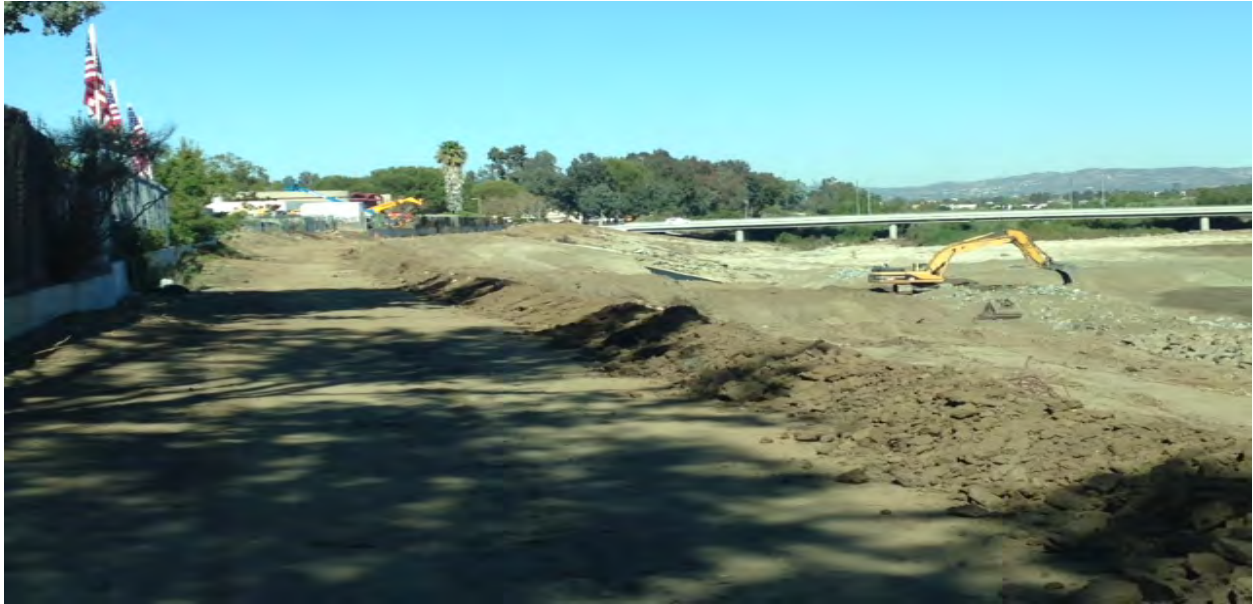
Picture shows riprap being installed as part of the permanent slope protection from Sta. 102+00 to 98+00. The earthen berm on top along the access road is a part of the temp. run-on control.

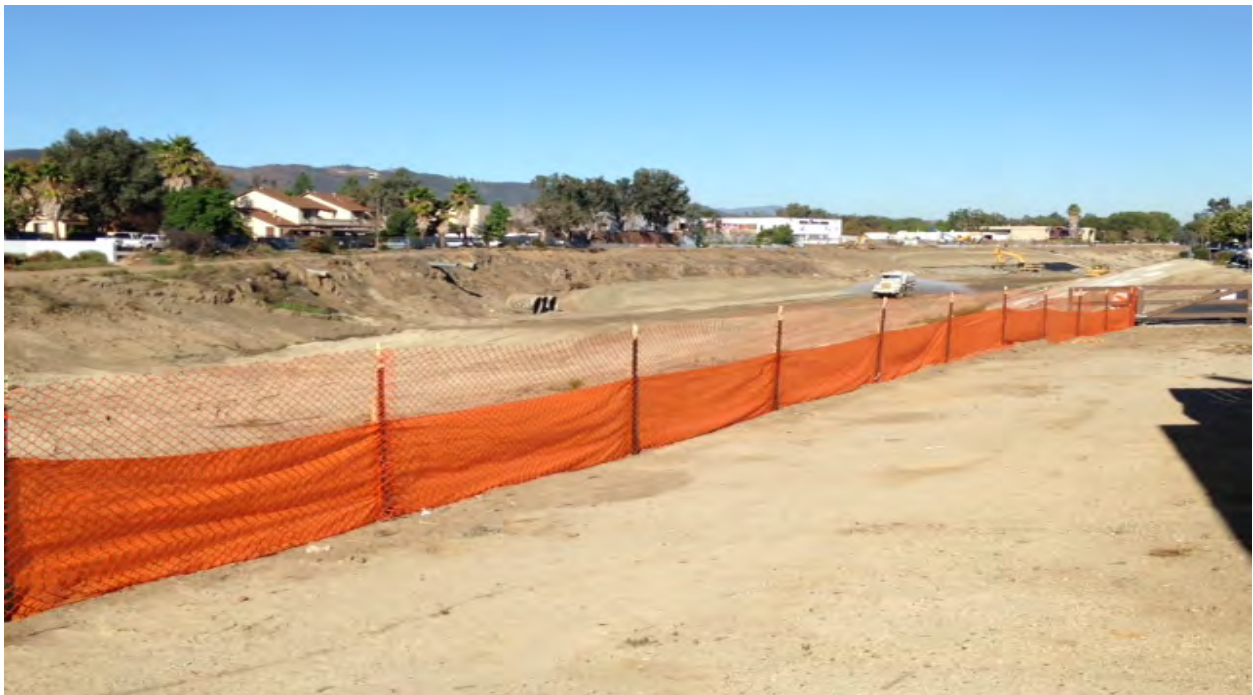
This is along the eastside of the creek approx. 1,500 ft downstream of the Rancho California Rd. OC. Silt fence is in place as part of the run-on control.

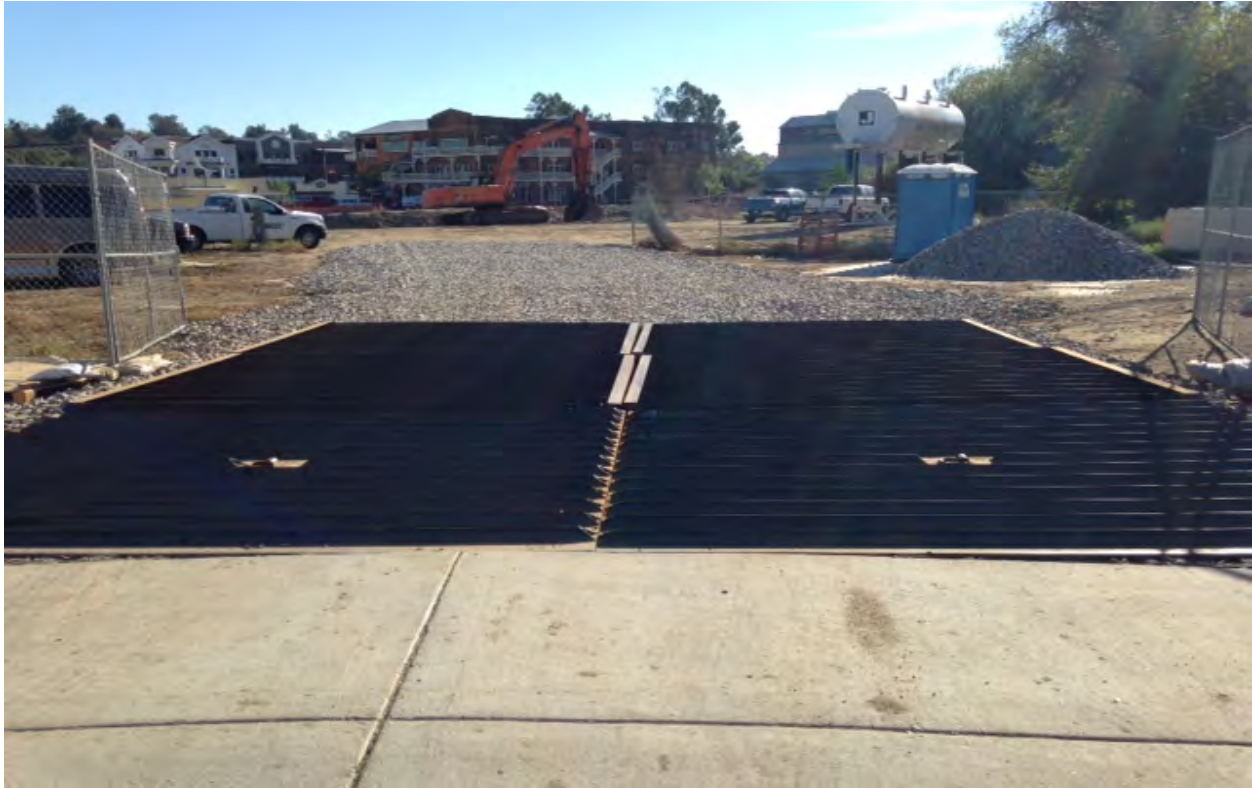
Main construction entrance near Felix Valdez Rd. (90def bend). Rock and track-out plates are cleaned and maintained daily or as needed.

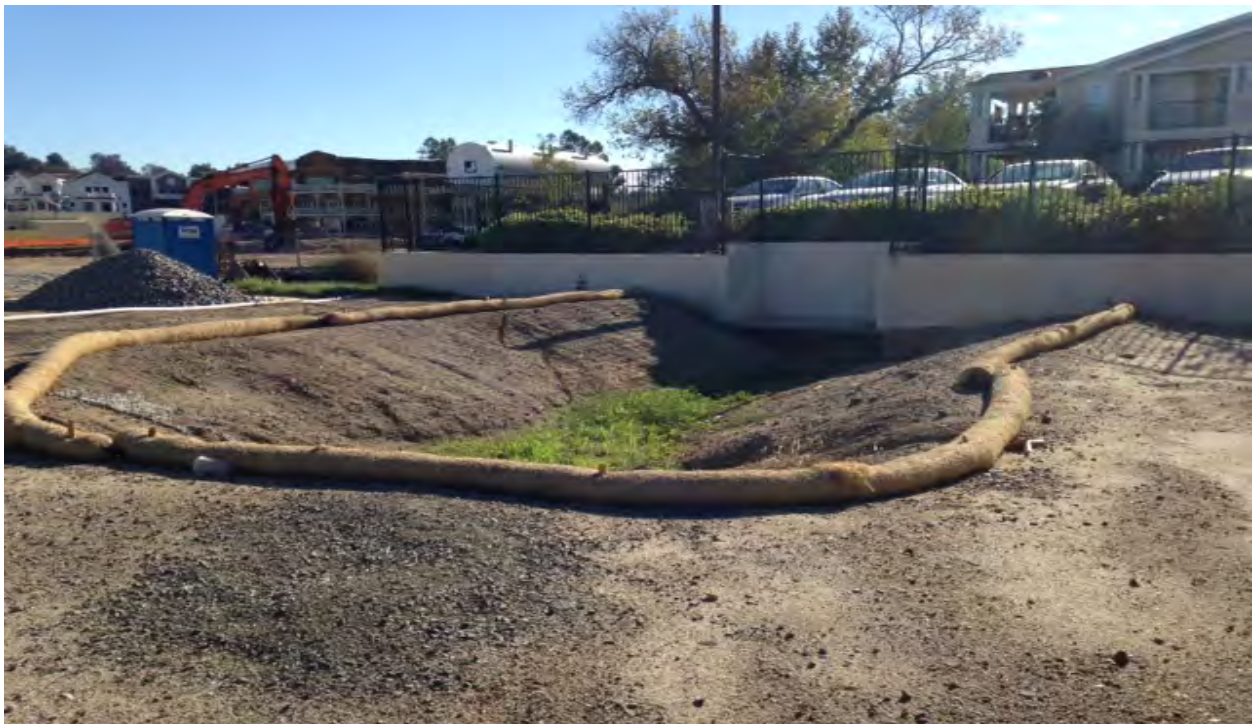
Earthen swale near Felix Valdez road is protected using fiber rolls as perimeter control.

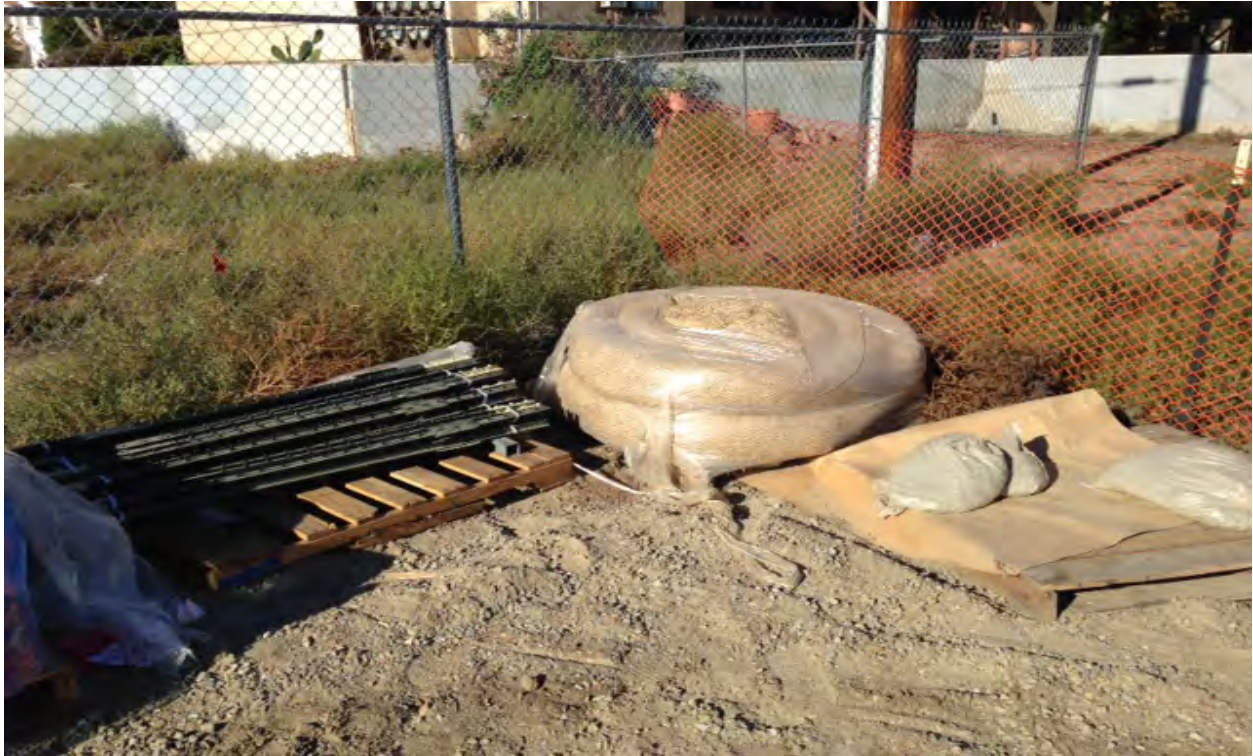
All materials are stored on pallets near the Field yard near Felix Valdez entrance.

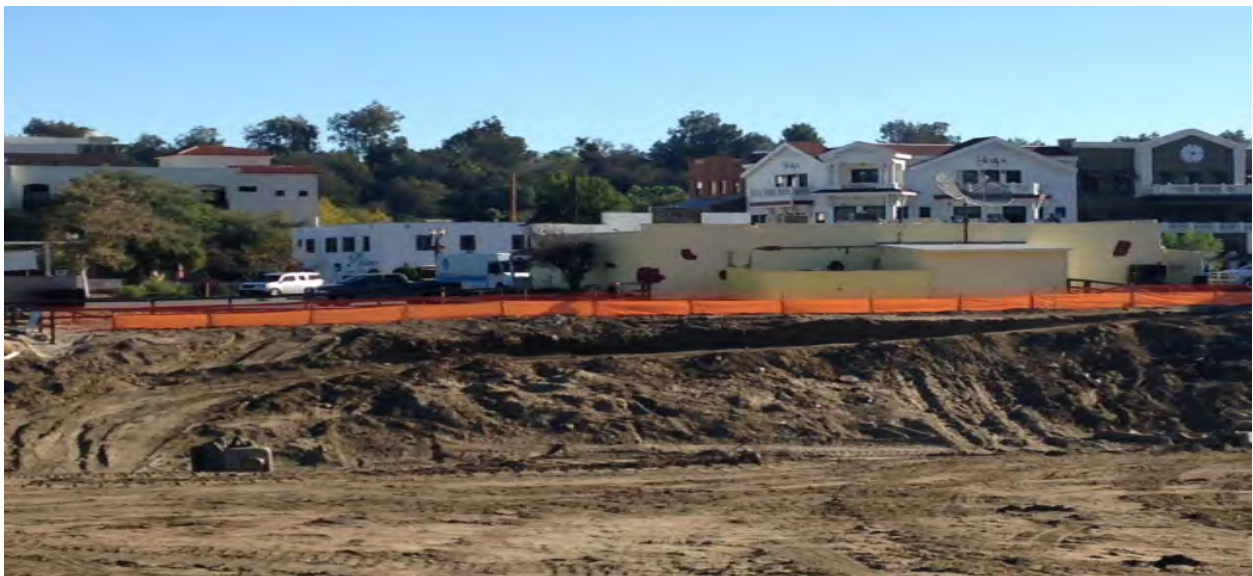
Eastside bank at Approx. Sta. 84+00 to 78+00. Silt fence in place for run-on control.

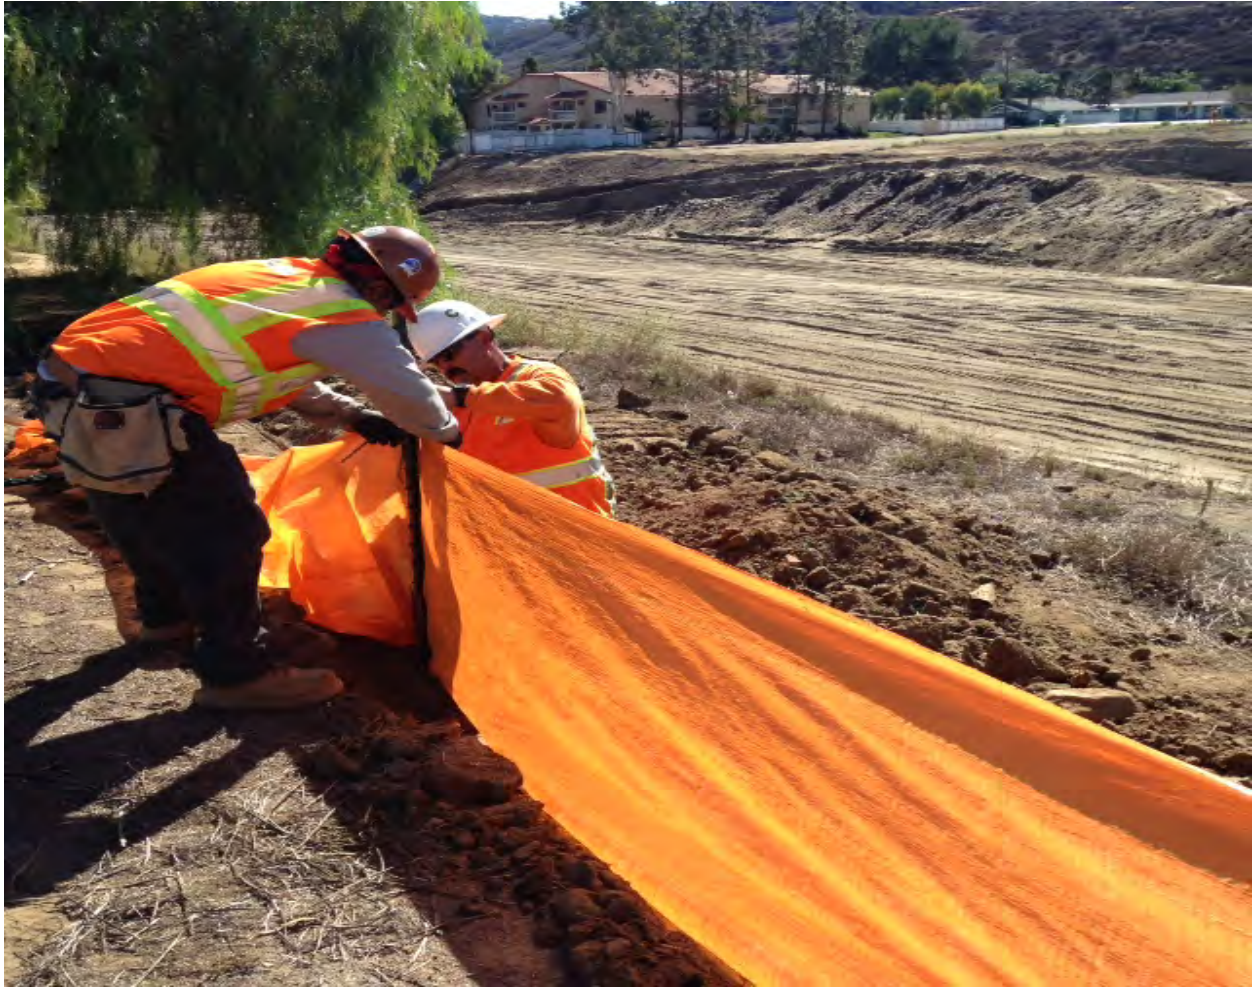
Crews installing additional silt fence along east bank Approx. Sta. 78+00 to 72+00.

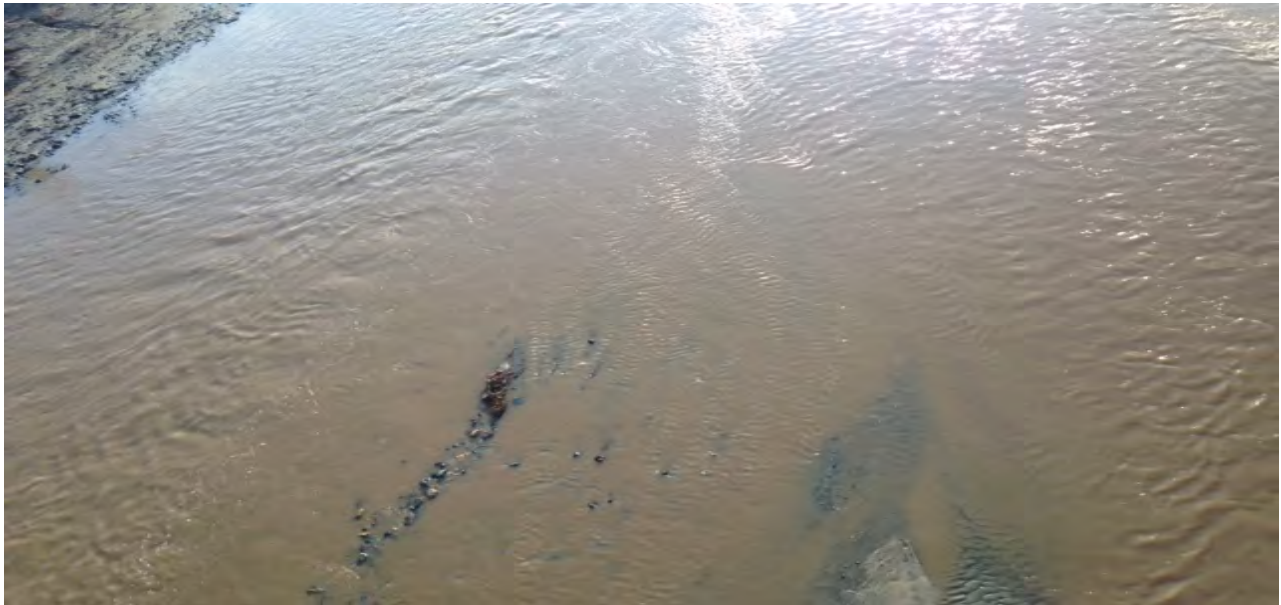
Picture is taken looking down from Rancho California Bridge downstream on 1/7/16. Rancho California bridge is upstream of the project limits.

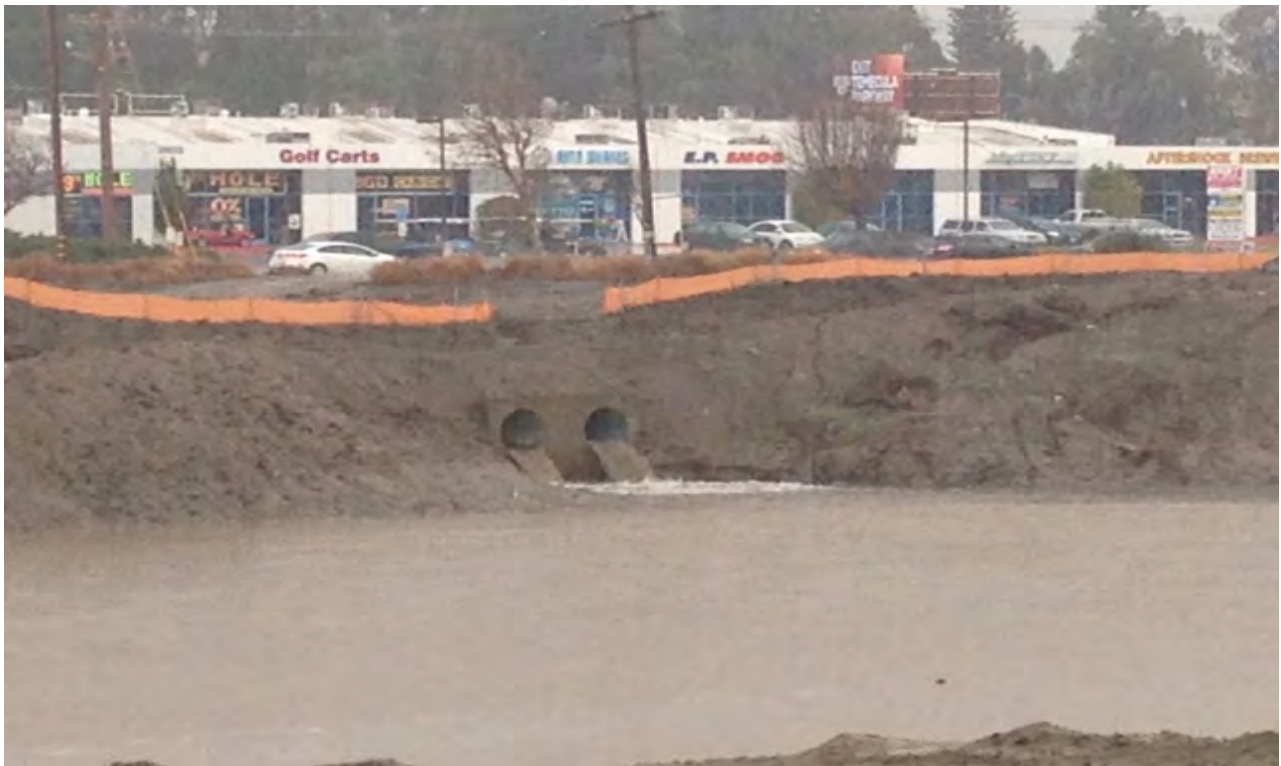
Approx. Sta. 62+00 near downstream project limits. Picture was taken during rain, shows approx. 8' high water level (from bottom of creek bed) and one of the side drains with heavy flows.

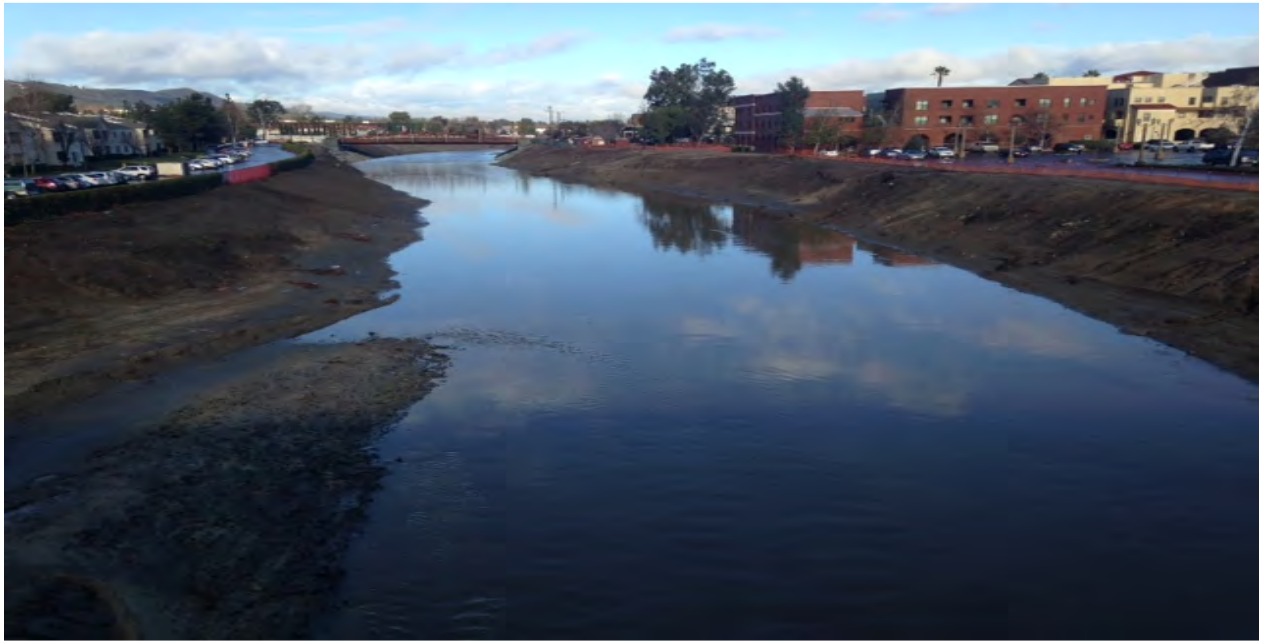
Picture is looking upstream from 1st St. Bridge on 1/7/16.

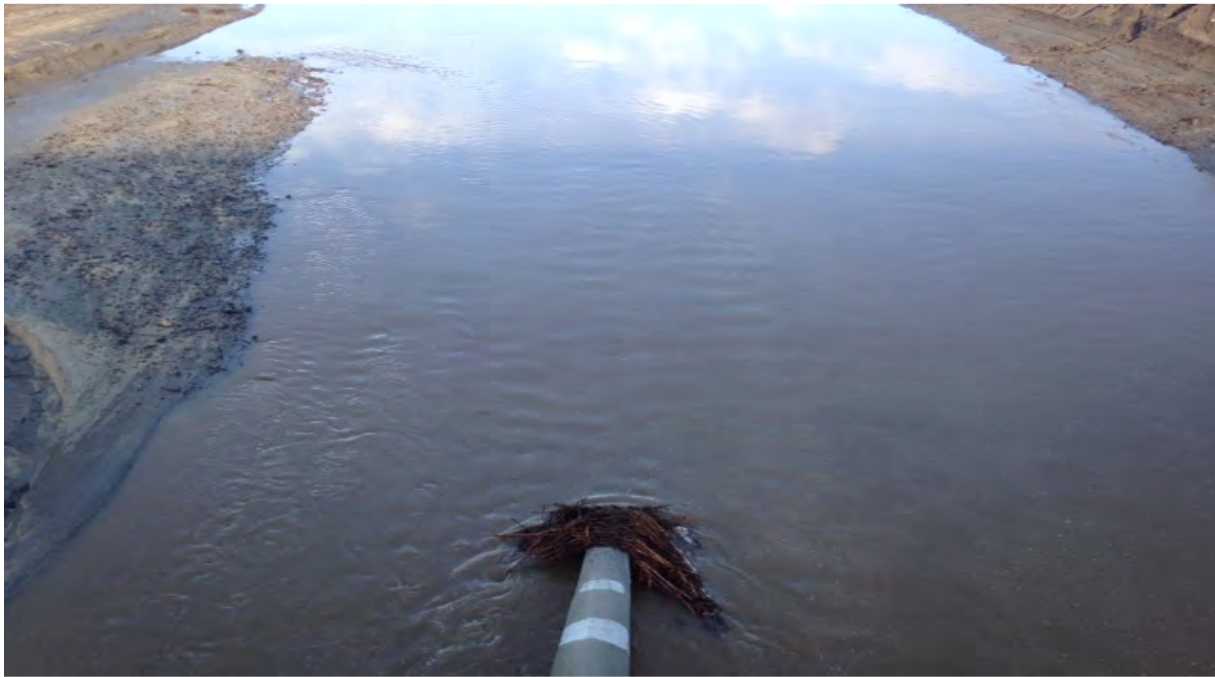
Picture is looking upstream directly down from 1st St. Bridge. 1st St. Bridge is within the project limits.
