WaterFix Construction Impacts—Yolo County Traffic, Road Safety, and Pavement Deterioration

Prepared by the County of Yolo for presentation to the State Water Resources Control Board

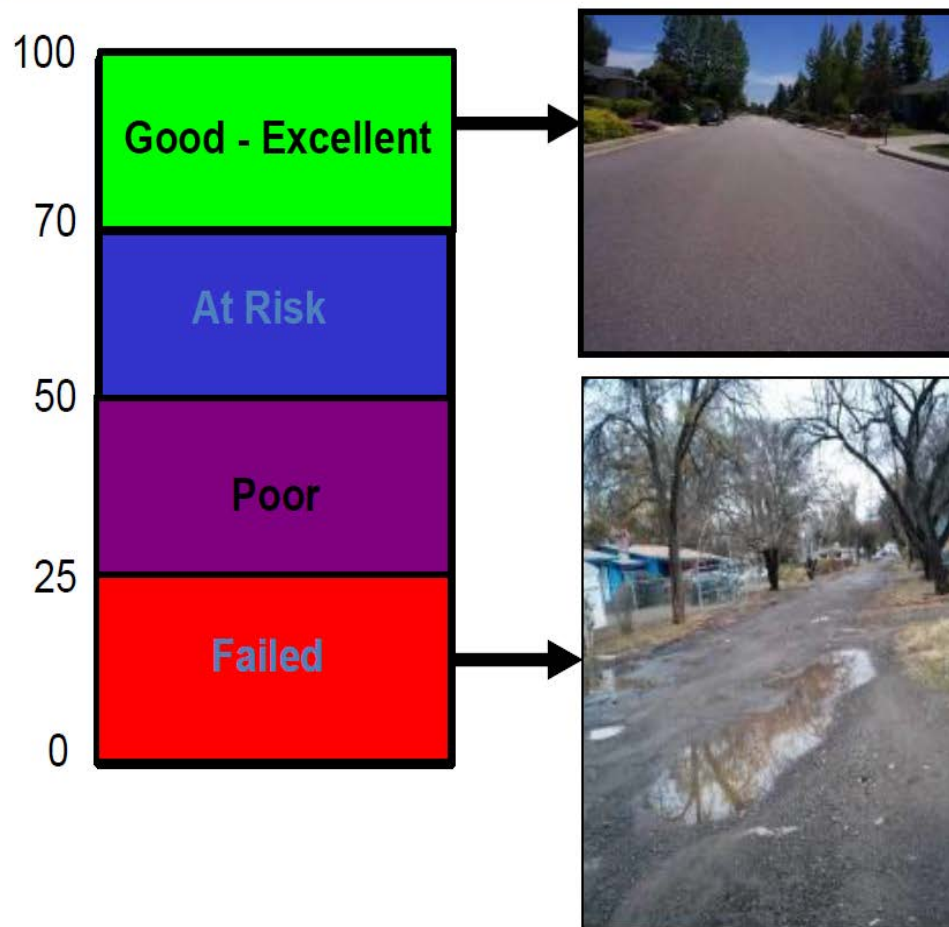
PCI for Affected Road Segments in Yolo County

Less than 70 = At Risk

Less than 50 = Poor

State Route 84 PCI from p. 19-19 of Final EIR/EIS. Based on International Roughness Index an equivalent system. IRI of greater than 170 = deficient

CT 33 SR 84 West Sacramento Courtland Rd Deficient Majority IRI range from 157 to 294. Approximately 1 mile better than acceptable (minority of segment length).
(Jefferson Blvd) City Limits

NAME	SECTION	START	END	LENGTH	PCI
YOL 01	SOUTH RIVER RD - 139	10	FREEPORT BRIDGE	ROSE RD	12,319	75
	SOUTH RIVER RD - 139	15	ROSE RD	PUMPHOUSE RD	3,560	95
	SOUTH RIVER RD - 139	25	PUMPHOUSE RD	WILLOW POINT RD	911	95
	SOUTH RIVER RD - 139	30	WILLOW POINT RD	NETHERLANDS RD	4,317	94
	SOUTH RIVER RD - 139	30	5580' N/O FREEPORT	FREEPORT BRDG	5,580	45
	SOUTH RIVER RD - 139	40	NETHERLANDS RD	CR141	3,910	100
	SOUTH RIVER RD - 139	50	CR141	MERRITT LANDING	9,120	86
	SOUTH RIVER RD - 139	60	MERRITT LANDING	CR142	4,420	80
	SOUTH RIVER RD - 140	70	CR142	5280' S/O CR142	5,280	57
	SOUTH RIVER RD - 140	74	5280' S/O CR 142	9585' S/O CR 142	4,305	41
	SOUTH RIVER RD - 140	83	9585' S/O CR 142	3360' N/O CR 143	5,000	37
	SOUTH RIVER RD - 140	87	3360' N/O CR 143	CR 143	3,360	44
	SOUTH RIVER RD - 140	90	CR143	COURTLAND RD	4,057	44
YOL 02	SOUTH RIVER RD - 140	90	COURTLAND RD	SACTO COUNTY	3,047	44
YOL03	COURTLAND RD - 158	10	SH 84	CR140	4,995	36
