Central Coast Regional Water Quality Control Board
Prosecution Team Evidence
in the matter of
Cease and Desist Order R3-2016-0015
Exhibit 6

Wastewater Analysis

Centrally Grown
Cambria, CA

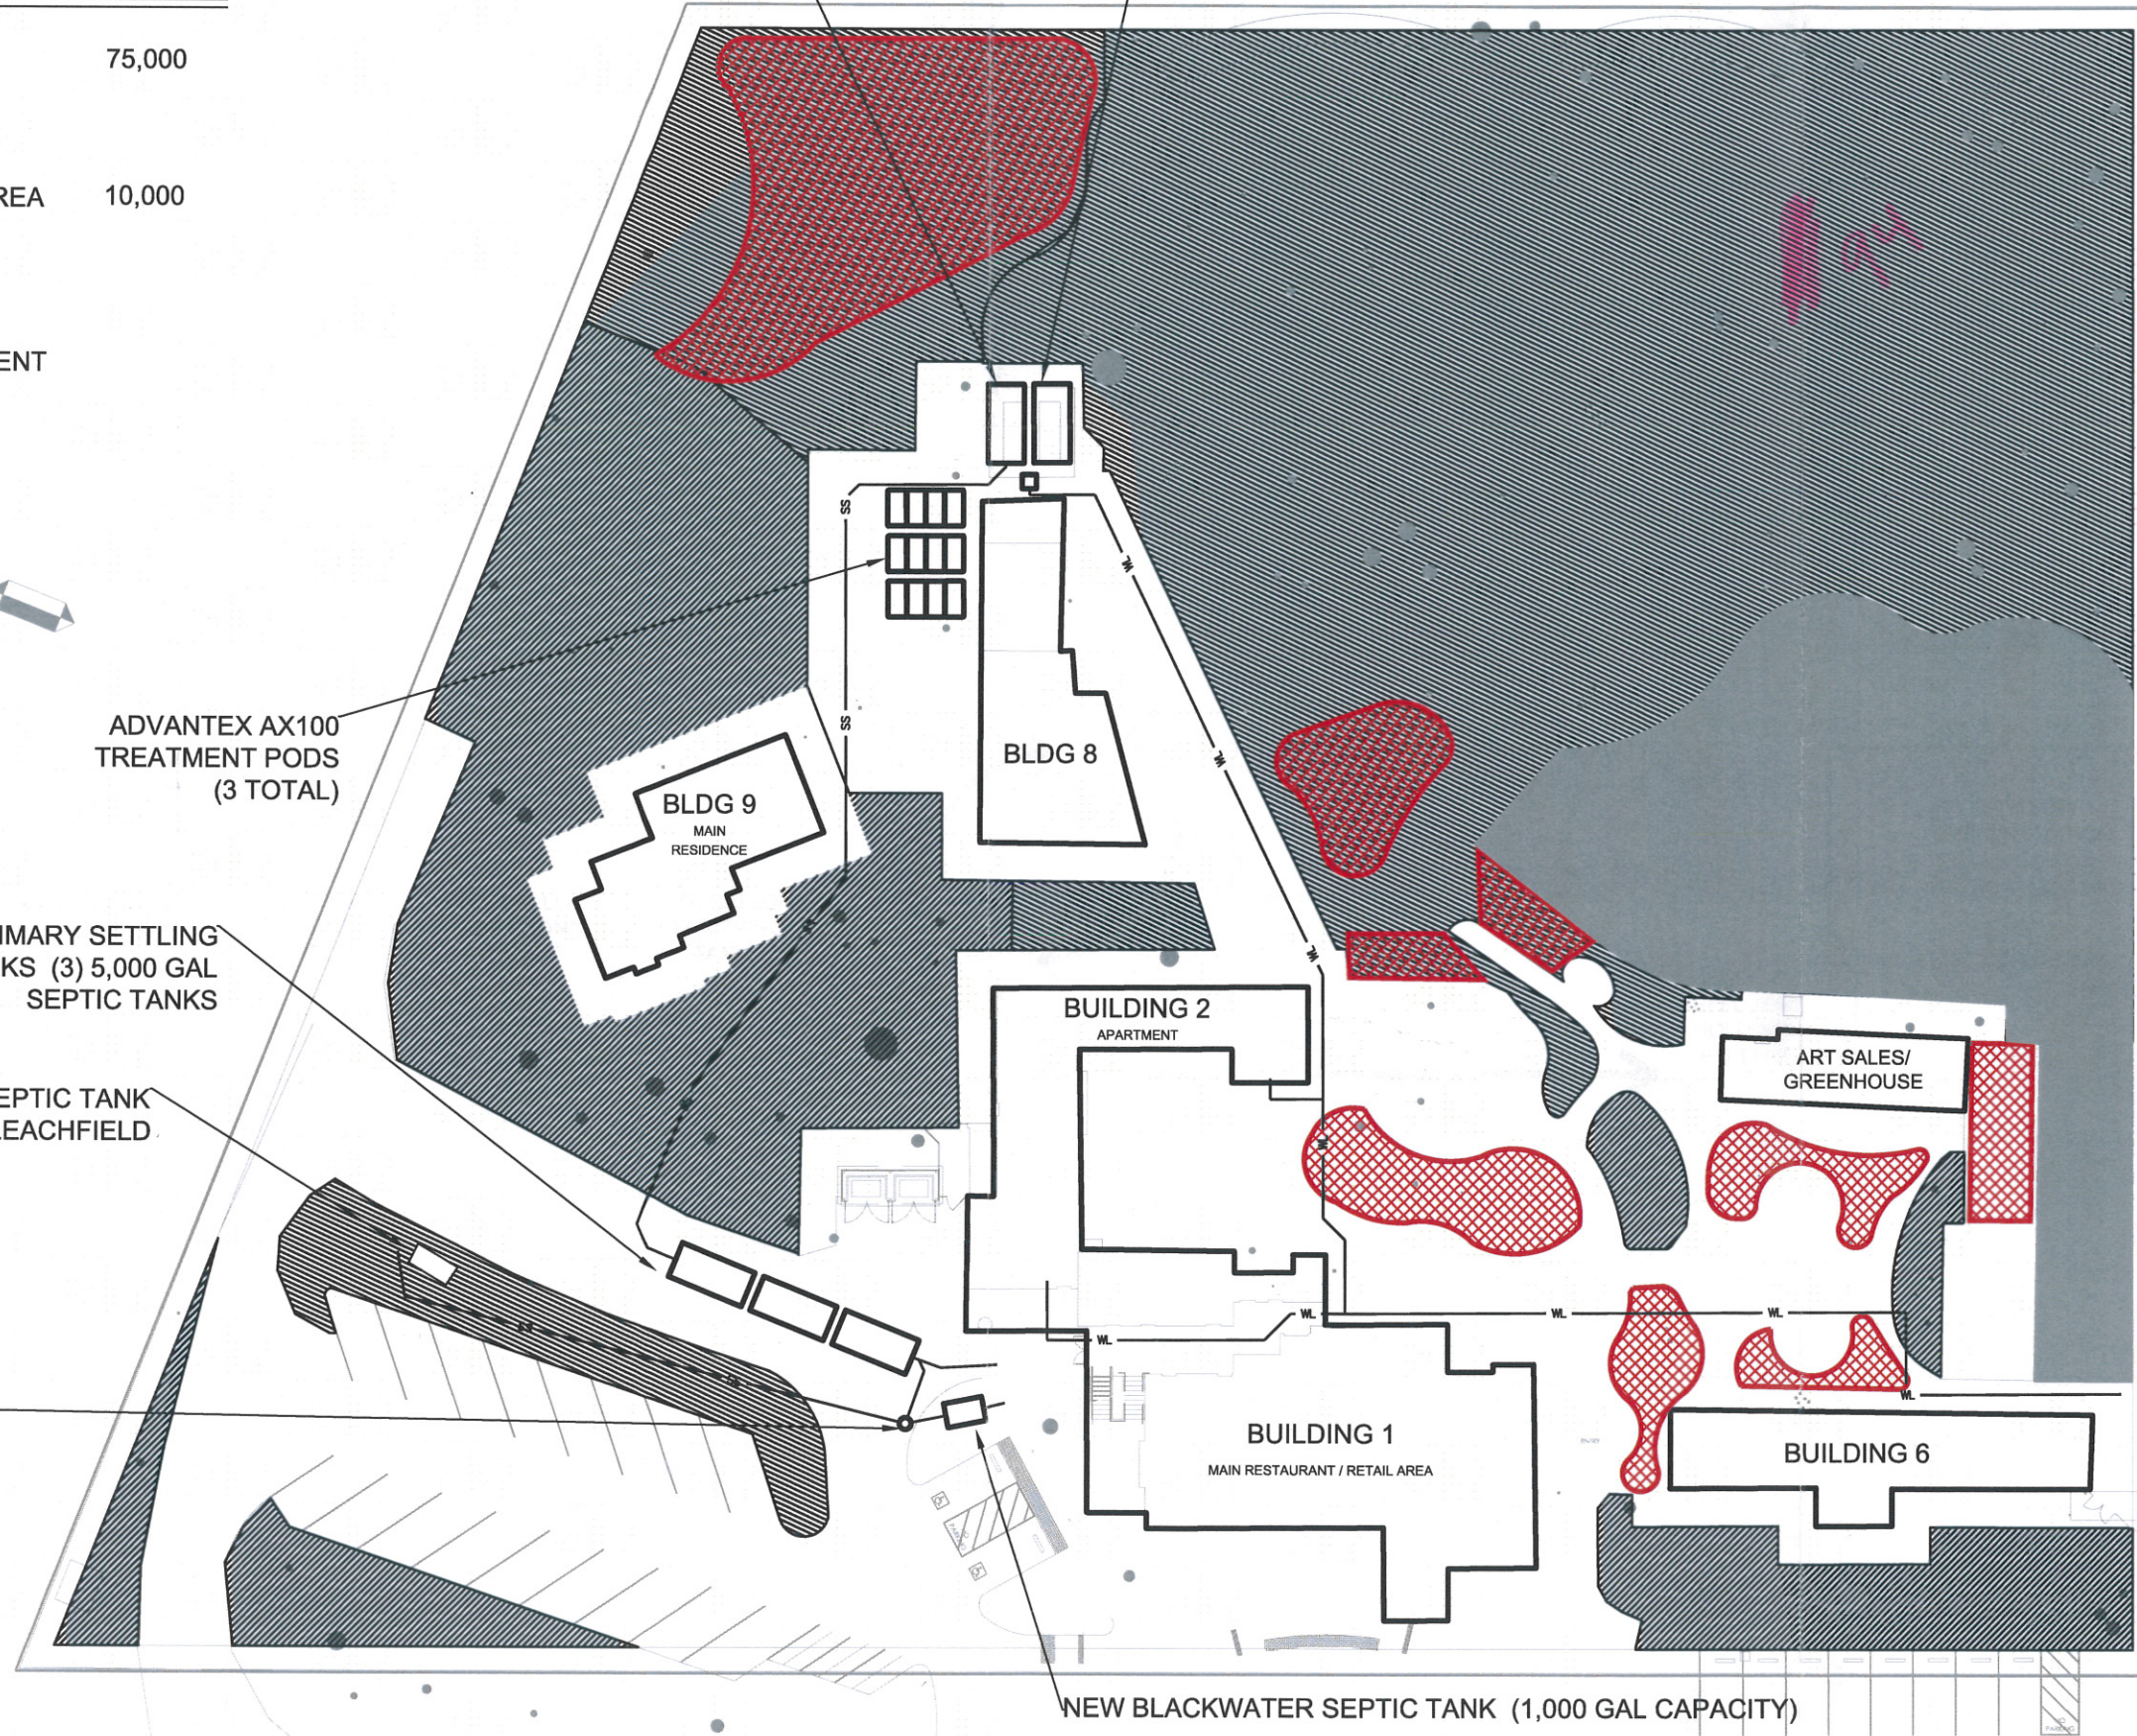
5,000 GALLON RECIRCULATION TANK FOR WASTEWATER TREATMENT

5,000 GALLON EFFLUENT STORAGE/EQUALIZATION TANK

ADVANTECH AX100 TREATMENT PODS (3 TOTAL)

PRIMARY SETTLING TANKS (3) 5,000 GAL SEPTIC TANKS

EXISTING SEPTIC TANK AND EXISTING LEACHFIELD

BLACKWATER SYSTEM OVERFLOW TO WASTEWATER TREATMENT PLANT

NEW BLACKWATER SEPTIC TANK (1,000 GAL CAPACITY)

Effluent from the blackwater system will be discharged to the existing leachfield, located in the northern part of the property. The existing leachfield has been operating for over 30 years with an average summer loading of 2,500 gpd (estimated) without sign of leachfield failure. In an effort to check for overflowing and/or daylighting, 17,350 gallons of water was recently added to the leachfield in 49 hours; no sign of leachfield failure was discovered. However, because the capacity of the existing leachfield cannot be confirmed in the conventional manner (no plans or drawings are available to locate the exact size of leachlines), the blackwater system will be designed with an overflow structure so that in the event the existing leachfield reaches capacity, the effluent from the blackwater septic tank will be diverted into the main wastewater treatment system. The location of the blackwater system septic tank is shown on Figure 1 and a process schematic of the entire wastewater system is shown in Figure 2.

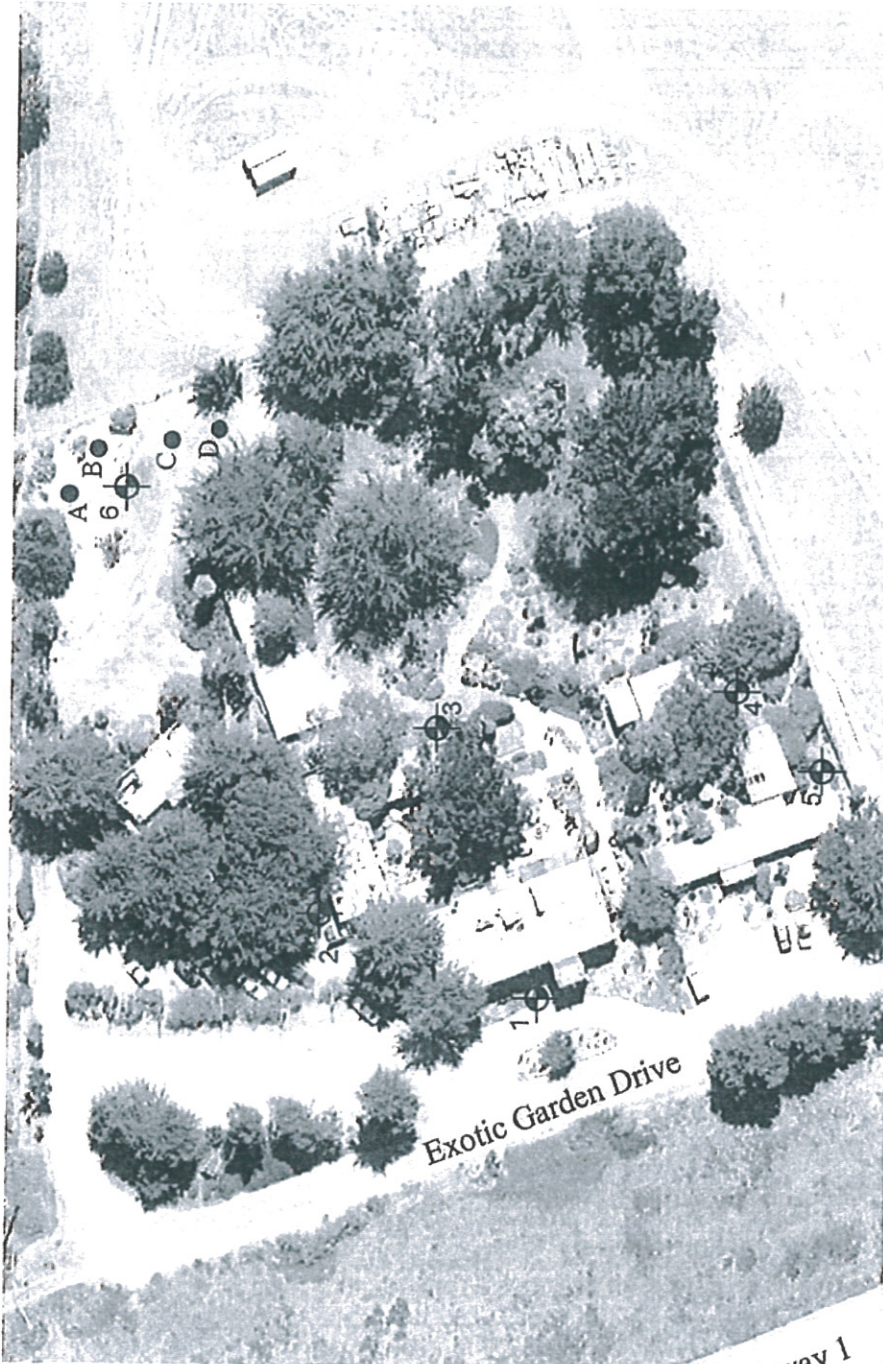
CENTRALLY GROWN

7432 Exotic Garden Drive
Cambria, California

A former two-story restaurant building at 7432 Exotic Gardens Drive in Cambria, California is to be repaired and remodeled for re-use as a retail facility. The building appears to be of wood and possibly steel-frame construction. The site includes extensive mature landscaping and trees at the rear of the existing restaurant building (hereinafter referred to as the "main building"), with walking paths surfaced with flatwork, pavers or gravel. Arranged around the front half of the property in various locations are several single-story wood-frame structures that appear to have been used as additional retail space, storage areas, and an aviary. The rear half of the site is comprised of trees and landscaping, with a perimeter fence line. To the northwest of the existing buildings and grounds is a two-story single-family residence; we understand this structure is not be part of the proposed project. The main building appears to occupy the highest elevation on the site, and the topography slopes down gradually from the main building in all directions. Exotic Gardens Drive, which dead-ends just north of the site, and State Highway 1 are to the west of the site. Beyond the site to the north, east and south is large acreage ranchland. The approximate locations of the existing improvements on the site are shown on the Boring Location Map in Appendix A.
