Re: **ANNUAL 2010 NPDES REPORT: DYNEGY MORRO BAY, LLC**

DISCHARGE MONITORING AND REPORTING PROGRAM
MORRO BAY POWER PLANT

ANNUAL REPORT
DISCHARGE MONITORING & REPORTING PROGRAM

MORRO BAY POWER PLANT

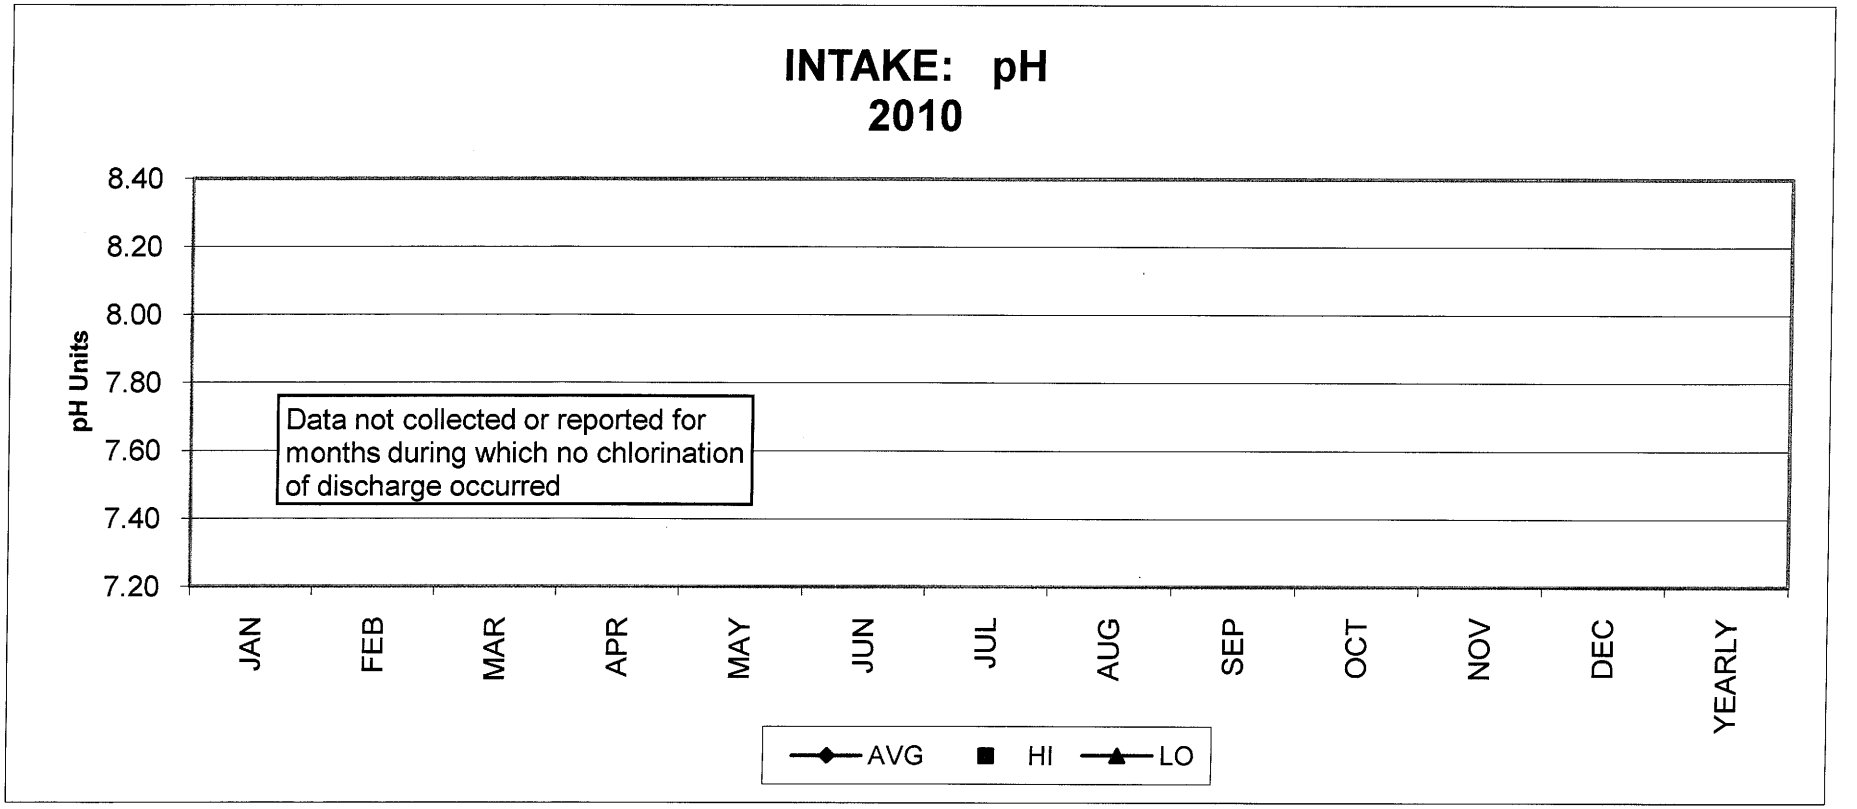
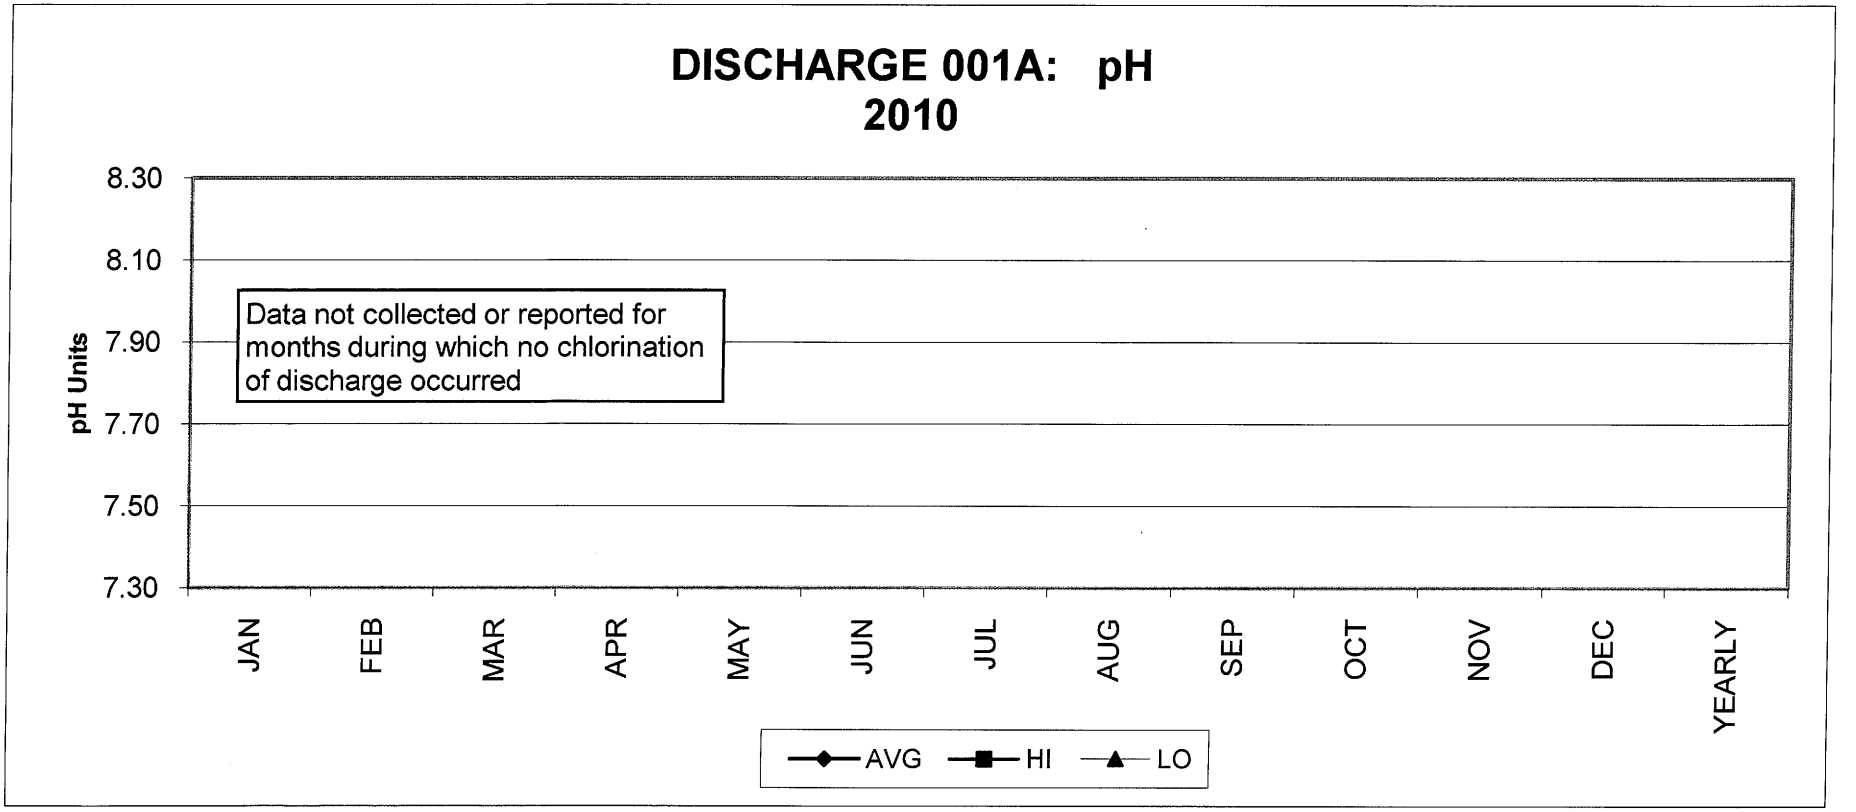
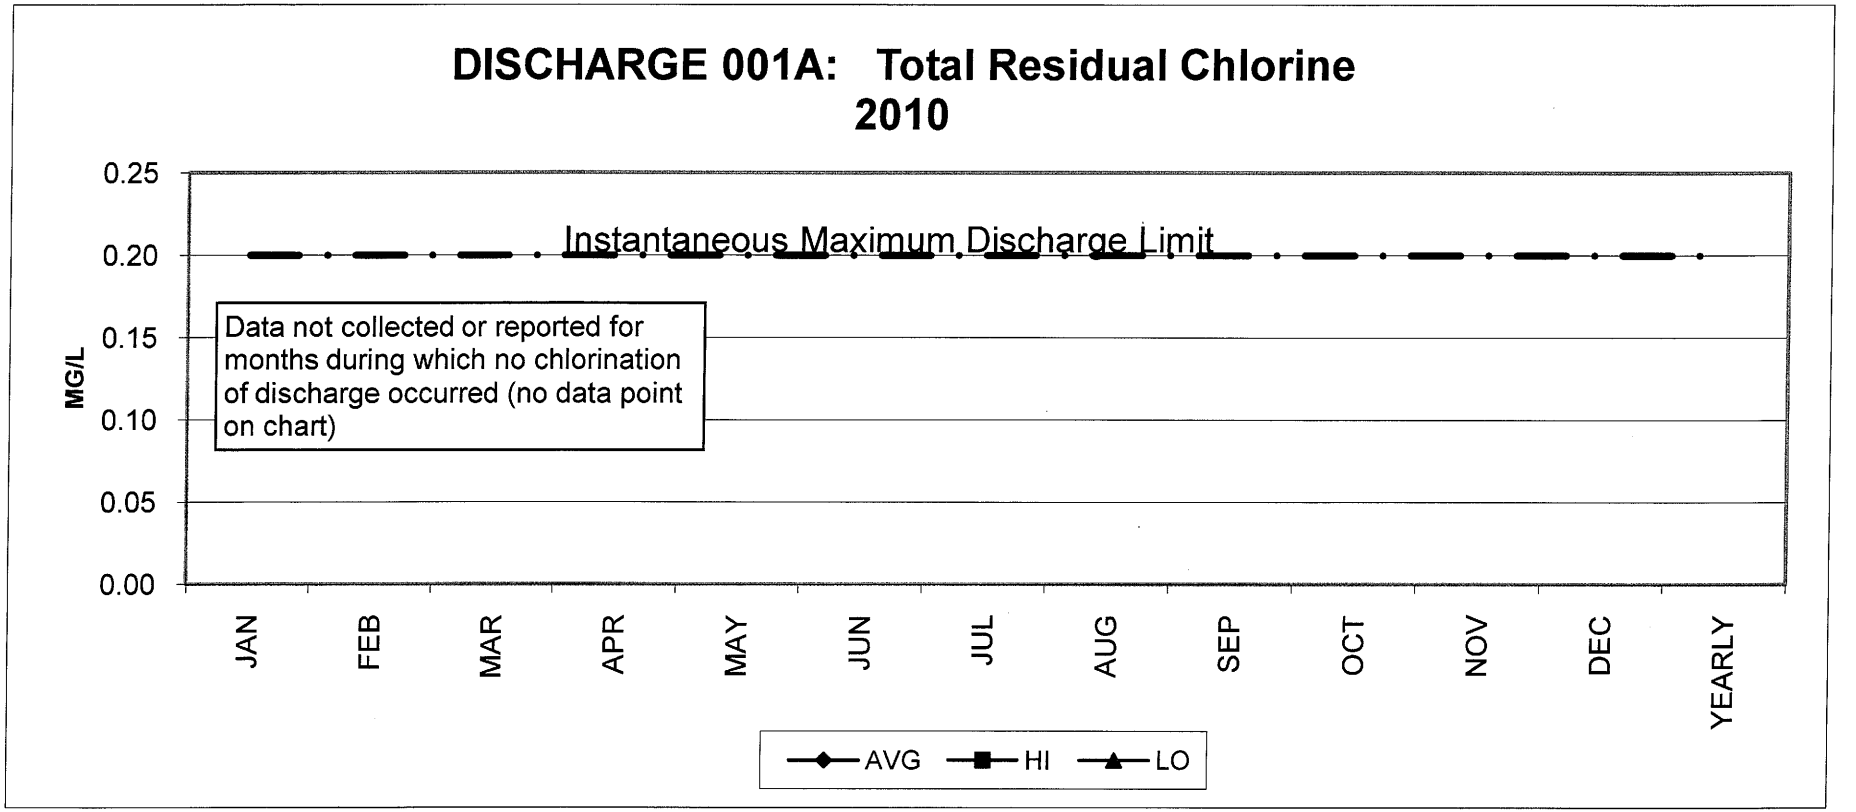
* No chlorination occurred during 2010. Biofouling system out of service.

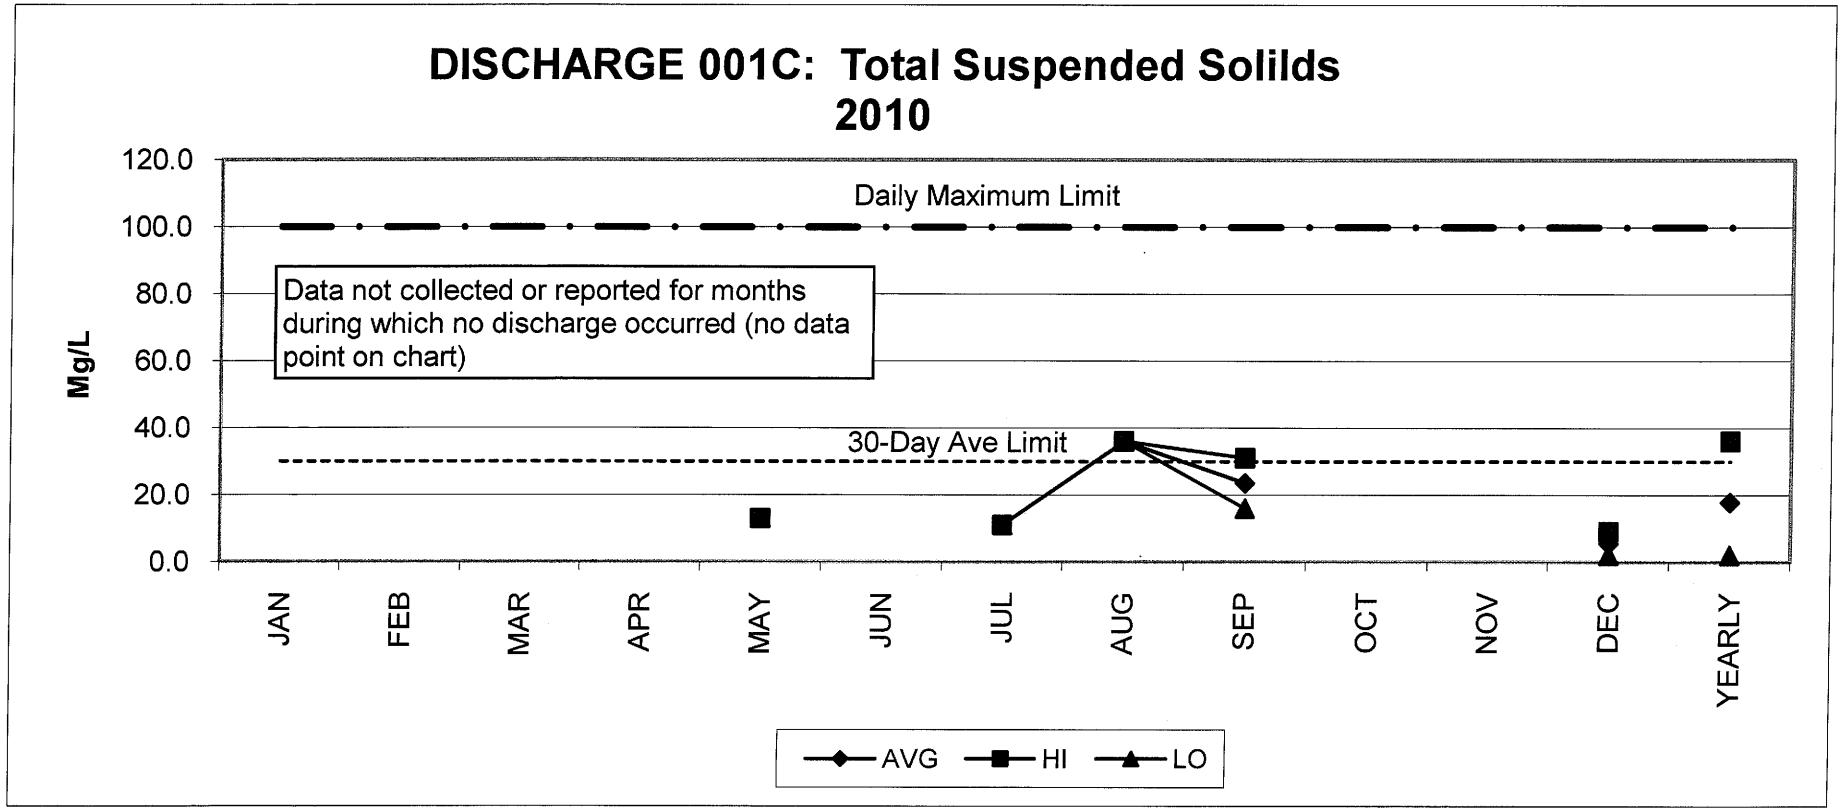
DISCHARGE 001C: Total Suspended Solilds
2010
120.0
100.0
80.0
60.0
40.0
20.0
0.0
Mg/L
Daily Maximum Limit
Data not collected or reported for months during which no discharge occurred (no data point on chart)
30-Day Ave Limit
JAN
FEB
MAR
APR
MAY
JUN
JUL
AUG
SEP
OCT
NOV
DEC
YEARLY
AVG
HI
LO

Initial test results from Discharge 001C showed total suspended solids (TSS) to be above the monthly average limit of 30 mg/L with a concentration of 36 mg/L. However, the inlet sample collected concurrently, showed an elevated TSS value of 30 mg/L (inlet was equal to the discharge limit). Unfortunately, sample results were not received until after the close of the month. A follow-up TSS sample was collected on September 1 to confirm initial results. With only a single sample for the month, the monthly average limit was exceeded. While investigating the cause of the exceedence, plant personnel discovered that concurrent dredging operations in Morro Bay were showing comparable (30 mg/L or greater) TSS values in their monthly monitoring program. It is the MBPP's opinion that since both the inlet source water and dredging samples collected in the main channel of the bay showed elevated TSS levels, elevated discharge results were not due to plant equipment operation but to dredging operations disturbing bottom sediment in the bay. Sample results from the dredging monitoring program are included for the month of August as an attachment to this report for documentation purposes.

Initial test results from Discharge 001C showed total suspended solids (TSS) to be above the monthly average limit of 30 mg/L with a concentration of 36 mg/L. However, the inlet sample collected concurrently, showed an elevated TSS value of 30 mg/L (inlet was equal to the discharge limit). Unfortunately, sample results were not received until after the close of the month. A follow-up TSS sample was collected on September 1 to confirm initial results. With only a single sample for the month, the monthly average limit was exceeded. While investigating the cause of the exceedence, plant personnel discovered that concurrent dredging operations in Morro Bay were showing comparable (30 mg/L or greater) TSS values in their monthly monitoring program. It is the MBPP's opinion that since the both the inlet source water and dredging samples collected in the main channel of the bay showed elevated TSS levels, elevated discharge results were not due to plant equipment operation but to dredging operations disturbing bottom sediment in the bay.

As a resolution to this matter, an explanation of this incident has been included in both the 3rd quarter and annual 2010 NPDES reports, and MBPP has resolved to not run the evaporator the last day of the month or collect samples during dredging operations.
