**INTERIM REMEDIAL MEASURES
REPORT**

**Sierra Pacific Industries
Arcata Division Sawmill
2593 New Navy Base Road
Arcata, California**

June 10, 2003

MFG, Inc.
consulting scientists and engineers

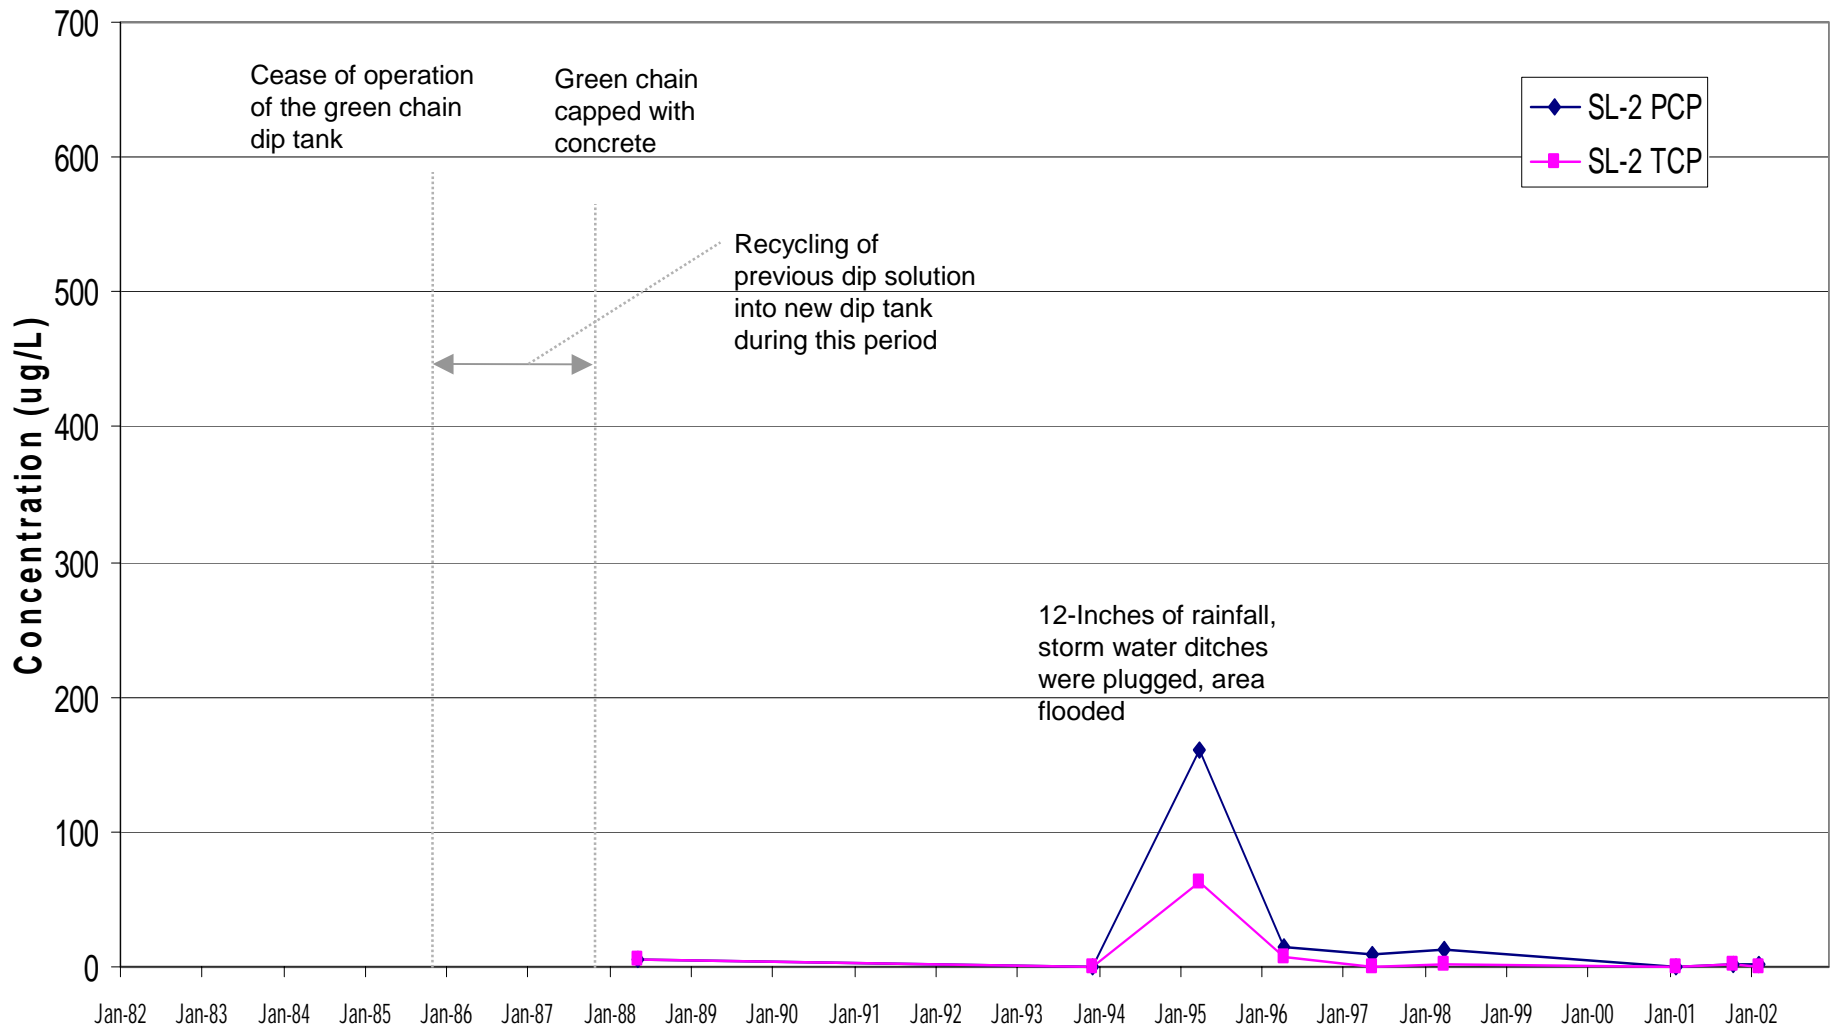
HISTORICAL STORM WATER CHEMICAL ANALYSIS RESULTS-SAMPLING LOCATION # 2 (SL-2) (1983-2002)

Note: Non detect results were set at 0 to generate this graph

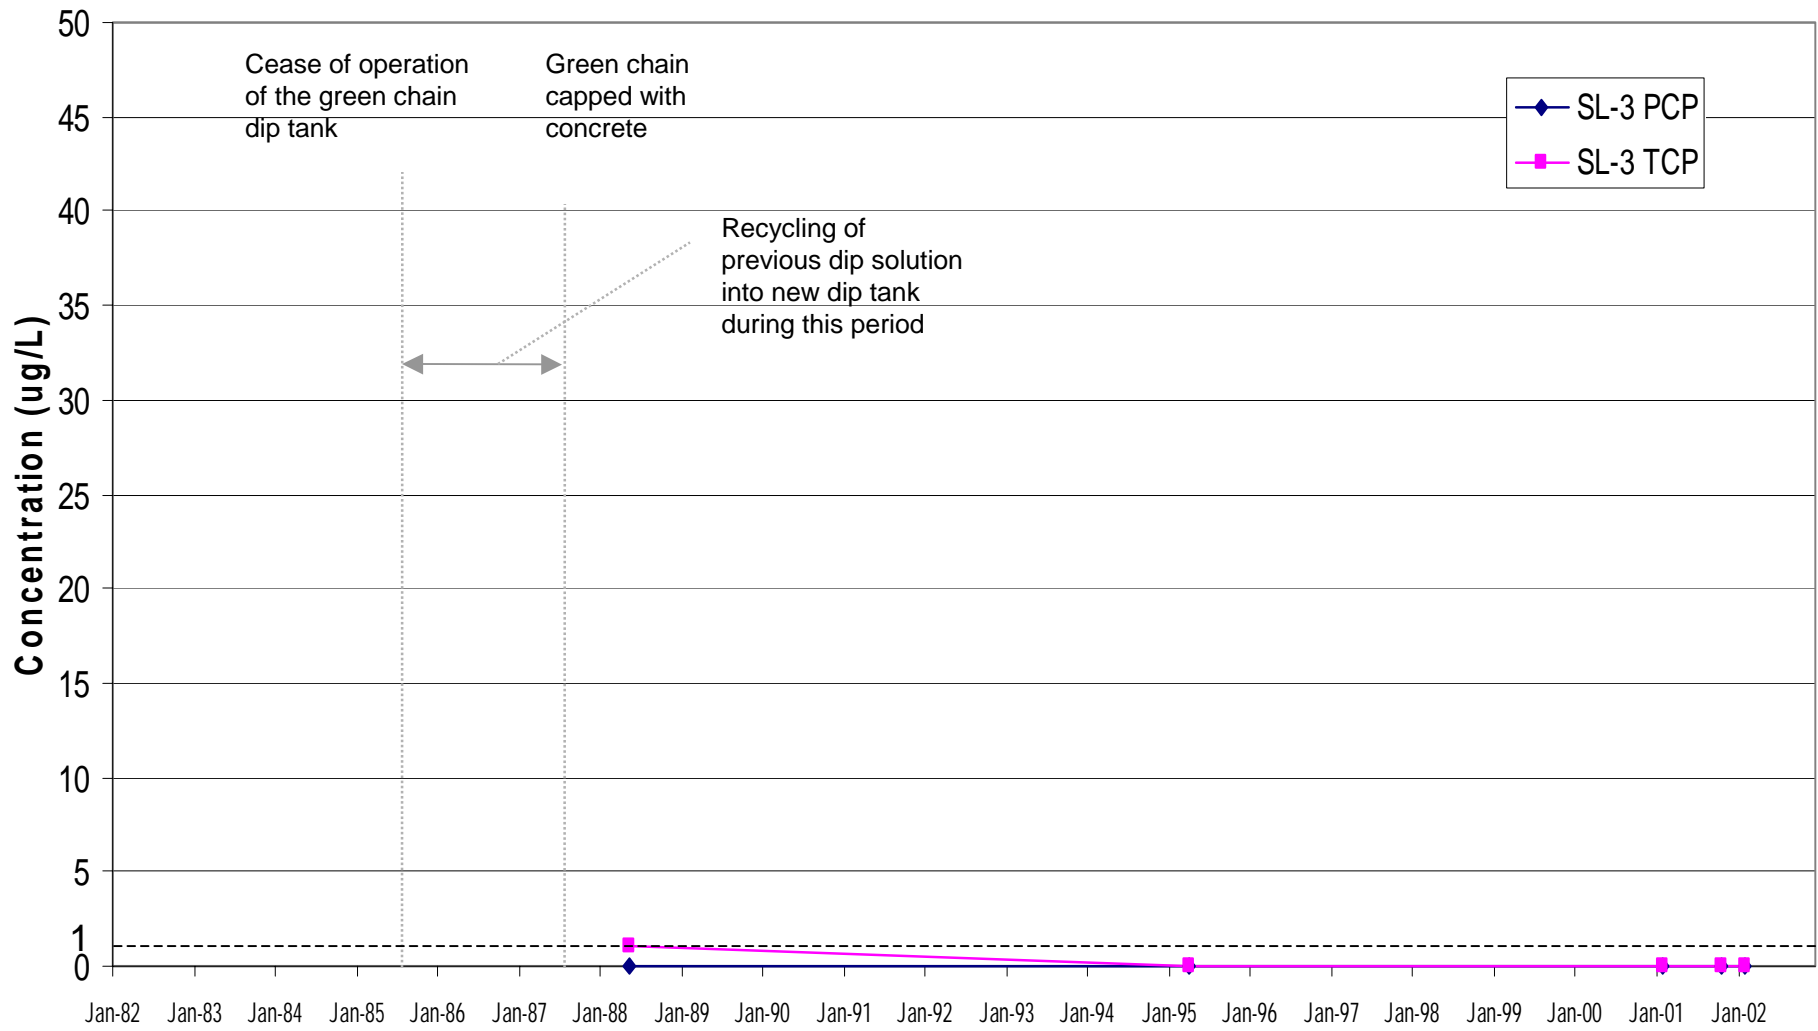
FIGURE 7

HISTORICAL STORM WATER CHEMICAL ANALYSIS RESULTS-SAMPLING LOCATION # 3 (SL-3) (1983-2002)

Note: Non detect results were set at 0 to generate this graph

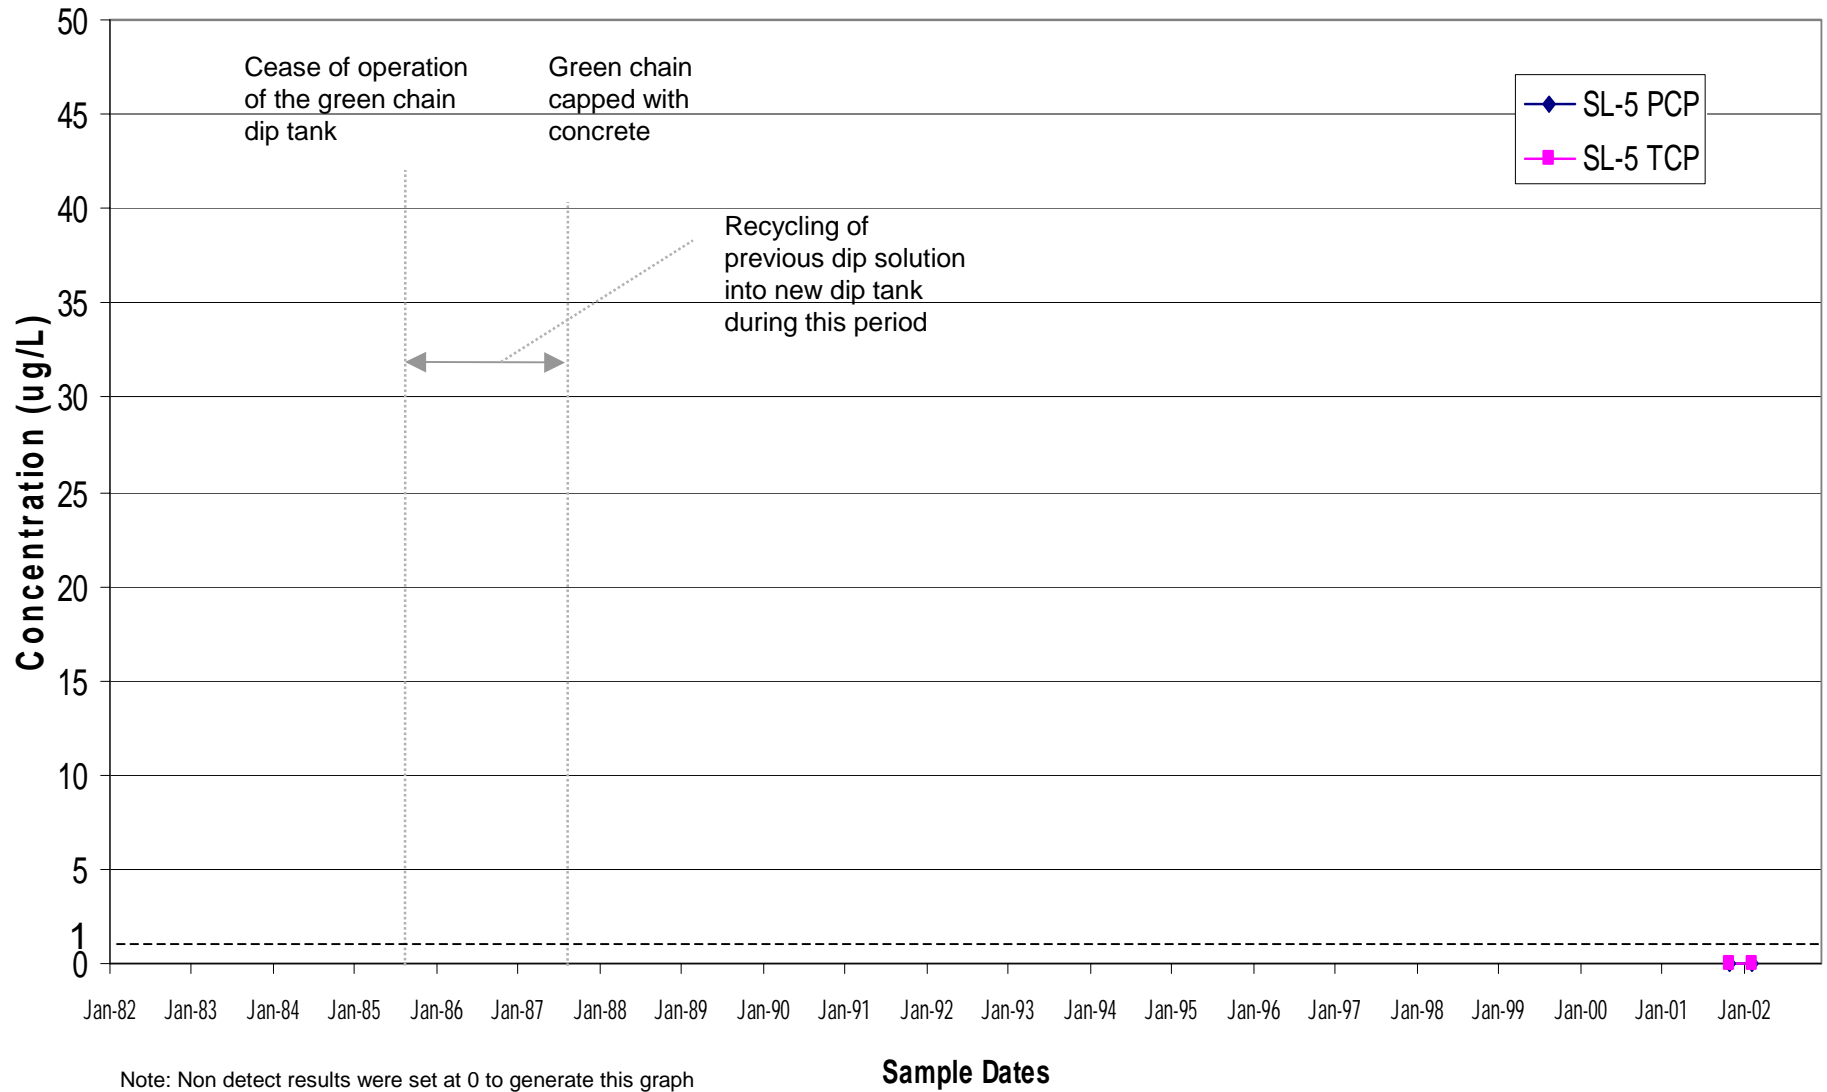
HISTORICAL STORM WATER CHEMICAL ANALYSIS RESULTS-SAMPLING LOCATION # 5 (SL-5) (1983-2002)

Note: Non detect results were set at 0 to generate this graph

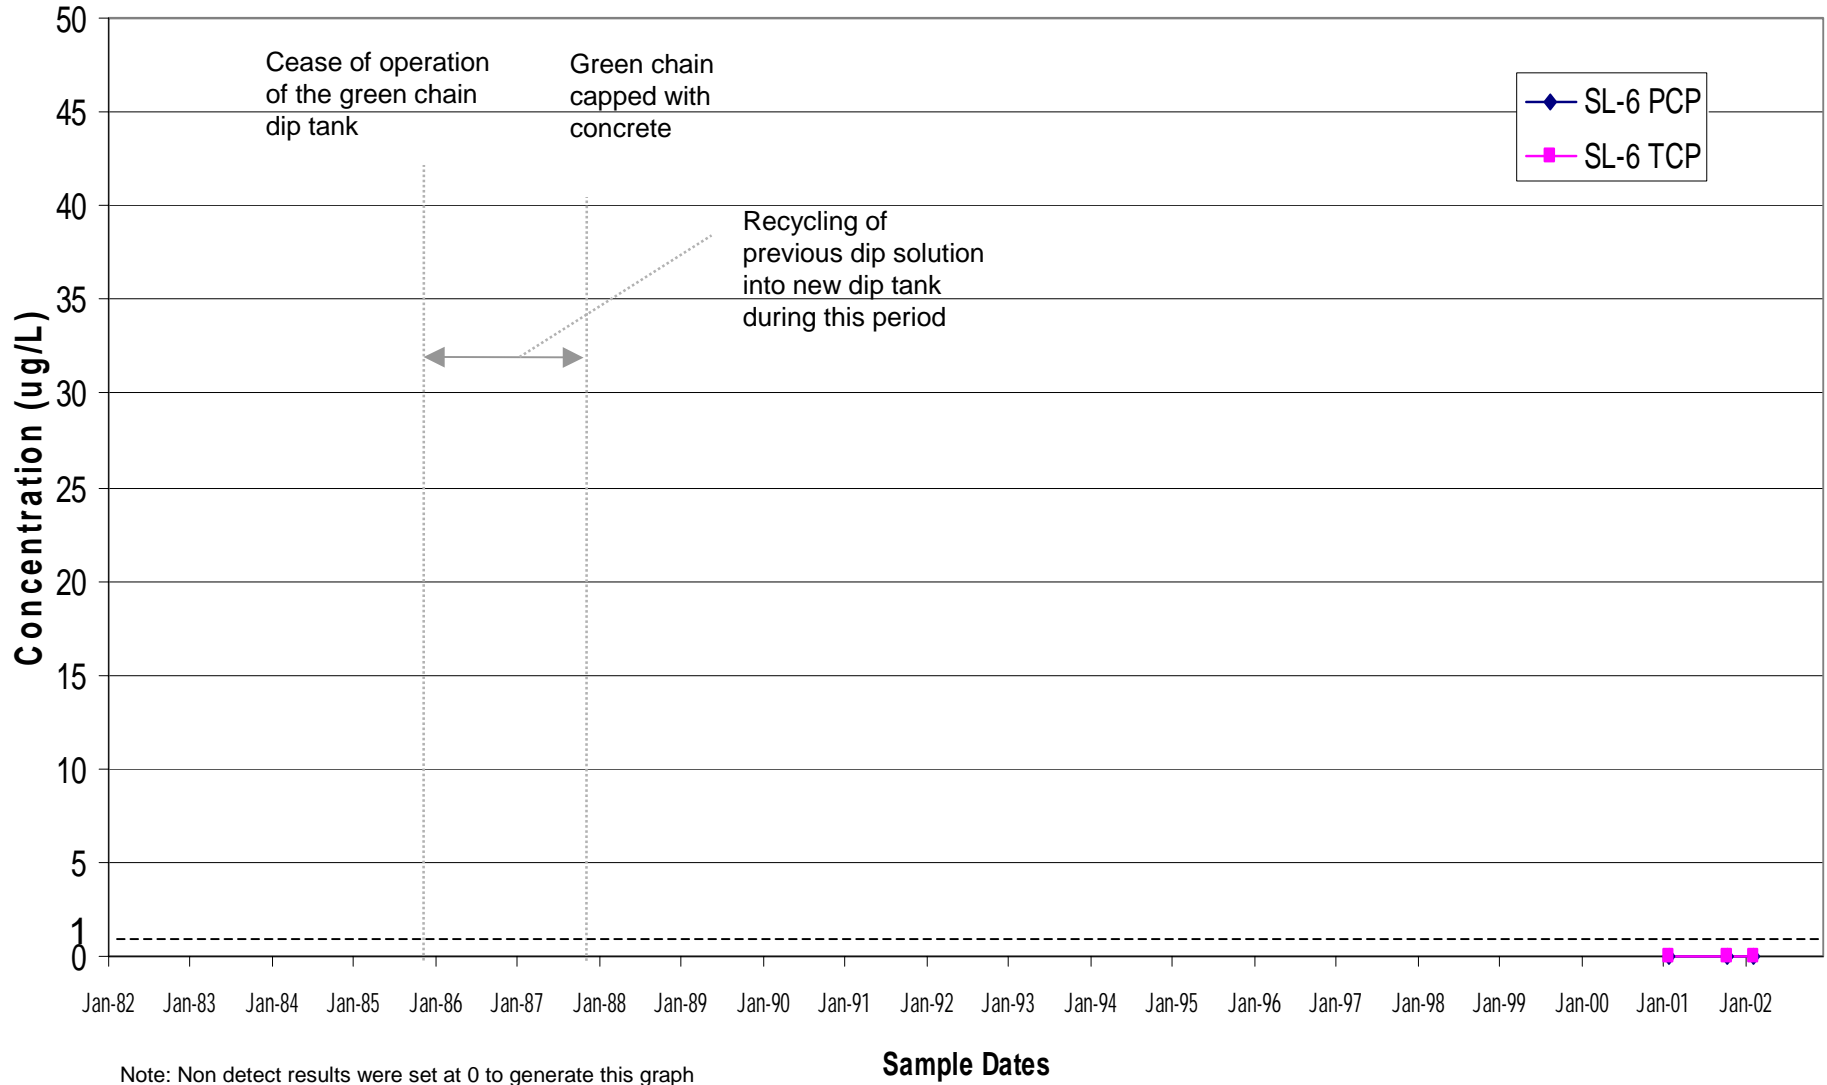
FIGURE 11

HISTORICAL STORM WATER CHEMICAL ANALYSIS RESULTS-SAMPLING LOCATION # 6 (SL-6) (1983-2002)

Note: Non detect results were set at 0 to generate this graph
