BIG SUR RIVER STEELHEAD ENHANCEMENT PLAN

Prepared for:
Department of Parks and Recreation
Monterey District
2211 Garden Road
Monterey, CA 93940

Prepared by:
Denise Duffy & Associates, Inc.
947 Cass Street
Monterey, CA 93940
Contact: Josh Harwayne

March 2003

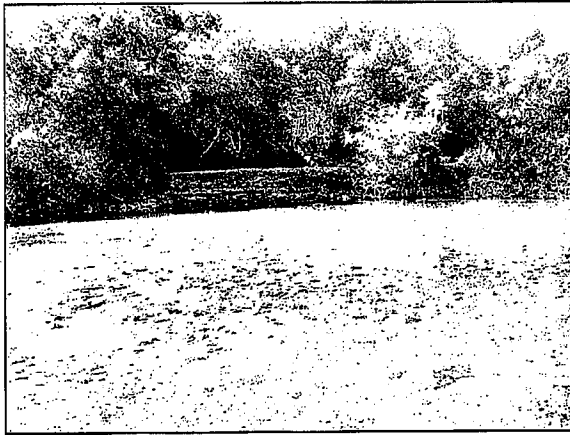
Right bank trail-related erosion at RM 0.09 Capital
improvement site CP-1.

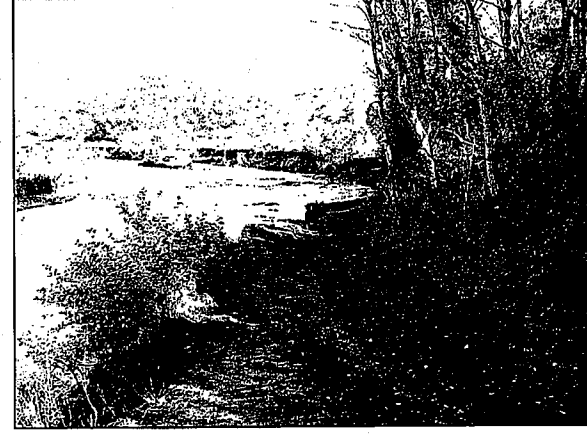
Left bank trail-related erosion at RM 0.18 Capital
improvement site CP-1.

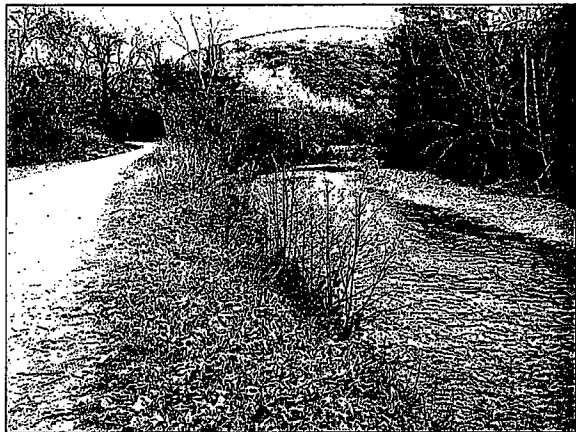
1997-98 Right bank failure at ranch road. (RM 1.29-1.32). Note alder and willow recruitment at toe. Road realignment and bio-engineered slope treatment proposed.

- **Capital Project 10: Construct bioengineered revetment at ranch road bank failure (RM 1.28-1.31) [Manual # 216, 254, 272] (CP-10)**

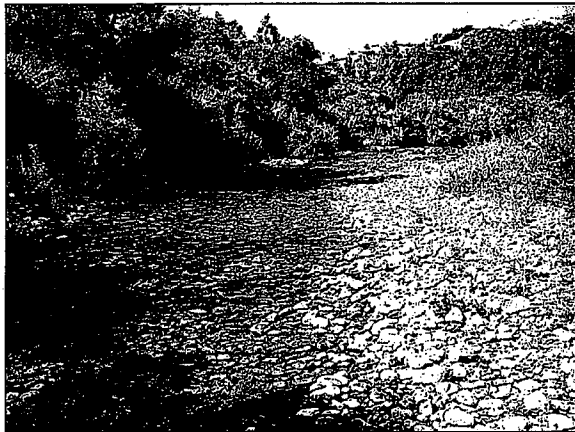
Shallow lateral riffle above the lagoon is unstable channel area. (RM 0.43)

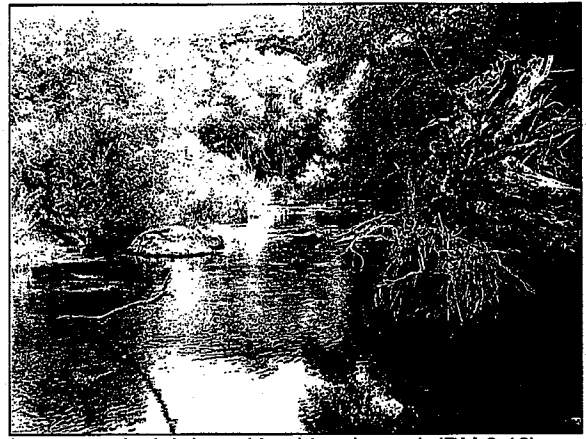
Large woody debris and boulder channel. (RM 3.16)
Upper Molera reach has best retention of large woody debris.

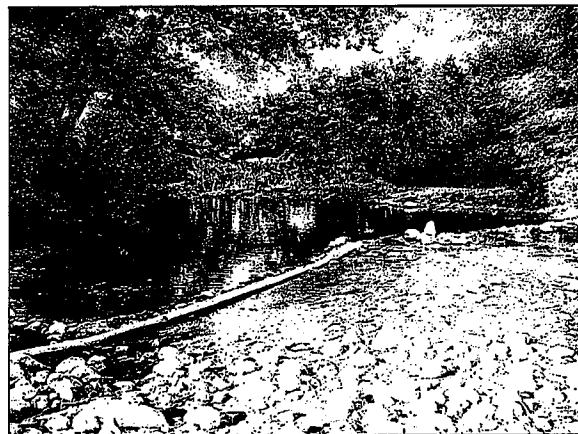
Sycamore scour pool. Near upstream boundary of Andrew Molera State Park. Heavy recreational use and channel modifications evident. Looking upstream. (RM 3.5)

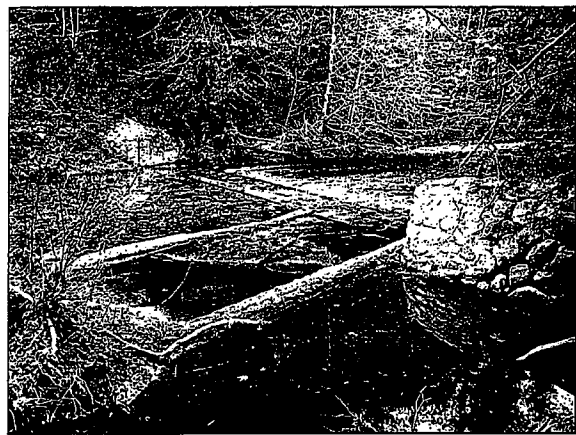
Old diversion dam site. (PBSRM 0.13) This existing structural grade control feature is one of 8 old instream grade controls that affect channel width/depth dimensions in PBS.

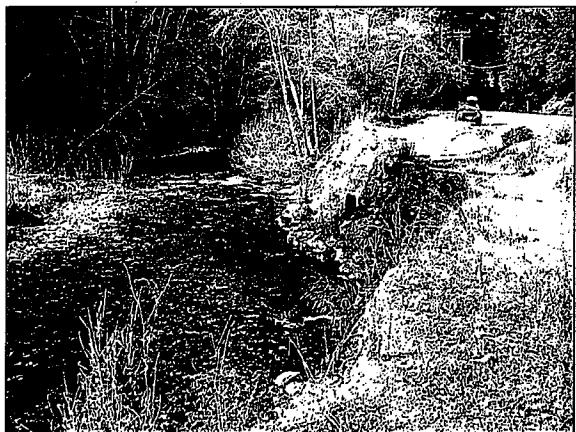
Highway 1 bank failure near PBS gate. (PBSRM 0.35) Site proposed for bio-engineered log wall to provide habitat, limit erosion and maintain road fill. Looking downstream.

- Complete design, permit and construct proposed year-round multi-use bridge to minimize instream trampling (CP-11).
 - Construct bioengineered revetment at Hwy 1 road bank failure (CP-9)

The project site is located on an outside meander bend of the Big Sur River. The bank is under cut and experiencing bank failure, as seen in Figure 6, a photo of current bank conditions. The bank is in close proximity to State Highway One, and if left unchanged, it is foreseeable that future flows could cause extensive erosion and bank instability and impact Highway One.

To restore the bank to a more stable and natural condition, the proposed project will include constructing a 115-foot long vegetated log-revetment wall and reshaping and vegetating the top bank to a milder slope. The log-revetment wall will be constructed from a combination of a concrete reinforced footer log and redwood logs. Each cell between each course of logs will be filled with a live willow brush mattress and soil, as shown in Figure 7. The logs will be tied to the existing slope using Chance soil anchors that are driven into the slope using a hydraulic auger. As the live willow mattress grow and mature, the root structure will provide long-term bank protection and erosion control. The top of the bank will be vegetated with native, locally available plants. The placement of vegetated rip-rap is proposed set at the toe of the wall to provide additional protection against scour.

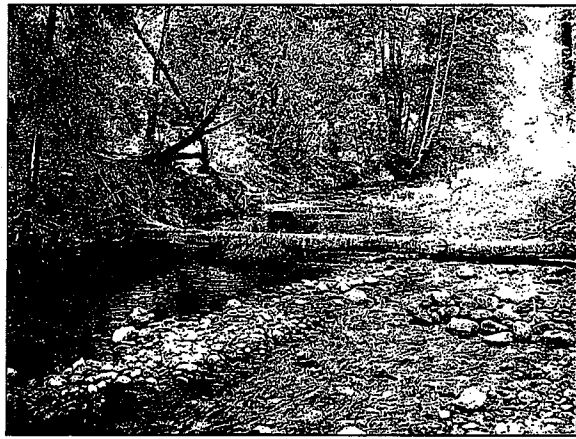
LWD related scour pool. (PBSRM 0.50)

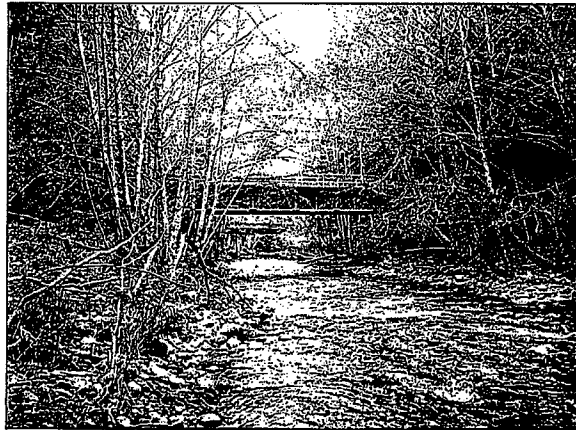
Campground and Highway 1 bridges serve as dividing line between lower PBS and Campground reaches. February 2002 conditions. (PBSRM 0.67-0.72)

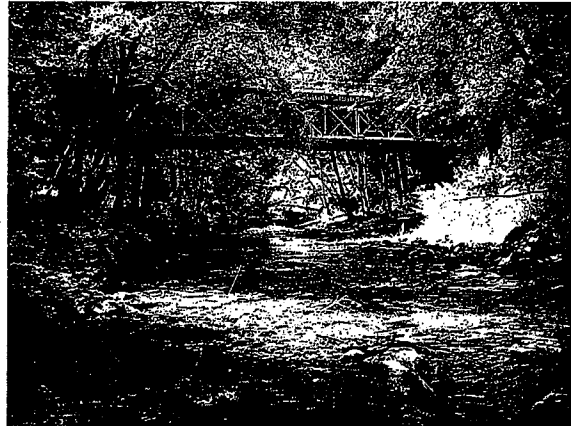
Summer conditions beneath Campground Bridge. Looking upstream. (PBSRM 0.67-0.72)

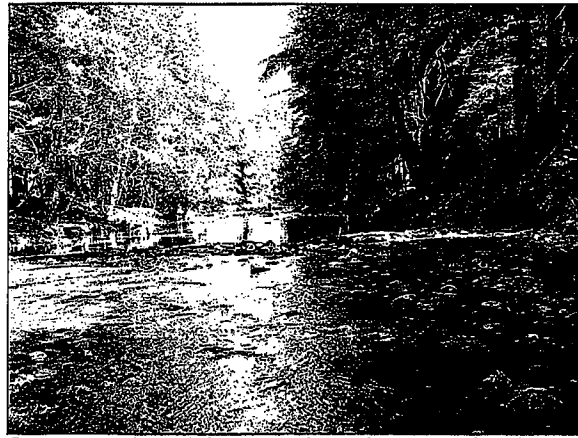
Campground reach has most intensive recreational use and streambed alterations, such as transitory rock and log dams. (PBSRM 0.86)

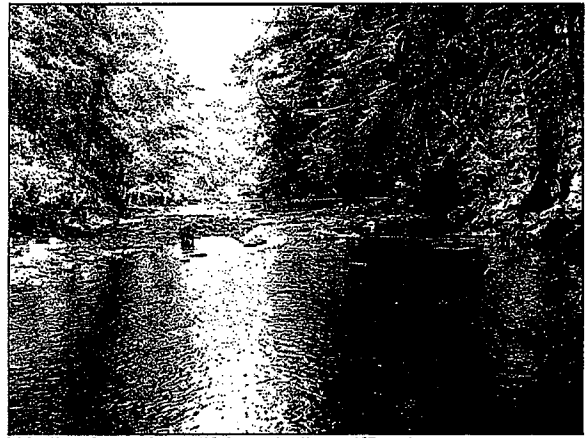
Wading in and modifying shallow riffles is a common activity throughout the year. (PBSRM 0.95)

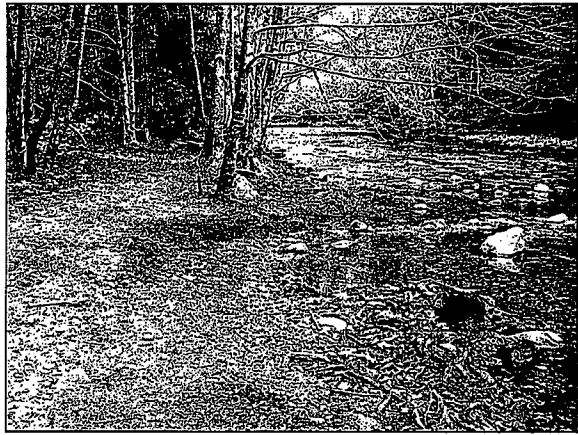
Riparian habitat at day use picnic area, denuded by recreational use. February 2002 conditions. (PBSRM 0.99)

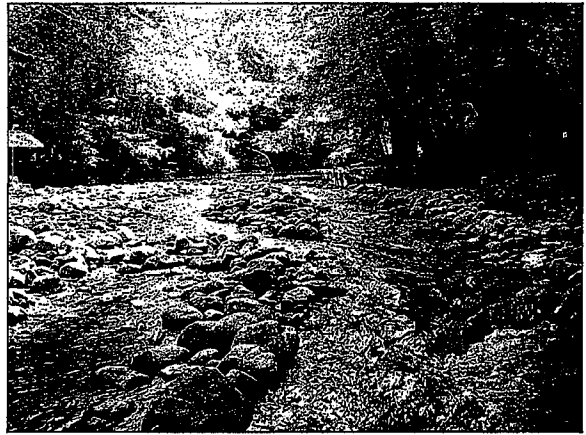
Concentrated recreation use in Main Camp bedrock pool and downstream riffle. (PBSRM 0.99)

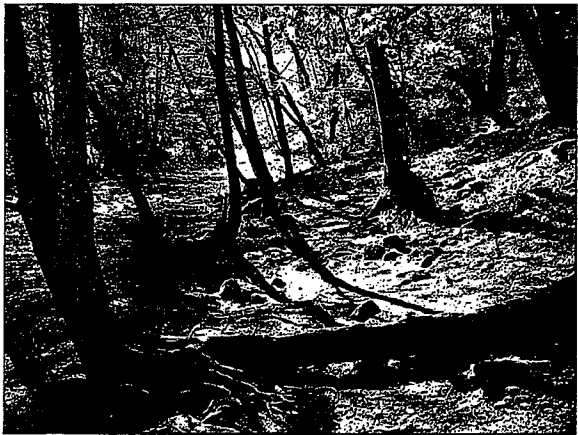
Denuded riparian habitat at river site # 13. (PBSRM 1.29)

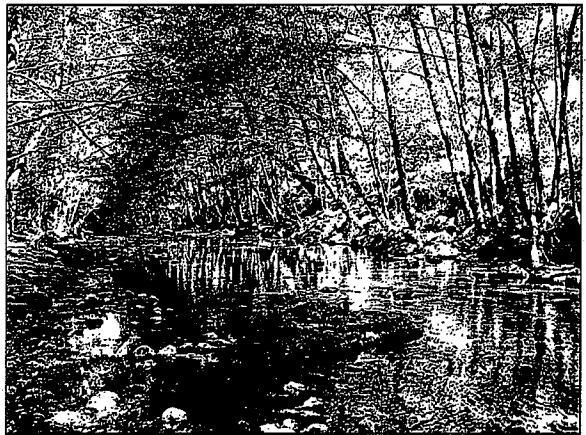
Narrow, even-aged alder riparian zone confined by right bank access road. (PBSRM 1.15-1.20)

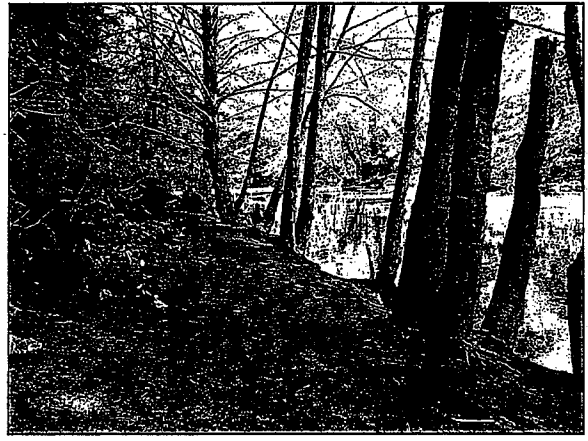
Severe bank trampling and heavy recreational use below USGS Big Sur Gage. Persistent modification of downstream control riffle by construction rockdams in the vicinity of PBSRM1.98, limits accuracy of realtime-remote gaged low-flow measurements. As a result, summer baseflows are most often estimated by USGS staff and are considered poor records. (PBSRM 2.02)

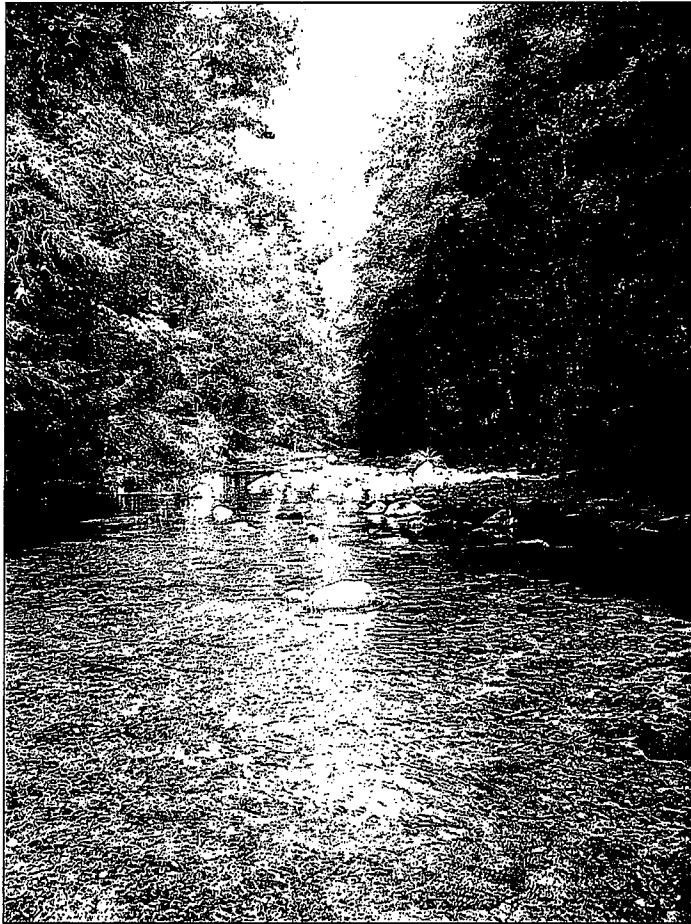
Intact riparian habitat reference reach (PBSRM. 1.94).

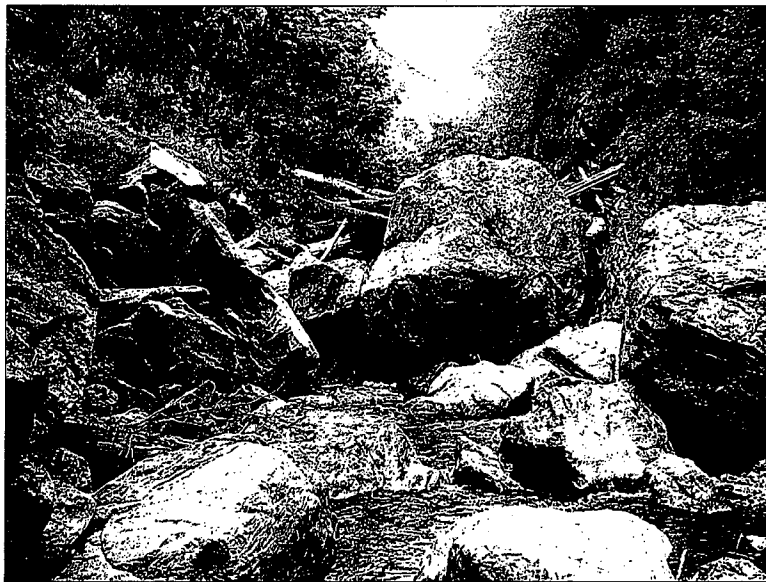
25-35' tall boulder and log jam barrier at upper end of Gorge. (PBSRM 2.51)

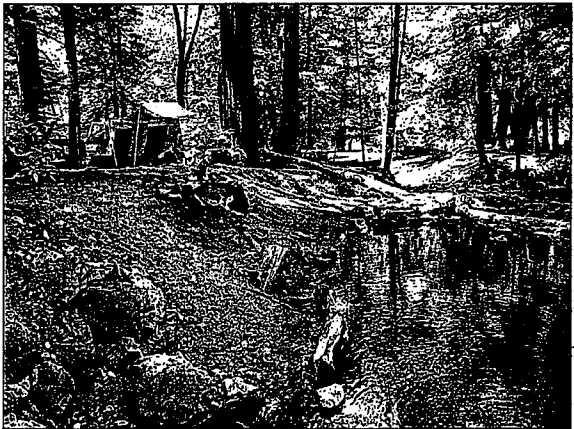
Post Creek degraded riparian zone between camp sites #104 and #106 proposed for removal. (PCRM 0.0865-0.11)
Revegetate with native species and install temporary riparian exclusion fencing to limit access to informal trails.

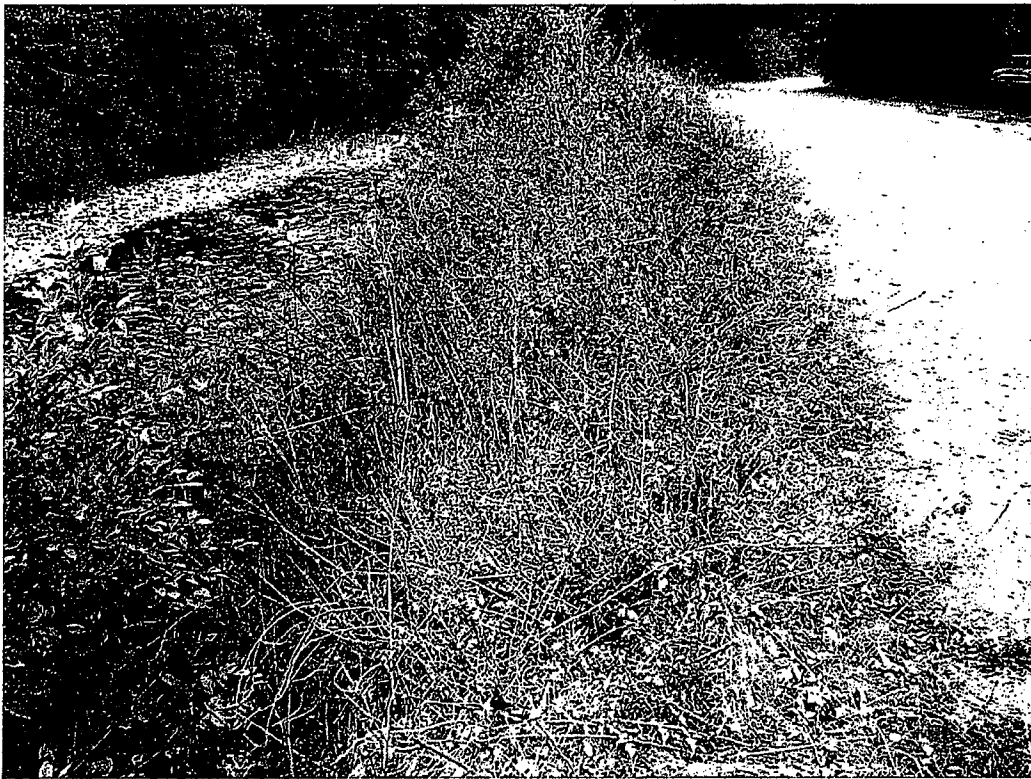
Figure 2. Andrew Molera State Park Project Site

The site is adjacent to a park access road and the position of the road has confined the river channel and upland riparian corridor to a narrow strip of land. The bank is near vertical along the reach and unstable and the amount, distribution and density of riparian vegetation on the stream bank and upland area are very sparse. Figure 2 presents a photo showing conditions looking downstream from the upstream edge of the site. Confining the channel and riparian corridor to a narrow strip of land reduces the riparian vegetation and bank stability, making the bank susceptible to erosion during high flow events. Erosion of the stream bank material has caused the angle of the bank to increase to nearly vertical. If left unchanged, it is foreseeable that future flows could cause further erosion and bank instability.
