**Habitat Restoration and Conservation Plan for Anadromous Salmonid
Habitat in Selected Tributaries of the Russian River Basin**

November 16, 2007

National Marine Fisheries Service
Southwest Region, Santa Rosa Area Office
777 Sonoma Avenue, Room 325
Santa Rosa, California 95404

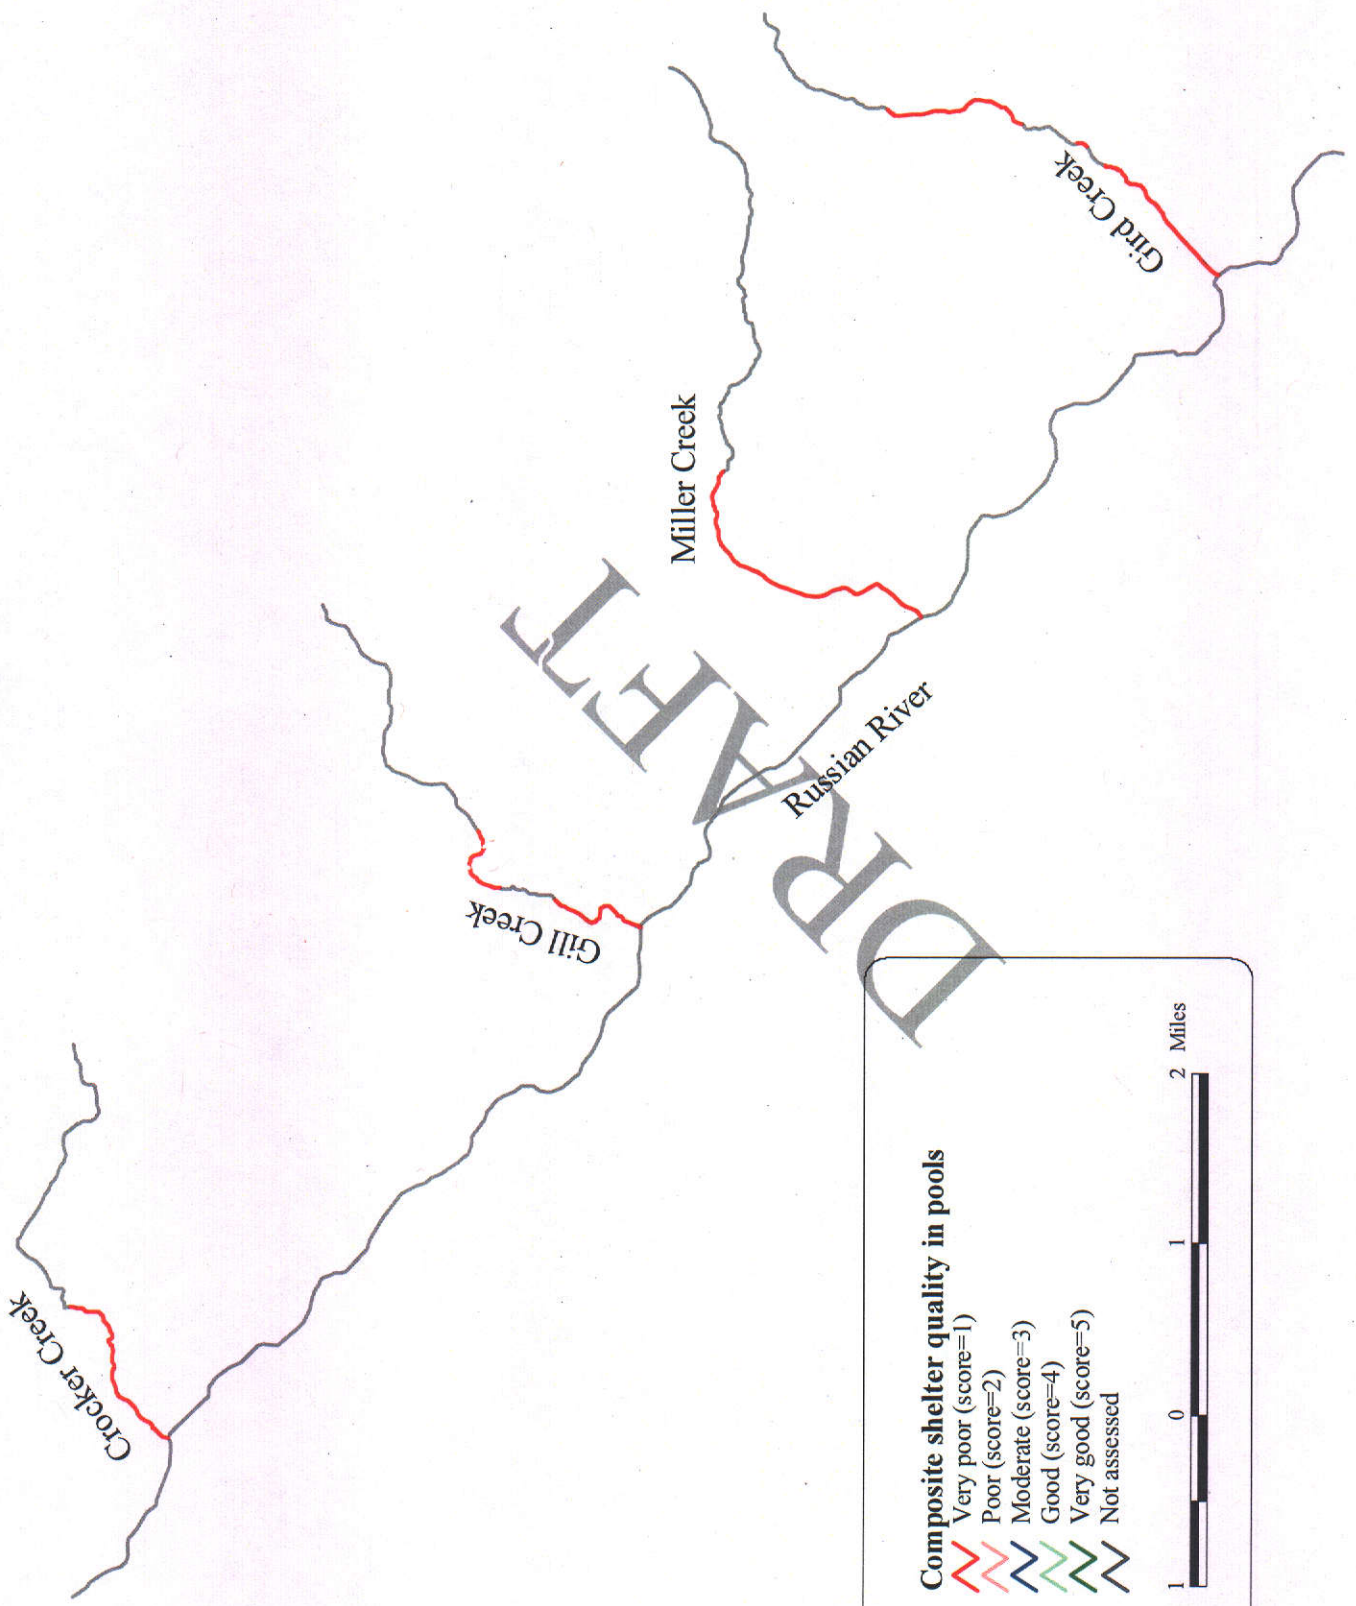
Figure A1-1e. Scores for composite shelter quality in pools in Alexander Valley project streams.

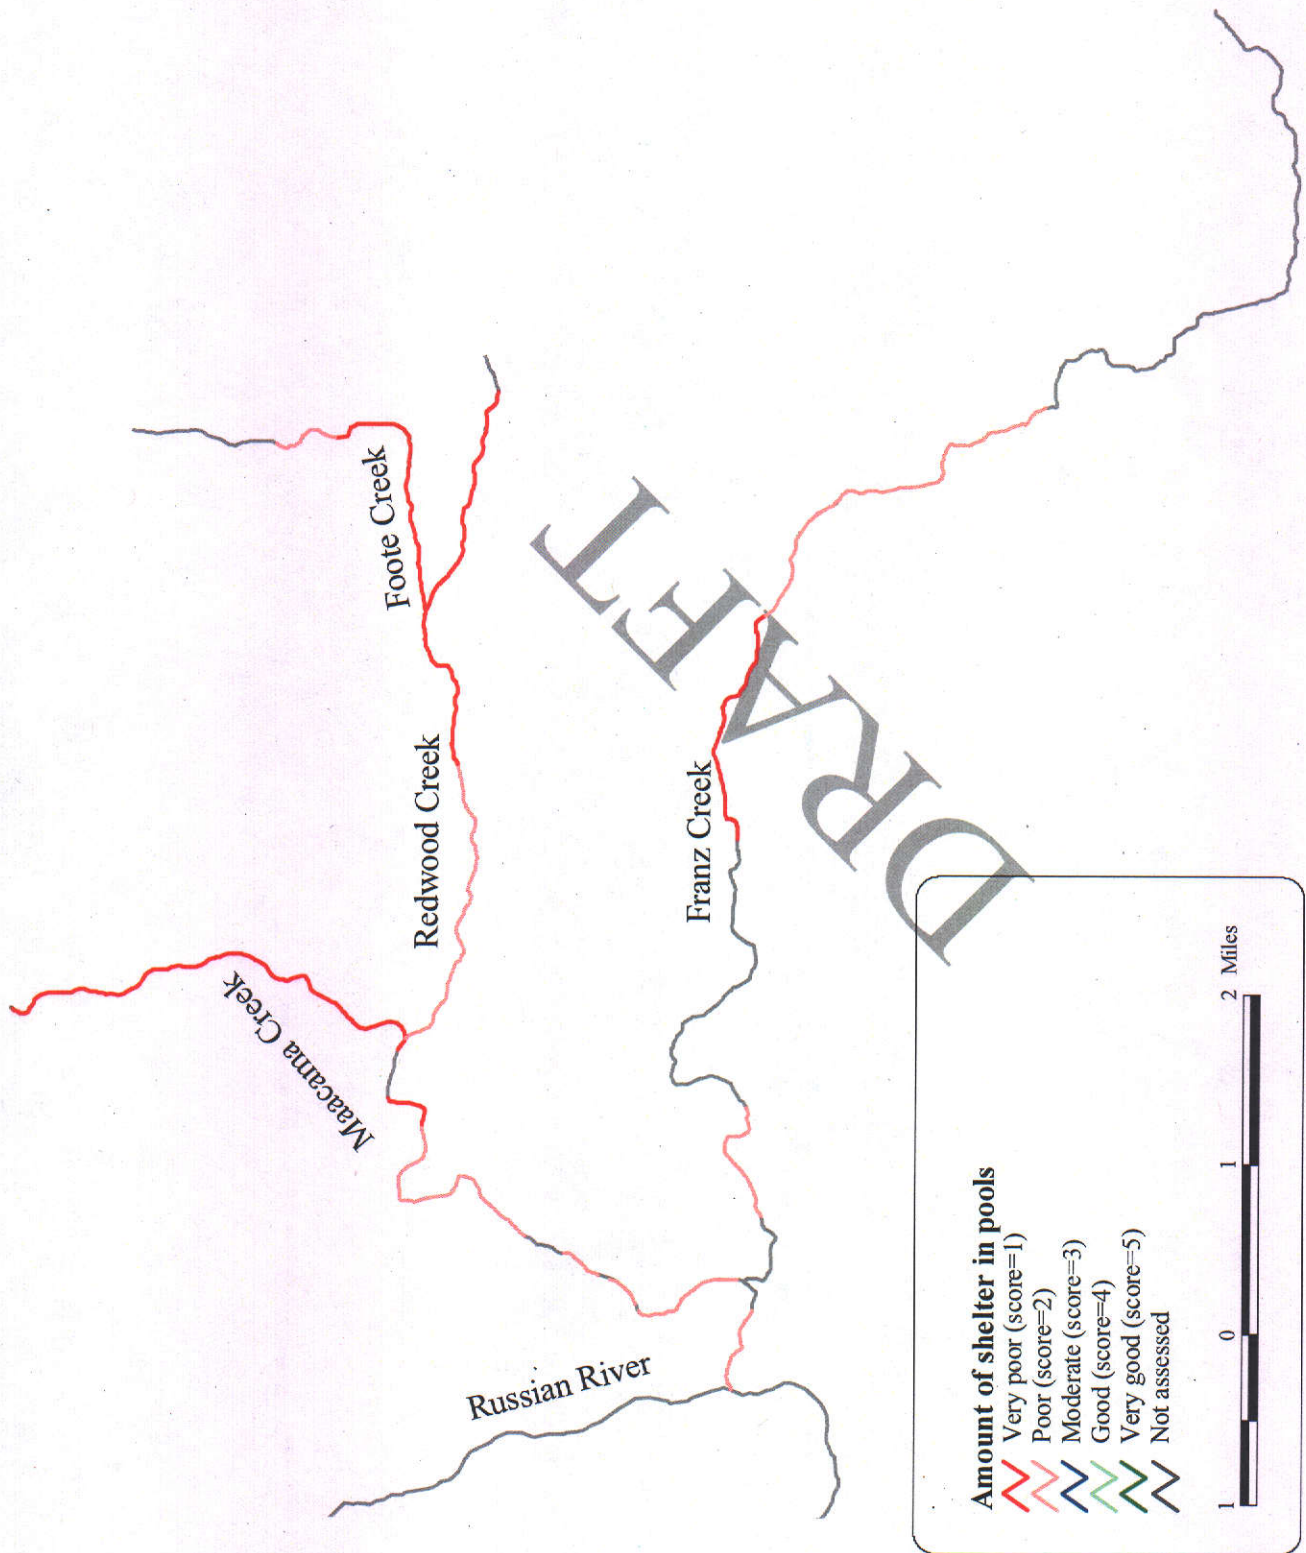
Figure A1-3c. Scores for amount of shelter in pools in Knights Valley project streams.
