PINECREST RESERVOIR LAKE LEVEL STUDY REPORT

**Spring Gap-Stanislaus Hydroelectric Project
(FERC Project No. 2130)**

***Pacific Gas and
Electric Company™***

April 2011

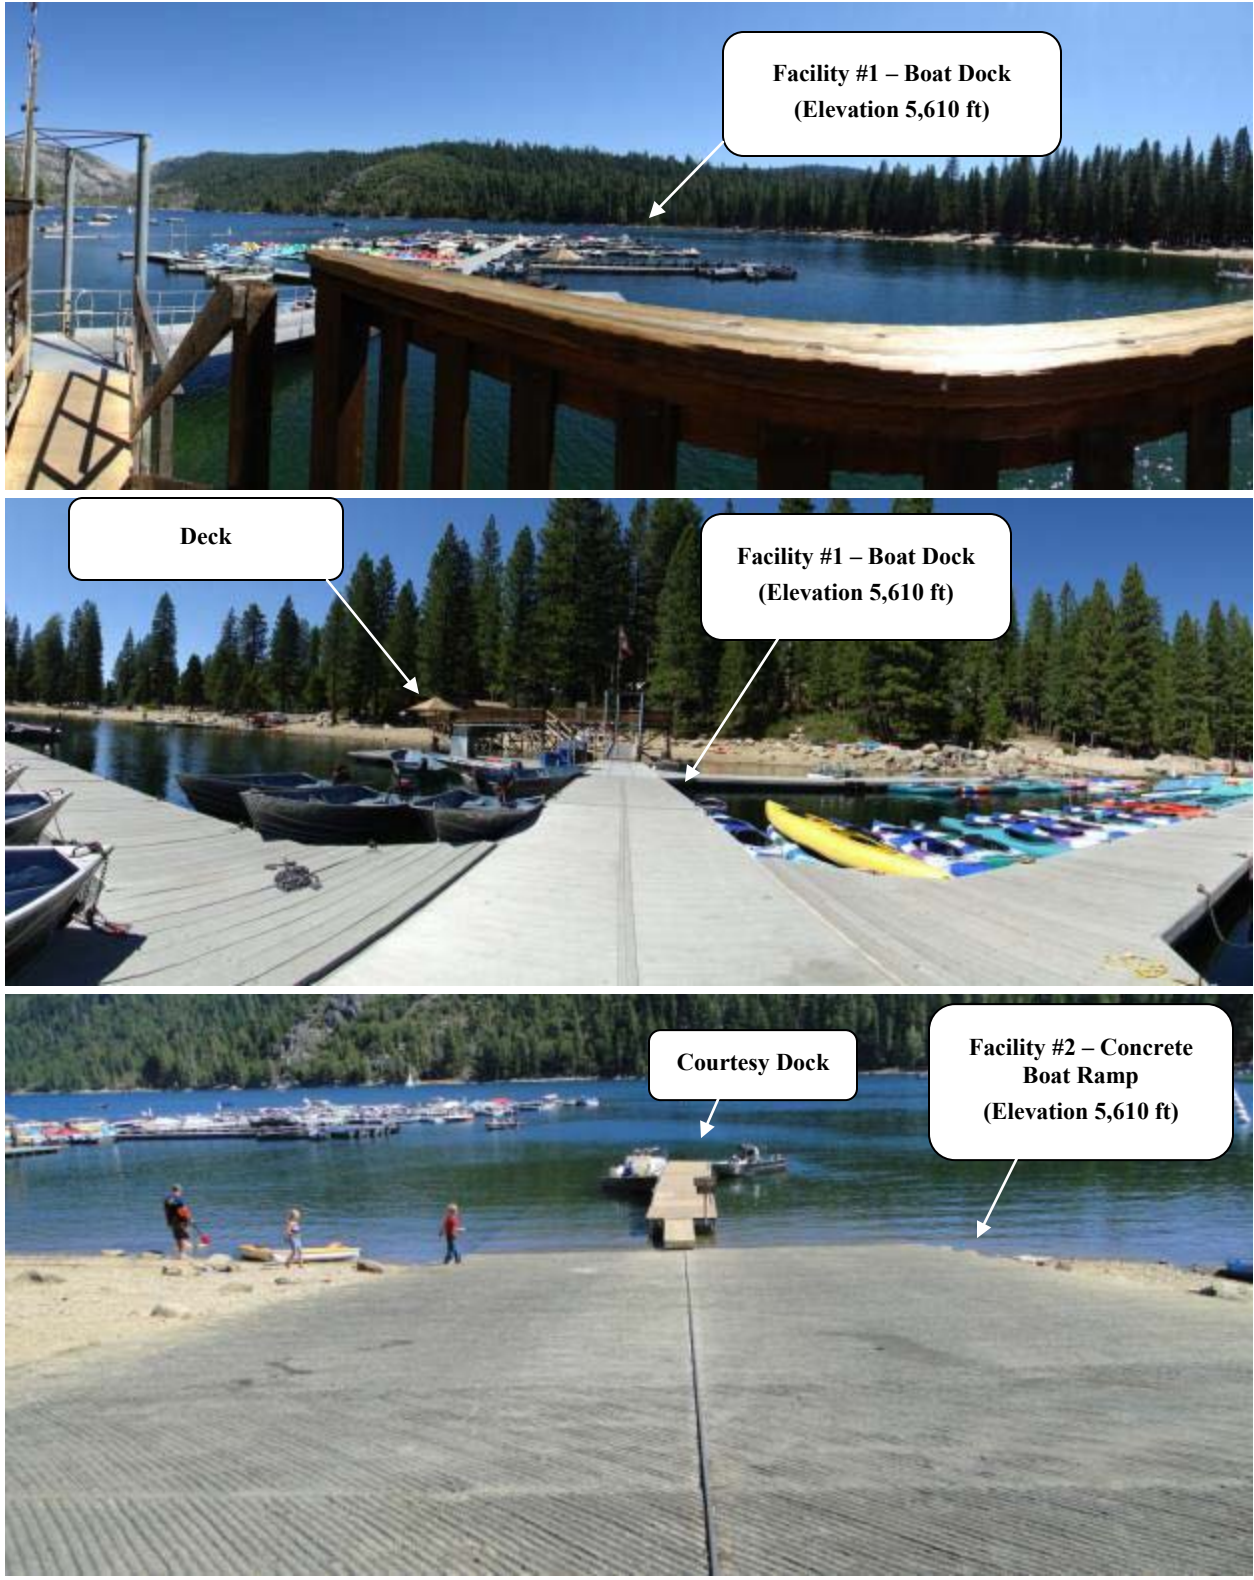
The boat ramp is located just south of the gas dock and slips. The boat ramp was constructed and is maintained by the Stanislaus National Forest (Figure 1-2). The boat launch has a concrete ramp and wooden courtesy dock that is located near the marina and day-use area. The length of the boat ramp provides concrete launch access during the recreation season. As the reservoir water surface elevation decreases in fall, the ramp becomes unusable in early October. Using the orthophoto provided by TUD, when the lake elevation drops below 5,585 ft, the concrete ramp and courtesy dock are no longer in contact with the water.

Figure 1-2. Facility #1 – Boat Dock and Facility #2 – Boat Ramp and Courtesy Dock

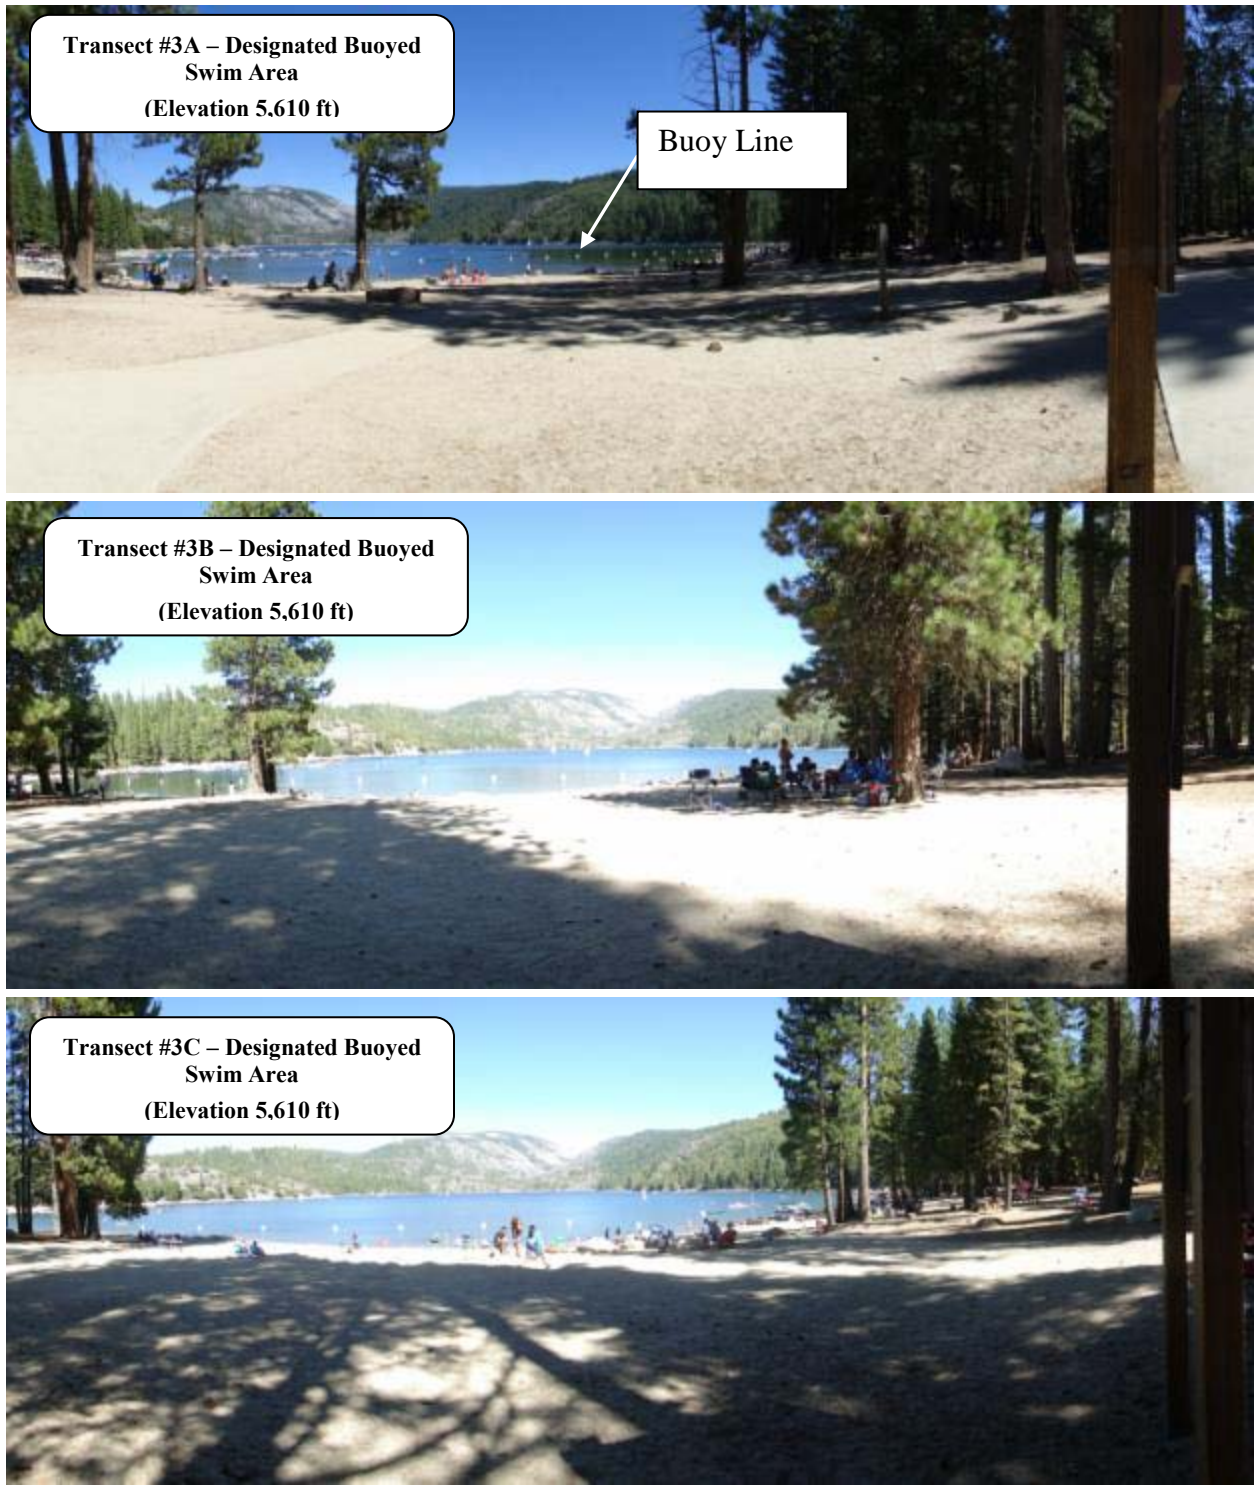
Figure 1-3. Facility #3 – Designated Buoyed Swim Area: Transects #3A, #3B, and #3C (photo taken from the top of each transect)

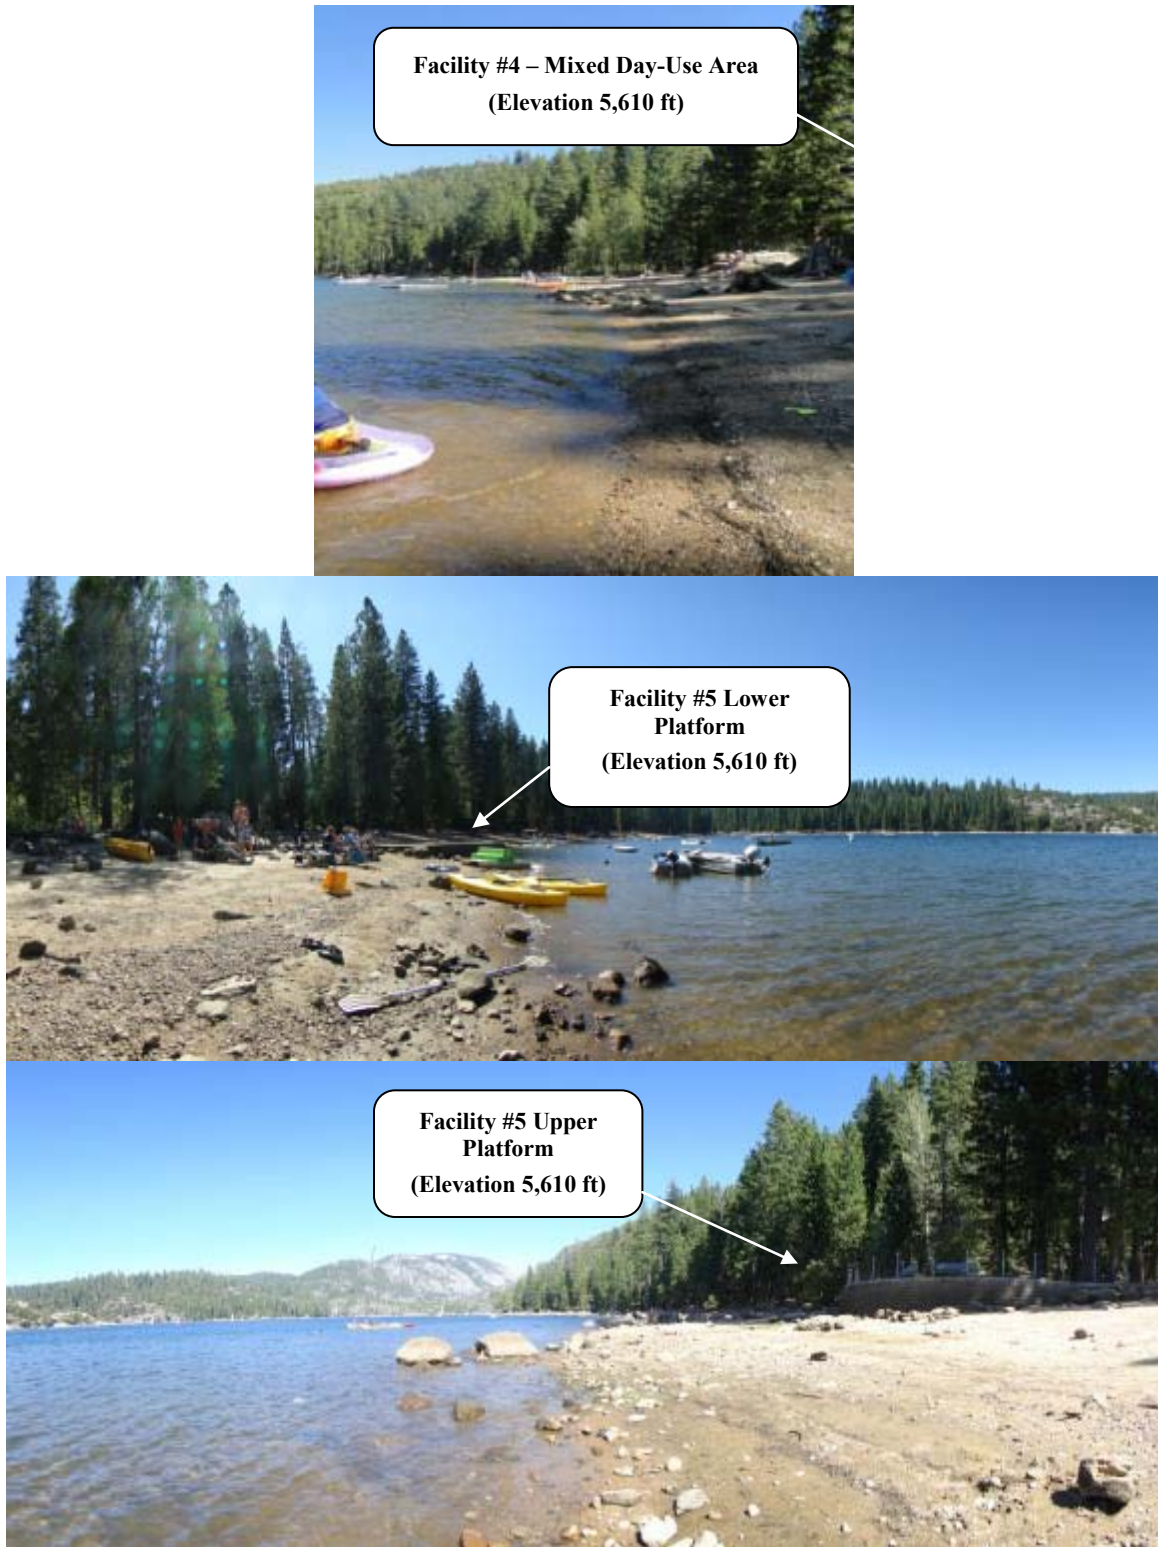
This facility is located in the southeastern portion of Pinecrest Lake, adjacent to Facility #4 (Figure 1-4). The facility is comprised of two semicircular concrete platforms connected by a concrete walkway. The platforms are accessible to persons with disabilities and allow anglers to cast directly into the water and fish at certain lake elevations (PG&E 2002). The recreation activity observed at this facility was fishing.

Figure 1-4. Recreation Facility #4 – Mixed Day-Use Area and Recreation Facility #5 – ADA-Accessible Fishing Platform

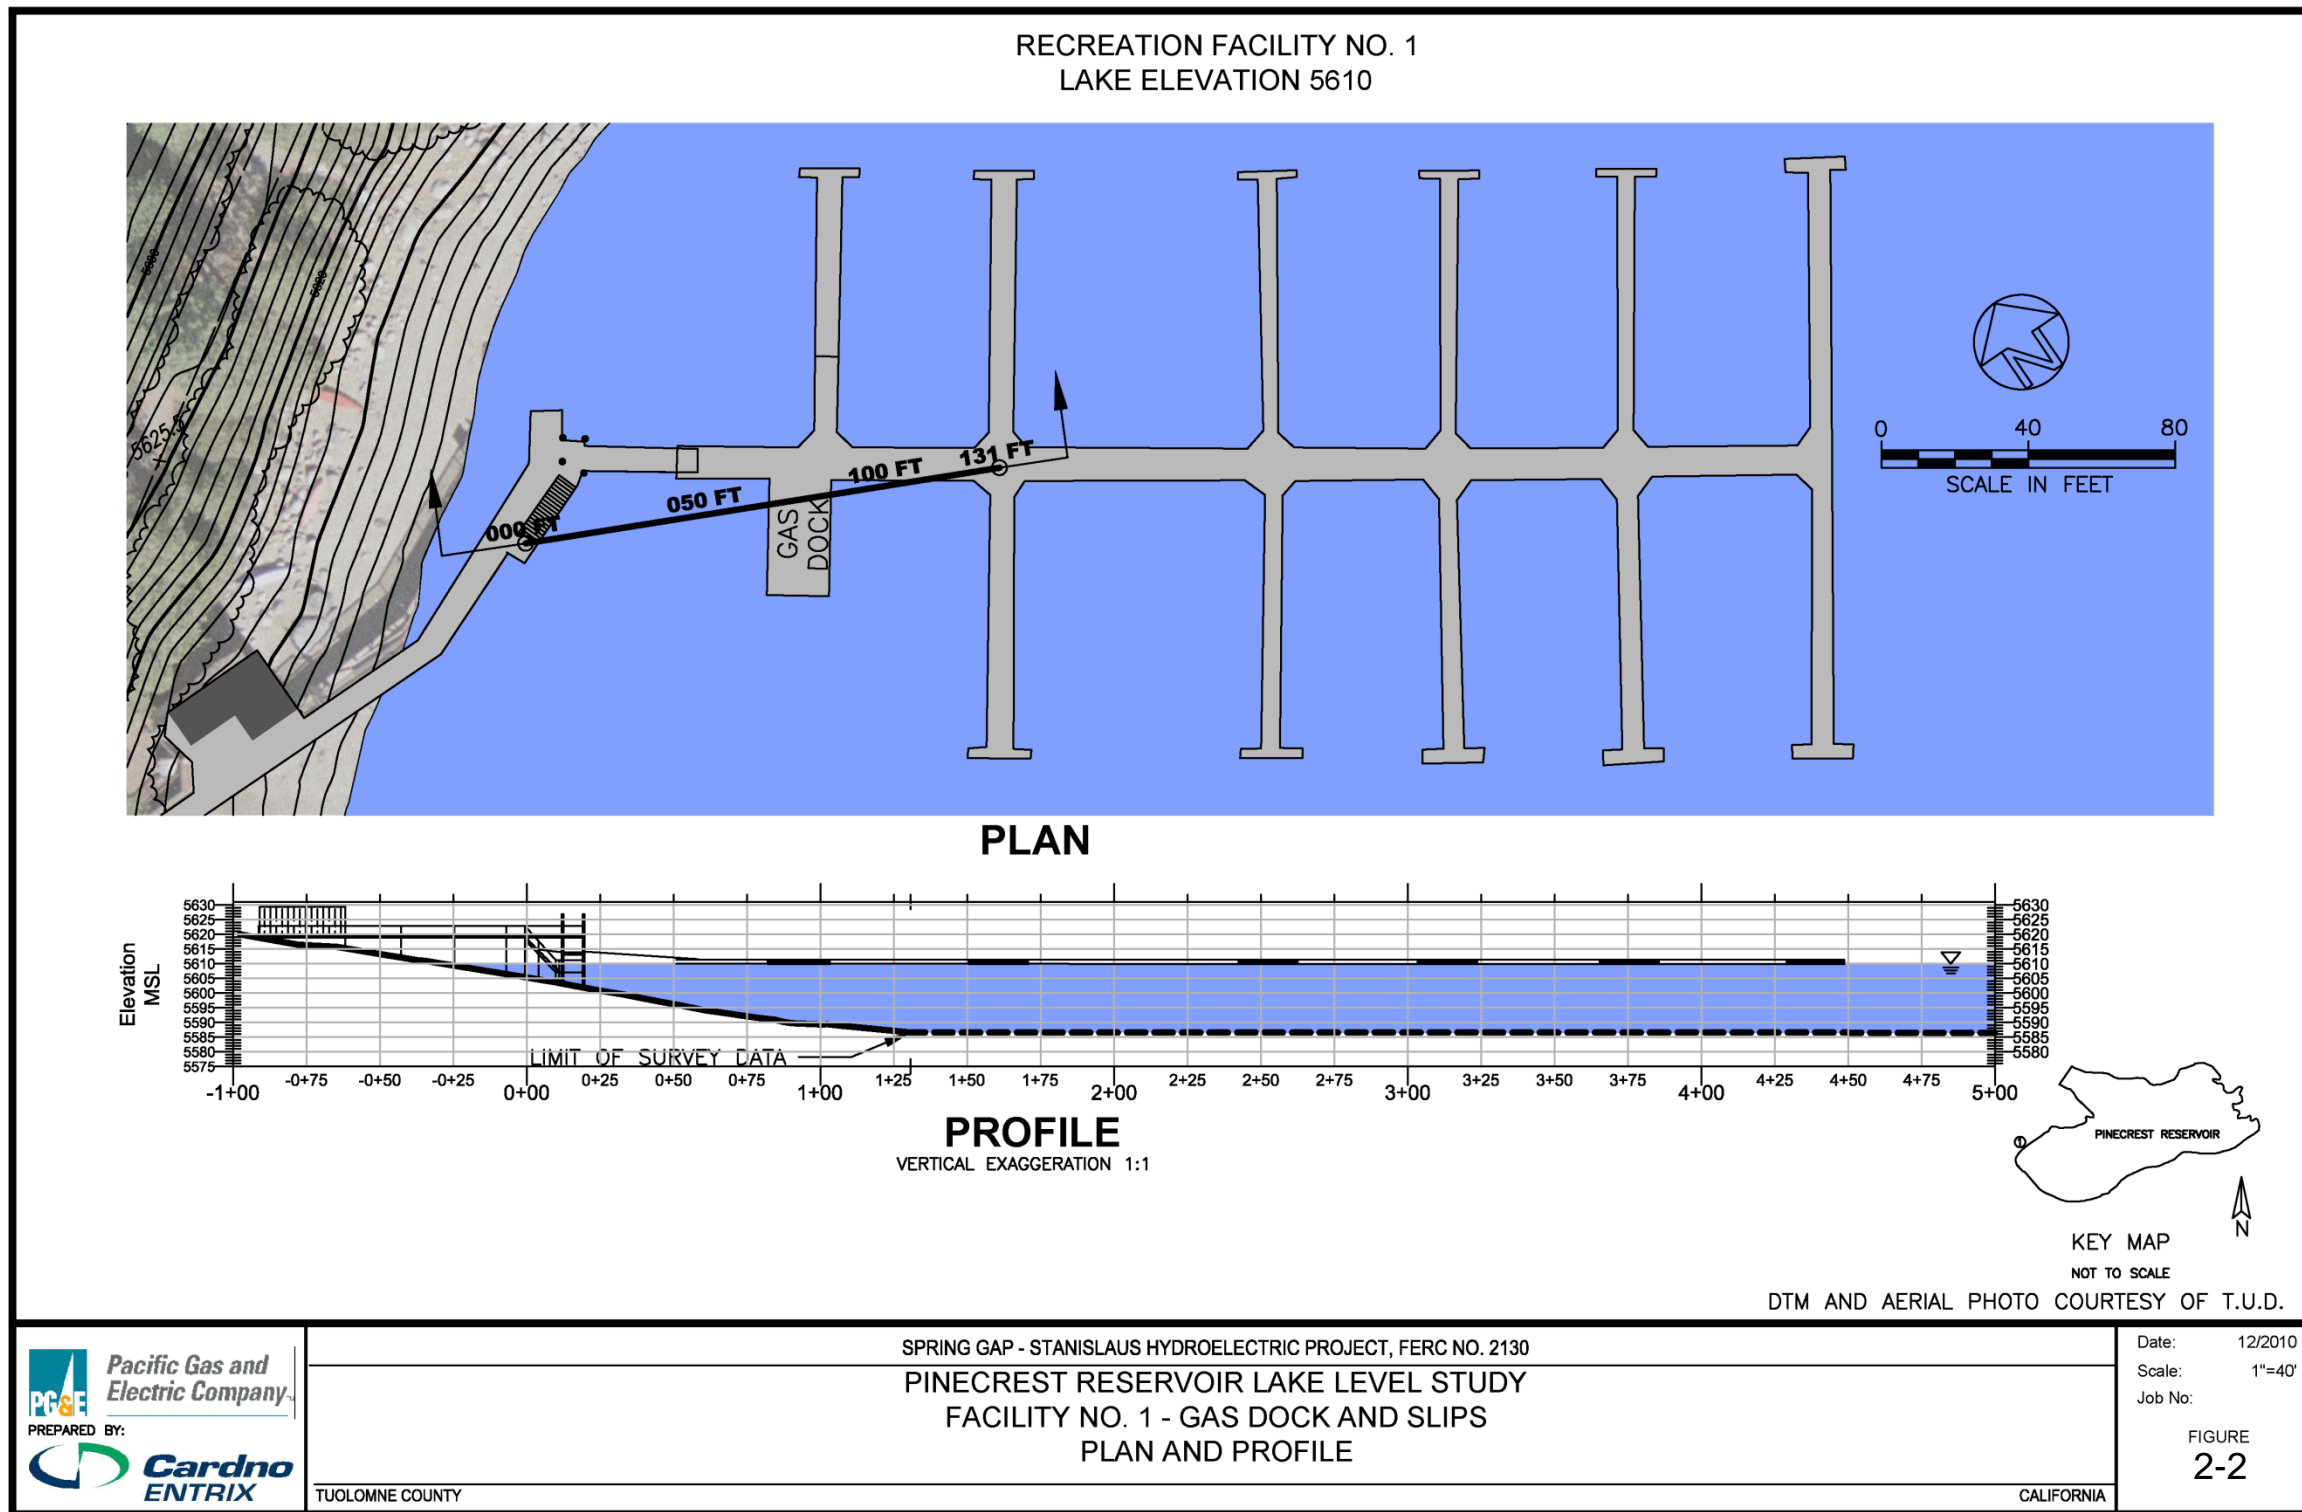
Figure 2-2. Plan and Profile Graphic for Recreation Facility #1 – Gas Dock and Slips (shown at elevation of 5,610 feet)

Figure 2-2 is an example of the plan and profile graphics developed from the 3D model. See Appendix B for a full set of plan and profile graphics.

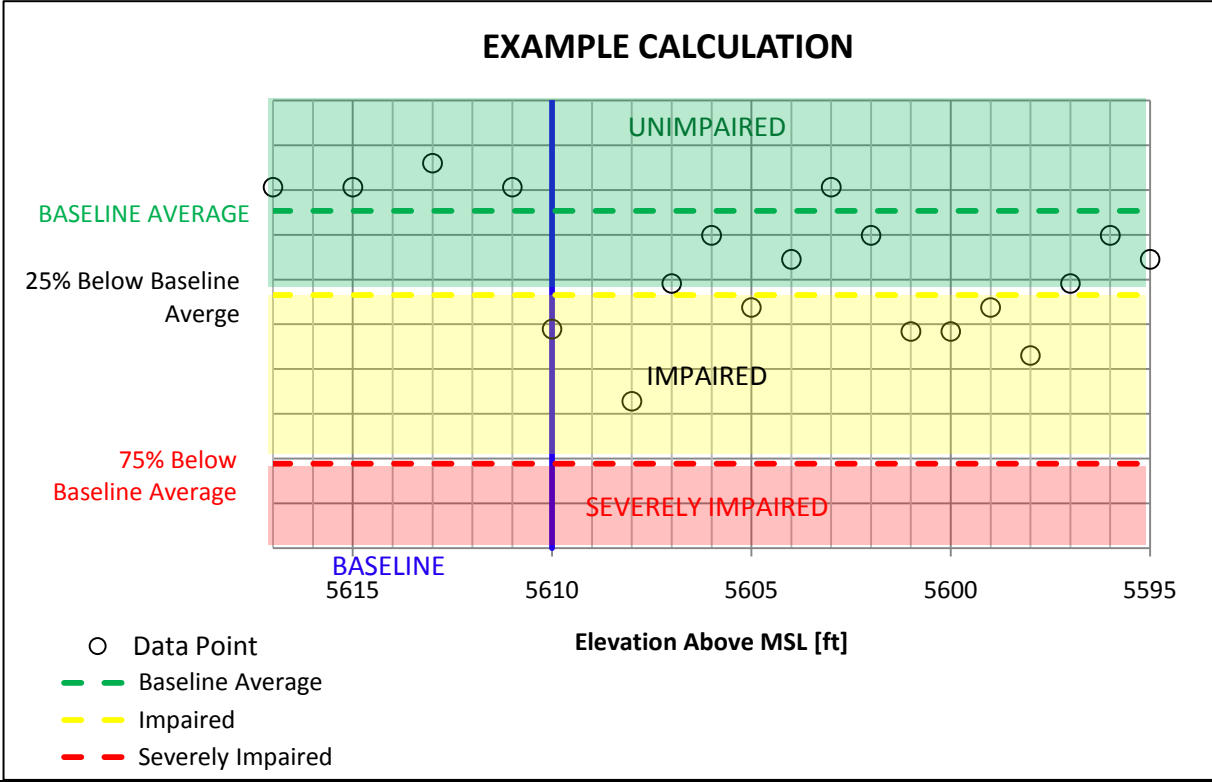
Figure 2-6. Example Calculation of “Unimpaired,” “Impaired,” and “Severely Impaired” for All Criteria Except Potential Swimming and Boating Hazards

For each elevation, the net usable beach area was compared to the baseline average and was categorized as “unimpaired,” “impaired,” or “severely impaired” using the same method described for pedestrian access quality (Figure 2-6). The data then were plotted to help visualize the comparison to the baseline average.

This section presents the results for each criterion described in Section 2 by facility.⁵ Each criterion is compared to the baseline average, and general descriptions for transitions in impairment status are discussed. After the results for each criterion for each facility are presented, the results are shown in tabular form. The tabular results are color coded using the definitions for unimpaired, impaired, and severely impaired as discussed previously and shown in Figures 2-6 and 2-11.

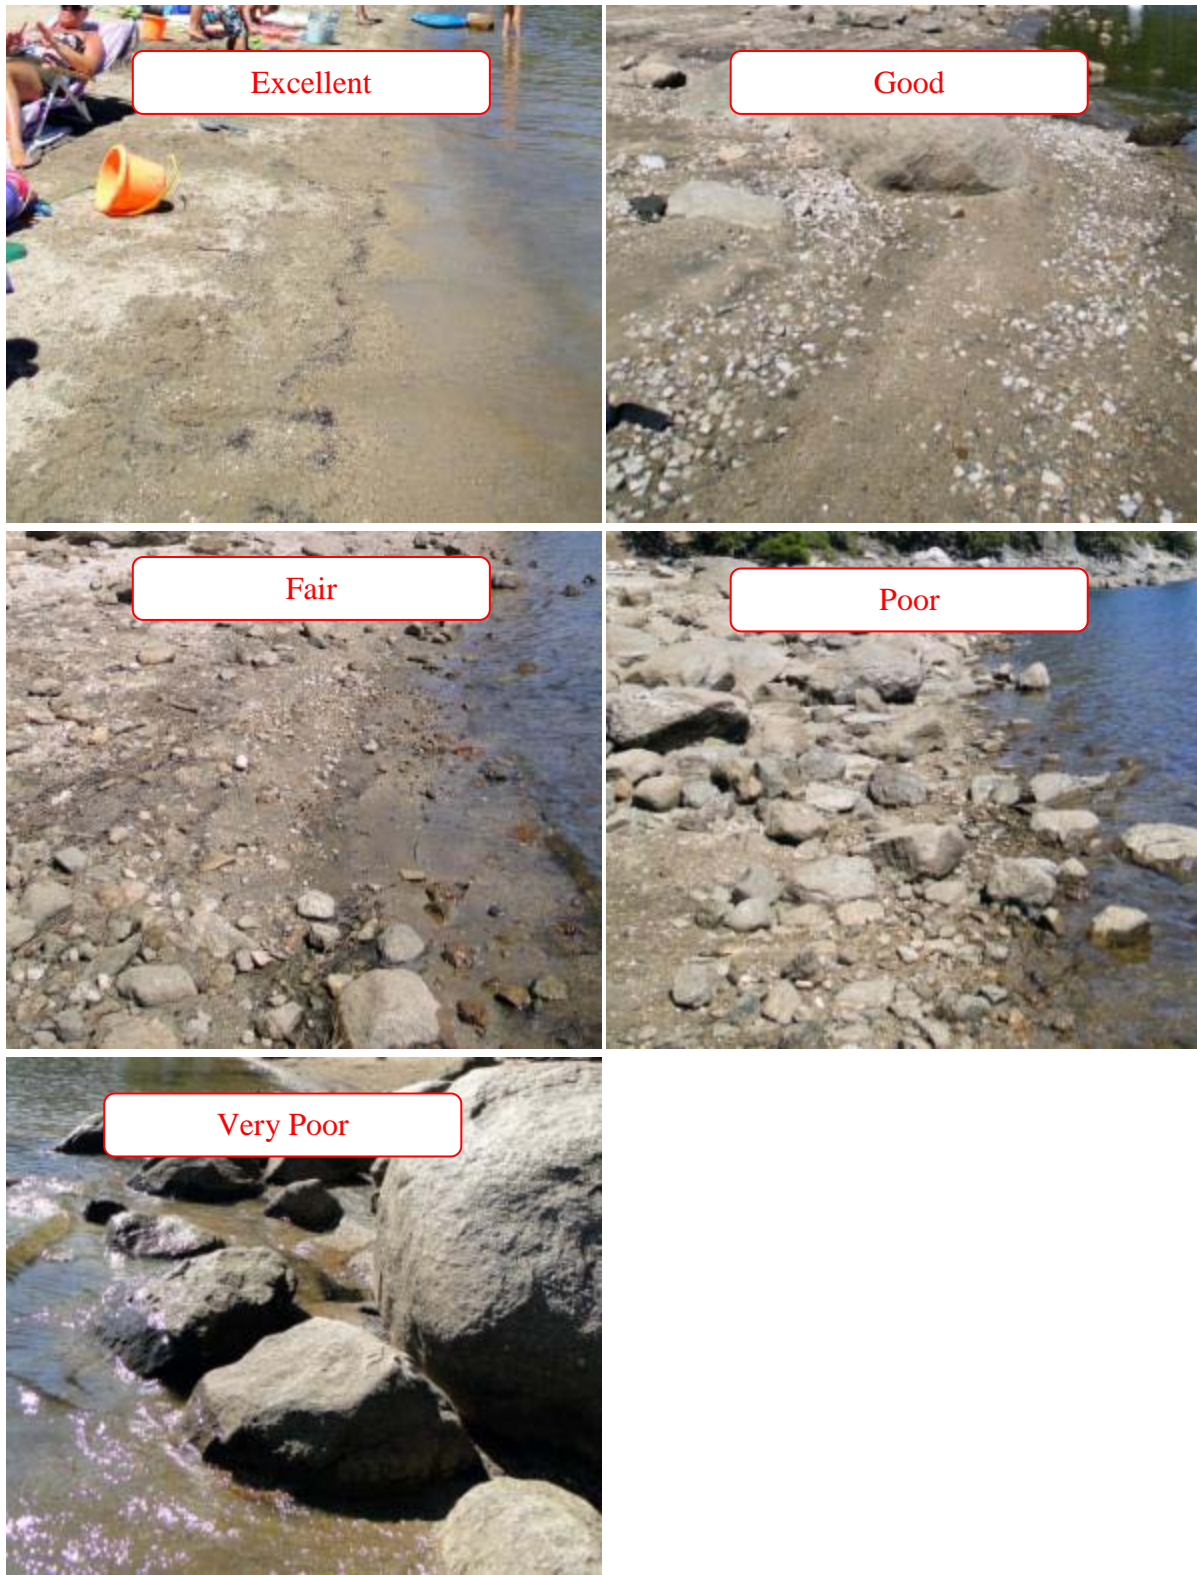
Figure 2-7. Examples of Beach Quality Rating Scale

Using a similar method as described above for pedestrian shoreline access quality, the beach quality was evaluated with a scale representing the range of conditions. Figure 2-7 provides examples of the beach quality rating scale. The field photos (shoreline left, shoreline right, and substrate) were evaluated at each lake level of the study using the following scale:

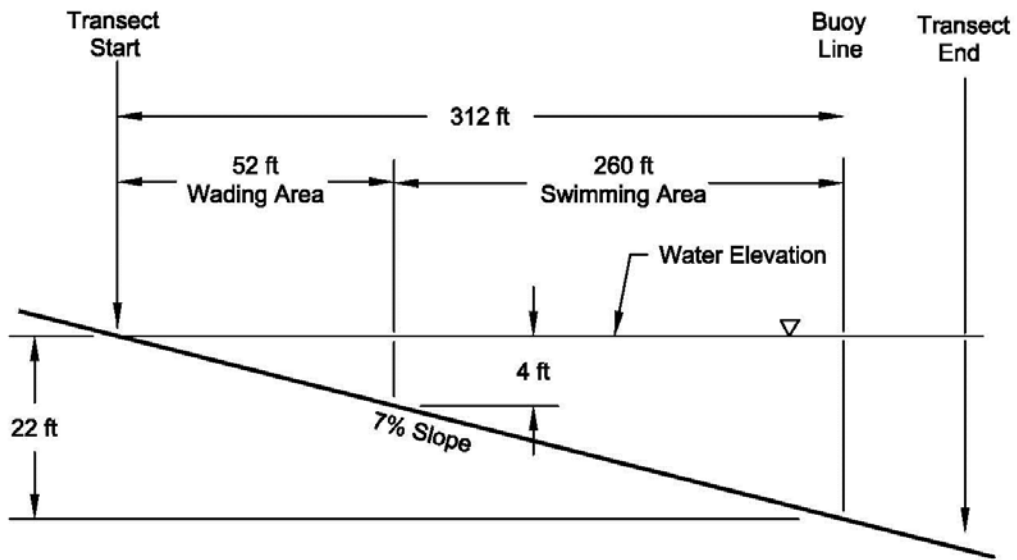
Figure 2-9. Example Calculation of Available Swimming Area and Usable Wading Area

To quantify the available swimming area, a 20-foot-wide representative area along each transect line was used. Swimming requires an adequate depth of water, in this study defined as greater than 4 ft. The length of the area available for swimming was measured from the point where the water depth reached 4 ft to the buoy line. This length then was multiplied by the representative width of 20 ft to obtain an index of the available swimming area. Figure 2-9 illustrates how the available swimming area was calculated.

For this study a wading depth was defined as any water depth from 0 to 4 ft. Therefore, the distance was calculated from the water’s edge to a 4-foot depth. As with the calculation for net usable beach area, the condition of the substrate directly affects the ability to wade. Substrates with high beach quality scores provide more wading area than similar areas with low beach quality scores. Therefore, the area calculated to a 4-foot depth of water was scaled by the beach quality score. This provides a measurement of the usable wading area. Figure 2-9 illustrates how the usable wading area was calculated.

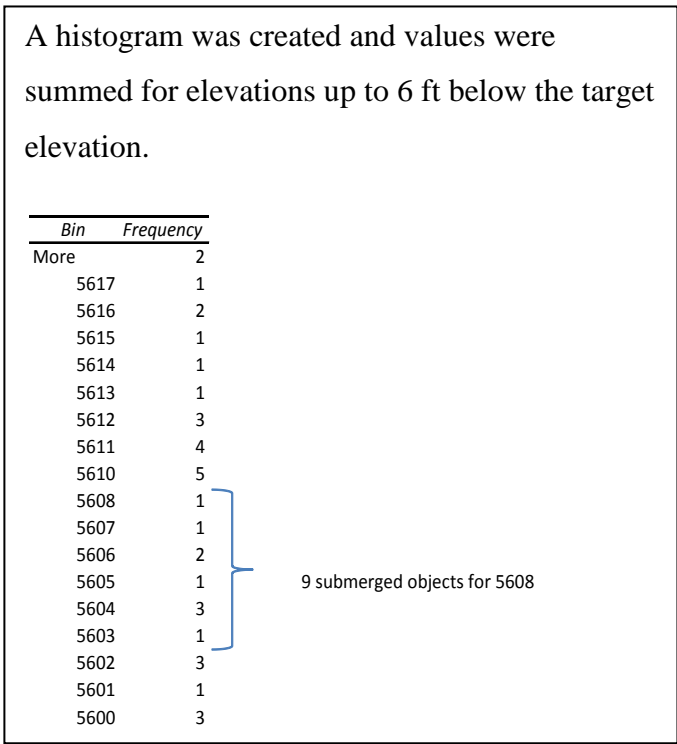
At elevation 5,608 ft, nine submerged objects are within 6 ft of the water surface within 10 ft of the transect line.

Figure 2-10. Example of Derivation of Number of Submerged Objects

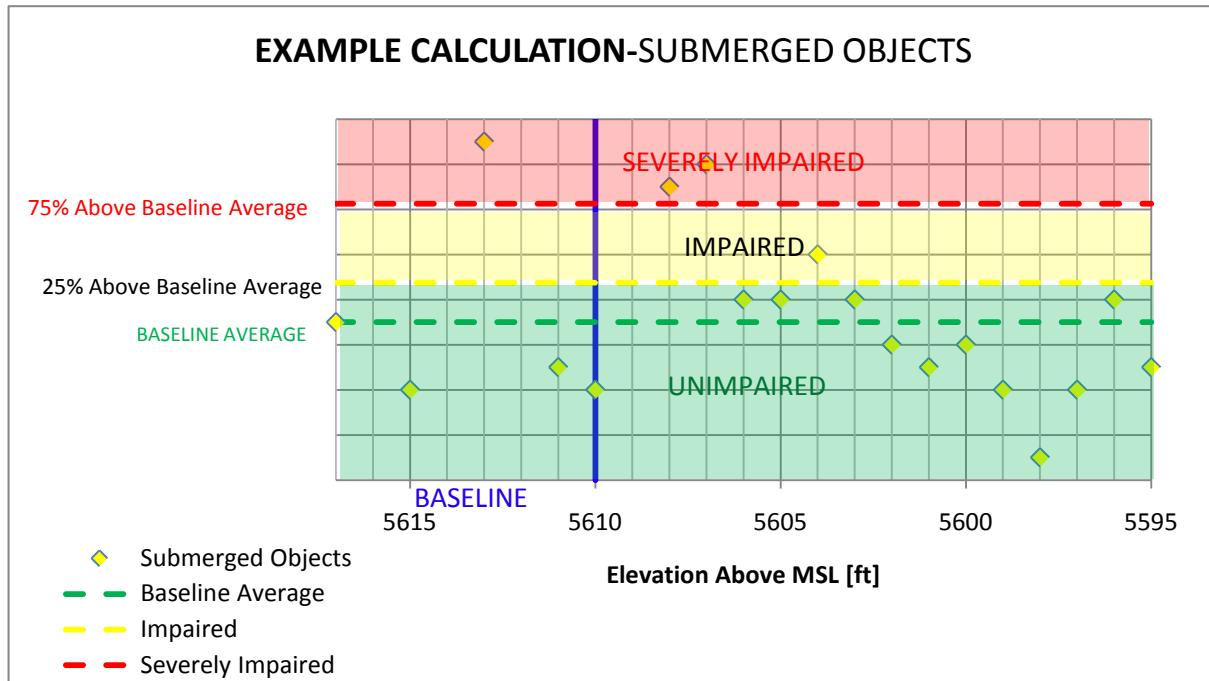
Figure 2-11. Example Calculation of “Unimpaired,” “Impaired,” and “Severely Impaired” for Potential Swimming and Boating Hazards (Submerged Objects)

Elevations were categorized as “unimpaired”, “impaired” and “severely impaired” using the same method described in section 2.3.1. Figure 2-11 provides an example of these categories. As with previous criteria, these data were plotted for each transect for comparison to the baseline average number of submerged objects.

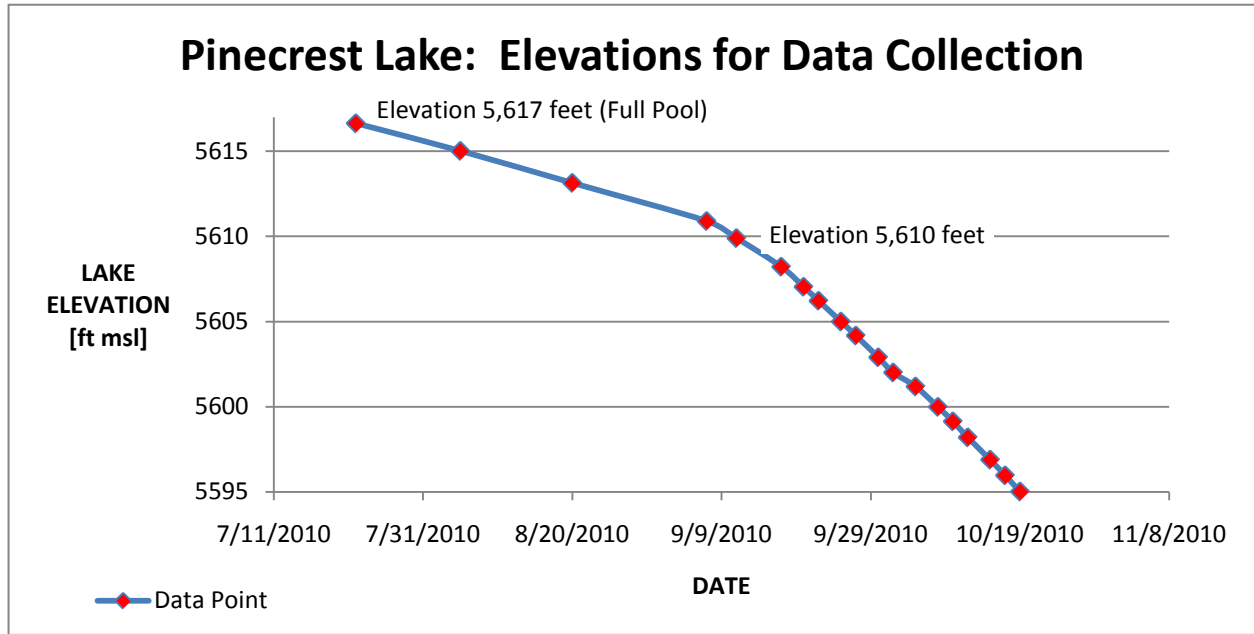
Figure 3-1. Pinecrest Lake Level Elevation: Data Collection Dates with Corresponding Lake Surface Elevations

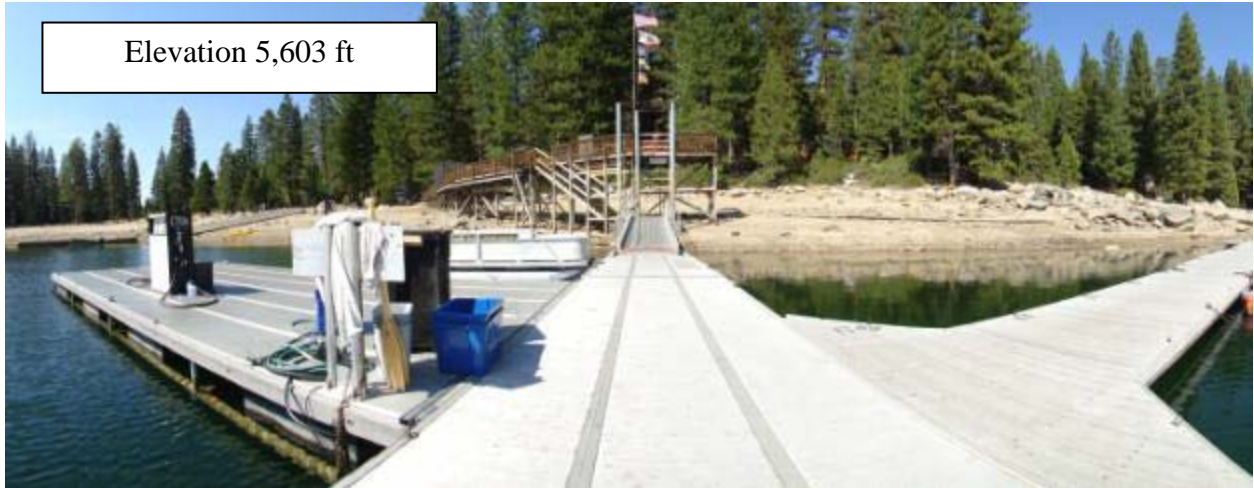
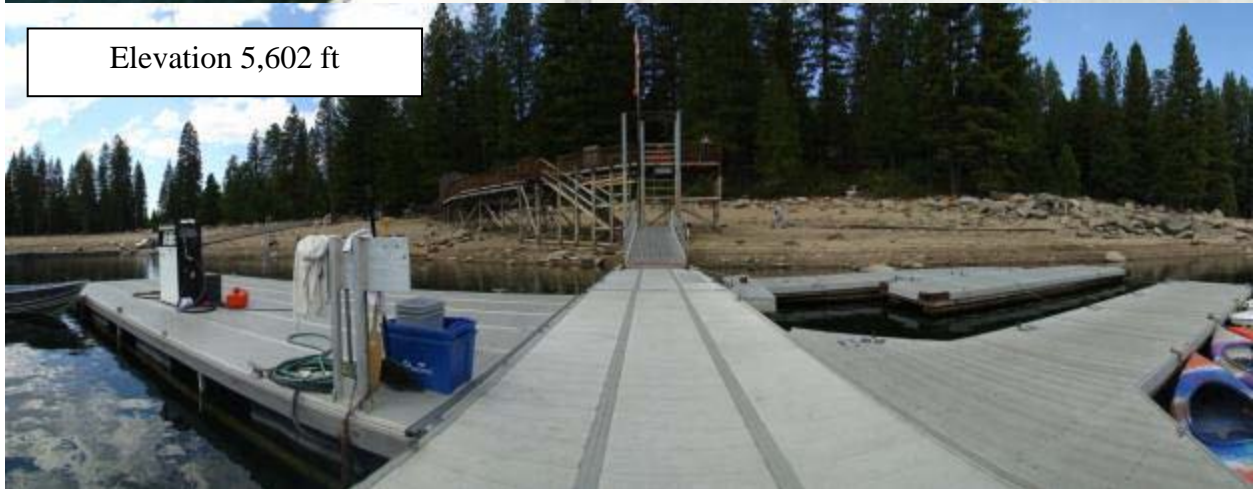
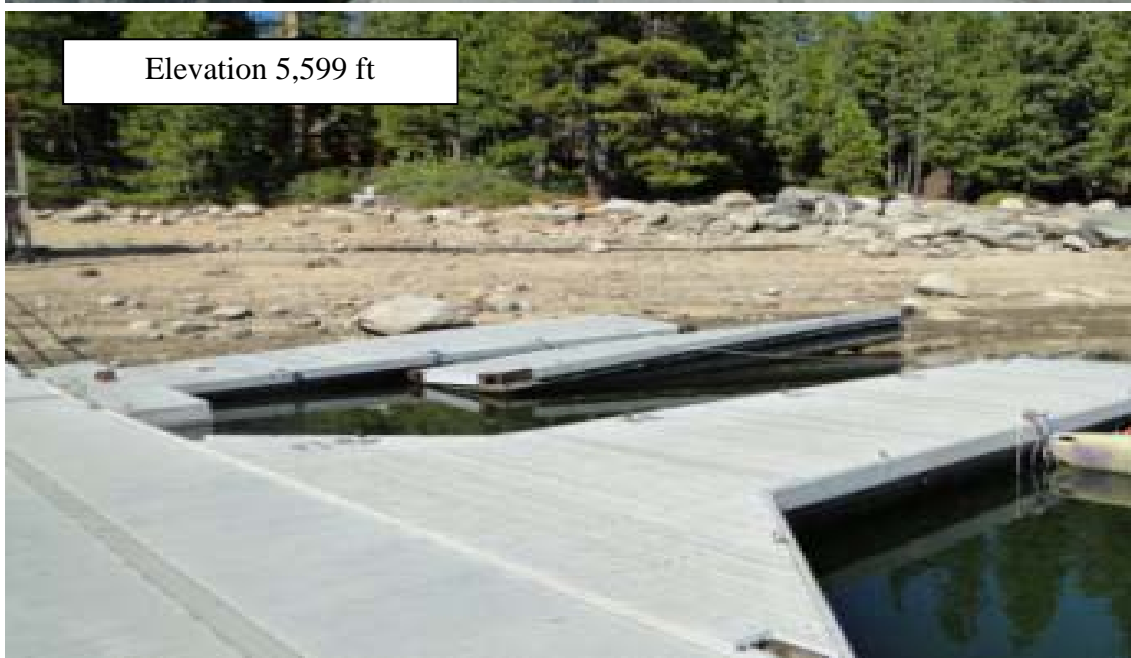
Figure 3-2. Transition from 12 Usable Fingers to 11.3 Usable Fingers

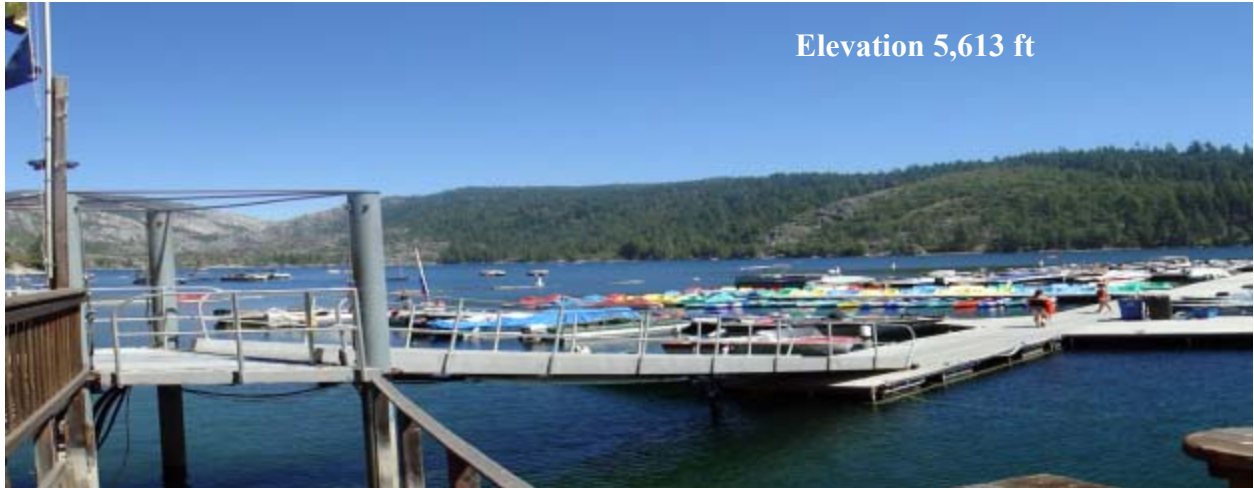
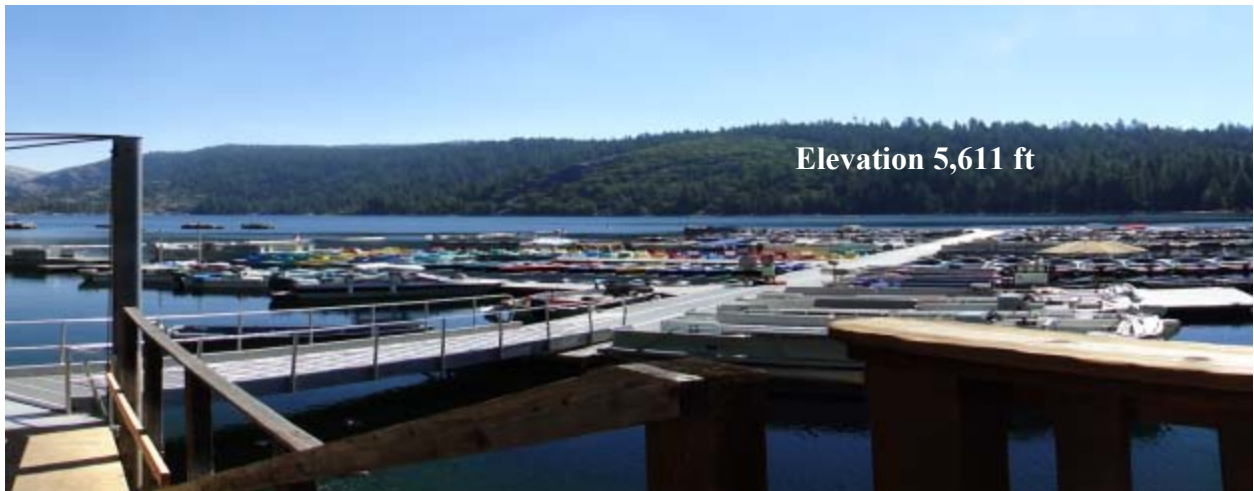
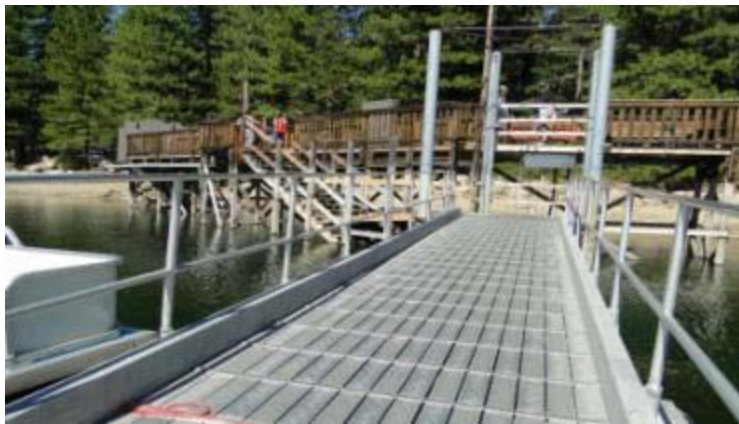
This photograph was taken at elevation 5,611 ft and shows access to the boat dock from the shoreline by use of the staircase.

Figure 3-3. Transition from Direct Deck Access to Boat Ramp and Slips
