PINECREST RESERVOIR LAKE LEVEL STUDY REPORT

**Spring Gap-Stanislaus Hydroelectric Project
(FERC Project No. 2130)**

***Pacific Gas and
Electric Company™***

April 2011

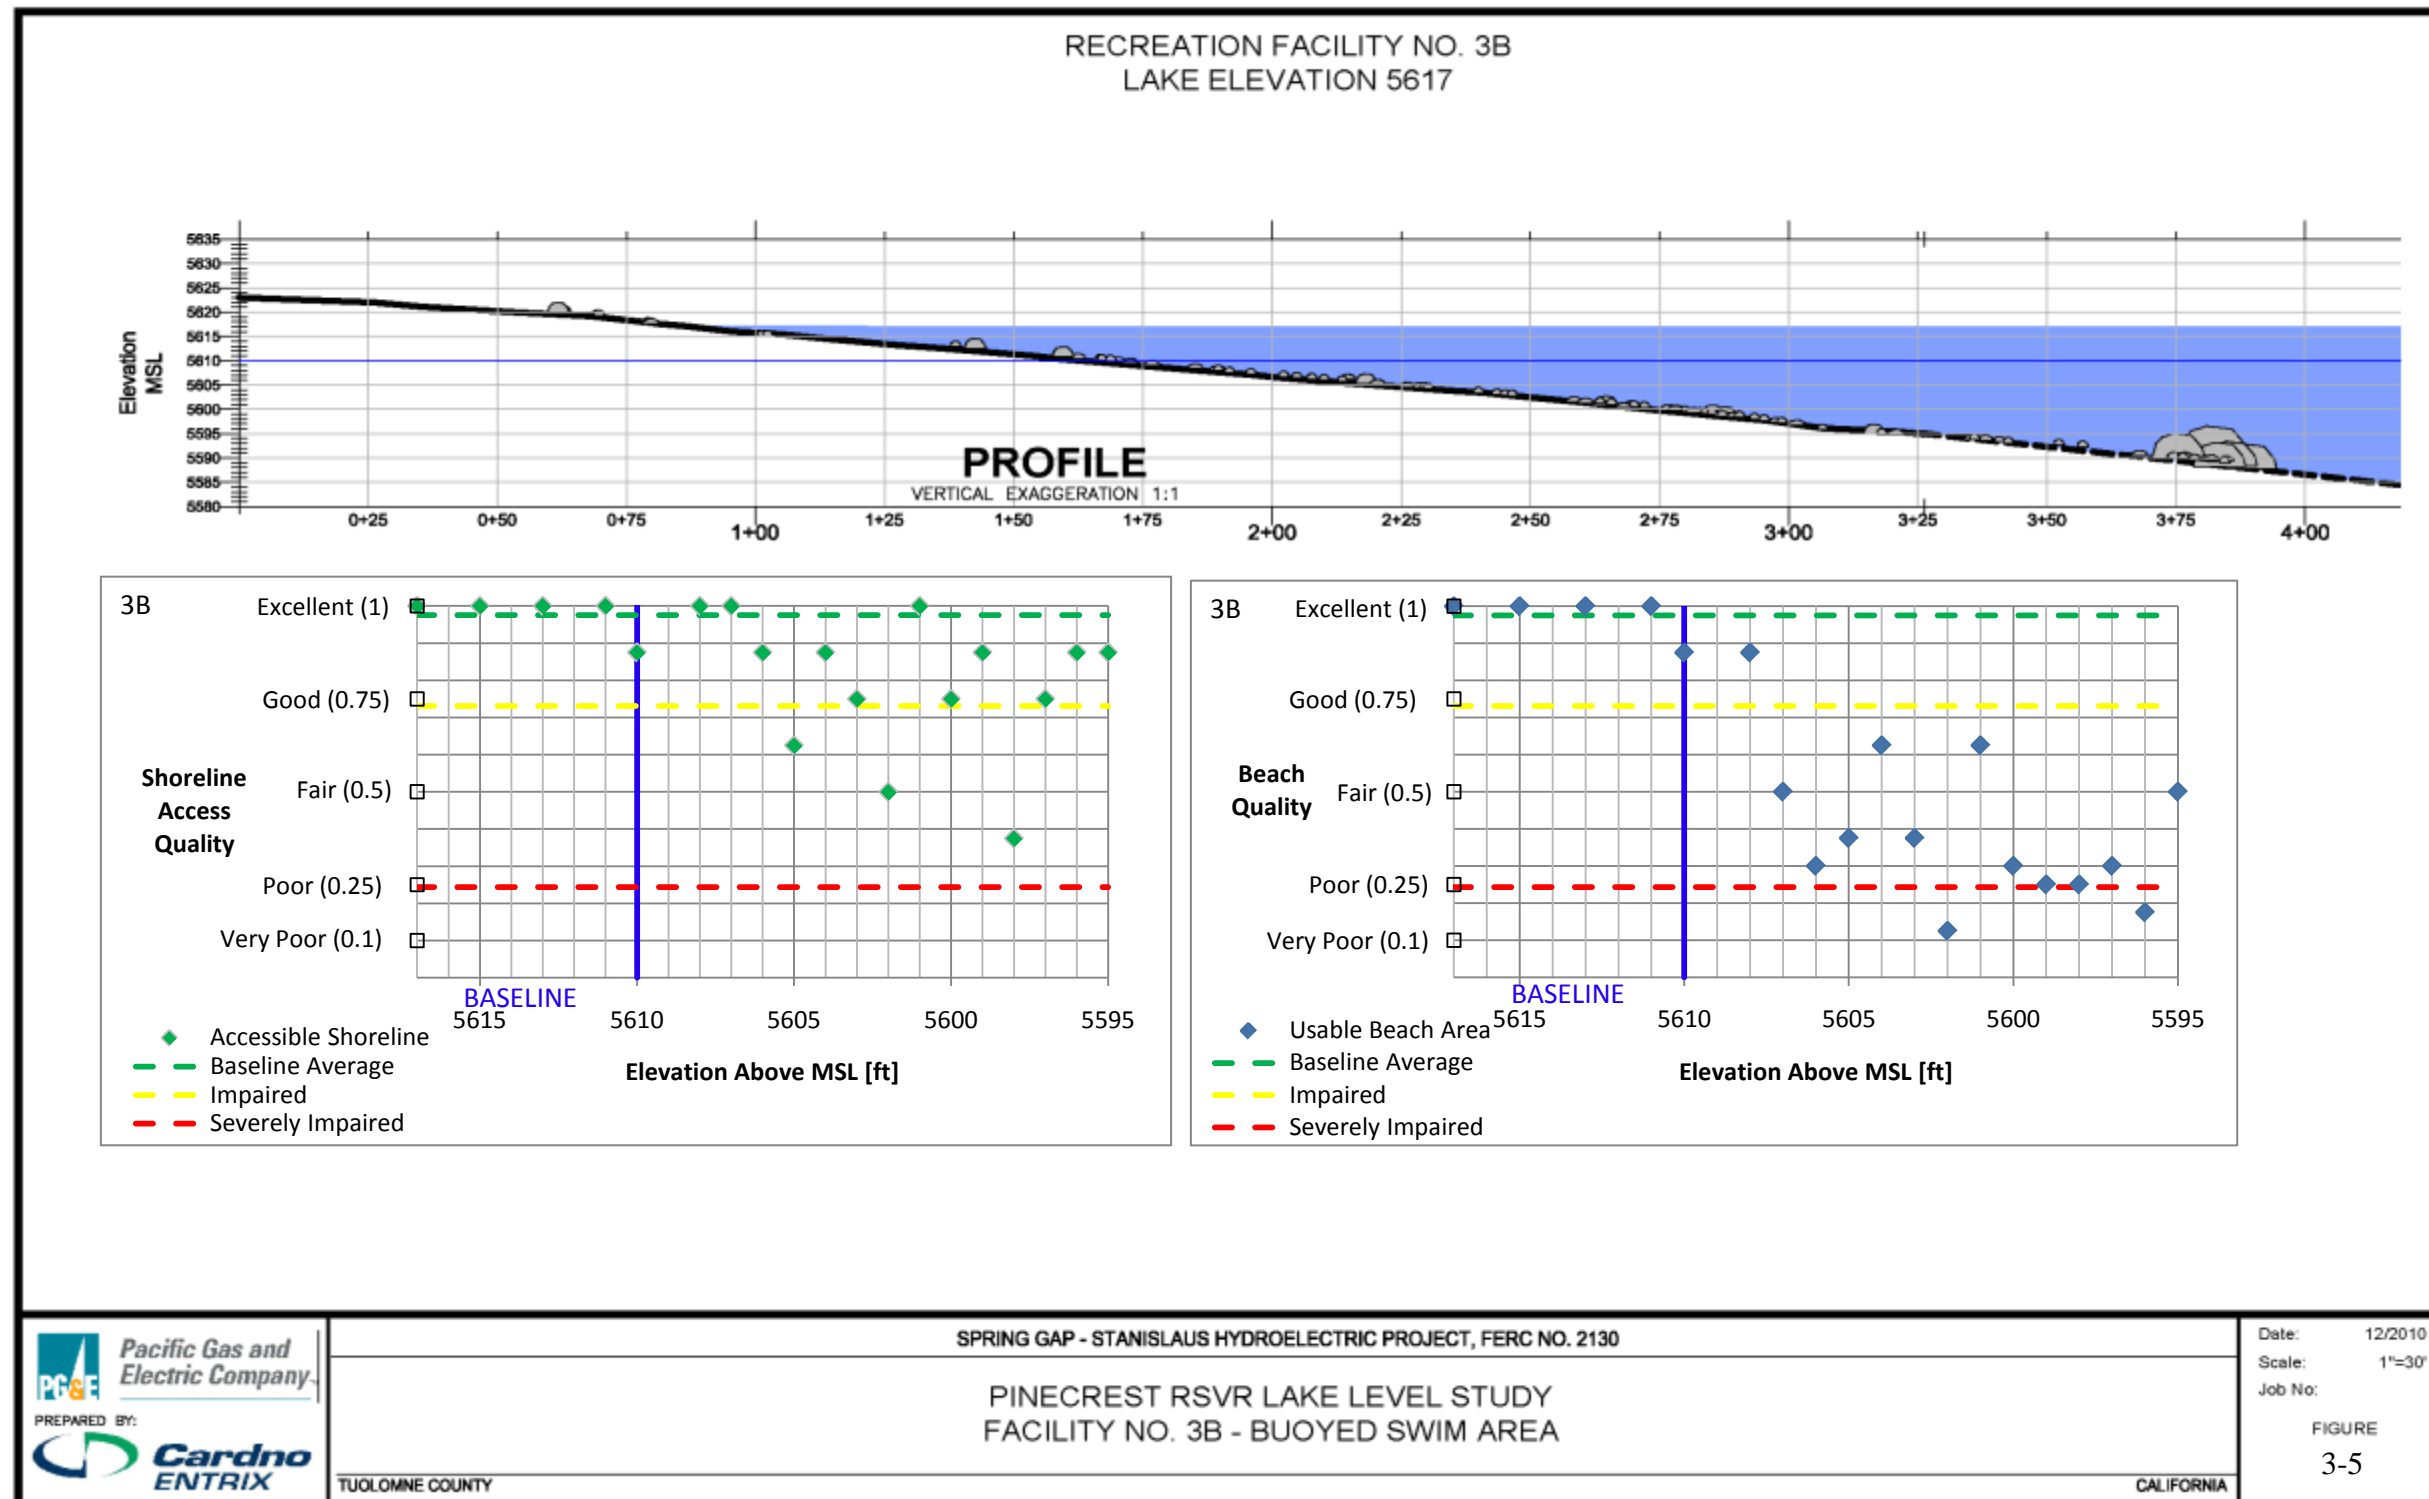
Figure 3-5. Pedestrian Shoreline Access Quality and Beach Quality Results for Transect #3B

Figure 3-5 shows Transect #3B. Access quality drops and becomes impaired for elevations 5,606, 5,602 and 5,598 ft.

Transect #3C shows no impaired values for beach quality at any elevation until 5,597 ft (Figure 3-5).

Both Transects #3A and #3B show a drop in the usable wading area as the water elevation drops (Figures 3-13 and 3-14, respectively). Again, this is due to the trend in beach quality seen in Figures 3-4 and 3-5.

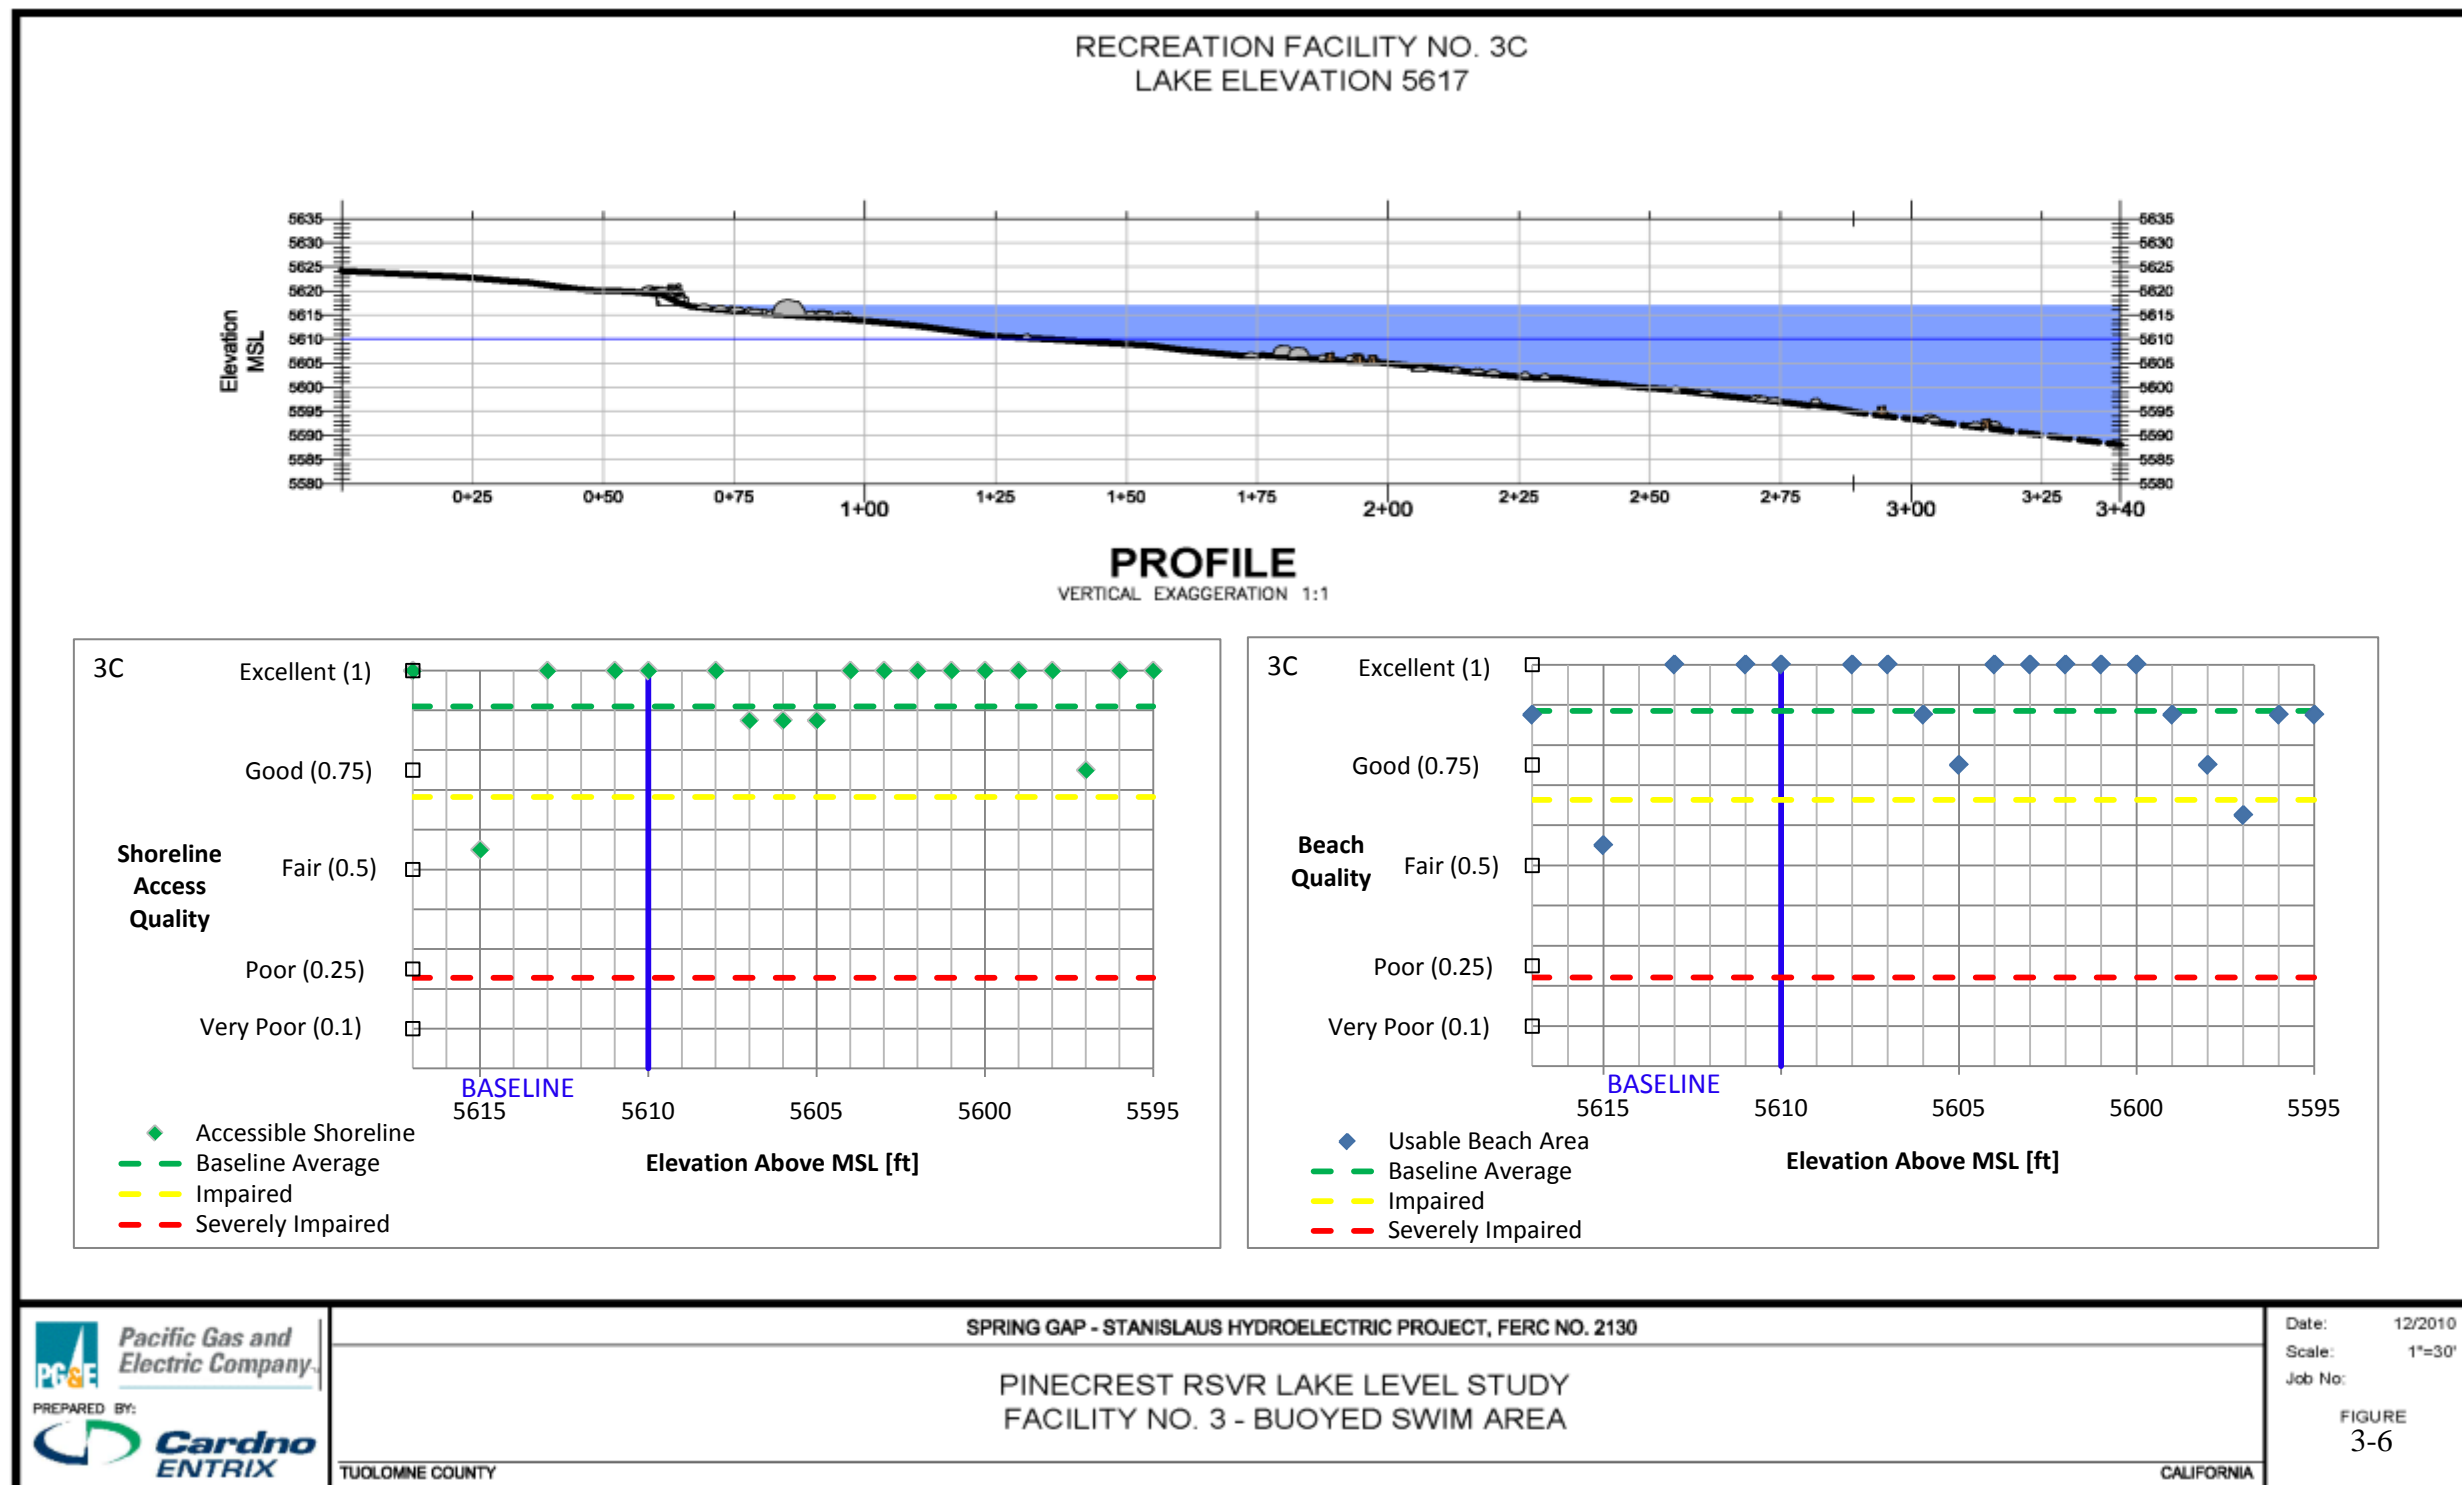
Figure 3-6. Pedestrian Shoreline Access Quality and Beach Quality Results for Transect #3C

Figure 3-6 shows Transect #3C to have no impaired shoreline access beyond the baseline values.

Transect #3B shows a large drop in beach quality, becoming either impaired or severely impaired at elevations 5,607-5,595 ft. (Figure 3-6).

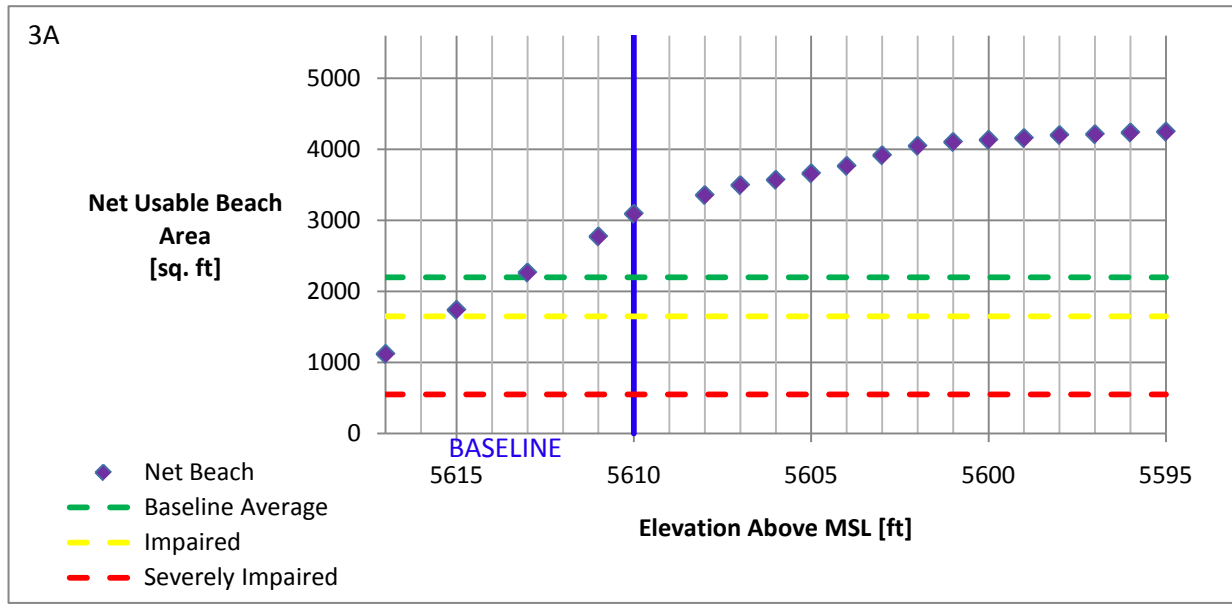
Figure 3-7. Net Usable Beach in Transect #3A

Net usable beach area quantifies the cumulative amount of exposed usable beach area as the water elevation falls. The gain in usable beach approaches zero at approximately elevation 5,602 ft in Transect #3A (Figure 3-7).

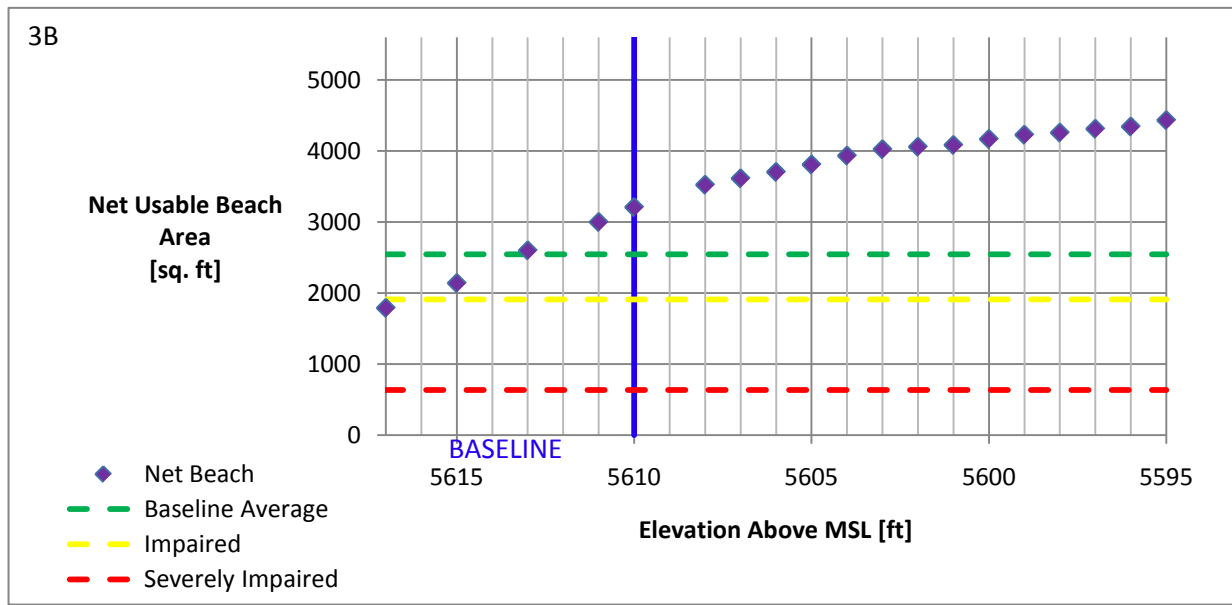
Figure 3-8. Net Usable Beach in Transect #3B

Transect #3B shows an increase in usable beach area at all elevation levels below baseline. However, the amount gained becomes reduced at approximately elevation 5,605 ft (Figure 3-8).

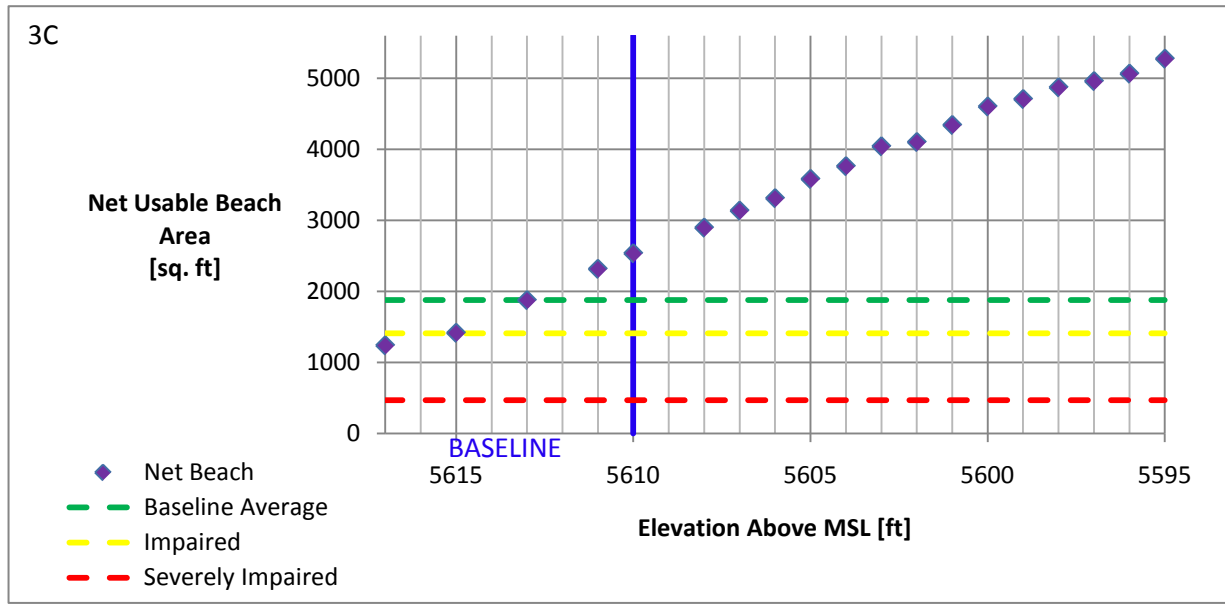
Figure 3-9. Net Usable Beach in Transect #3C

Unlike Transects #3A and #3B, there is no reduction in the usable beach area gained as elevations drop for Transect #3C (Figure 3-9). No elevations below the baseline result in impaired conditions.

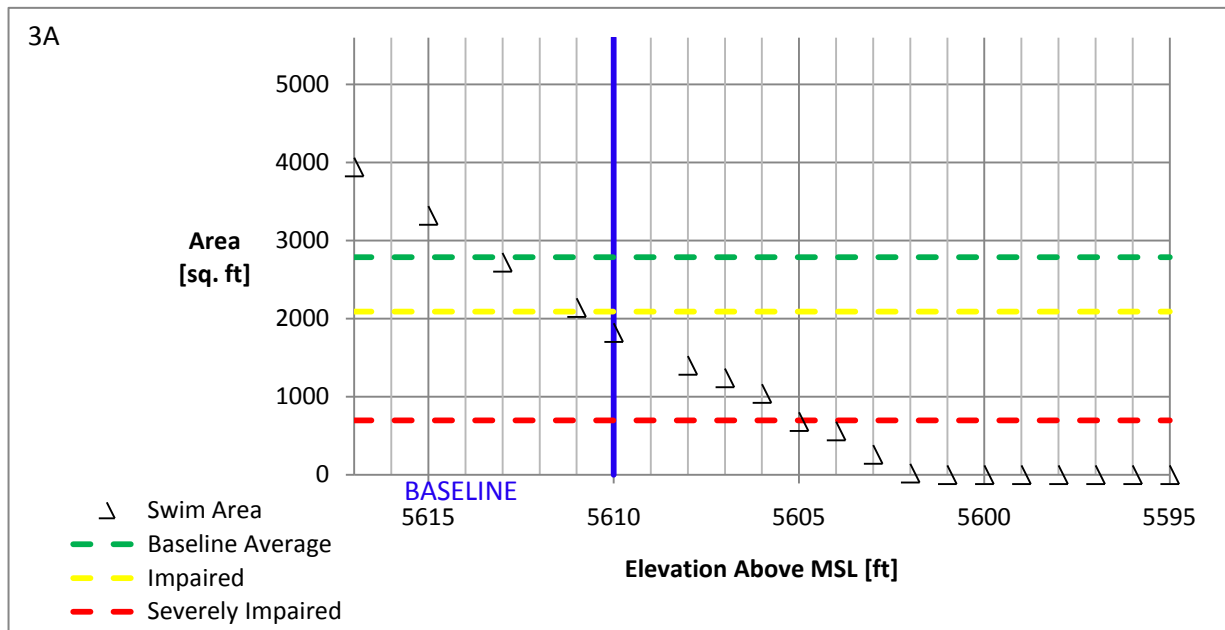
Figure 3-10. Available Swimming Area in Transect #3A

The available swimming area is calculated using the distance from the water to the buoy line, minus the distance for wading. Because the location of the buoy line does not change, as water levels decrease, the available swimming area decreases at each elevation (Figures 3-10, 3-11, and 3-12). As the elevation drops to approximately 5,603 ft, there is no water in the designated buoyed swimming area. This was defined as zero area available for swimming.

Overall, all of the transects show nearly identical relationships for available swimming area. There are slight differences in the starting distances to the buoy line and in the amount of beach left exposed by falling water surface elevation. However, the overall relationship is the same for the entire designated buoyed swimming area; the swimming area becomes impaired at approximately 5,608 ft and severely impaired at approximately 5,605 ft as compared to the baseline average.

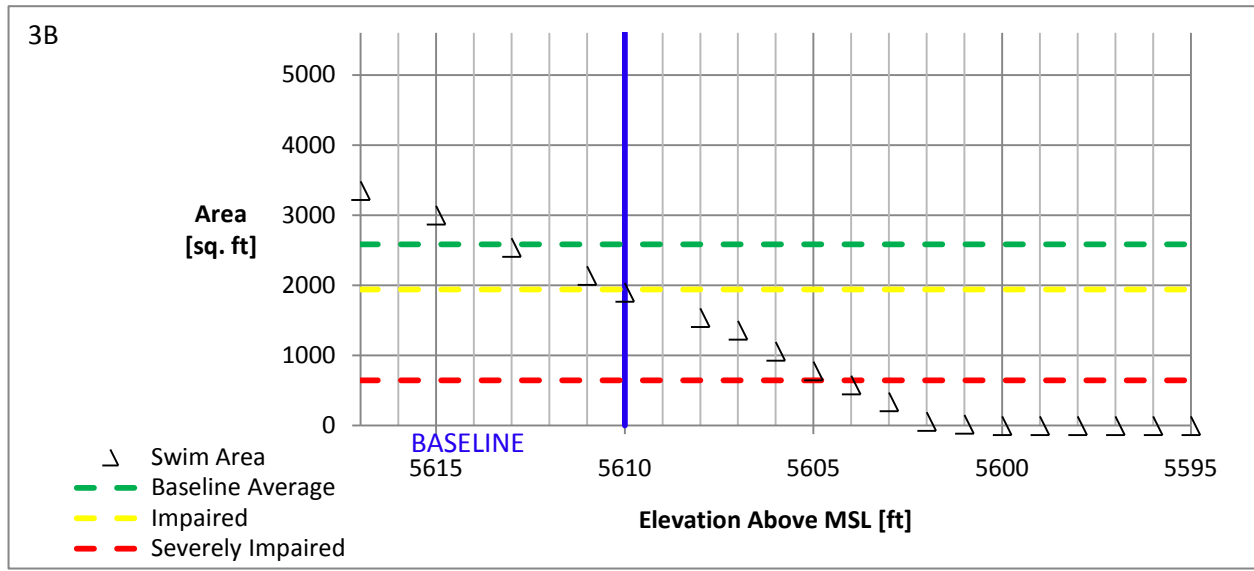
Figure 3-11. Available Swimming Area in Transect #3B

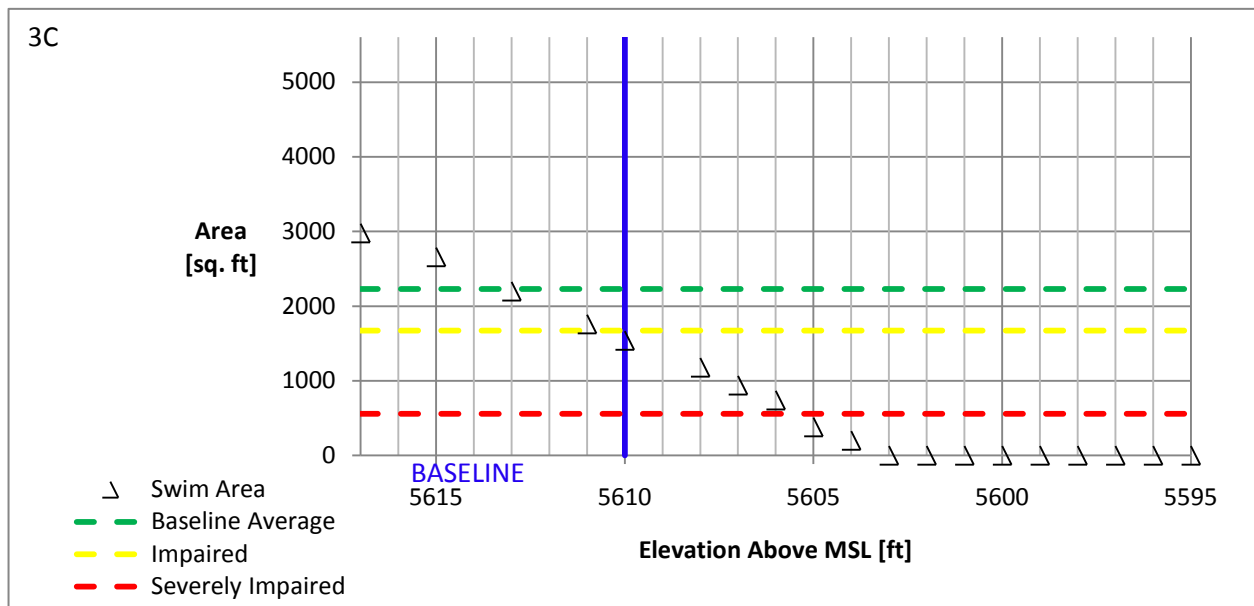
Figure 3-12. Available Swimming Area in Transect #3C

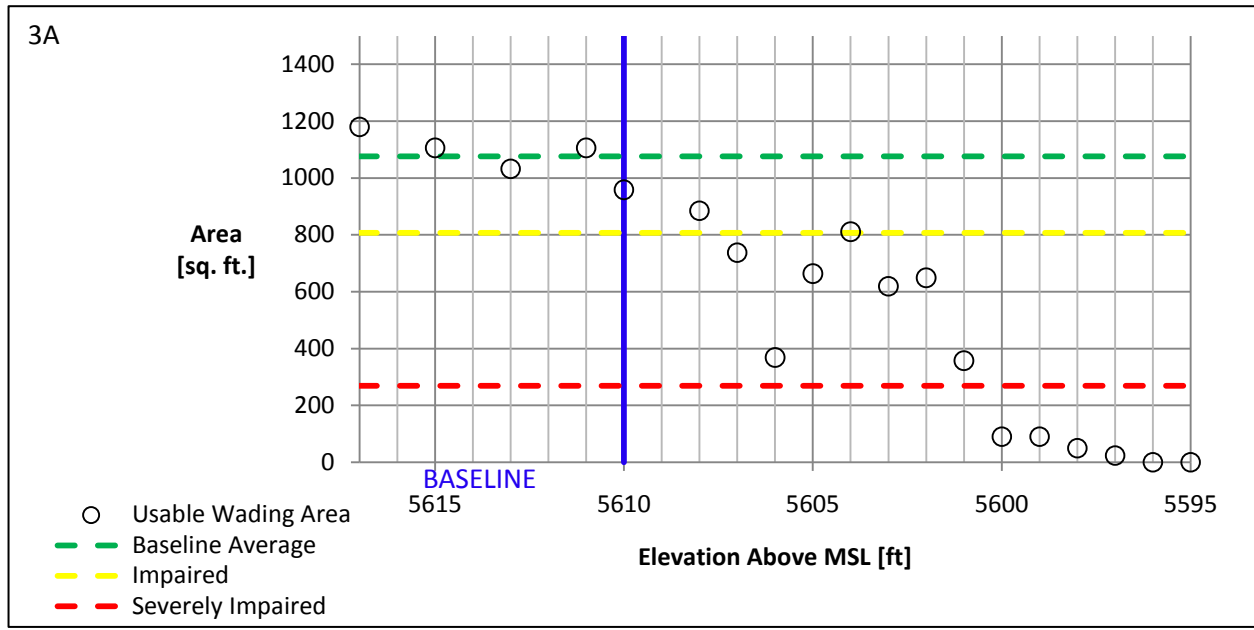
Figure 3-13. Usable Wading Area in Transect #3A

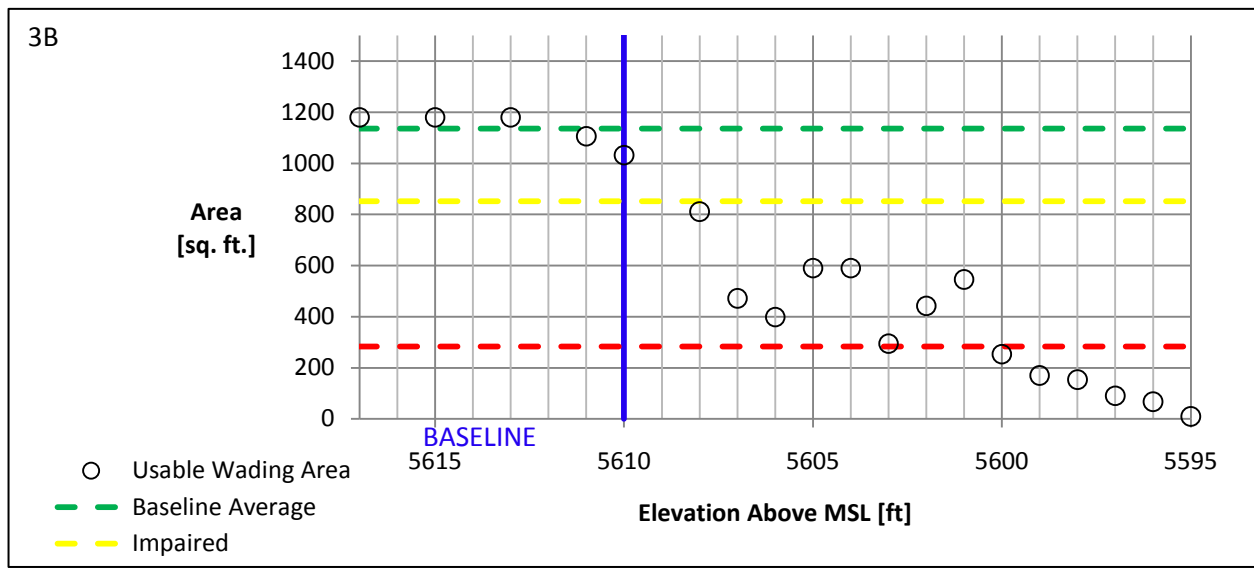
Figure 3-14. Usable Wading Area in Transect #3B

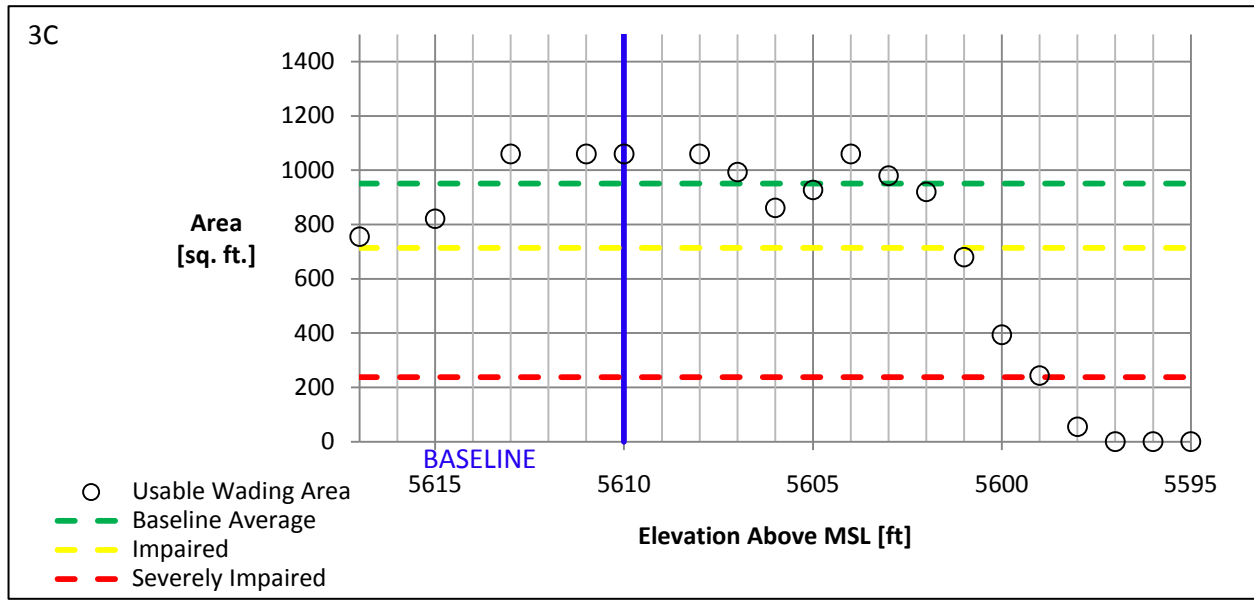
Figure 3-15. Usable Wading Area in Transect #3C

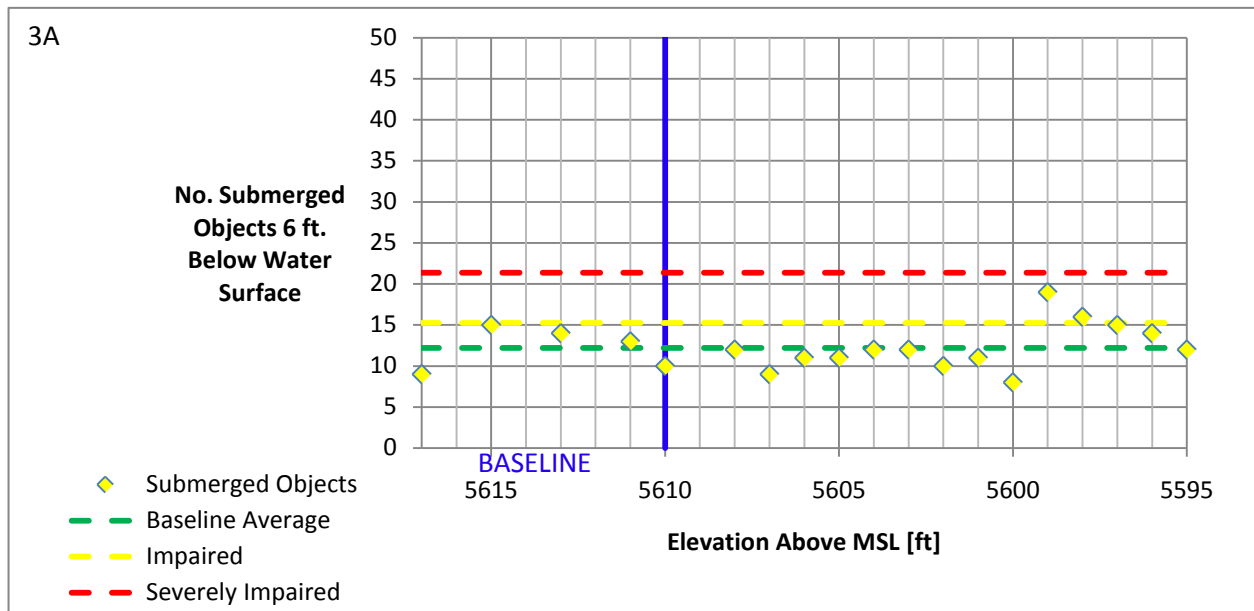
Figure 3-16. Potential Swimming Hazards within 6 Feet of Water Surface in Transect #3A

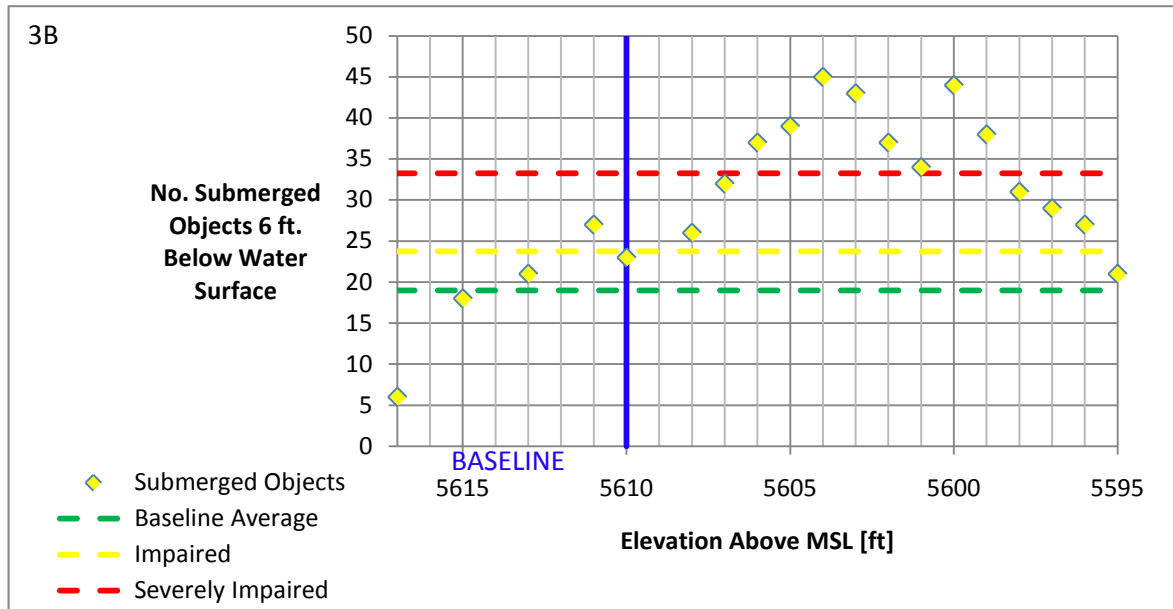
Figure 3-17. Potential Swimming Hazards within 6 Feet of Water Surface in Transect #3B

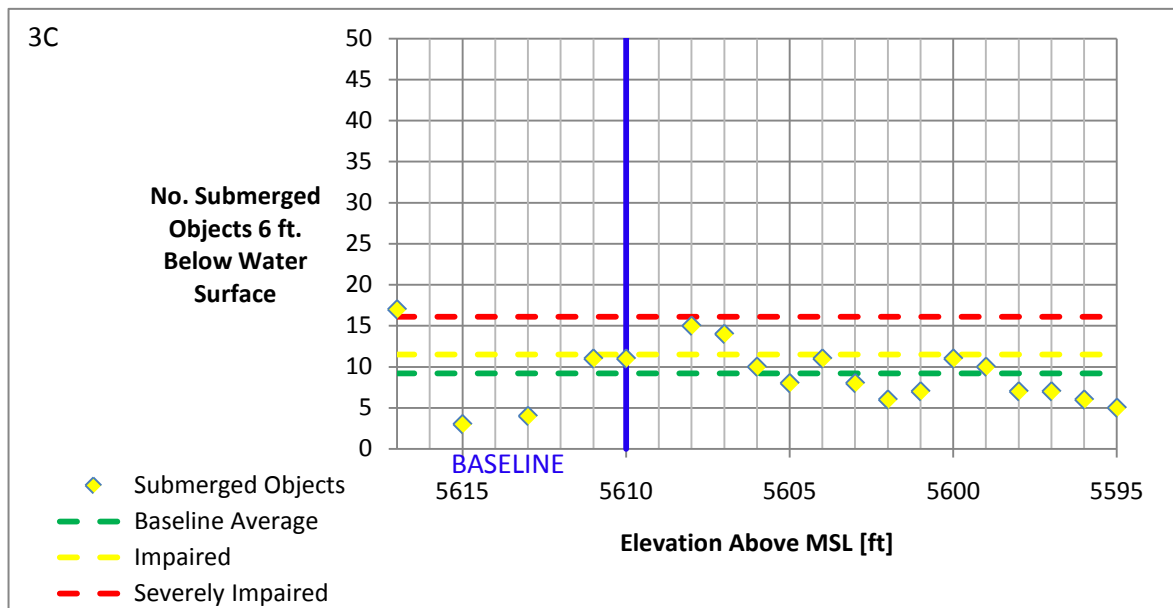
Figure 3-18. Potential Swimming Hazards within 6 Feet of Water Surface in Transect #3C

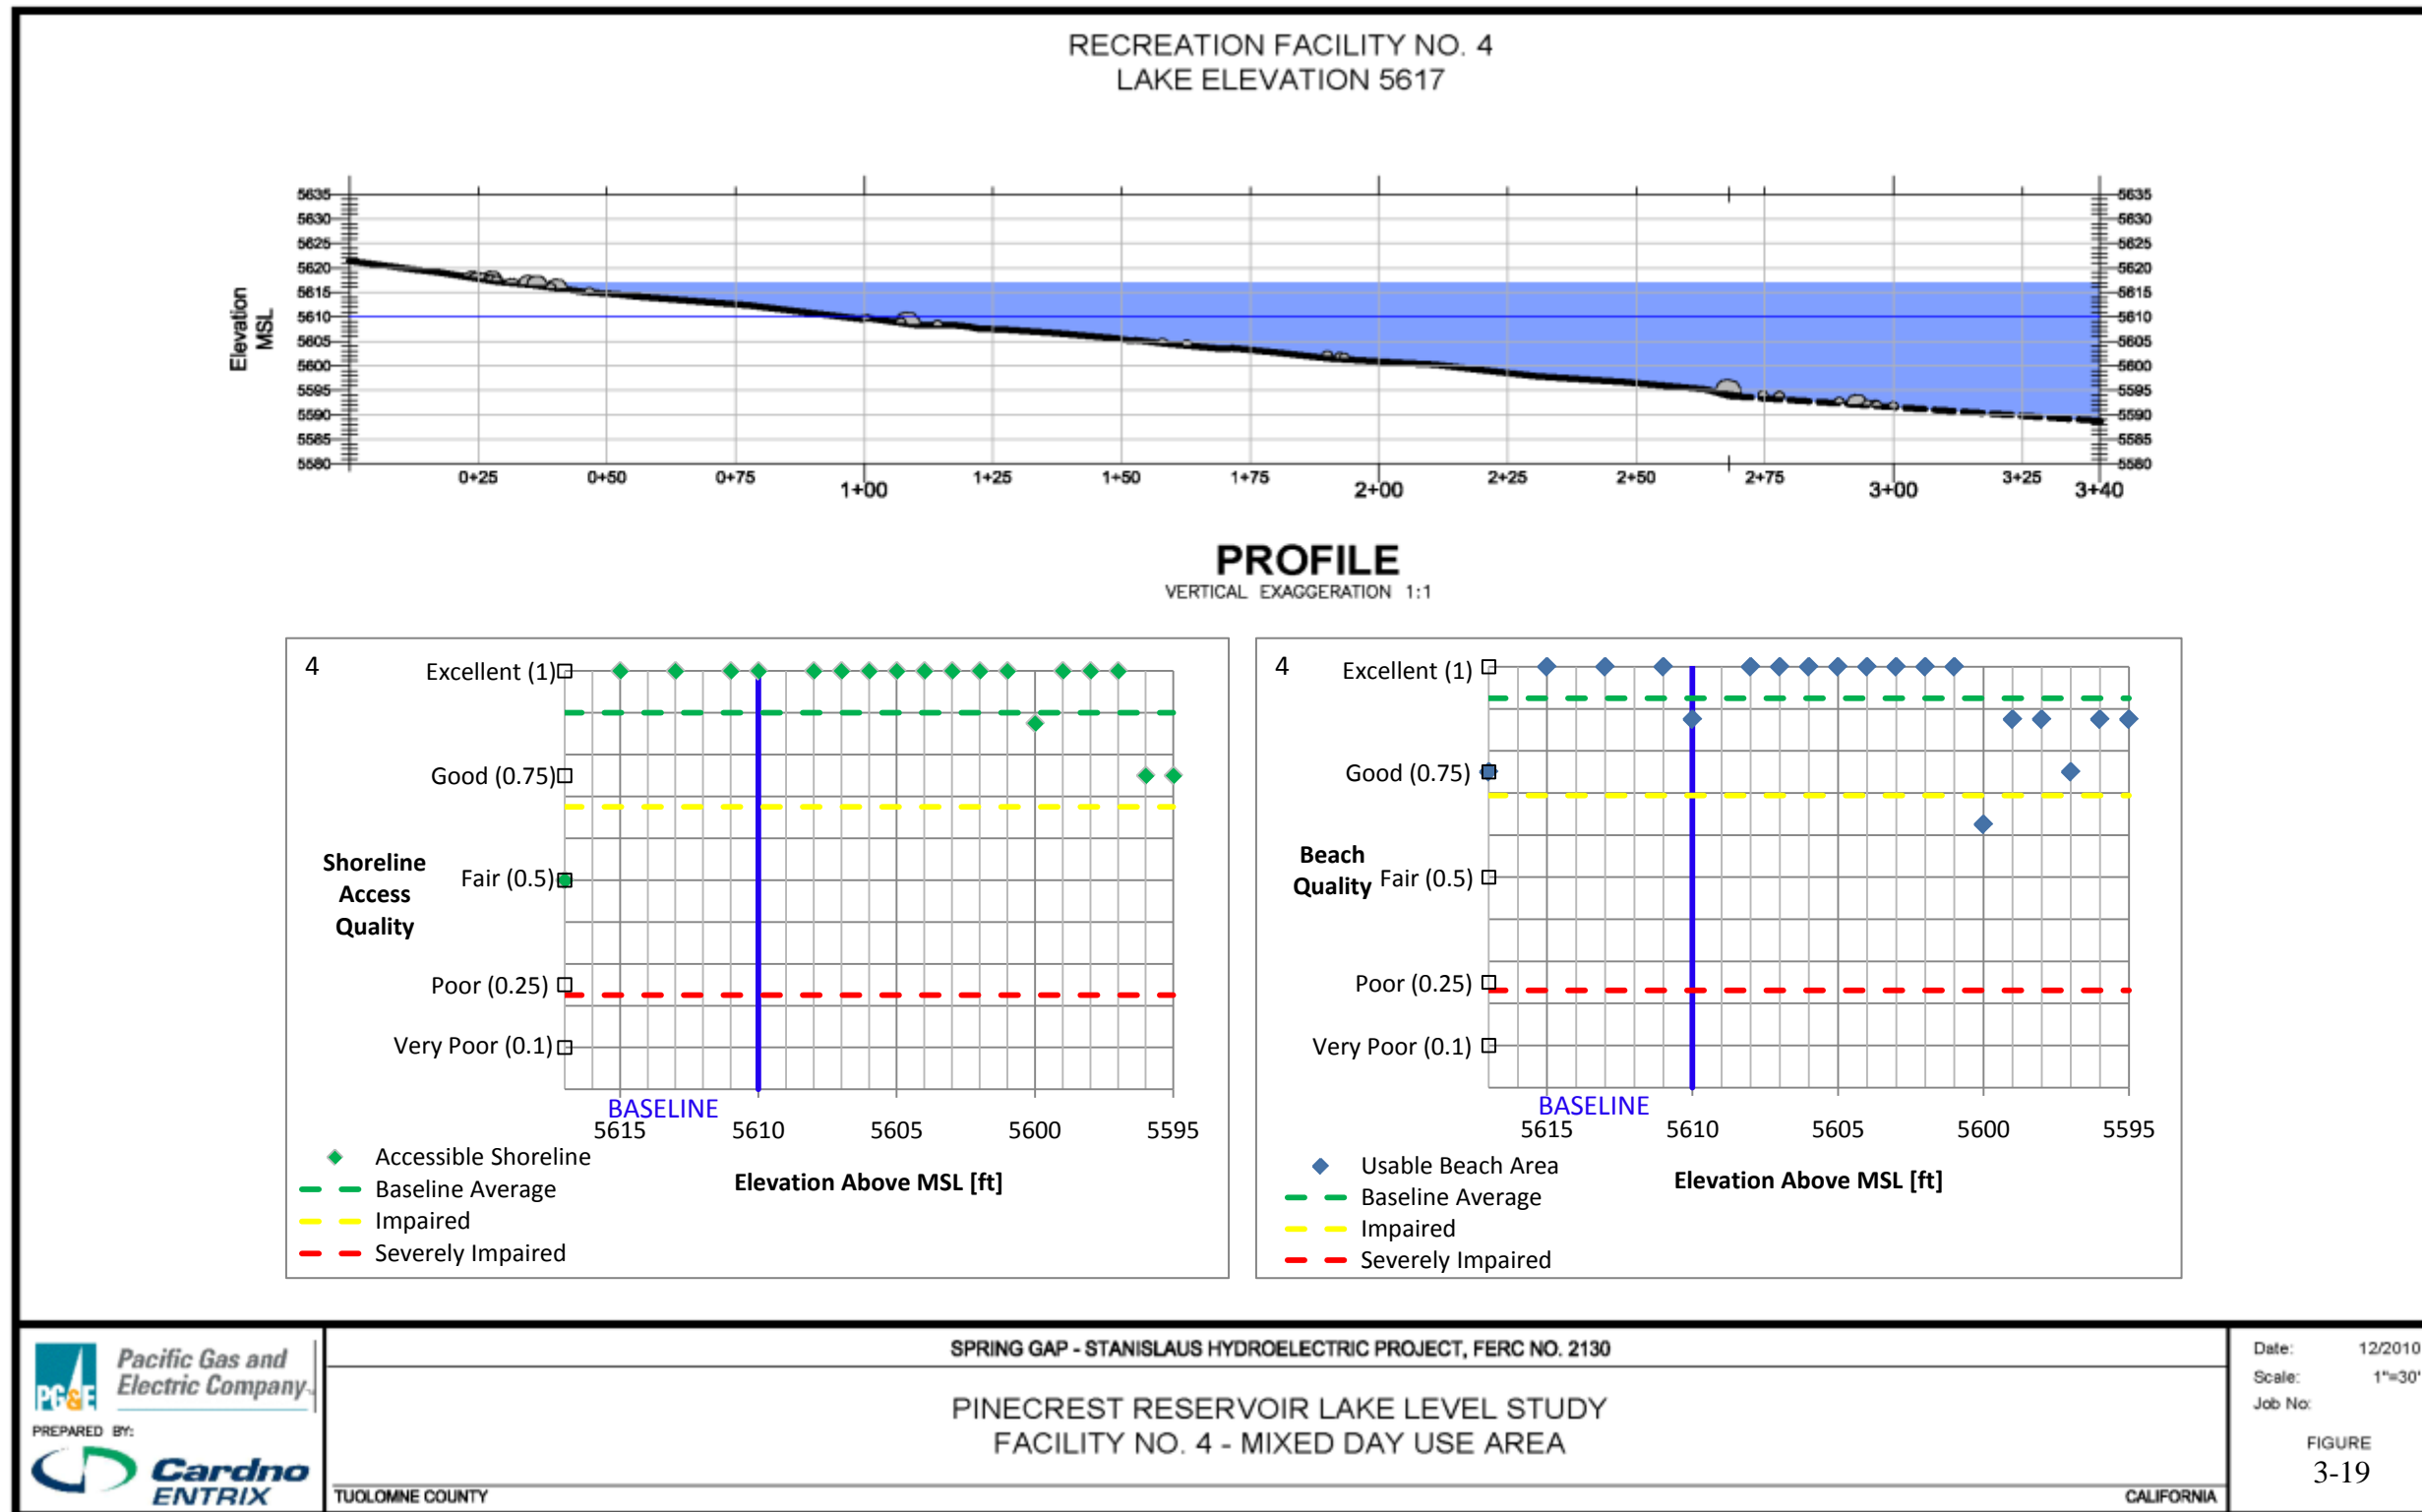
Figure 3-19. Pedestrian Shoreline Access Quality and Beach Quality Results for Recreation Facility #4

As described for Transects #3A, #3B, and #3C, a 20-ft-wide swath of beach was evaluated for the quality of pedestrian shoreline access. Defining “impaired” access at levels below 75 percent and “severely impaired” at levels below 25 percent of the baseline average, no elevations at the mixed day-use area contain impaired or severely impaired pedestrian shoreline access (Figure 3-19).

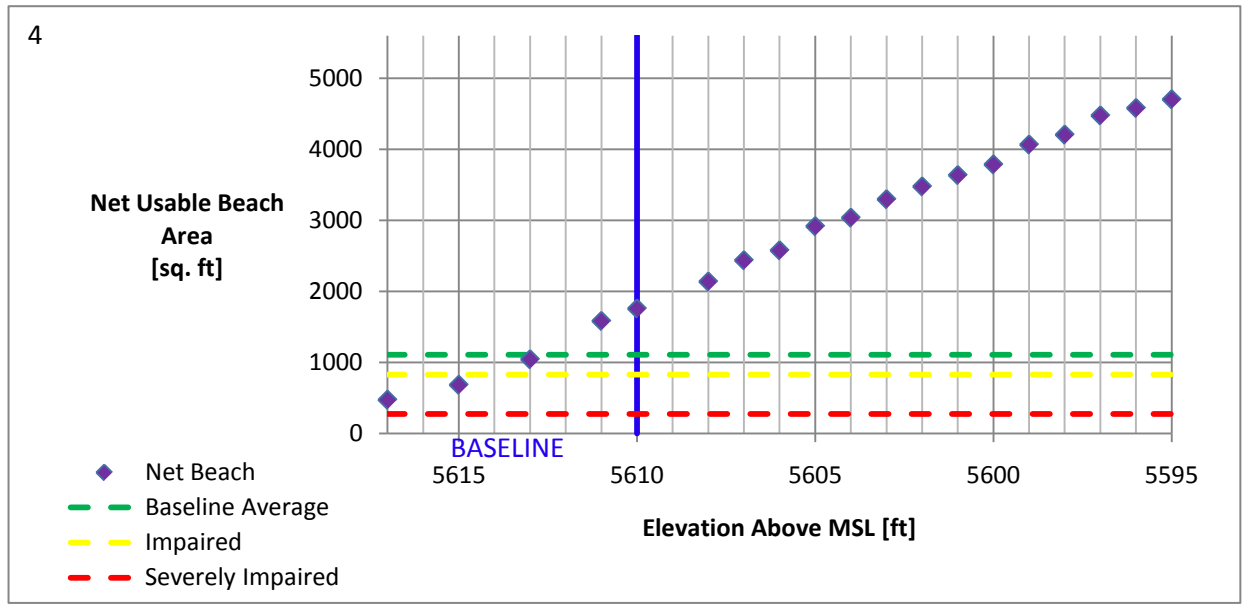
Figure 3-20. Net Usable Beach at Recreation Facility #4

At the mixed day-use area, net usable beach area continues to grow at approximately the same rate found during baseline elevations (Figure 3-20). As there is only one instance of impaired beach quality at the mixed day-use area, each resulting drop in water elevation provides approximately the same amount of additional usable beach area.

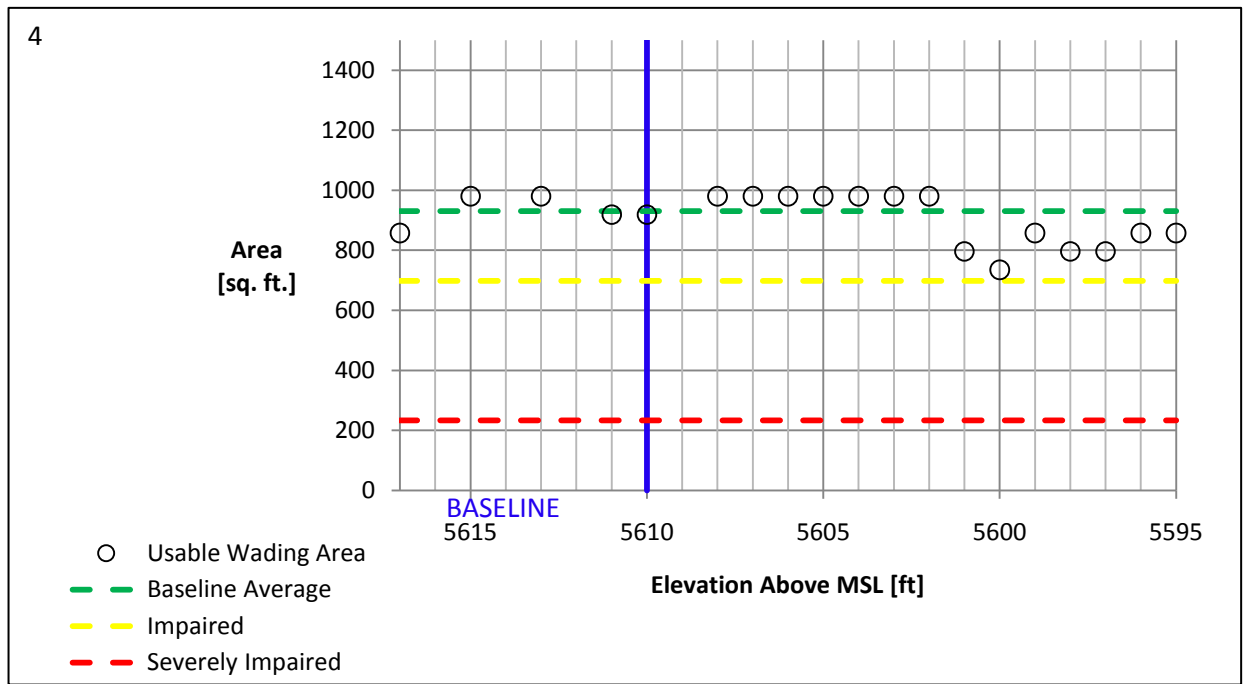
Figure 3-21. Usable Wading Area at Recreation Facility #4
