PINECREST RESERVOIR LAKE LEVEL STUDY REPORT

**Spring Gap-Stanislaus Hydroelectric Project
(FERC Project No. 2130)**

***Pacific Gas and
Electric Company™***

April 2011

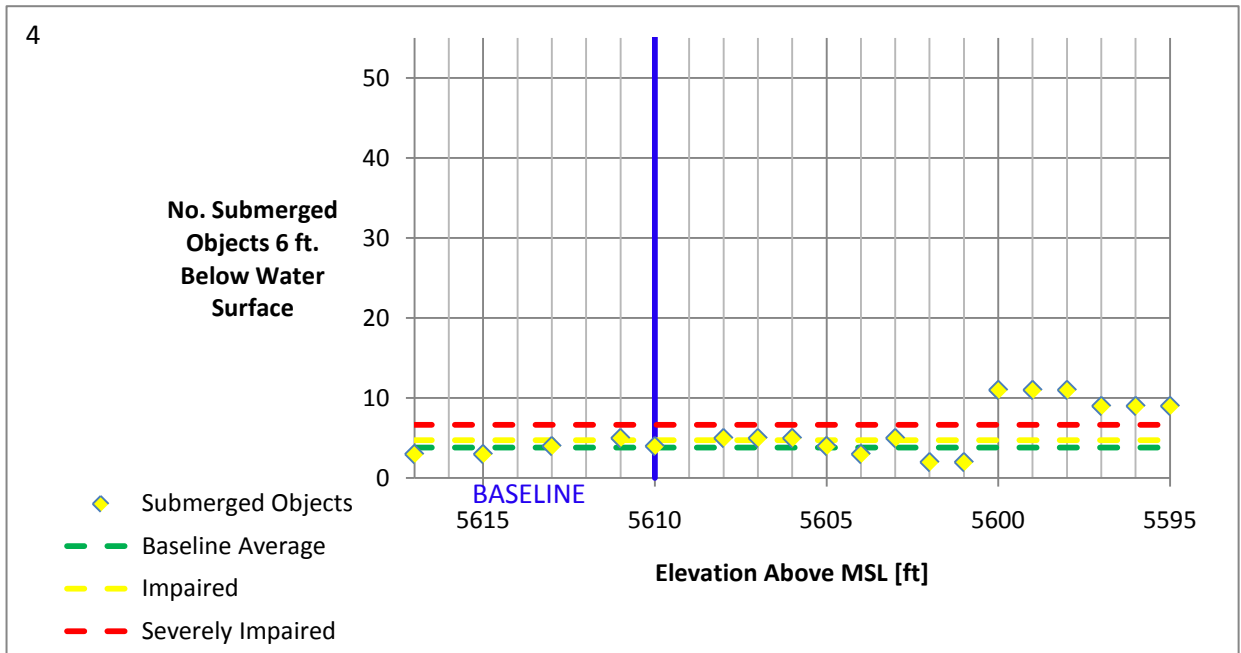
Figure 3-22. Potential Swimming Hazards within 6 Feet of Water Surface at Recreation Facility #4

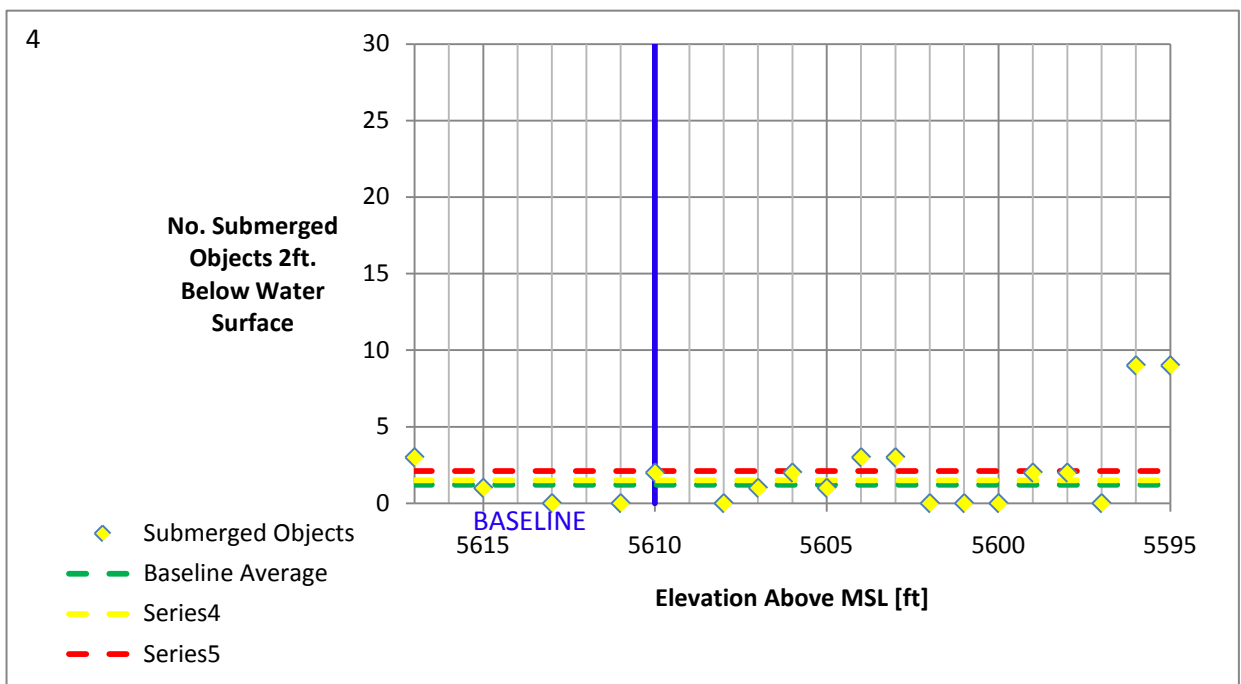
Figure 3-23. Potential Boating Hazards within 2 Feet of Water Surface at Recreation Facility #4

The other variable evaluated for boating use considered objects located within 2 ft of the water surface. These objects pose potential hazards to boats with a draft of 2 ft or greater, the maximum draft found on typical non-motorized boats. The number of potential boating hazards becomes impaired at elevations 5,606, 5,599 and 5,598 and severely impaired at elevations 5,604, 5,603, 5,596 and 5,595 ft (Figure 3-23). However, as there are no impairments to boating access, there are no elevations that contain impairments to both boating access and potential hazards. This results in usability being categorized as unimpaired for all study elevations.

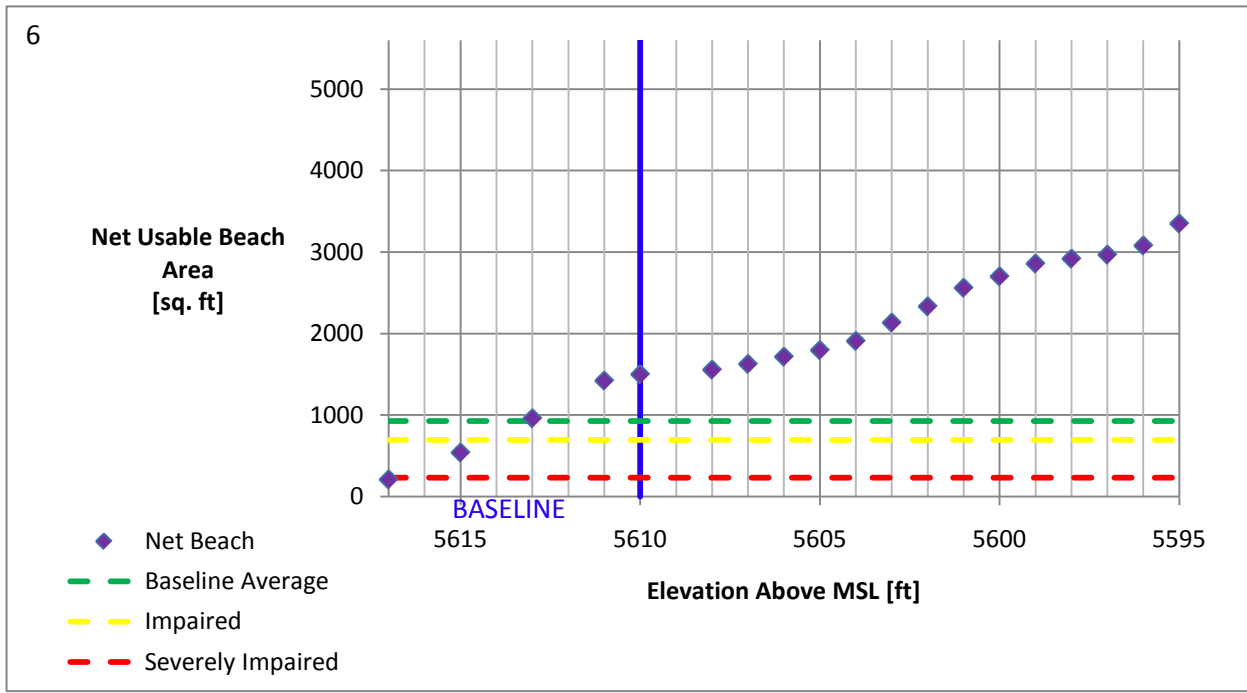
Figure 3-25. Net Usable Beach at Recreation Facility #6

At this facility, the net usable beach available increases overall for the studied elevations. The rate of increase decreases for elevations 5,610 through 5,605 ft and elevations 5,599 through 5,598 ft (Figure 3-25).

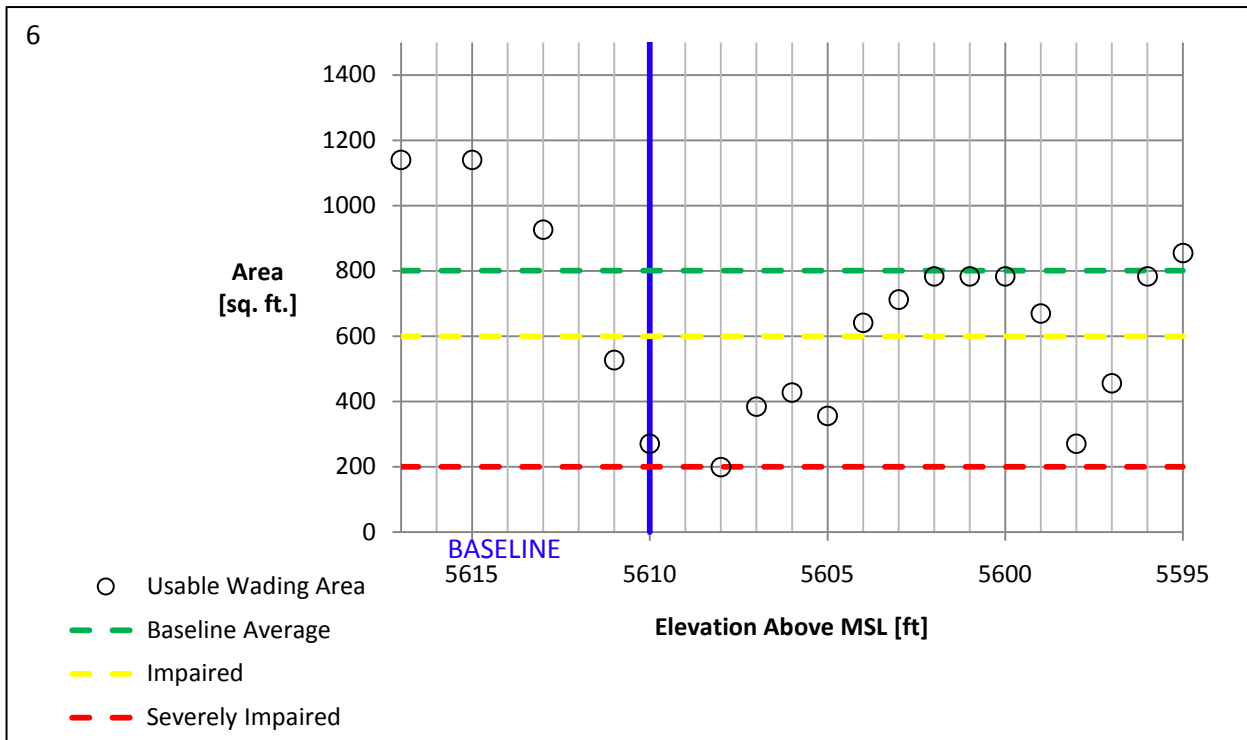
Figure 3-26. Usable Wading Area at Recreation Facility #6

The usable wading area at Recreation Facility #6 shows unimpaired use at elevations 5,604-5,599 and 5,596-5,595 ft. (Figure 3-26).

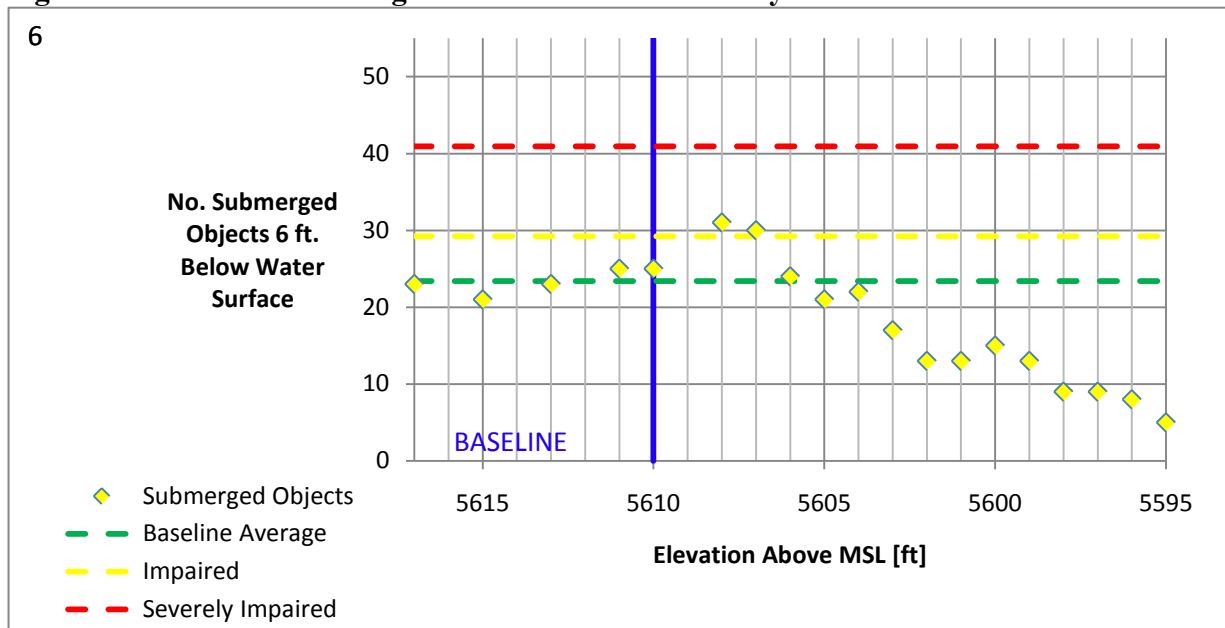
Figure 3-27. Potential Swimming Hazards within 6 Feet of Water Surface at Recreation Facility #6

At Recreation Facility #6, potential swimming hazards are categorized as impaired at elevation 5,608 and 5,607 ft. After elevation 5,607 ft, however, the number of submerged objects falls within 25 percent of the baseline average and remains categorized as unimpaired until elevation 5,598 ft (Figure 3-27).

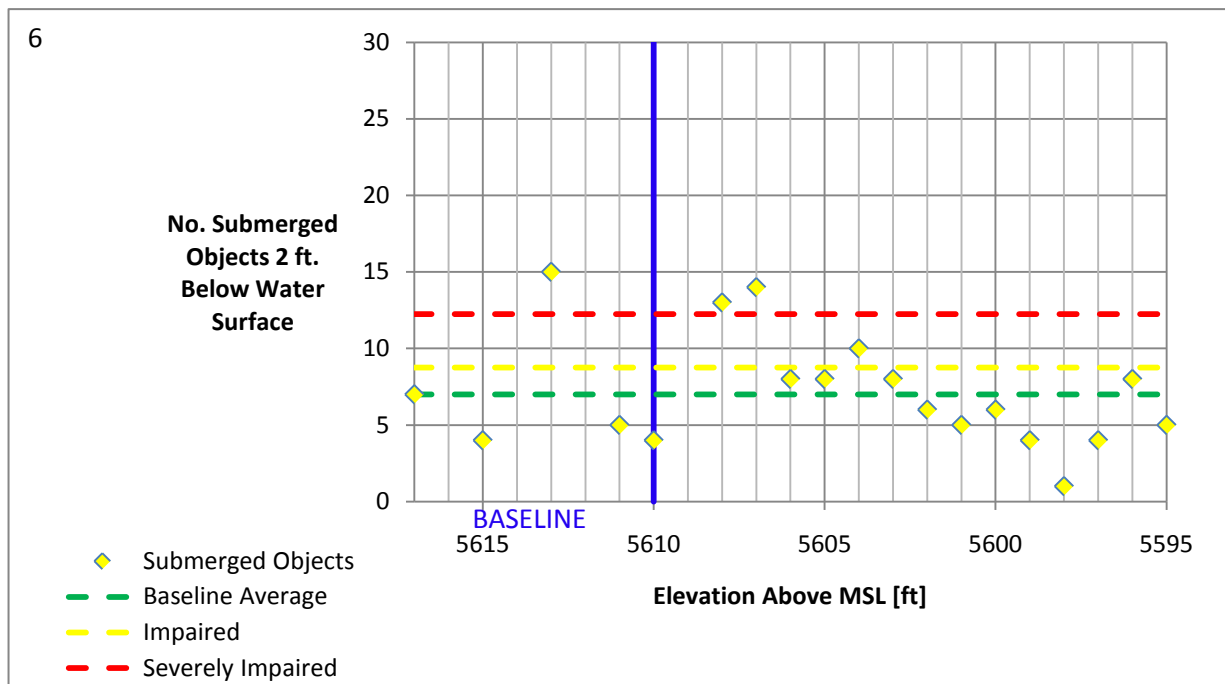
Figure 3-28. Potential Boating Hazards within 2 Feet of Water Surface at Recreation Facility #6

Impaired shoreline access quality is present at elevation 5,608, 5,607, 5,605 and 5,597 ft, caused by a greater number of submerged objects, at elevation 5,607 ft (Figures 3-24 and 3-28, respectively). Both elevations 5,608 and 5,607 ft. also contain impaired or severely impaired potential boating hazard values. No other elevations contain both impaired access quality and potential hazards. This results in usability for criterion #6 being categorized as impaired and severely impaired at elevations 5,608 and 5,607, respectively.

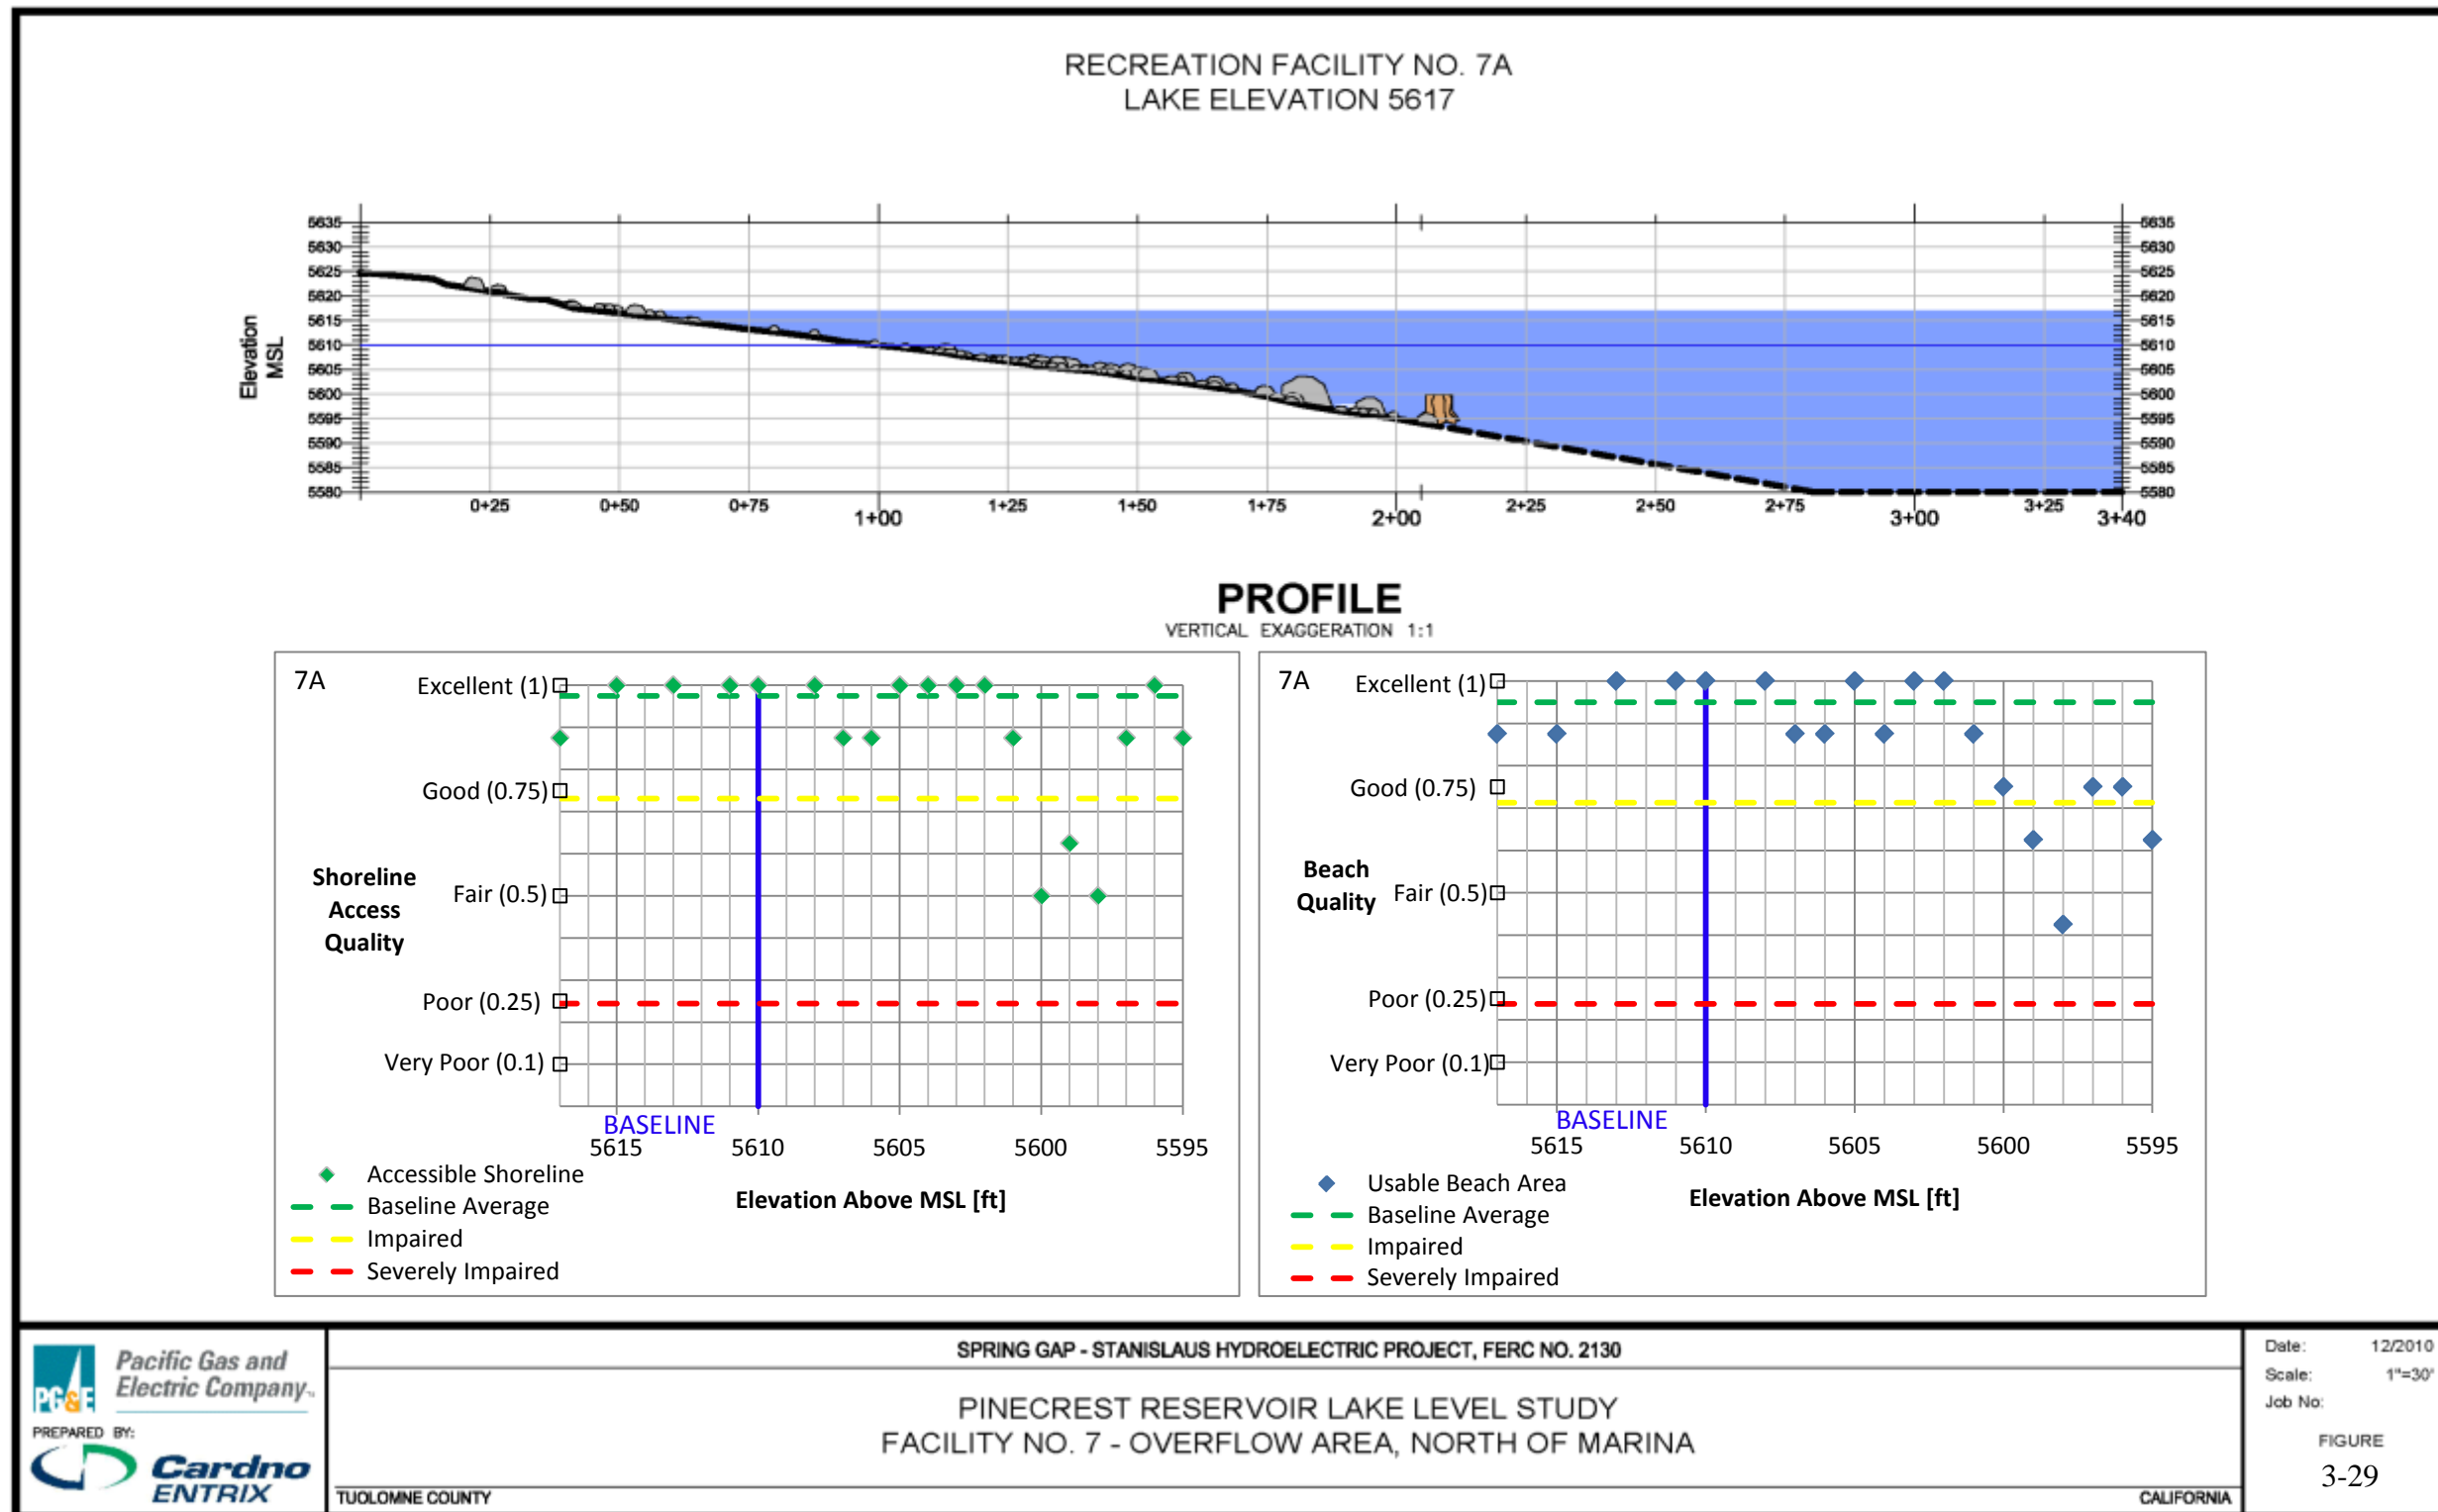
Figure 3-29. Pedestrian Shoreline Access Quality and Beach Quality Results for Transect #7A

Pedestrian shoreline access quality becomes impaired at elevations 5,600, 5,599, and 5,598 ft for Transect #7A (Figure 3-29). However, the beach area below these elevations improves in terms of accessible shoreline.

Along Transect #7A, beach quality becomes impaired at three elevations: 5,599, 5,598, and 5,595 ft (Figure 3-29).

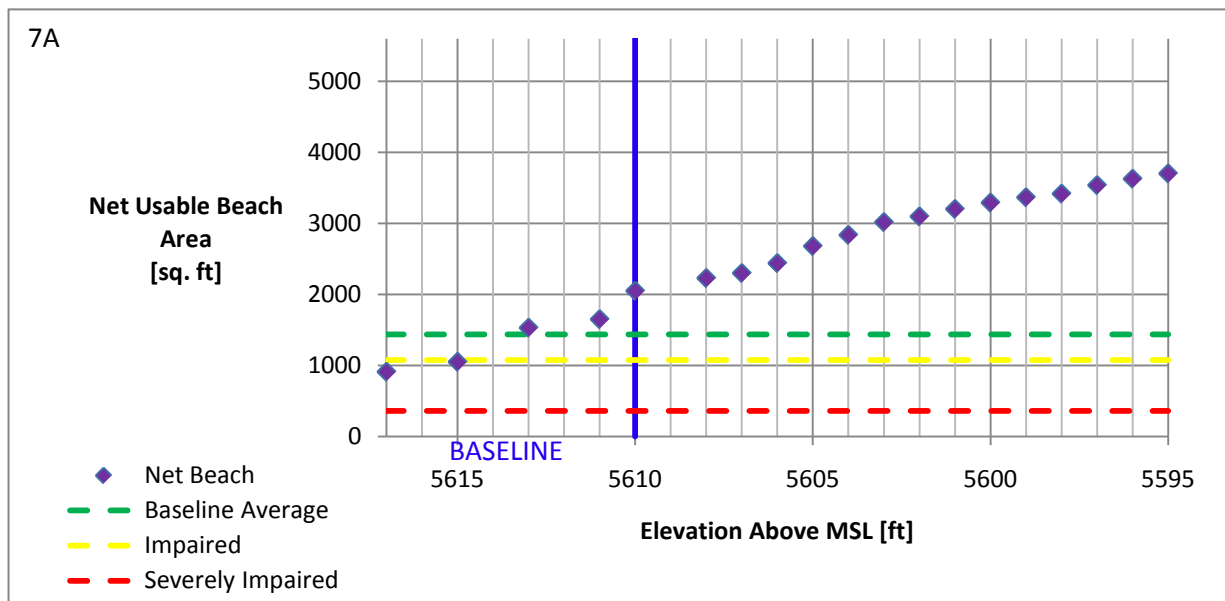
Figure 3-31. Net Usable Beach in Transect #7A

Both Transects #7A and #7B show increases in the net usable beach area for all elevations. Transect #7A maintains a rate of increase comparable to that seen in the baseline values (Figure 3-31).

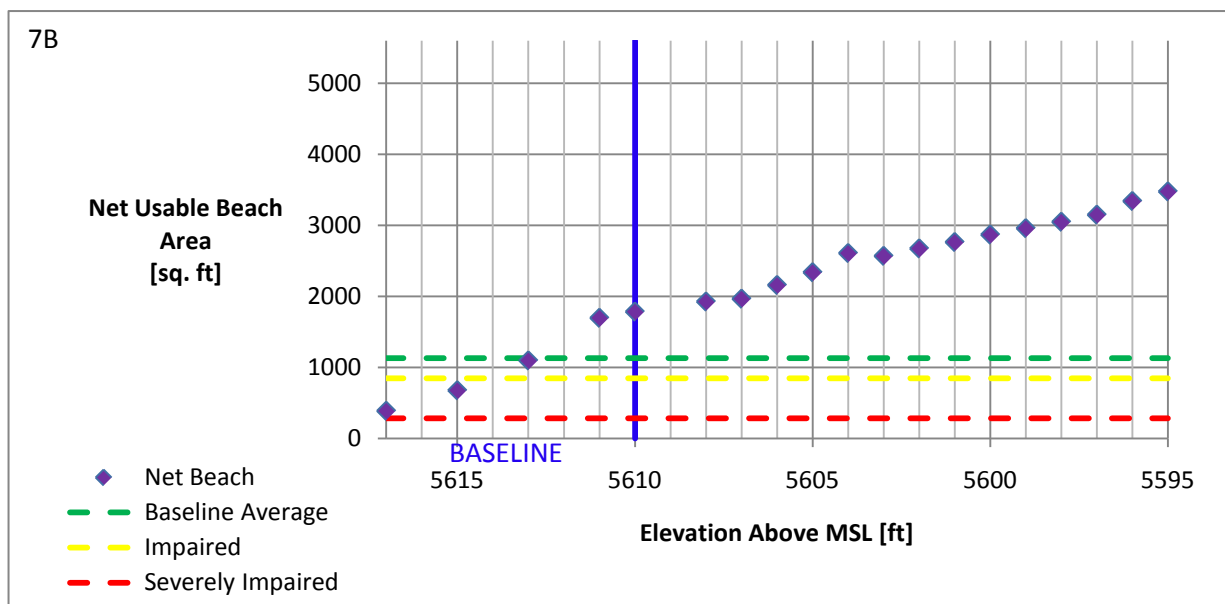
Figure 3-32. Net Usable Beach in Transect #7B

Transect #7B also has a positive rate of increase, approximately the same as the rate present during the baseline (Figure 3-32).

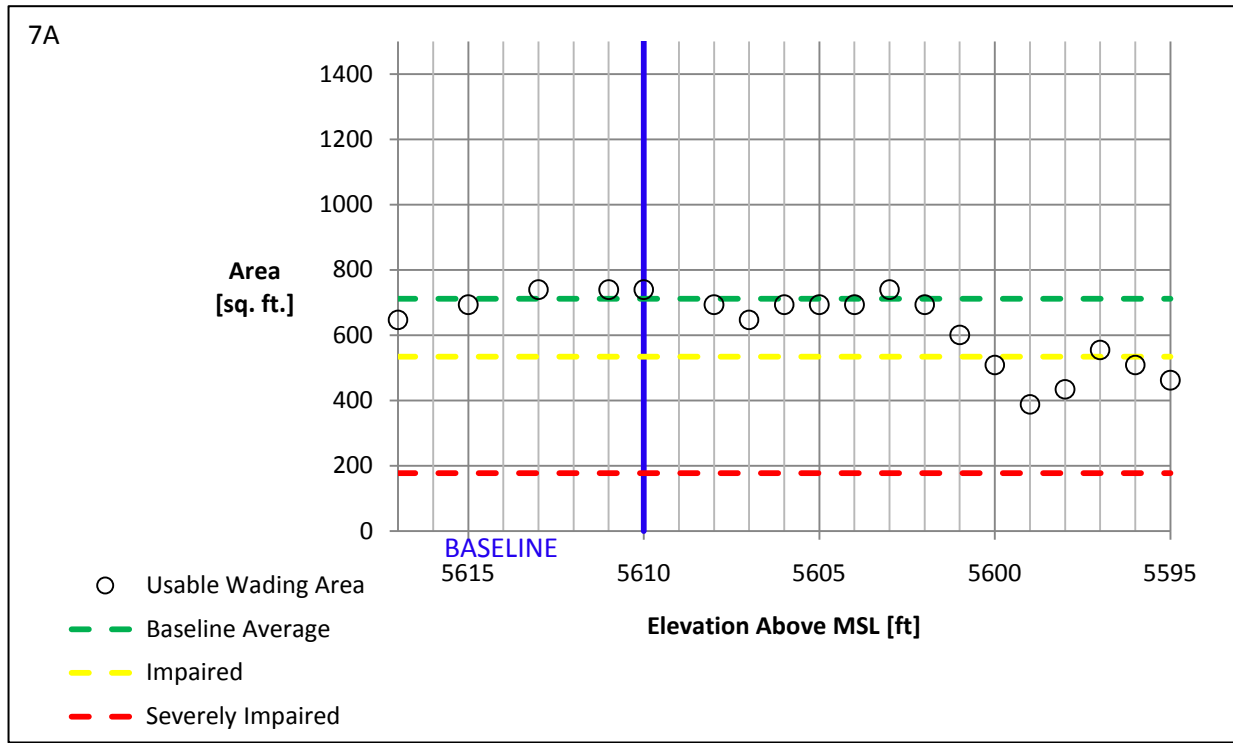
Figure 3-33. Usable Wading Area in Transect #7A

Along Transect #7A, the usable wading area does not change until elevation 5,600 ft. After this elevation, the area of usable wading area becomes impaired until elevation 5,597. Usable wading area is also impaired for elevations 5,596 and 5,595 (Figure 3-33).

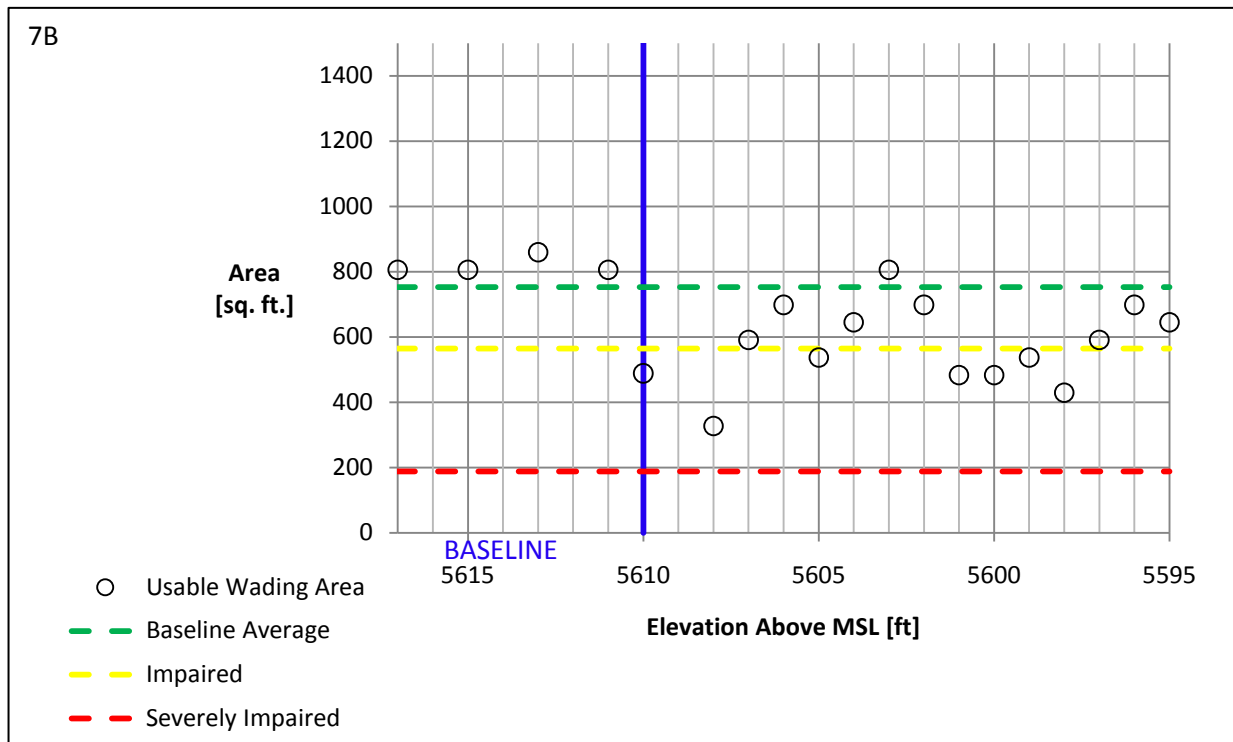
Figure 3-34. Usable Wading Area in Transect #7B

Transect #7B is impaired for elevations 5,608, 5,605 and 5,601-5,598 ft. (Figure 3-34).

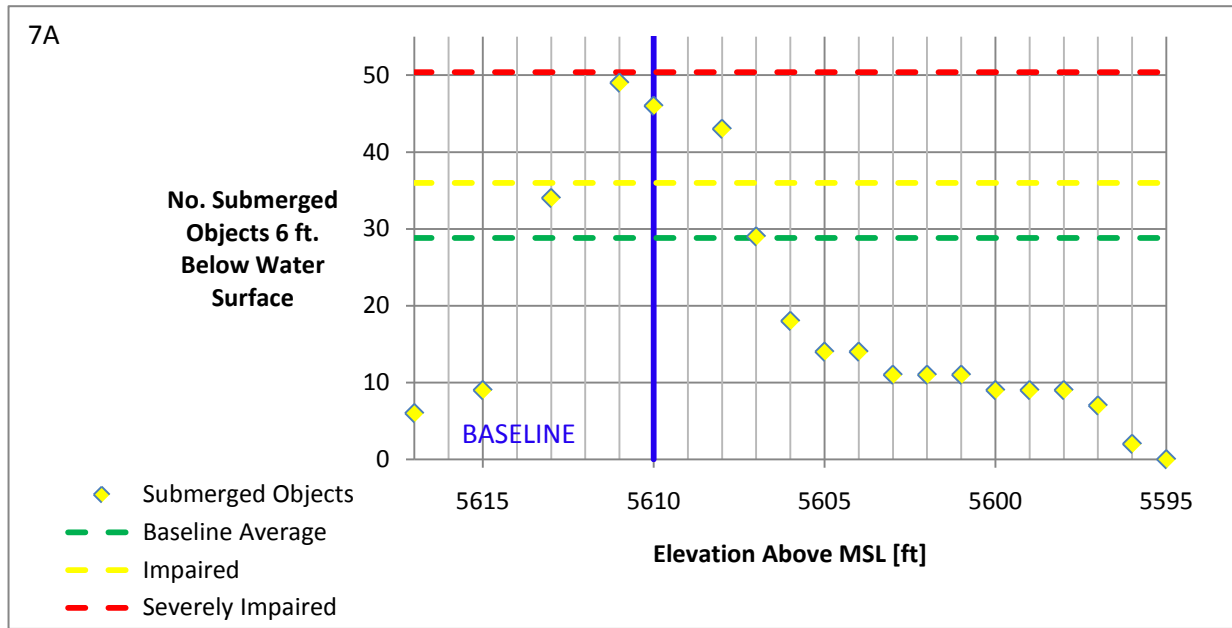
Figure 3-35. Potential Swimming Hazards within 6 Feet of Water Surface in Transect #7A

The number of submerged objects that pose potential swimming hazards in Transect #7A is impaired at elevation 5,608 ft (Figure 3-35).

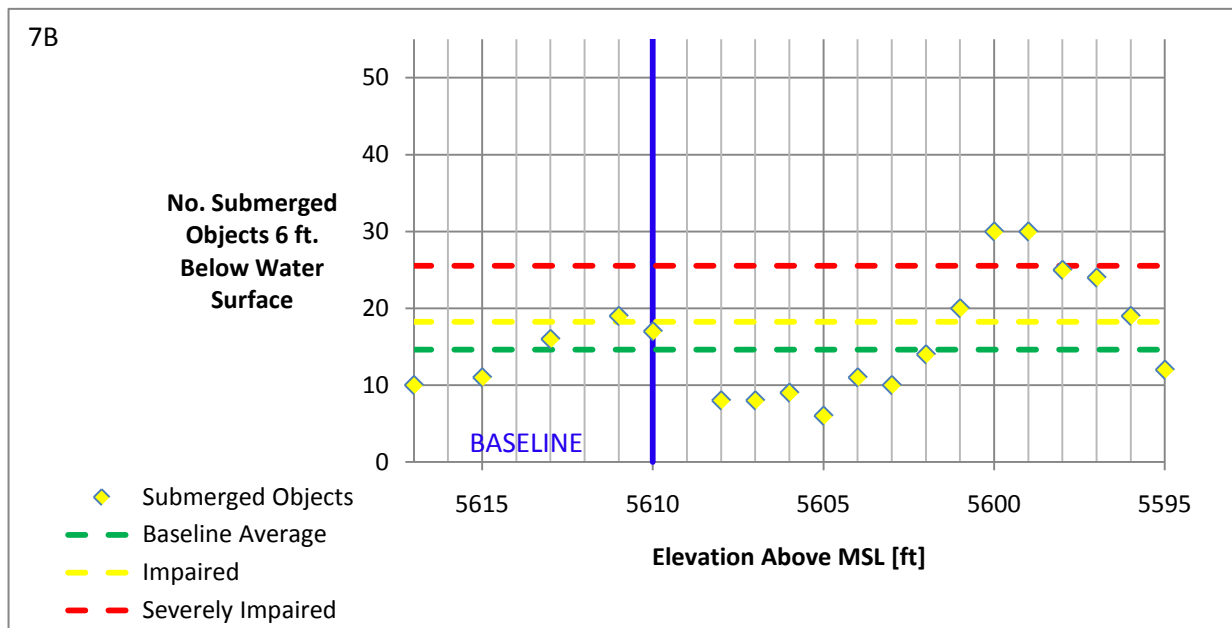
Figure 3-36. Potential Swimming Hazards within 6 Feet of Water Surface in Transect #7B

In comparison, Transect #7B contains two elevations where the status is severely impaired (5,600 and 5,999 ft) and four elevations where the status is impaired, 5,600 and 5,598-5,596 (Figure 3-36).

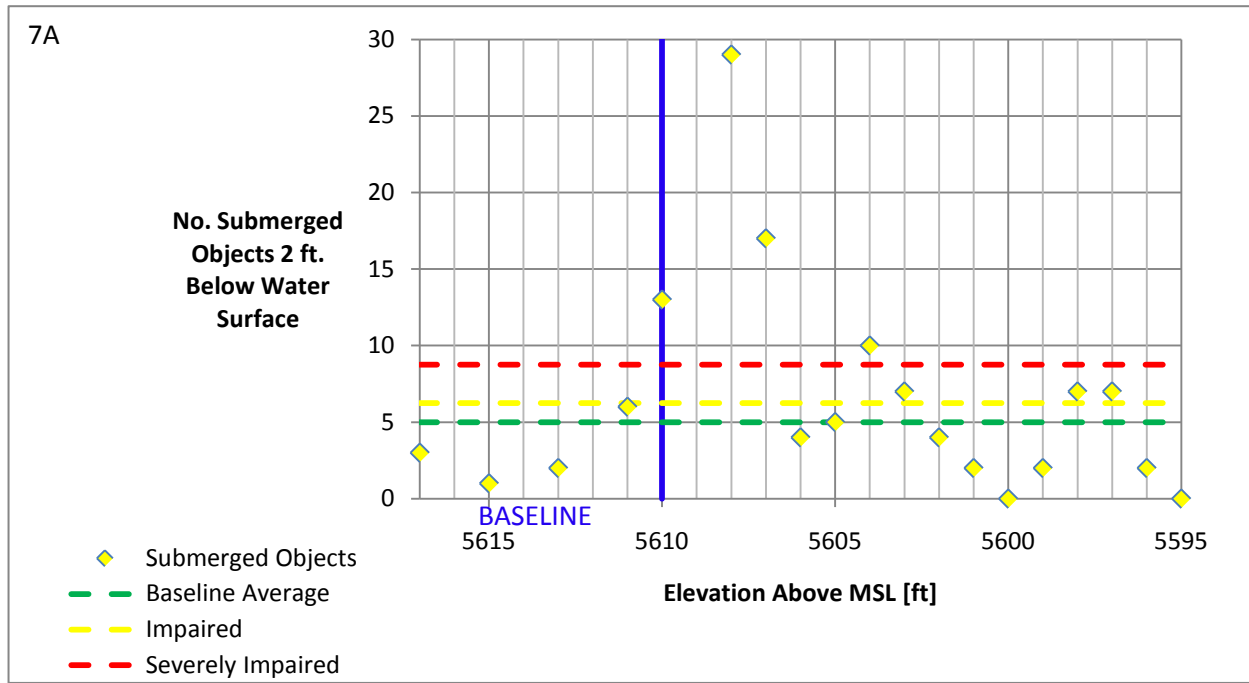
Figure 3-37. Potential Boating Hazards within 2 Feet of Water Surface in Transect #7A

Along Transects #7A, potential boating hazards are designated as severely impaired at elevations 5,608, 5,607, and 5,604 ft and impaired at elevations 5,603, 5,598 and 5,597 ft (Figure 3-37).

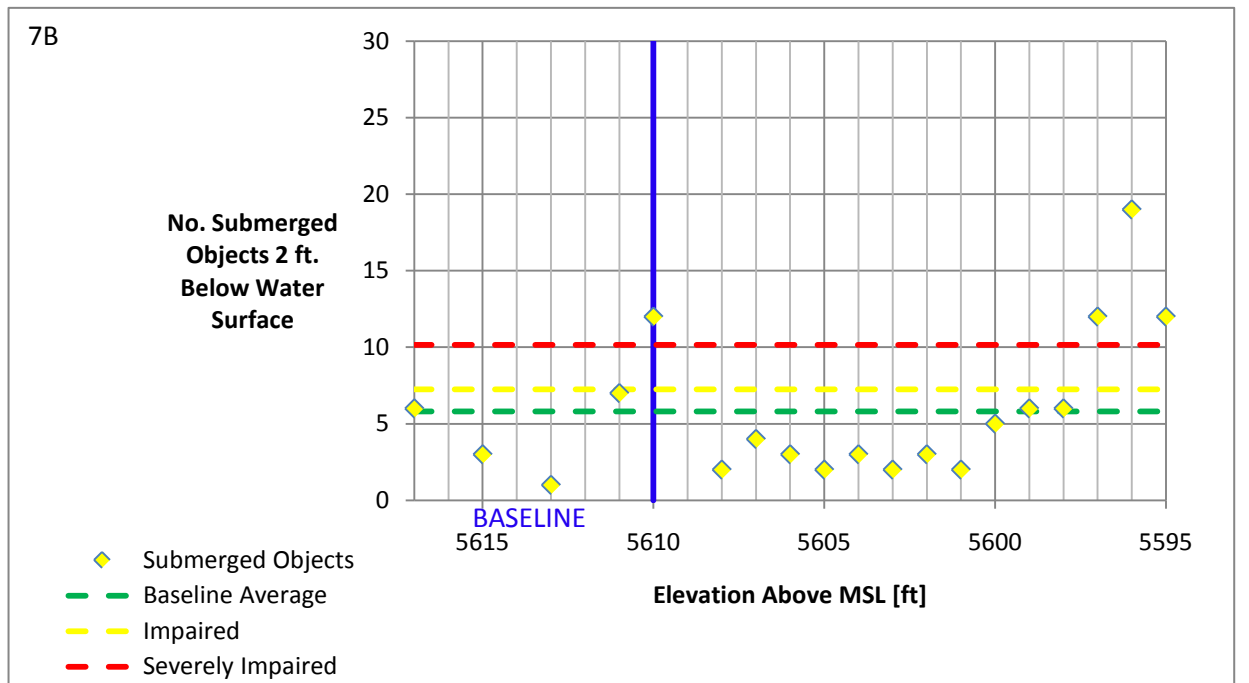
Figure 3-38. Potential Boating Hazards within 2 Feet of Water Surface in Transect #7B

Potential boating hazards in Transect #7B are categorized as unimpaired within the study elevation range until the final three elevations studied (5,597–5,595 ft) (Figure 3-38). At these elevations, the status is severely impaired. There is a corresponding impairment to pedestrian shoreline access at elevation 5,597, resulting in an overall impairment to criterion #6 at this elevation.
