Timber Harvest Information Form

TIMBER HARVEST PLAN FACT SHEET

**Castro Valley Ranch
Timber Harvest Plan Summary
(to accompany THP Fact Sheet submitted to RWQCB)**

**Castro Valley Ranch THP
Ownership Map**

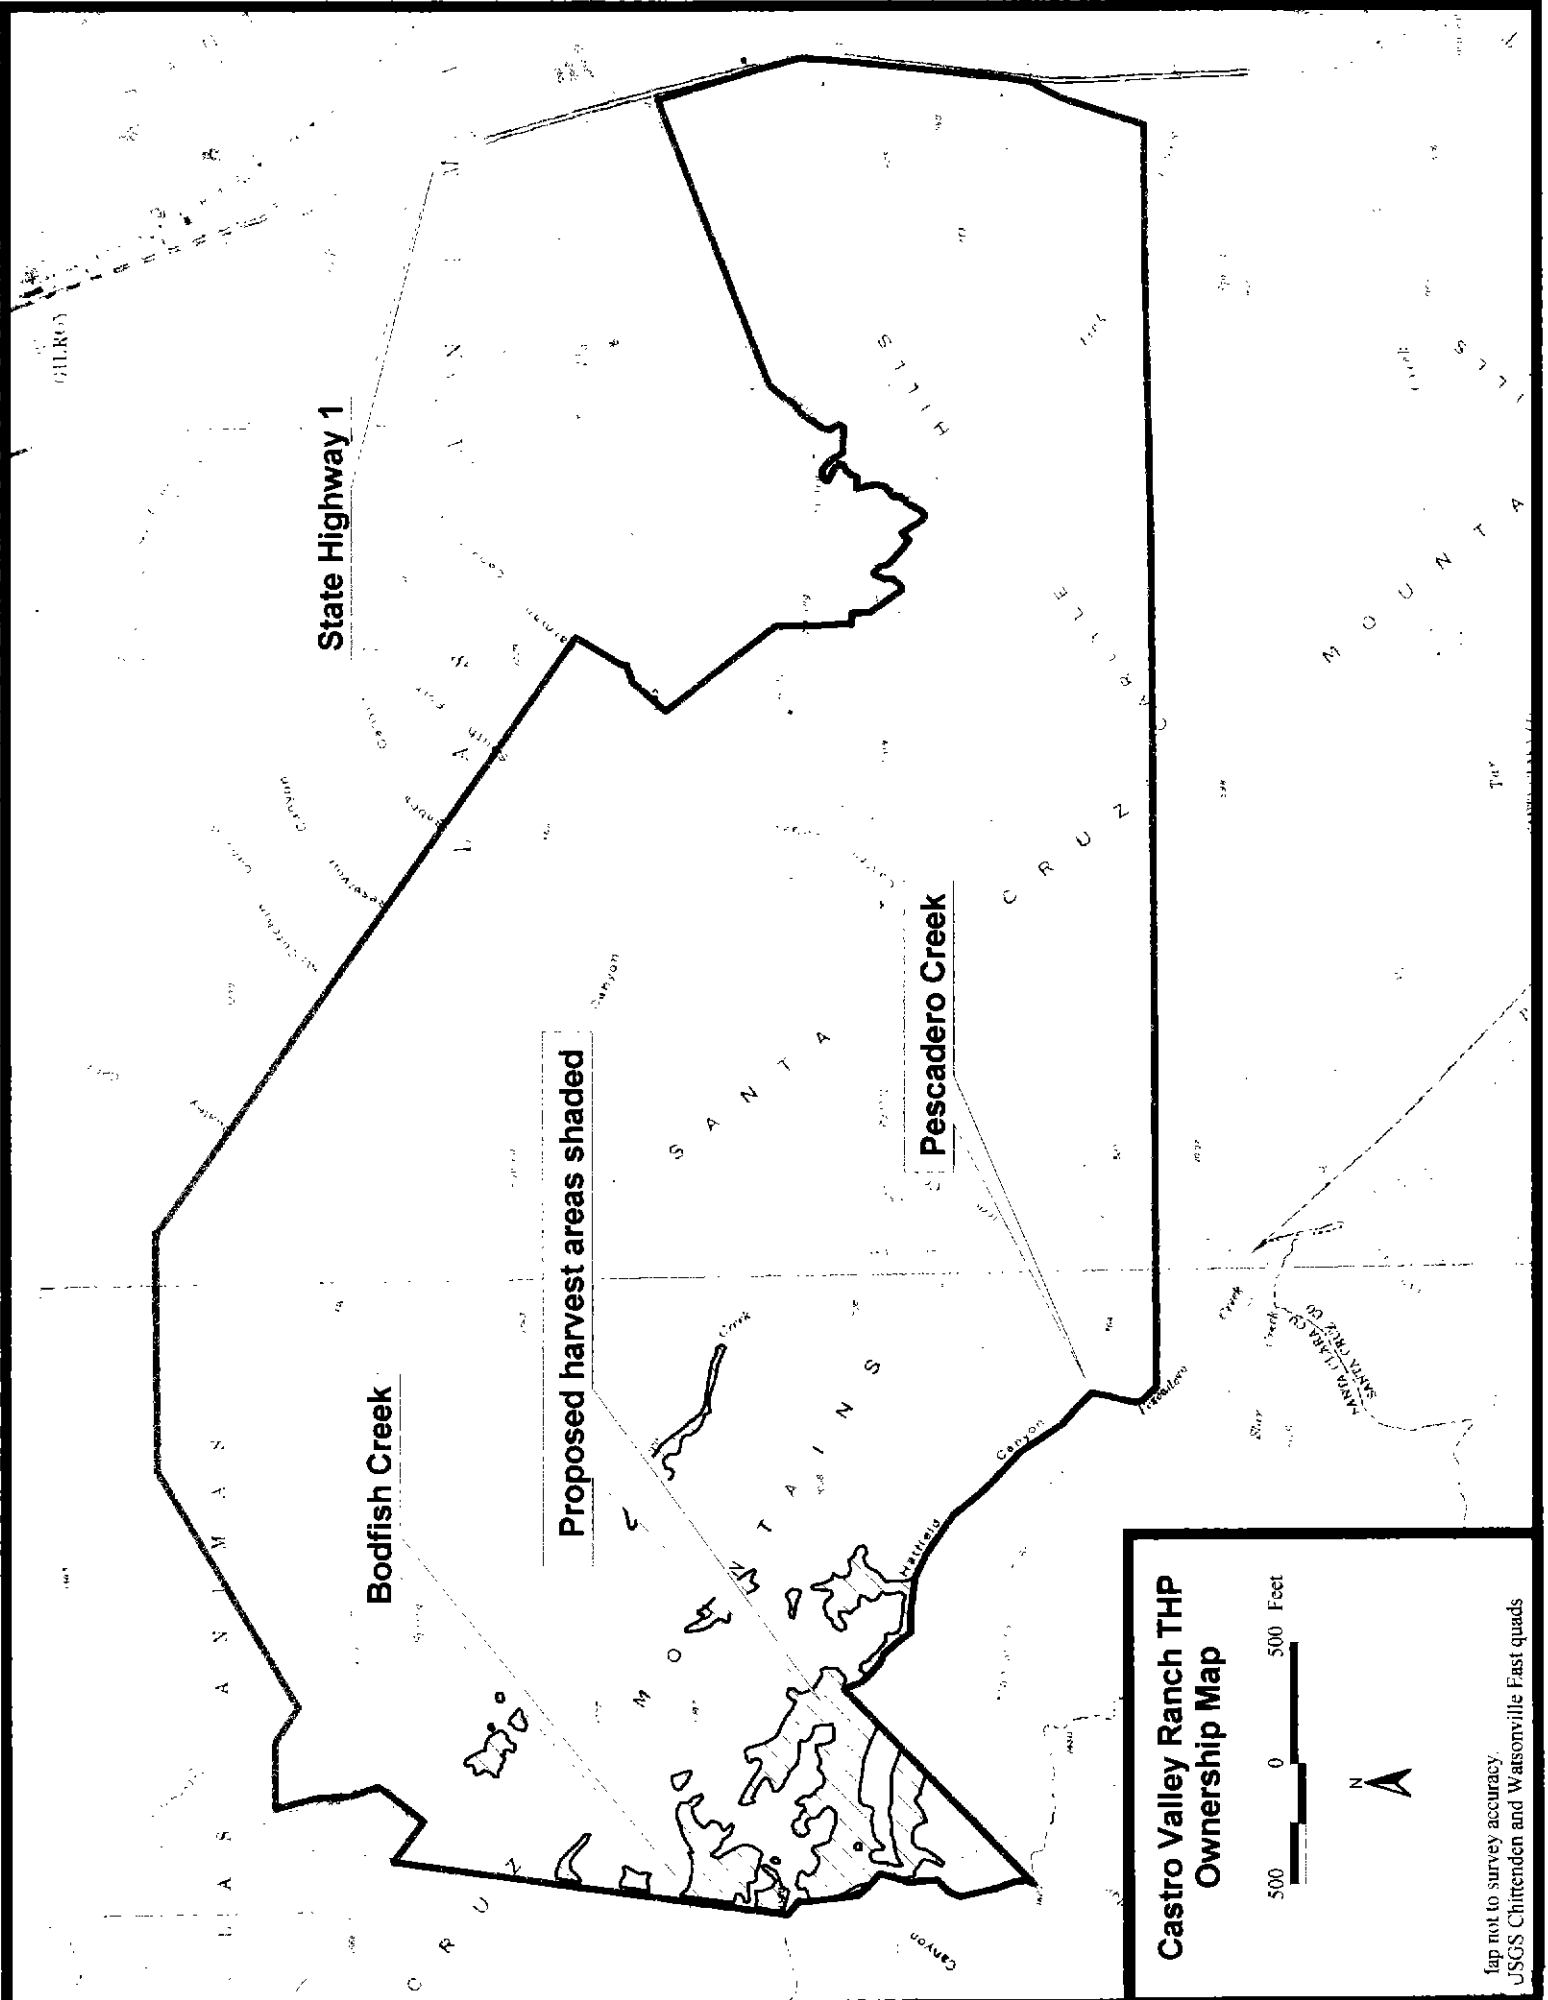
Proposed harvest areas shaded

Map not to survey accuracy.
JSGS Chittenden and Watsonville East quads

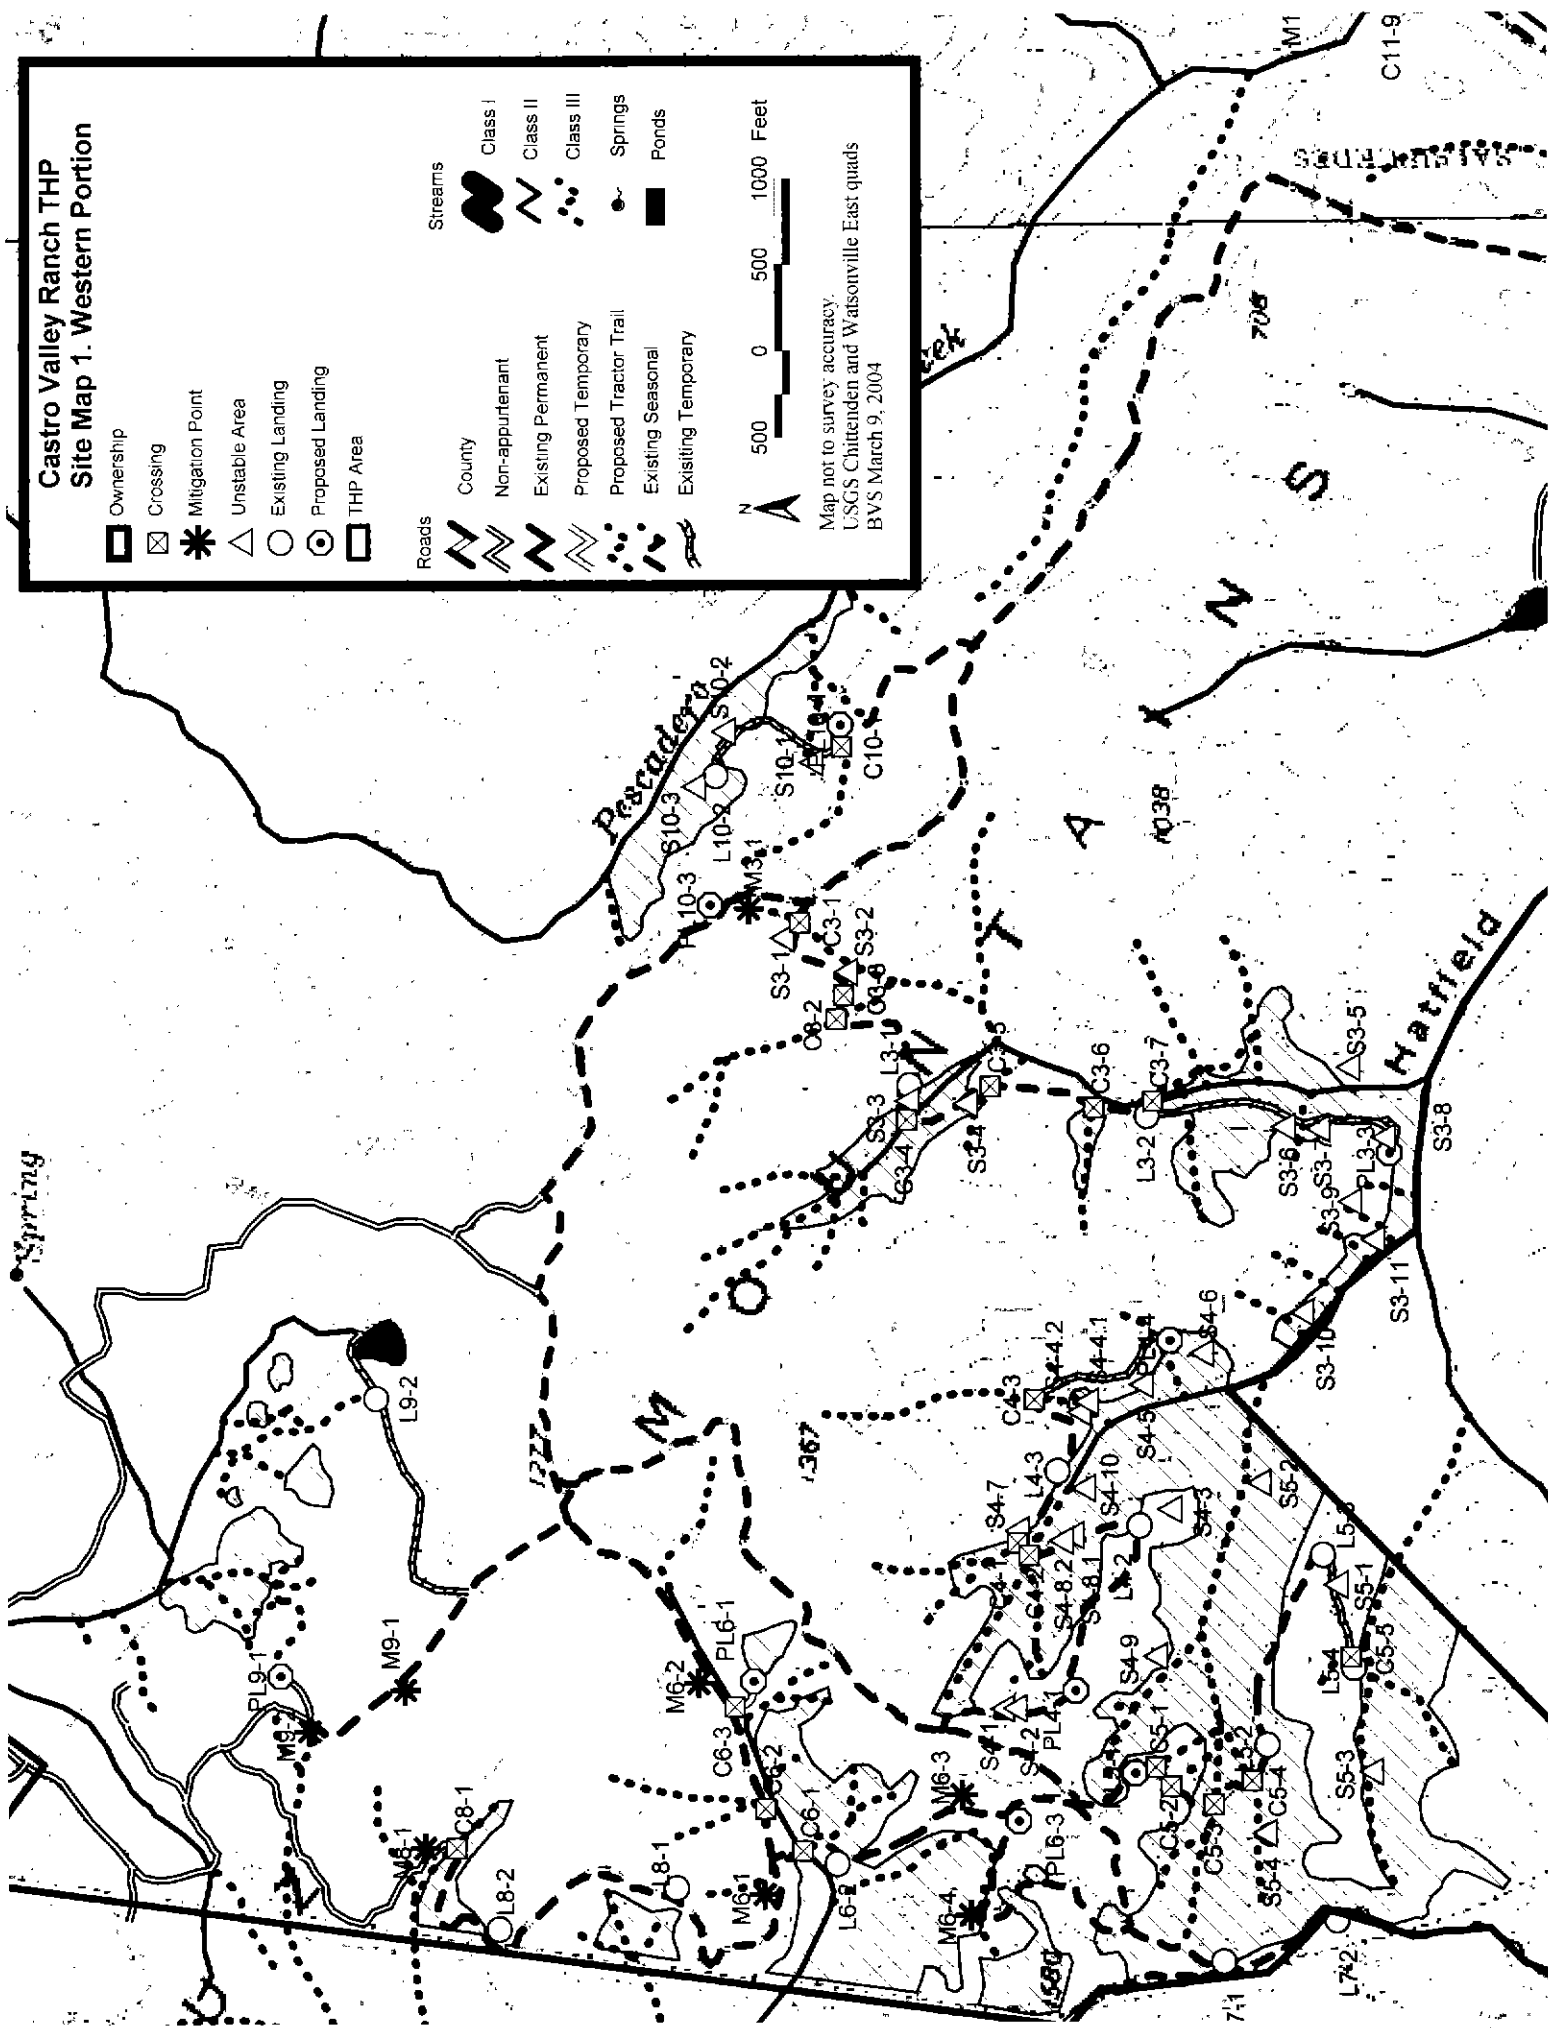
Castro Valley Ranch THP Site Map 1. Western Portion

Map not to survey accuracy.
USGS Chittenden and Watsonville East quads
BVS March 9, 2004

The proposed project is the second selective harvest of redwood on Castro Valley Ranch. During the first harvest, in 1986, the road network was completed and is substantially in useable condition today. The current forester was also responsible for that first operation. The attached map includes an exhaustive inventory of road problems; most of these are quite minor. However, a few are more significant and will be highlighted herein.

Existing culverts or fords in good condition:	23 each. These variously require clearing of inlet, refurbishment of trash racks, and occasional installation of Sacrete headwalls.
Culverts requiring repair (or substitute ford):	4 each. C3-4 and C4-2 are major failures owing to debris or uncompacted fill. Existing pipes will be retrieved (sizing will be checked for 100 year event), and fill will be compacted in 12" lifts using plate vibrating compactor, Sacrete headwall, new trash racks, and relief dip will be installed. C5-4 and C6-1 are susceptible to continuing plugging. After hauling (but before the first winter period) they will be replaced with armoured fords.
Flatcar bridge:	One (temporary) at C11-9.
Temporary Crossings:	Two at C3-7 and C6-2. These will not be operated if flowing or in the winter period. Avoid disturbance of channel bed or walls – install then remove clean gravel and/or a temporary pipe. Upon conclusion remove pipe and gravel (without excavation), seed and mulch approaches, and "tanktrap" to prevent access..

Roads – In addition to features noted above, two areas will require special mitigation to reduce chronic problems. Near C6-2, rolling dips will be flagged, selected road surfaces will be rocked, and nearby streamsides have Sacrete walls installed to prevent bank cutting. Near C11-9, rolling dips, rock, and sediment traps will be installed. Also, at M6-1, M8-1, M9-1, and M9-2 rock will be installed to protect road surfaces or where positive drainage is not possible.

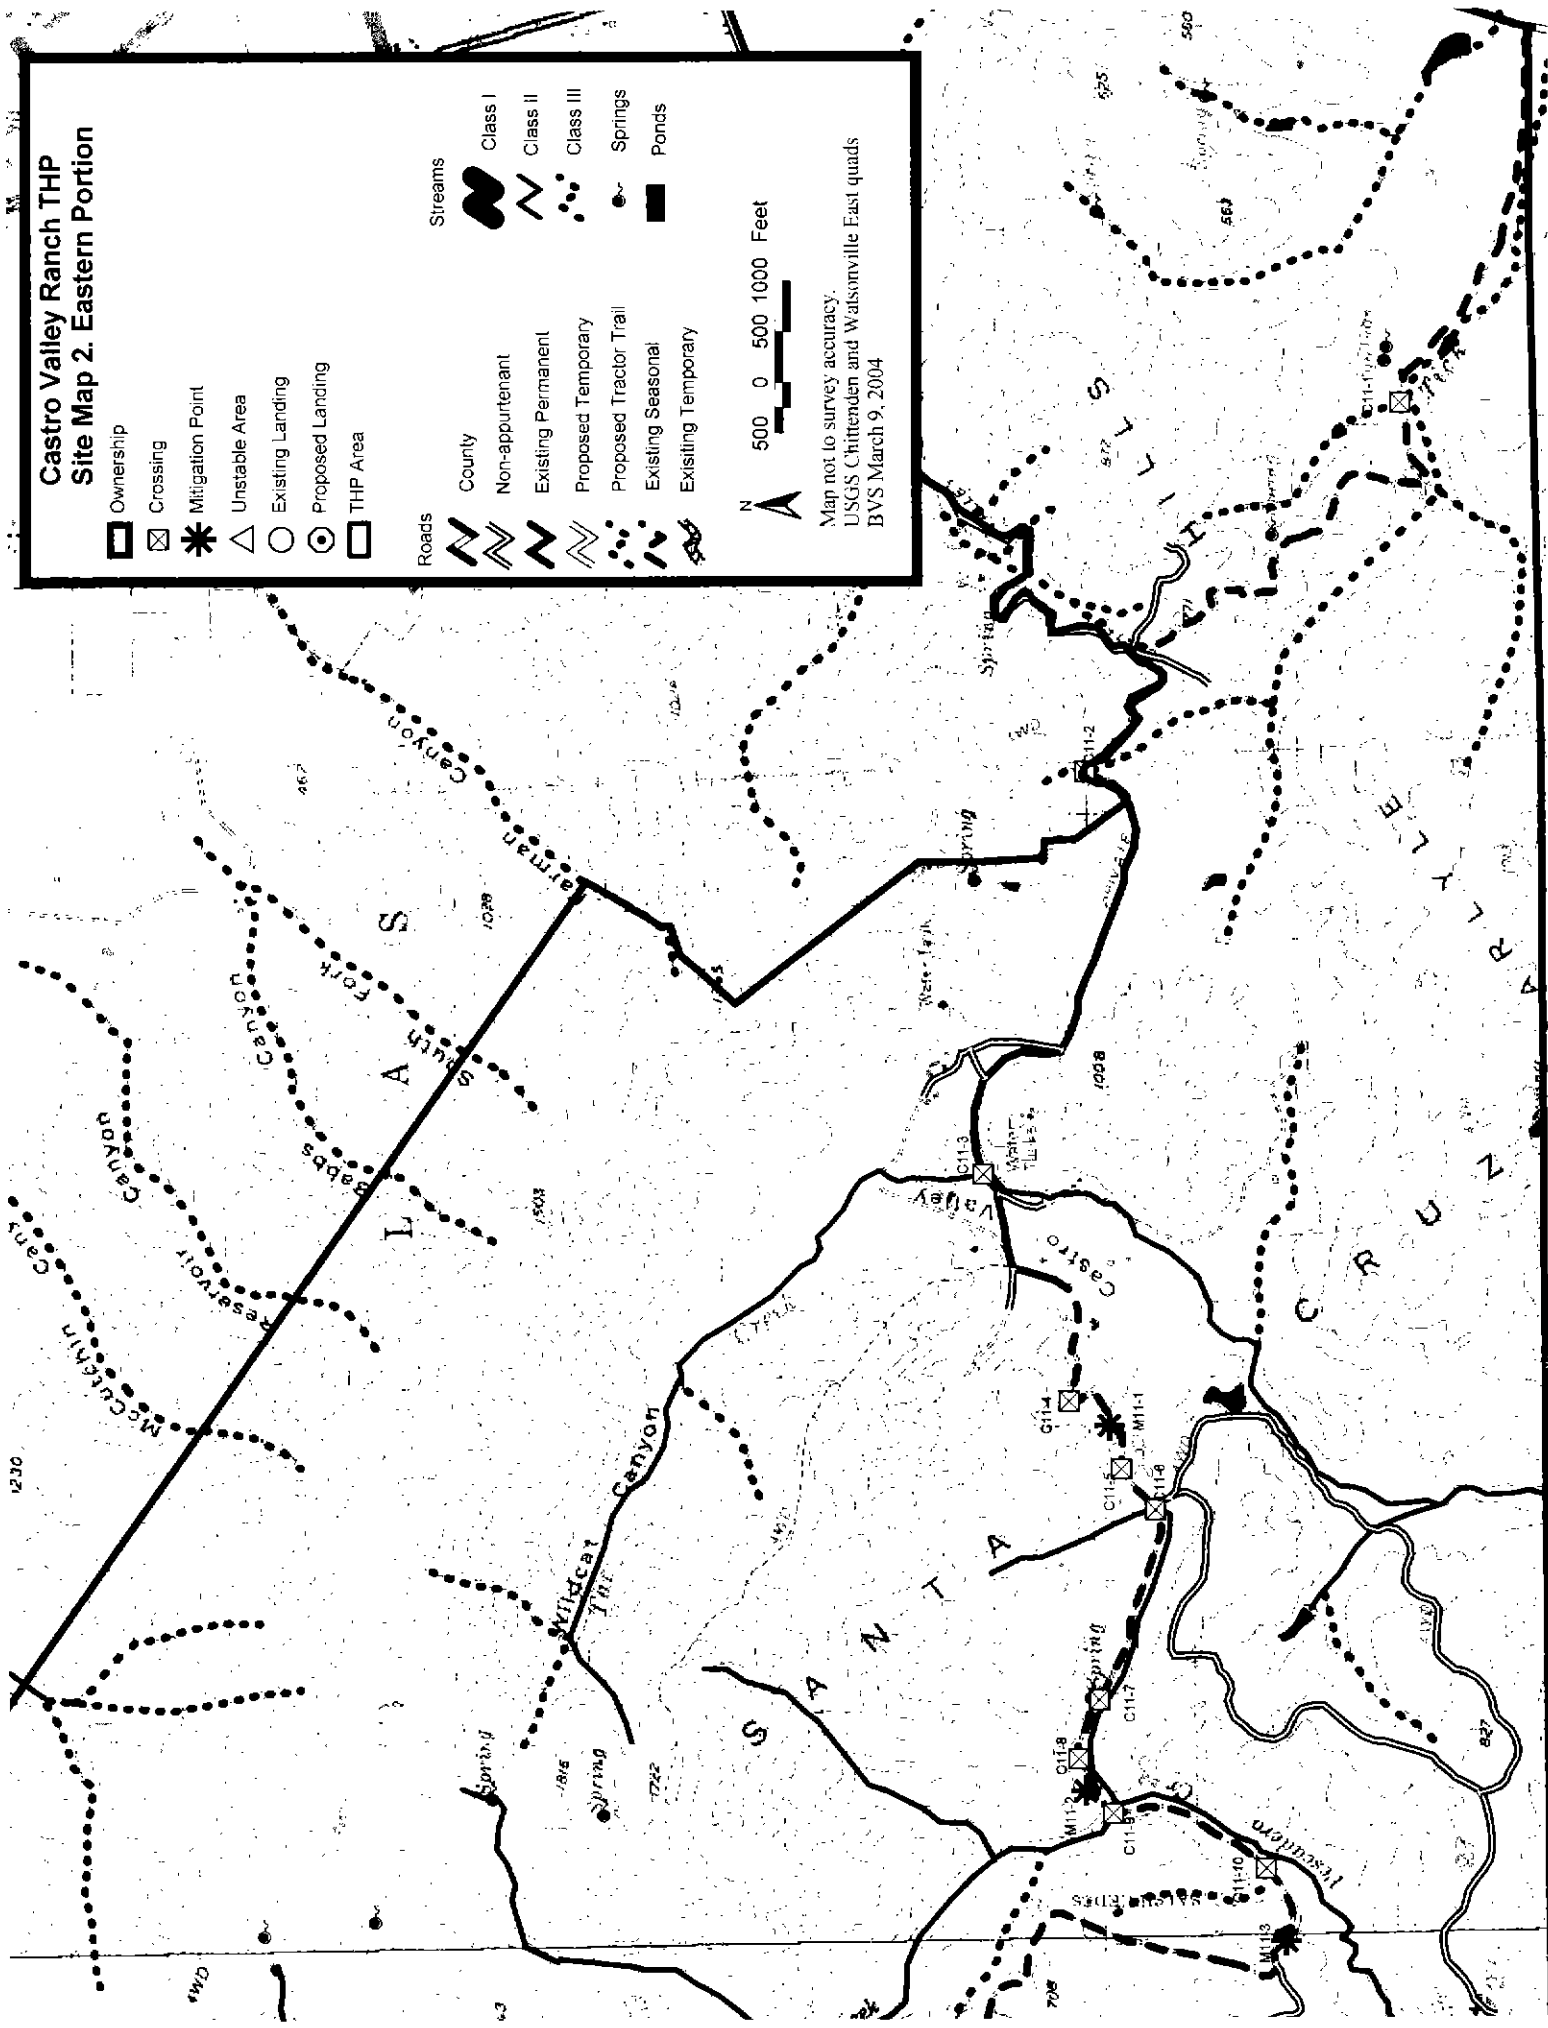
Castro Valley Ranch THP Site Map 2. Eastern Portion

Map not to survey accuracy.
USGS Chittenden and Watsonville East quads
BVS March 9, 2004
