Lahontan Regional Water Quality Control Board

**ADOPTION OF SETTLEMENT AGREEMENT AND STIPULATION FOR ENTRY OF
ADMINISTRATIVE CIVIL LIABILITY ORDER NO. R6T-2016-0063, ACTION
MOTORSPORTS OF TAHOE, INC., MEEKS BAY MARINA, EL DORADO COUNTY**

Figure 1. Site Map, From Page 18 of Meeks Bay Marina June 3, 2015 SWPPP

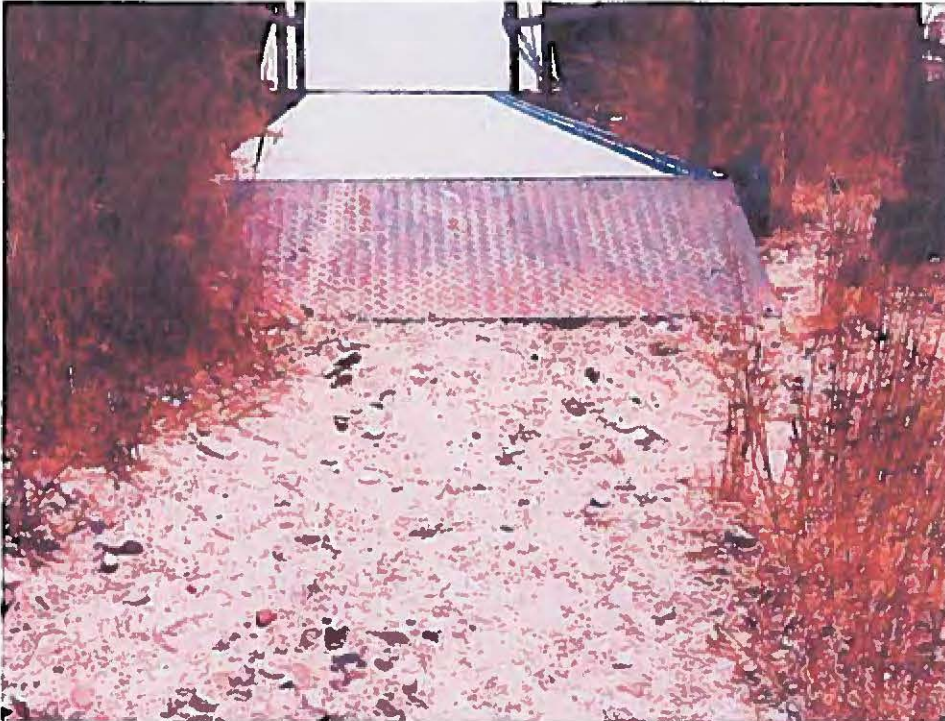
Picture 2: The walkway is downward sloping from the parking lot to the gangways. Potential for rill or gully erosion into the marina surface waters is possible.

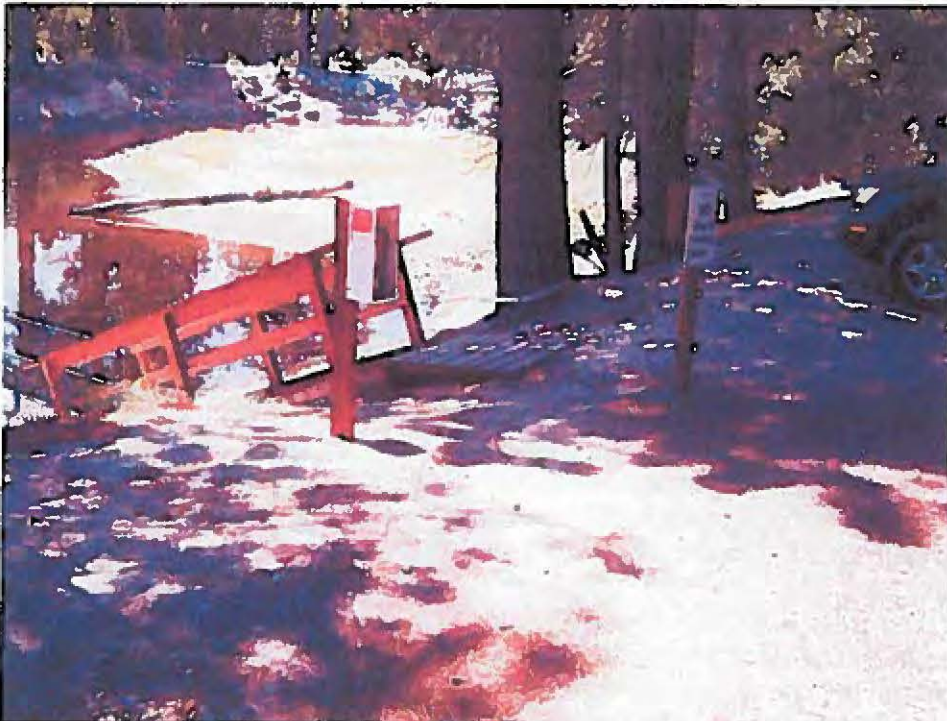
Picture 3: Gangway number three is also in a low depression of the hillside. These are potential sediment sources as there are no BMPs installed.

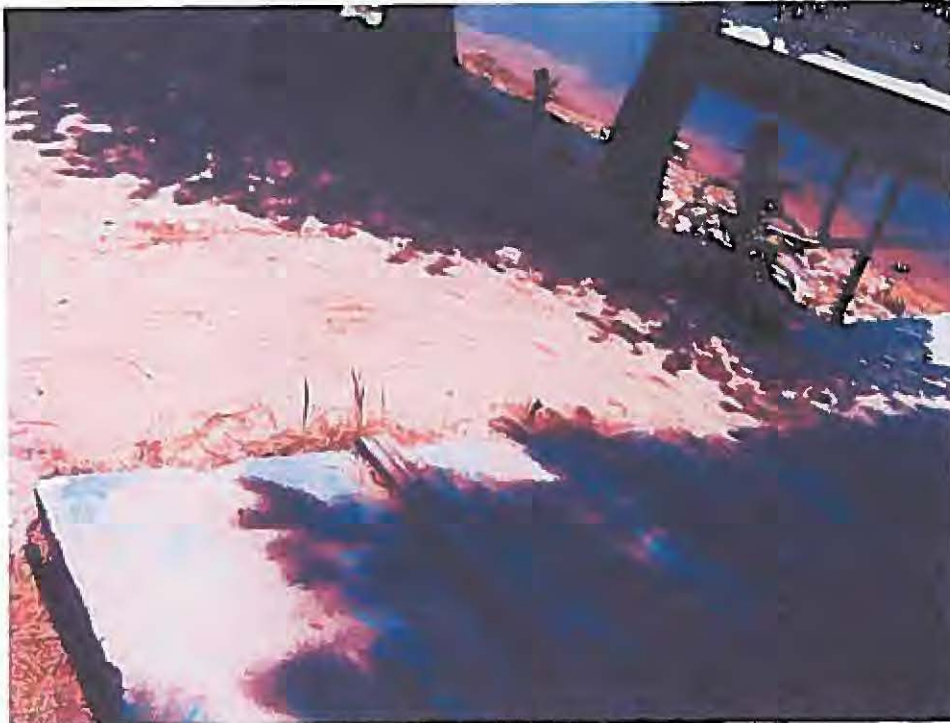
Picture 4: This is gangway number 1, closest to the lake. Due to the topography of the parking lot, a low spot forms at the top and runs down during significant rain events.

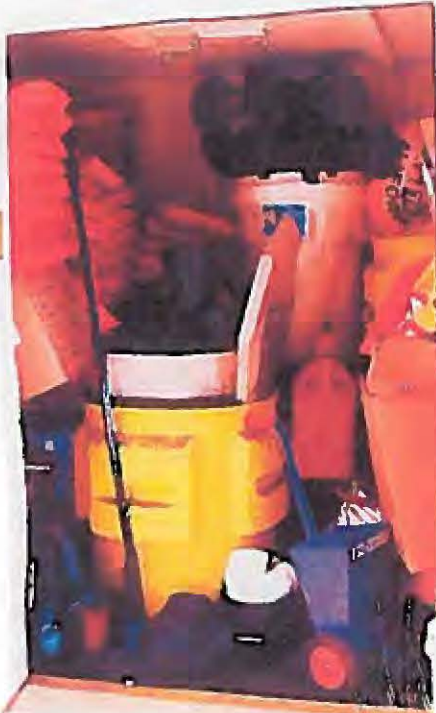
Picture 5: The waste oil is contained in a second container. Oil rags are also double contained up in the right hand corner. The rest of the items are stored floatation devices, etc.

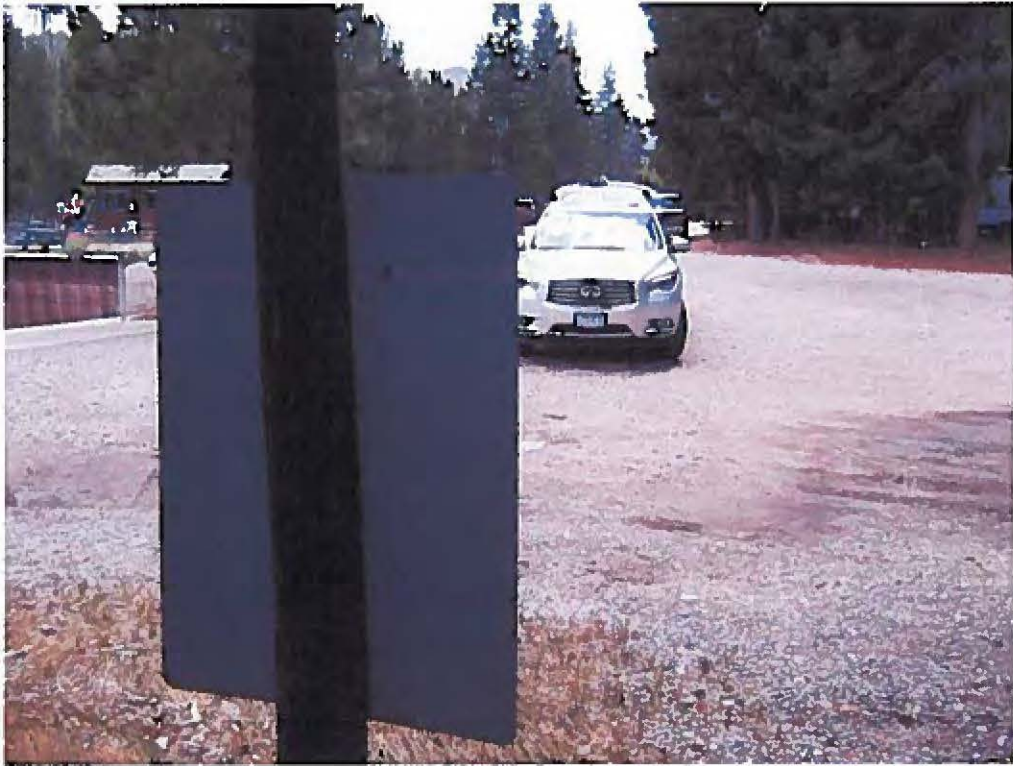
Photograph 01 - Facing West Toward Parking Area, Boat ramp on far left

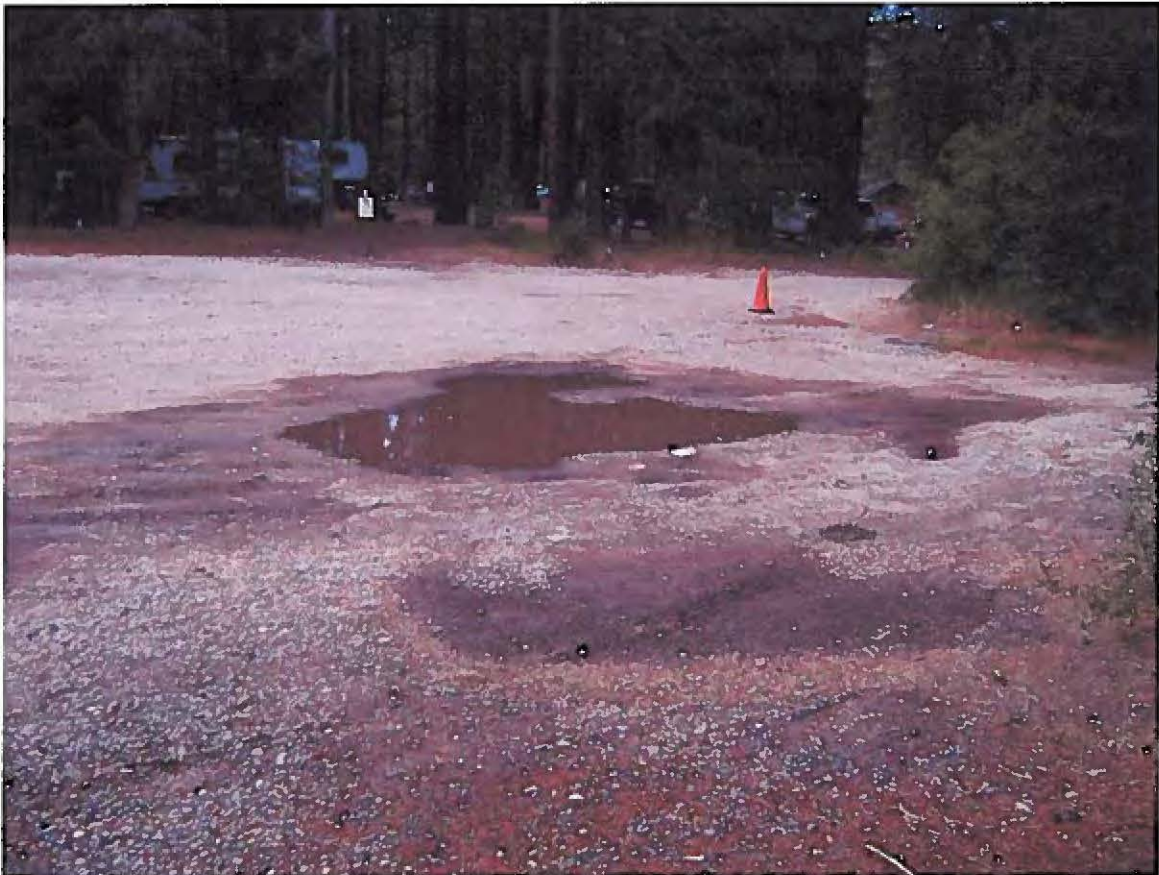
Photograph 02 - Facing West Toward Parking Area, Panning right of Photo 1, Standing Pooled Water in Lot From Recent Rains

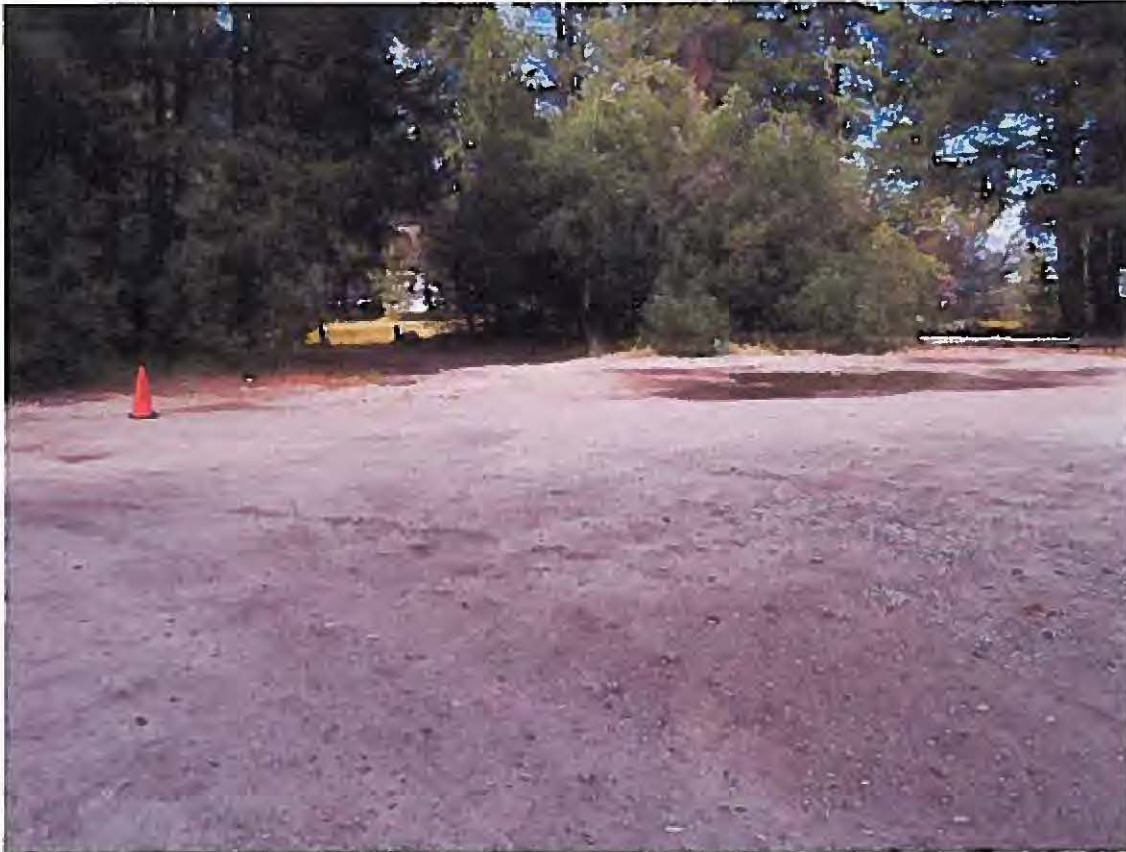
Photograph 03 - At Northeast area, Looking Northeast at Ponded Water In Parking Area. Per the SWPPP, the infiltration area should be located roughly where the willow stand in the center of the photograph is located. This Photograph was taken at the conclusion of the inspection at approximately 3:10 p.m.

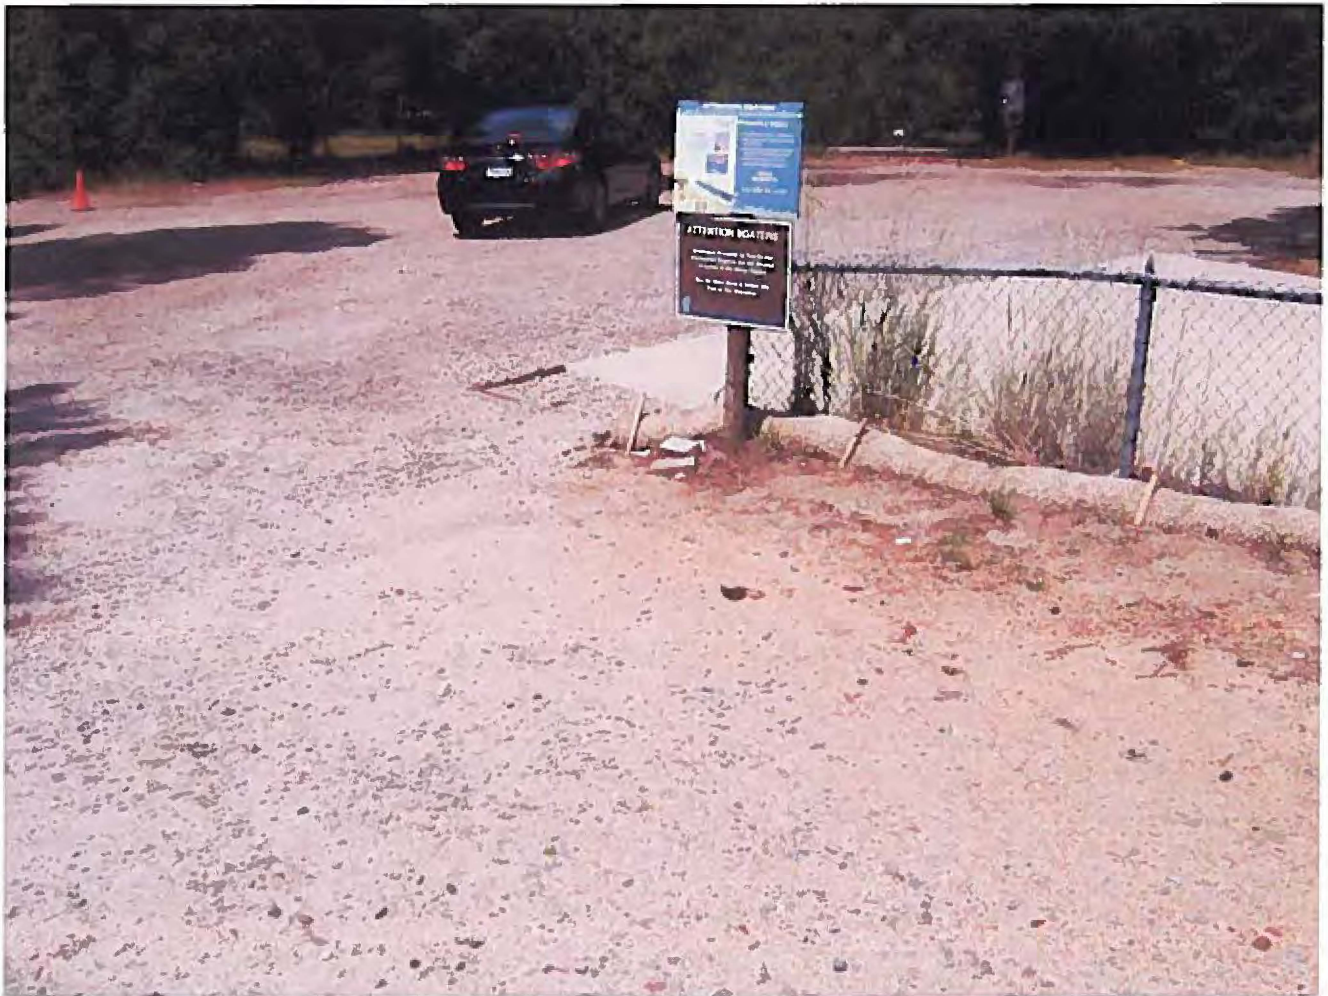
Photograph 04 - Looking East, Northeast at fiber roll. The fiber roll is not J-Hooked at its end which is also installed perpendicular to the grade lower than the rest of the fiber roll, and not parallel to the grade. Any runoff that flows toward the fiber will flow along it toward the downgradient end and, eventually, down the boat ramp and into the marina.

- Install and maintain fiber rolls to maintain a minimum height of four inches of fiber roll above grade (see entrenchment detail).
- Remove accumulated sediment behind the fiber roll when sediment accumulation reaches one-half the designated sediment storage depth, usually one half the distance between the top of the fiber roll and the adjacent ground surface.

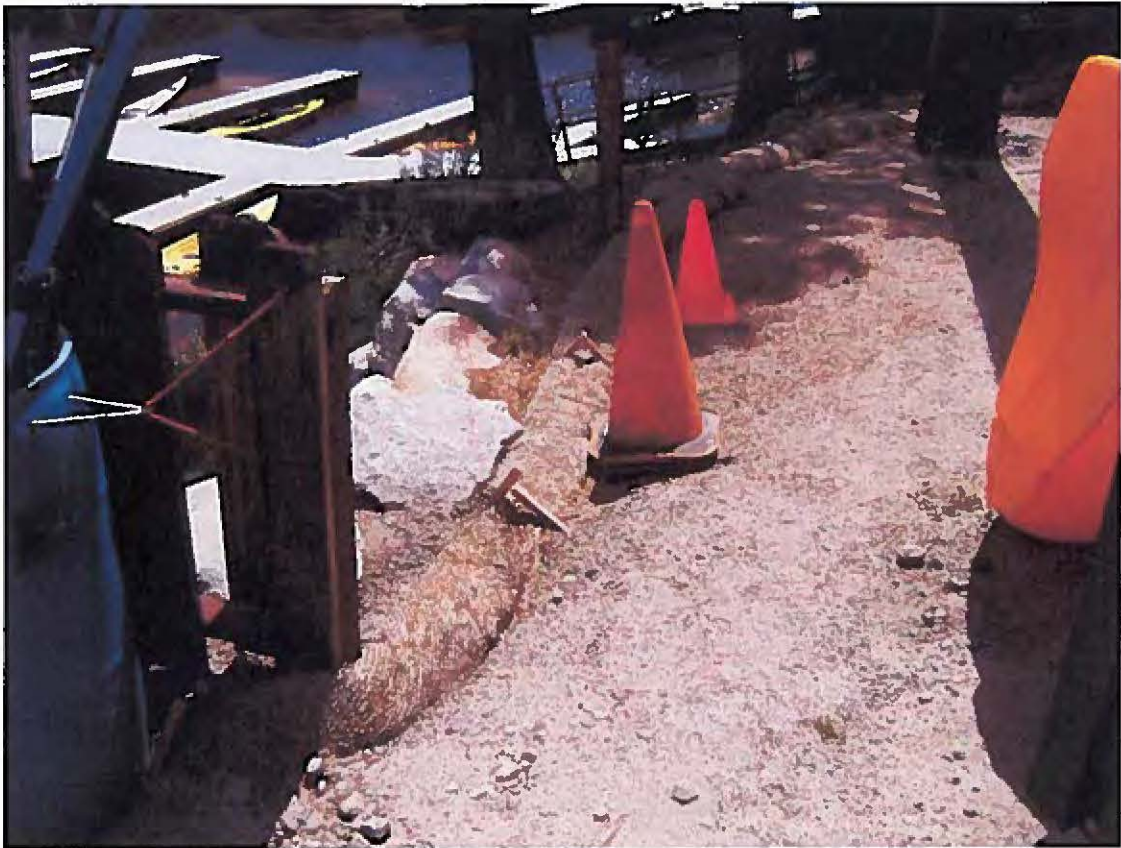
Photograph 05 - Flattened fiber roll adjacent to marina office, facing southwest. Also, the end of the fiber roll is installed perpendicular to the gradient, which will channelize storm water runoff.

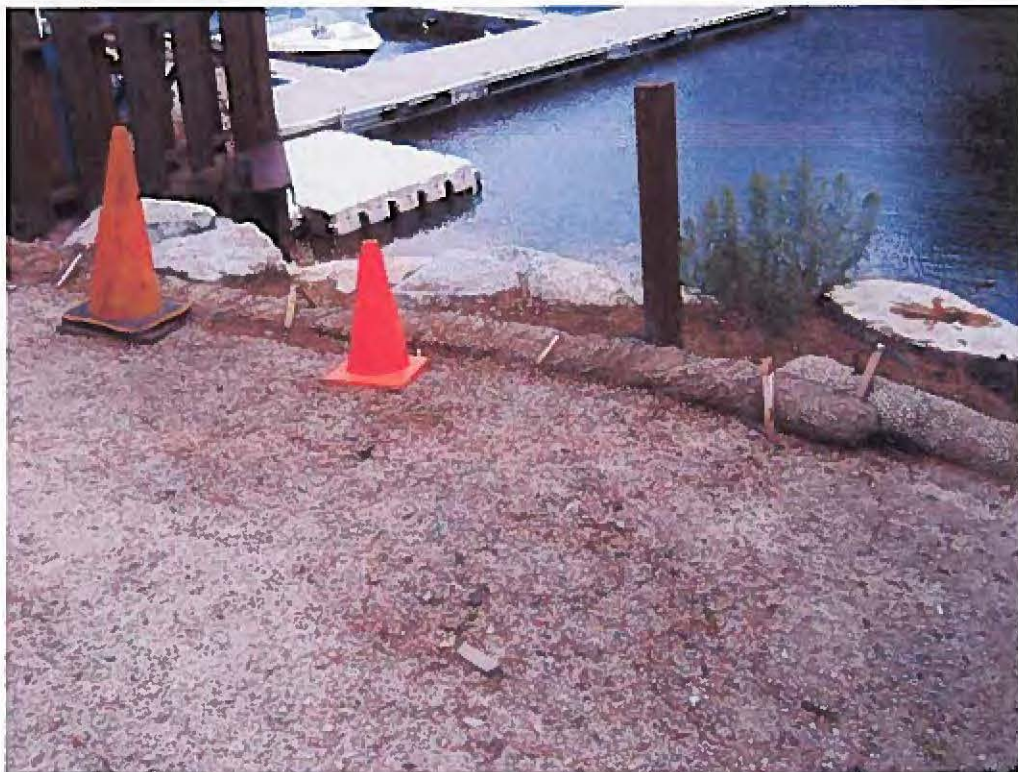
Photograph 06 - BMP joint is not J-hooked, and the fiber roll section by the pylons has been flattened. This area is by marina office, facing southeast

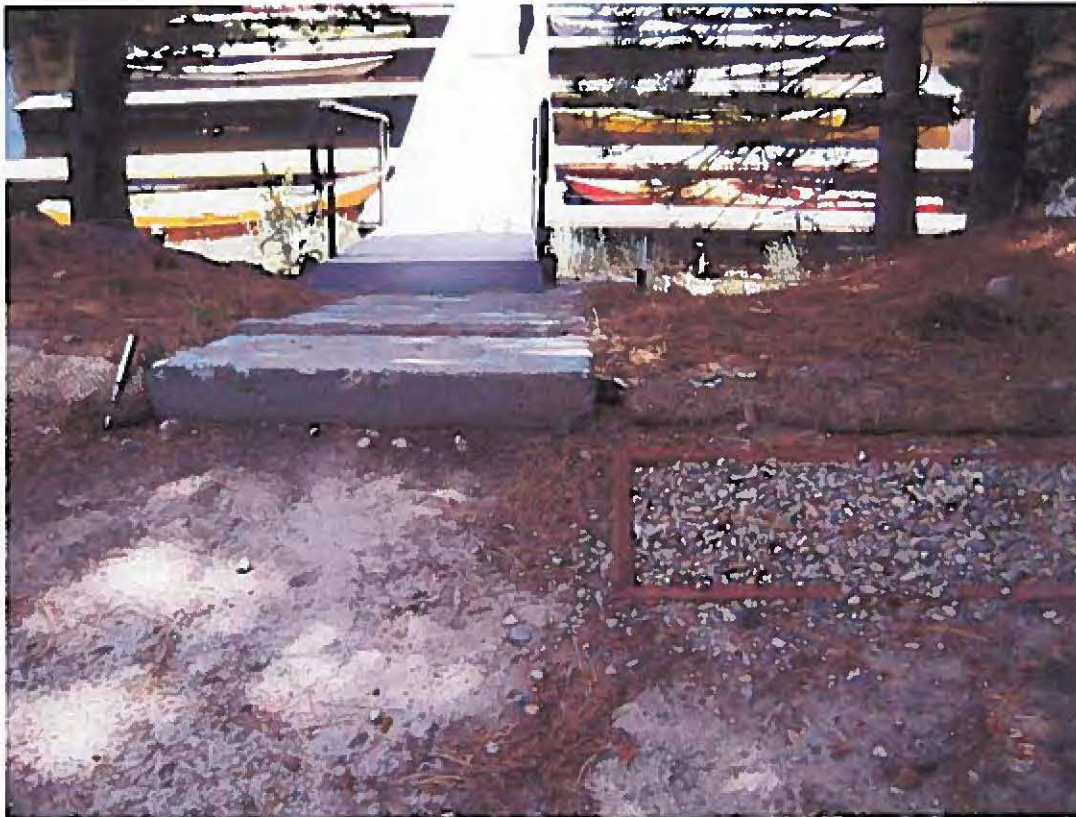
Photograph 07 - First ramp west of office, facing south. A gap exists between the concrete section of the ramp walkway and the fiber roll to the right (west) of the ramp. Runoff that bypasses the drainage ditch will flow through this area and into the marina.

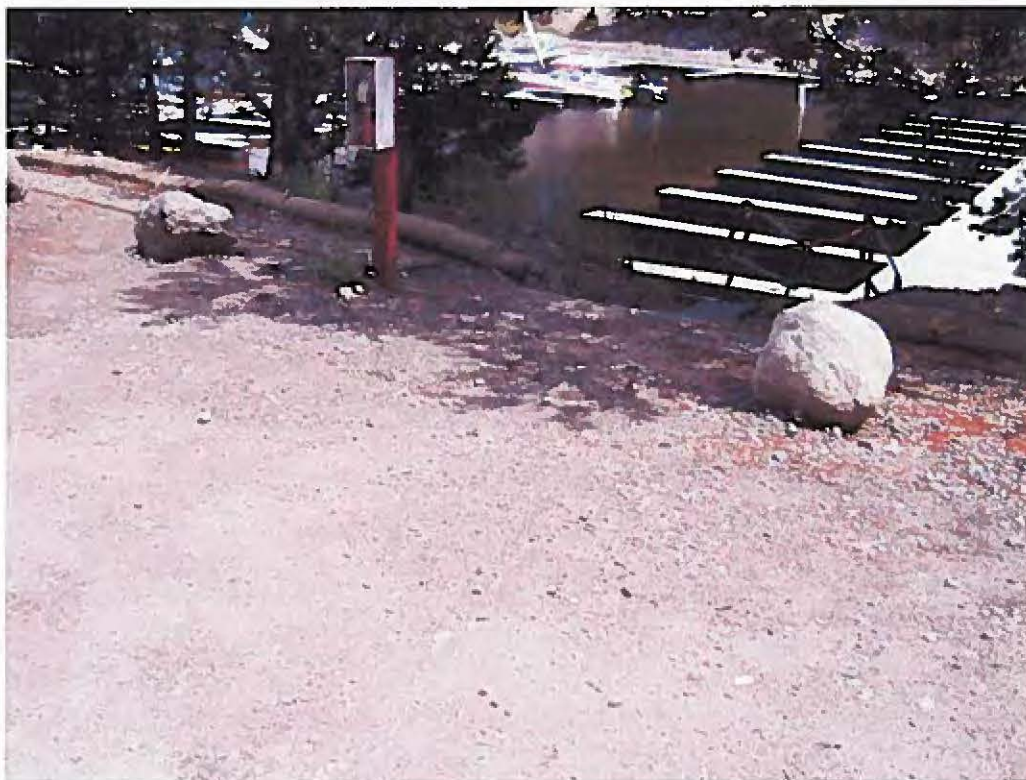
Photograph 08 - Second ramp west of office, facing southeast. Fiber rolls do not prevent runoff from going down ramp and into marina.

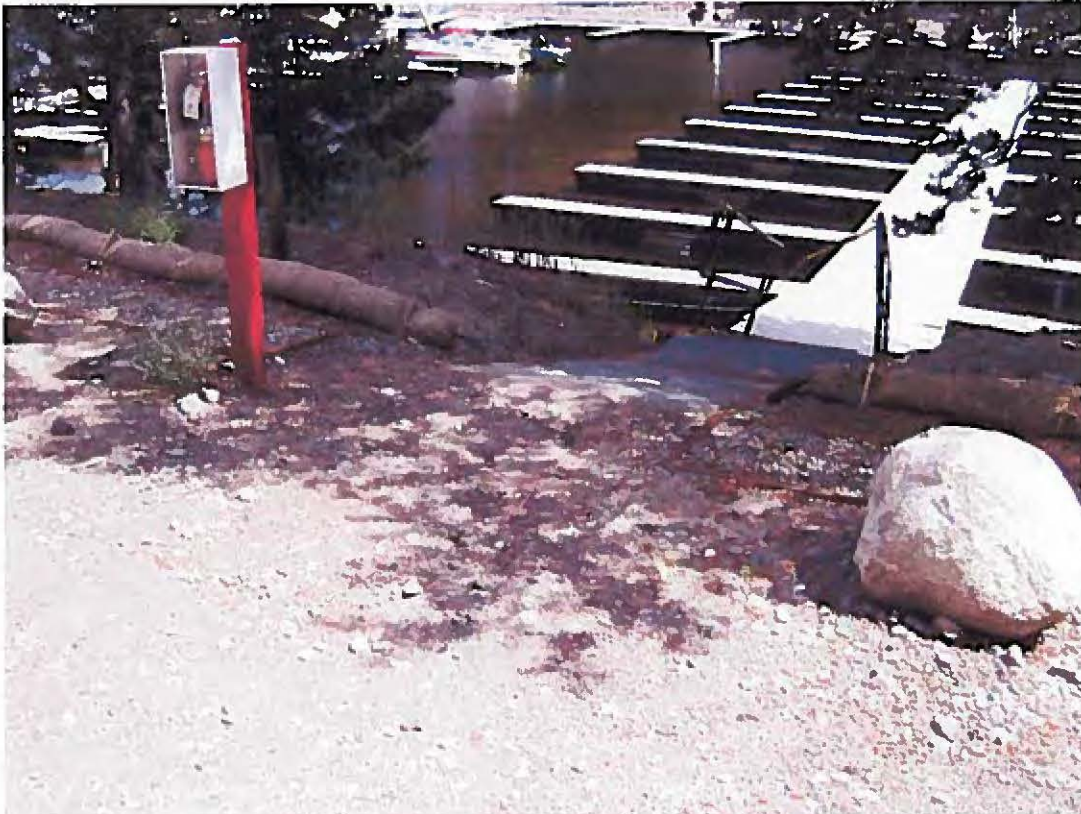
Photograph 09 – Close up of Photograph No. 08. Note that ends of fiber rolls are not J-Hooked.

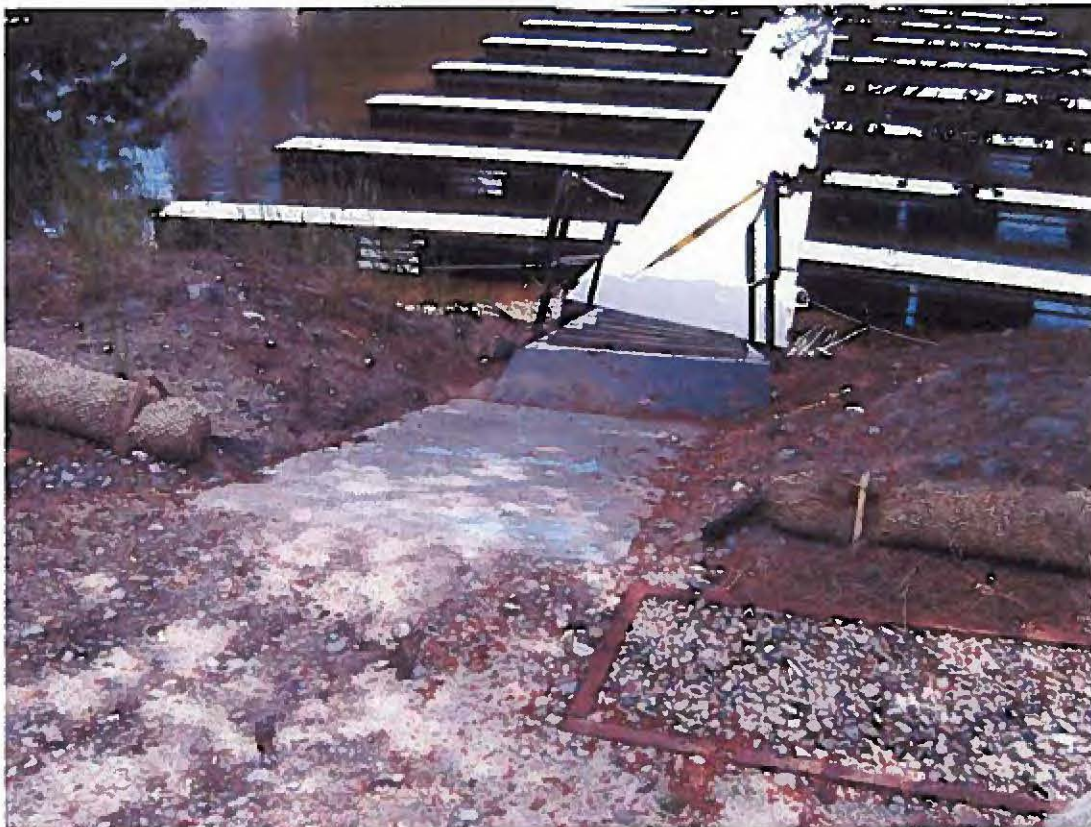
Photograph 10 – Moving closer to the ramp to get a further close-up of Photograph No. 08. Note that the fiber rolls do not prevent runoff from going down ramp and into marina

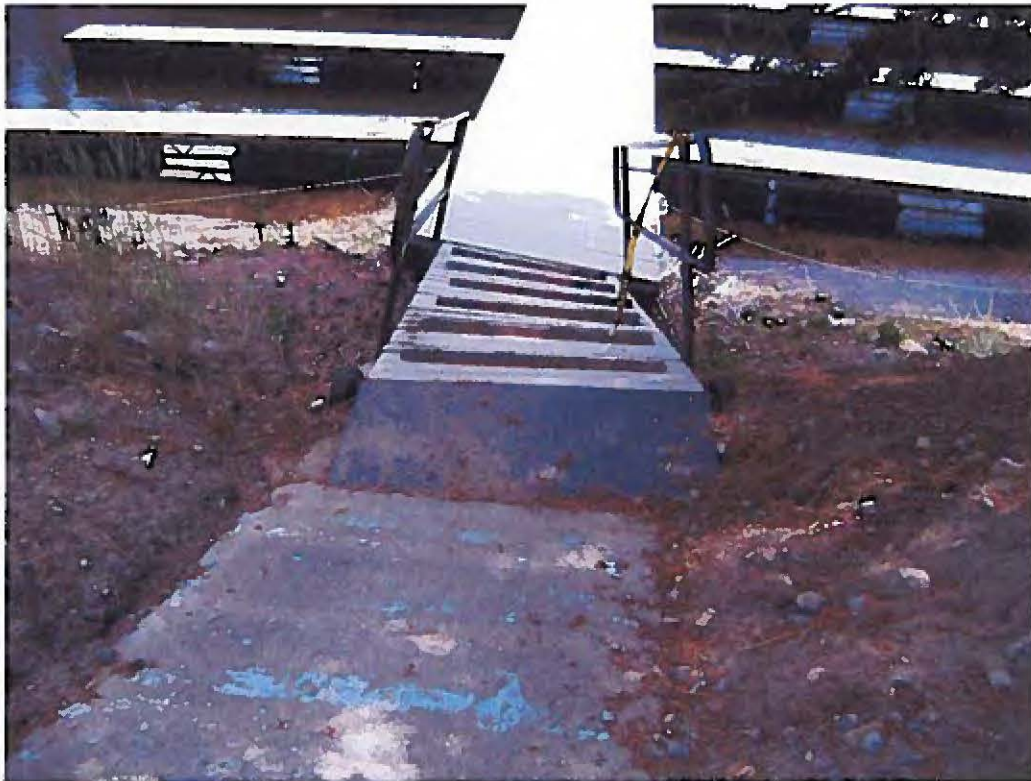
Photograph 11 – Moving closer to the second ramp west of office to get a further close up.

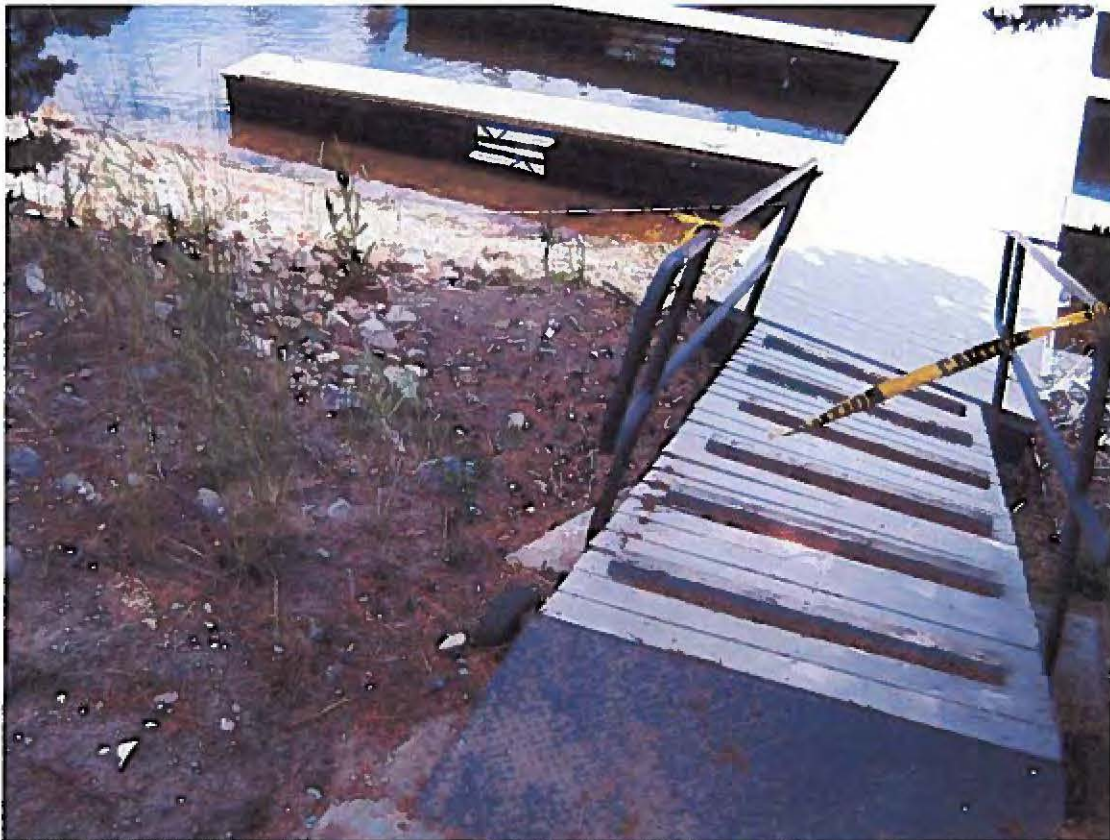
Photo 12 - Moving closer to the second ramp west of office to get a further close up within the marina area. Note that the fiber rolls were unable to prevent runoff from going down ramp and into marina, as evidenced by a sediment deposit in marina located on left (east) side of ramp.

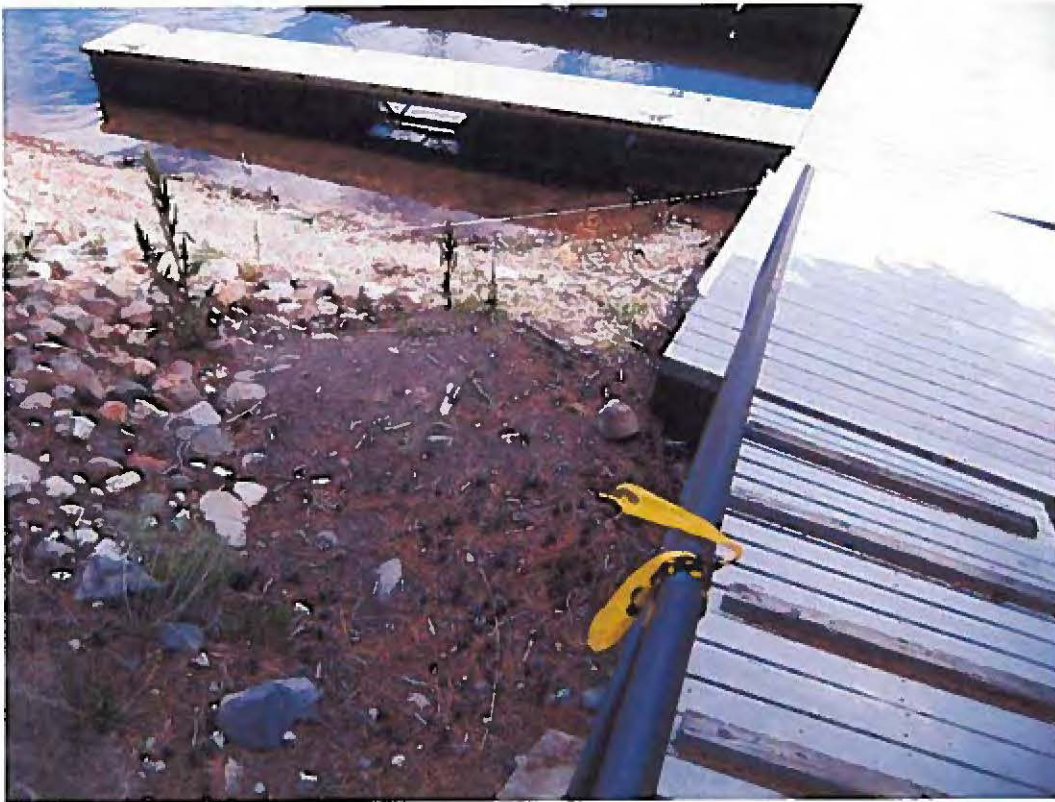
Photograph 13 – Close up of sediment deposit noted in Photograph No. 12.

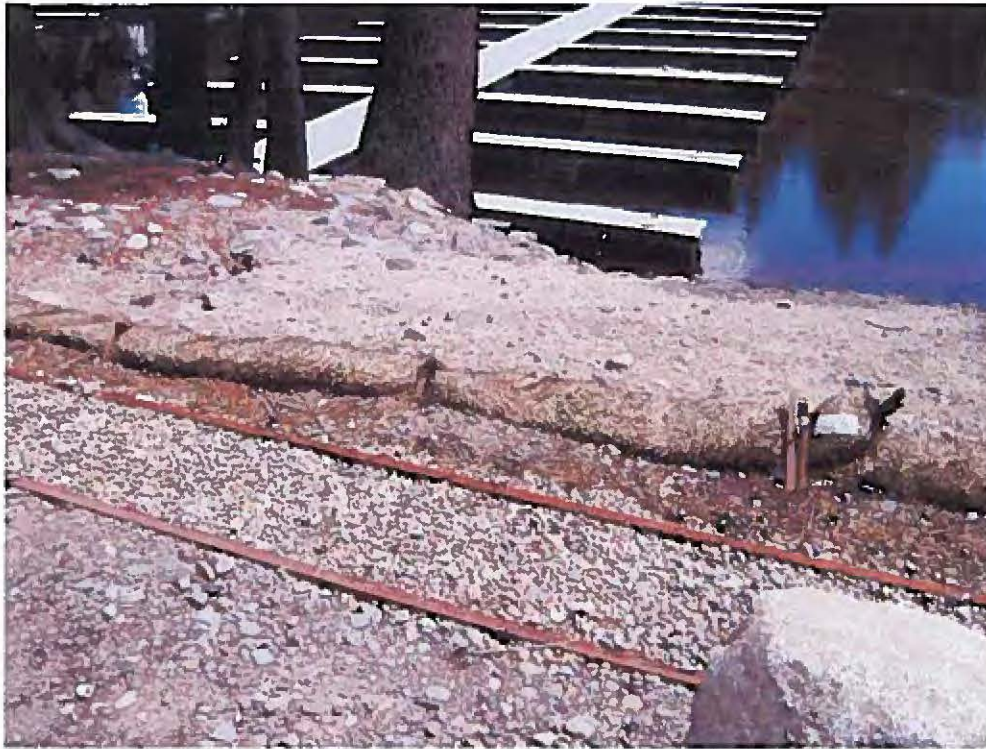
Photograph 15 - About 20 feet west of 2nd ramp west from office, looking south-southeast. The fiber roll has been degraded degraded and flattened.

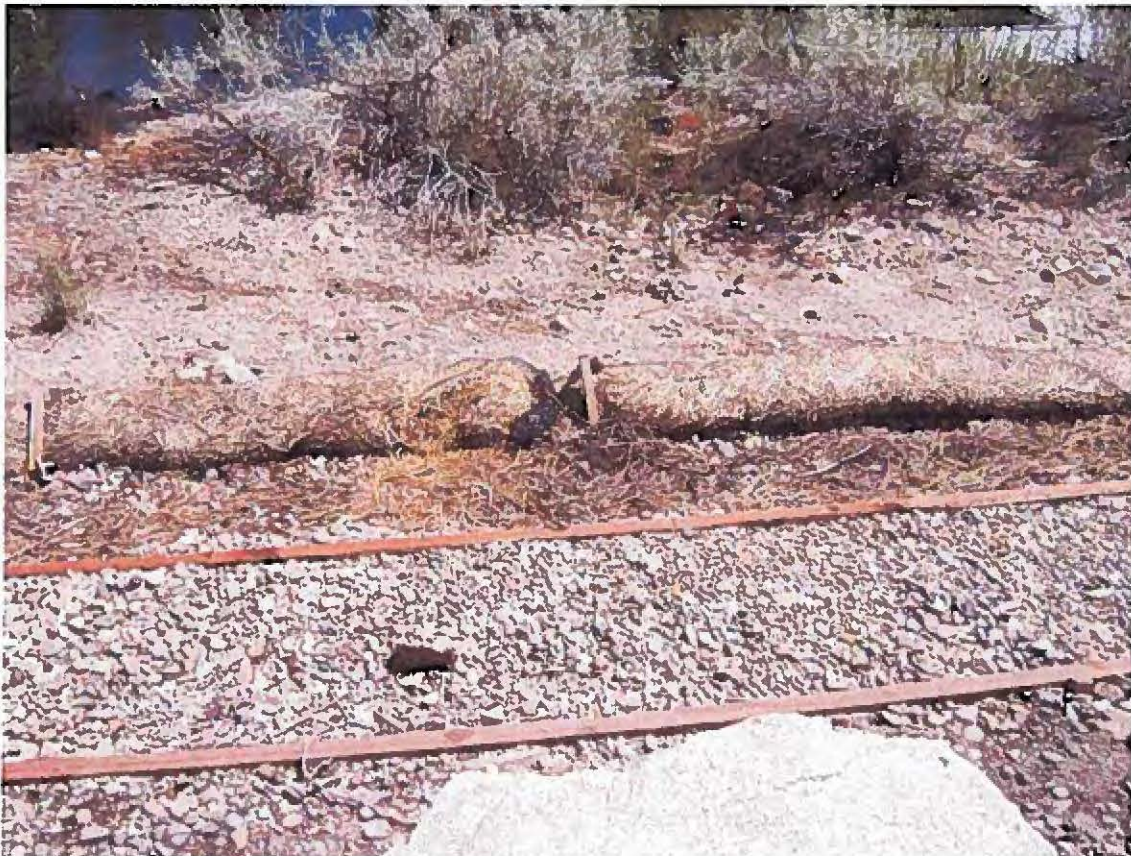
Photograph 16 - Mid-way between 2nd and 3rd ramps west from the office. The fiber rolls have been slightly flattened, and the ends have not been overlapped leaving a gap between the rolls where stormwater runoff can become concentrated.

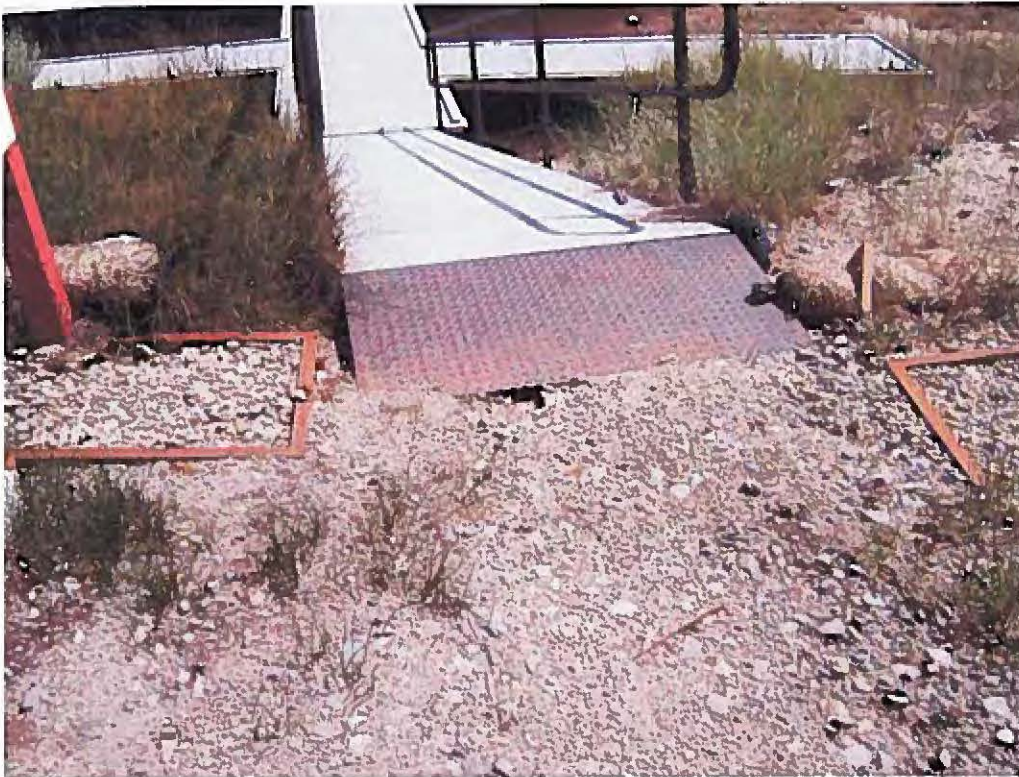
Photograph 17 - 3rd ramp west from office, facing south. A rill has formed beneath the metal plate, creating a threatened discharge of sediments into the marina. No fiber rolls or other BMP exists to prevent runoff from flowing down this area and causing bank erosion.

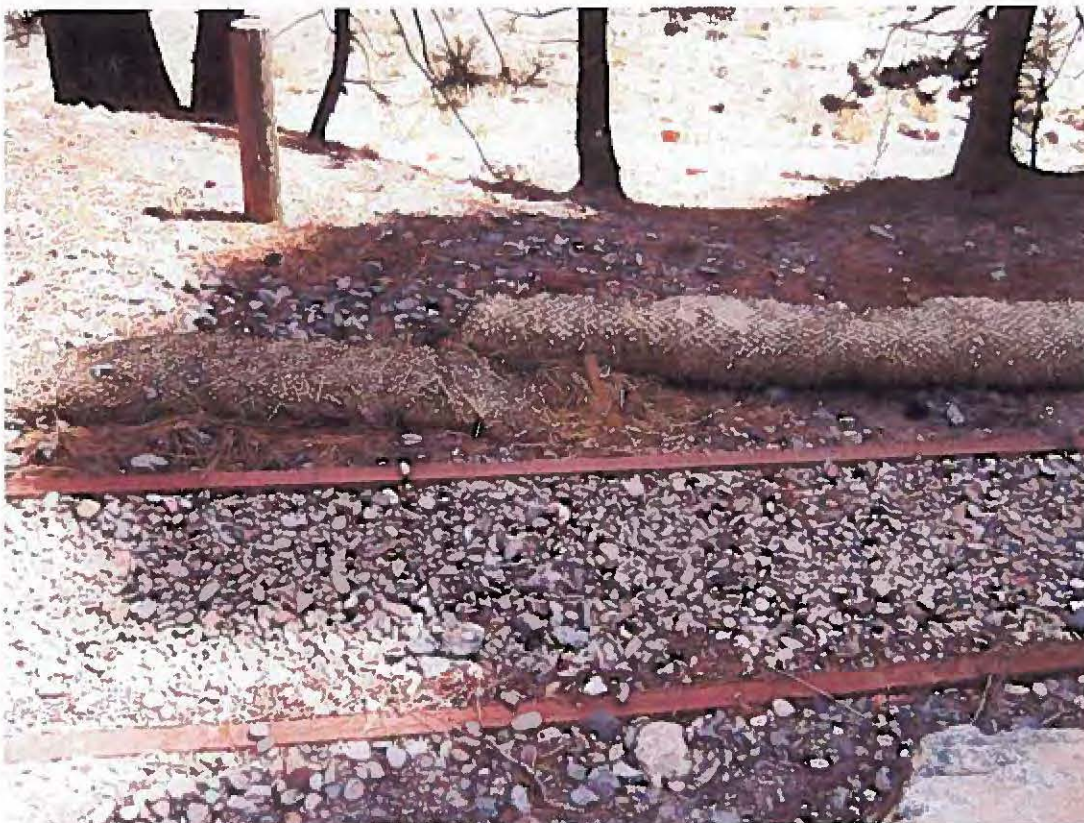
Photograph 18 - Midway between 3rd and 4th ramps west of office. The ends of the fiber rolls are degrading, and they are barely overlapped.

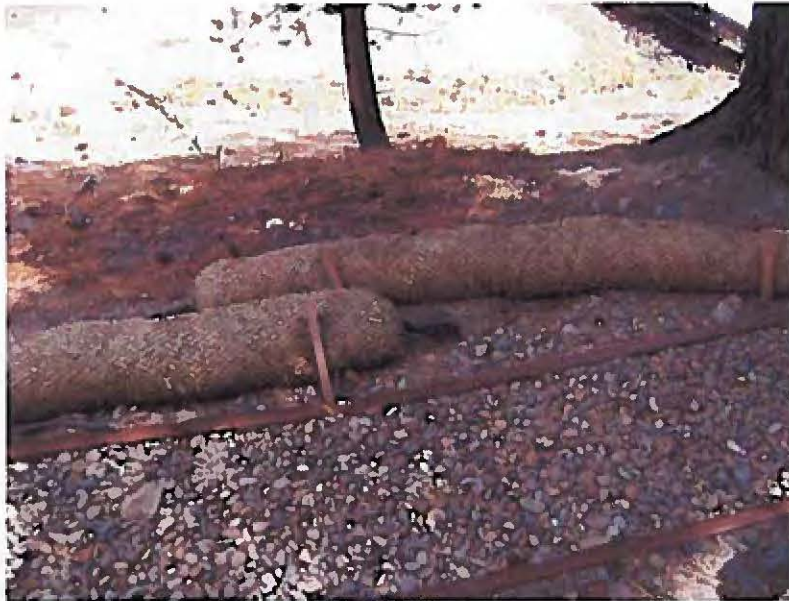
Photograph 19 - West of photo 18, between 3rd and 4th ramps west of office. In this area, the fiber rolls are adequately overlapped.

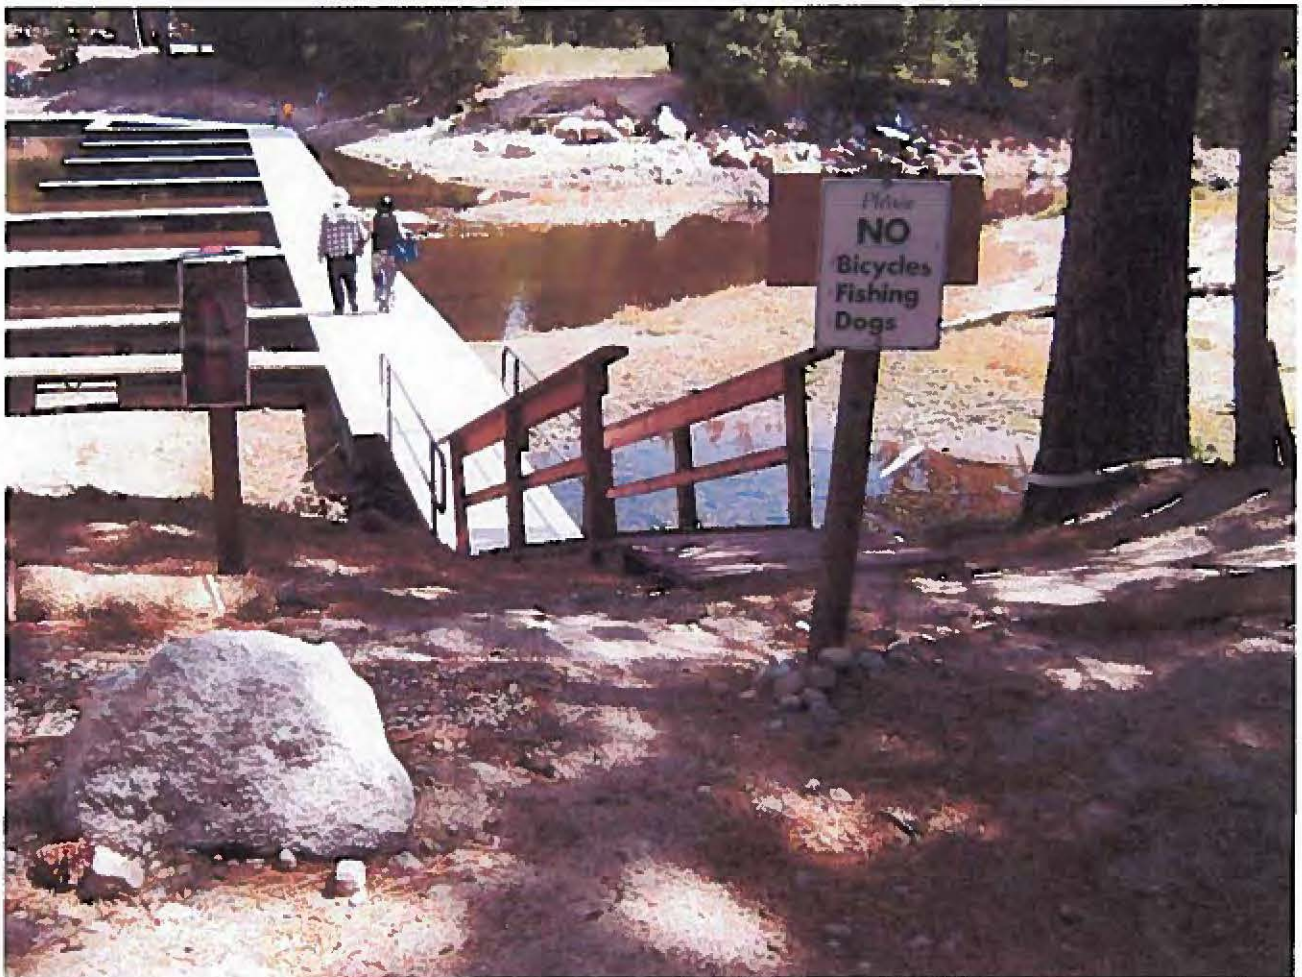
Photograph 20 - At 4th walkway ramp west of office. Fiber rolls to left of walkway and above walkway are not J-hooked at their ends. Fiber roll on right and above walkway is inundated with sediment, and evidence of sediment discharge into the marina is apparent.

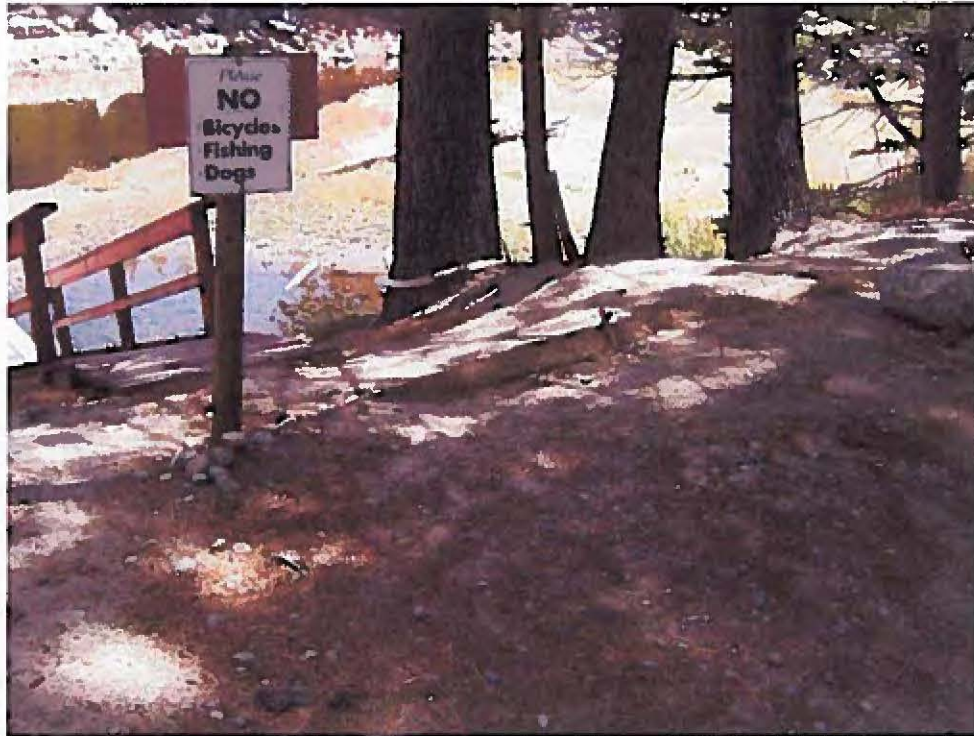
Photograph 21 – Close up of the sediment-inundated fiber roll shown in Photograph No. 20.

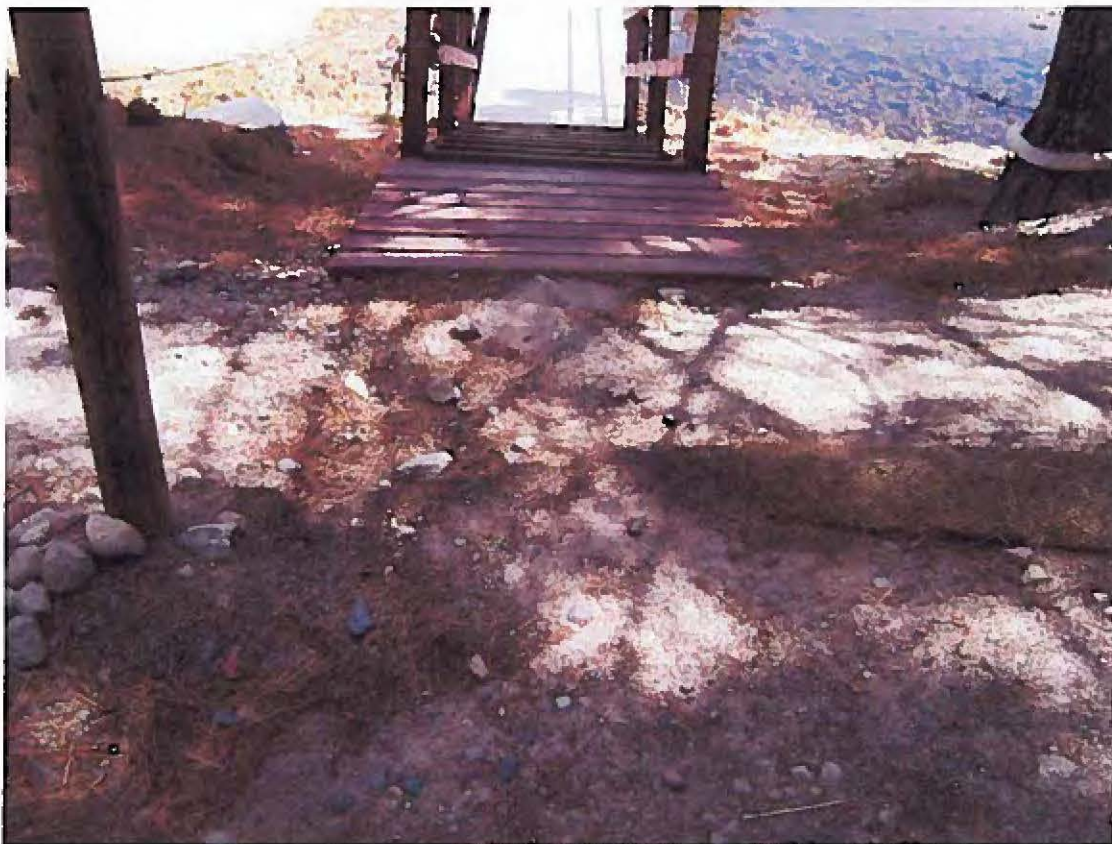
Photograph 22 - Close up of the sediment-inundated fiber roll shown in Photograph No. 20, also showing sediment deposits down along the embankment and into Lake Tahoe.

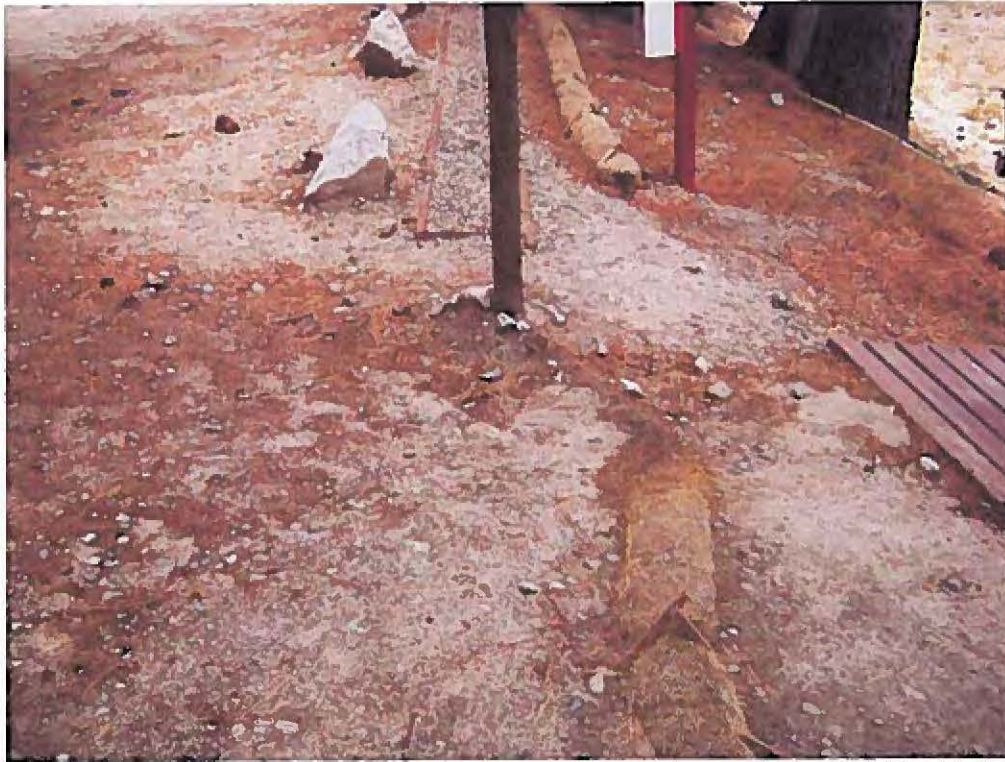
Photograph 23 - Close up of the sediment-inundated fiber roll shown in Photograph No. 20, facing east. The fiber roll end in the foreground was slightly J-Hooked to capture runoff and sediment, while the end of the fiber roll at the top of the photograph is not J-Hooked and allows runoff to flow down the embankment. Photograph taken by Will Chen.
